SAIPAN SHORELINE ACCESS AND SHORELINE ENHANCEMENT ASSESSMENT (SASEA)

Island of Saipan, Commonwealth of the Northern Mariana Islands

March 2018

Sea Engineering, Inc.
Makai Research Pier
41-305 Kalanianaʻole Hwy
Waimanalo, HI 96795

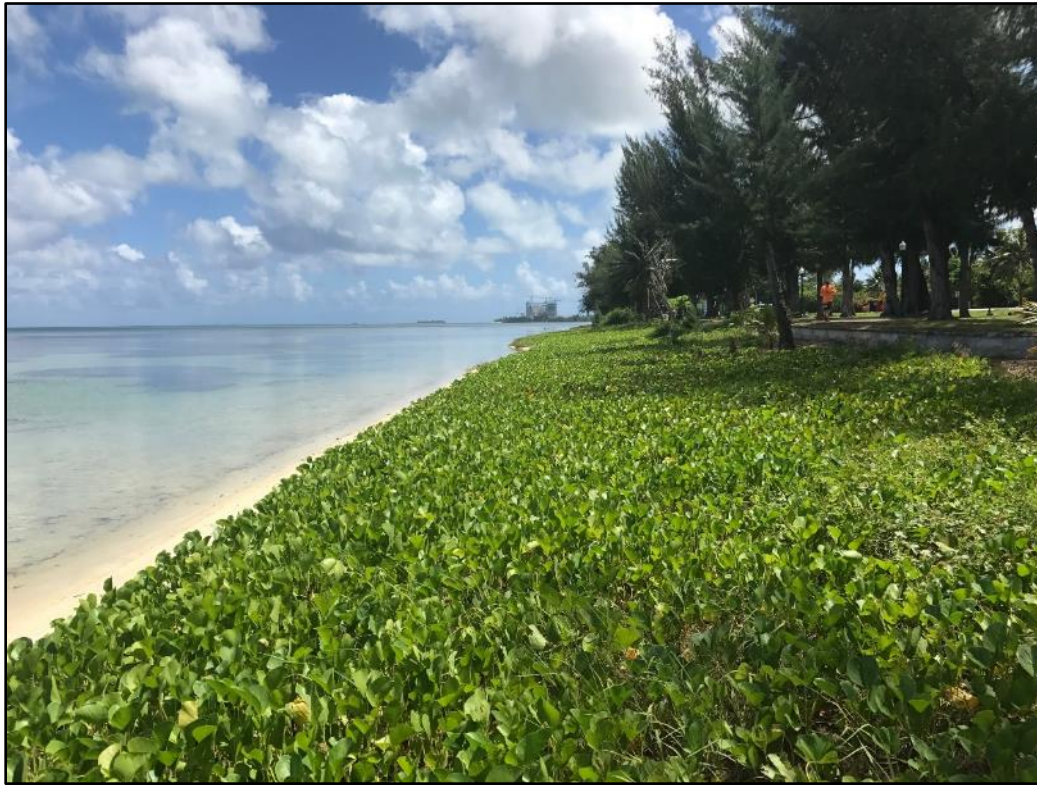
In some cases, prolific vegetation growth can negatively impact the scenic and recreational value of a beach. This was particularly evident at Laly 4 (San Isidro Beach Park), Beach Road Pathway, and Quartermaster Area (Red Beach) (Figure 2). In some areas, the entire beach was covered by encroaching vegetation and beach users were forced to wade through the water to move laterally along the shoreline.

Figure 2 Encroaching shoreline vegetation at Quartermaster Area (Red Beach)

The benefits of maintaining healthy vegetation along the shoreline should be balanced with the need to maintain high-quality beaches and safe lateral access along the shoreline. Removal of vegetation should not be permitted in areas where the removal would negatively impact the beach or expose the backshore area to inundation or erosion; however, a reasonable amount of vegetation removal and/or maintenance should be permitted in order to maintain recreational beach areas and maintain or enhance lateral shoreline public access.

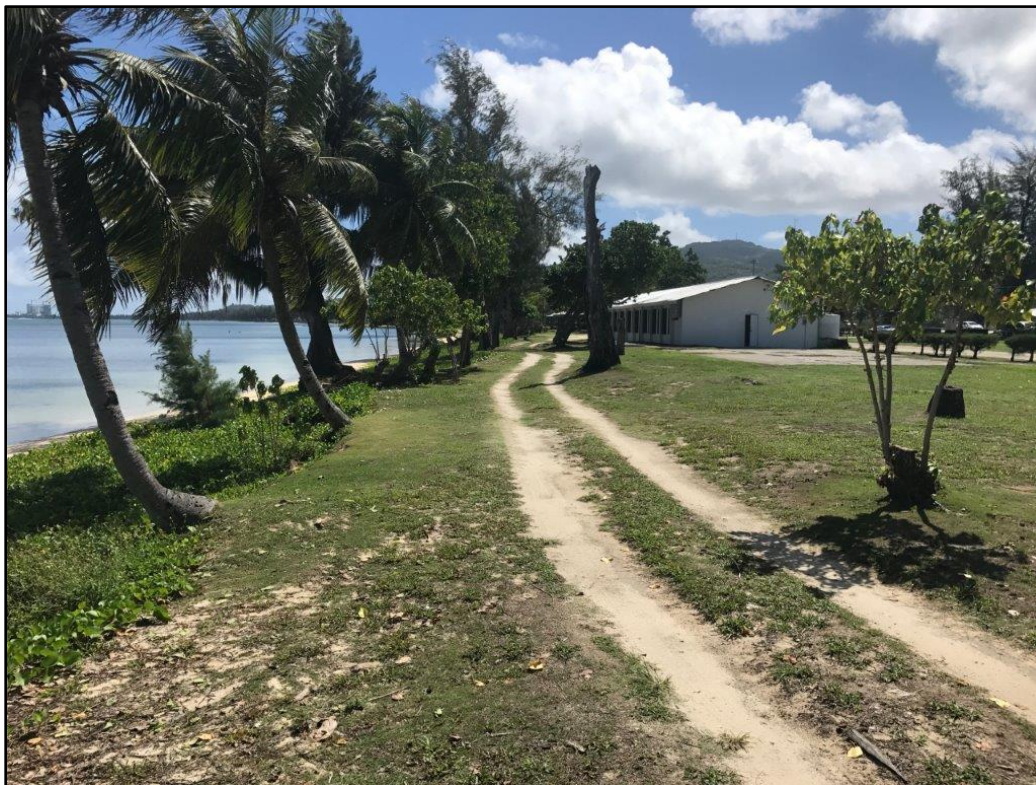
SEI observed off-road driving and parking along berms at Sugar Dock Beach, Susupe Beach Park, Kilili Beach (Civic Center), Oleai Beach, Quartermaster Area (Red Beach), and Beach Road Pathway (Figure 3). These areas were found to have less-stable vegetation and highly-compacted soils along the berm crest. In some areas, off-road driving and parking may also damage nesting sites for threatened green sea turtles. Funding should be allocated to continue and expand the “Walk it, Don’t Drive it” program to improve awareness and enforcement. Bollards, berms, or access gates should be installed at high-use beaches or beaches where vehicle strandings are frequent. Improved parking may help to reduce these impacts at high-use beaches.

Figure 3 Evidence of vehicle traffic on beach berm at Kilili Beach (Civic Center)

Recommendations

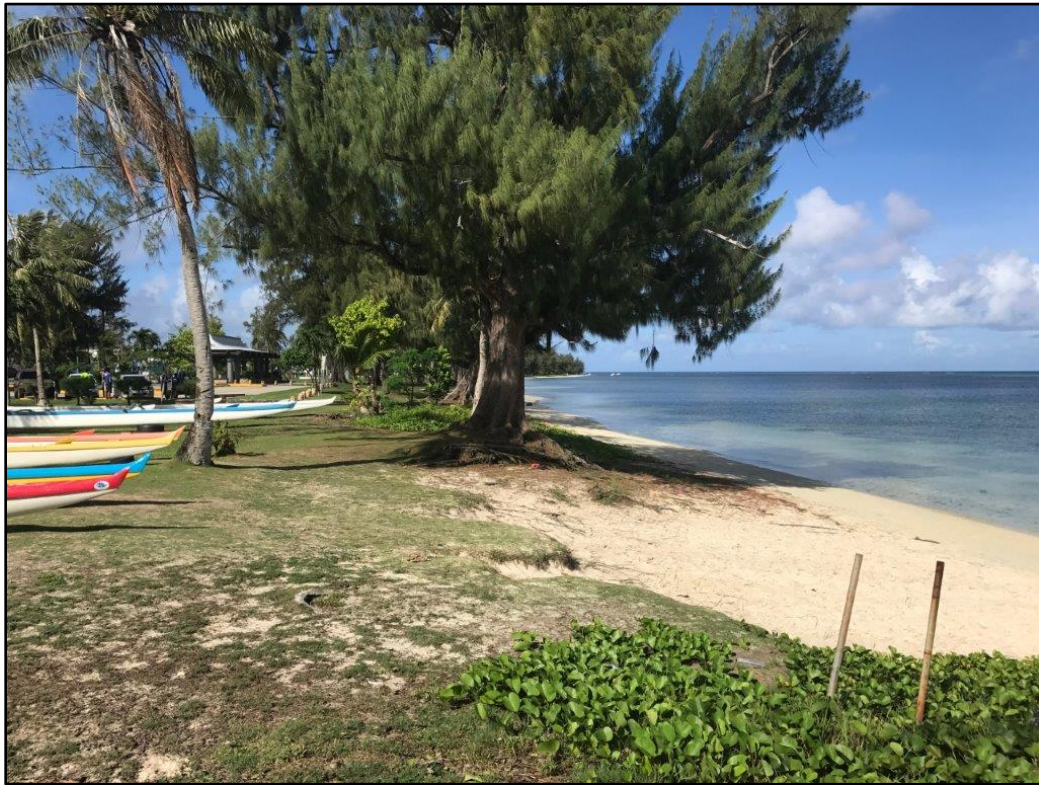
Figure 16 Erosion due to foot traffic at Kili Beach (Civic Center)

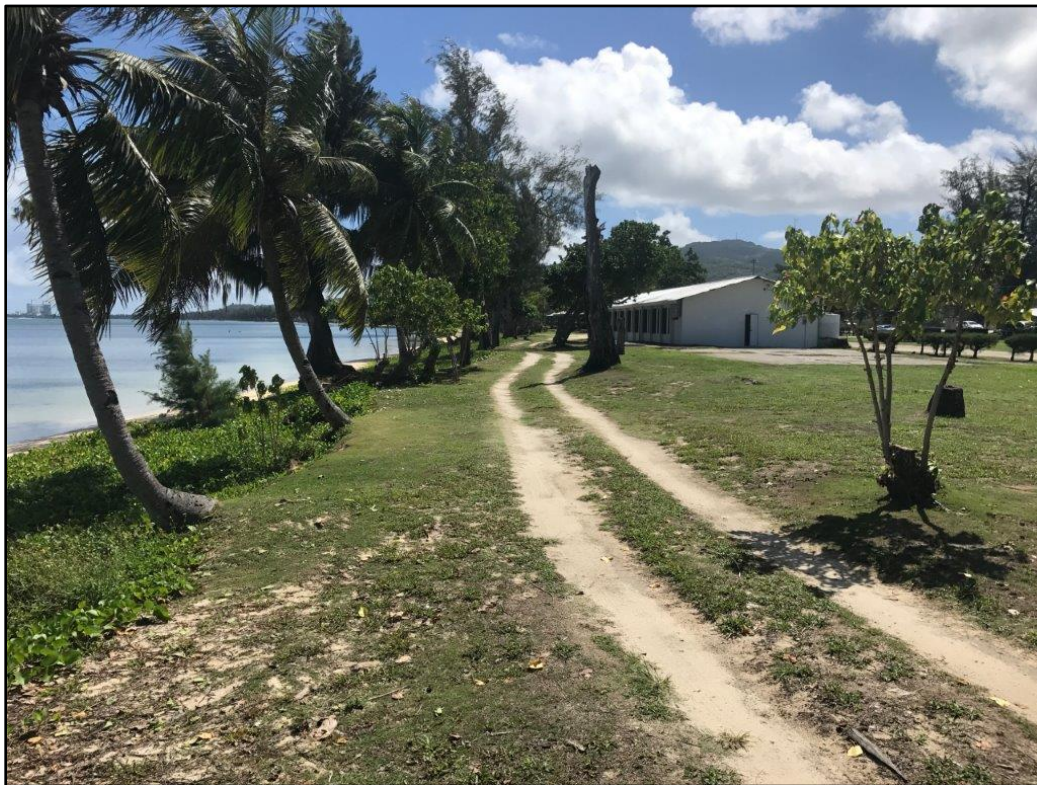
SEI observed off-road driving and parking along berms at many of the beaches included in this assessment including Sugar Dock Beach, Susupe Beach Park, Kili Beach (Civic Center) (Figure 18), Oleai Beach, Quartermaster Area (Red Beach), and Beach Road Pathway. These areas were found to have less-stable vegetation and highly-compacted soils along the berm crest. Vehicle strandings are reportedly common at Oleai Beach and Sugar Dock. In some areas, off-road driving and parking may also damage nesting sites for threatened green sea turtles. In 2002, DCRM initiated an interagency educational and outreach campaign called “Walk it, Don’t Drive it”. Bollards, access gates, and educational signage were installed to discourage beach driving.

Figure 18 Evidence of vehicle traffic on beach berm at Kili Beach (Civic Center)

Recommendation G(i): Enforcement and education to reduce vehicle use on berms.

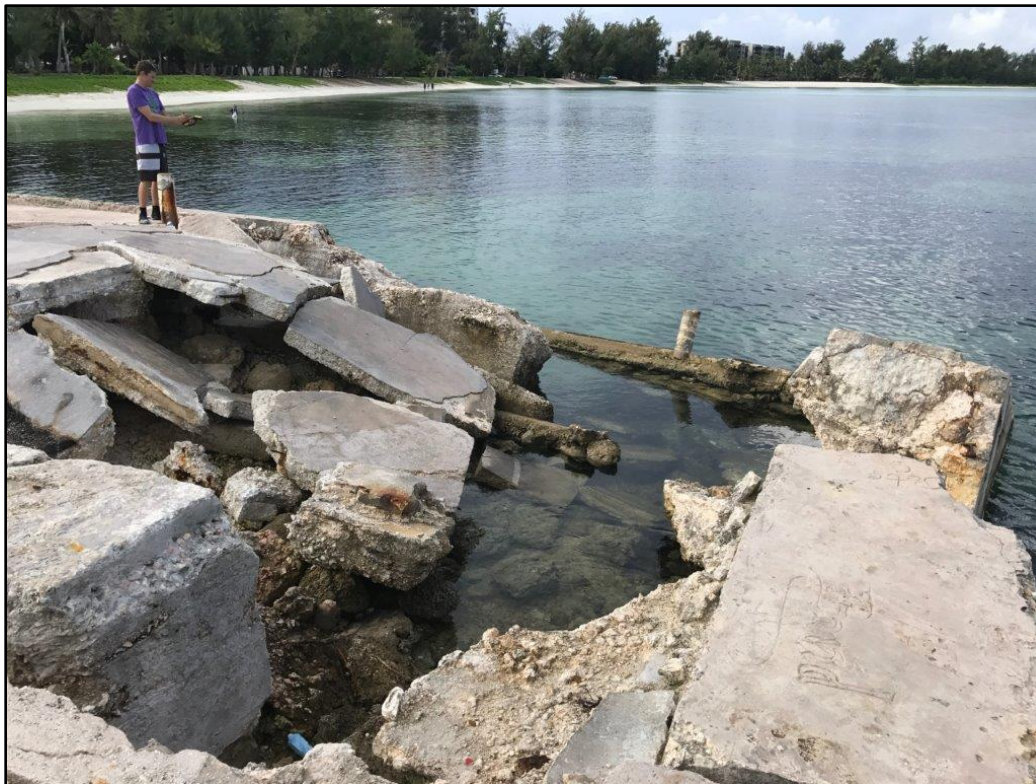
SEI observed several areas where public infrastructure was noticeably damaged, particularly at Fishing Base and Sugar Dock (Figure 19). In both cases, the pier docks had sustained significant structural damage, presumably caused by typhoon waves. The damage may compromise the structural integrity of the structures or cause a potential risk to public health and safety.

Figure 19 Structural damage to pier at Sugar Dock

Recommendation H(i): Assess damage and prioritize repairs to public infrastructure.

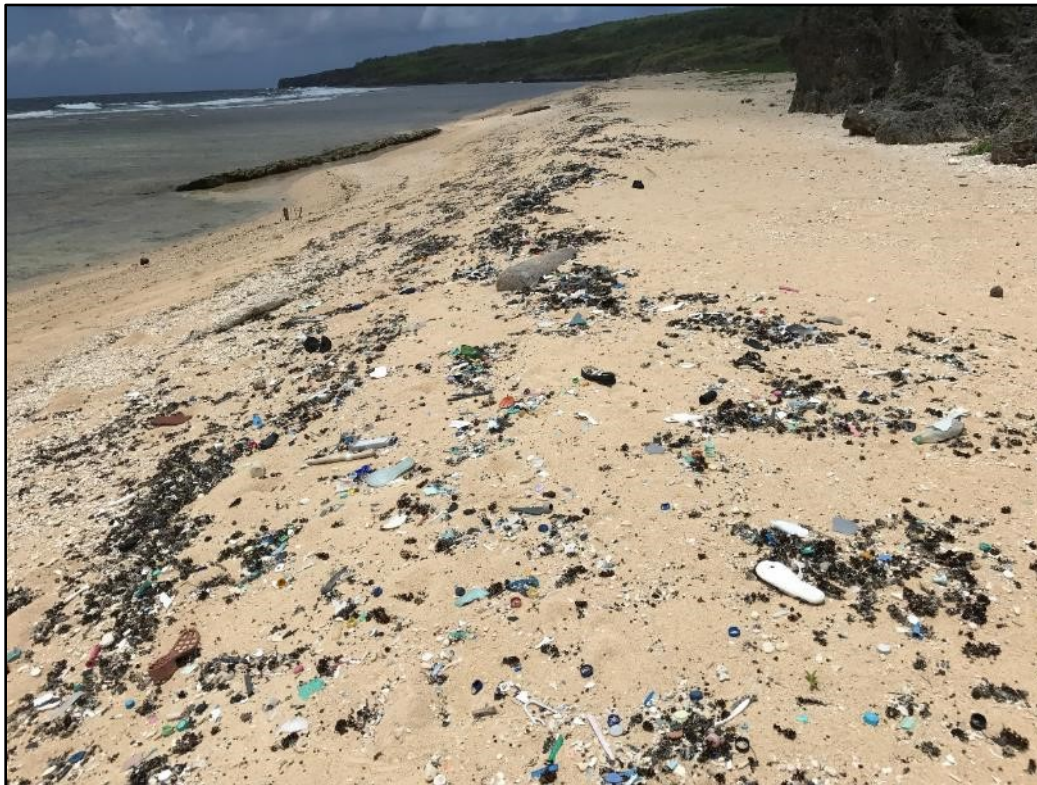
Marine debris is commonly found on beaches in the Pacific Islands. Common types of marine debris include plastics, metals, rubber, paper, textiles, and derelict fishing gear. Shorelines along the windward (east) coast of Saipan are particularly prone to the accumulation of marine debris due to their exposure to the prevailing tradewinds. SEI observed significant amounts of marine debris along the beaches at Jeffrey's Beach and Tank Beach (Figure 23).

Figure 23 Extensive marine debris on active beach at Tank Beach

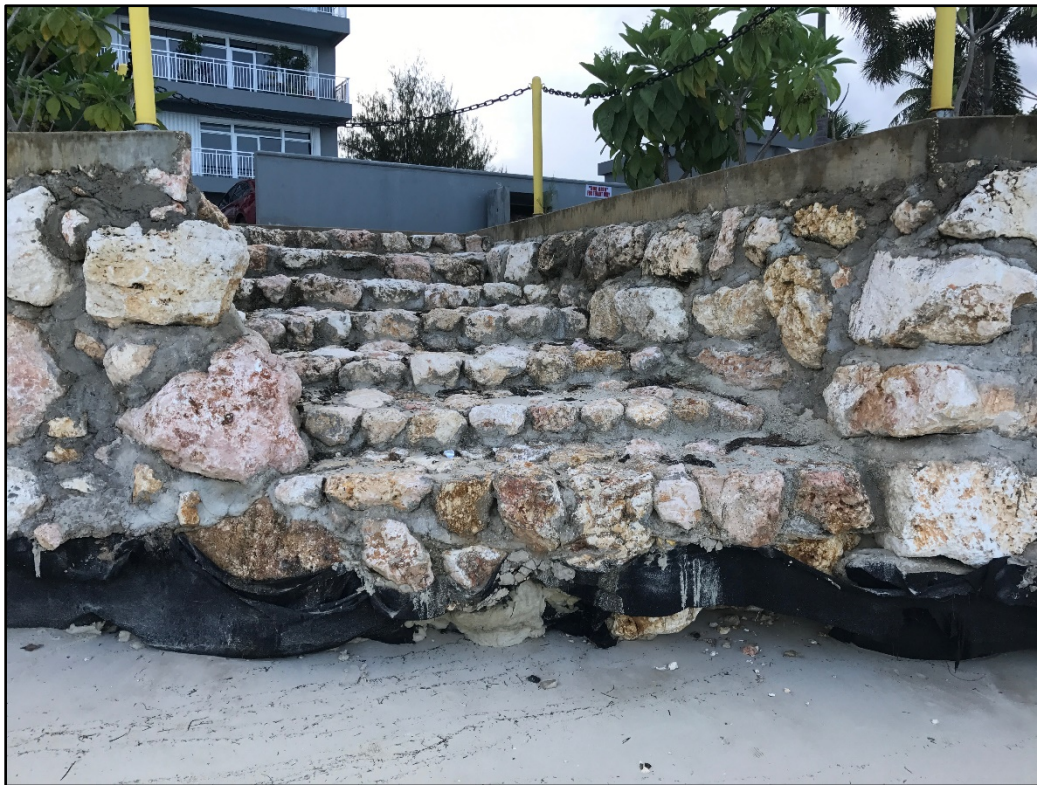
Figure 22 Sugar Dock Beach, seawall damage due to undermining (6/30/2017)

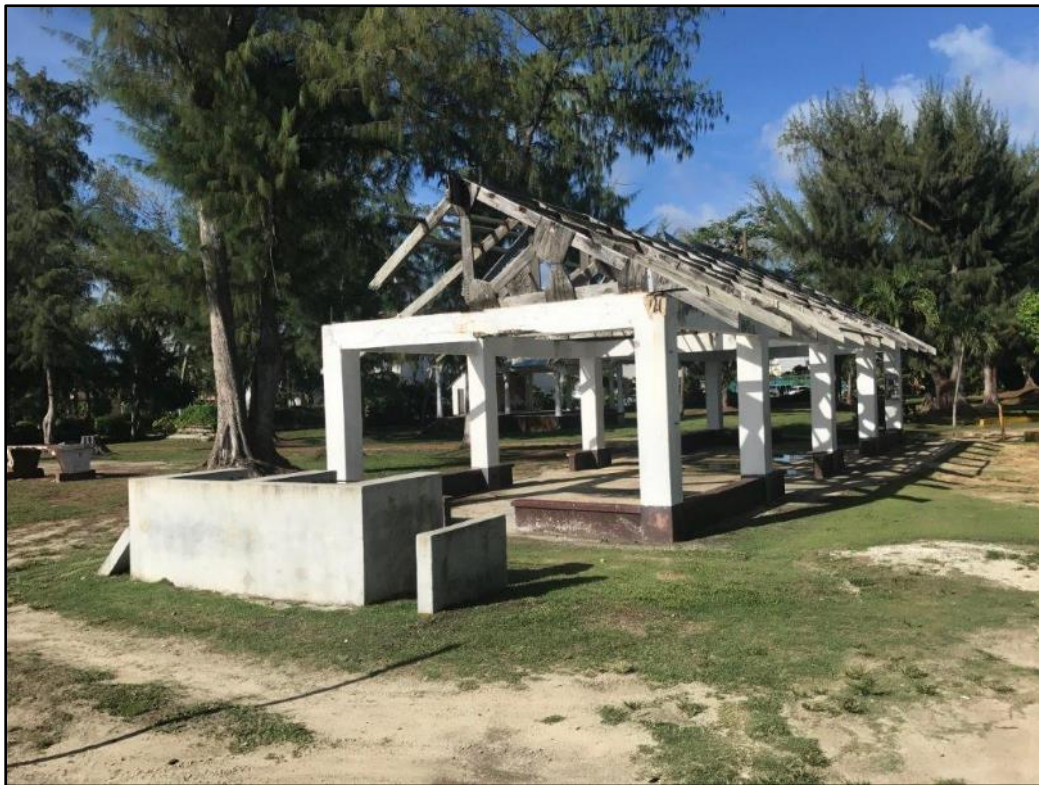
Figure 32 Susupe Beach Park, damaged palapalas (6/30/2017)

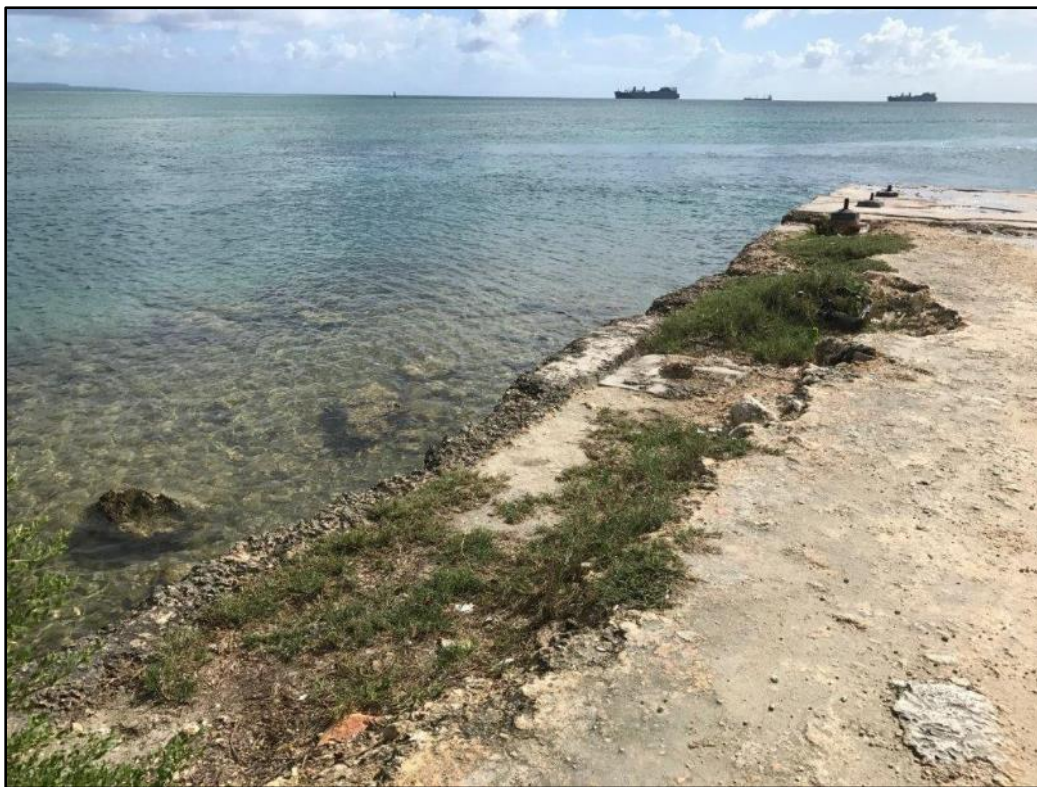
Figure 84 Fishing Base, damage at seaward end of pier (7/1/2017)

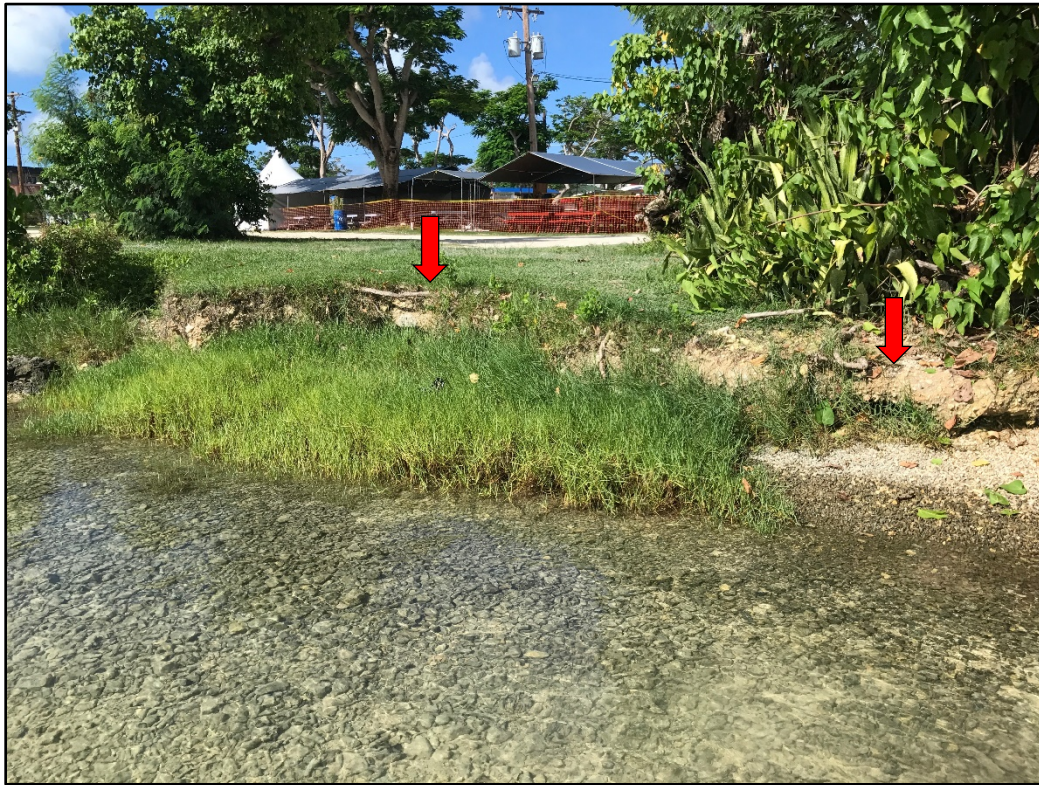
Figure 87 Fishing Base, active erosion scarp along northern section of shoreline (7/1/2017)

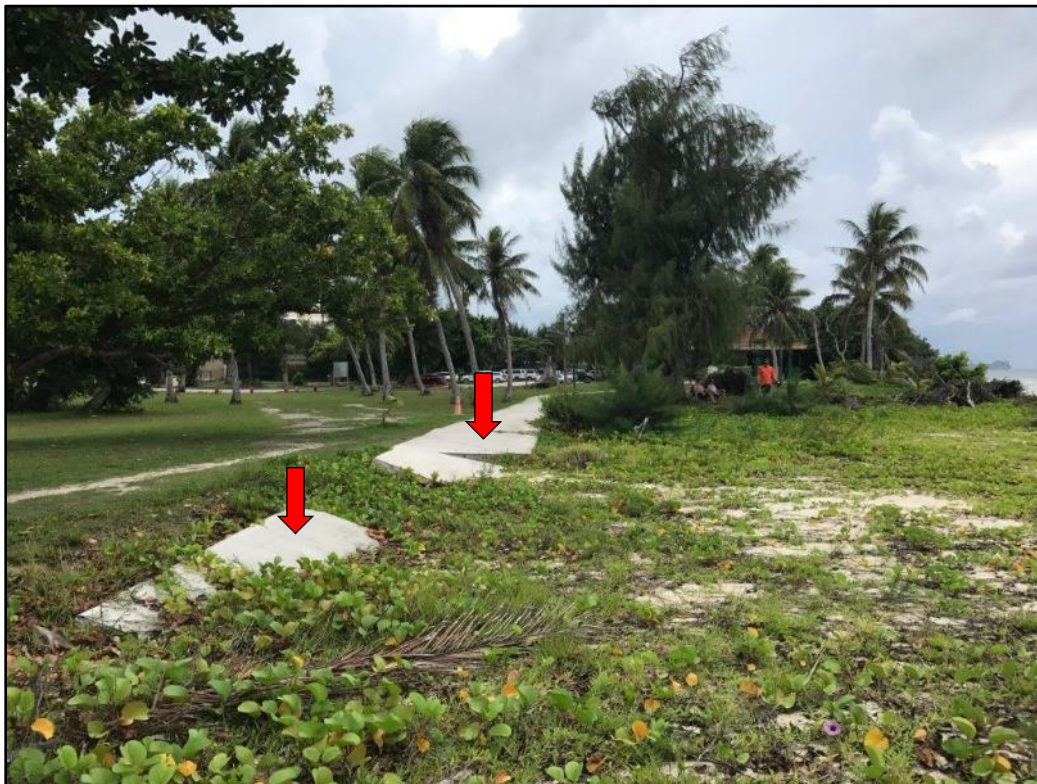
Figure 127 Micro Beach, damaged coastal access path (7/2/2017)
