Shoreline Monitoring Beach Profile Report: Saipan and Mañagaha

March 2021 – March 2022

Division of Coastal Resources Management
CNMI Bureau of Environmental Coastal
Quality

Award No.: NA20NOS4190179

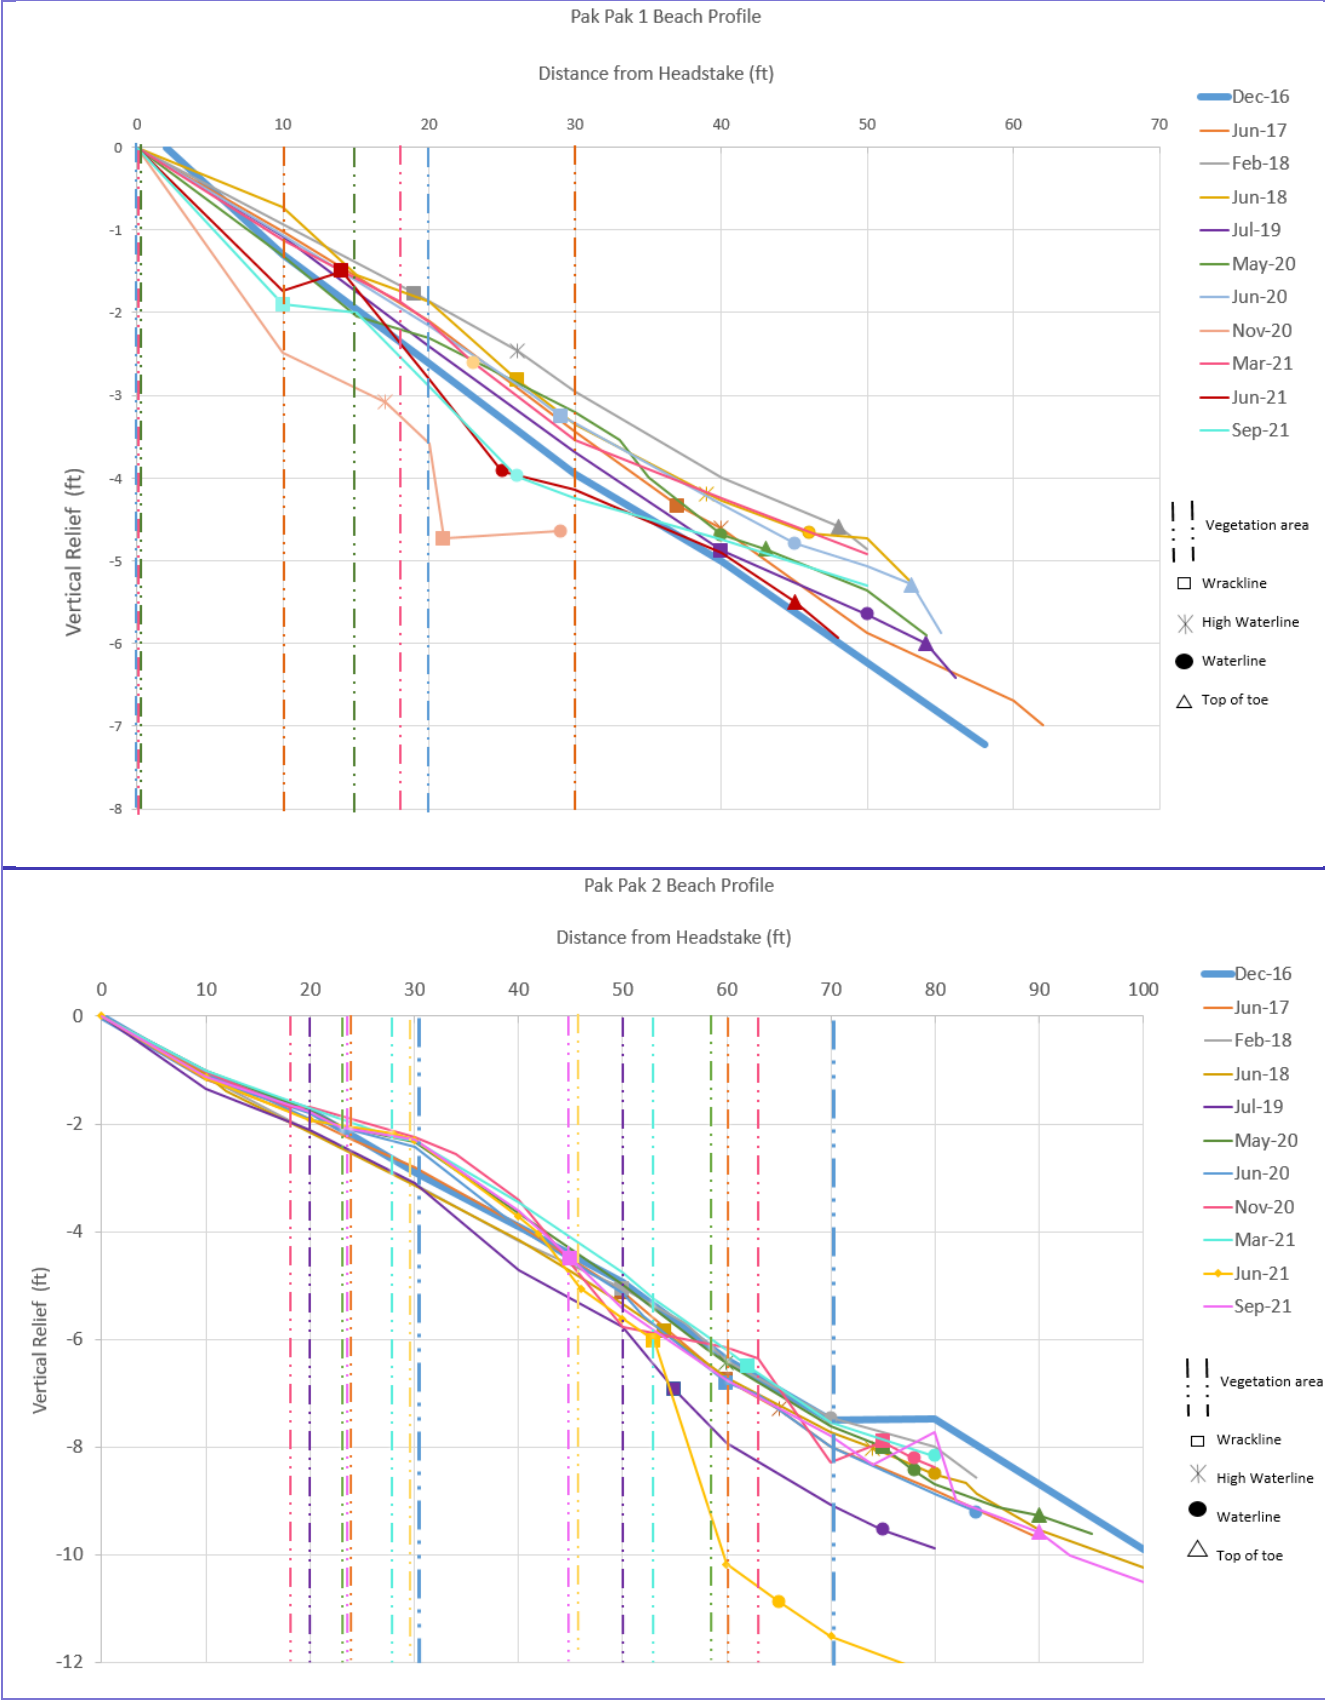
Pak Pak Beach Profiles

Sheltered by the nearby reef (approximately 500 meters away) and Agingan Point, Pak Pak Beach has exhibited stable shoreline since 2016. In 2018, storm surge damaged vegetation. Compared to last year, Pak Pak beach's vegetation has developed, signifying stability since then.

As observed, southwest typhoon conditions appear to be more damaging than north-northwest especially due to the proximity of the storm. However, the beach may be receiving sediment from the adjacent reef and Agingan Point. Greyish rubble-textured rocks were found along the shoreline after one storm event, potentially from Agingan Point.

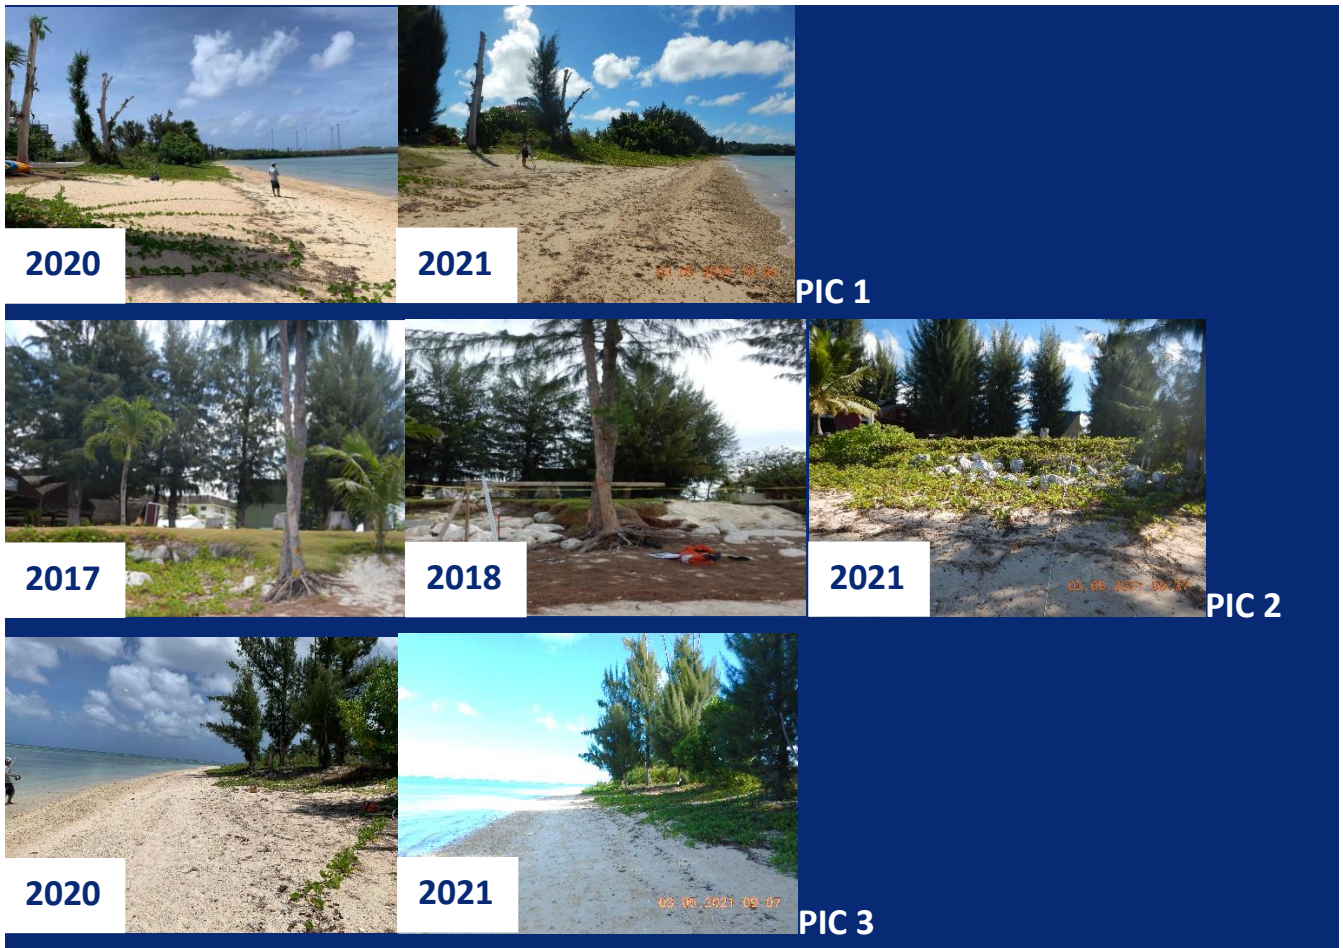
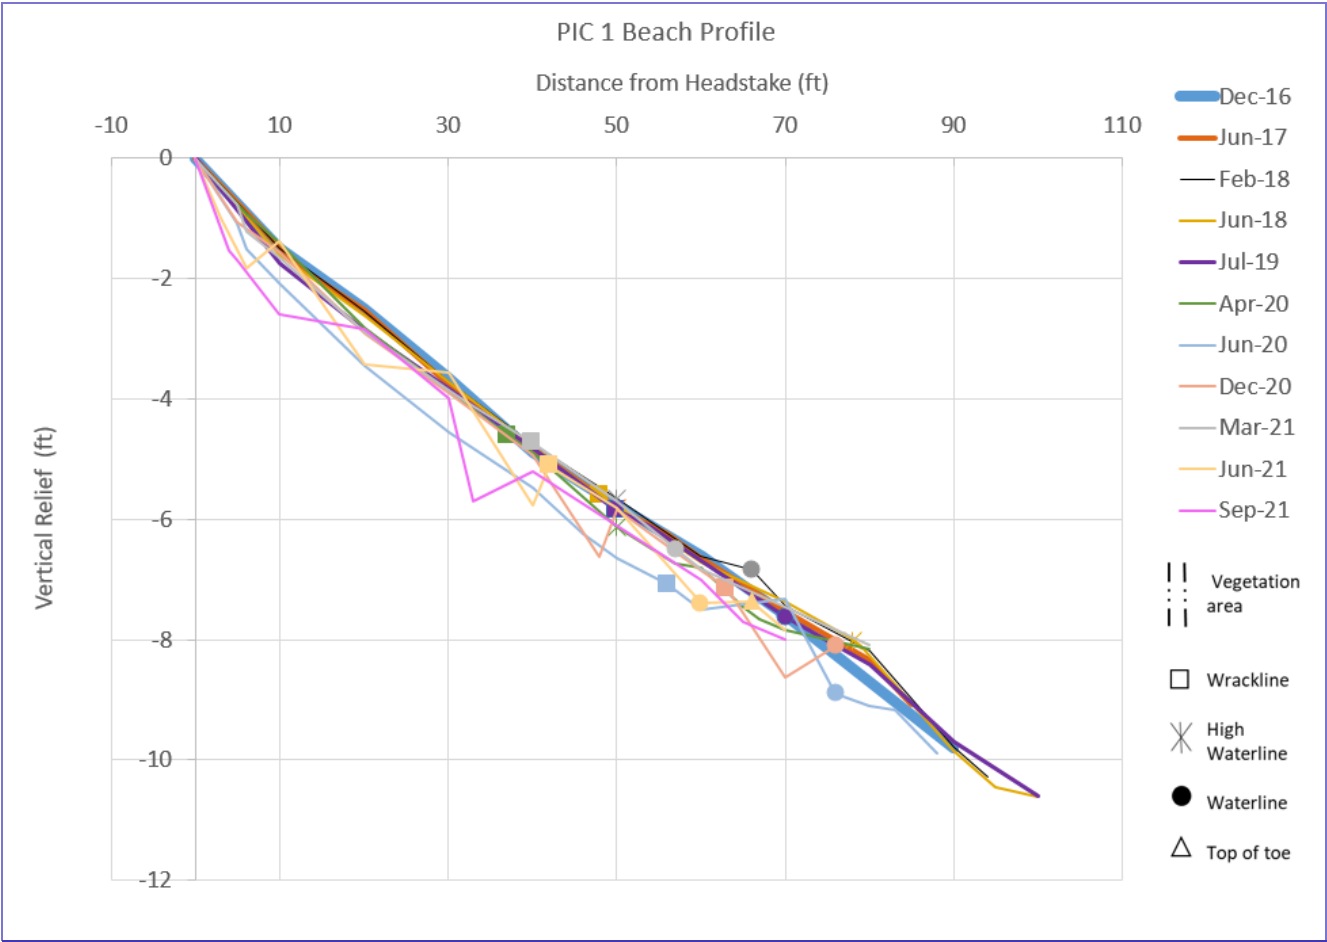
PIC Beach Profiles

PIC is adjacent to the Chalan Kanoa reef, which is 500 meters away from the headstake. This shoreline is subjected to storm-induced erosion. The storms of 2018 have abraded the shoreline and fell trees located on the berm. As a response, the PIC hotel has placed sand bags and rocks in hopes of stabilizing the highly eroding storm berm. Fortunately, the storms in this period have not damaged the berm. Wild native vegetation has prospered since their settlement, indicating stability for now. Southwest typhoon conditions appear to be more damaging than north-northwest especially due to the proximity of the storm. Intense storm surge events in the future may erode the shoreline further.

- ERODING with a Wrackline that ranges 37 – 63 ft and an elevation difference of 9 ft
- Erosion to the shoreline occurred in Dec-20 at a 40 ft distance and more.
- Foot traffic continues to discourage vegetation growth.

- STABLE with a Wrackline that ranges 45 – 50 ft and an elevation difference of 9 ft
- Construction happening nearby in the backshore

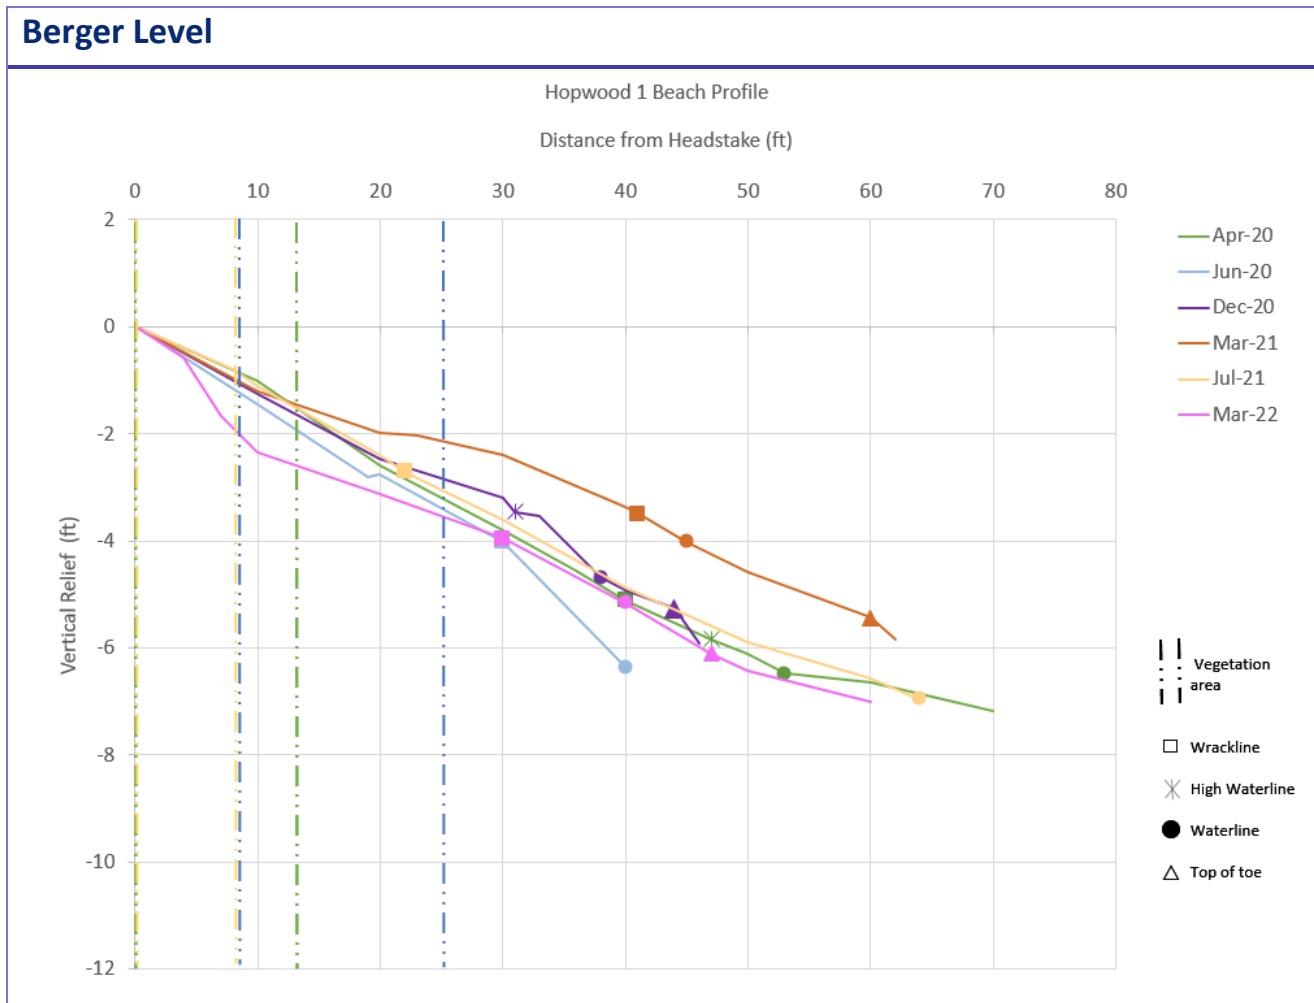
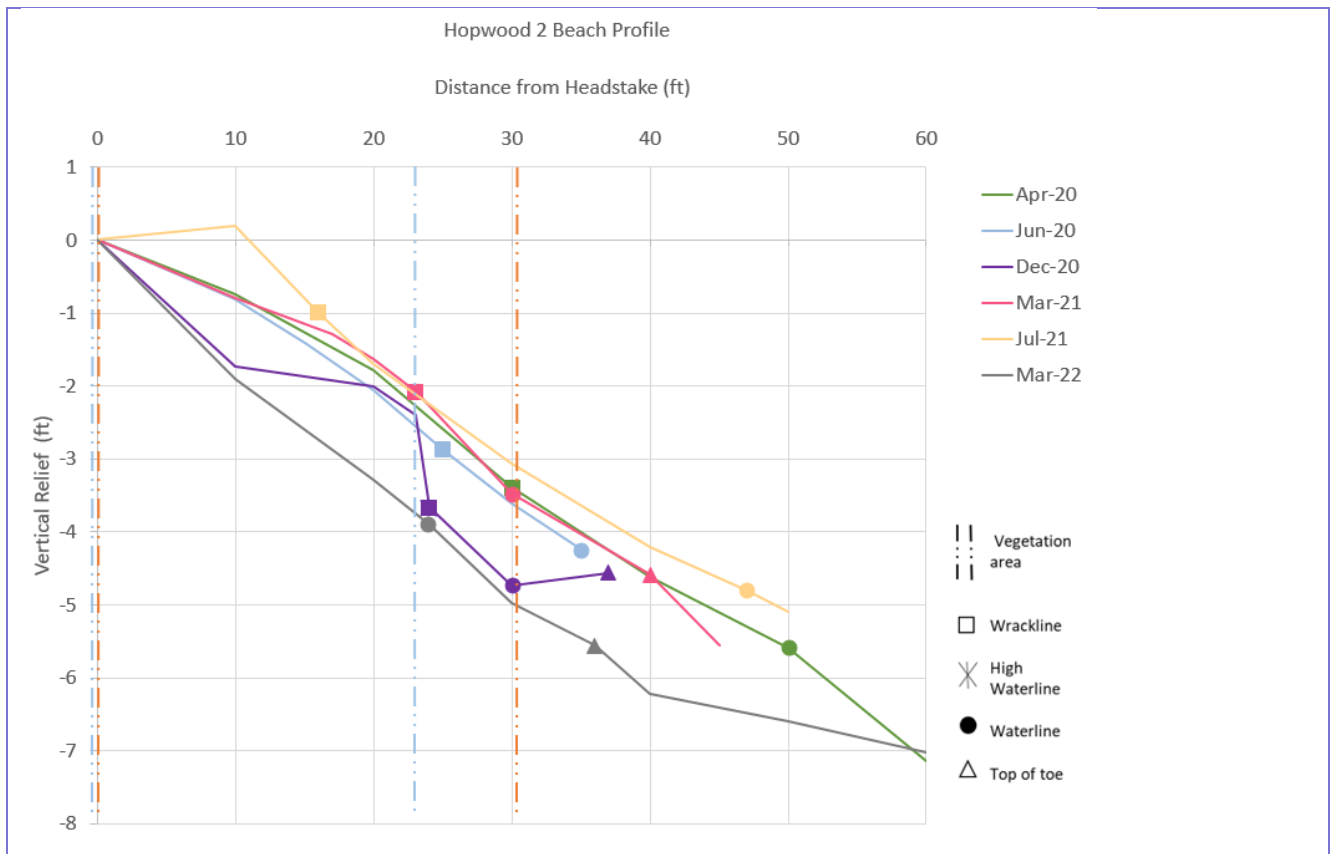
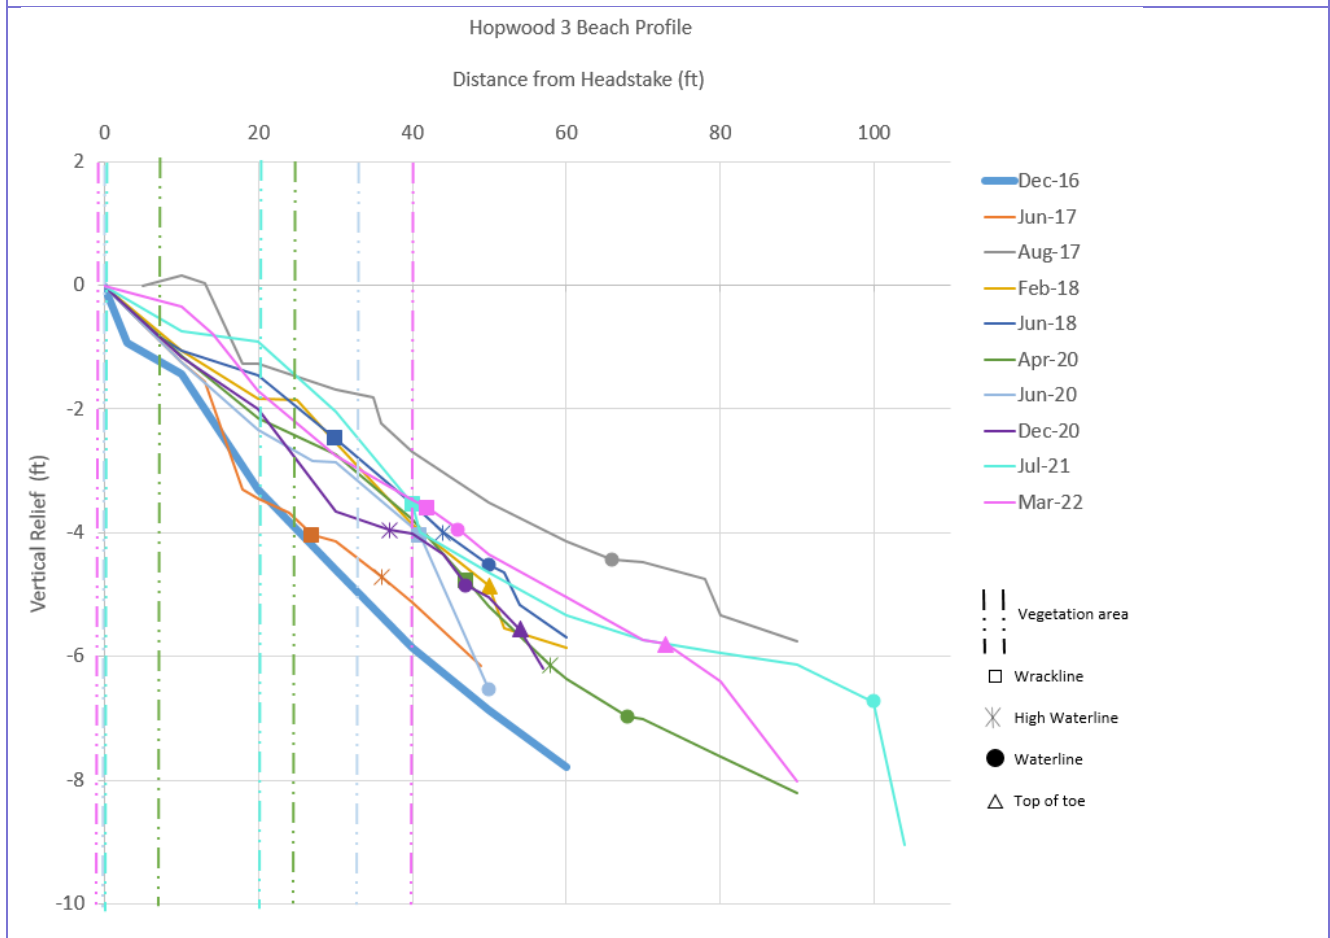
Hopwood Beach Profiles

Adjacent to the Chalan Kanoa reef at a distance of approximately 500 meters, the Hopwood shoreline is subjected to 100-year flood and additional velocity hazard (wave action). An account from a resident suggests that this shoreline has experienced accretion since the mid-1900s. Thus, the vegetation and sand in this area may be several decades old. Shoreline is susceptible to **incidental erosion**, in which the beach profile may be restored after erosion generated from an extreme storm event.

Flourishing vegetation line indicates how that **storm surge** has not reached the backshore during this period. The short width makes the shoreline susceptible to future sea level rise and the reach of storm surge. Wave overtopping and overwhelmed tidal flows from the channel down south may impact this site during both typhoon wave conditions. It appears that southwest conditions could greatly impact this site. Under southwest conditions, longshore could potentially be going from south to north while north-northwest conditions indicate the opposite.

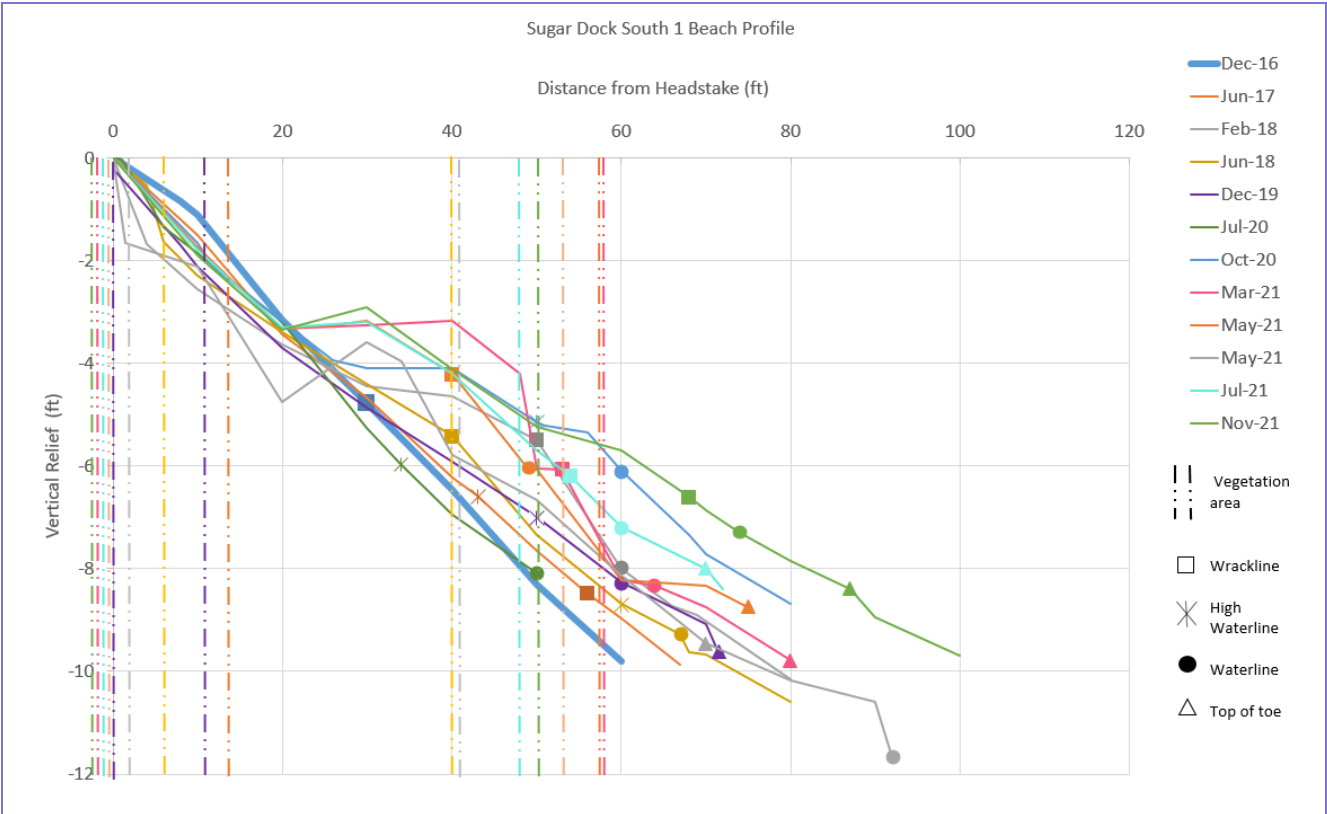
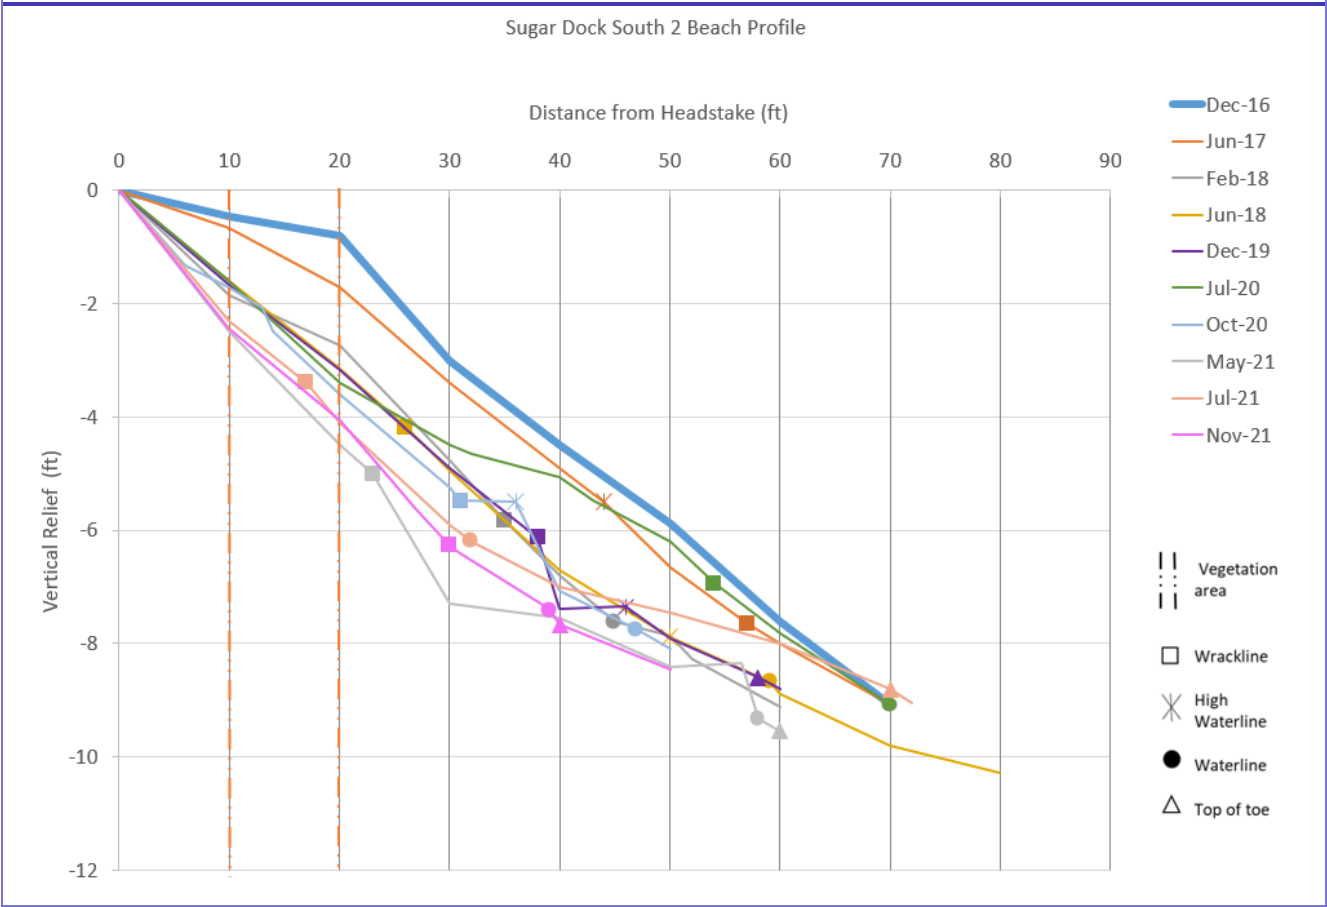
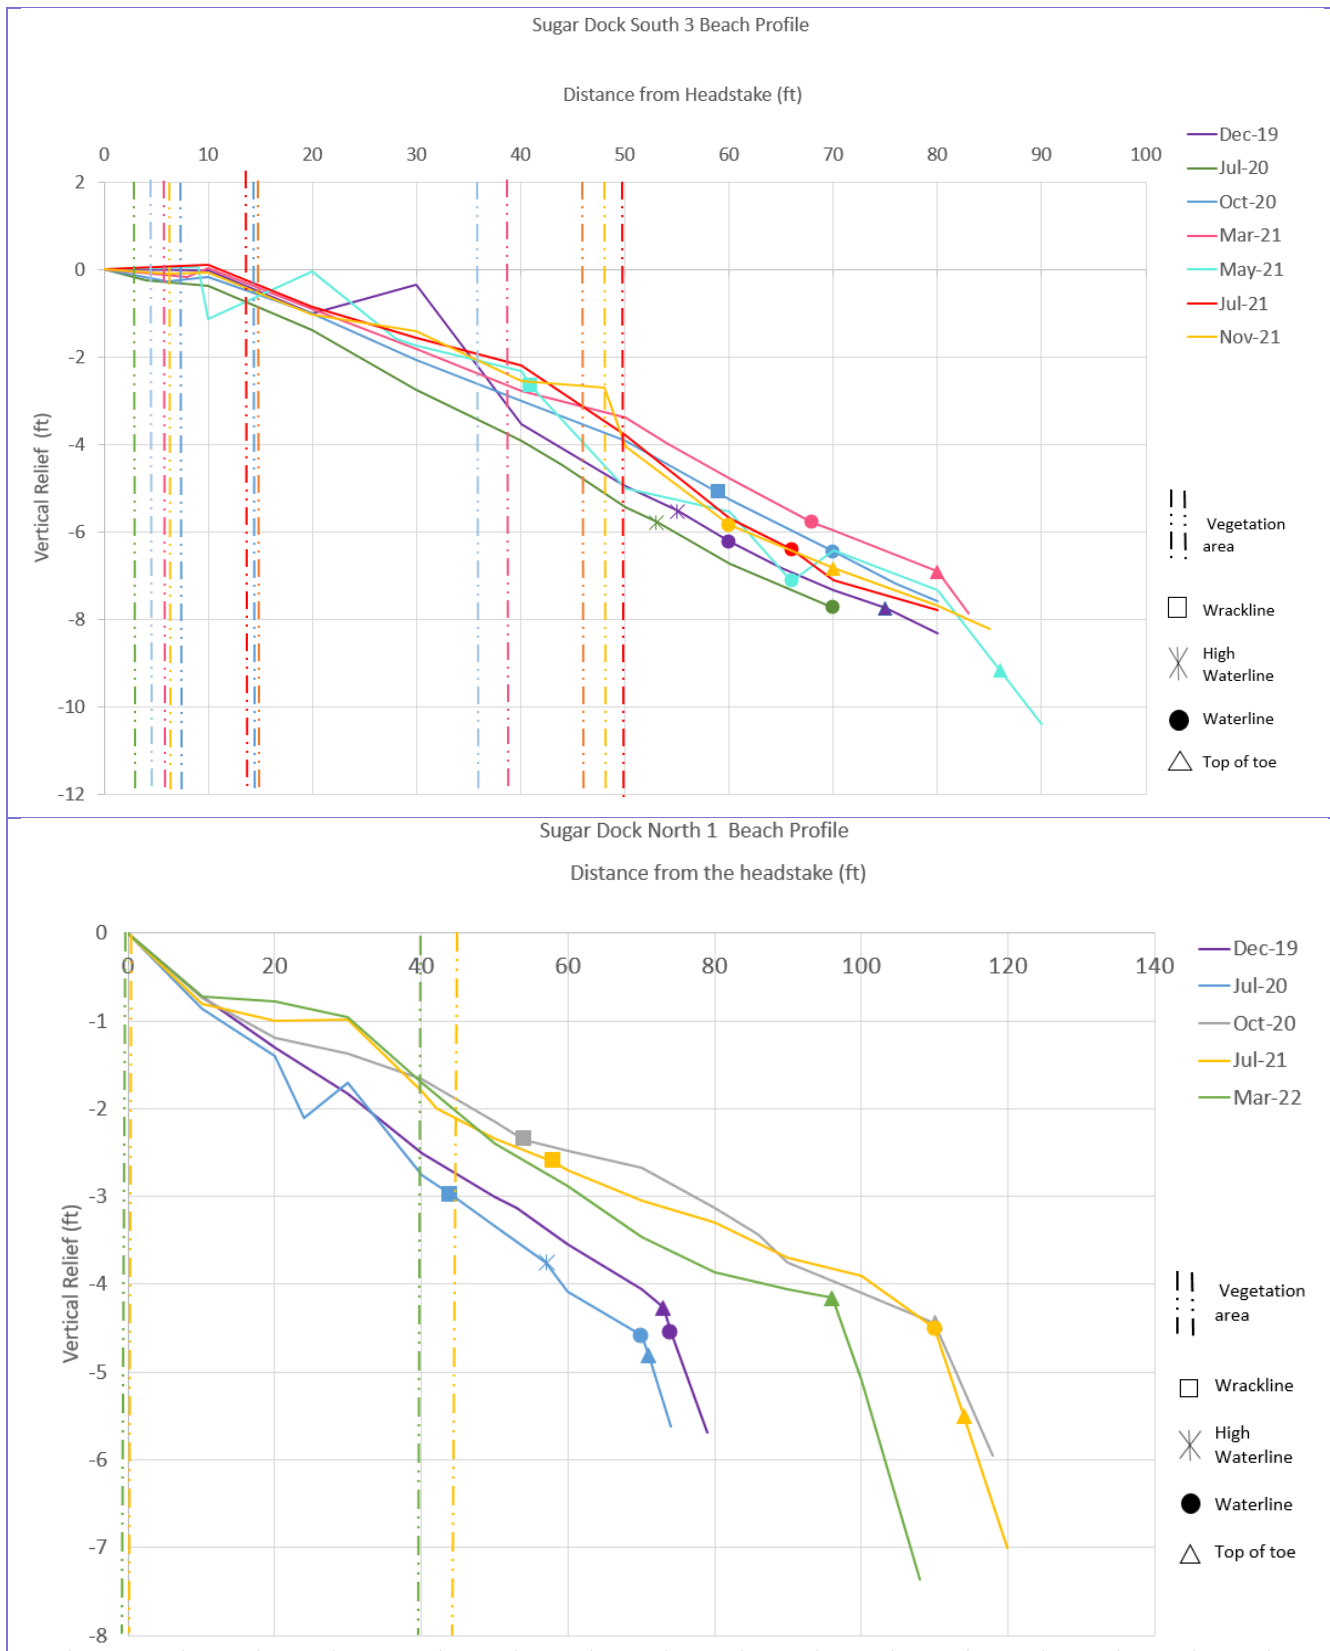
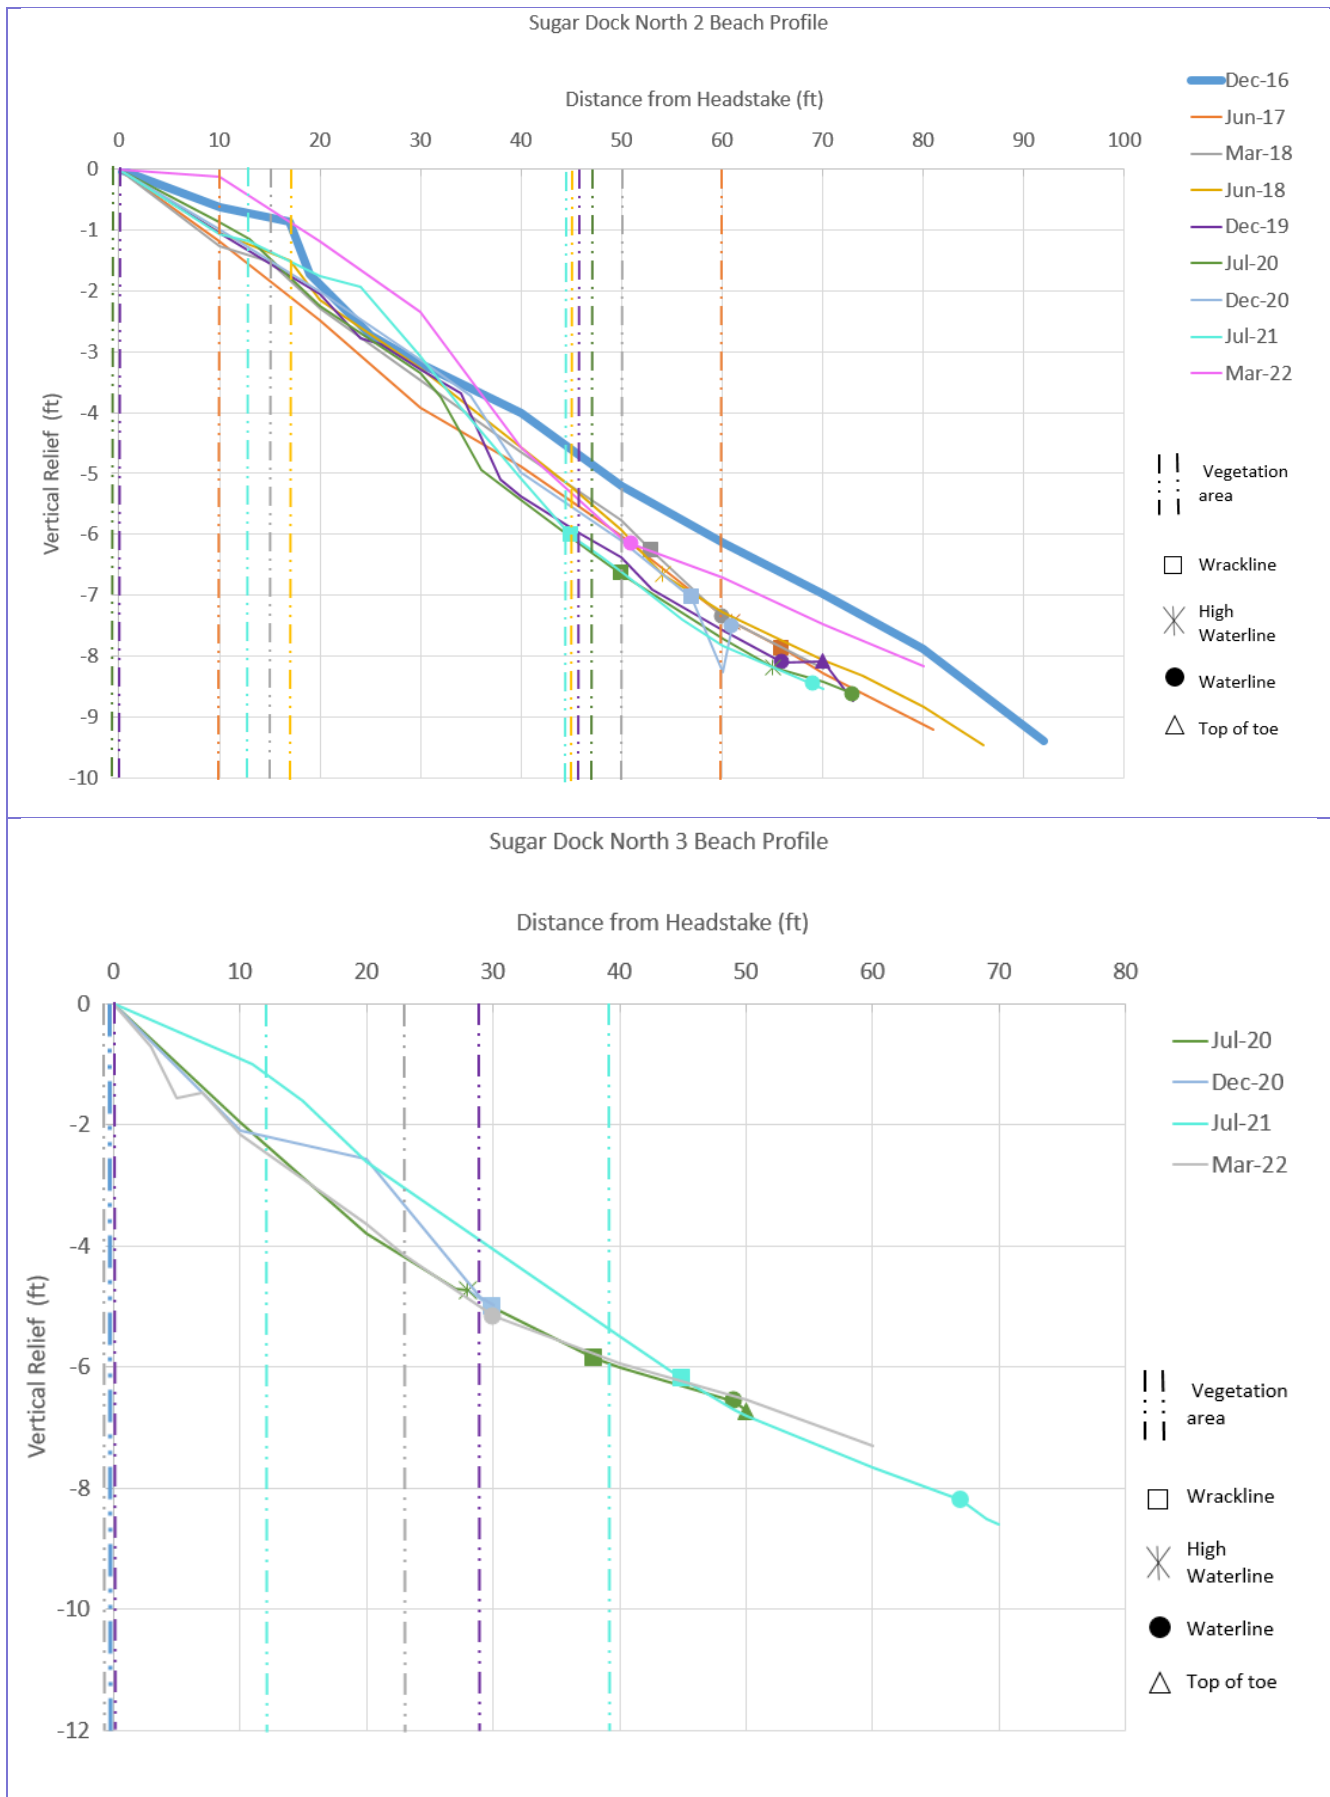
Sugar Dock Beach Profiles

Parallel to the Chalan Kanoa Reef, Sugar Dock shoreline is generally eroding. The Chalan Kanoa Channel is adjacent to the southern portion. Obstruction of sediment transport from the dock infrastructure is the largest anthropogenic influence. The accumulation on the northern side of the dock poses a public access issue for boaters since the water depth is not suitable for unloading. Dredging remains of interest and is in planning stage.

- ACCRETING from Dec 2016 to Feb 2018 then June 2021 to Nov 2021
- ERODING from Feb 2018 to Dec 2019 then October 2020 to current
- Wrackline that ranges 30 – 70 ft with an elevation difference of 9 ft
- Short-term erosion and accretion events define this profile. The sand bar could influence this dynamic behavior, suggesting that sand is pushed during typical winter conditions and pulled during typhoon conditions.

- ERODING with a Wrackline that ranges 17 – 60 ft with an elevation difference of 9 ft
- The berm has completely worn away, so the headstake (tree) is right when the slope begins to steadily drop into the waterline.

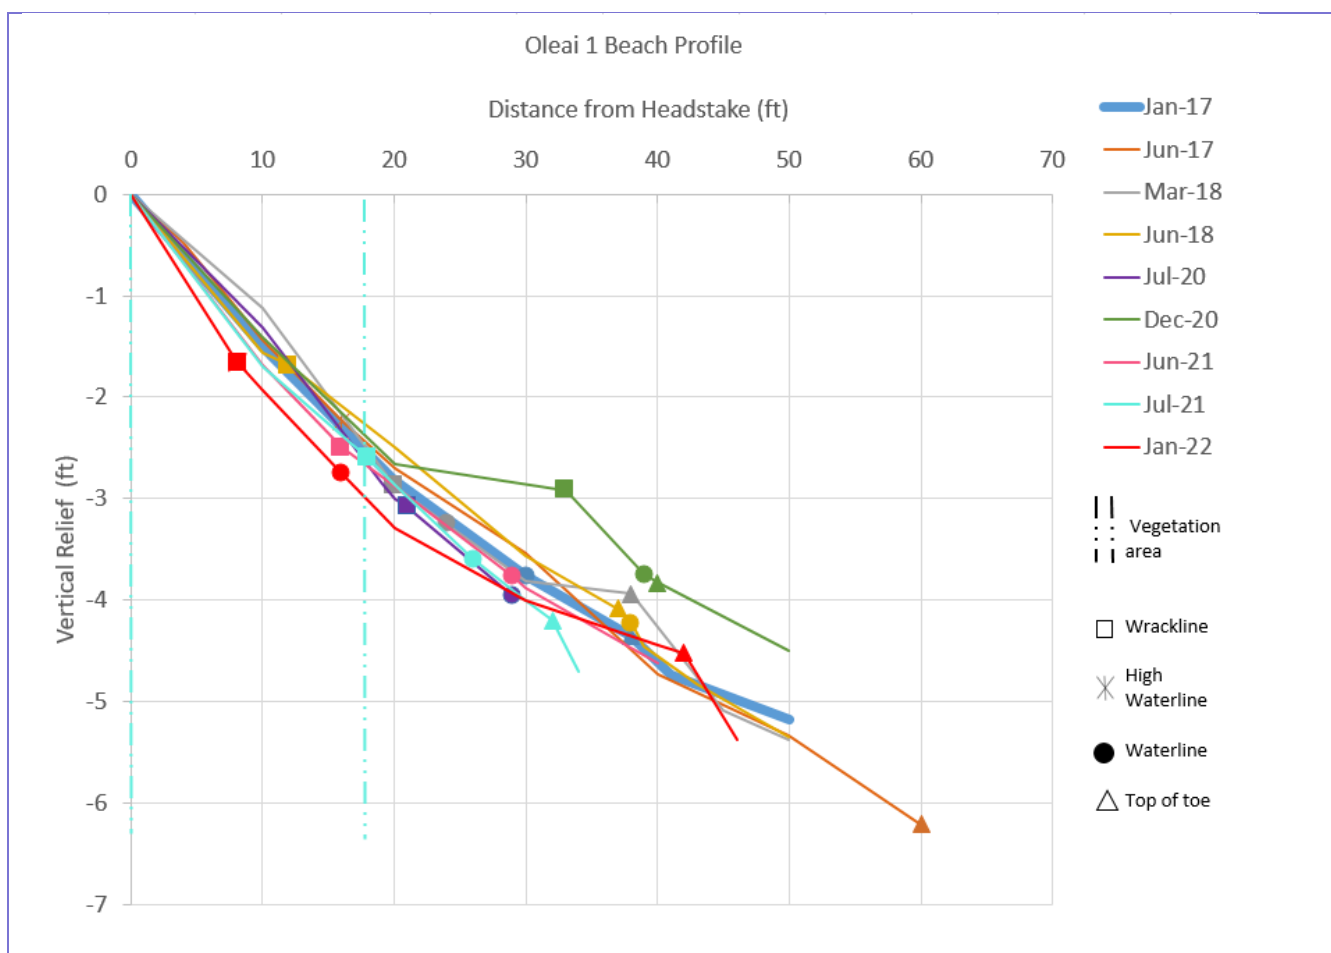
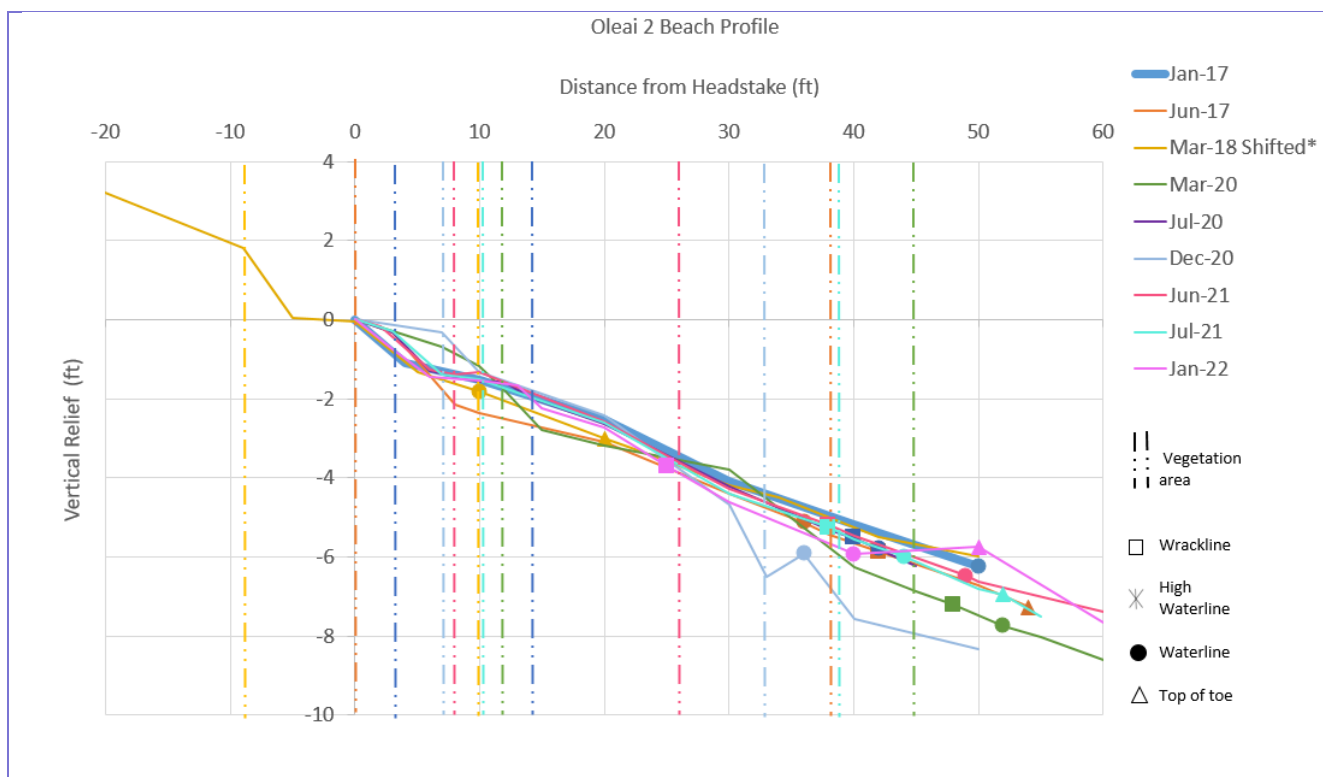
Oleai Beach Profiles

Parallel to the Garapan reef, Oleai shoreline is short and adjacent to the parking lot of Oleai Beach Bar. The restaurant facility in Oleai 1 transect is less than 50 ft away from the waterline indicating that the restaurant is vulnerable to storm surge and sea level rise.

- ERODING with a Wrackline that ranges 8 – 33 ft and an elevation difference of more than 6 ft
- Tides and seasonal wave conditions influence the beach width. The shoreline receives grooming through the restaurant's management to move washed up debris more inland to expose a sandy shoreline.

Stabilization measures are necessary to protecting the infrastructure from an encroaching waterline, so recording the shoreline position may assist proper decision-making in addressing this issue. Wave overtopping and overwhelmed tidal flows may impact this site during both typhoon wave conditions. It appears that southwest conditions could greatly impact this site.

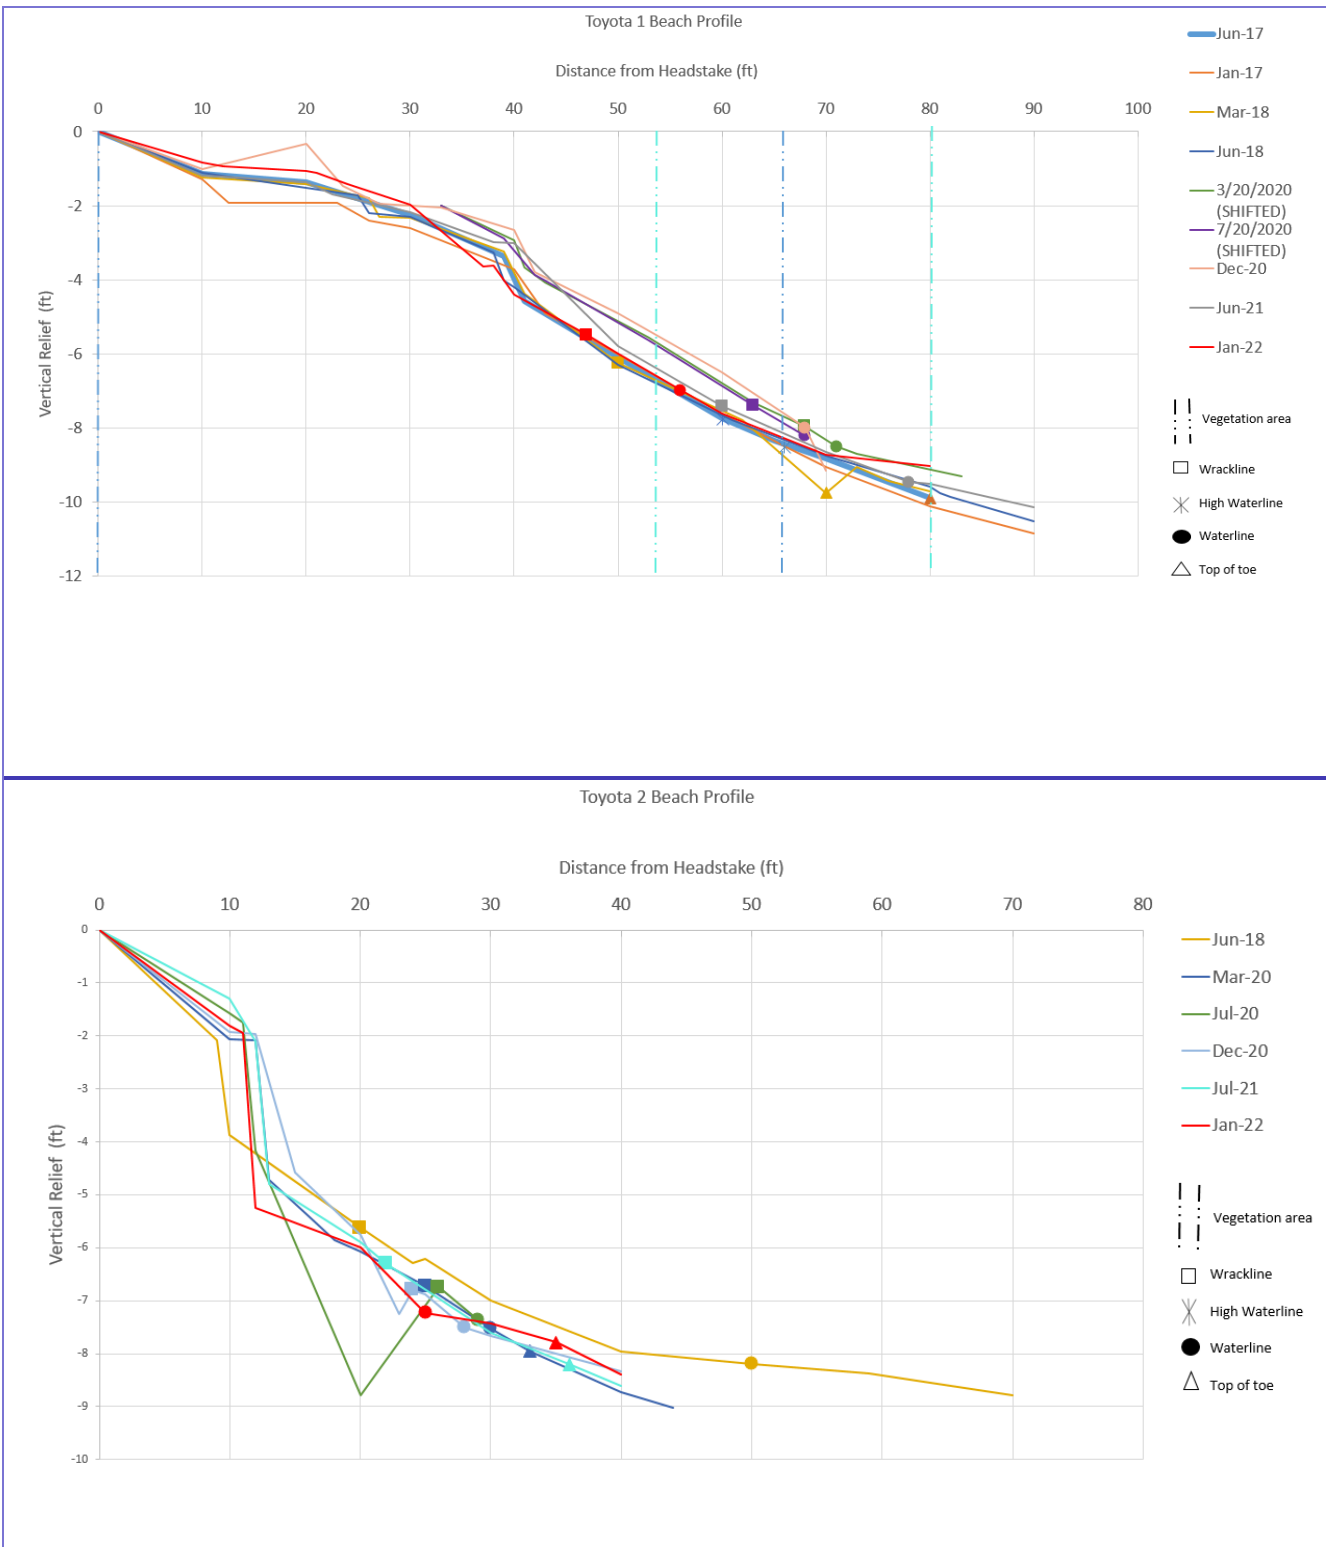
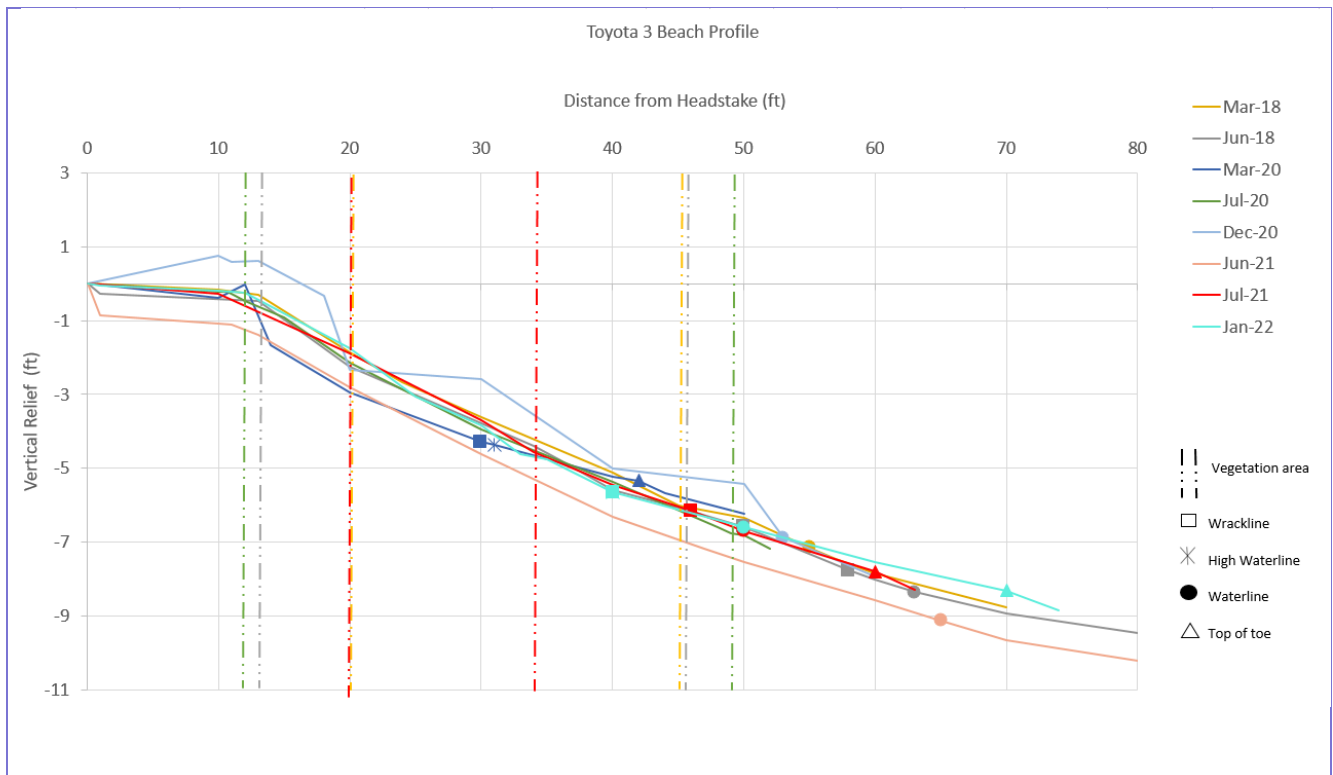
Toyota Beach Profiles

Toyota shoreline encompasses a portion of the Beach Road pathway with the railing and ADA pathway down to the shore. This area is prone to abrasion after storm surge events, which has historically damaged the pathway infrastructure. The toe is exposed during low tide.

Along with erosion by storm surge, sea level rise threatens this shoreline and its highly developed backshore, the Toyota intersection and the surrounding businesses. Both typhoon conditions bring strong wave energies that greatly erode the short shoreline away. Wave overtopping and overwhelmed tidal flows may impact this site during both typhoon wave conditions. It appears that southwest conditions could greatly impact this site. However, improved resolution on nearshore dynamics may explain longshore processes for this area.
