Shoreline Monitoring Beach Profile Report: Saipan and Mañagaha

March 2021 – March 2022

Division of Coastal Resources Management
CNMI Bureau of Environmental Coastal
Quality

Award No.: NA20NOS4190179

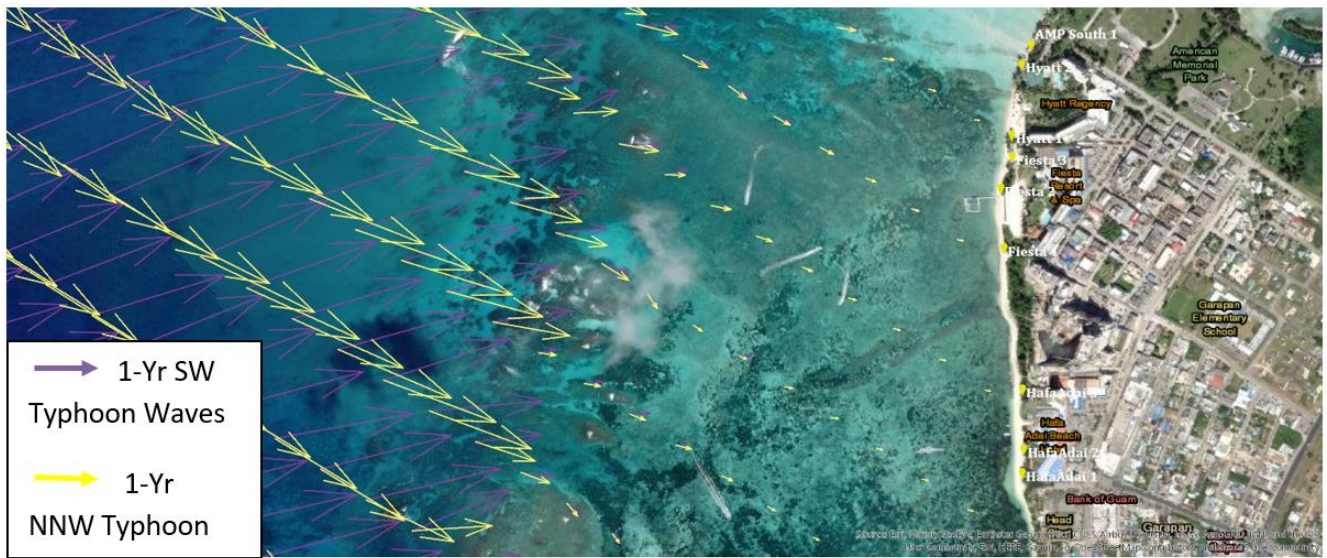
- ERODING and REPLACED
- LOSS of shoreline by ~20 ft since 2018
- Beach profile of Feb 2021 to Jul 2021 showed the **High Waterline** ranges 30 – 40 ft with an elevation difference of 6 ft
- **History:** The January 2018 to July 2020 headstake indicated a berm loss of around 10 ft from Jan 2018 through July 2020. The shoreline grew steeper, which enabled further erosion of the shoreline. The one displayed here preceded and was abraded by a September 2021 storm.

- ERODING and REPLACED
- LOSS of shoreline by ~60 ft since 2017
- Beach profile of Jun 2017 to Jun 2021 showed the **High Waterline** ranges 30 – 55 ft with an elevation difference of less than 6 ft
- **History:** From 2017 – 2020, the berm has retreated ~36 ft. Then from Feb 2020 – Jun 2021, erosion has reached the headstake, indicating additional of loss 16 ft. Storm-induced wave action is abrading the beach and weakening the sand. The late storms of 2021 have eaten up to the headstake and reached the road. Vehicles accessing this road are subjected to getting stuck in the softened sand or falling into the water. They are also compacting the sand. The wrackline is nonexistent due to a lack of seagrass or other potential debris in the adjacent waters.

- ❖ The active retreat of the shoreline based on the loss of Fiesta 2 & 3 headstakes calls for a shift in the current shoreline setbacks. Currently, driving and parking are compacting the loose sandy beach due to the unavailability of the Crowne Plaza Hotel’s parking lot and its on-going construction. The following points indicate why the parking areas should shift in-land as well:

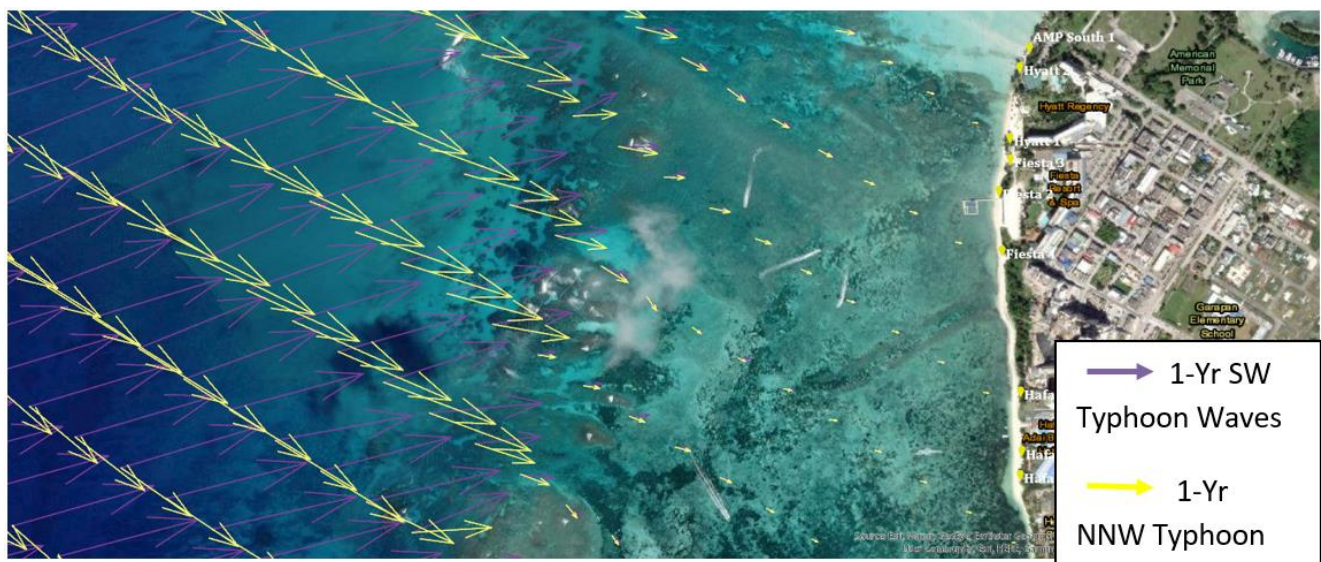
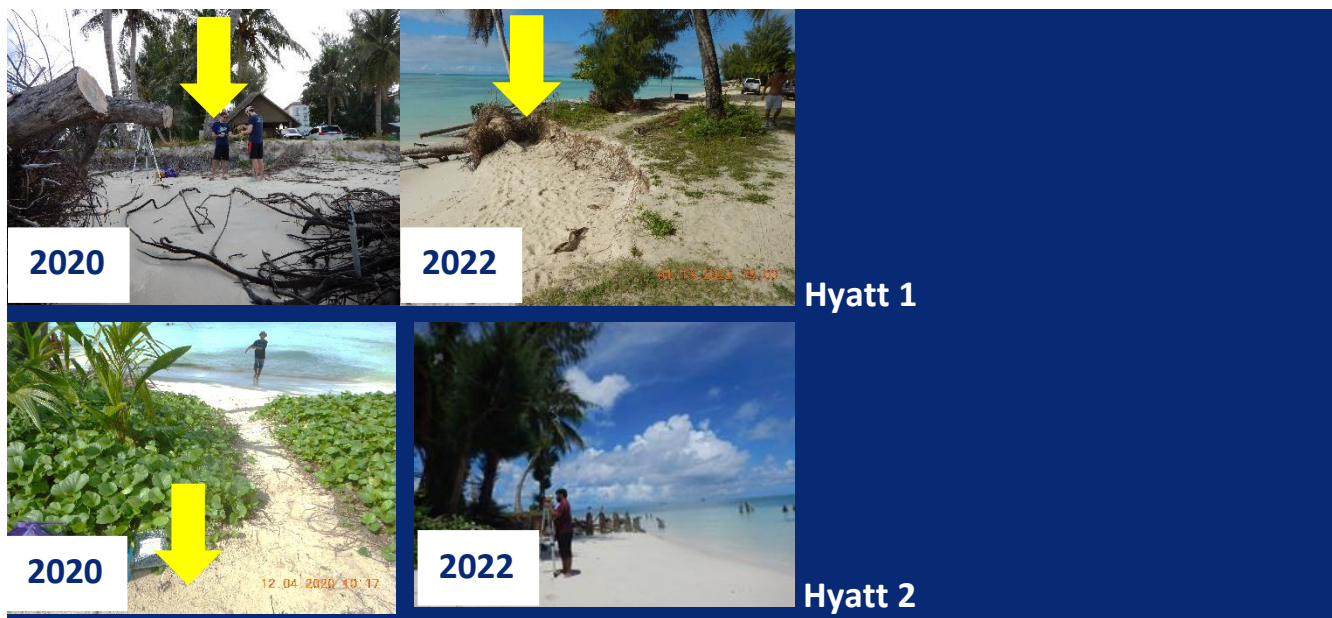
- ERODING and REPLACED with a Wrackline that ranges 30 – 55 ft and an elevation difference of less than 6 ft
- LOSS of shoreline by ~60 ft since 2017
- Outfall influenced

- ERODING and REPLACED
- LOSS of shoreline by ~30 ft since 2020
- Beach profile of Feb 2021 to Jul 2021 showed the elevation difference was less than 3 ft
- **History:** This area serves as a pathway from Micro Beach to the marine sports area north of Hyatt. It is eroding on the long term due to the abrasion exposing the bedrock after the September 2021 storm. The sand is pulled into the water during high wave energy conditions and pushed into the shore during lower wave energy conditions. We intend on replacing the headstake with a tree farther back.

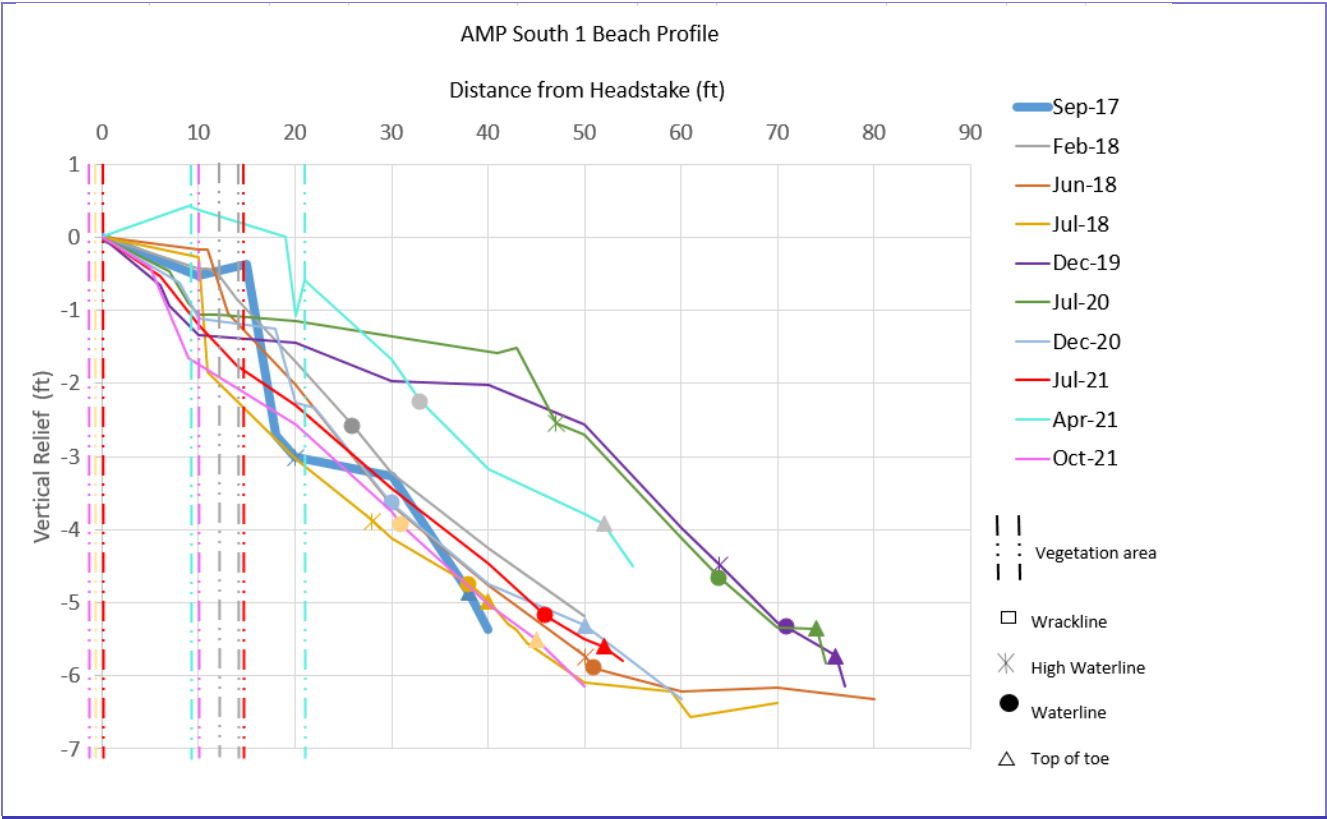
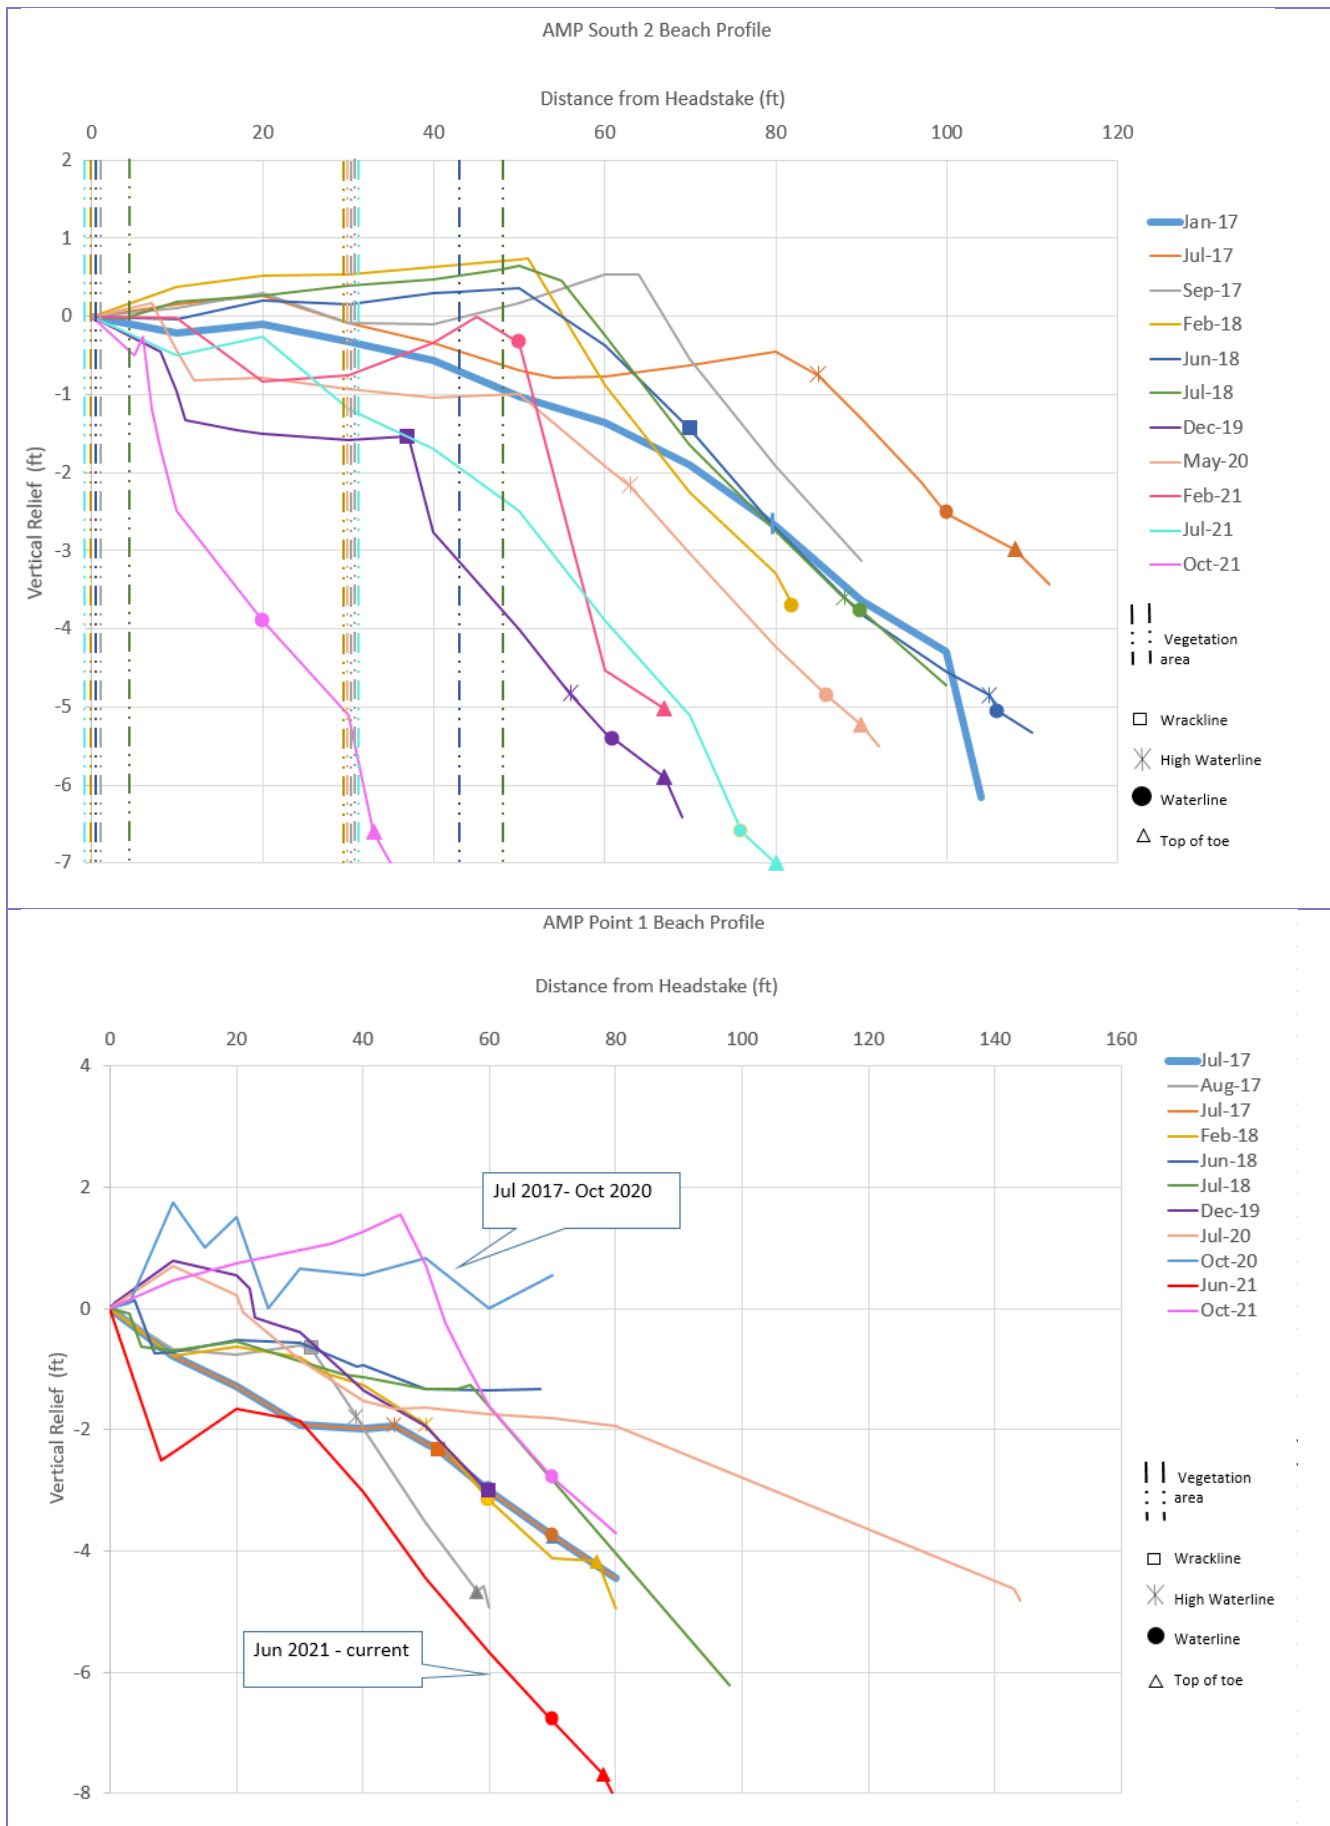
American Memorial Park Beach Profiles

- ERODING in the long-term
- LOSS of shoreline by 35~ ft since 2020
- Elevation difference is less than 3 ft
- This area is eroding on the long term but is a highly dynamic. Sediment transport may contribute to the variation of shoreline position throughout time but the encroaching waterline and wave energy during high tide/storm events suggest this shoreline is eroding. The sand is pulled into the water during high wave energy conditions and pushed into the shore during lower wave energy conditions.

- ERODING in the short-term and REPLACED
- Wrackline ranges 30 – 60 ft and an **elevation difference** of less than 5 ft
- LOSS of shoreline is less than 70 ft since 2020
- In 2017, the sediment input appears to increase in the summer of 2017. The typhoon season of that year abraded the shoreline. After Super Typhoon Yutu, the berm has retreated significantly and the toe is deeper and closer to the waterline. Then the beach accreted until Feb 2021, when storms started eating away at the beach and ripped up the vegetation. Similar to AMP South 1, the seasonal sediment input may be a great contributor to a different shoreline position.

- ERODING in the short-term with a Wrackline that ranges 45– 150 ft and an **elevation difference** of less than 5 ft
- LOSS of shoreline is less than 70 ft since 2020
- **History:** This profile is subjected to damage by storms. It has accreted on Jan 2017 – July 2018. After Super Typhoon Yutu, the shoreline noticeably abraded. However, the September 2021 storm has eroded the shoreline by more than 50 feet. The sand in this area migrated to the northern transects. There is potential for the beach to rebuild itself.
