Mañagaha Island Shoreline Stability Assessment

Coastal Resources Management Office
Commonwealth of the Northern Mariana Islands
2007

Coastal Geology Group, Department of Geology and Geophysics,
School of Ocean and Earth Science and Technology (SOEST), University of Hawaii
1680 East-West Road, Honolulu, HI, 96822 USA

Fletcher, C.H., Barbee, M., Dyer, M., Genz, A., Vitousek, S., 2007. Mañagaha Island Shoreline Stability Assessment, Report to the Coastal Resources Management Office, Commonwealth of the Northern Mariana Islands, Saipan, 90 p.

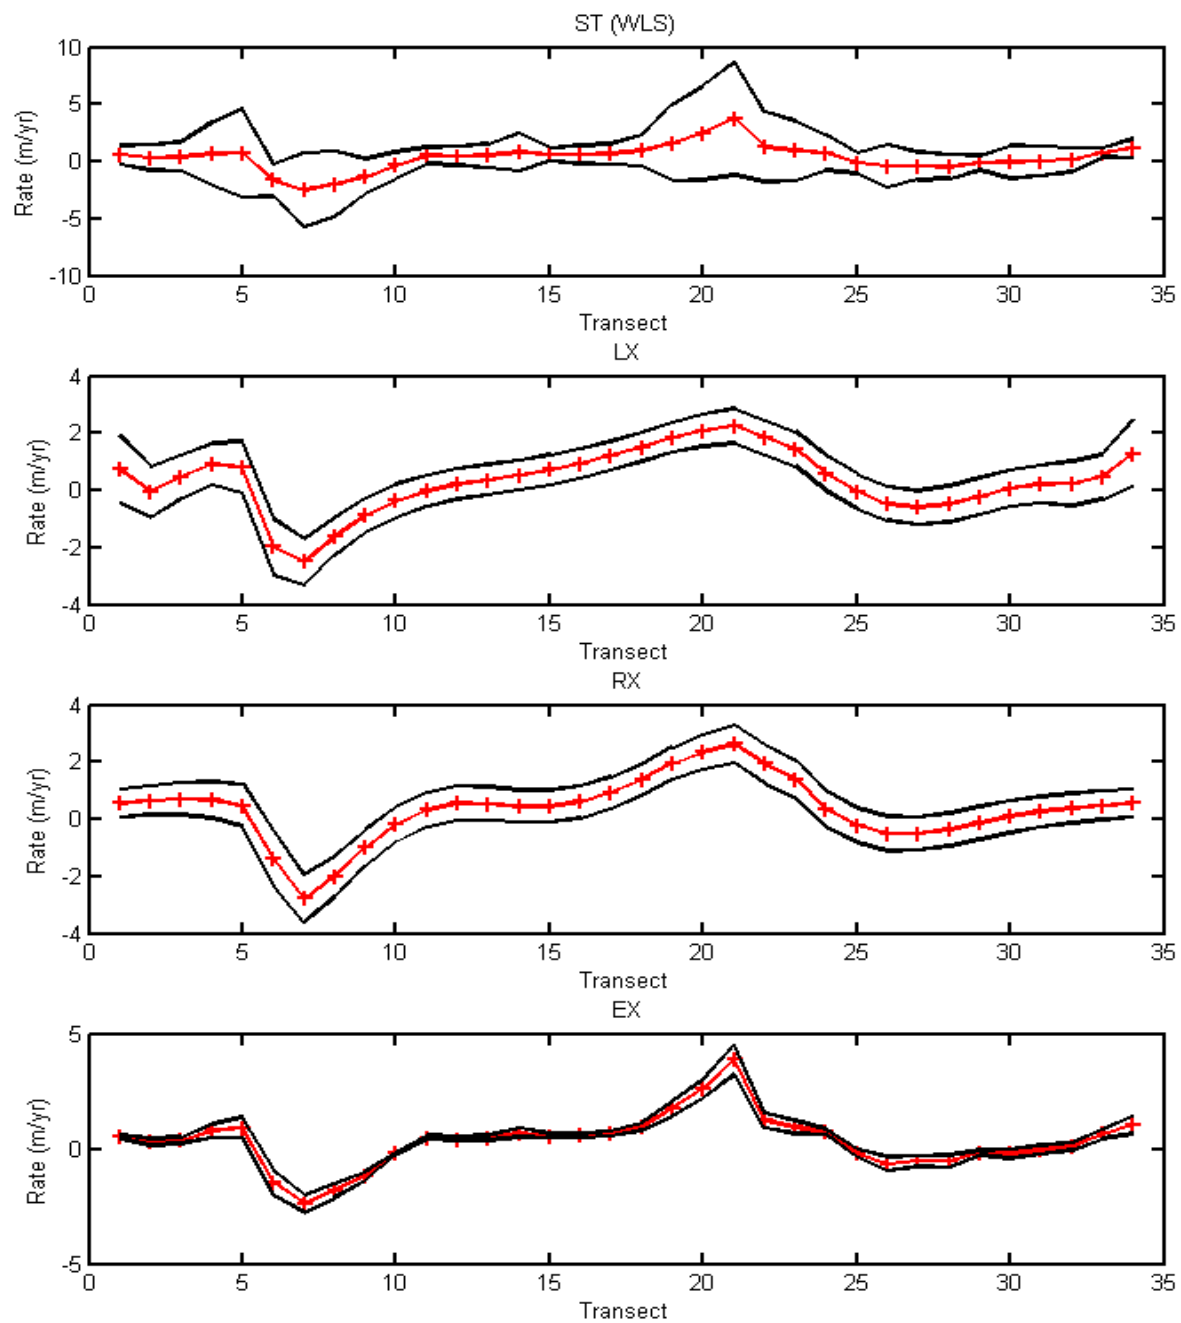
Figure 10. Shoreline change 1987-2006 and 95% confidence band.

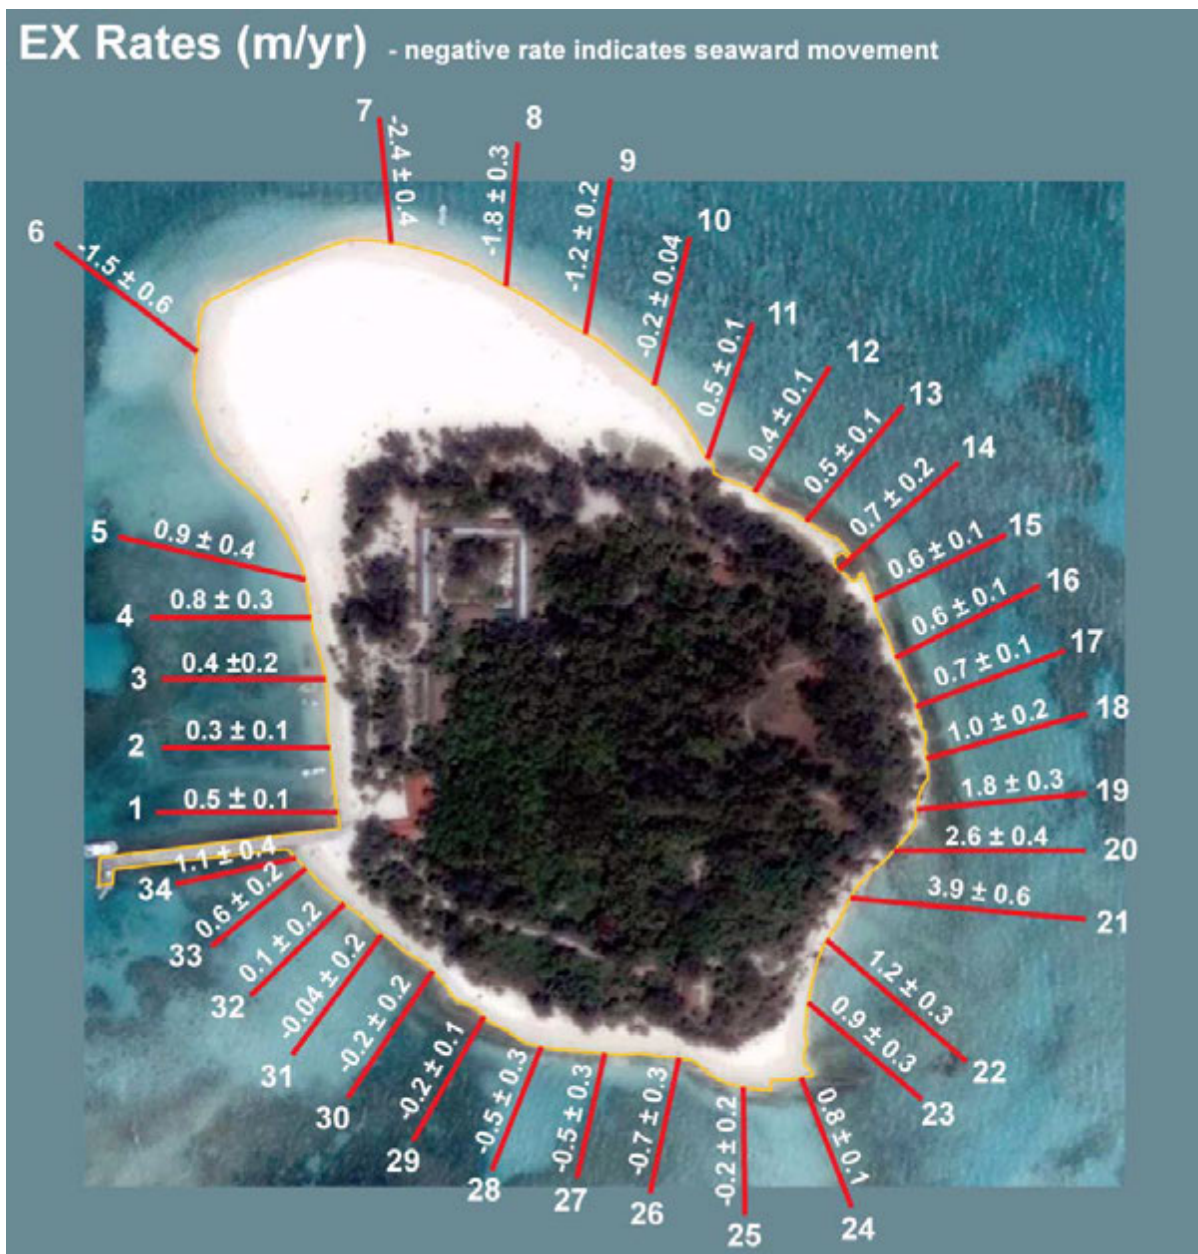
Figure 11. EX rates of historical shoreline change at Mañagaha Island 1987-2006 (-/accretion, +/erosion).

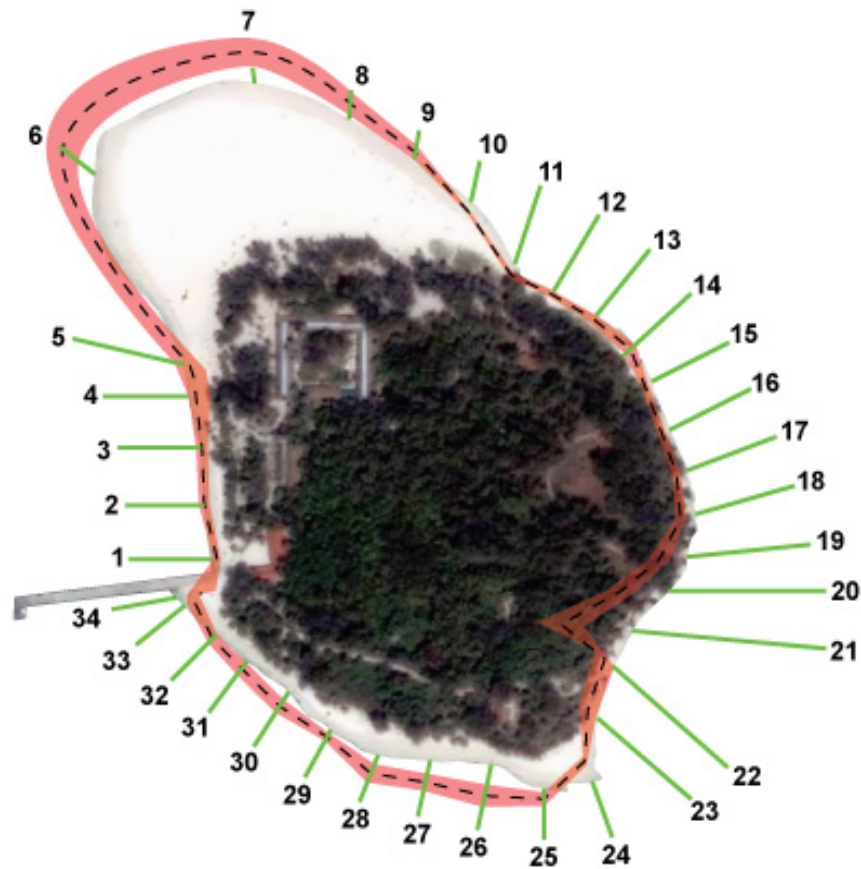
Figure 12. EX 10-year shoreline position (dashed line) with 95% confidence (red band) on 2006 Quickbird. As a result of the location and orientation of transect 21, the predicted shoreline position appears as a sharp indentation. This is due in part to the location of the transect (perpendicular to the trend of historical shorelines) and in part to re-orientation of the shoreline following debris removal in 1996. The true future shoreline will most likely be in the shape of a smooth, gradually curving arc at the same location.

Based on EX rates, it is possible to forecast the future shoreline hazard. Figure 12 illustrates the 10 year hazard zone and 95% confidence band based on the assumption of linear change over 1987-2006. However, if the rate of change has accelerated since 1996, this projection underestimates the hazard. This projection implies several consequences: 1) The NW shoreline will experience continued accretion due to sediment delivery largely from the east; 2) The eastern shoreline will experience continued sediment deficiency and chronic shoreline recession due to sediment loss to the NW and S with the greatest recession located in the area of transects

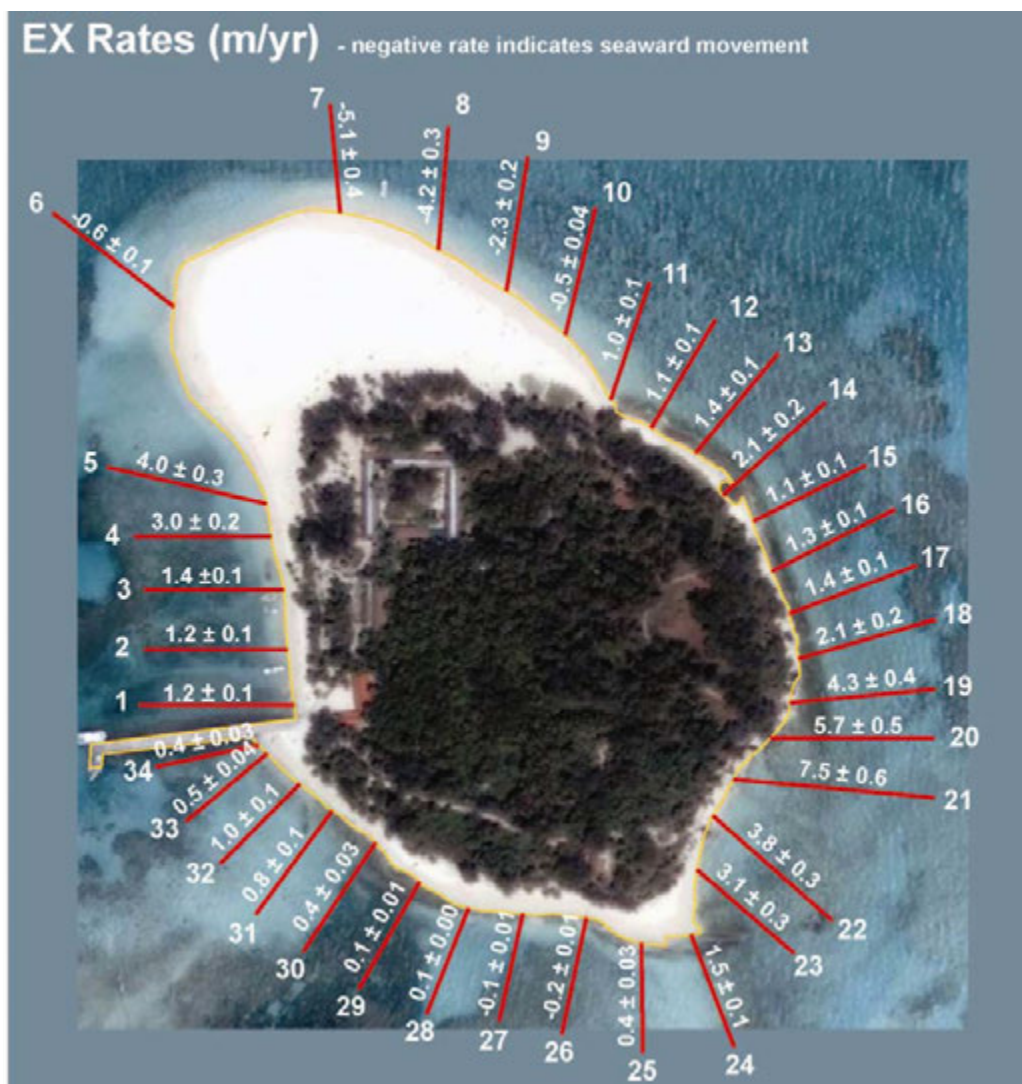
Transects 25-34 show a variable history, including a zone of transition from the adjacent eastern shoreline. Transects 23-25 indicate that erosion has moderated in the past 2 years. Whether this is short term or a new phase of shoreline stabilization will only be known in hindsight. This area is marked today by an accreting sandy spit reminiscent of earlier features on the island at this location. Continued monitoring is valuable in this regard. Transects 26-32 all show erosion since 1996 as well as no significant sign of decrease since that time. Field observations however indicate the shoreline has stabilized in the past year and former erosion has abated, at least temporarily. Overall transects 25-32 show continued erosion at rates that are less than the neighboring shoreline to the east. Transects 33 and 34 record moderate accretion, this is due to sand accumulation on the down drift side of the pier and is a localized effect.

Figure 13. Shoreline change 1996-2006, using EX (-/accretion, +/-erosion).

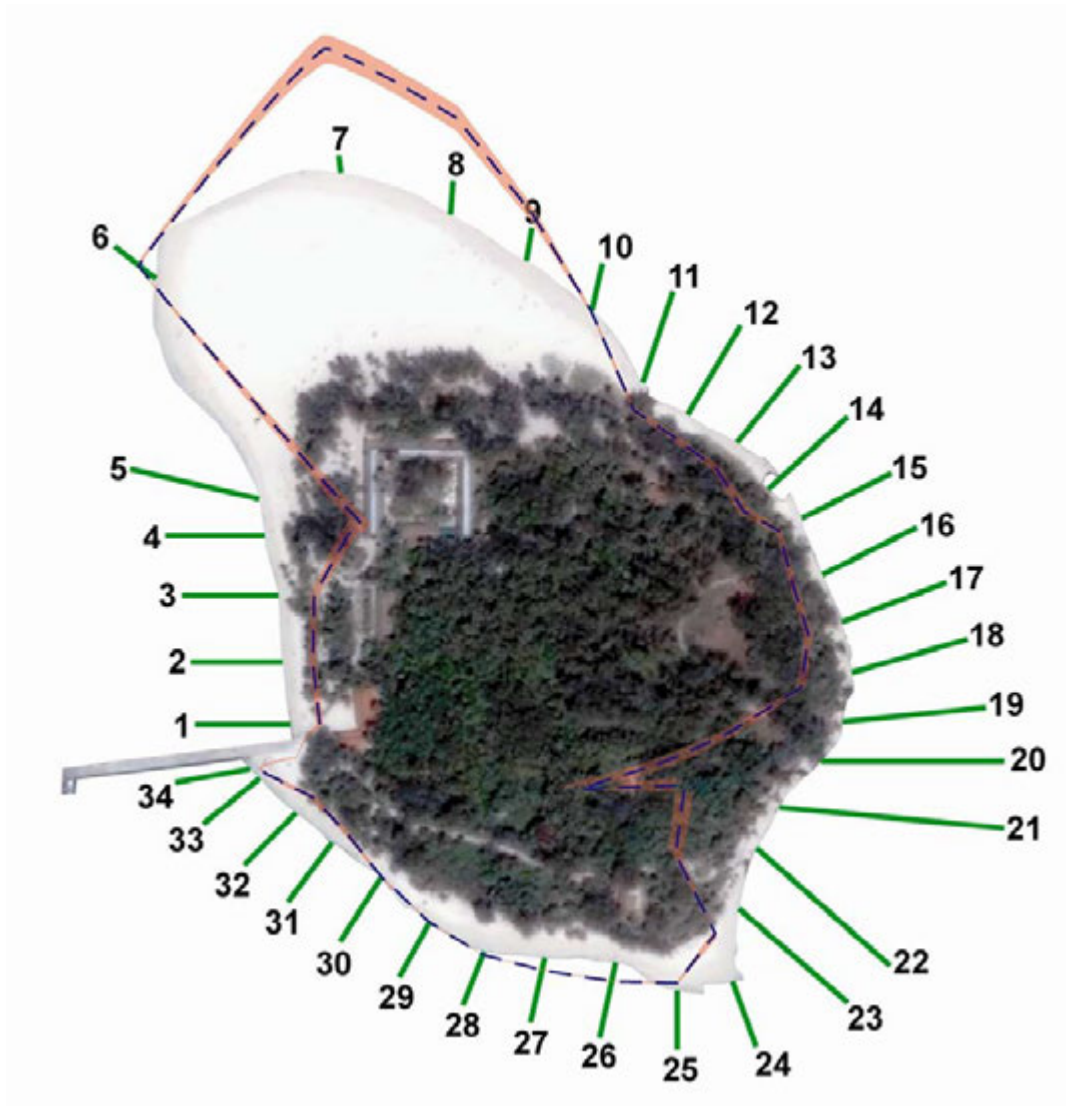
Figure 14. Map of 10 year hazard with 95% confidence (red band) based on EX model 1996-2006.

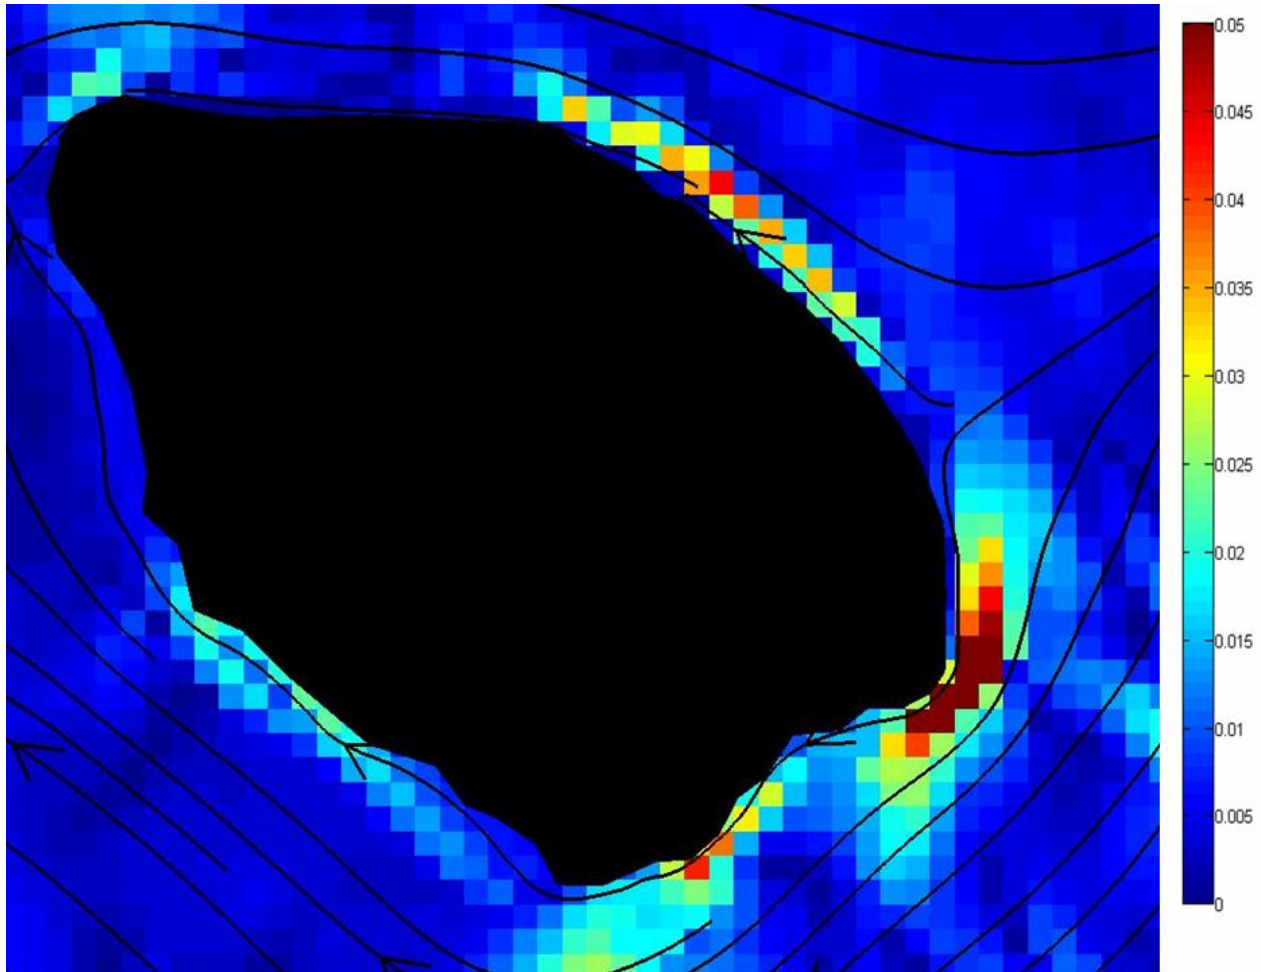
Figure 15. Average currents in m/s over several tidal cycles based on harmonic tides and wind forcing of 16 knots out of the east. Island outline represents the location of the 2006 vegetation line.

Modeling of current velocities reveals: 1) erosion at transects 1-5 on the west beach is not due to high current velocities, rather it is due to sediment starvation; 2) high rates of flow in the area of transects 11-23 indicate that erosion is related to scour and sediment transport away from this shoreline segment; 3) sediment is moving both clockwise and counterclockwise from the area of transects 18-22. Hence the area of greatest erosion (the eastern shore) is the likely source of sand to accreting segments at transects 6-10 and portions of the southern shore. 4) Currents generated by easterly trade winds split into two directions. One current travels to the west along the north shore and one current travels to the south along the eastern shore. This suggests that the area of greatest erosion is a null point marking the boundary between two littoral cells, one to the south

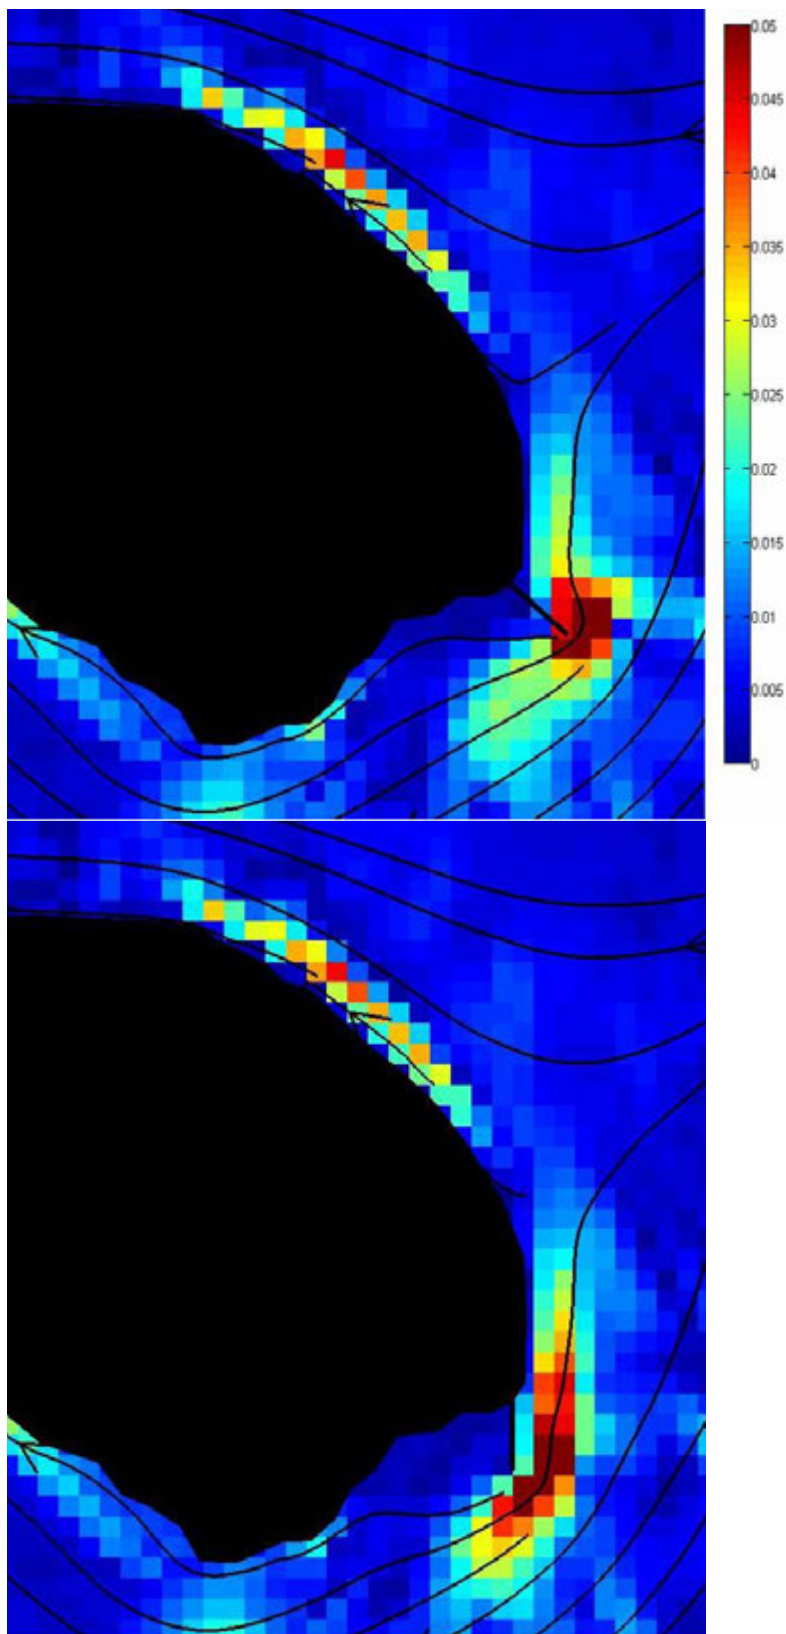
One approach to this is to test the use of a groin in the position and orientation of the lost debris. Figure 16 depicts the results of modeling two groin orientations, SE and S. The south orientation produces a larger wave shadow on the eastern shoreline which should lead to a reduction in erosion rate there. However, high current velocities at the location where the S groin attaches to the land indicate it may suffer flanking (erosion). Mitigation of this affect must be planned for. A SE orientation produces a reduced threat of flanking and better matches the position of the debris removed in 1996. Additionally, it is important to realize that reduction of erosion on the eastern shoreline will result in loss of sand in transport to the northwest. Accretion in the area of transects 6-10 will decrease and it is possible that the northwest coast may shift from accretion to erosion. Impacts to the west coast are uncertain.

Figure 16. Two groin configurations: SE and S. The S option offers greater protection to the eastern shore.

Given the volatility of the island to changes in wave exposure, any attempts at stabilizing the shoreline with a groin should use sand bags or some other temporary method that can be easily reconfigured or removed in case of unanticipated negative impacts. If sand bags are used, an offsite source of sand needs to be used in filling the bags to avoid impacting the limited sand budget at Mañagaha. Construction of a groin should be accompanied by sand back passing from the area of transects 6-10 into the lee of the groin to rebuild the shoreline in the area of transects 20-23. Consideration should also be given to sand passing onto the west beach in the area of transects 1-5.

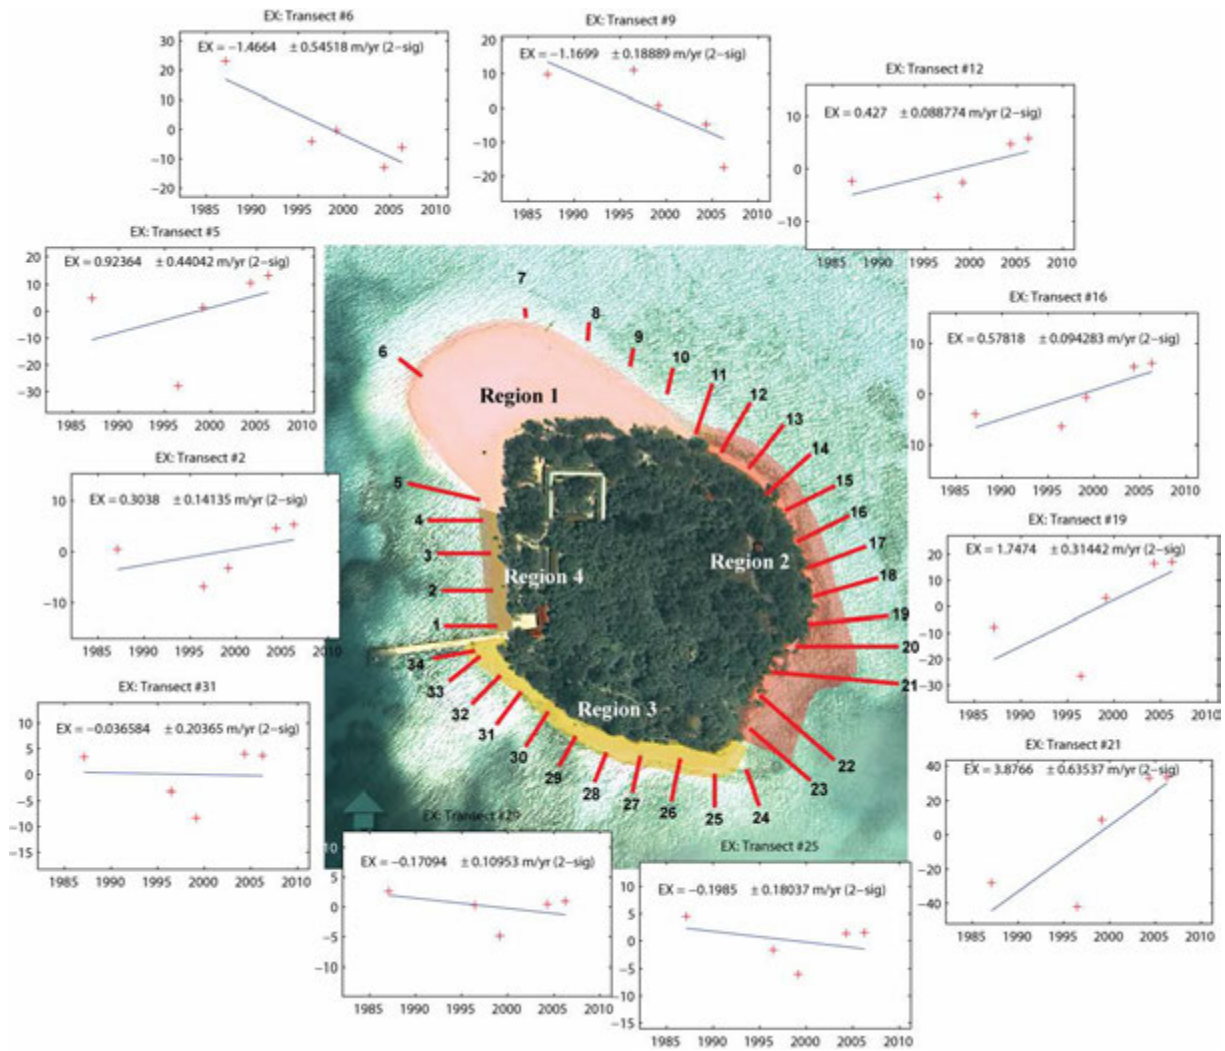
Below, we offer a general description of conditions at Mañagaha Island using this scheme. The shoreline has moved into a condition of net accretion in Region 1 largely due to trade-wind driven, alongshore sediment transport whereby sand in Region 2 feeds Region 1 (Fig. 18). Chronic erosion characterizes Region 2 as it yields sand to both Region 1 and the eastern section of Region 3 under energy conditions associated with typical trade wind flow. Region 3 is characterized by quasi-stability to moderate accretion in the eastern section due to sediment input from Region 2 and erosion in the central section that has perhaps temporarily stabilized (ca. March, 2007). Region 4, starved of alongshore sand delivery by accretion in Region 1, is sediment deficient. Aerial photographs also reveal down drift offset due to sediment impoundment in Region 3 by the pier.

Figure 17. Using EX modeling for the period 1987-2006, four general regions characterize Mañagaha.

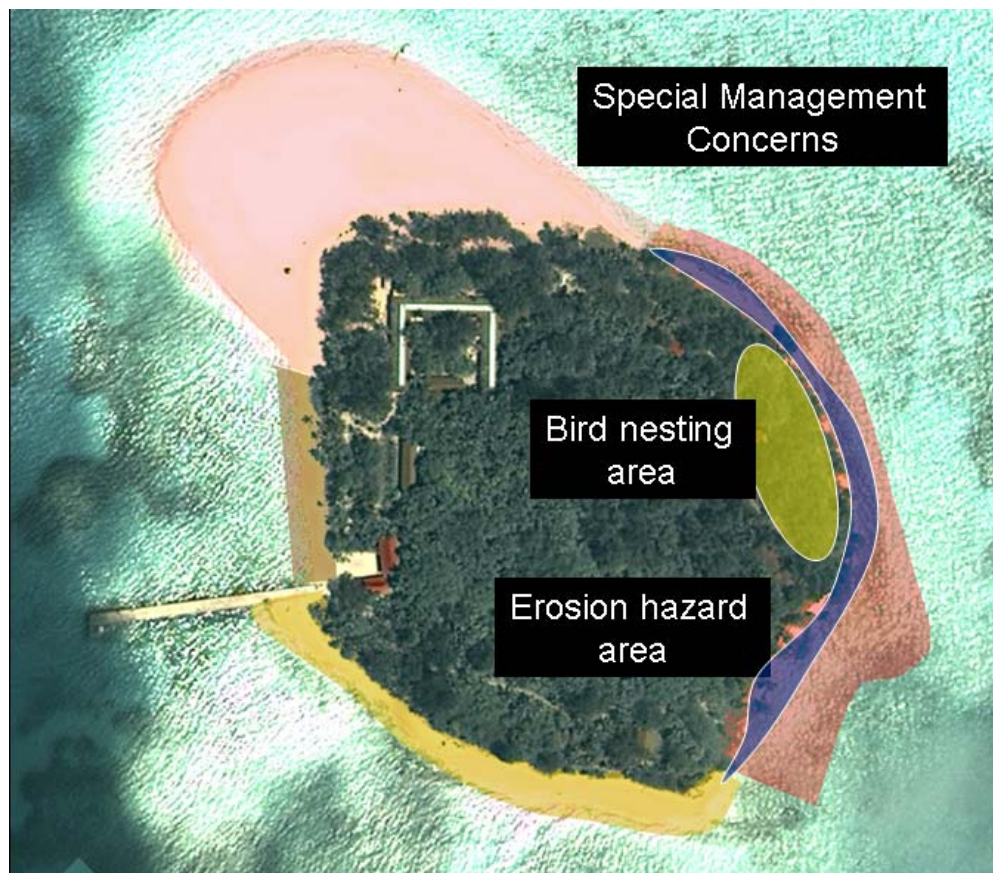
Erosion also undermines vegetation and exposes metallic and concrete debris. This and the fallen trees in Region 2 present a safety hazard for visitors. The concessionaire expressed concern that the debris is also unsightly and negatively impacts the visitor experience.

Figure 19. Special management concerns include visitor safety, visual impact, and a nesting area.

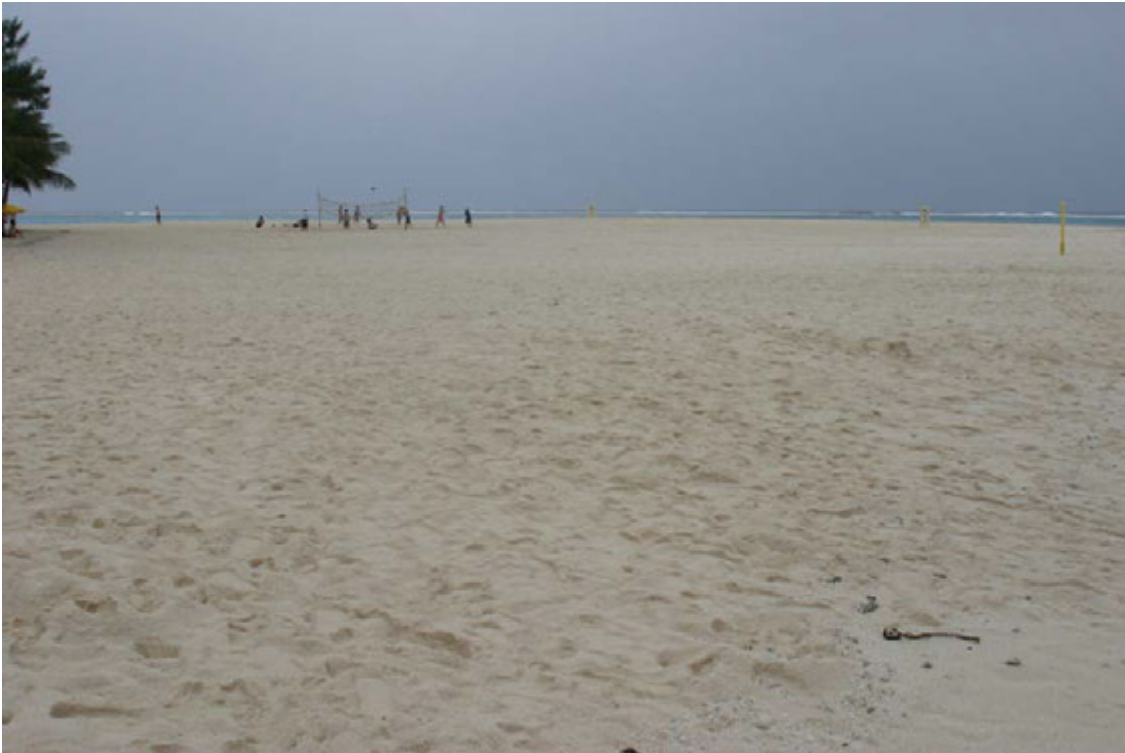
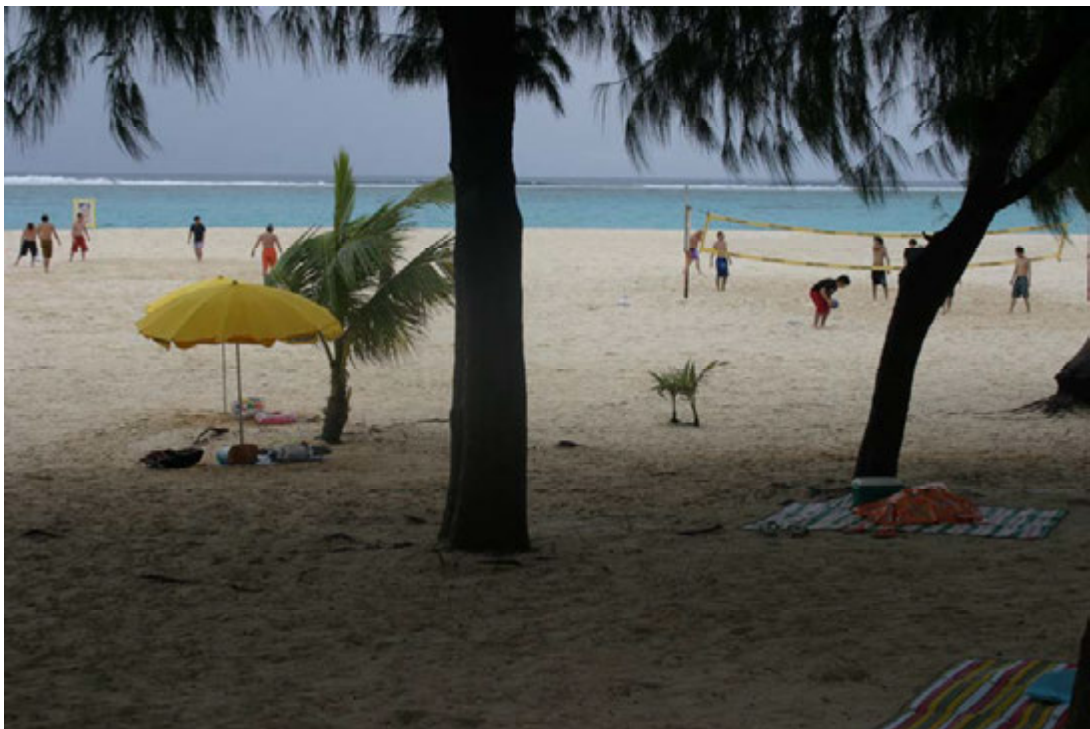
Region 1 is a broad accreting sandy plain that is generally extending in the north and northwest direction (Fig. 20).

Figure 20. View of Region 1 looking northwest along transect 6 (top) and north along transect 8 (bottom).

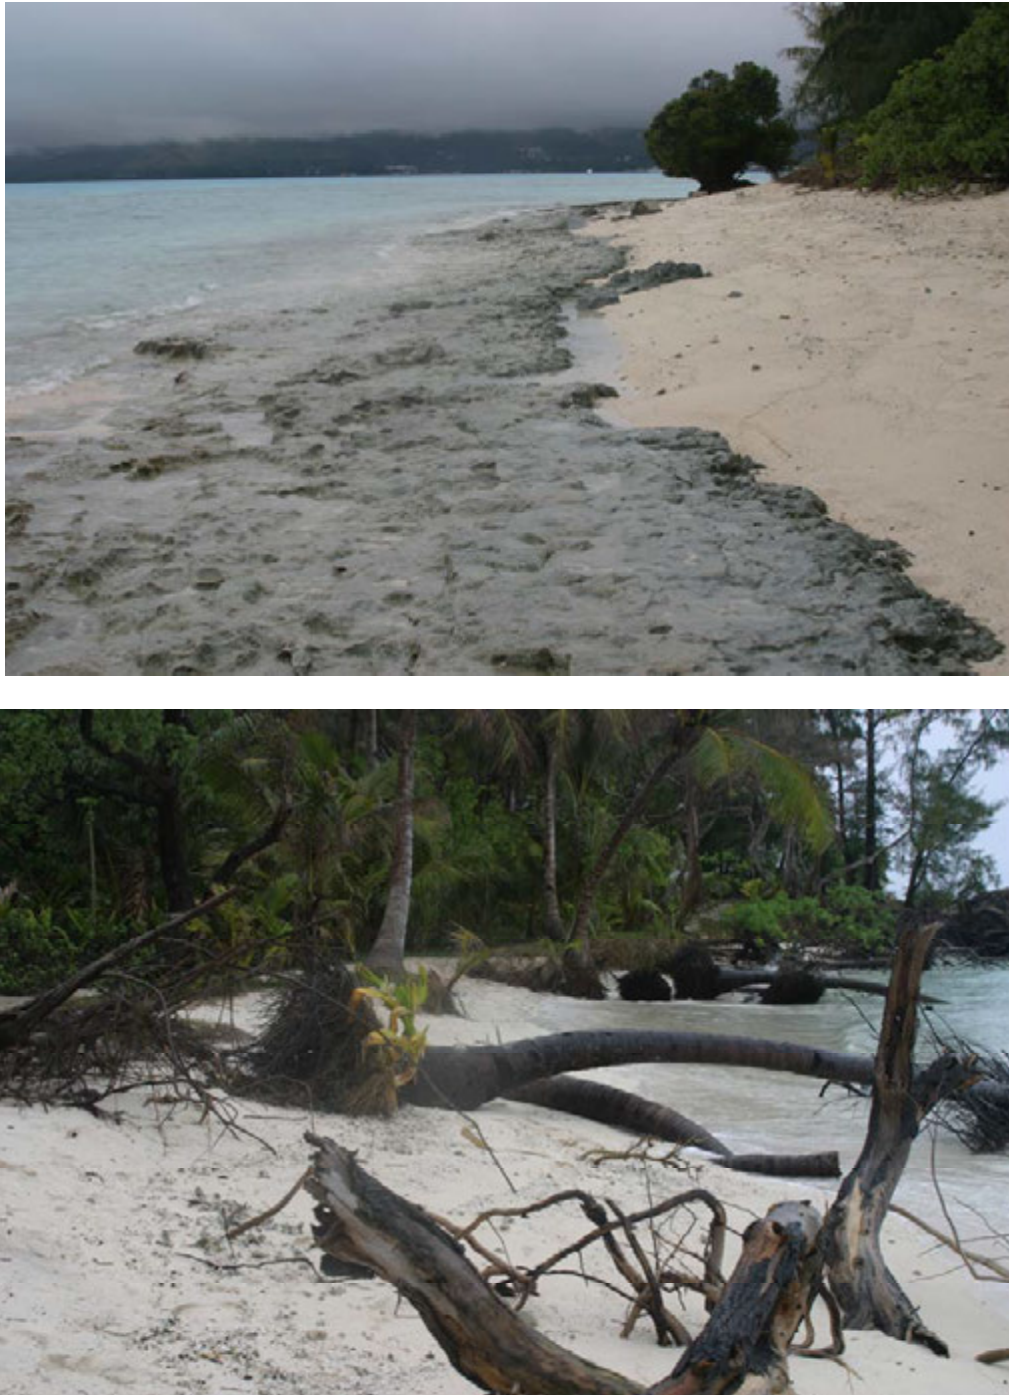
Region 2 faces north and east and is characterized by chronic erosion since the removal of debris located offshore of the sandy shoreline. Fallen trees, exposed beach rock, undercut vegetation, and recession of the upland are signs of ongoing chronic erosion (Fig. 21).

Figure 21. View of Region 2 looking east at the area of transects 12 and 13 (top) and looking north from transect 23 toward transects 22 and 21 (bottom). Note that a beach still exists despite land loss.

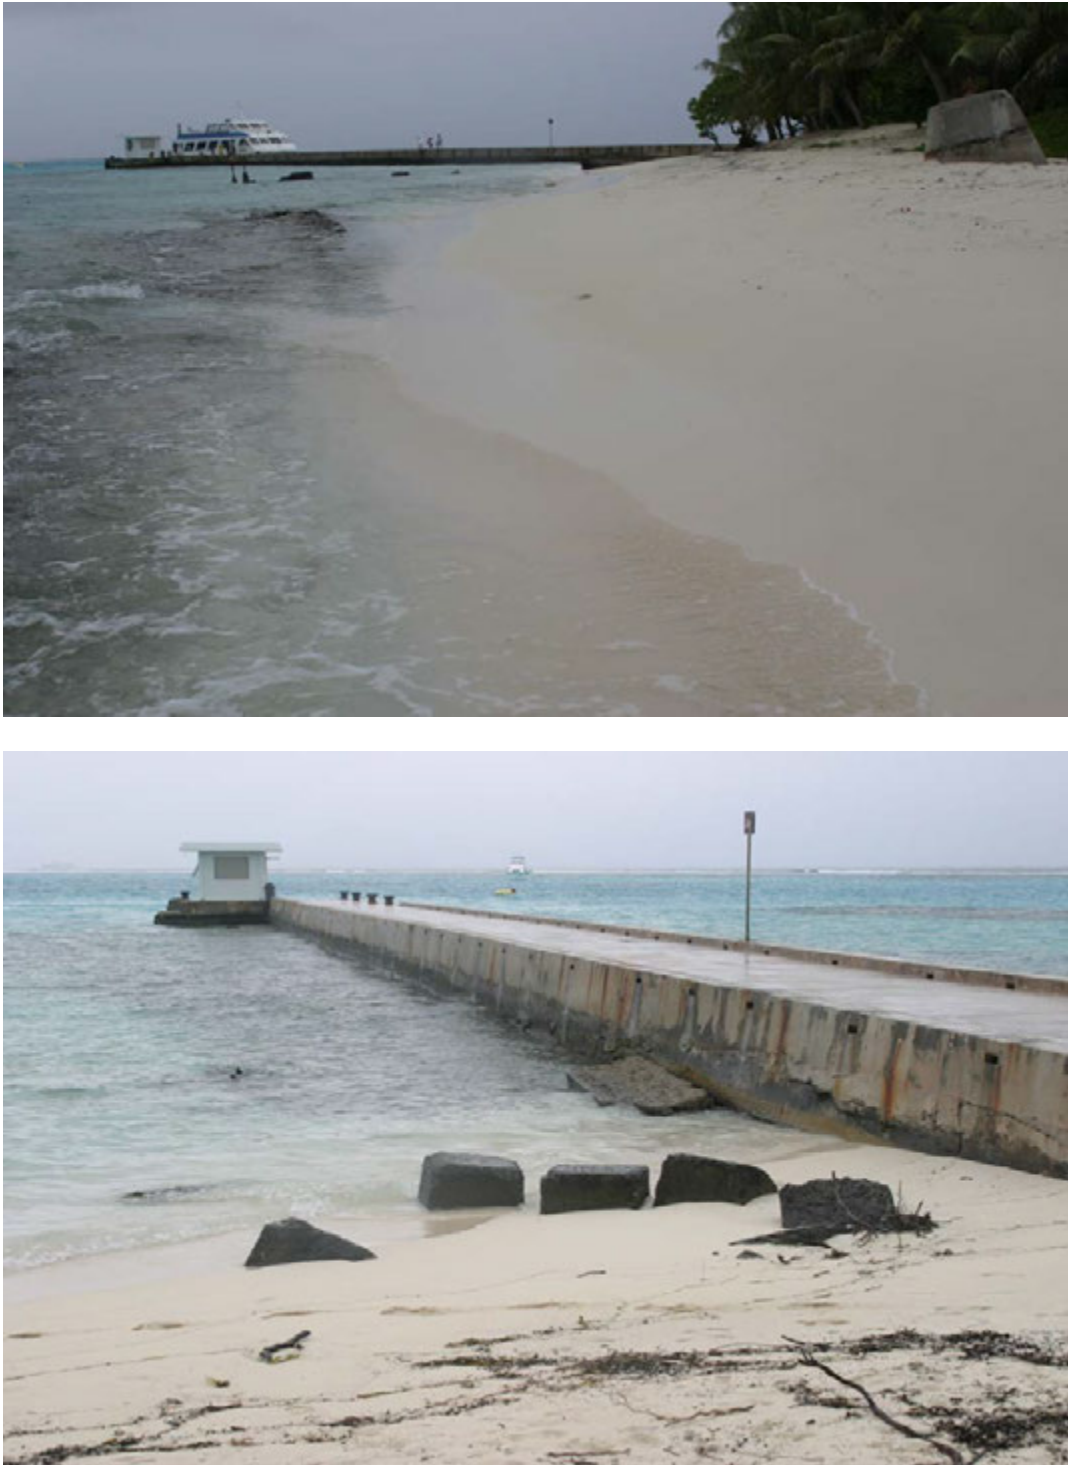
Region 3 has a southern exposure. The eastern portion (transects 25-28) has been quasi-stable to accreting and the western portion (transects 31-32) has been undergoing erosion. (Fig. 22).

Figure 22. Looking north toward the pier from transect 28 (top). View of flanking erosion on the south side of the pier (bottom).

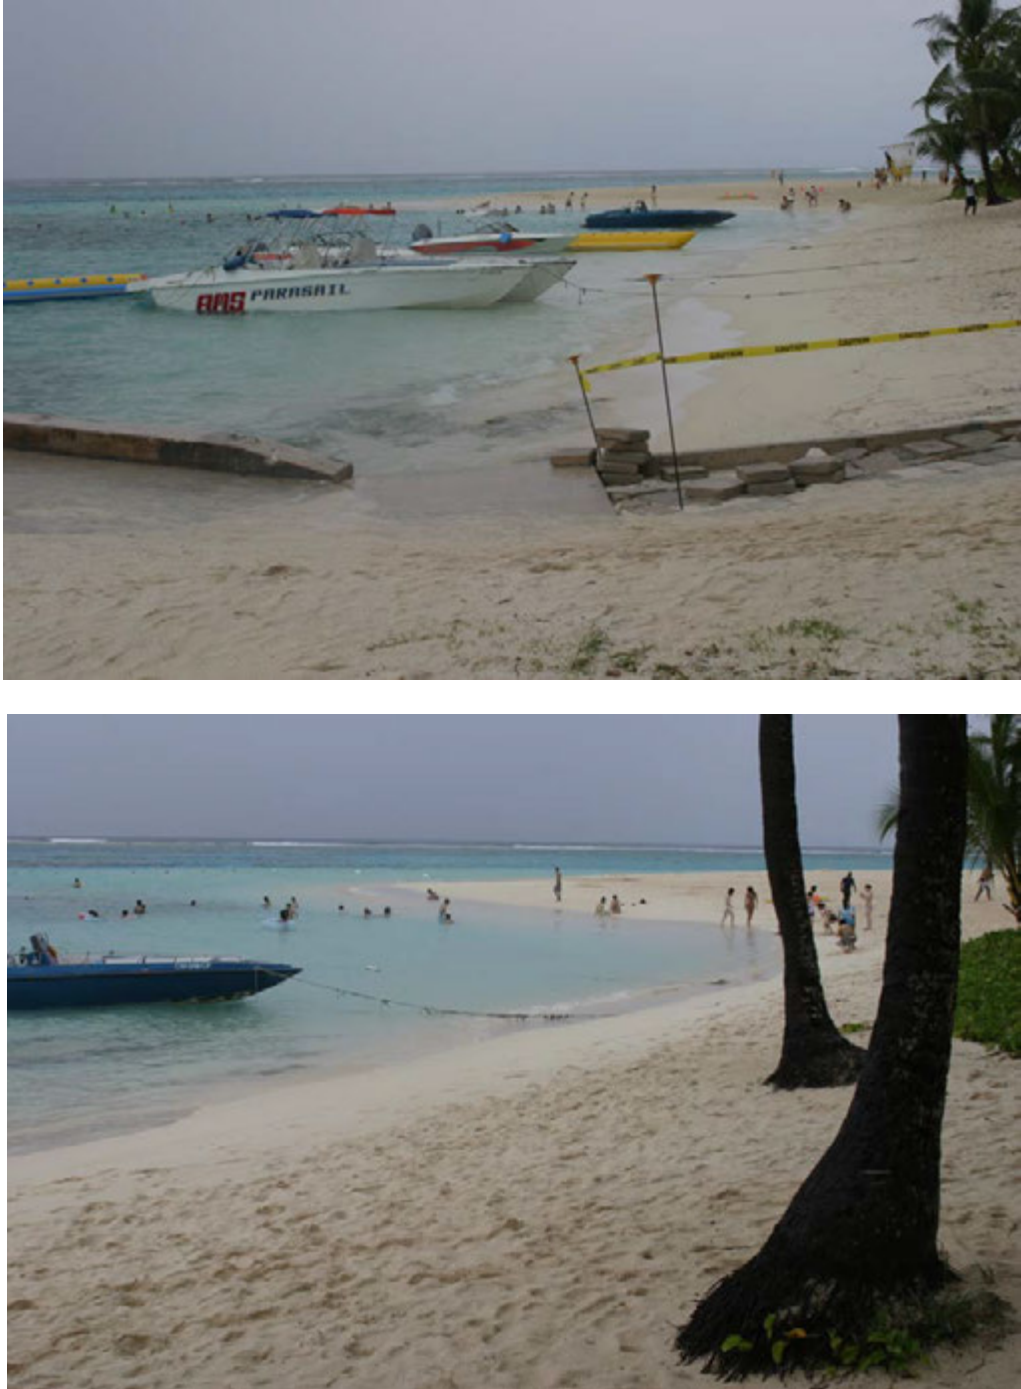
Region 4 is to the immediate north of the solid pier (Fig. 23). The pier acts as a groin and blocks sand movement from Region 3 into Region 4. However, it is also likely that Region 4 is eroding as a result of sediment deficiency due to accretion in Region 1.

Figure 23. View looking north from the pier (foreground) across all of Region 4 (top). View of receding shoreline in the northern portion (transects 4 and 5) of Region 4 (bottom).

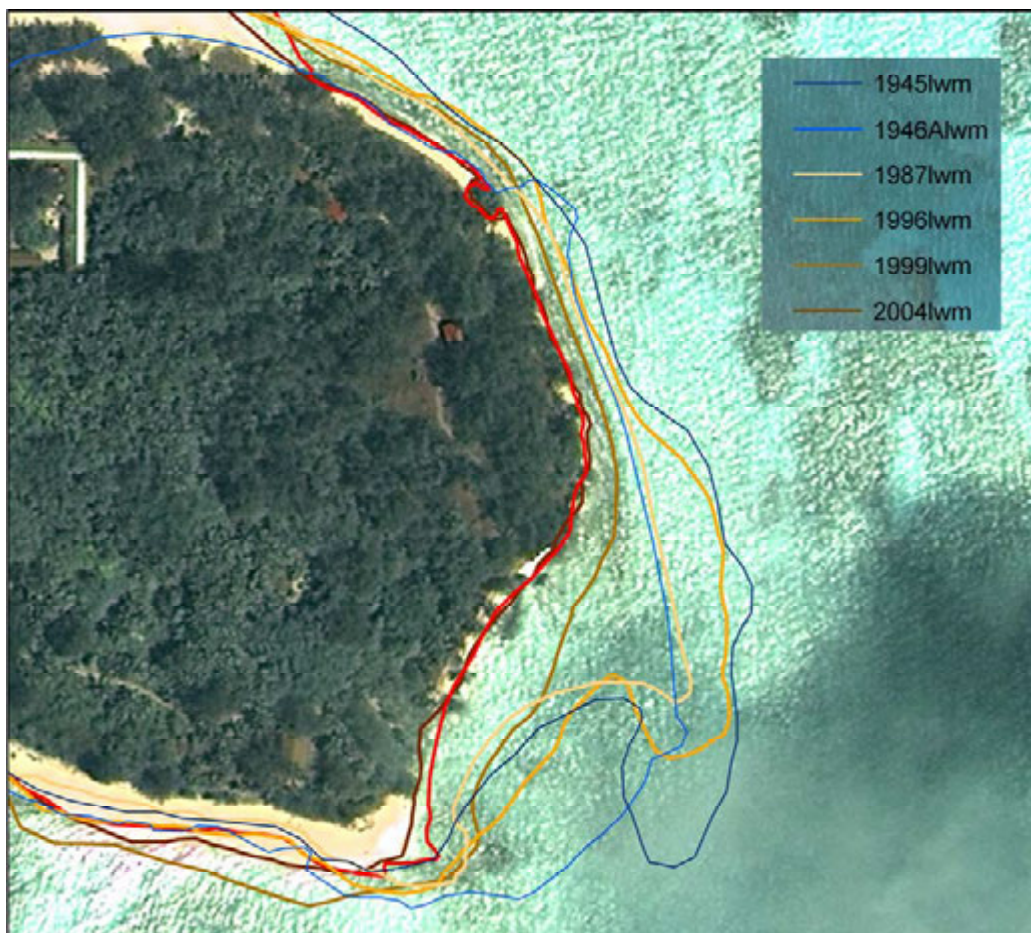
Figure 30. Changes on the eastern shore.

Alternatively, to avoid a structural approach, a sand back-passing system without a groin is recommended employing a pump in Region 1 that delivers sand to Region 2. If shoreline stability increases (erosion decreases) in the near term, before Summer 2009, then we recommend utilizing an elevated walkway in conjunction with leaving the shore in its present condition as the preferred option to accommodate management concerns in light of the visitor experience.

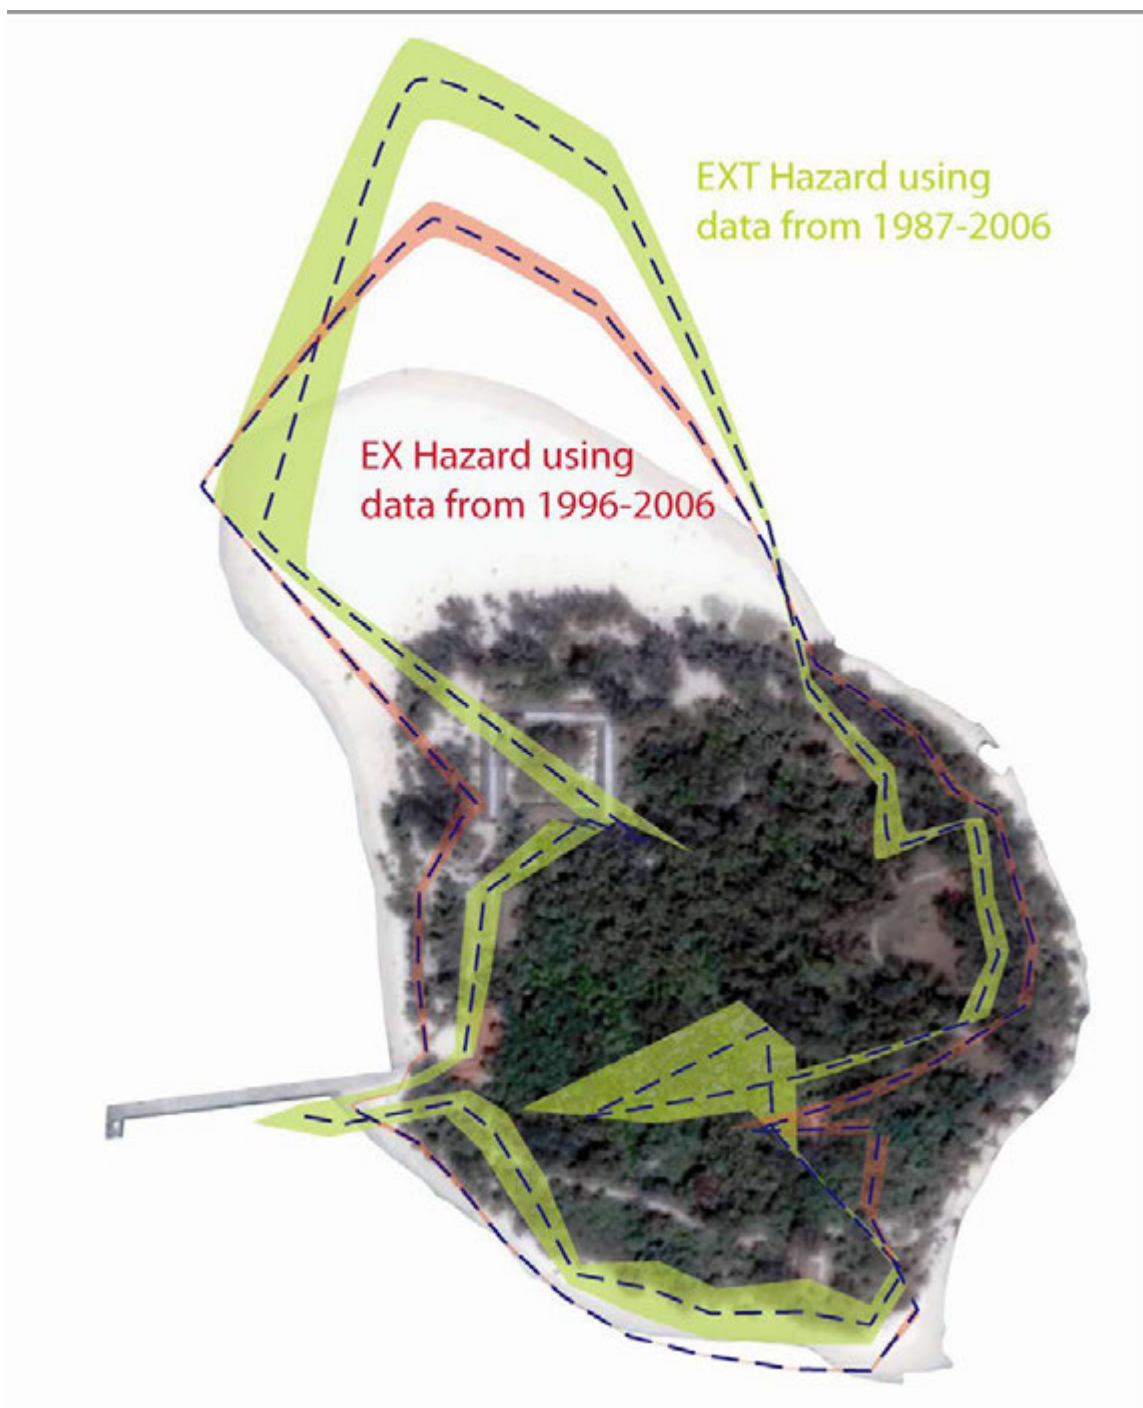
APPENDIX D

Appendix D displays a 10 year shoreline hazard map based on extrapolation of EXT (1987-2006) and EX 1996-2006 rates to the year 2016. It should be emphasized that a 10 year projection on the basis of only 10 years of data is not statistically valid. However, if present rates of erosion continue, or accelerate, the projection may be valid and for this reason it is especially important to continue to monitor the shoreline to test the validity of the projection.

10 year shoreline hazard projection using EXT (1987-2006) and EX (1996-2006).
