Shoreline Monitoring Beach Profile Report: Saipan and Mañagaha

August 2024

Division of Coastal Resources Management
- CNMI Bureau of Environmental Coastal
Quality

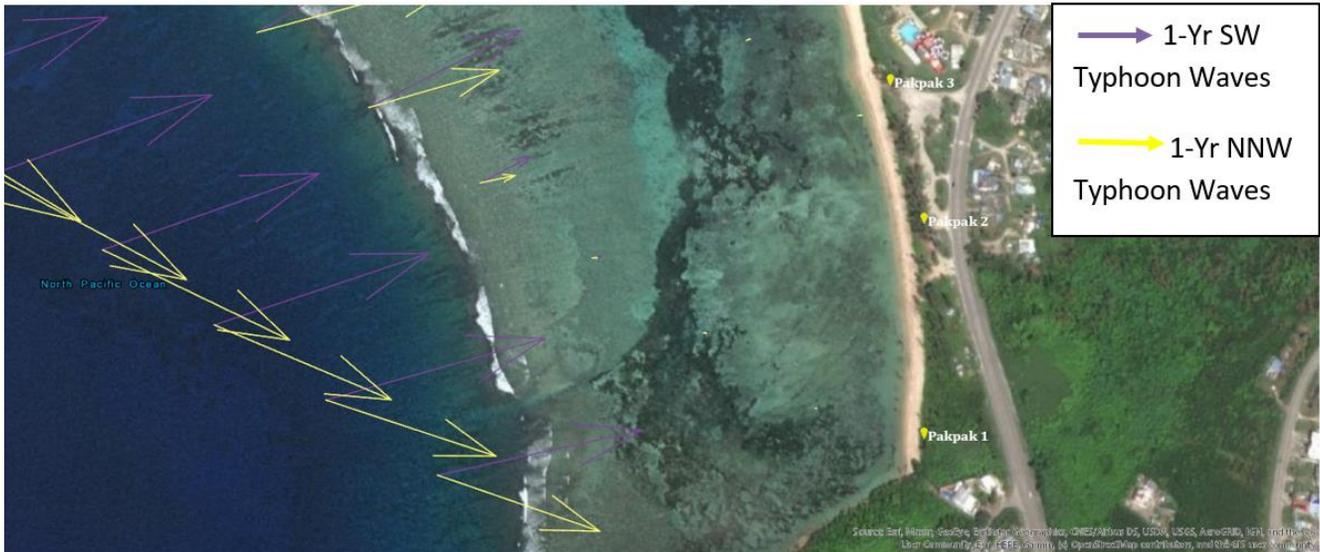
Figure 9 - Hydrodynamic map of the stretch of Pak Pak. The arrows show the intensity of waves generated from the south west (in dark purple) and the northnorthwest wave conditions (in yellow).

Sheltered by the nearby reef (approximately 500 meters away) and Agingan Point, Pak Pak Beach has exhibited a stable shoreline since 2016. In 2018, a Super Typhoon Yutu-driven storm surge damaged vegetation. Pak Pak Beach's vegetation has matured, signifying stability since then.

As observed from the Hydrodynamic study, southwest typhoon conditions appear to be more damaging than north-northwest due to the increased swell energy. However, the beach may receive sediment from the adjacent reef and Agingan Point based on the shards of glass, reddish sand color, and occasionally dark rubble comprising the nearshore area.

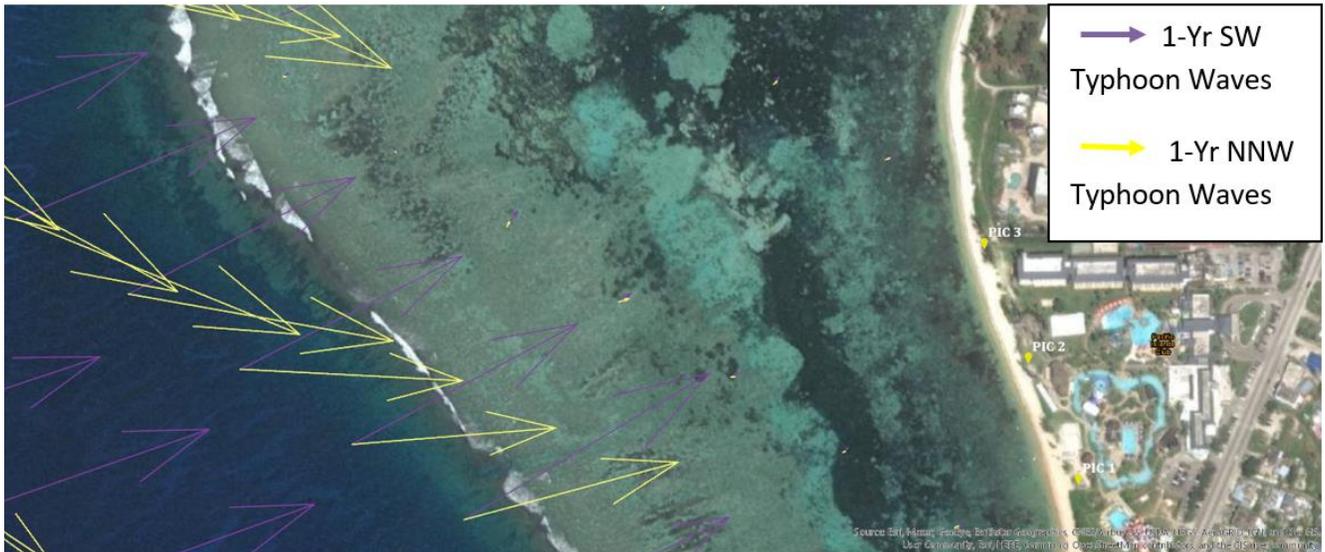
Figure 11- Hydrodynamic map of the stretch of PIC. The arrows show the intensity of waves generated from the south west (in dark purple) and the northnorthwest wave conditions (in yellow).

The “Pacific Islands Club” site (PIC) is adjacent to the Chalan Kanoa reef, which provides wave buffering 500 meters away from the headstakes. This shoreline is subjected to storm-induced erosion. The storms of 2018 have damaged the shoreline. In response to the incidental erosion, the Pacific Islands Club Saipan hotel placed sand bags and boulders to stabilize the highly eroding storm berm not too far from the Seaside Grill facilities. Fortunately, the storms during this period have not damaged the berm. Wild native vegetation has prospered since their settlement after the significant erosion events. Southwest typhoon conditions appear to be more damaging than north-northwest especially due to the proximity of the storm. Future intense storm surge events coupled with sea level rise in the future may erode the shoreline further.

- STABLE
- Wrackline that ranges 48 – 50 ft and an elevation difference of 9 ft
- Construction of a hotel is located in the backshore
- Based on the Shoreline linear regression analysis (see pg 21), the shoreline has a rate of 0.4 ft from 2016-2024.

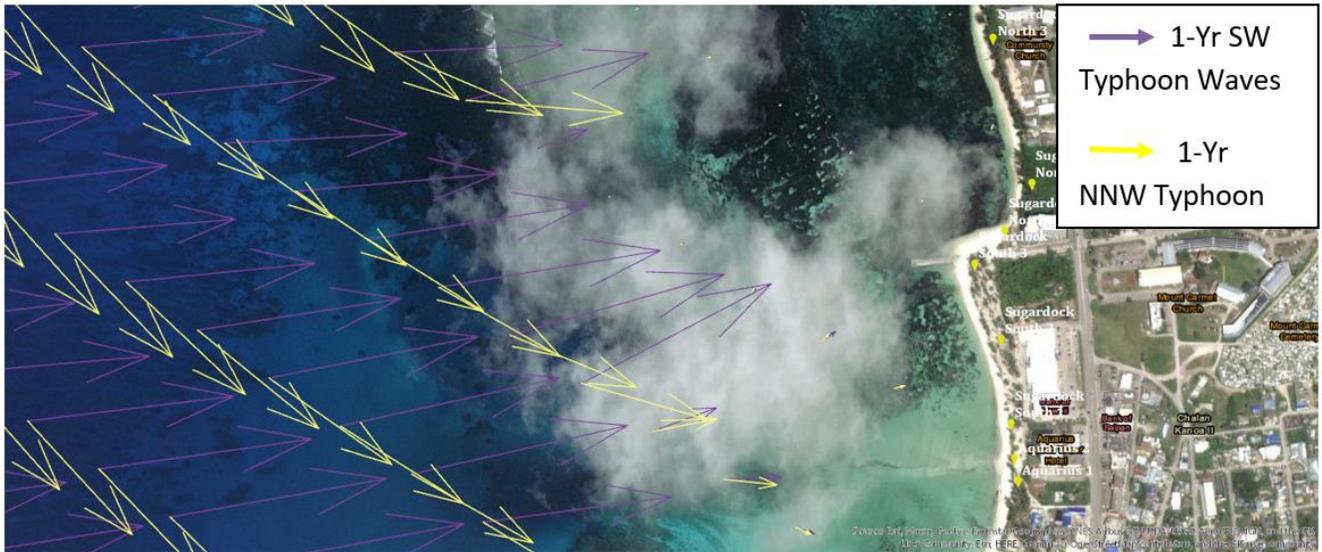
Figure 14 - Hydrodynamic map of the stretch of Aquarius with the open wave energies entering through the channel opening. The arrows show the intensity of waves generated from the south west (in dark purple) and the northnorthwest wave conditions (in yellow).

Aquarius is parallel to the Chalan Kanoa channel, which greatly influences movement through the flow in and out of the southern lagoon. The nearby sand bar indicates the active sediment transport in this area during higher wave conditions. It also acts as a sand source, filling in shoreline areas during gentle wave conditions (winterly). Depending on their direction and strength, waves can pull sand into the water and push sand back up to shore. The gentle northeast winter trade winds have been observed to push sand up into the shore.

Overwhelming tidal flows from the channel down south may impact this site during both typhoon wave conditions. It appears that southwest conditions could greatly impact this site. Under southwest conditions, longshore transport could potentially be going from south to north while north-northwest conditions indicate the opposite.

- Discontinued; Previously ACCRETING
- Wrackline that ranges 35 – 92 ft with an elevation difference of 10 ft
- Short-term erosion events have occurred. The sand bar could influence this dynamic behavior, suggesting that sand is pushed during typical winter conditions and pulled during typhoon conditions.
- Based on the Shoreline linear regression analysis (see pg 31), the shoreline has a rate of +1.9 ft from 2016-2023.

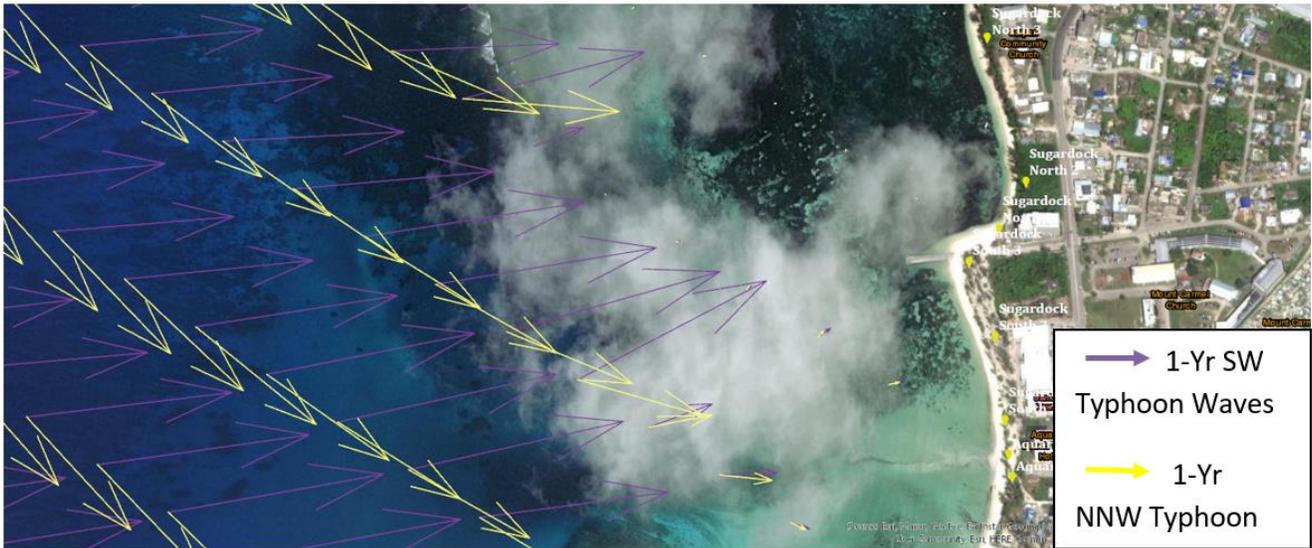
Figure 16 - Hydrodynamic map of the stretch of Sugar Dock with the open wave energies entering through the channel opening. The arrows show the intensity of waves generated from the south west (in dark purple) and the northnorthwest wave conditions (in yellow).

Parallel to the Chalan Kanoa Reef and channel, the Sugar Dock shoreline is dynamic given the sediment transport sensitivity to the dock and the channel. During typhoon conditions, the channel may exacerbate and even shift sediment transport processes. The dock lost its ability to allow sediment passage underneath the infrastructure from north to south. The result is a beach on the northern side of the dock rather than a deep boat ramp, causing a public access issue for those who need to launch their boats. To resolve this issue, the beach has been dredged in early August 2024. Plans exist to demolish and rebuild the dock to an improved design allowing for sediment transport.

The north of this accreted area was observed with less of a berm and a slightly steeper shoreline, suggesting a sediment deficiency. Beach loss by future erosion and storm surge threatens the Saipan Community School and Church and the Tasi Homes complex.

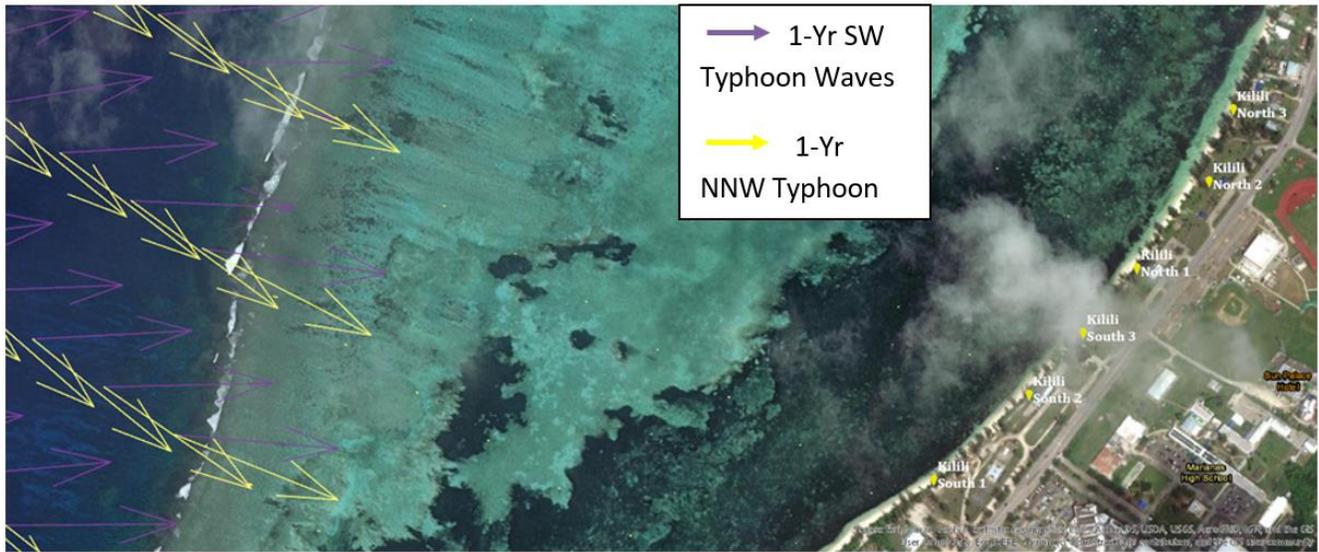
Figure 19 - Hydrodynamic map of the stretch of Kili Beach The arrows show the intensity of waves generated from the south west (in dark purple) and the northnorthwest wave conditions (in yellow).

Kilili Beach is protected by a fringing reef located approximately 4,500 feet away. Erosion has been observed, but natural sediment input suggests that the lost beach may return seasonally and rapidly. Historical shoreline change indicates that this shoreline has experienced cycles of erosion and accretion, with rates of up to about 1 meter per year for either condition (SASEA, pg 112). Seasonal accretion rates of under 1 foot support this. The underwater sand sources are closer to the reef.

Information from a cultural practitioner familiar with this shoreline suggests that this stretch of beach is at risk of storm surge during powerful storm events. It seems that southwest conditions could significantly impact this site. Kilili Beach shows noticeable variation in seasonal wave conditions. However, obtaining a more detailed understanding of nearshore dynamics might help explain longshore processes in this area.

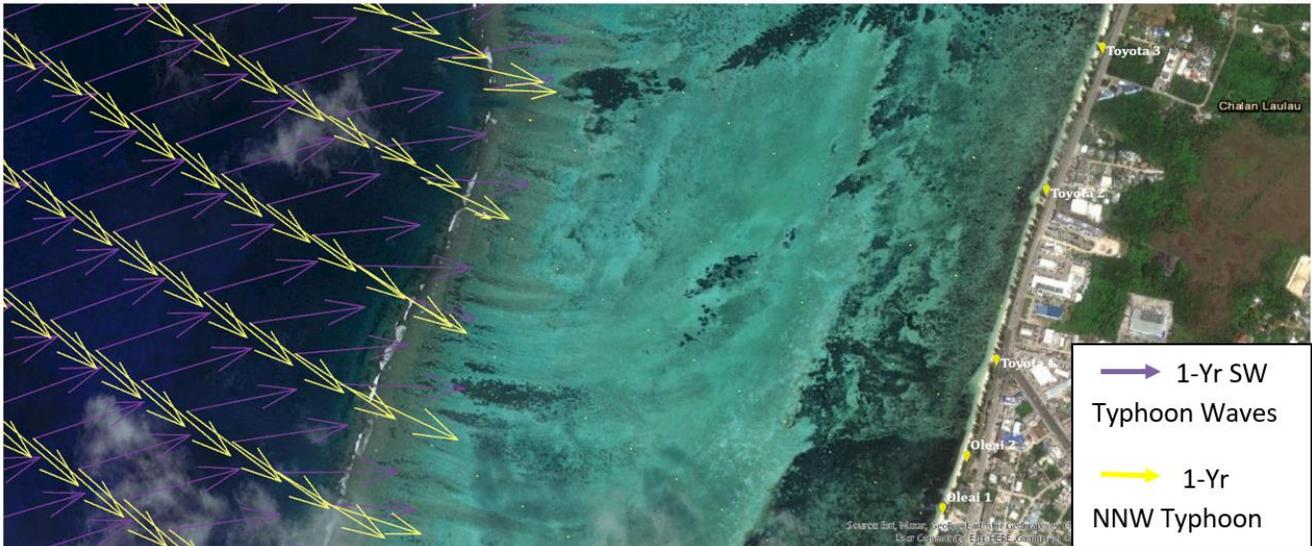
Figure 21 - Hydrodynamic map of the stretch of Oleai and Toyota (close to the traffic light) with the ocean wave energies buffered by the reef. The arrows show the intensity of waves generated from the south west (in dark purple) and the northnorthwest wave conditions (in yellow).

It is crucial to implement stabilization measures to protect the restaurant infrastructure from the encroaching waterline. Monitoring the shoreline position can aid in making informed decisions to address this issue. Despite occasional erosion events, the beach seems to be relatively stable. However, during typhoon wave conditions, wave overtopping and overwhelmed tidal flows could impact this area. It seems that southwest conditions may have a significant impact on this site.

- STABLE
- Wrackline that ranges 8 – 33 ft and an elevation difference of more than 6 ft
- Tides and seasonal wave conditions influence the beach width. Restaurant management grooms the shoreline by pushing washed up debris more inland in a pile.
- Based on the Shoreline linear regression analysis (see pg 58), the shoreline has a rate of -0.2 ft from 2016-2023.

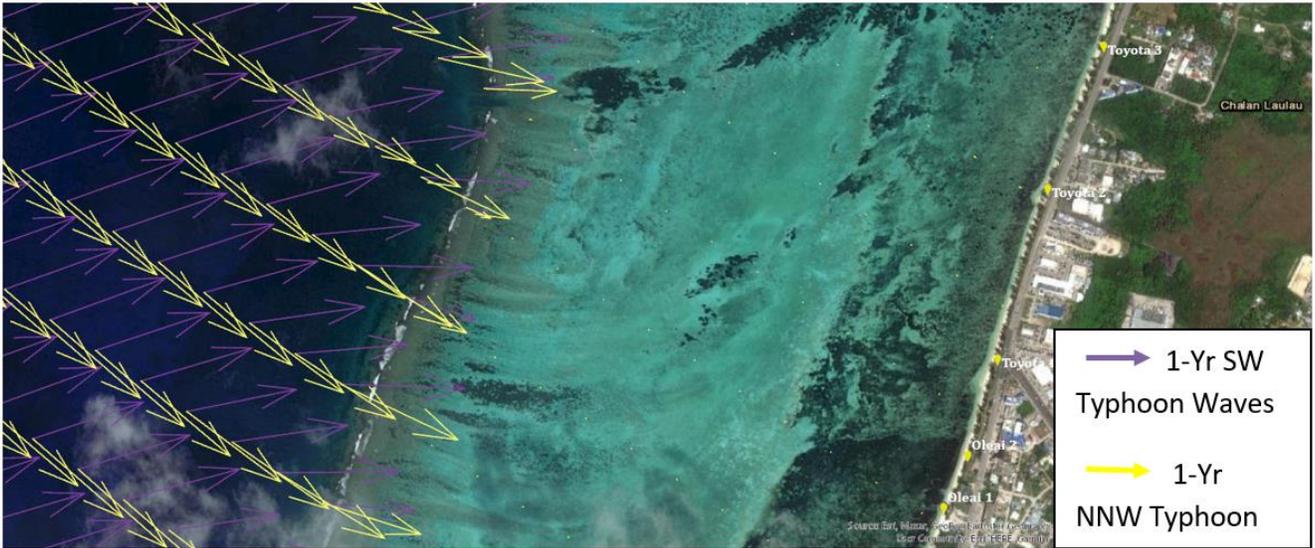
Figure 23 - Hydrodynamic map of the stretch of Oleai and Toyota (close to the traffic light) with the ocean wave energies buffered by the reef. The arrows show the intensity of waves generated from the south west (in dark purple) and the northnorthwest wave conditions (in yellow).

The Toyota shoreline stretches from the traffic light to the walled structures beyond the boardwalk of Beach Road pathway. This area has historically experienced damage after storm surge events, affecting the pathway infrastructure. During low tide, the exposed shoreline provides space for fishing.

The rise in sea level poses a threat to this shoreline, as well as the developed areas behind it, including the Toyota intersection and surrounding businesses. The strong wave energy during typhoon conditions causes erosion, leading to a decrease in shoreline width. This can result in wave overtopping and overwhelmed tidal flows during typhoon wave conditions. However, the shoreline seems to gradually recover after these events.

- ACCRETING
- Wrackline that ranges 30 – 58 ft and an elevation difference of 8 ft
- Periods of erosion and accretion
- Based on the Shoreline linear regression analysis (see pg 63), the shoreline has a rate of +0.7 ft from 2016-2023.

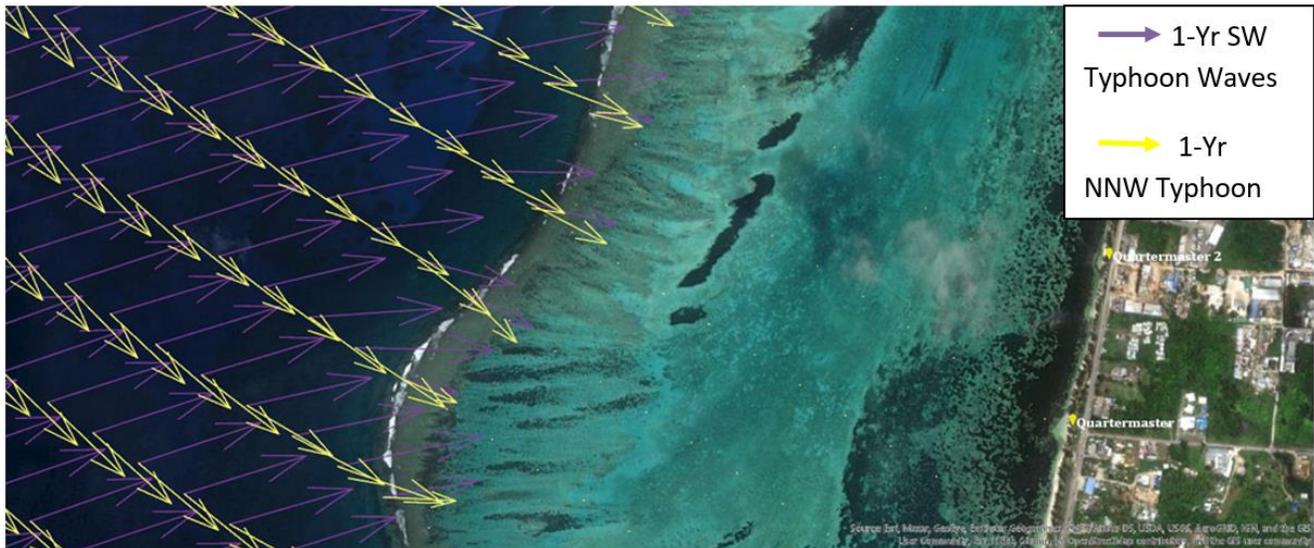
Figure 25 - Hydrodynamic map of the stretch of Quartermaster with the ocean wave energies buffered by the reef. The arrows show the intensity of waves generated from the south west (in dark purple) and the northnorthwest wave conditions (in yellow).

The Quartermaster shoreline has very few sandy areas. The beach profiles suggest that the area has been relatively stable or dynamic since the beginning of this program, likely due to sediment transport influenced by the flows of the Light House Channel and the outfalls. However, the short length of this shoreline is alarming and indicates high vulnerability to storm surge and sea level rise. The backshore has critical infrastructure, including Beach Road, in close proximity. The headstakes are a few feet away from the park infrastructure and then several feet away from the main road.

Seagrass beds help in reducing wave energy. However, other stabilization measures have been sought to address the loss of shoreline. This shoreline has a moderate steepness with high tidal influence. Both wave overtopping and overwhelmed tidal flows may impact this site during typhoon wave conditions. It appears that southwest conditions could greatly impact this site. However, a better understanding of nearshore dynamics may provide insight into longshore processes for this area.

- STABLE
- Wrackline that ranges 30 – 47 ft with an elevation difference of 6 ft
- Low tide difference is highly noticeable
- Based on the Shoreline linear regression analysis (see pg 69), the shoreline has a rate of +0.13 ft from 2016-2023.

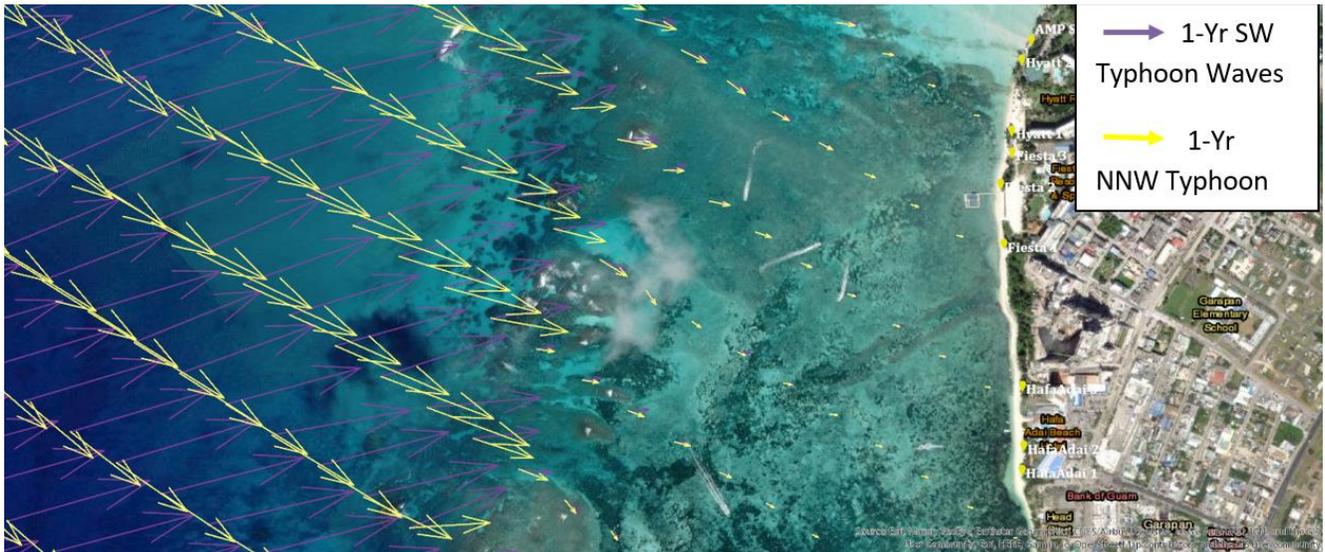
The beach at Grandvrio Hotel, DCRM calls the "Hafa Adai site", is expanding due to the accumulation of sand in the Garapan Lagoon next to a patch reef. This growth is in contrast to the shorelines of Fiesta and Hyatt to the north, as well as the Garapan district shoreline to the south. The presence of thriving young ironwood trees in the nearshore area indicates that this location has not been damaged by the storms of 2021-2022, but rather may have experienced the deposit of sand during storm events. The outfall south of the hotel is believed to have a hydraulic impact on the shoreline, but real-time monitoring efforts have not observed its direct influence on the accumulation. It is possible that sediment from the north is shifting towards the south. Additionally, this area provides better shelter from typhoon waves compared to the northern sites.

- ACCRETING
- Wrackline that that ranges 40 – 88 ft and an elevation difference of 6.5 ft
- As the shoreline has been gaining volume and length in three years, this stretch of shore naturally developed infrastructure. From July 2020 through Feb 2021, a row of ironwood trees grew and blocked the transect, making surveying difficult from Feb 2021 and onward.
- Based on the Shoreline linear regression analysis (see pg 74), the shoreline has a rate of +2.1 ft from 2016-2023.

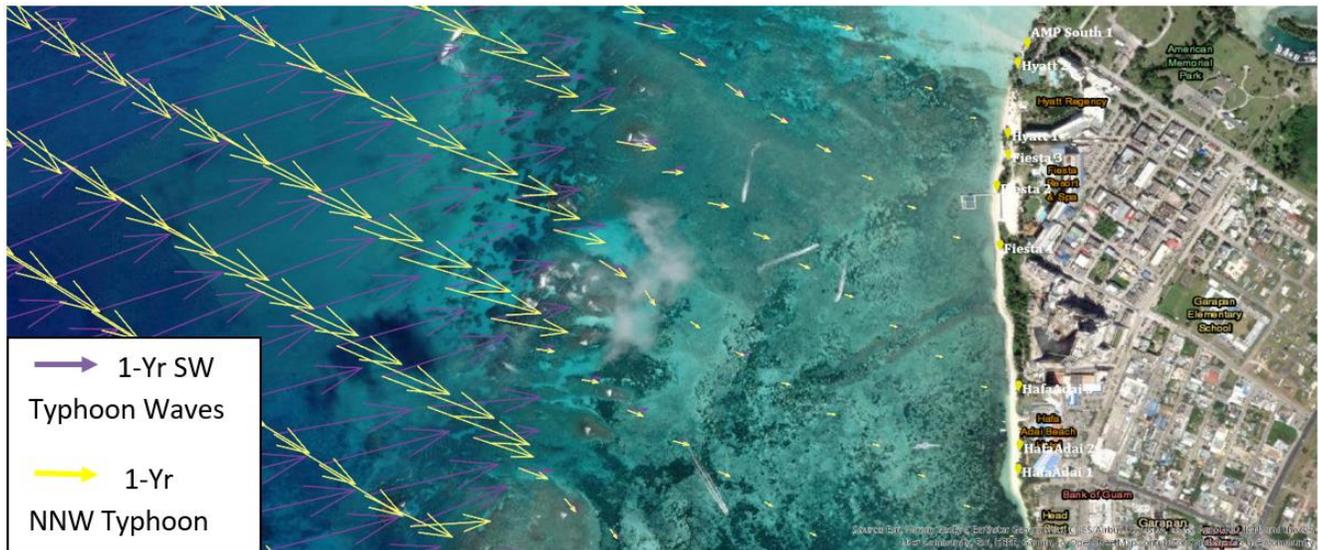
Figure 29 - Hydrodynamic map of the stretch of Hafa Adai, Fiesta, and Hyatt sites with the ocean wave energies buffered by the reef, openings enable higher wave energies to enter into the reef. The arrows show the intensity of waves generated from the south west

The decrease in shoreline area has affected watersports and hotel operators. The area bordering the IPI Casino building to the south may be influenced by the nearby outfall located north of the area. The Department of Coastal Resources and Minerals (DCRM) Shoreline Monitoring uses the Trimble Geo7x and Total Station to assess wave damage to the beach following storm and swell events. Additionally, two headstakes have been removed due to storm damage in late 2021, making it challenging to conduct long-term beach profiling in this area.

- ERODING and REPLACED
- LOSS of shoreline by ~60 ft since 2017
- Beach profile of Jun 2017 to Jun 2021 showed the High Waterline ranges 30 – 55 ft with an elevation difference of less than 6 ft
- **History:** From 2017 – 2020, the berm has retreated ~36 ft. Then from Feb 2020 – Jun 2021, erosion has reached the headstake, indicating additional of loss 16 ft. Storm-induced wave action is abrading the beach and weakening the sand. The late storms of 2021 have eaten up to the headstake and eaten up to the seaward portion of a previous road. This resulted in the area being closed off.
- This shoreline has been eroding from 2016-2023.

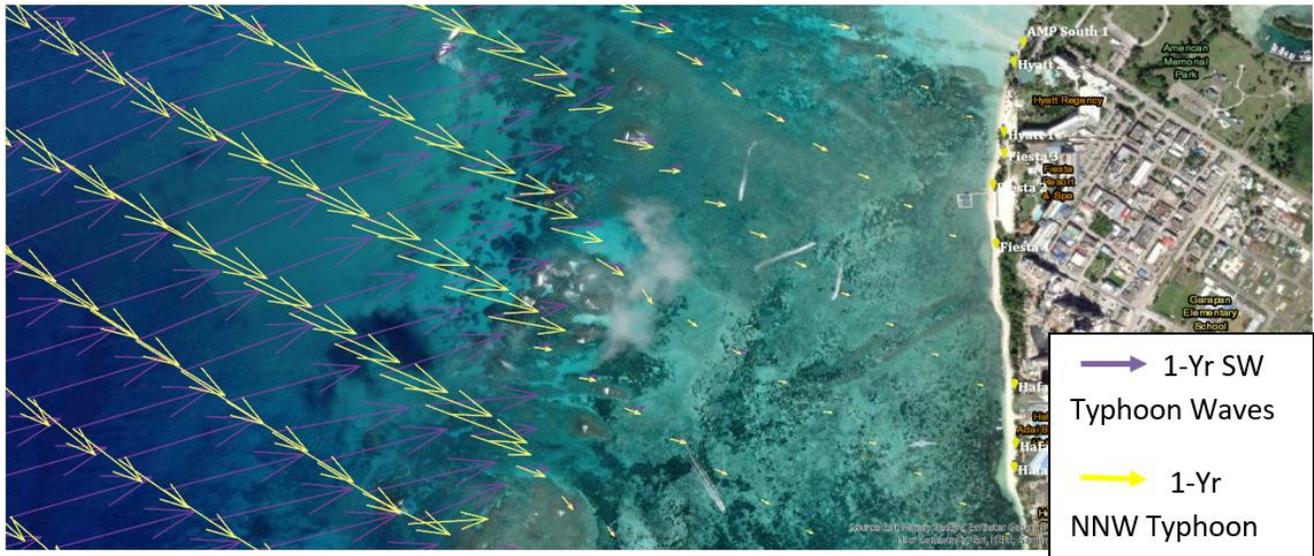
Figure 30 - Hydrodynamic map of the stretch of Hafa Adai, Fiesta, and Hyatt sites with the ocean wave energies buffered by the reef, openings enable higher wave energies to enter into the reef. The arrows show the intensity of waves generated from the south west

The Hyatt shoreline in this area has been actively eroding, similar to Fiesta, because of powerful waves caused by storms. Two head stakes were pulled into the water and have become ineffective. The shoreline is being eroded by the increased wave energy from storm conditions and higher sea levels entering through the channel. The tropical disturbance in September 2021 caused significant damage in a short period of time from north-northwest flows. Southwest typhoon wave conditions also contribute to the erosion of the shoreline.

- NEW HEADSTAKE
- Previous headstake showed a LOSS of shoreline by ~70 ft since 2017
- **History:** This area serves as a pathway from Micro Beach to the marine sports area north of Hyatt. It is eroding on the long term determined by the abrasion exposing the bedrock after the September 2021 storm. The sand is pulled into the water during high wave energy conditions and pushed into the shore during lower wave energy conditions. The new operational headstake is tree farther back. LOSS of shoreline by ~30 ft since 2020.

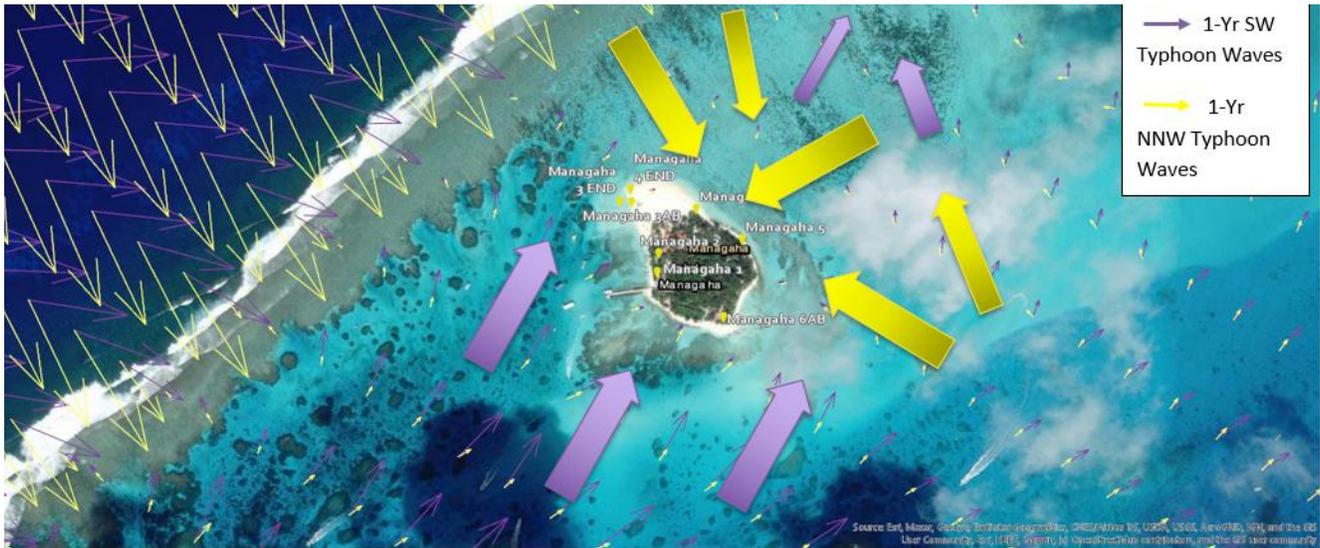
Figure 39 - Hydrodynamic map of Mañagaha and the wave directions based on the south west typhoon wave conditions (in dark purple) and the north north west typhoon wave conditions (in yellow). The arrows show the intensity of waves generated from the south west.

The Mañagaha Study (Fletcher, 2007) predicted that the island may potentially stabilize in the future. In the case it may not, shoreline interventions may be necessary to protect the eastern side. The sandy nearshore remains a valuable feature of this islet.
