# Laolao Bay Watershed

## Existing Conditions and Opportunities

### Interim Report

August 2020 DRAFT

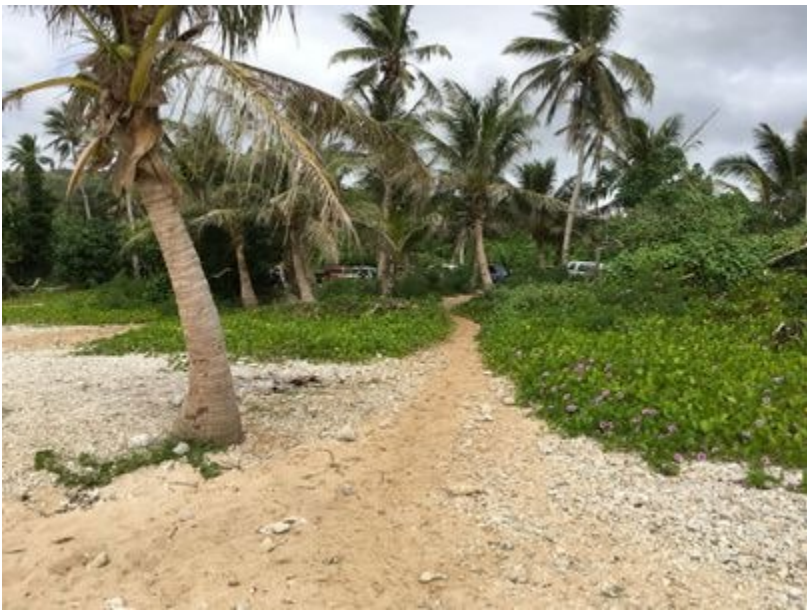
<b>Site ID:</b> LL103	<b>Watershed:</b> Laolao
<b>Crew:</b> EH	<b>Date/Time:</b> 01/21/2020 8:44 PM
<b>Project Type:</b> <ul style="list-style-type: none"> <li>Shoreline Stabilization</li> <li>Watershed Education/Signage</li> </ul>

<b>Enforcement Needed:</b> No	
<b>Severity Rating:</b> 3	
<b>Implementation Priority:</b> Love it! (High)	
<b>Descriptions of Existing Conditions:</b> Uncontrolled pedestrian circulation eroding shoreline. Multiple access points to beach.	
<b>Description of Proposed Opportunity:</b> Organize circulation. Limit access points to 2. Stabilize path, add boardwalk? Part of dive site improvement/organization. Educational opportunity with signage etc.	
<b>Challenges/Constraints:</b> Heavy use, storms, hard to change user habits.	
<b>Additional Notes:</b> See previous dive site concept.	
<b>Site Photo</b>

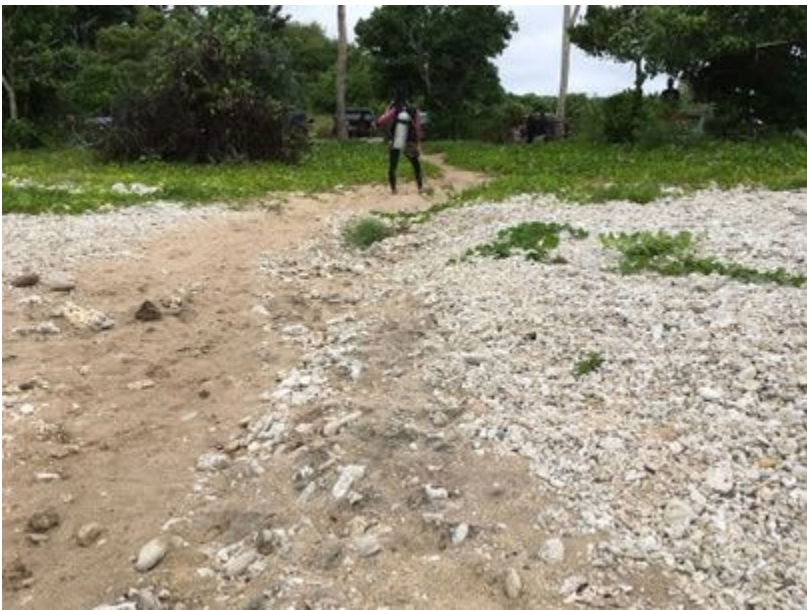
<b>Site ID:</b> LL104	<b>Watershed:</b> Laolao
<b>Crew:</b> EH	<b>Date/Time:</b> 01/21/2020 8:48 PM
<b>Project Type:</b> <ul style="list-style-type: none"> <li>Stormwater Retrofit</li> <li>Shoreline Stabilization</li> <li>Watershed Education/Signage</li> </ul>

<b>Enforcement Needed:</b> No	
<b>Severity Rating:</b> 4	
<b>Implementation Priority:</b> Love it! (High)	
<b>Descriptions of Existing Conditions:</b> Parking lot runoff eroding shoreline along pedestrian path.	
<b>Description of Proposed Opportunity:</b> Parking lot reorganization. Control drainage. Stabilization and reorganization of circulation. Stabilize path.	
<b>Challenges/Constraints:</b> Heavy use, hard to change user habits.	
<b>Additional Notes:</b> See previous dive site concept and new sketch.	
<b>Site Photo</b>

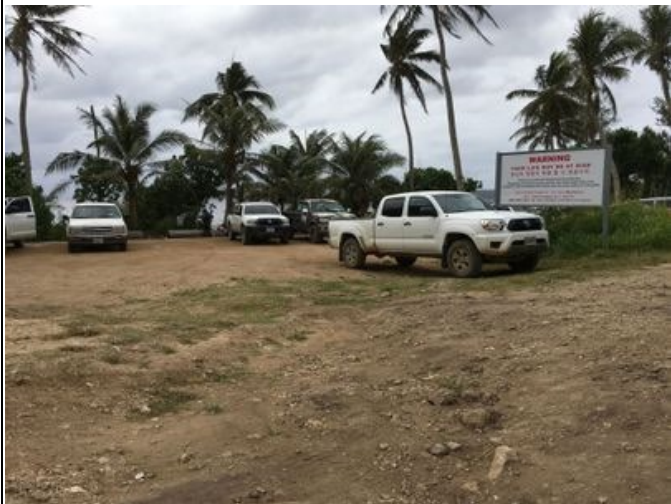
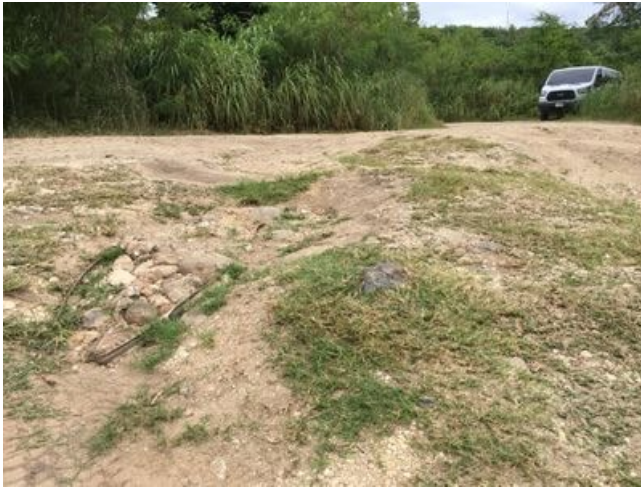
<b>Enforcement Needed:</b> No	
<b>Severity Rating:</b> 3	
<b>Implementation Priority:</b> Love it! (High)	
<b>Descriptions of Existing Conditions:</b> Runoff from Laolao Bay Rd eroding entrance to parking area and shoreline. Uncontrolled runoff.	
<b>Description of Proposed Opportunity:</b> Intercept runoff before entering dive site. Water bars with stormwater infiltration. Improve drainage along the road.	
<b>Challenges/Constraints:</b> Amount and velocity of runoff. Soils and infiltration capacity may be limited?	
<b>Additional Notes:</b>	
<b>Site Photo</b>	
<div style="display: flex; justify-content: space-around;">

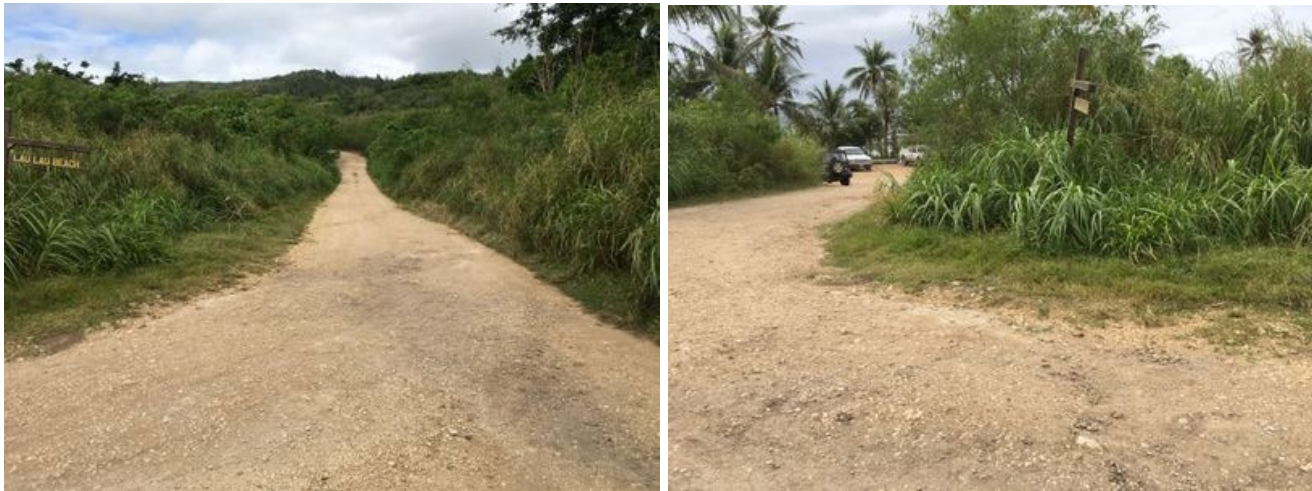
<b>Site ID:</b> LL109	<b>Watershed:</b> Laolao
<b>Crew:</b> EH	<b>Date/Time:</b> 01/21/2020 9:35 PM
<b>Project Type:</b> <ul style="list-style-type: none"> <li>Stormwater Retrofit</li> <li>Unpaved Road Stabilization</li> </ul>

<b>Enforcement Needed:</b> No	
<b>Severity Rating:</b> 3	
<b>Implementation Priority:</b> Love it! (High)	
<b>Descriptions of Existing Conditions:</b> Entrance to parking. See LL108.	
<b>Description of Proposed Opportunity:</b> See LL108.	
<b>Challenges/Constraints:</b>	
<b>Additional Notes:</b>	
<b>Site Photo</b>

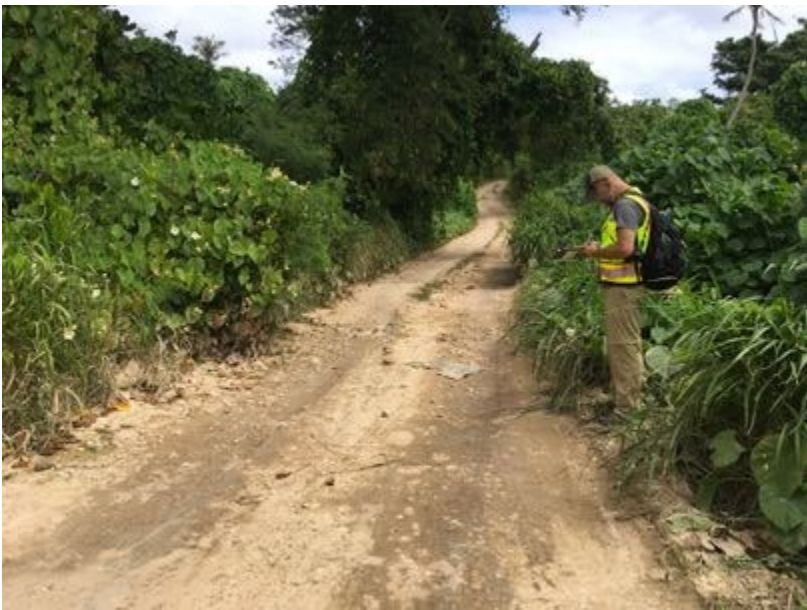
<b>Site ID:</b> LL112	<b>Watershed:</b> Laolao
<b>Crew:</b> EH	<b>Date/Time:</b> 01/21/2020 9:45 PM
<b>Project Type:</b> <ul style="list-style-type: none"> <li>• Drainage Infrastr., Maint. &amp; Repair</li> <li>• Stormwater Retrofit</li> <li>• Unpaved Road Stabilization</li> </ul>

<b>Enforcement Needed:</b> No	
<b>Severity Rating:</b> 4	
<b>Implementation Priority:</b> Love it! (High)	
<b>Descriptions of Existing Conditions:</b> Culvert at road concentrates flow into narrow channel. Road grading is rough mounds and dips.	
<b>Description of Proposed Opportunity:</b> Replace and widen culvert (convert to a large box culvert). Construct broad dip or other diversion at low point to direct road runoff into ditch.	
<b>Challenges/Constraints:</b> Road traffic and frequency of use. Subsurface material? Depth of culvert (very deep from road surface).	
<b>Additional Notes:</b>	
<b>Site Photo</b>

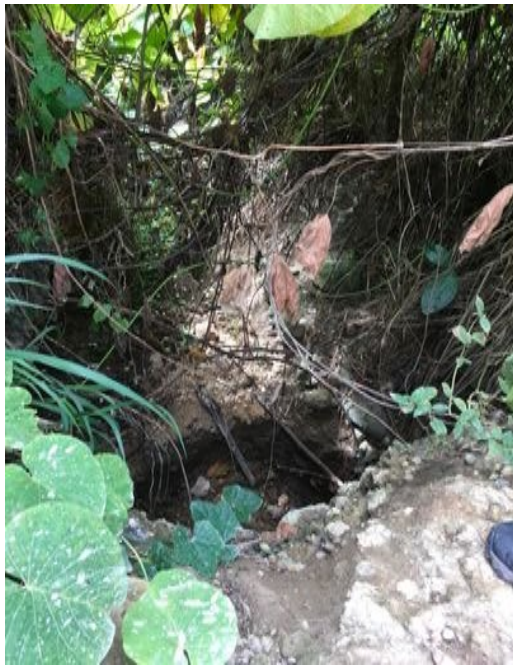
<b>Site ID:</b> LL113	<b>Watershed:</b> Laolao
<b>Crew:</b> EH	<b>Date/Time:</b> 01/21/2020 9:57 PM
<b>Project Type:</b> <ul style="list-style-type: none"> <li>• Drainage Infrastr., Maint. &amp; Repair</li> <li>• Unpaved Road Stabilization</li> </ul>

<b>Enforcement Needed:</b> No	
<b>Severity Rating:</b> 5 (Severe)	
<b>Implementation Priority:</b> Love it! (High)	
<b>Descriptions of Existing Conditions:</b> Runoff discharges off road at uncontrolled location causing scouring and erosion down to very deep pool. 9' down to plunge pool. 3' wide. Inflow to east comes onto road ~100 ft uphill and runs along road. Contributing	
<b>Description of Proposed Opportunity:</b> Create broad dip and formalize overflow. Upstream drainage: pitch discharges to road. Runs along eastern edge to informal drainage overflow.	
<b>Challenges/Constraints:</b> Large volume and high velocity of runoff discharge onto road. No culvert crossing.

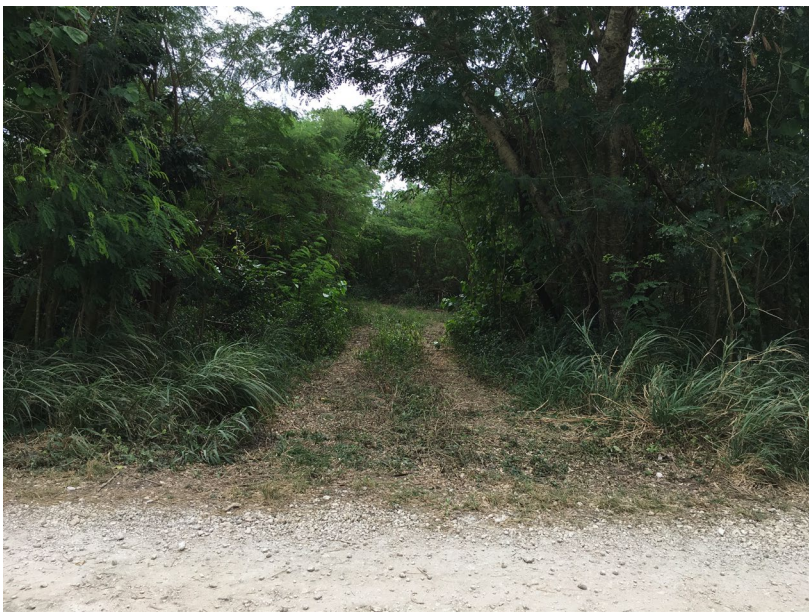
<b>Site ID:</b> LL117	<b>Watershed:</b> Laolao
<b>Crew:</b> EH	<b>Date/Time:</b> 01/21/2020 10:21 PM
<b>Project Type:</b>

<b>Enforcement Needed:</b> No	
<b>Severity Rating:</b> 1	
<b>Implementation Priority:</b> Not that important (Low)	
<b>Descriptions of Existing Conditions:</b> Grass track, possibly to homestead or lookout?	
<b>Description of Proposed Opportunity:</b> Monitor for possible issues.	
<b>Challenges/Constraints:</b>	
<b>Additional Notes:</b>	
<b>Site Photo</b>

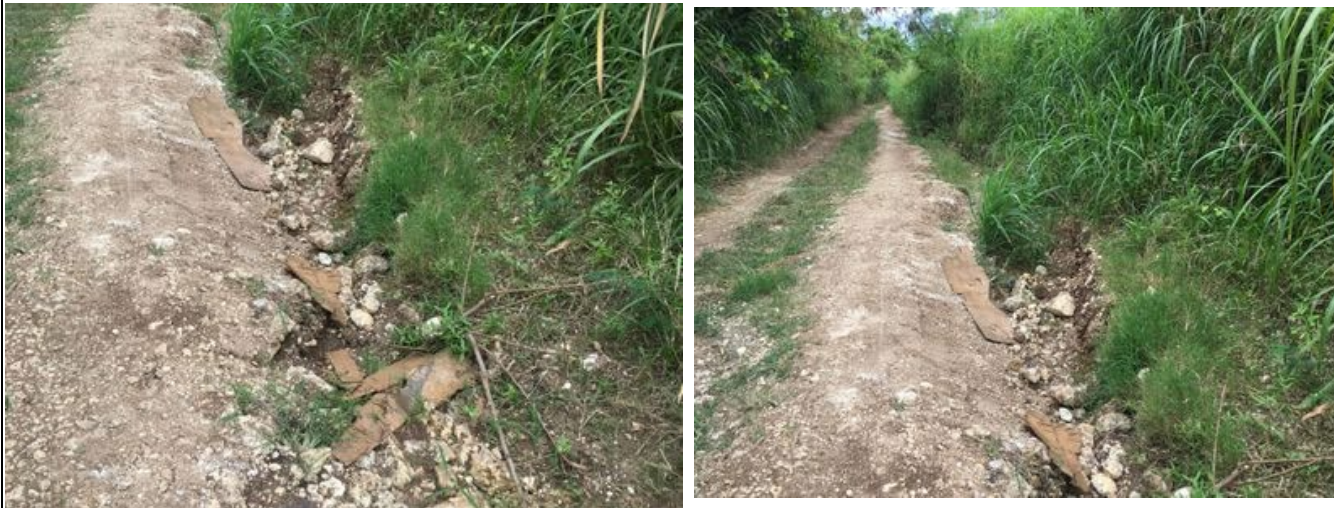
<b>Site ID:</b> LL124	<b>Watershed:</b> Laolao
<b>Crew:</b> EH	<b>Date/Time:</b> 01/21/2020 11:06 PM
<b>Project Type:</b> <ul style="list-style-type: none"> <li>Stormwater Retrofit</li> <li>Unpaved Road Stabilization</li> </ul>

<b>Enforcement Needed:</b> No	
<b>Severity Rating:</b> 5 (Severe)	
<b>Implementation Priority:</b> Love it! (High)	
<b>Descriptions of Existing Conditions:</b> Washout and erosion along Gap Gap Road. See previous conceptual plans	
<b>Description of Proposed Opportunity:</b> See previous plans. Proposed improvements to drainage were confirmed and remain valid.	
<b>Challenges/Constraints:</b> Very steep road, accessibility and long-term maintenance.	
<b>Additional Notes:</b>	
<b>Site Photo</b>

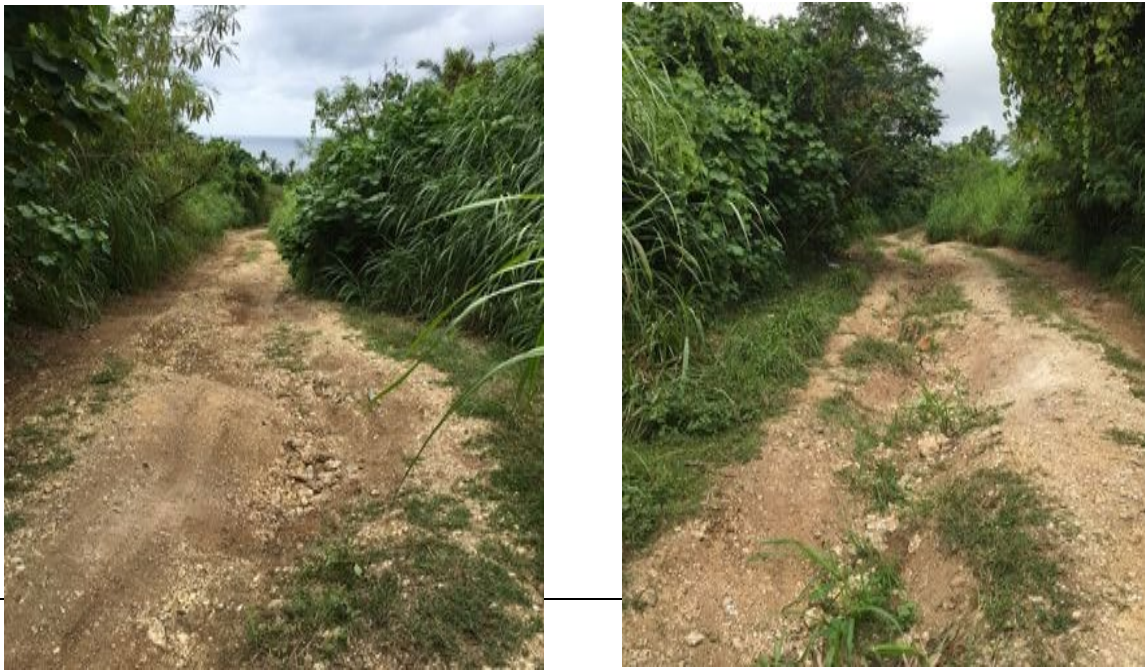
<b>Enforcement Needed:</b> No	
<b>Severity Rating:</b> 5 (Severe)	
<b>Implementation Priority:</b> Love it! (High)	
<b>Descriptions of Existing Conditions:</b> Washout and erosion along Gap Gap Road. See previous conceptual plans	
<b>Description of Proposed Opportunity:</b> See previous plans. Proposed improvements to drainage were confirmed and remain valid.	
<b>Challenges/Constraints:</b> Very steep road, accessibility and long-term maintenance.	
<b>Additional Notes:</b>	
<b>Site Photo</b>

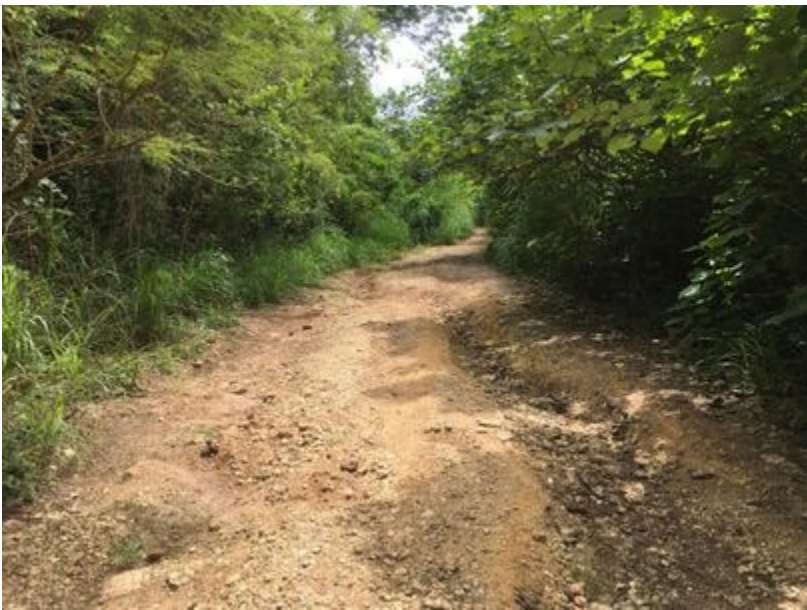
<b>Site ID:</b> LL126	<b>Watershed:</b> Laolao
<b>Crew:</b> BK	<b>Date/Time:</b> 01/21/2020 11:14 PM
<b>Project Type:</b> <ul style="list-style-type: none"> <li>Unpaved Road Stabilization</li> </ul>

<b>Enforcement Needed:</b> No	
<b>Severity Rating:</b> 5 (Severe)	
<b>Implementation Priority:</b> Love it! (High)	
<b>Descriptions of Existing Conditions:</b> Washout and erosion along Gap Gap Road. See previous conceptual plans	
<b>Description of Proposed Opportunity:</b> See previous plans. Proposed improvements to drainage were confirmed and remain valid.	
<b>Challenges/Constraints:</b> Very steep road, accessibility and long-term maintenance.	
<b>Additional Notes:</b>	
<b>Site Photo</b>

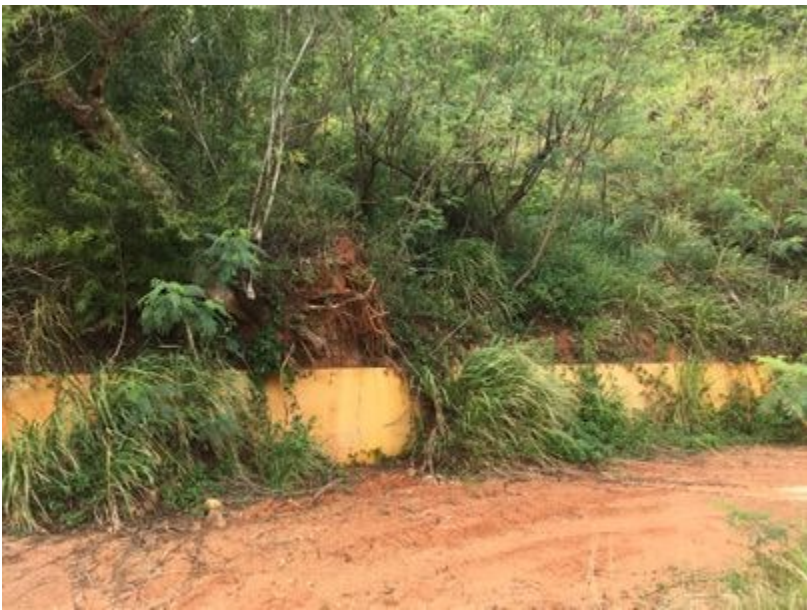
<b>Enforcement Needed:</b> Yes	
<b>Severity Rating:</b> 5 (Severe)	
<b>Implementation Priority:</b> It's OK (Med)	
<b>Descriptions of Existing Conditions:</b> Tree blown down over retaining wall with root destabilization. Excessively steep slope above retaining wall (which appears too short). Bare dirt/mudslide on steep slope. Sediment source to parking lot/rain garden and	
<b>Description of Proposed Opportunity:</b> Clean up sediment and slope. Extend wall and stabilize slope.	
<b>Challenges/Constraints:</b> Very steep slopes. Detention center may be abandoned so may only be feasible if detention center is in use.	
<b>Additional Notes:</b>	
<b>Site Photo</b>

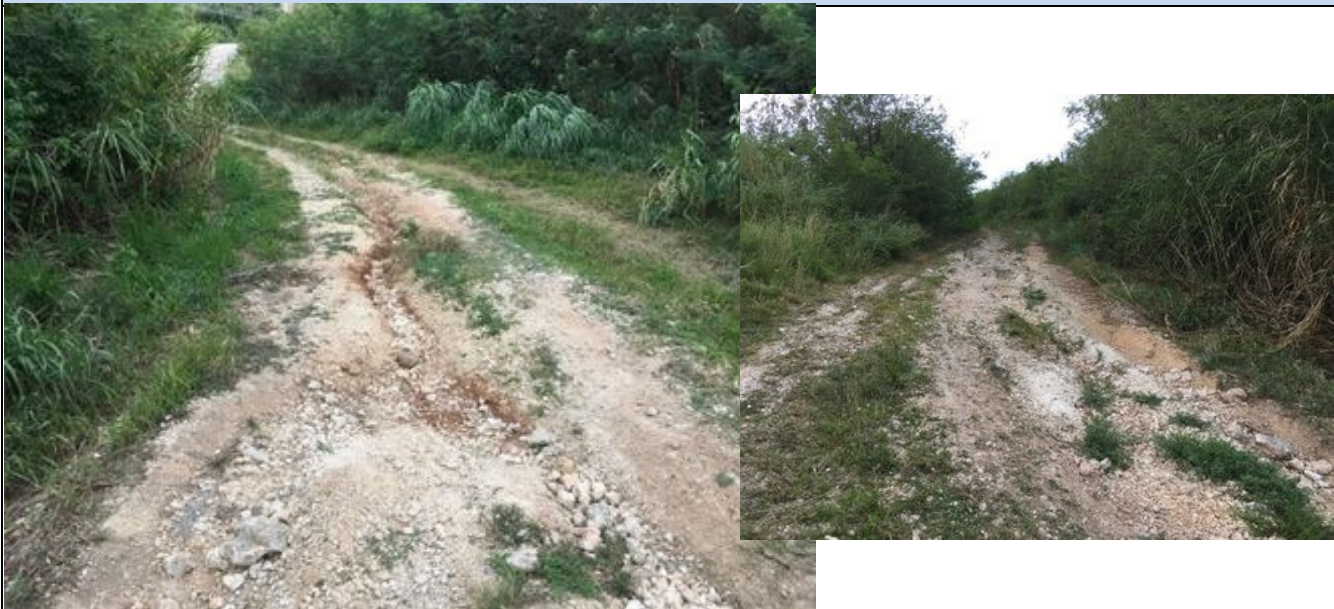
<p>USGS The National Map: National Boun... Powered by Esri</p>
<b>Enforcement Needed:</b> Yes	
<b>Severity Rating:</b> 4	
<b>Implementation Priority:</b> Not that important (Low)	
<b>Descriptions of Existing Conditions:</b> Eroded dirt road to water tank at top of watershed.	
<b>Description of Proposed Opportunity:</b> Stabilize and remove sediment source. Apply dirt road strategies, such as dips and water bars to shed runoff. Regrade & stabilize.	
<b>Challenges/Constraints:</b> Steep slopes.	
<b>Additional Notes:</b>	
<b>Site Photo</b>

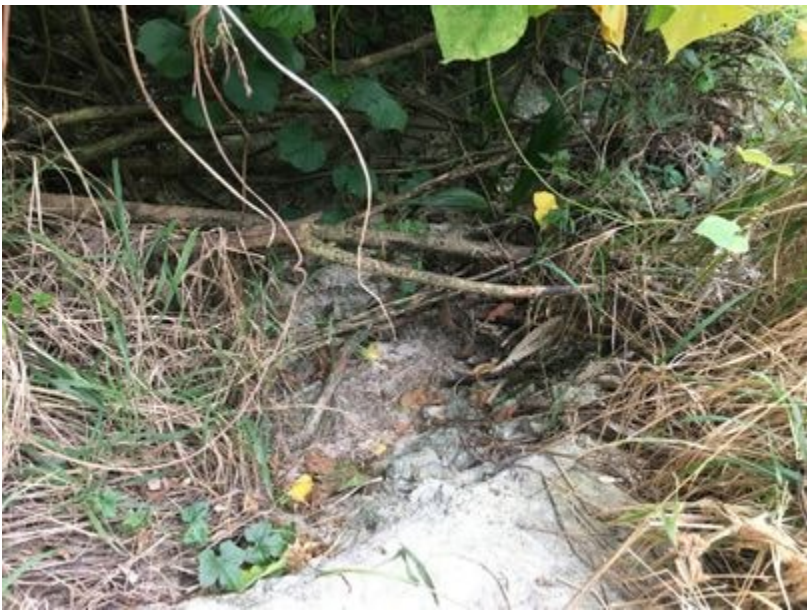
<b>Site ID:</b> LL135	<b>Watershed:</b> Laolao
<b>Crew:</b> EH	<b>Date/Time:</b> 01/22/2020 12:45 AM
<b>Project Type:</b> <ul style="list-style-type: none"> <li>• Drainage Infrastr., Maint. &amp; Repair</li> <li>• Unpaved Road Stabilization</li> </ul>

<b>Enforcement Needed:</b> No	
<b>Severity Rating:</b> 3	
<b>Implementation Priority:</b> It's OK (Med)	
<b>Descriptions of Existing Conditions:</b> Broad dip with swales (formalized downstream)	
<b>Description of Proposed Opportunity:</b> Clean swale, regrade road. Add second broad dip uphill.	
<b>Challenges/Constraints:</b> Steel slope, erosion at edge of conc. Ongoing maintenance and erosion at interface of concrete and dirt road.	
<b>Additional Notes:</b> Appears to be functional.	
<b>Site Photo</b>

<b>Site Overview Caption:</b> Clean.

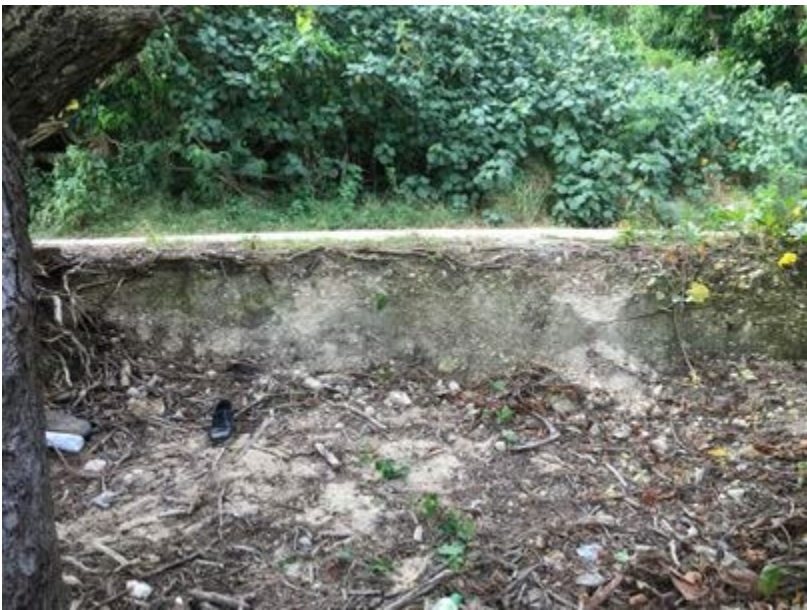
<b>Enforcement Needed:</b> No	
<b>Severity Rating:</b> 4	
<b>Implementation Priority:</b> It's OK (Med)	
<b>Descriptions of Existing Conditions:</b> Seaward edge of road. 3' drop at start. Guess low energy. Rocky sand. Trees present. (with LL143)	
<b>Description of Proposed Opportunity:</b> Start living shoreline. Use gabion walls or green walls.	
<b>Challenges/Constraints:</b> Road abuts top of shoreline, so limited space. High traffic, exposure to future storms.	
<b>Additional Notes:</b>	
<b>Site Photo</b>

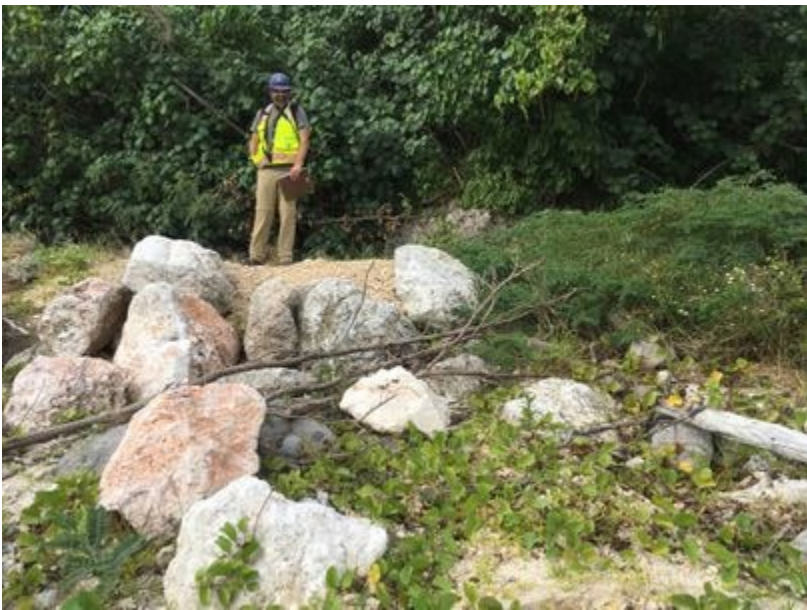
<b>Enforcement Needed:</b> No	
<b>Severity Rating:</b> 4	
<b>Implementation Priority:</b> It's OK (Med)	
<b>Descriptions of Existing Conditions:</b> End living shoreline/shoreline restoration. (with LL139)	
<b>Description of Proposed Opportunity:</b> See LL139.	
<b>Challenges/Constraints:</b> See LL139.	
<b>Additional Notes:</b>	
<b>Site Photo</b>

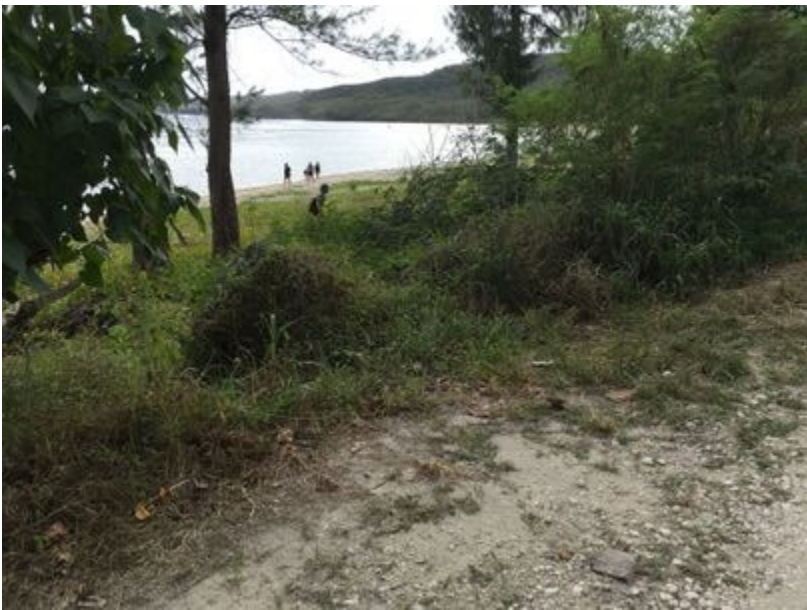
<b>Enforcement Needed:</b> No	
<b>Severity Rating:</b> 4	
<b>Implementation Priority:</b> It's OK (Med)	
<b>Descriptions of Existing Conditions:</b> End shoreline restoration. (with LL145)	
<b>Description of Proposed Opportunity:</b> Living shoreline (see notes for LL139/LL143/LL144)	
<b>Challenges/Constraints:</b>	
<b>Additional Notes:</b>	
<b>Site Photo</b>

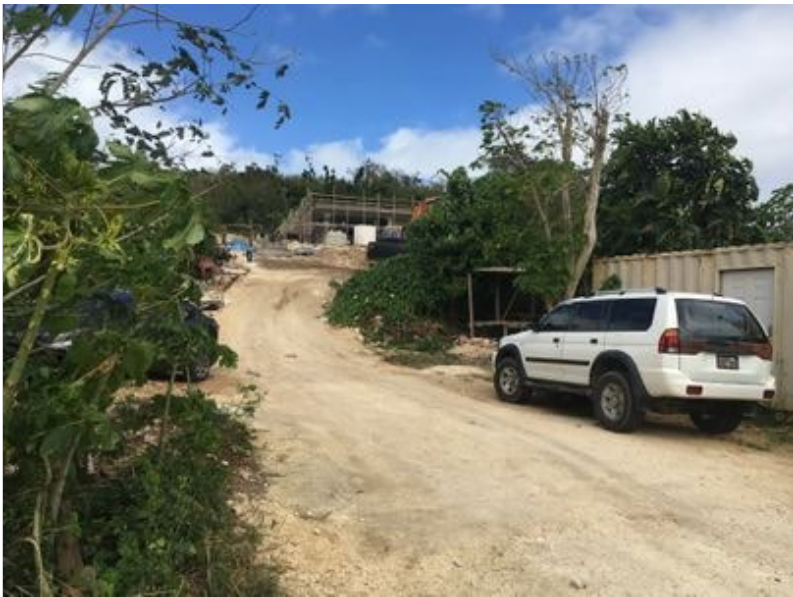
<p>USGS The National Map: National Boun... Powered by Esri</p>
<b>Enforcement Needed:</b> Yes	
<b>Severity Rating:</b> 5 (Severe)	
<b>Implementation Priority:</b> Love it! (High)	
<b>Descriptions of Existing Conditions:</b> Palu Road construction. No ERSC - full catch basin at Isa Dr. No silt sack. No track pad. Staging area at top of hill with brush clear. Street next to Palu Road also has construction and not much ESC was observed.	
<b>Description of Proposed Opportunity:</b> Enforcement. ERSC - lack of awareness by DPW. Silt sack in ex. cbs. cover stockpiles, silt sock around stockpiles.	
<b>Challenges/Constraints:</b> Saw this too much at construction site. clearing before ERSC.	
<b>Additional Notes:</b> No erosion control measures from construction up above, staging area at top of hill but no ESC
