# Achugao Watershed Existing Conditions and Opportunities Interim Report

December 2020 DRAFT

CNMI Bureau of Environmental and Coastal Quality Division of Coastal Resource Management

Horsley Witten Group, Inc. KOA Consulting, Inc. Sea Change Consulting

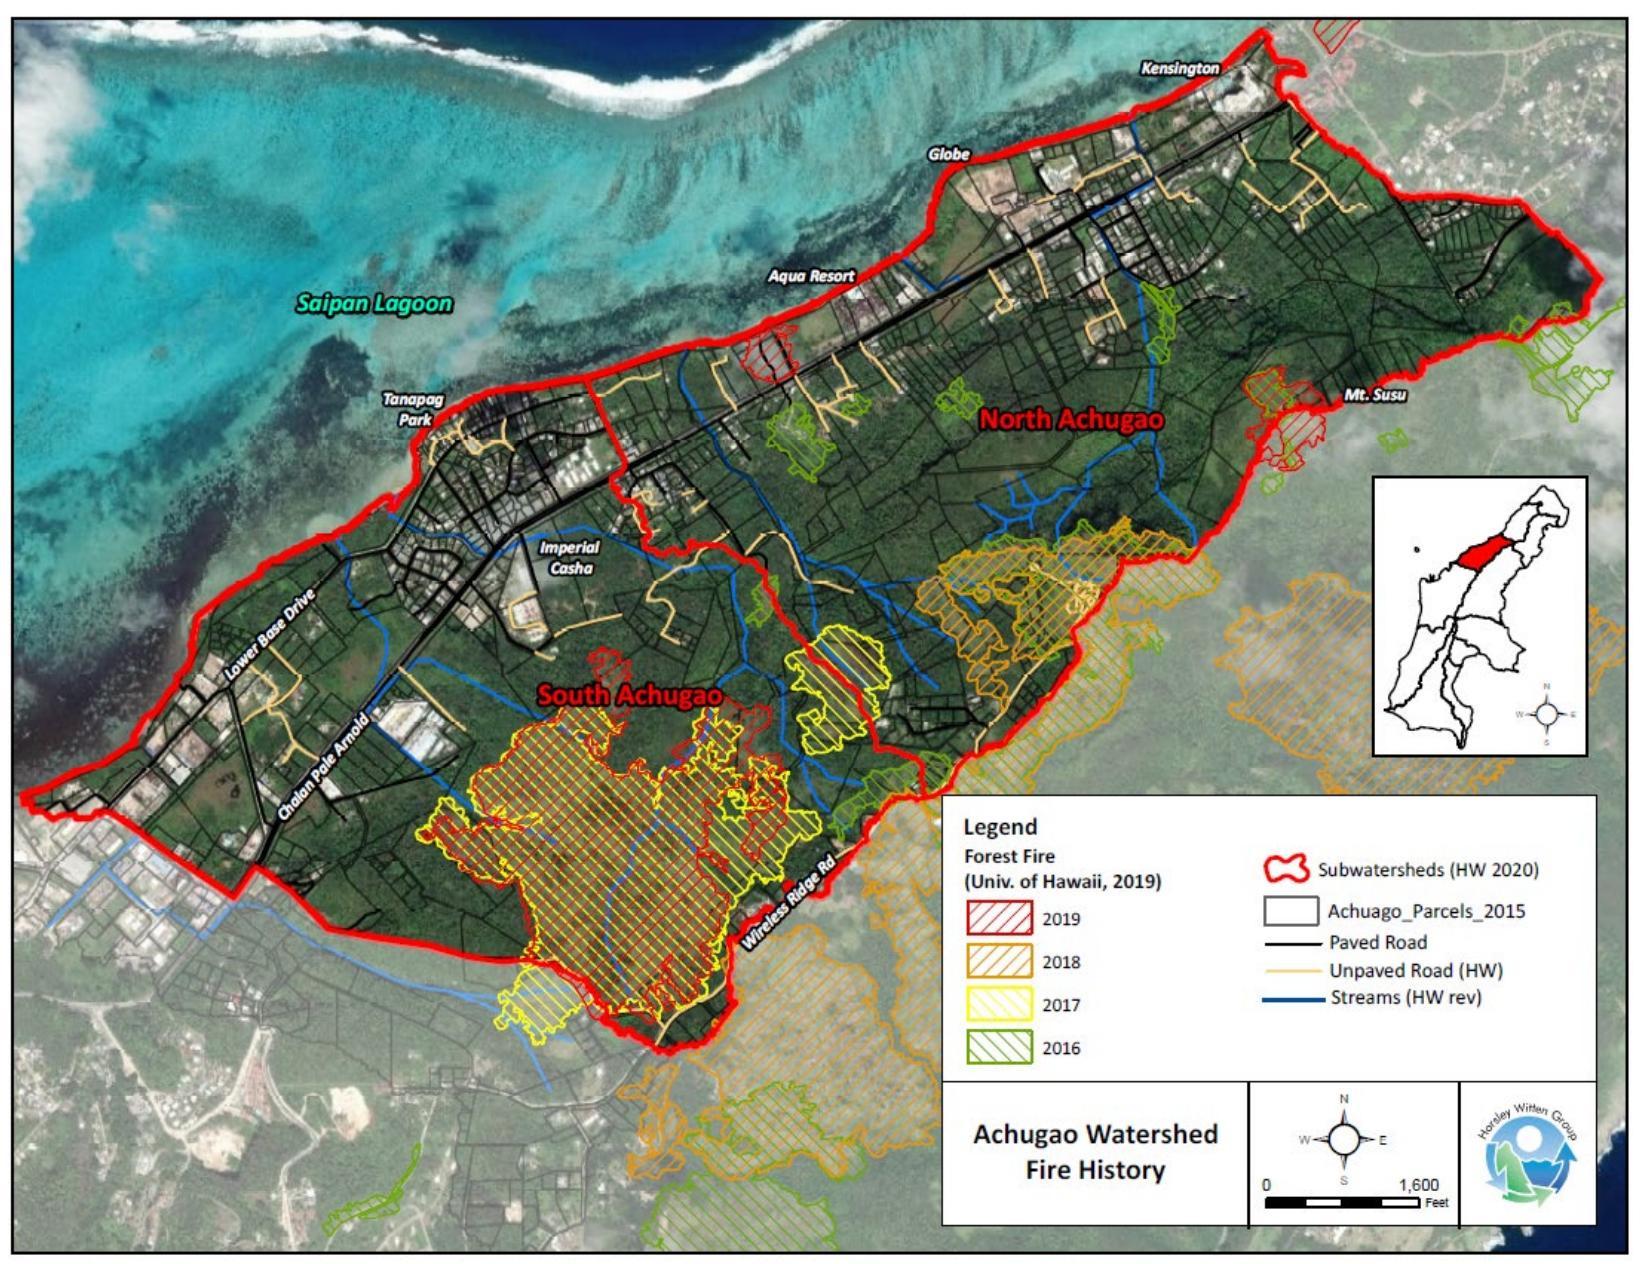
Wildfires for land clearing have been a recurring issue in this area and in other headwaters in Achugao (**Figures 7** and **8**). Achugao had large acreages burned in 2017 and 2019 (**Table 2**). Fires in 2016 were smaller but more distributed. Fires in 2018 only burned a small area in Achugao, but a large portion of the adjacent Talafofo watershed. The loss of vegetation and soil exposure associated with fires were identified in the 2017 bacteria TMDL as a likely and significant source of sediment and *Enterococci* (Paradigm Environmental, 2017).

Figure 7a. Forest fire extent between 2016-2019.

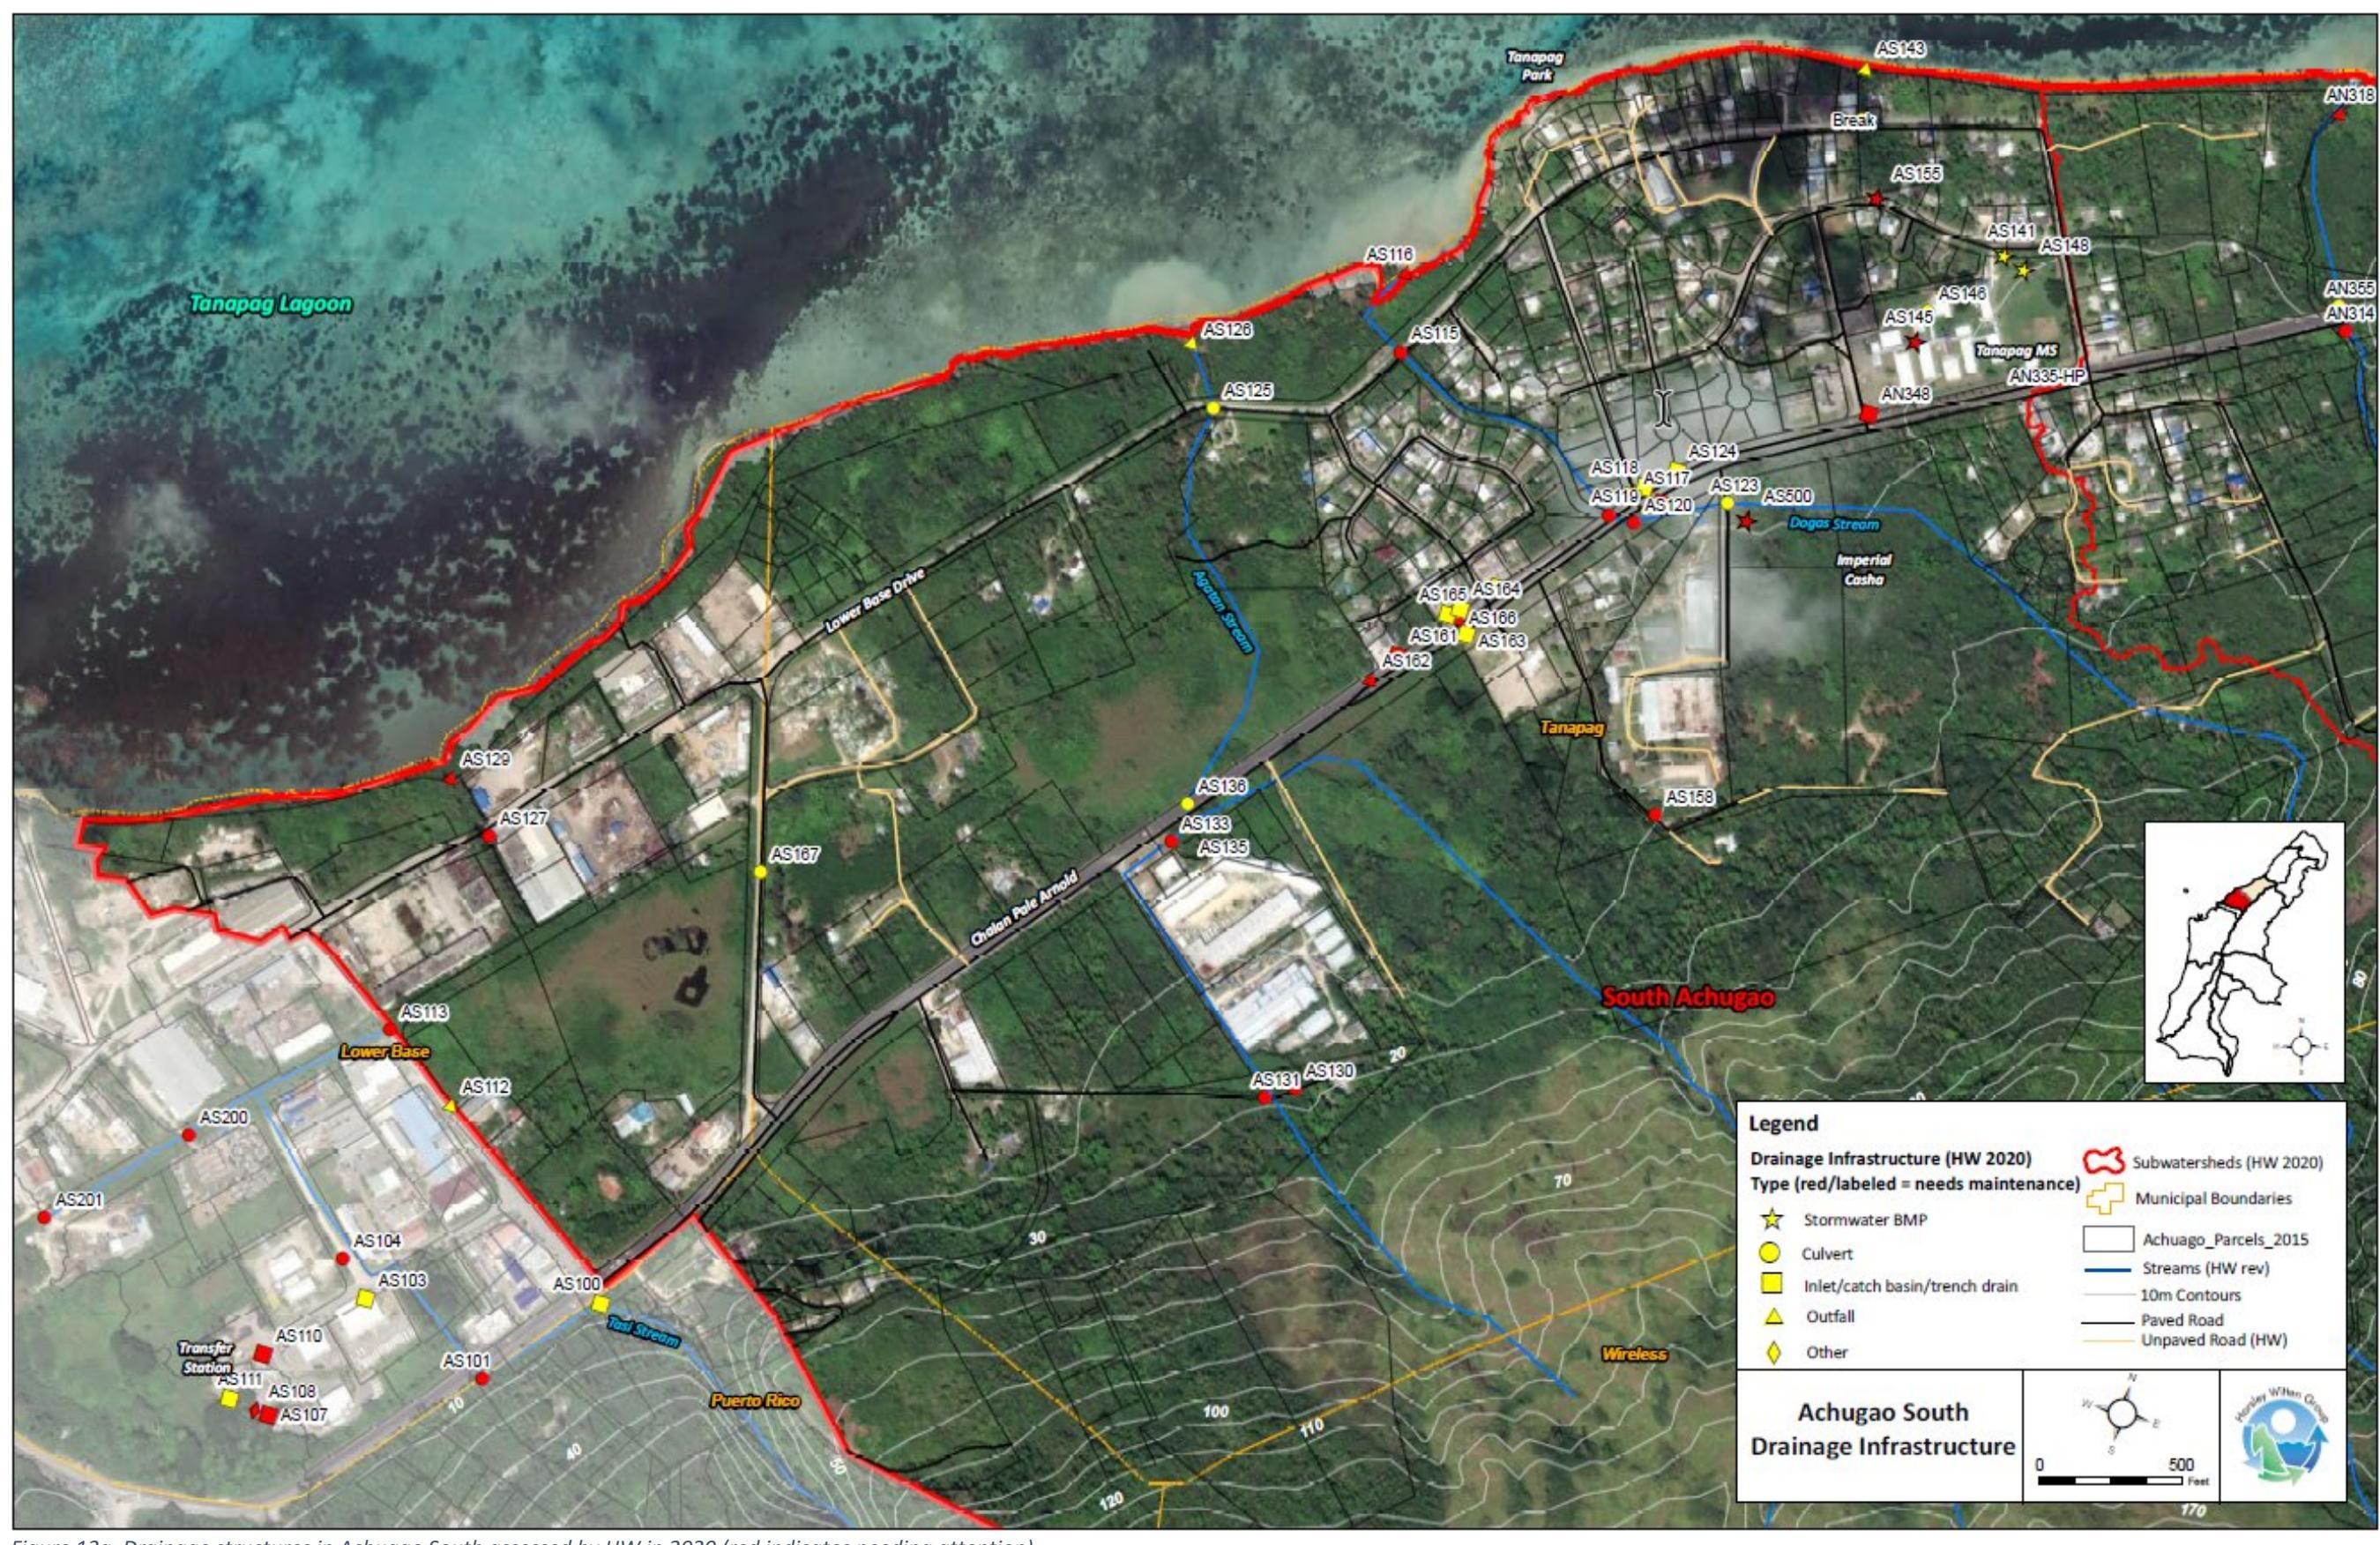
Storm drain network mapping was not available. During the week of January 20, 2020, HW and KOA field crews assisted by BECQ mapped and assessed over 100 drainage structures (e.g., inlets and catch basins, culverts, manholes, BMPs, outfalls, stream outlets, and other). The condition, dimensions, and invert elevations were documented for each structure (**Figure 12**). Based on field observations, almost 60% of the structures evaluated require maintenance, repair, or other attention due to clogging, high sediment accumulation, visible damage, associated erosion, or other observations.

Figure 12a. Drainage structures in Achugao South assessed by HW in 2020 (red indicates needing attention)

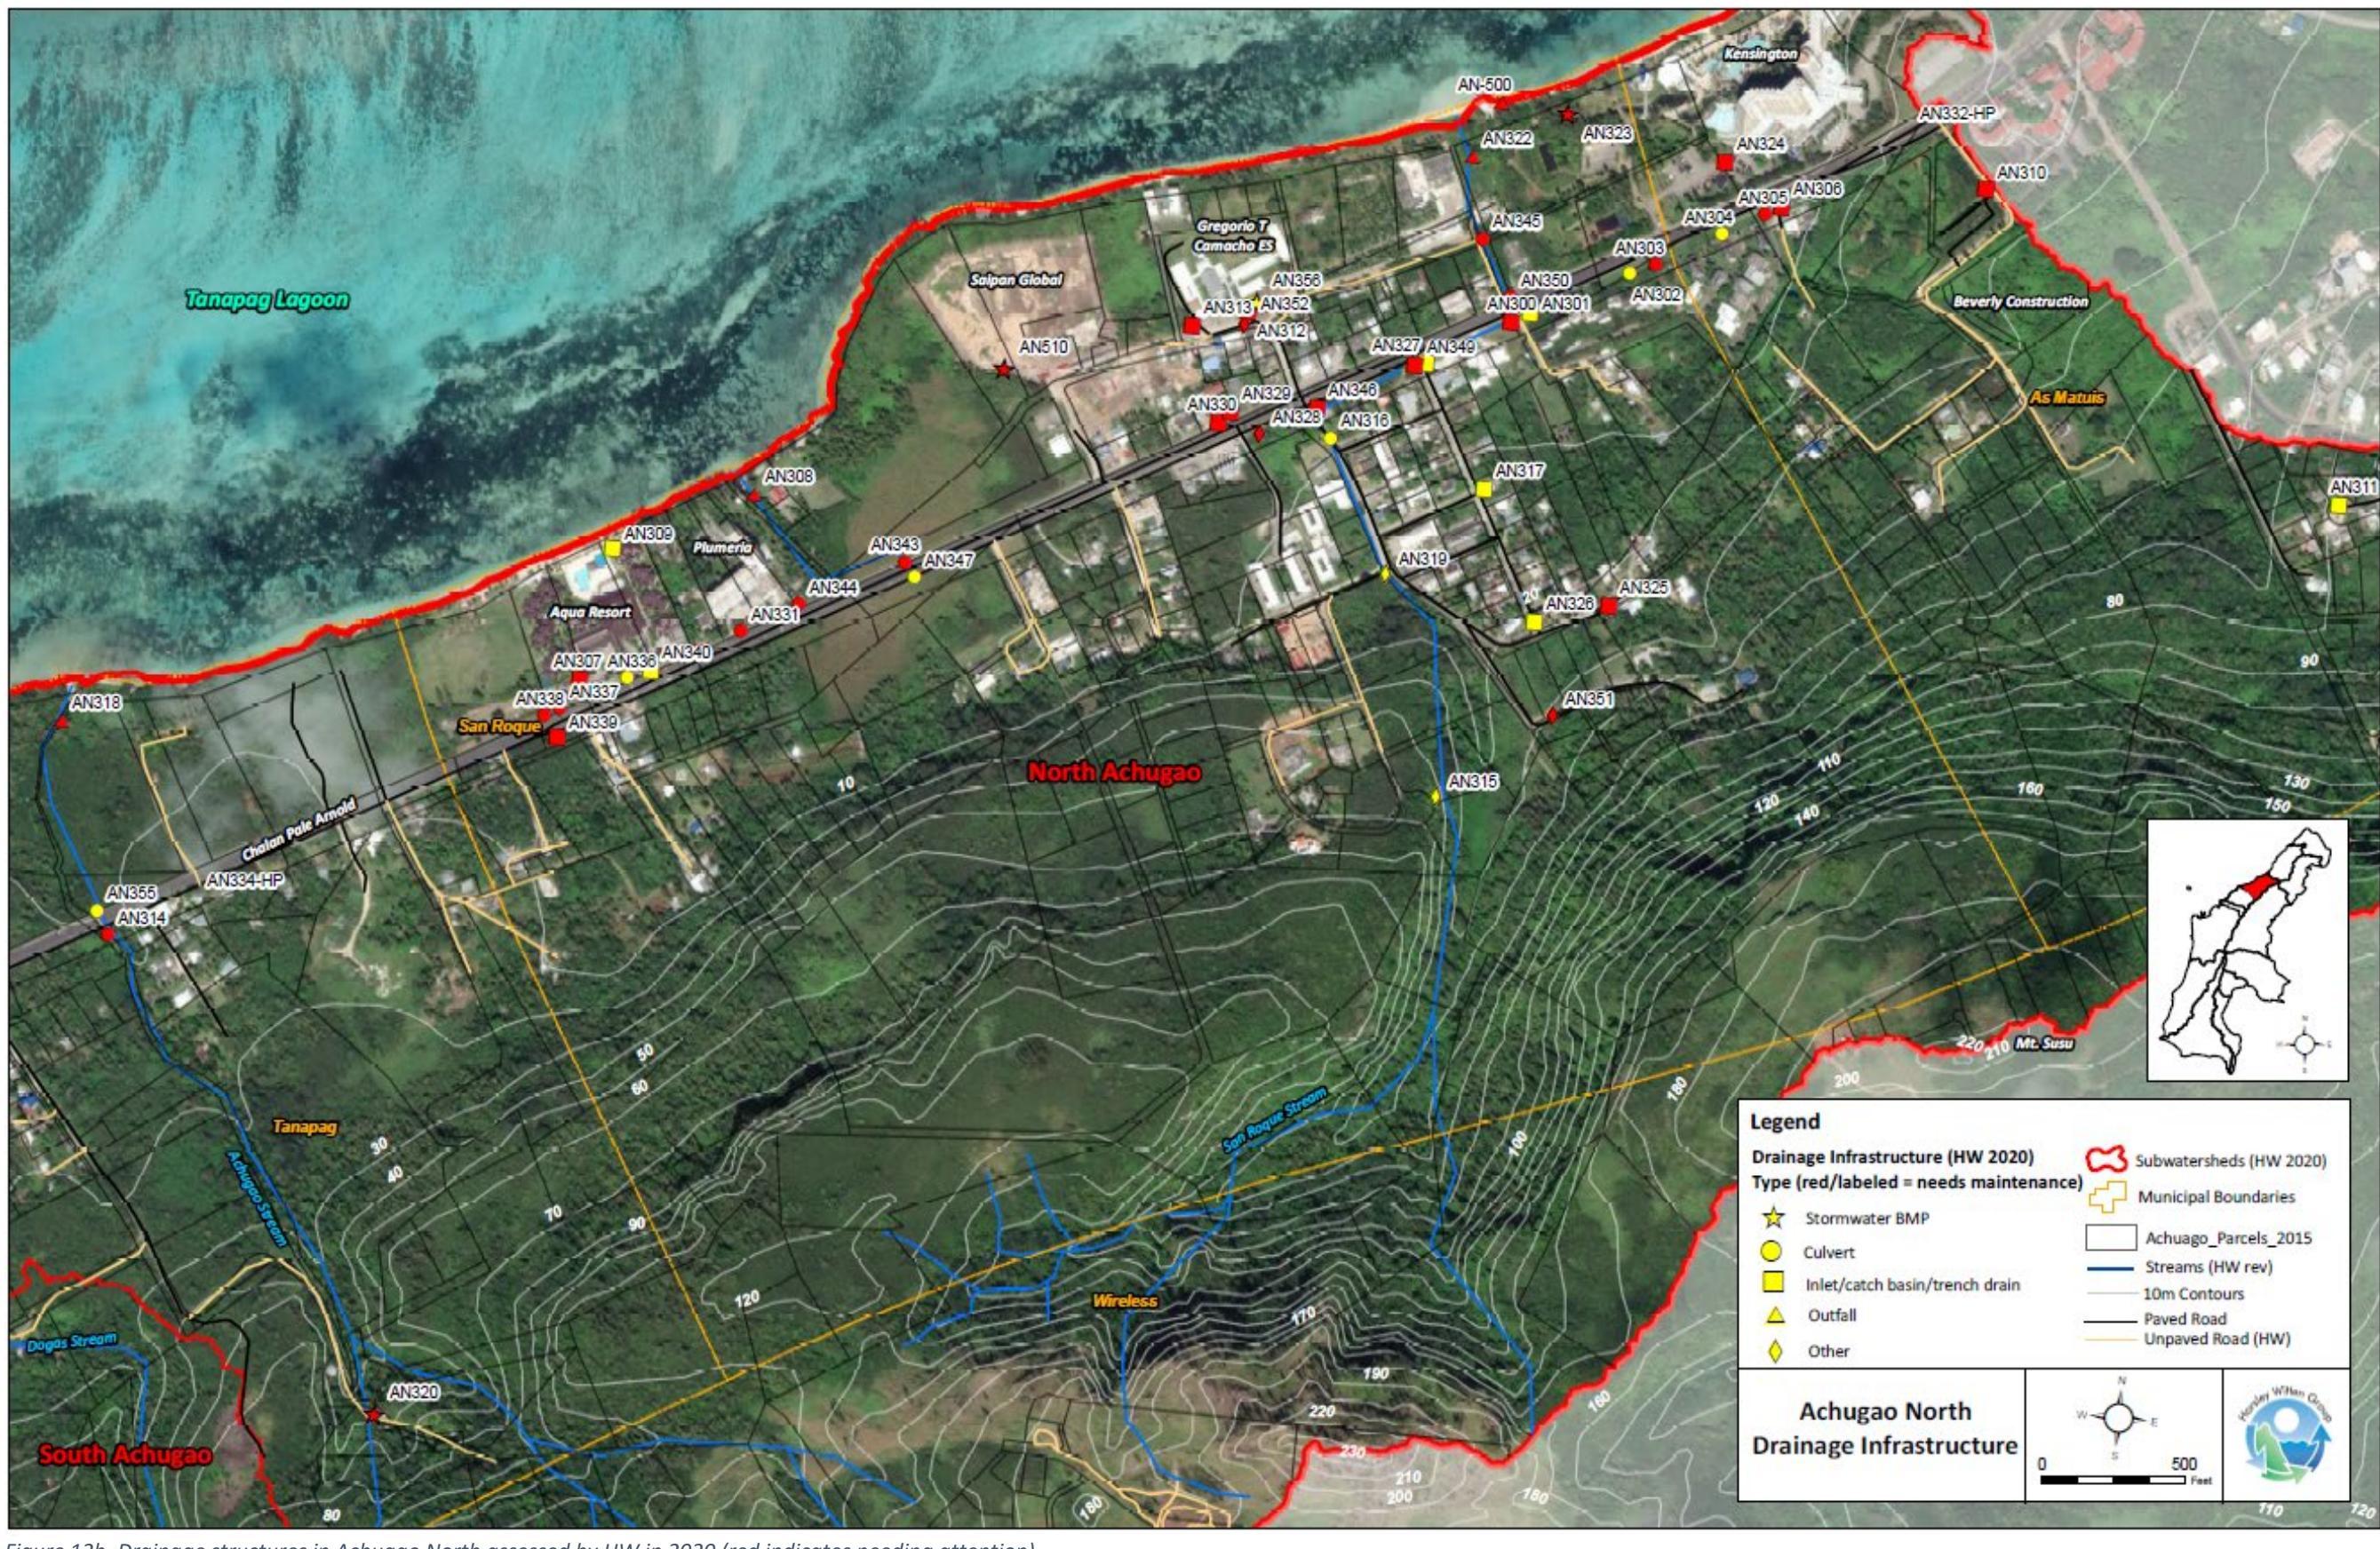
Figure 12b. Drainage structures in Achugao North assessed by HW in 2020 (red indicates needing attention)

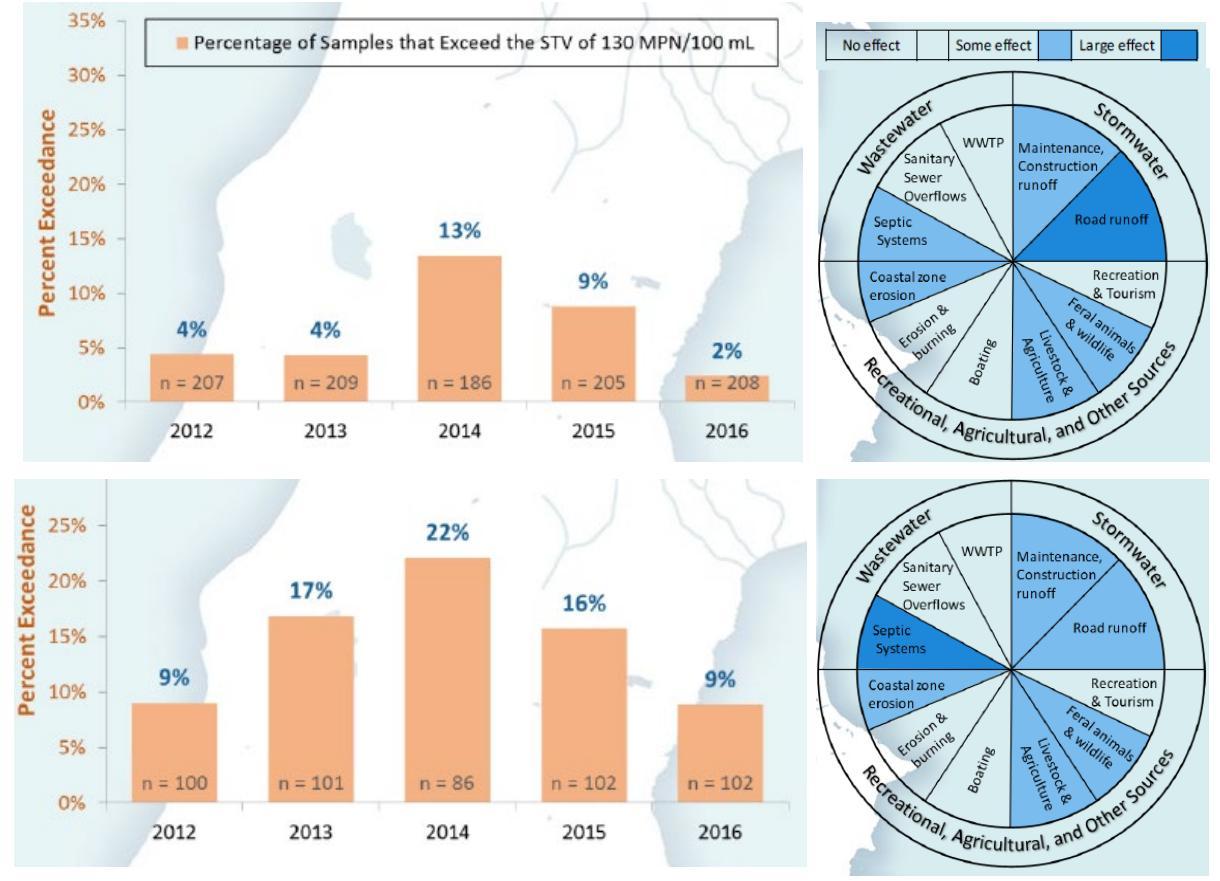
replacements since then have been credited with improved water quality. Similarly, Achugao South experienced multiple sewage overflows and system failures, specifically associated with worker's barracks (converted garment factories). Several instances of raw sewage overflow into wetlands were observed in 2017 and violations issued. In addition, piggeries at homesteads in the upper watershed have been cited as bacteria sources. Stormwater runoff and feral animals have also been identified as likely sources of bacteria; however dry weather flows (at least in Achugao south) seem to be the predominant issue (**Figure 31**).

*Figure 31. STV exceedances for Enterococcus between 2012-2016 and presumed sources in Achugao North (top) and South (bottom) subwatersheds (from 2017 Bacteria TMDL fact sheet).*

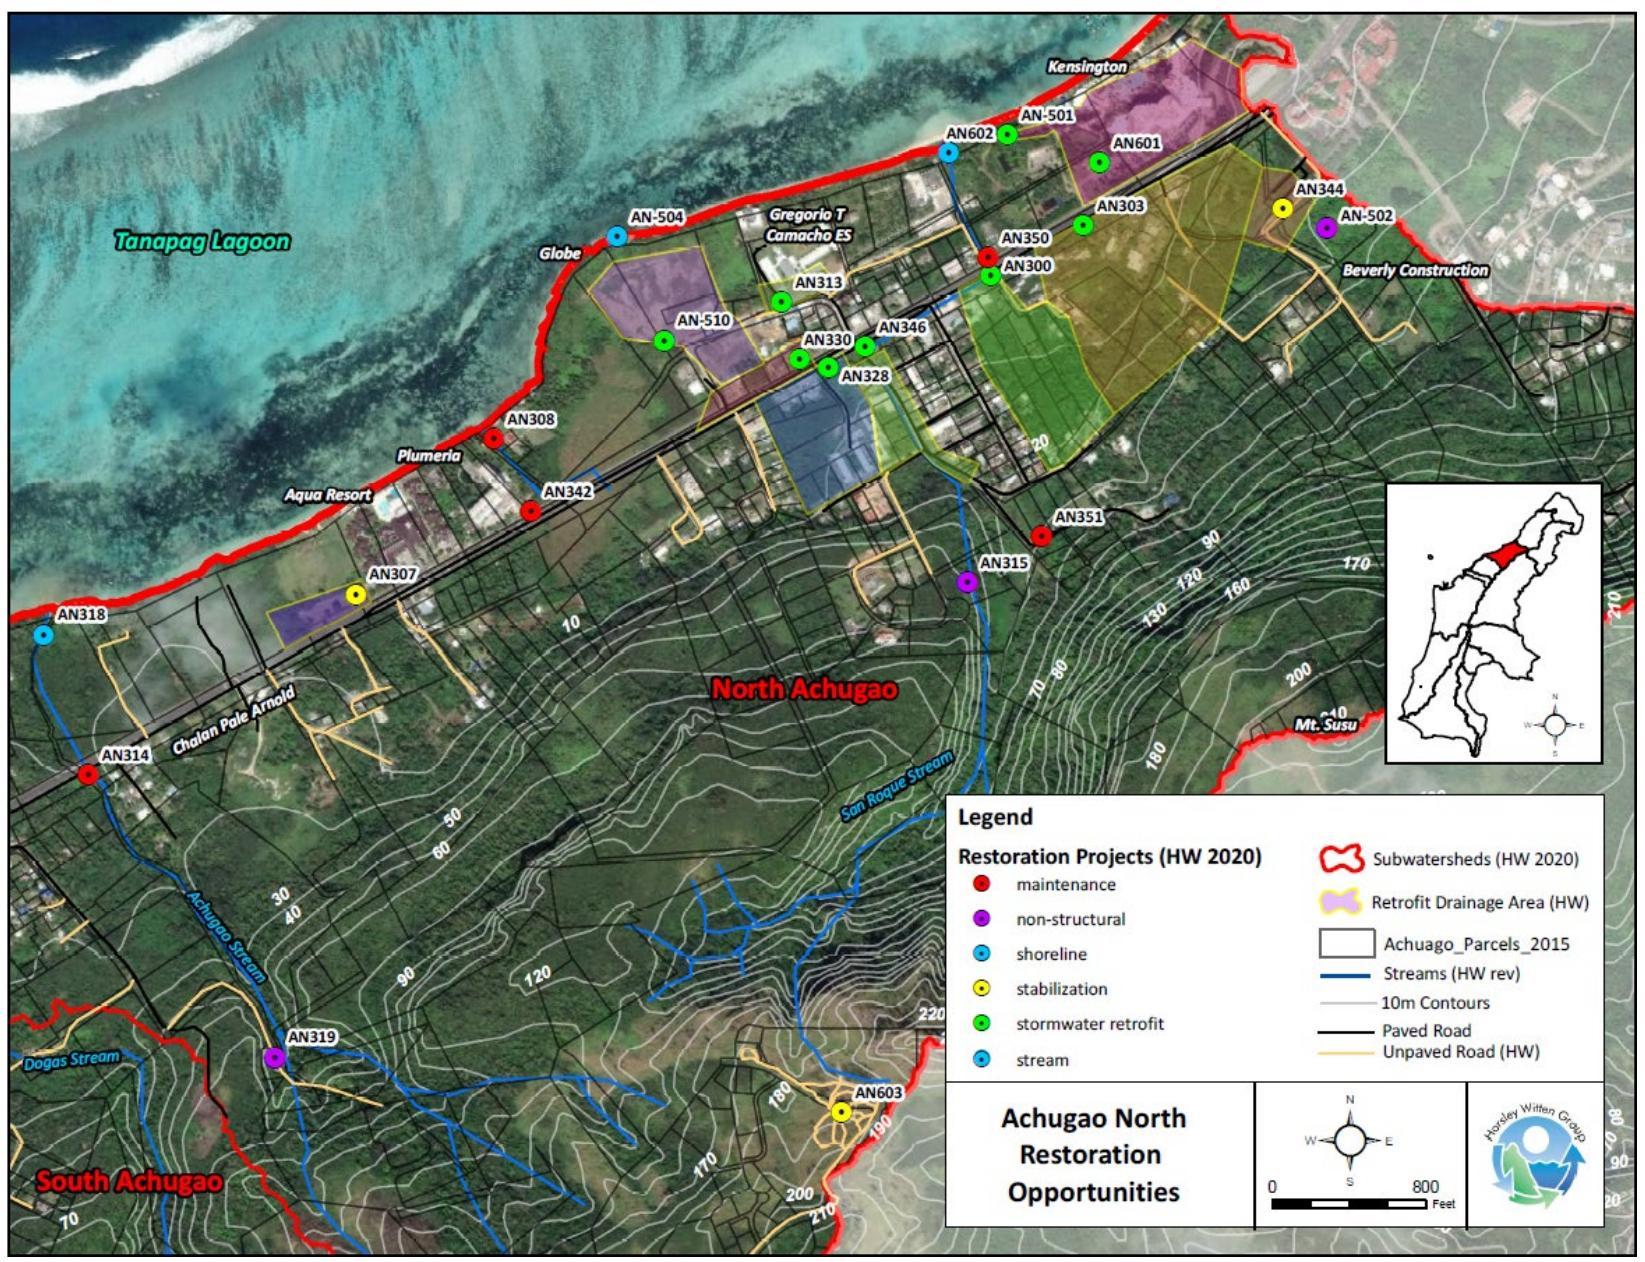
Figure 33a. Potential restoration opportunities identified in Achugao North by HW field crews, January 2020

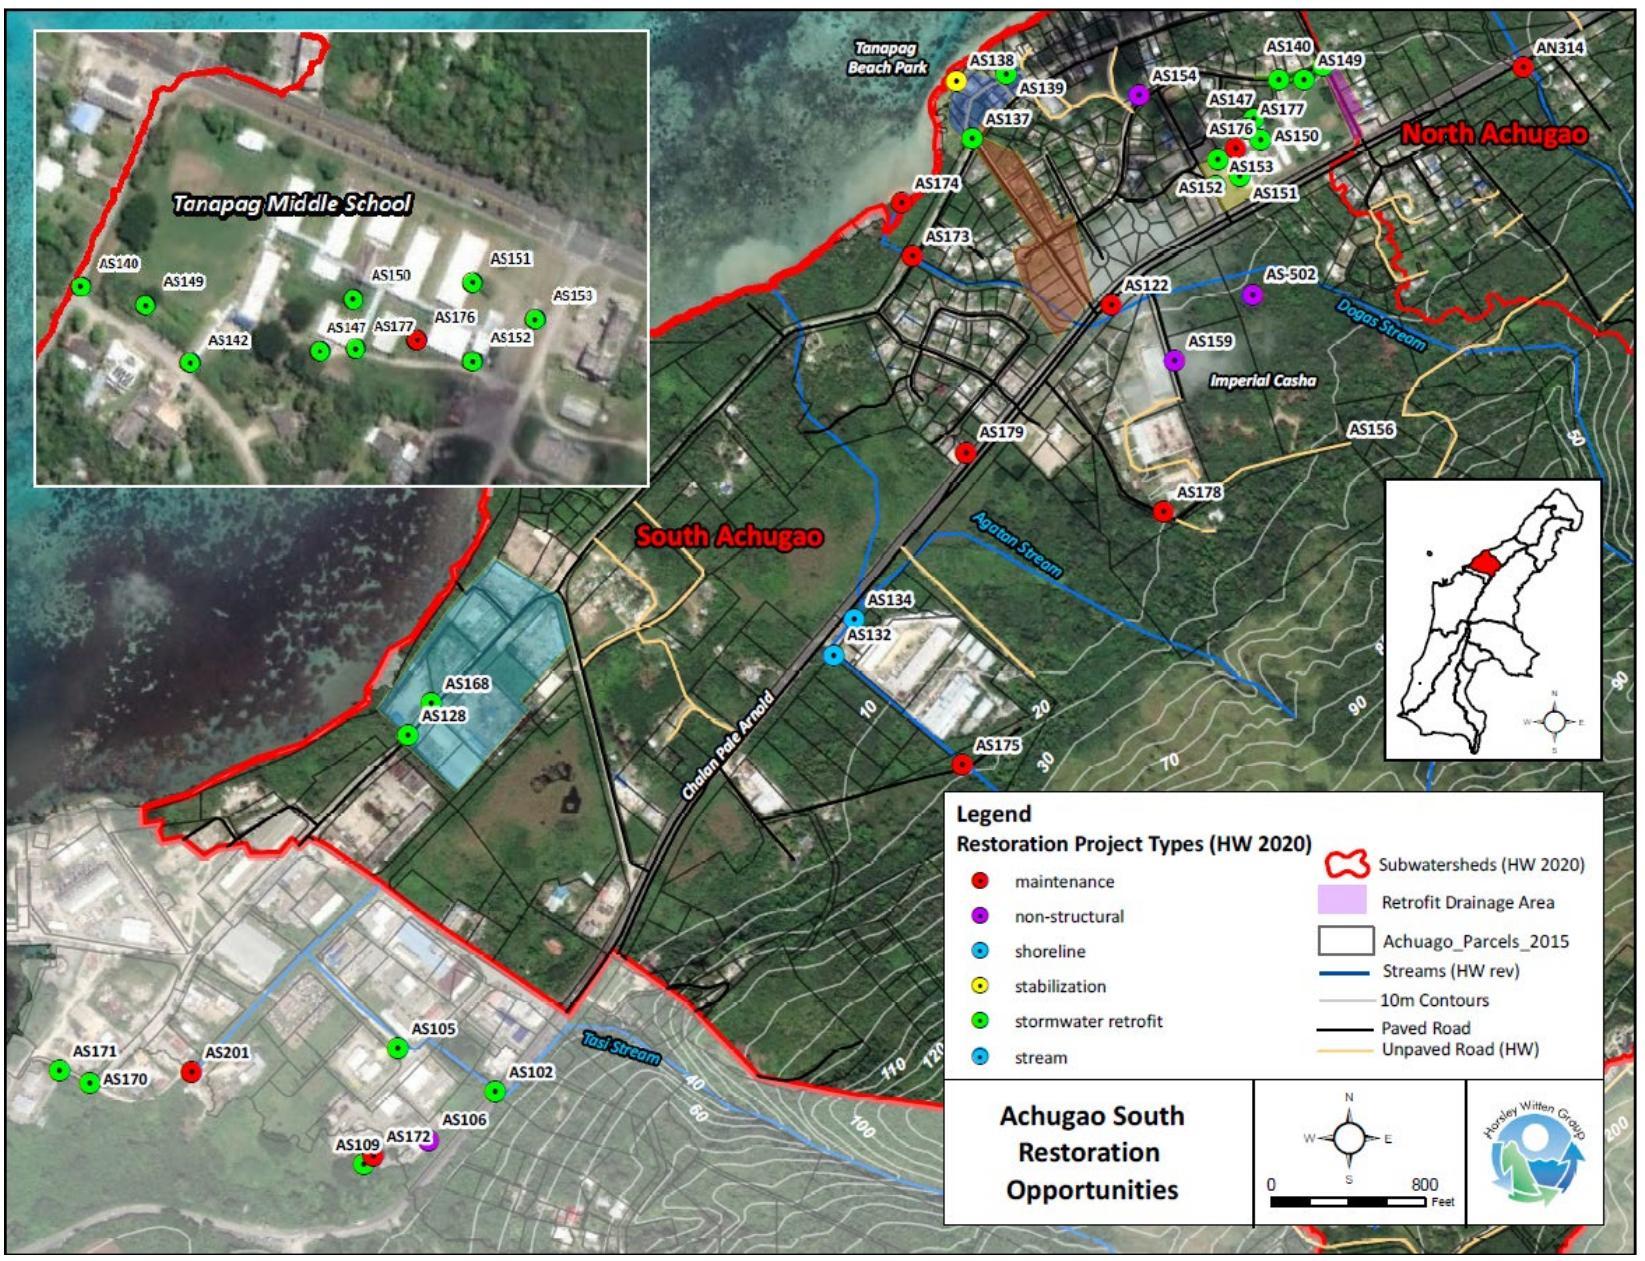
Figure 33b. Potential restoration opportunities identified in Achugao South by HW field crews, January 2020
