Shoreline Monitoring Beach Profile Report: Saipan and Mañagaha

May 2023

Division of Coastal Resources Management -
CNMI Bureau of Environmental Coastal
Quality

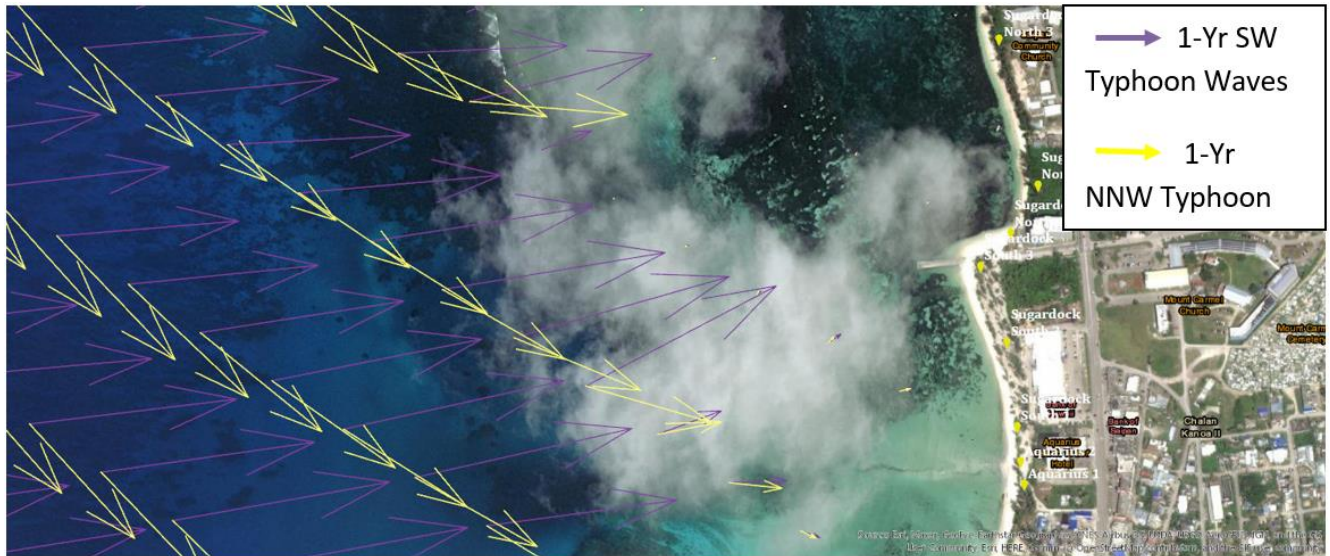
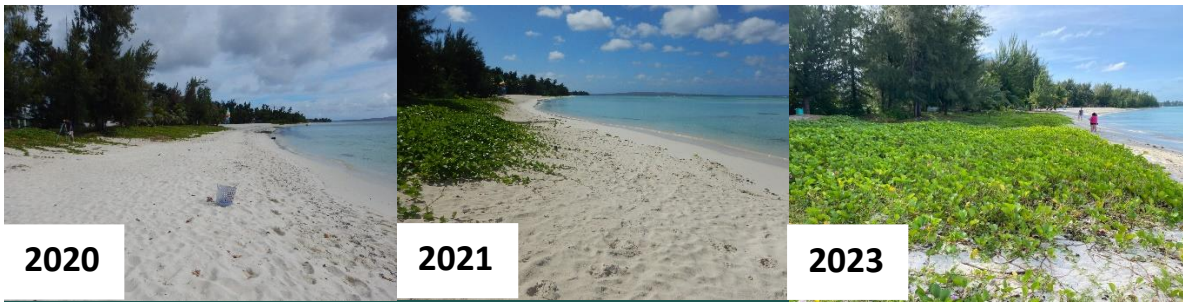
Aquarius 2 Highlights:

- ACCRETING
- Wrackline that ranges 35 – 92 ft with an elevation difference of 10 ft
- Short-term erosion events have occurred. The sand bar could influence this dynamic behavior, suggesting that sand is pushed during typical winter conditions and pulled during typhoon conditions.
- Based on the Shoreline linear regression analysis (see pg 29), the shoreline has a rate of +1.9 ft from 2016-2023.

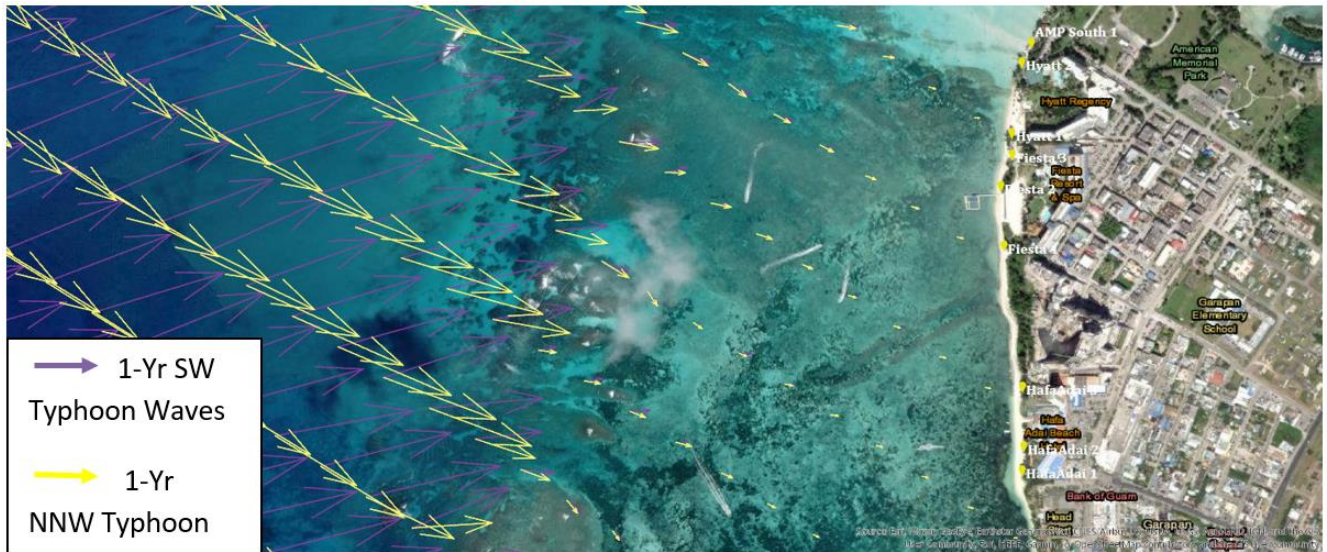
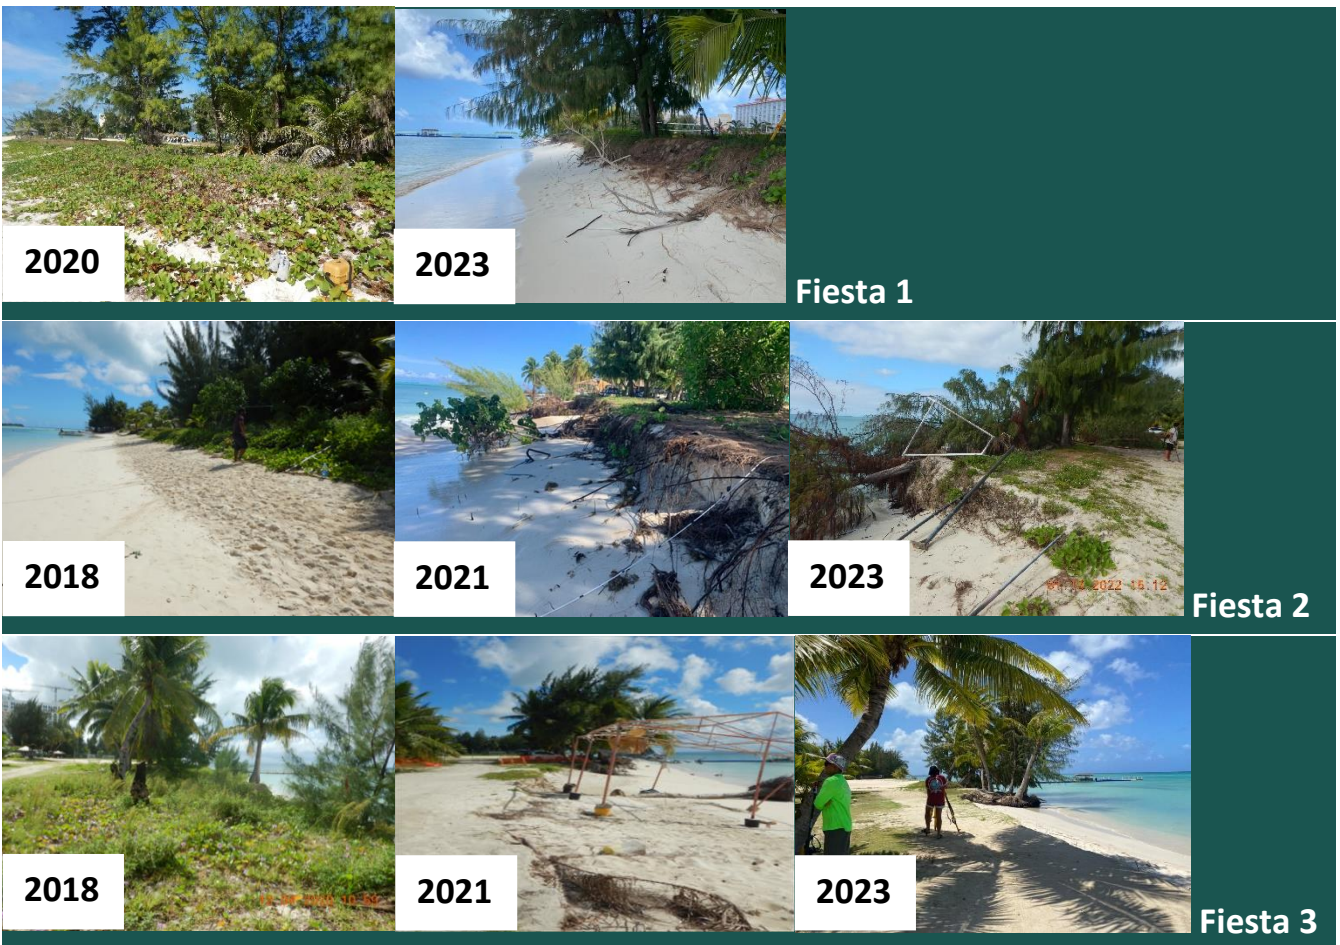
Fiesta 3 Highlights:

- ERODING and REPLACED
- LOSS of shoreline by ~60 ft since 2017
- Beach profile of Jun 2017 to Jun 2021 showed the High Waterline ranges 30 – 55 ft with an elevation difference of less than 6 ft
- **History:** From 2017 – 2020, the berm has retreated ~36 ft. Then from Feb 2020 – Jun 2021, erosion has reached the headstake, indicating additional of loss 16 ft. Storm-induced wave action is abrading the beach and weakening the sand. The late storms of 2021 have eaten up to the headstake and eaten up to the seaward portion of a previous road. This resulted in the area being closed off.
- This shoreline has been eroding from 2016-2023.

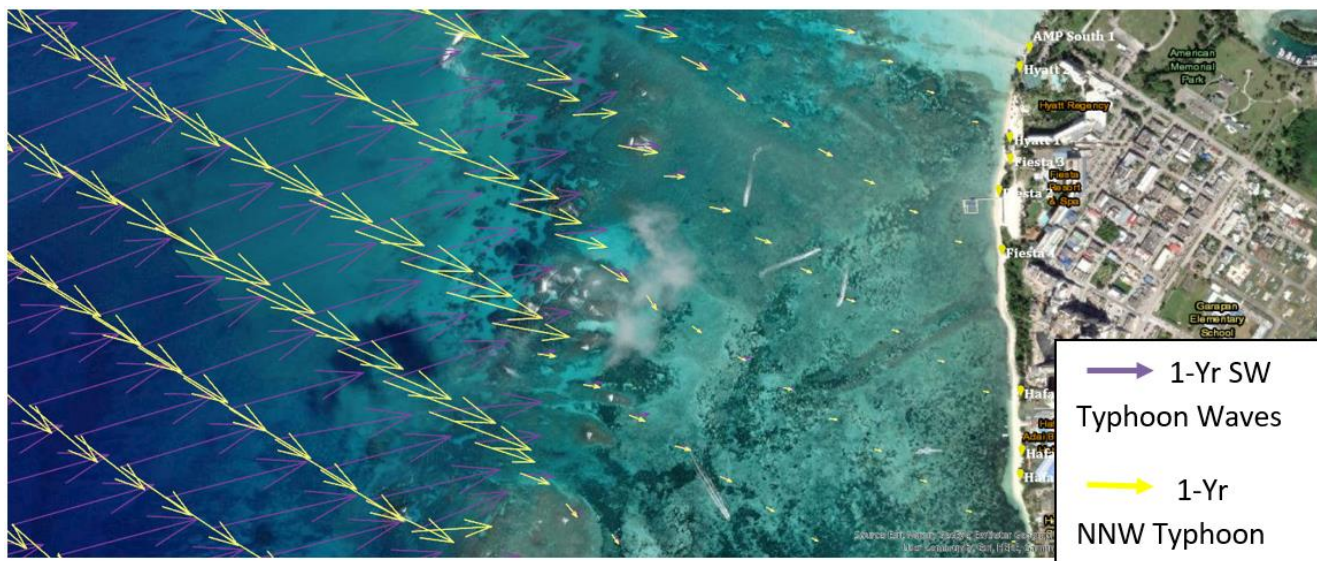
Hyatt 2 Highlights:

- ERODING
- LOSS of shoreline by ~70 ft since 2017
- **History:** This area serves as a pathway from Micro Beach to the marine sports area north of Hyatt. It is eroding on the long term determined by the abrasion exposing the bedrock after the September 2021 storm. The sand is pulled into the water during high wave energy conditions and pushed into the shore during lower wave energy conditions. The new operational headstake is tree farther back. LOSS of shoreline by ~30 ft since 2020.

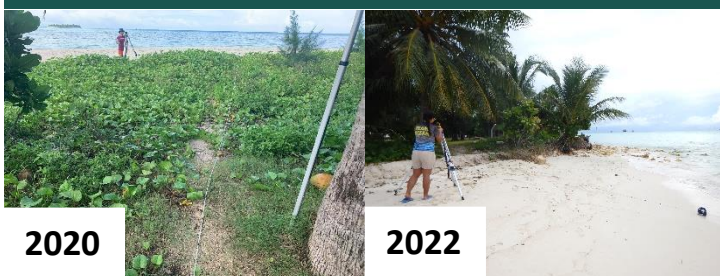
American Memorial Park Point 1

[No photo is available for 2023. Conditions

had naturally replenished sand.]
