DCRM Shoreline Profile Monitoring Data Report

Saipan and Mañagaha

August 2018 – February 2021

Bureau of Environmental Coastal Quality - Division of Coastal Resources Management

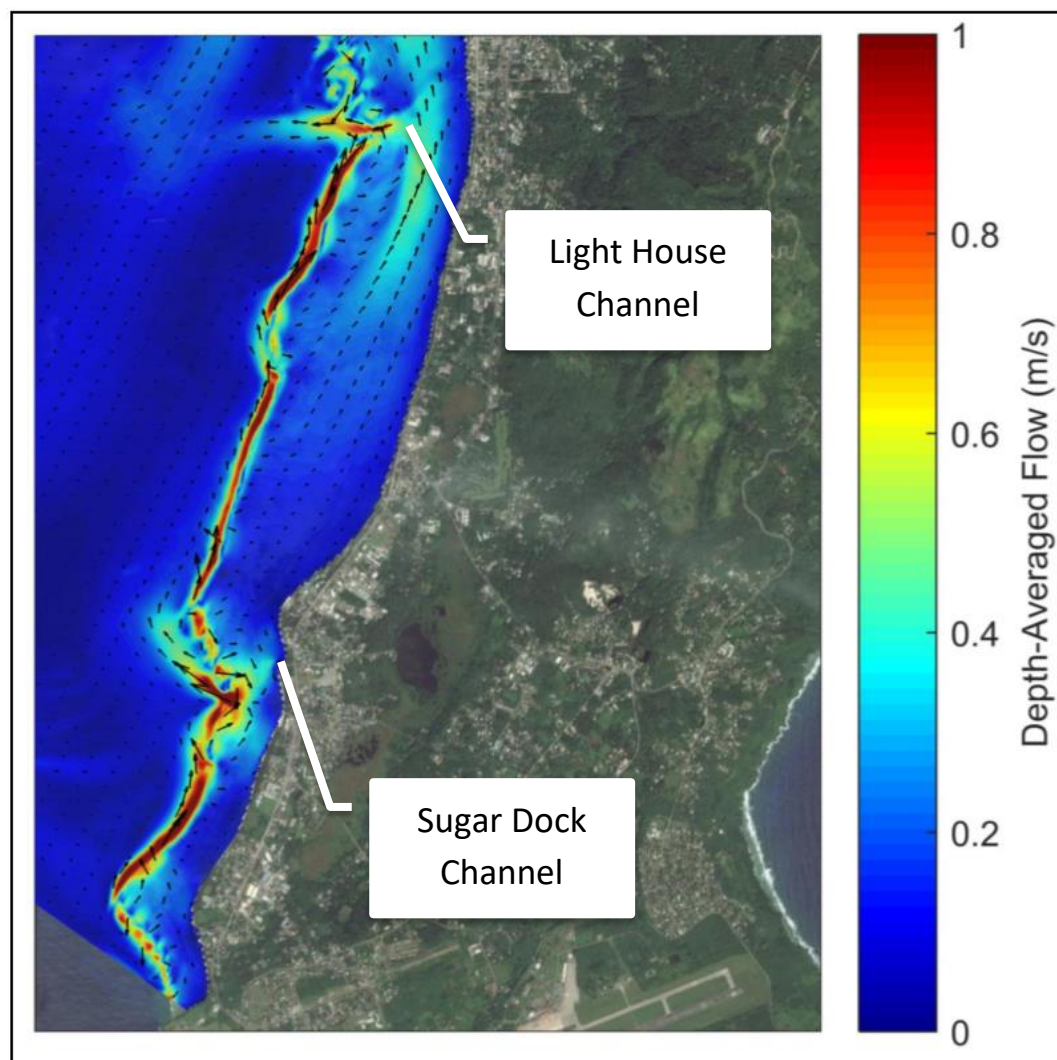
Down south, the shoreline is generally sheltered by reef and the only channel is around Sugar Dock. The area close to Sugar Dock are dynamic but the rest remain stable.

Average flow within Garapan Lagoon generated by southwest typhoon conditions

(the highest modelled wave energy condition for this area). Map extracted from the SASEA.

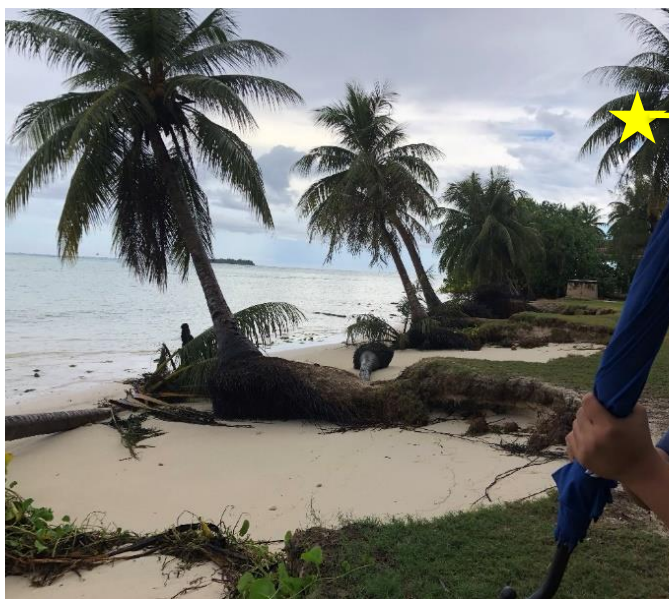
Picture taken on August 2018 before Yutu. The waterline is close to a row of coconut trees and slumping and appears to be occurring in places around the coconut tree roots.

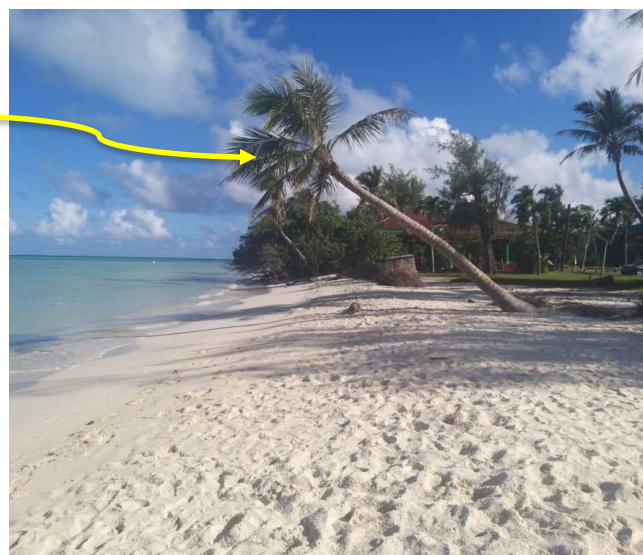
Picture taken December 2019. The coconut tree at the backshore is the only surviving. The row of coconut tree are uprooted and the sand within the berm have poured into the shoreline, exposing it to long-shore transport.

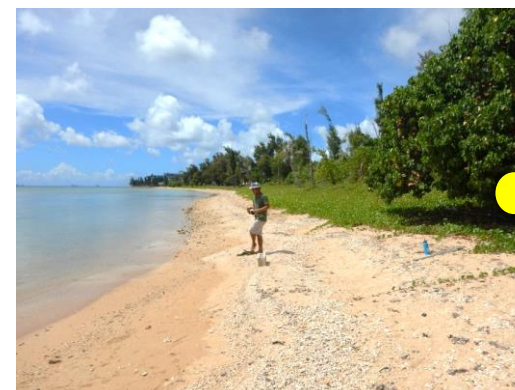
Pakpak 1 appears to be generally stable. The wrackline ranges from 19 ft to 40 ft. The elevation difference from the headstake to the farthest top of toe is about 5 ft. The Nov 2020 transect is an outlier, potentially from surveyor error. The direction of the transect line may greatly contribute to a different transect captured since that area is on the corner of a curving shoreline.

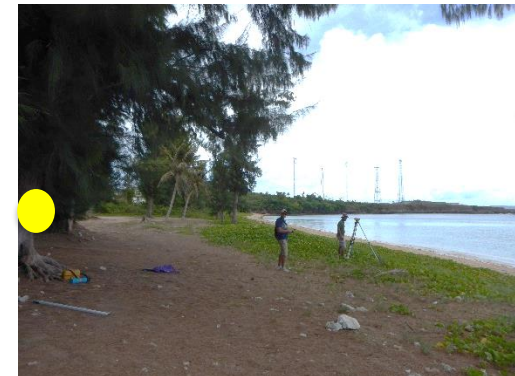
Pakpak 2 appears generally stable with July 2019 being an outlier. The wrackline ranges from 50 to 75 ft. The elevation difference from the headstake to the farthest top of toe is about 9 ft. Tidal influence is uncertain in the shoreline length as Feb 2018 and Nov 2020 are outliers.

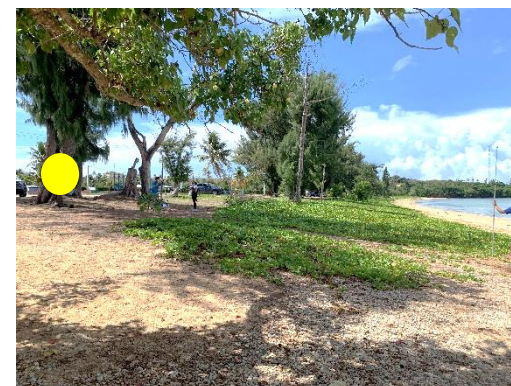
Pakpak 3 is generally stable with little variation over time. The wrackline ranges from 47 ft to 77 ft. The elevation difference from the headstake to the farthest top of toe is about 8 ft.

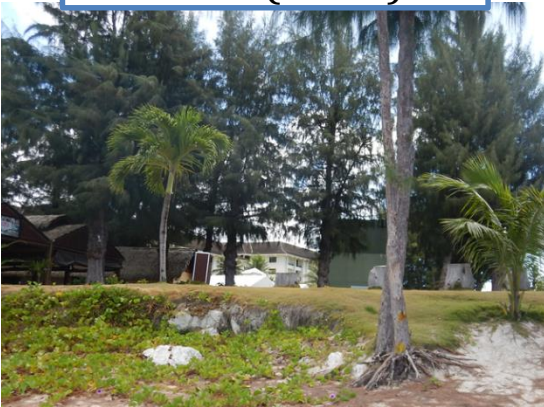
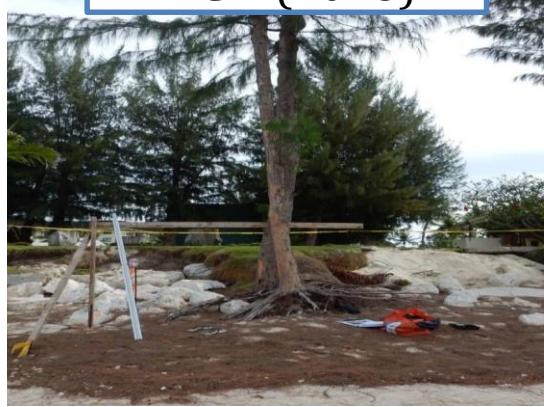
PIC is adjacent to the Chalan Kanoa reef, around 500 meters away from the headstake. This shoreline exhibits subsection to storm-induced erosion. The shoreline received some beach nourishment given its nearby commercial use. The storms of 2018 have abraded the shoreline and fell palm and ironwood trees located on the berm. South west typhoon conditions appear to be more damaging than north-north west especially due to the proximity of the storm.

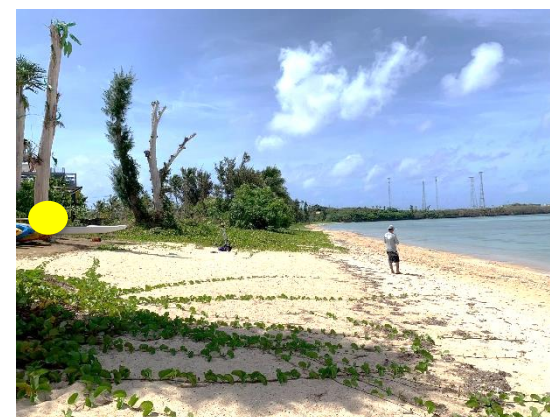
The PIC 1 berm appears to be relatively stable. The Jun-20 record is an outlier from surveyor error. Dec-20 suggests that there were abrasions in after 40 ft. The wrackline ranges from 37 ft to 56 ft. The elevation difference from the headstake to the farthest toe is around 9 ft. This beach profile lacks stabilizing vegetation due to heavy foot traffic.

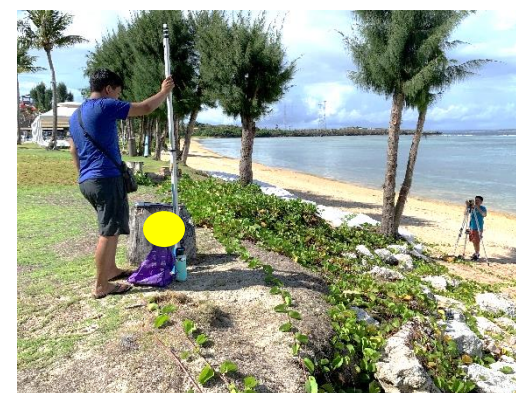
The berm has notably eroded around June 2017 when the shoreline has abraded. This berm exhibited stability when rocks were placed until Typhoon Yutu (2018) deepened the drop. The head stake acts like a good boundary of the PIC property. The loss of the head stake may indicate that the property is at a higher risk of shoreline erosion especially from storm surge. See pictures at [page 31](#). The wrackline ranges from 35 to 48 ft. The elevation difference of the headstake to the toe is around 9 ft.

The stretch from Micro Beach to Fiesta is highly eroded from high wave conditions generated during the winter and summer typhoon tradewind conditions. Other erosion hotspots include PIC 2 and Hopwood 1.

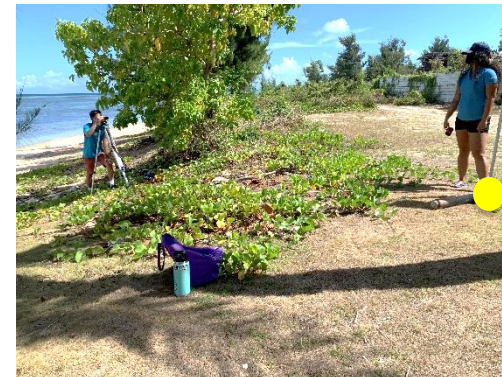
PIC 3 appears fairly stable. This section of shoreline may have received some beach nourishment in the past. The wrackline ranges from 45 ft to 50 ft. The elevation difference from the headstake to the farthest top of toe is around 9 ft.

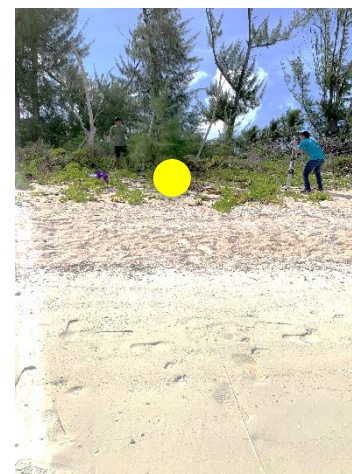
Hopwood 1 appears eroding and has changed dramatically over the years. The wrackline ranges from 30 ft to 76 ft. Through observation, it is speculated that storm surges from powerful storms may influence the shoreline vegetation dynamics. Thus, locating the headstake, which is a tree, increases the likelihood of error. The elevation distance from the headstake to the furthest top of toe is 7 ft.

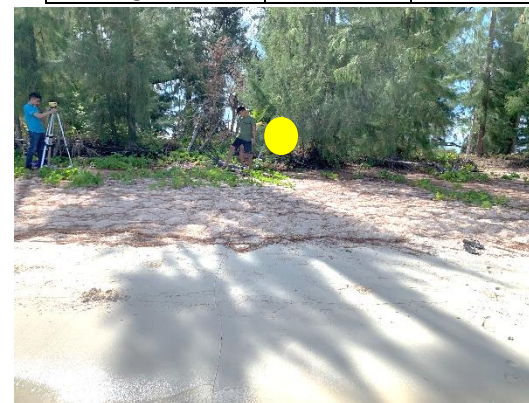
Hopwood 2 is undetermined given the misidentification of the headstake. Dec-16 through Aug-17 was the initial headstake until it went undetected after a storm event. Dec 2020 record is an outlier from surveyor error. The wrackline ranges from 20 ft to 37 ft. The high proximity to the headstake (tree line) poses sea level rise concerns. The elevation difference from the headstake to the furthest top of toe is around 5 ft.

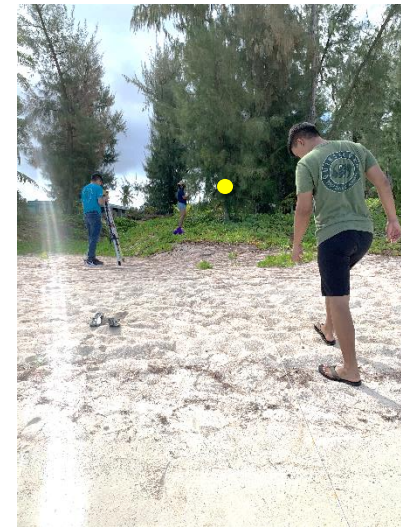
Hopwood 3 appears to be dynamic so its status is undetermined. Its proximity to an outflow may also contribute to the variation of this shoreline. The wrackline ranges from 27 ft to 47 ft. The elevation difference from the headstake to the top of the toe is 7 ft.

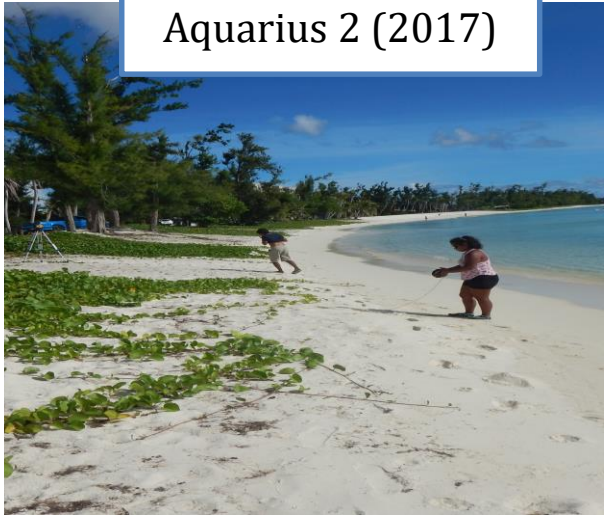
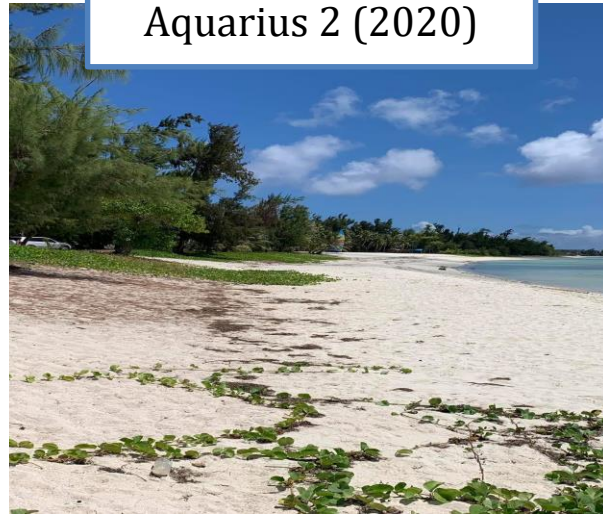
Trend: Accreting

Future data and observations may improve understanding of this on-going trend. Wave overtopping and overwhelmed tidal flows from the channel down south may impact this site during both typhoon wave conditions. It appears that southwest conditions could greatly impact this site. Under southwest conditions, longshore could potentially be going from south to north while north-northwest conditions indicate the opposite. Improvements to nearshore dynamics could explain the source of the accretion.

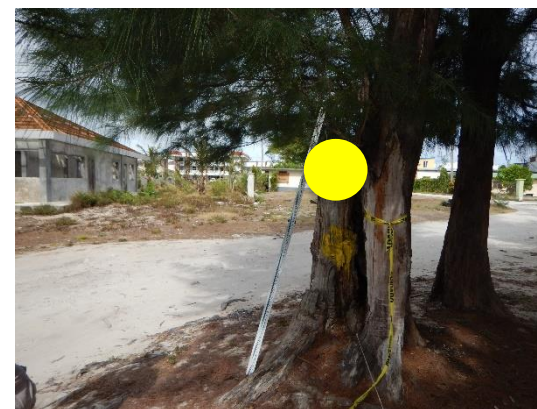
Aquarius 1 is undetermined. This transect has a history of two different headstakes. The first one, surveyed from Jun 2017 – Jun 2018, is parallel to the most recent headstake but closer to the waterline. The most recent headstake was pushed more inland. The current headstake appears to be accreting and gaining some height at the berms until Oct 2020. Oct-20 is an outlier. The wrackline has not been observed at the current headstake. However, this shoreline is long with a two berms. The distance from the headstake to the furthest top of toe is around a little bit past 8 ft.

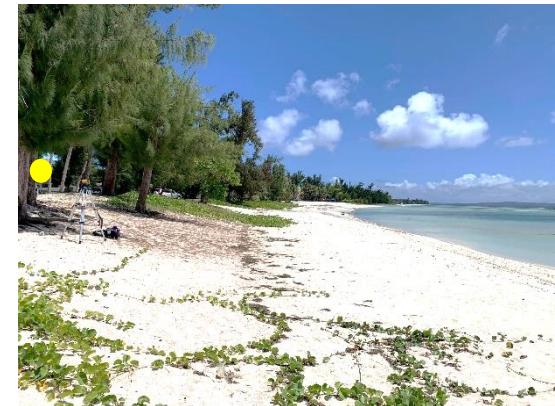
Aquarius 2 appears to be accreting since July 2020. Erosion occurred from 2016 to April 2020. The wrackline ranges from 35 to 92 ft for the current headstake. This wide range may be due to the accretion of this previously eroding shoreline. The elevation distance from the headstake to the furthest top of toe is 10 ft.

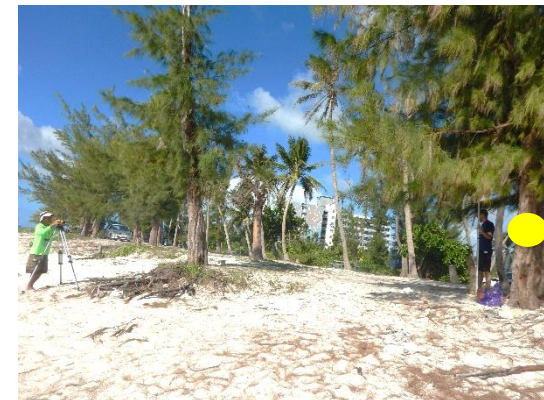
Sugar Dock South 2 is eroding. The berm has completely worn away, so the headstake (tree) is right when the slope begins to steadily drop into the waterline. Vehicle compaction regularly occurs here and may be another physical factor to the smoothing of this shoreline. The wrackline ranges from 26 to 57 ft. The elevation difference from the headstake to the furthest top of toe is around 10 ft.

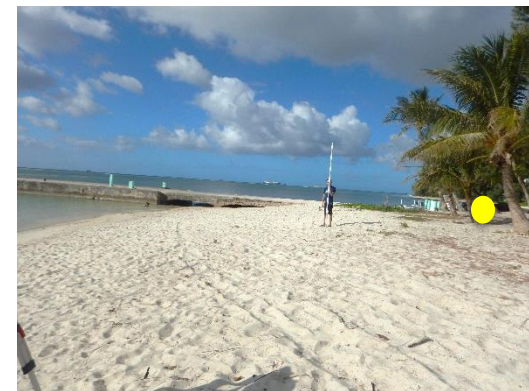
Sugar Dock South 3 is generally eroding. The shoreline is generally getting deeper, until some naturally sediment accumulated on Oct 2020. This sediment input suggests the occurrence of sediment deposition at this area. The wrackline ranges from 59 to 89 ft. The elevation difference is from the headstake to the furthest top of toe is around 9 ft.

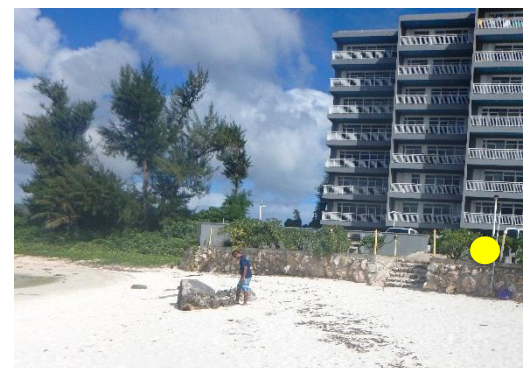
Sugar Dock North 1 has been included into monitoring due to the residential building in close proximity. The wrackline is more of interest to planning purposes get the distance from the headstake (seawall of the residential building). High surveyor error is evident in this transect especially due to the curvature of the sand accumulation. Improved, precise transect laying will be integrated to better capture this tide-dependent shoreline. Blockage of the Sugar Dock structure has caused this area to accrete. Future dredging to recover proper function of the boating ramp will greatly reduce this shoreline profile. Wrackline ranges from 44 to 54 ft. The elevation difference is from the headstake to the furthest top of toe is around 4.5 ft.

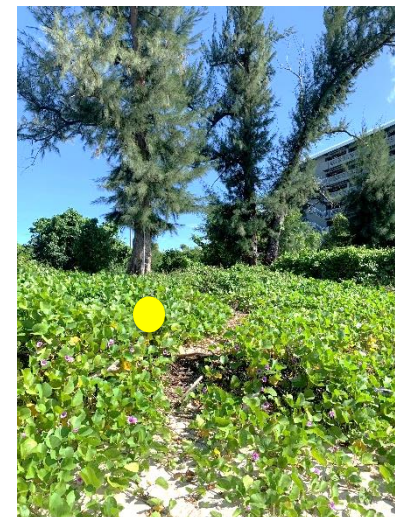
Sugar Dock North 2 is generally eroding. A development of the berm indicates abrasion at around 35 feet from the headstake. The wrackline ranges from 50 to 66 ft. The elevation distance from the headstake to the furthest top of toe is around 8 ft.

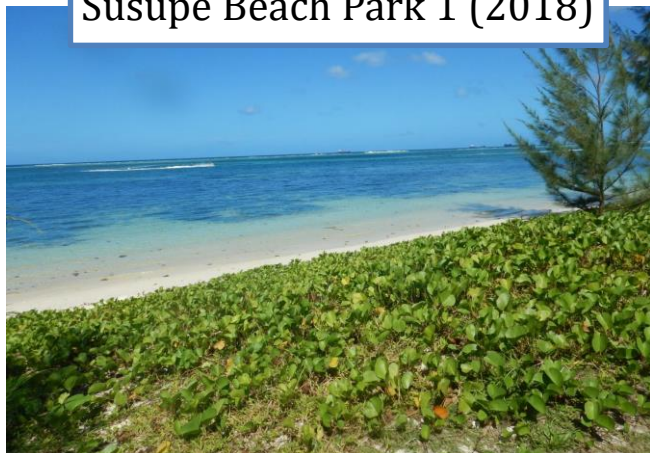
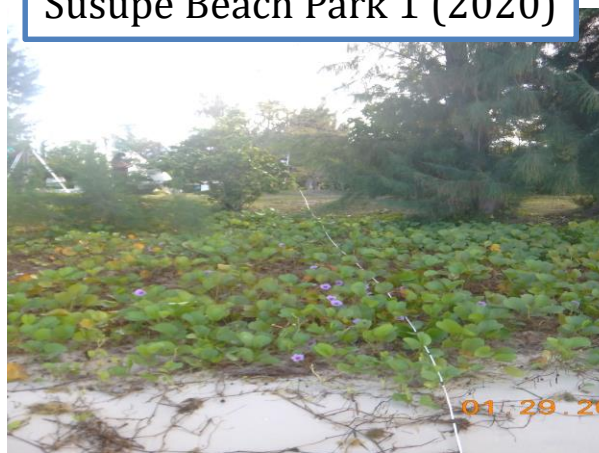
Trend: Variable

Nearly 800 meters away from the sheltering Chalan Kanoa Reef, Susupe Beach Park is relatively stable but may be prone to sea level rise. Backshore vegetation remains relatively stable and the ironwood trees appears to be thriving. Most of the foreshore environment is vegetated. Previous account from the Saipan's Misbehaving Beaches Story Map (2014) found that this piece of shoreline experienced vegetation loss from wave run-up observed that year. During this reporting period, access to the shoreline was limited due to the closure of the beach park due to its proximity to a COVID-19 quarantine site. Thus, only two rounds of data collection were pursued for this site this period. Wave overtopping and overwhelmed tidal flows may impact this site during both typhoon wave conditions. It appears that southwest conditions could greatly impact this site. However, improved resolution on nearshore dynamics may explain longshore processes for this area.

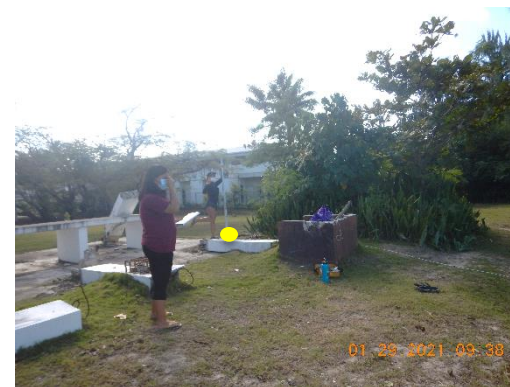
Susupe Beach Park 1 has undetermined status. Mar-18 and Jun-18 are outliers. Misidentification of the headstake may have occurred in Oct-20 and used the down slope yellow-marked tree. The wrackline ranges from 40 ft to 52 ft. The elevation difference from the headstake to the furthest top of toe is around 8 ft.

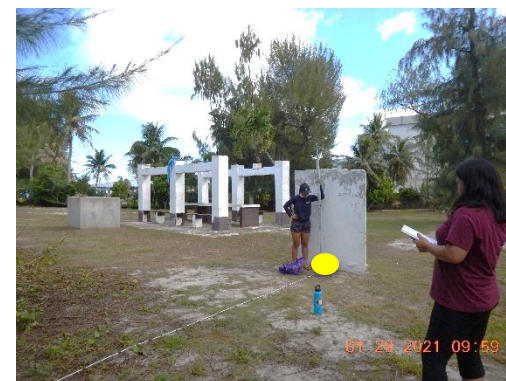
Susupe Beach Park 2 is relatively stable. Slight variation on the berm could be from surveyor error. The wrackline ranges from 47 ft to 70 ft. The elevation difference from the headstake to the furthest top of toe is around 8 ft.

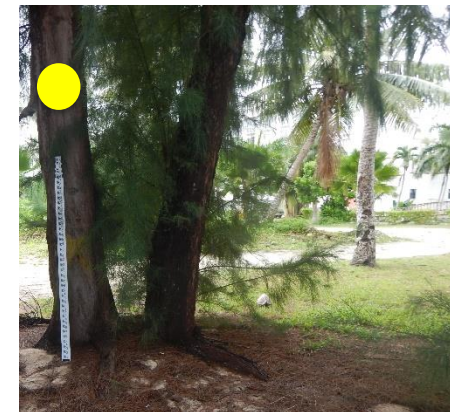
Susupe Beach Park 3 is relatively stable. Slight variation on the berm could be from surveyor error. The wrackline ranges from 29 ft to 50 ft. The elevation difference from the headstake to the furthest top of toe is around 7 ft.

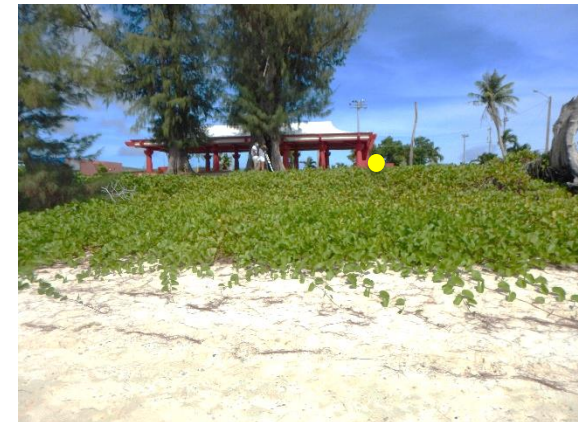
Kilili North 1 appears to be accreting. From Jun 2017, a significant volume of sediment accumulated over the years. Nov-20 seems to be an outlier based by surveyor error. The wrackline ranges from 44 to 120 ft based on this record history. The elevation difference from the headstake to the furthest top of toe is around 10 ft.

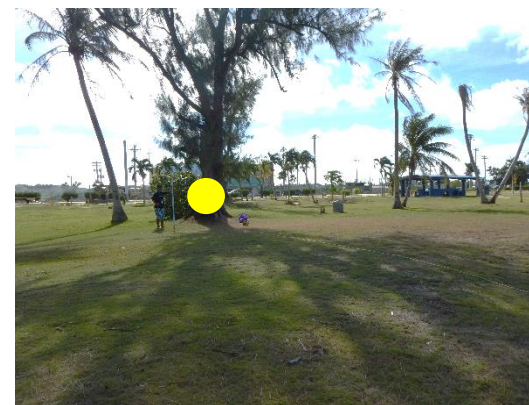
Kilili North 2 is generally stable. There are discrepancies in the data caused by surveyor error. Given that the headstake is further inland, this profile is expected to be longer and indicates an estimation of the proximity to the high tide line, or wrackline, is from the pavilions. Sea level rise may be concerning factor in the erosion of this shoreline. The wrackline ranges from 50 to 79 ft. The elevation difference from the headstake to the furthest top of toe is around 7 ft.

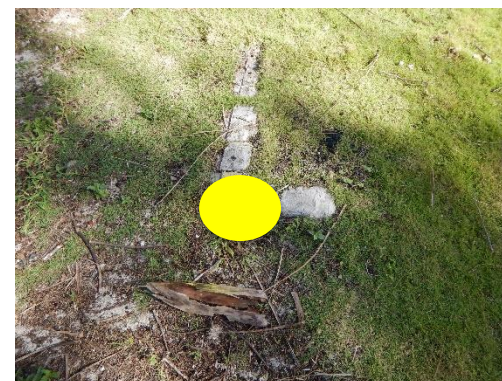
Kilili North 3 appears to be stable. There are discrepancies in the data caused by surveyor error. The wrackline ranges from 40 ft to 56 ft. The elevation difference from headstake to top of toe is about 8 ft.

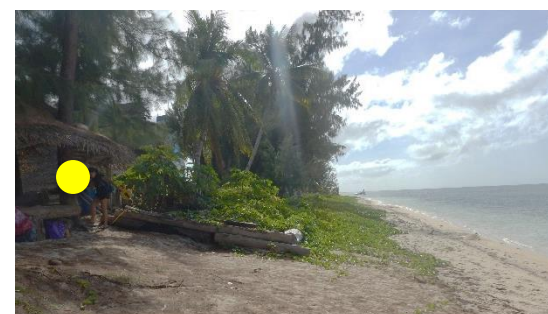
Kilili South 1 appears to be accreting. A potential factor to this accretion is sediment pushed from the backshore due to foot traffic influence. The wrackline ranges from 23 ft to 40 ft. The elevation difference from the headstake to the furthest top of toe is around 6 ft.

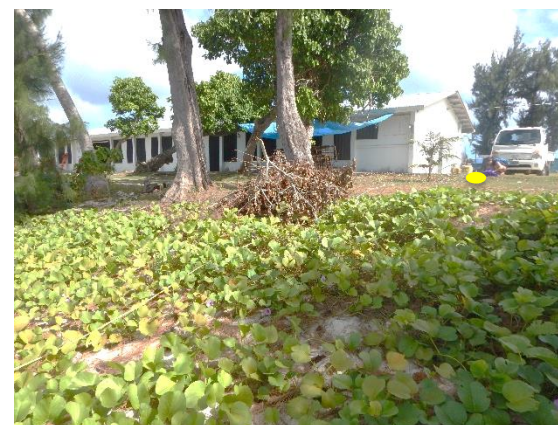
Kilili South 2 is relatively stable. Slight variation on the berm could be from surveyor error. The wrackline ranges from 47 ft to 70 ft. The elevation difference from the headstake to the furthest top of toe is around 8 ft.

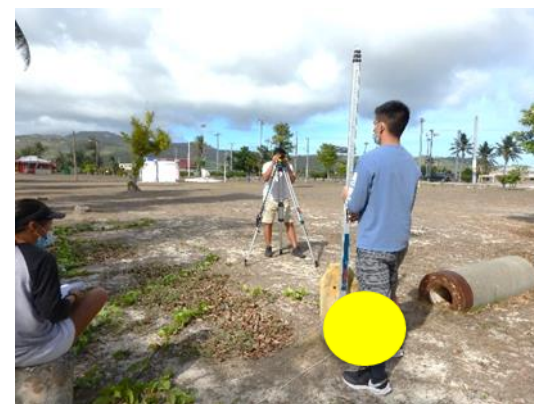
Kilili South 3 is dynamic and has an undetermined status, with the shoreline berm changing throughout the years. This shifting shoreline feature may suggest sediment entering and exiting the area. Due to the presence of a blocking ironwood tree, the headstake is discontinued as of June 2020; however, the newly selected headstake to replace this one is nearby and marked with yellow paint. The wrackline ranges from 42 ft to 53 ft. The elevation distance from the headstake to the furthest top of toe is 8 ft.

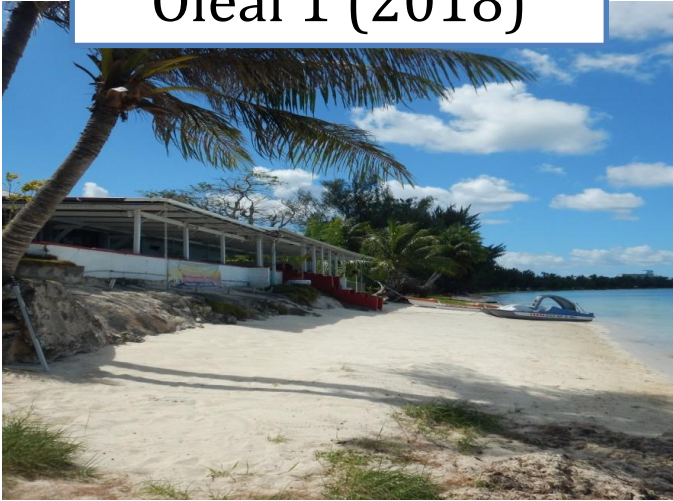
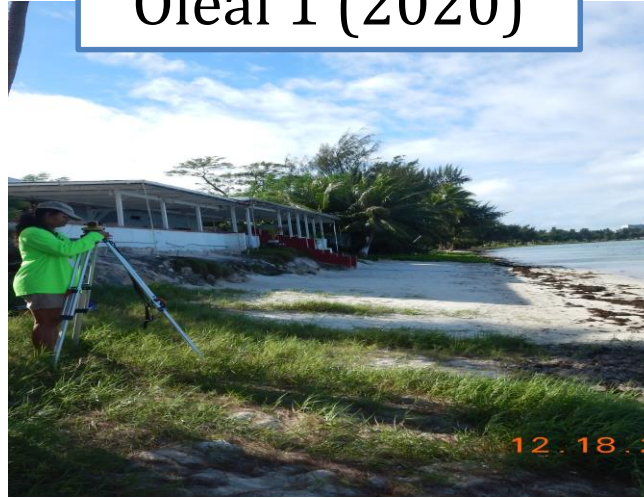
Oleai 1 (2018)

Trend: Eroding

EPHR: Medium

Average length: 36.5 ft

Parallel to the Garapan reef, Oleai shoreline is short and adjacent to the parking lot of Oleai Beach Bar. The restaurant facility in Oleai 1 transect is less than 50 ft away from the waterline indicating that the restaurant is vulnerable to storm surge and sea level rise. Stabilization measures are necessary to protecting the infrastructure from an encroaching waterline, so recording the shoreline position may assist proper decision-making in addressing this issue. Wave overtopping and overwhelmed tidal flows may impact this site during both typhoon wave conditions. It appears that southwest conditions could greatly impact this site. However, improved resolution on nearshore dynamics may explain longshore processes for this area.

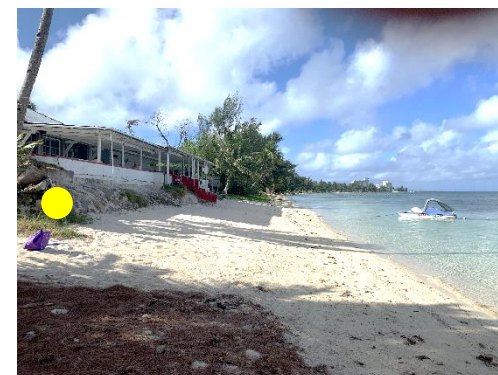
Day Recorded	Tide	Shoreline Length
Jan 20, 2017	1.36 ft	30 ft
Jun 26, 2017	0.2 ft	16 ft
Mar 8, 2018	1.57 ft	24 ft
Jun 22, 2018	1.49 ft	38 ft
Mar 13, 2020	1.64 ft	27 ft
Jul 8, 2020	1.9 ft	29 ft
Dec 18, 2020	1.19 ft	39 ft
Average		29 ft

Oleai 1 is undetermined given its dynamic nature impacted by tidal influence. The variation occurs past the 20 ft distance mark. The short length of the shoreline is concerning as the wrackline encroaches on the infrastructure. The wrackline ranges from 16 ft to 33 ft. The elevation difference from headstake to top of toe is about 6 ft.

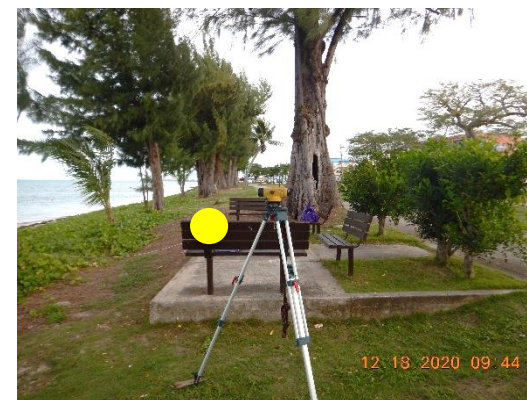
Oleai 2 is generally eroding. Oleai 2 headstake was prone to misidentification. Entries were done at the original headstake (corner of cemented foundation for sidewalk) while outliers were done at a marked tree. They are adjacent to each other but the marked tree headstake is several feet inland compared to the other. The wrackline ranges from 23 ft to 48 ft. The elevation difference from headstake to top of toe is about 7 ft.

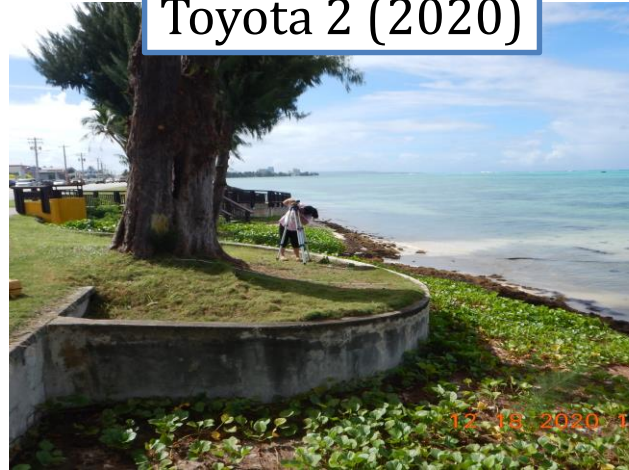
Toyota 2 (2020)

Trend: Eroding

EPHR: High

Toyota shoreline encompasses a portion of the Beach Road pathway with the railing and ADA pathway down to the shore. This area is prone to abrasion after storm surge events, which has historically damaged the pathway infrastructure. The toe of this shoreline is exposed during low tide. Along with erosion by storm surge, sea level rise threatens this shoreline and its highly developed backshore, the Toyota intersection and the surrounding businesses. Both typhoon conditions bring strong wave energies that greatly erode the short shoreline away. Wave overtopping and overwhelmed tidal flows may impact this site during both typhoon wave conditions. It appears that southwest conditions could greatly impact this site. However, improved resolution on nearshore dynamics may explain longshore processes for this area.

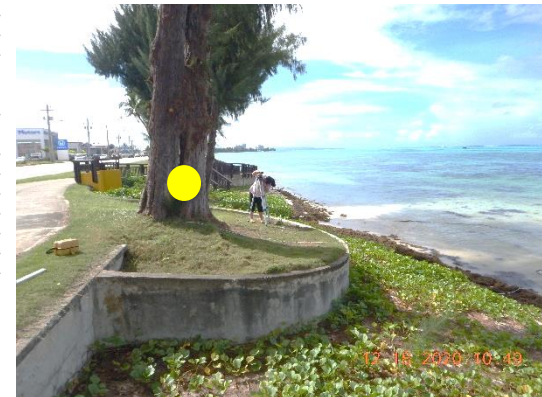
Toyota – 2

Day Recorded	Tide	Shoreline Length
Jan 27, 2017	1.23 ft	Not recorded
Jun 26, 2017	-0.39 ft	Not recorded
Mar 8, 2018	1.32 ft	53 ft
Jun 22, 2018	0.52 ft	50 ft
Mar 13, 2020	1.96 ft	30 ft
Jul 8, 2020	1.7 ft	29 ft
Average		38 ft

Toyota 2 is generally eroding since Jan 2017. This transect has been hardened to protect the berm where the tree stands. Although surveyor error is evident, strong abrasion of the shoreline happened on June 2018. The wrackline ranges from 20 ft to 30 ft. The elevation difference from headstake to top of toe is about 9 ft.

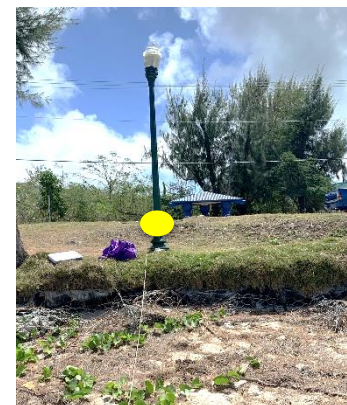
Toyota – 3

Day Recorded	Tide	Shoreline Length
Jan 27, 2017	1.31 ft	40 ft
Jun 26, 2017	-0.55 ft	18 ft
Mar 8, 2018	1.18 ft	55 ft
Jun 22, 2018	0.63 ft	63 ft
Mar 13, 2020	1.73 ft	31 ft
Jul 8, 2020	1.6 ft	52 ft
Dec 18, 2020	1.92 ft	53 ft
Average		44.6 ft

Toyota 3 appears to be generally stable with periods of erosion and accretion. The wrackline ranges from 17 ft to 50 ft. The elevation difference from headstake to top of toe is about 9 ft.

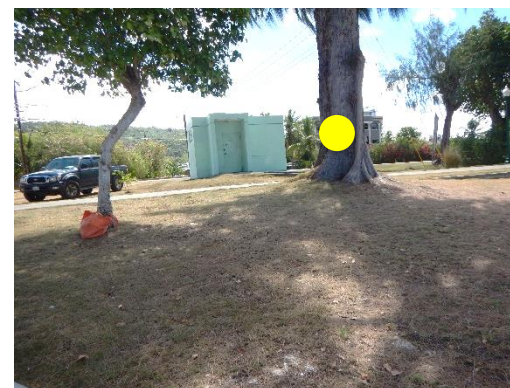
Day Recorded	Tide	Shoreline Length
Jan 27, 2017	1.37 ft	50 ft
Jun 6, 2017	0.54 ft	Not recorded
Mar 13, 2018	1.19 ft	43 ft
Jun 25, 2018	0.5 ft	57 ft
Feb 6, 2020	1.54 ft	56 ft
Jul 20, 2020	0.13 ft	114 ft
Aug 24, 2020	1.09 ft	54 ft
Dec 22, 2020	1.06 ft	48 ft
Average		60.3 ft

Quartermaster 1 is relatively stable, yet dynamic, with sediment entering and exiting the area. The June 2020 transect was an outlier due to the exposure of the toe from low tide influence. During low tide, the shoreline extended up to 114 ft. However, the wrackline of this transect ranges from 35 to 40 ft. The elevation difference from the headstake to the furthest recorded top of toe is 7.5 ft.

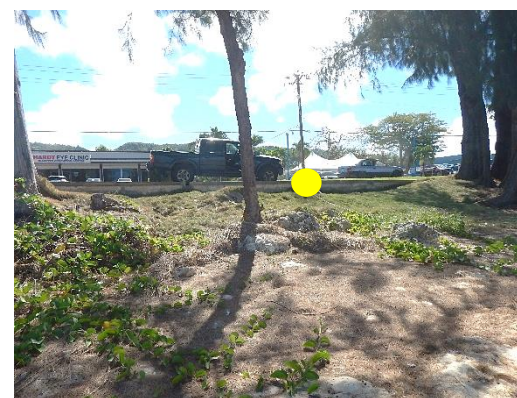
Quartermaster – 2

Quartermaster 2 is relatively stable, with sediment entering and exiting the area with an encroaching wrackline. There may also be some surveyor error association with July 2020 as an outlier. In low tide, the shoreline extended to 110 ft. The wrackline of this transect ranges from 30 to 52 ft. The elevation difference from the headstake to the furthest recorded waterline (alternative to the unrecorded top of toe) is 7 ft.

Day Recorded	Tide	Shoreline Length
Jan 27, 2017	1.37 ft	Not recorded
Jun 6, 2017	Not recorded	Not recorded
Mar 13, 2018	Not recorded	40 ft
Jun 25, 2018	0.84 ft	63 ft
Feb 6, 2020	1.54 ft	52 ft
Jul 20, 2020	0.13 ft	110 ft
Aug 24, 2020	1.09 ft	47 ft
Dec 22, 2020	1.37 ft	50 ft
Feb 22, 2021	1.34 ft	45 ft
Average		58.1 ft

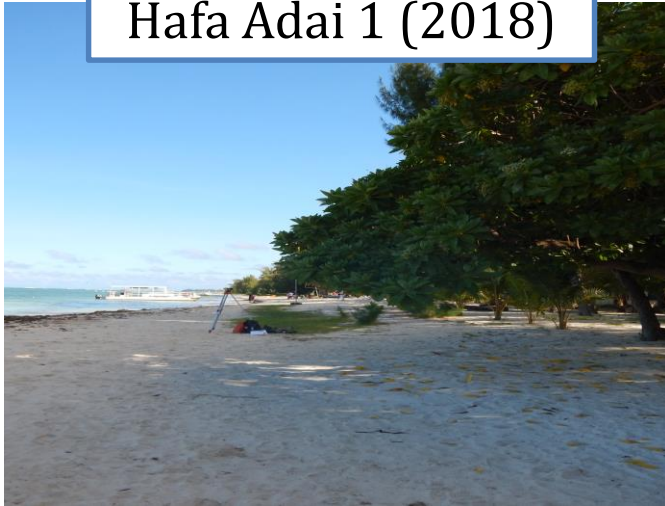
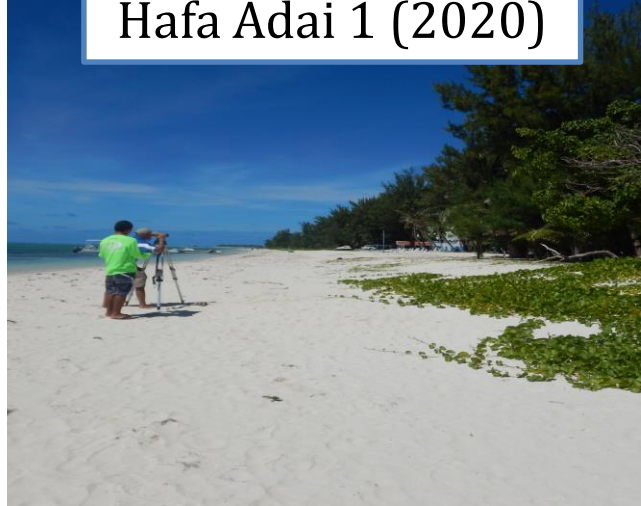
Hafa Adai 1 (2018)

Trend: Accreting

Located within the Garapan Lagoon and adjacent to patch reef, Hafa Adai beach appears to be accreting. This accretion brings a stark contrast when compared to Fiesta and Hyatt shoreline to the north and Garapan district shoreline to the south. There is an outfall nearby that may have some effect on the shoreline but there is insufficient evidence of its direct contribution to the accumulation. For both typhoon wave conditions, this area appears better sheltered from the patch reef than the northern sites. However, improved resolution on nearshore dynamics may explain the accretion.

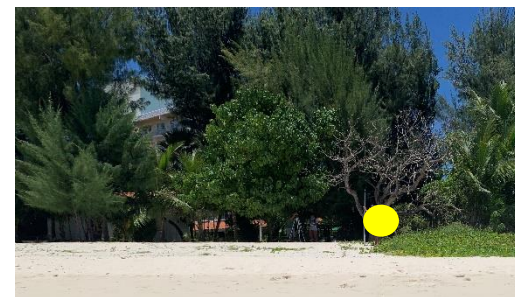
Day Recorded	Tide	Shoreline Length
Jan 19, 2017	1.73 ft	36 ft
Jun 27, 2017	1.91 ft	Not recorded
Mar 13, 2018	1.37 ft	60 ft
Jun 25, 2018	0.5 ft	80 ft
Feb 28, 2020	1.54 ft	68 ft
Jul 20, 2020	0.13 ft	60 ft
Jan 12, 2021	1.31 ft	60 ft
Average		60.7 ft

Hafa Adai 1 appears to be seasonally changing so its status is undetermined. The wrackline of this transect ranges from 20 to 52 ft. The elevation difference from the headstake to the furthest recorded waterline (alternative to the unrecorded top of toe) is around 5 ft.

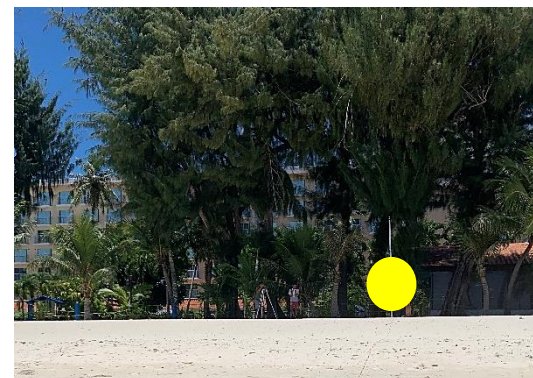
Hafa Adai – 2

Day Recorded	Tide	Shoreline Length
Jan 19, 2017	1.69 ft	60 ft
Jun 27, 2017	0.2 ft	Not recorded
Mar 13, 2020	1.35 ft	73 ft
Jun 25, 2018	0.41 ft	84 ft
Feb 28, 2020	1.1 ft	80 ft
Jul 20, 2020	-0.11 ft	116 ft
Jan 12, 2021	1.6 ft	Not recorded
Average		82.6 ft

Hafa Adai 2 appears to be accreting since Jun 2018. The wrackline of this transect ranges from 56 to 79 ft. The elevation difference from the headstake to the furthest recorded waterline (alternative to the unrecorded top of toe) is 7 ft.

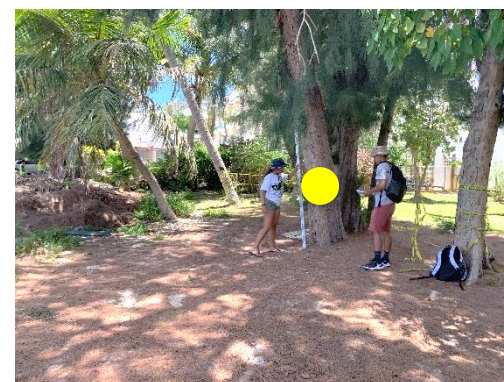
Hafa Adai – 3

Day Recorded	Tide	Shoreline Length
Jan 19, 2017	1.64 ft	50 ft
Jun 27, 2017	1.95 ft	Not recorded
Mar 13, 2020	1.29 ft	70 ft
Jun 25, 2018	0.41 ft	88 ft
Feb 28, 2020	1.37 ft	100 ft
Jul 20, 2020	0.05 ft	115 ft
Feb 19, 2021	1.58 ft	95 ft
Average		86.3 ft

Hafa Adai 3 is accreting. As the shoreline has been gaining volume and length in three years, this stretch of shore naturally developed infrastructure. From July 2020 through Feb 2021, a row of ironwood trees grown and blocked the transect, making surveying difficult from Feb 2021 and onward. The wrackline ranges from 40 to 88 ft. The elevation distance from the headstake to the furthest top of toe is around 6.5 ft.

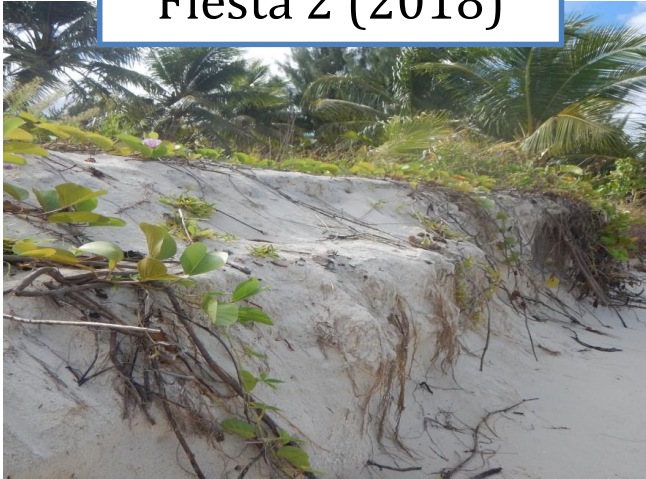
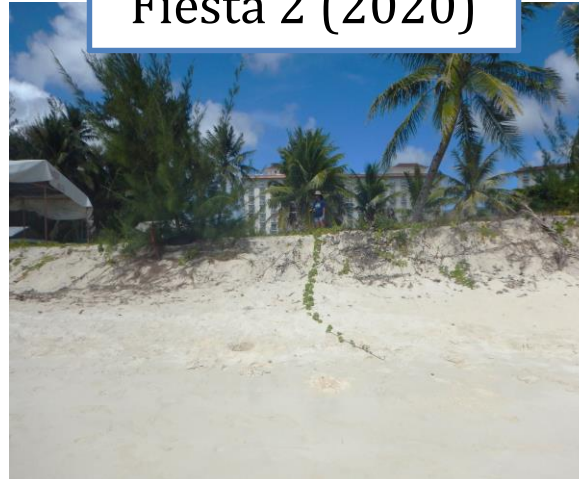
Fiesta 2 (2018)

Trend: Eroding

EPHR: High

Unlike down south, Fiesta has less reef and seagrass protection from wave energy. Thus, this exposure enables high energy waves to erode the shoreline during storm events. Fiesta beach, like Hyatt, have steep abraded berms retreating inland that will endanger marine sports operator facilities and hotel beach amenities in the future. The south transect, bordering the IPI Casino building, is speculated to have sediment influence from the nearby outfall. Southwest typhoon conditions bring greater wave energies due to the high waves entering in through the channel. But given the potential of powerful north-northwest flows to overtop, it would be worthwhile to examine this area during or after these conditions.

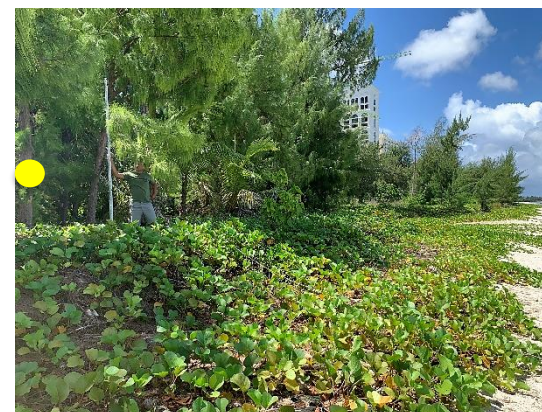
Date Recorded	Tide	Shoreline Length
Jan 19, 2017	1.6 ft	60 ft
Jun 27, 2017	1.68 ft	Not recorded
Mar 15, 2018	1.36 ft	50 ft
Jun 28, 2018	1.01 ft	57 ft
Jul 20, 2018	0.68 ft	56 ft
Feb 28, 2020	0.68 ft	57 ft
Jul 20, 2020	0.57 ft	64 ft
Jan 12, 2021	1.77 ft	Not recorded
Average		57.3 ft

Fiesta 1 appears relatively stable. The outfall may contribute to the sediment volume of this shoreline position. The wrackline ranges from 30 to 50 ft. The elevation distance from the headstake to the furthest top of toe is around 7 ft.

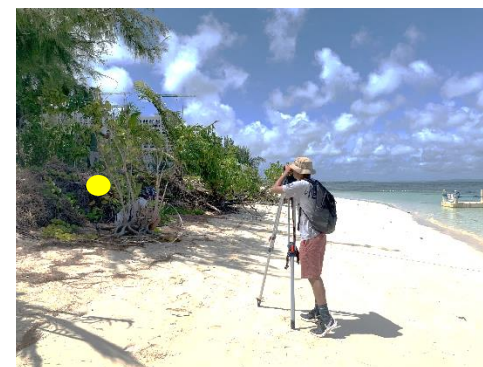
Fiesta 2 is eroding and has lost headstakes throughout the recording period. The first headstake indicated a berm loss of around 10 ft from Jan 2018 through July 2020. The shoreline grew steeper, which may allow for further erosion of the shoreline. The high waterline ranges from 30 to 40 ft. The wrackline is nonexistent because there are no seagrass in the adjacent waters. High wave conditions of early 2021 has further chipped away at the berm causing trees to fall into the water. The headstake is changed to an ironwood tree nearly 10 ft inland adjacent to the previous headstake. The elevation distance from the first headstake to the furthest top of toe is around 8 ft and the second saw a decline at 6 ft.

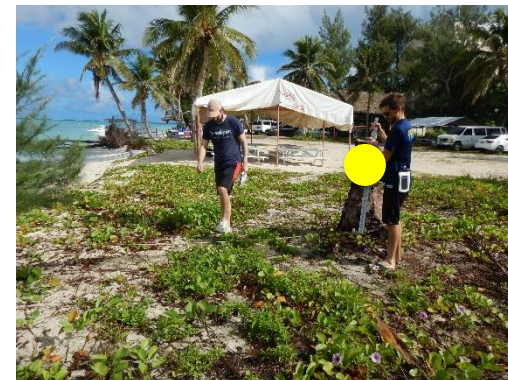
Day Recorded	Tide	Shoreline Length
Jun 27, 2017	1.41 ft	Not recorded
Mar 15, 2018	1.51 ft	55 ft
Jun 28, 2018	0.81 ft	56 ft
July 20, 2018	0.81 ft	58 ft
Feb 7, 2020	1.61 ft	Not recorded
Jul 20, 2020	0.67 ft	45 ft
Dec 4, 2020	1.82 ft	30 ft
Average		48.8 ft

The shoreline has drastically abraded due to the loss of the deepened berm. From 2017 – 2020, the berm has retreated ~36 ft. The berm is not as steep previously, however, it is still capable of allowing wave energy to further abrade the shoreline. The wrackline is nonexistent due to a lack of seagrass or other potential debris in the adjacent waters. The elevation distance from the headstake to the furthest top of toe is around 8 ft.

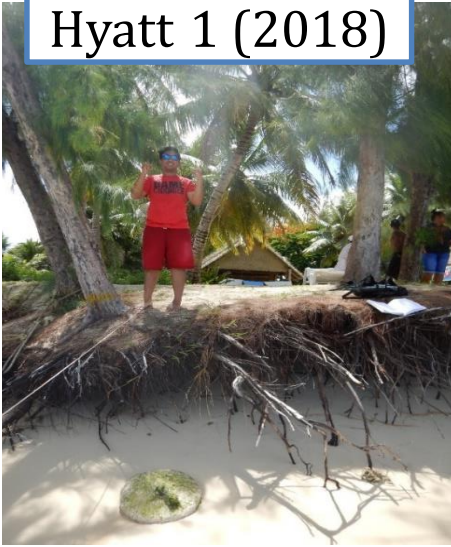
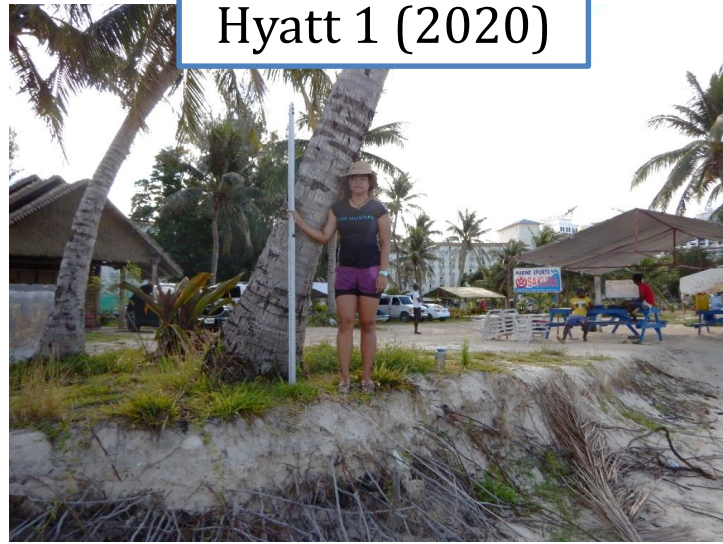
Hyatt 1 (2018)

Trend: Variable

EPHR: High

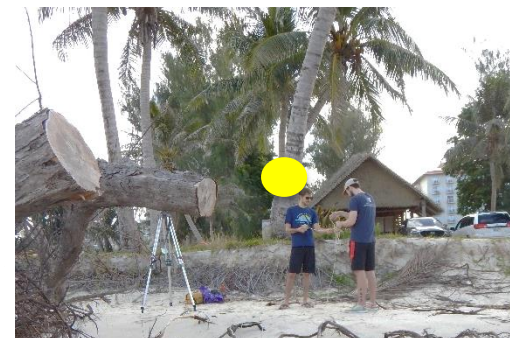
Day Recorded	Tide	Shoreline Length
Jan 19, 2017	1.48 ft	13 ft
Jun 27, 2017	0.78 ft	Not recorded
Sep 21, 2017	1.5 ft	10 ft
Mar 15, 2018	1.32 ft	20 ft
Jun 28, 2018	0.69 ft	50 ft
Jul 20, 2018	0.89 ft	47 ft
Aug 9, 2018	0.22 ft	54 ft
Feb 7, 2020	1.54 ft	26 ft
Jul 20, 2020	0.88 ft	32 ft
Dec 4, 2020	1.75 ft	14 ft
Average		41.3 ft

The shoreline has drastically abraded due to the loss of the deepened berm. From 2018 – 2020, the berm has retreated ~26 ft. The berm is not as steep previously, however, its eroded steepness may allow wave energy to further abrade the shoreline. The waterline differences are based on the difference of tides on the days. The wrackline is nonexistent because there are no natural debris available, such as seagrass, in the adjacent waters. The elevation distance from the headstake to the furthest top of toe is around 8 ft.

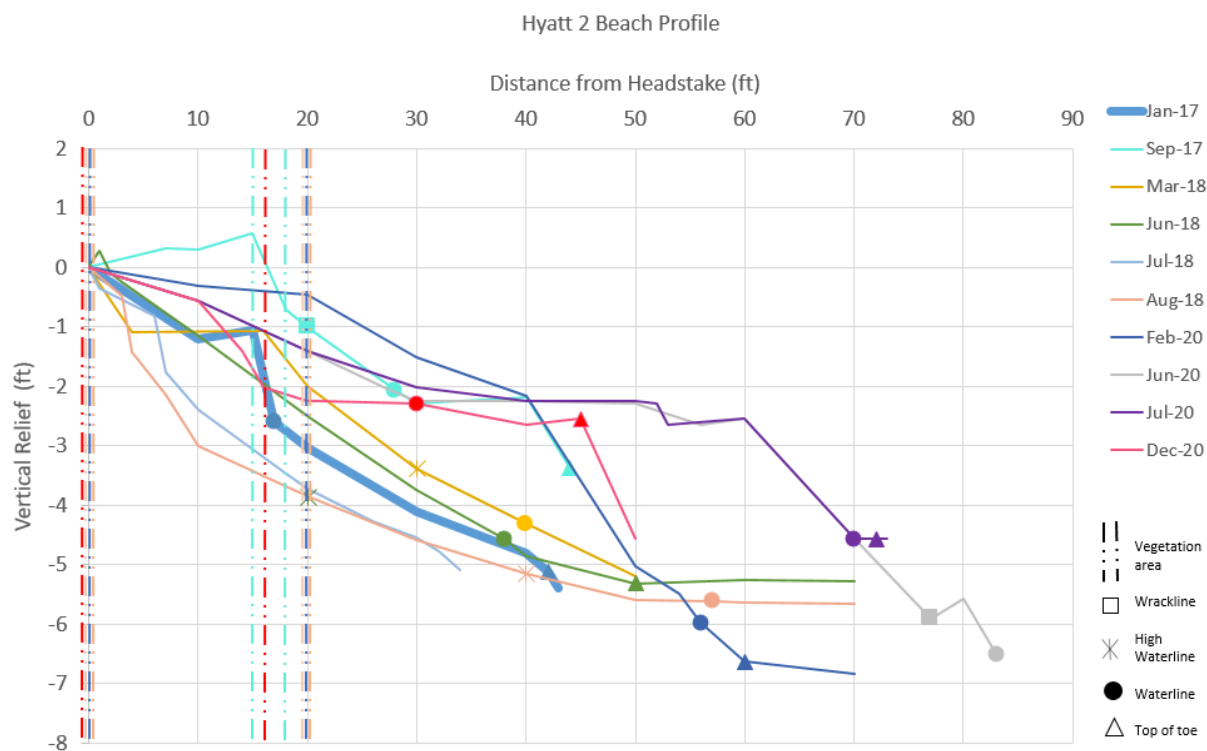
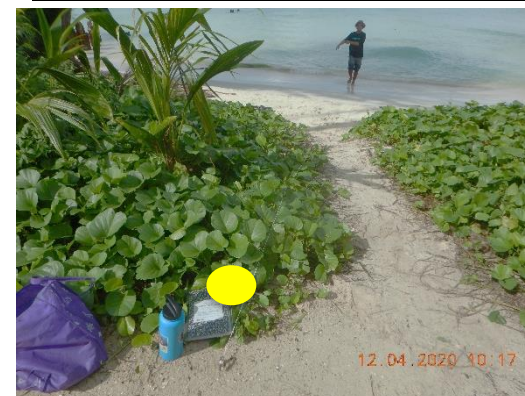
Day Recorded	Tide	Shoreline Length
Jan 19, 2017	1.43 ft	Not recorded
Jun 27, 2017	0.69 ft	Not recorded
Sep 21, 2017	Not recorded	28 ft
Mar 15, 2018	1.27 ft	40 ft
Jun 2, 2018	1.12 ft	40 ft
Jul 20, 2018	1.08 ft	26 ft
Aug 9, 2018	0.1 ft	57 ft
Feb 7, 2020	1.66 ft	56 ft
Jun 19, 2020	-0.0 ft	83 ft
Jul 20, 2020	1 ft	70 ft
Dec 4, 2020	1.59 ft	30 ft
Average		47.8 ft

Hyatt 2 is an eroding and highly dynamic transect, influenced by storm surge and tides. Sediment transport may contribute to the variation of shoreline position throughout time but the encroaching waterline and wave energy during high tide/storm events suggest this shoreline is eroding. The elevation distance from the headstake to the furthest top of toe is around 6 ft.

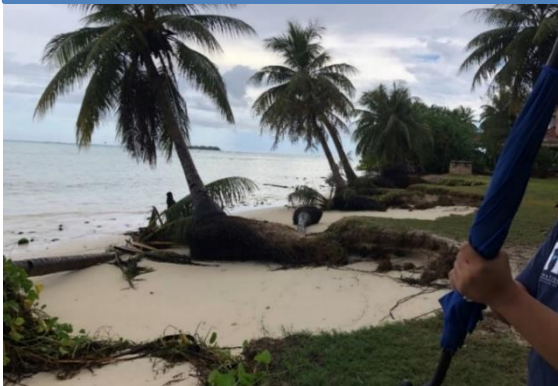
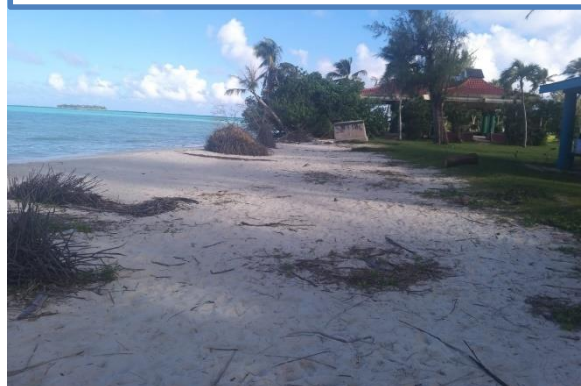
AMP South 1 (Sept 2017)

Trend: Variable

As shown in the previous page, this transect has experienced significant changes since 2017. It is evident that this area is highly dynamic due to its geographical vulnerability to the hydrodynamics of the Saipan Lagoon and wave energy from powerful storms. The berm has been declining in elevation while the length shoreline appeared to be increasing until December 2020. Prior to Super Typhoon Yutu, the berm has been deepening from lesser powerful storms. In the event of Yutu, the uprooting of ironwood and coconut trees may have greatly loosened the berm, pouring fresh new sand into the toe and expanding the shoreline. The headstake itself, a once-standing ironwood tree, remains fallen and may have to be replaced in the near future. This transect is hypothesized to have seasonal sediment input while experiencing export during high wave energy events as suggested by the Dec 2020 transect line. The high waterline range is 20 ft – 64 ft.

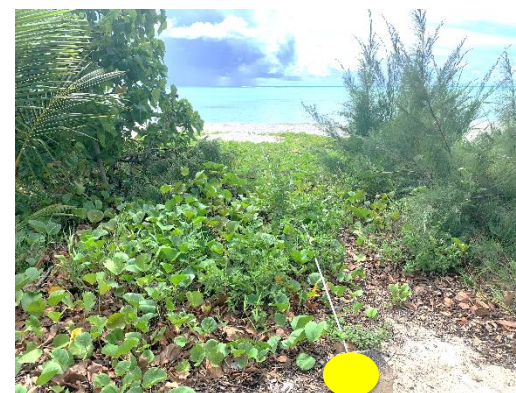
Day Recorded	Tide	Shoreline Length
Jan 19, 2017	1.08 ft	80 ft
July 10, 2017	1.12 ft	97 ft
Sept 21, 2017	0.48 ft	Not recorded
Feb 2, 2018	2.02 ft	82 ft
Jun 28, 2018	-0.19 ft	106 ft
Jul 12, 2018	0.68 ft	93 ft
Dec 11, 2019	1.5 ft	61 ft
May 22, 2020	0.65 ft	86 ft
Feb 19, 2021	1.31 ft	50 ft
Average		81.9 ft

Since 2017, AMP South 2 has shown to be another dynamic transect so its status is undetermined. In 2017, the sediment input appears to increase in the summer of 2017. The typhoon season of that year abraded the shoreline. After Super Typhoon Yutu, the berm has retreated significantly and the toe is deeper and closer to the waterline. The loss of sand is great. Similar to AMP South 1, the seasonal sediment input may be a great contributor to a different shoreline position. The wrackline range is 37 to 70 ft.
