DCRM Shoreline Profile Monitoring Data Report

Saipan and Mañagaha

August 2018 – February 2021

Bureau of Environmental Coastal Quality - Division of Coastal Resources Management

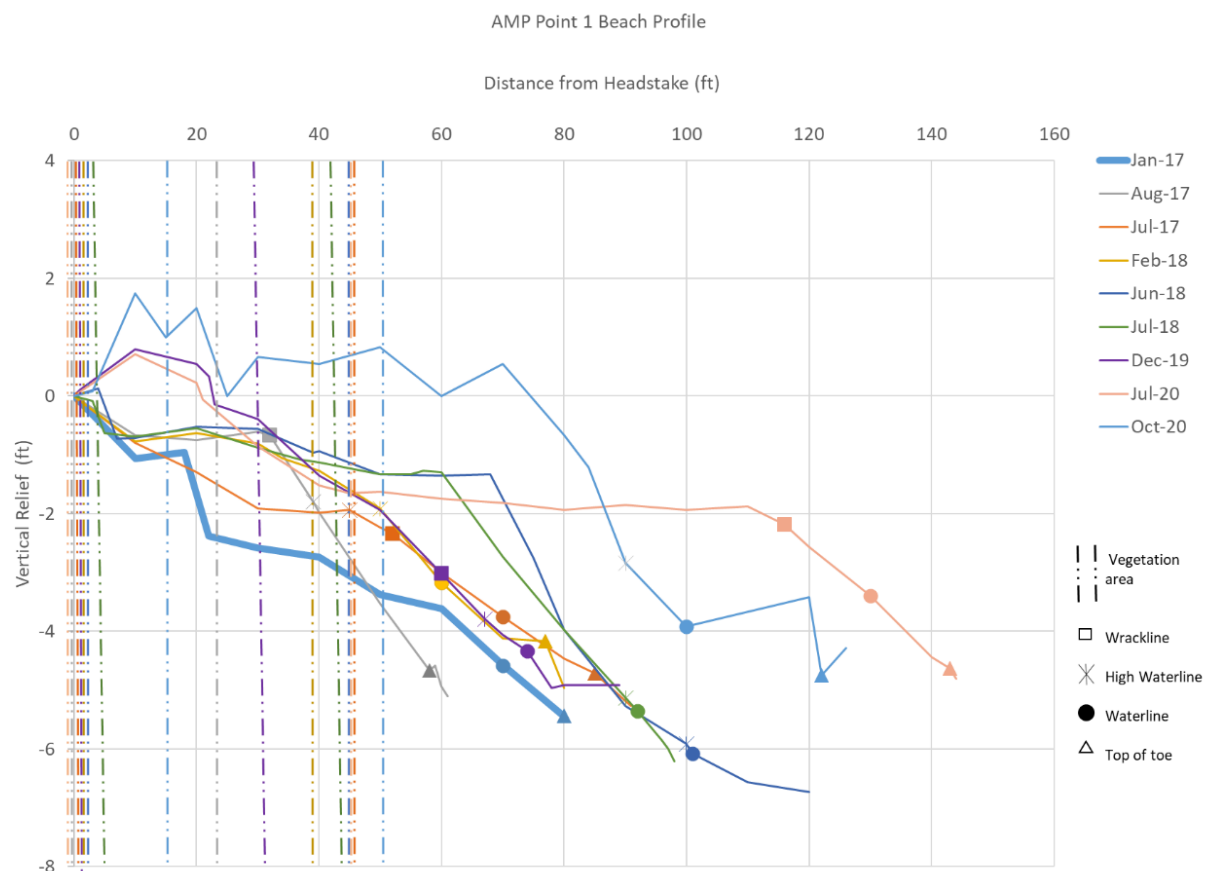
AMP Point 1

Day Recorded	Tide	Shoreline Length
Jan 19, 2017	1.27 ft	70 ft
July 10, 2017	1 ft	70 ft
Aug 7, 2017	1.95 ft	39 ft
Feb 2, 2018	1.53 ft	60 ft
Jun 28, 2018	-0.029 ft	101 ft
Jul 12, 2018	0.18 ft	96 ft
Dec 11, 2019	1.38 ft	74 ft
Jul 20, 2020	1.2 ft	130 ft
Oct 29, 2020	1.27 ft	100 ft
Average		82.2 ft

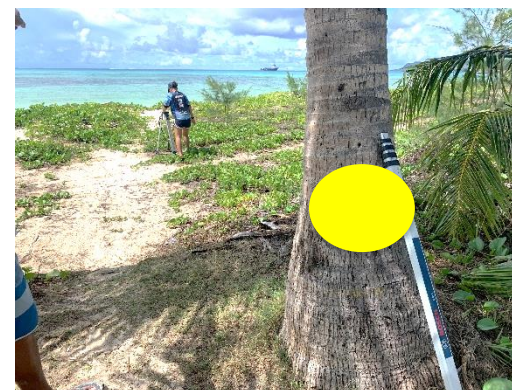
Day Recorded	Tide	Shoreline Length
Jan 19, 2017	1.16 ft	Not recorded
July 10, 2017	0.92 ft	56 ft
Aug 7, 2017	Not recorded	110 ft
Feb 2, 2018	Not recorded	130 ft
Jun 28, 2018	-0.14 ft	163 ft
Jul 13, 2018	1.18 ft	140 ft
Dec 11, 2019	1.29 ft	97 ft
Jul 10, 2020	0.74 ft	80 ft
Oct 10, 2020	1.57 ft	158 ft
Average		121.3 ft

AMP Point 2 appeared to be accreting from Jan 2017 – July 2018. After Super Typhoon Yutu, the shoreline noticeably abraded. There was a huge variation between the July 2020 and Oct 2020, which may indicate surveyor error. The high waterline ranged from 43 to 150 ft. The elevation difference from the farthest top of toe is 6 feet.

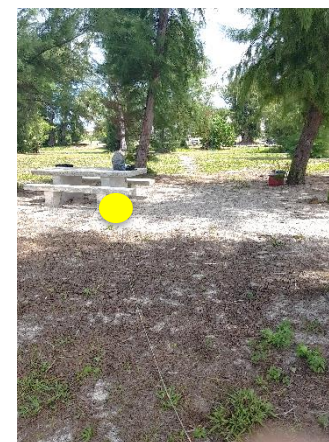
Day Recorded	Tide	Shoreline Length
Jan 19, 2017	1.42 ft	64 ft
Jul 10, 2017	0.6 ft	46 ft
Sept 21, 2017	0.35 ft	50 ft
Feb 2, 2018	1.6 ft	65 ft
Jun 28, 2018	0.13 ft	85 ft
Jul 13, 2018	1.07 ft	70 ft
Dec 5, 2018	1.79 ft	100 ft
May 22, 2020	0.94 ft	98 ft
Jul 10, 2020	0.87 ft	113 ft
Oct 29, 2020	1.22 ft	140 ft
Average		83.1 ft

AMP North 2 appears to be accreting since Jun 2018. The shoreline length has doubled within the past three years. The wrackline ranges from 30 ft to 80 ft. The elevation difference from the farthest top of toe is 8 ft.

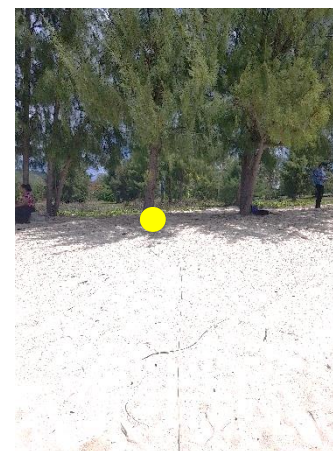
Day Recorded	Tide	Shoreline Length
Jan 19, 2017	1.52 ft	Not recorded
July 10, 2017	0.52 ft	35 ft
Sept 21, 2017	Not recorded	30 ft
Feb 2, 2018	1.75 ft	20 ft
Jun 28, 2018	0.23 ft	Not recorded
Jul 13, 2018	0.97 ft	29 ft
Dec 11, 2019	1.25 ft	60 ft
May 22, 2020	1.01 ft	52 ft
Jul 10, 2020	0.95 ft	47 ft
Oct 23, 2020	0.52 ft	70 ft
Average		42.9 ft

AMP North 3 appears to be accreting. Oct 2020 appears to be an outlier compared to the previous months of 2020. Future measurements will verify this accretion.

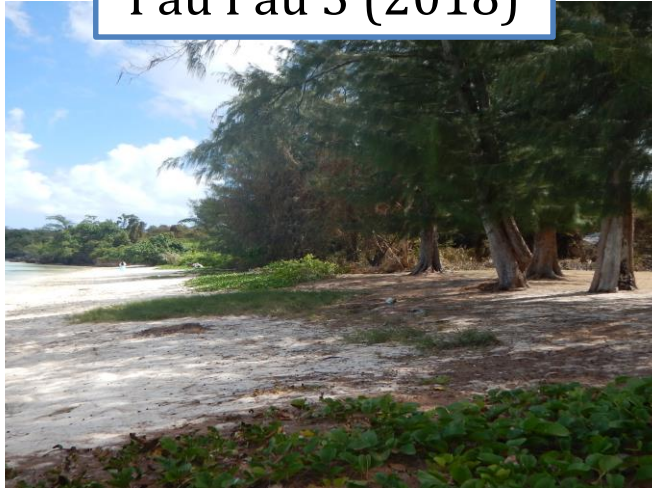
Pau Pau 3 (2018)

Pau Pau is generally stable with the shoreline length declining from the south to north. The nearby reef attenuates wave energy but wave overtopping may contribute to short-term erosion. Tides may influence the length of this shoreline. For both typhoon wave conditions, this area receives high wave energy. North-northwest typhoon conditions fare worse with significant wave height potential of up to 3 m.

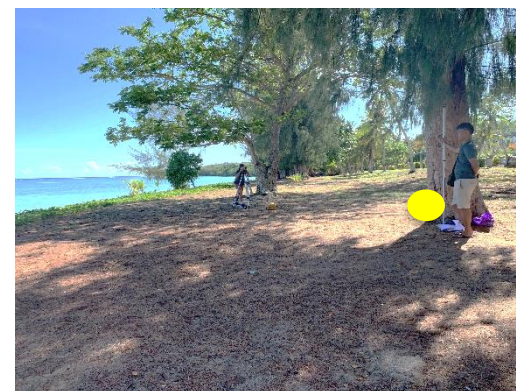
Day Recorded	Tide	Shoreline Length
Jan 5, 2017	1.21 ft	80 ft
July 11, 2017	-0.05 ft	103 ft
Feb 9 2018	1.37 ft	No recorded
Jun 12, 2018	0.89 ft	87 ft
Jan 31, 2020	1.24 ft	78 ft
Jul 6, 2020	0.95 ft	80 ft
Oct 30, 2020	0.96 ft	93 ft
Average		86.8 ft

Pau Pau 1 transect appears generally stable. The wrackline ranges from 70 to 90 ft. The elevation difference between the headstake to the furthest top of toe is around 9 ft.

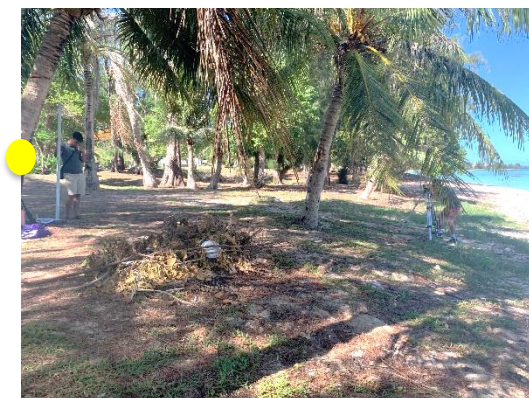
Day Recorded	Tide	Shoreline Length
Jan 5, 2017	1.56 ft	90 ft
July 11, 2017	-0.14 ft	80 ft
Feb 9 2018	1.42 ft	48 ft
Jun 12, 2018	0.66 ft	69 ft
Jan 31, 2020	1.33 ft	58 ft
Jul 6, 2019	1.4 ft	63 ft
Oct 30, 2020	0.85 ft	80 ft
Average		69.7 ft

Pau Pau 2 transect has seen a shift in January 2017. The shoreline appears to have experienced some abrasion in Feb 2018 but then has generally stabilized over time. The wrackline ranges from 40 to 60 ft. The elevation difference between the headstake to the furthest top of toe is around 8 ft.

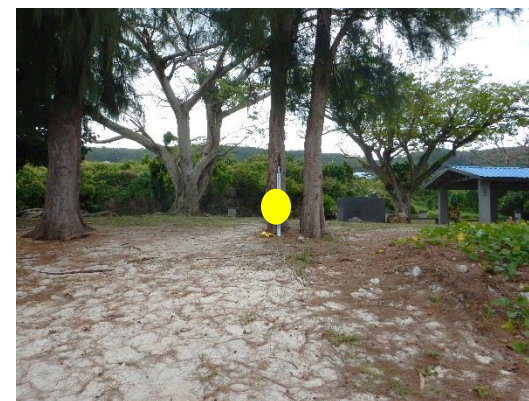
Day Recorded	Tide	Shoreline Length
Jan 5, 2017	1.6 ft	50 ft
July 11, 2017	-0.16 ft	44 ft
Feb 9 2018	1.45 ft	40 ft
Jun 12, 2018	0.53 ft	53 ft
Jan 21, 2020	1.61 ft	50 ft
Jul 6, 2020	1.21 ft	50 ft
Oct 30, 2020	0.8 ft	60 ft
Average		49.6 ft

Pau Pau 3 transect is stable but appears to be more variable in shoreline position compared to the other two transects in the site. The wrackline ranges from 26 to 50 ft. The elevation difference between the headstake to the furthest top of toe is around 9.5 ft.

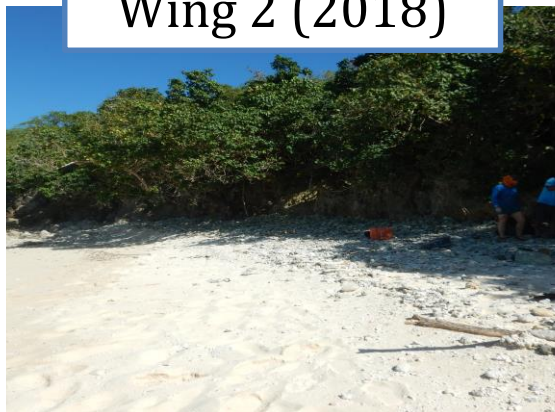
Wing 2 (2018)

Wing 2 status is undetermined. Locating the headstake was challenging for this area given the loss of visible marking. Thus, there may be three differing headstakes for this transect. The 2020 data share the same known headstake. Based on observations from the Feb-21 record shows, a high tide with a high wave event greatly abrades the berm along this transect. With the input of coral rubble from the nearby reef, recovery to the average shoreline length is anticipated. The elevation difference between the headstake to the furthest top of toe is around 11 ft.

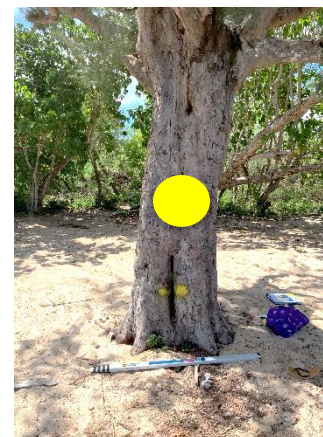
Wing 1 transect appears generally stable. This beach profile may suggest that the shoreline experiences a good amount of sediment input and output from the influence of the nearby reef system. Feb 2018 had the most erosion while July 2017 saw the most accretion. The wrackline ranges from 58 - 91 ft. The elevation difference between the headstake to the furthest top of toe is around 11.5 ft.

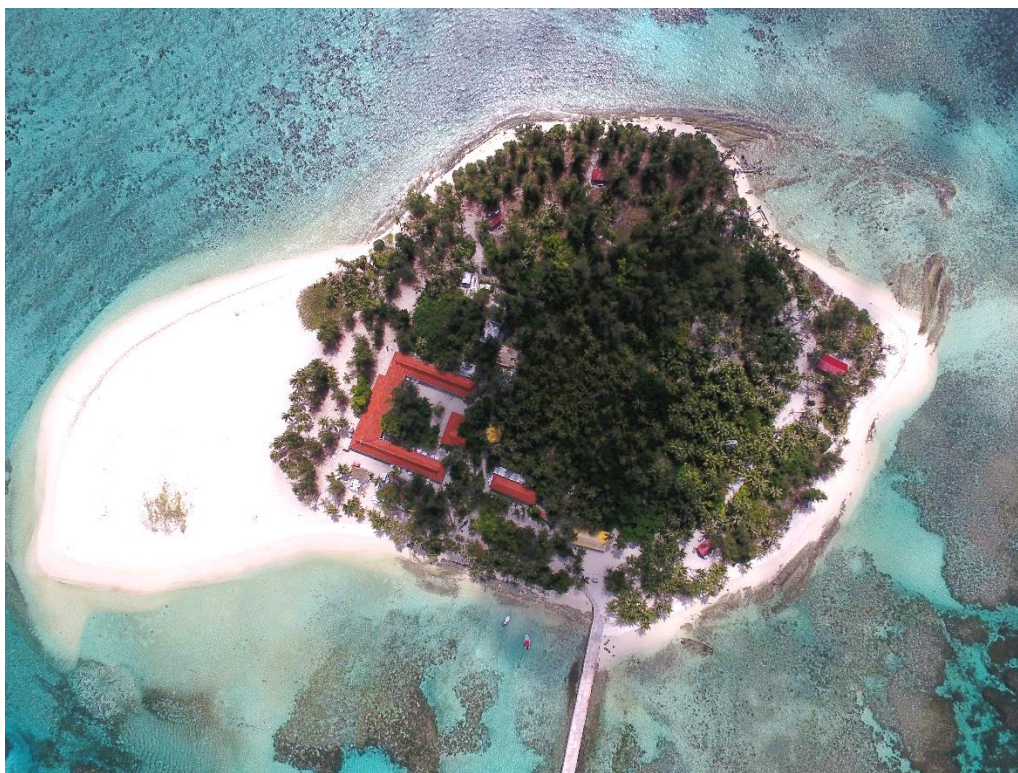
Mañagaha Island taken by the DCRM Drone in 2020

Shoreline Monitoring on Mañagaha was conducted on 2017, 2018, and 2020. Aerial imagery was captured during these times and indicated that the sand bar has been growing. A sand berm developed and its height continues to increase. The erosion on the east side is not easily shown through aerial imagery but natural infrastructure, such as fallen ironwood trees and shoreline vegetation, and WWII relicts appear to be interacting with on-going longshore processes. Locating headstakes on the west side – especially Transect #3 (see pg 96) set on this newly developed berm – poses challenges and may be responsible for the error in the generated 3A and 3B beach profiles. Nonetheless, other beach profiles generated through Shoreline Monitoring have allowed for on the ground documentation of erosion at the east-side shoreline of the islet. Due to the high surveyor error in the Aug 2020 dataset, that was omitted.

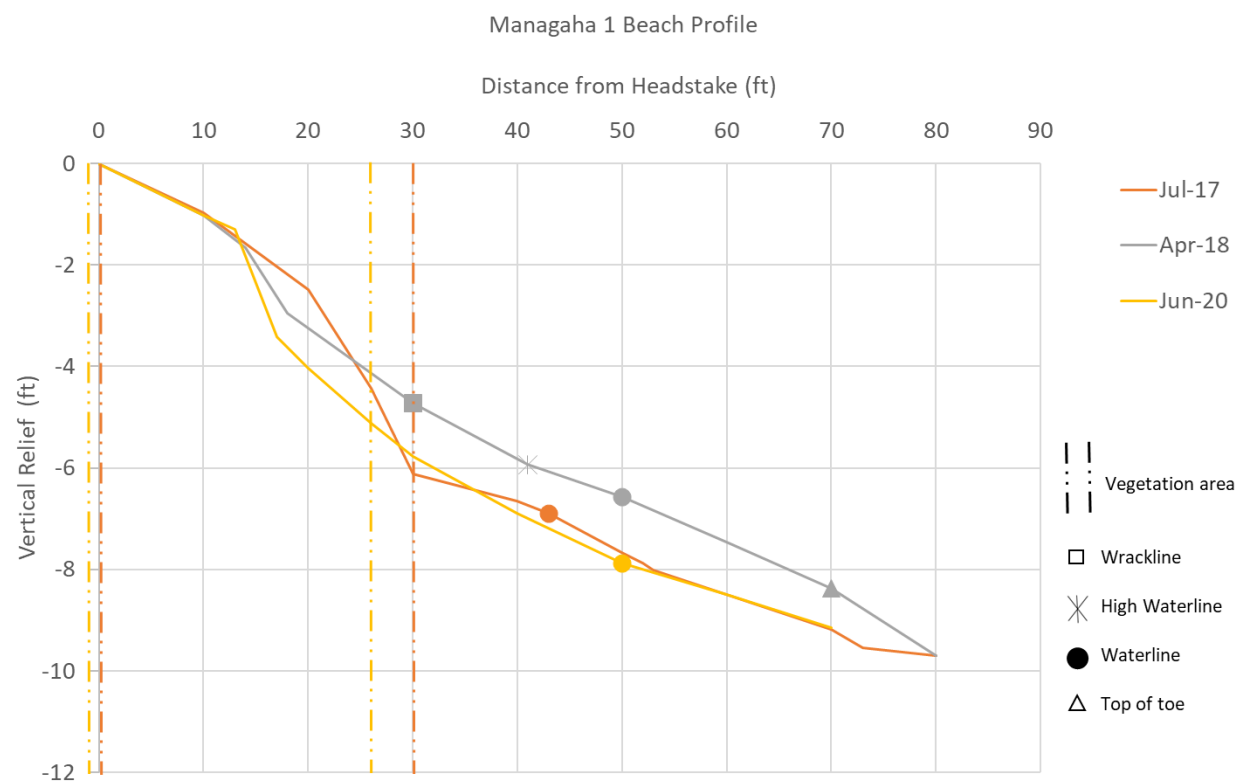
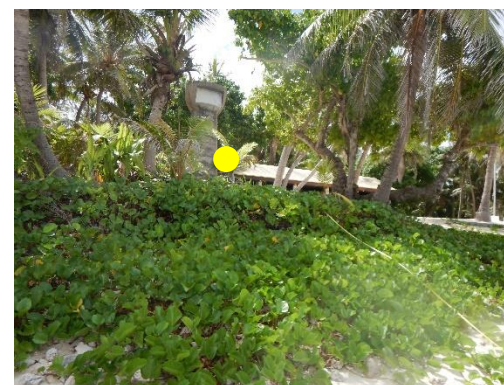
Mañagaha 1 transect appears to be eroding based on the steepening berm. There is a rocky segment that extends past the toe. Surveyor error may have skewed the measurements, but the headstake has remained the same. The wackline ranges from 30 ft to 40 ft. The waterline has been fairly consistent. The elevation from the headstake to the furthest toe is 8 ft.

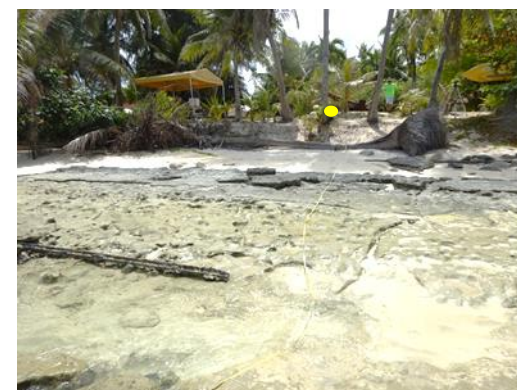
Mañagaha 2 transect exhibits erosion. The berm remained the same over the years but variation begins past the 25 ft distance from the headstake. Surveyor error may have scewed the measurements. The elevation from the headstake to the furthest toe is around 11 ft.

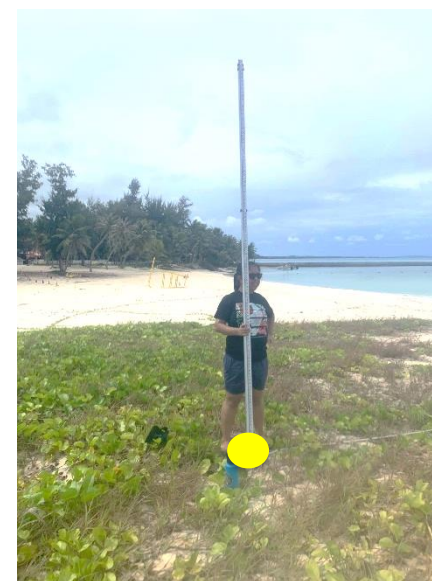
Mañagaha 3A transect has high variation due to surveyor error. The misidentification of the exact location of the headstake happen due to the loss of the physical headstake (a pole on the ground). However, despite this, the increasing length and physical observations confirm that this area is accreting. The headstake is on berm with increasing height. The elevation from the headstake to the furthest toe is around 8 ft.

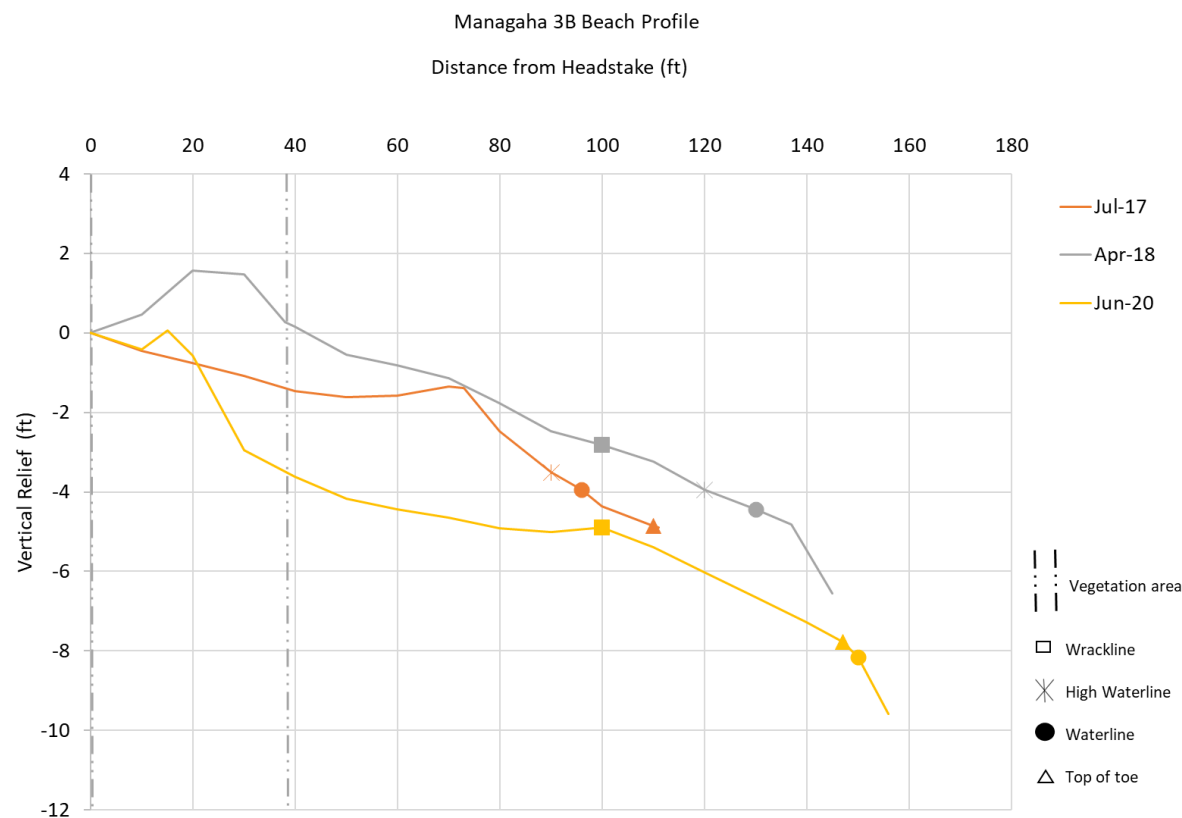
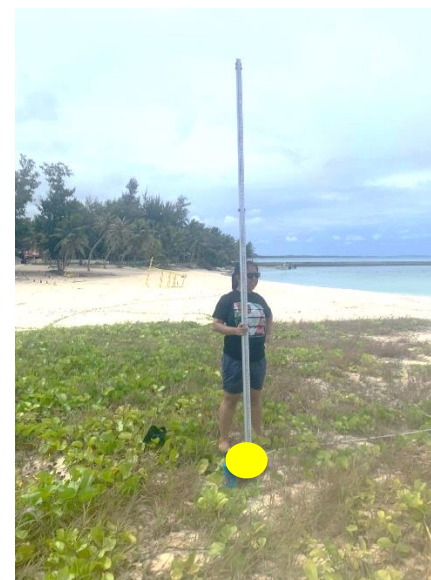
Like Mañagaha 3A, Mañagaha 3B transect has high variation due to surveyor error, which may also be misidentification of the exact location of the headstake (which is the same as 3A). However, despite this, the increasing length and physical observation confirm that this area is accreting. The wrackline ranges from 90 to 100 ft. The headstake is on a growing berm that is getting higher.

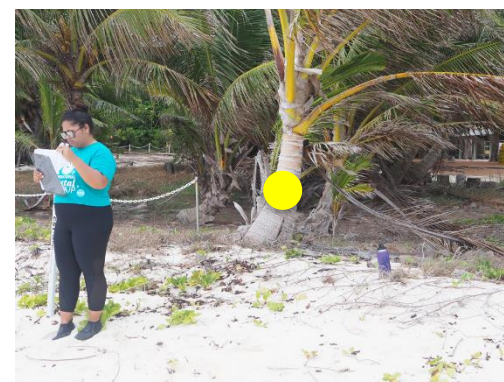
Mañagaha 4 is eroding. The deep berm in Jul-17 has smoothen and retreated closer to the head stake over the years. The elevation from the headstake to the furthest toe is around 11 ft.

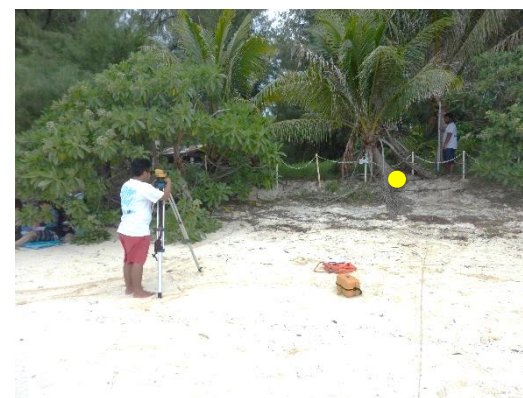
Mañagaha 5 appears relatively stable. Aug-20 transect record is an outlier and could be due to surveyor error. The wrackline ranges from 22 to 32 ft. The elevation from the headstake to the furthest toe is around 9 ft.

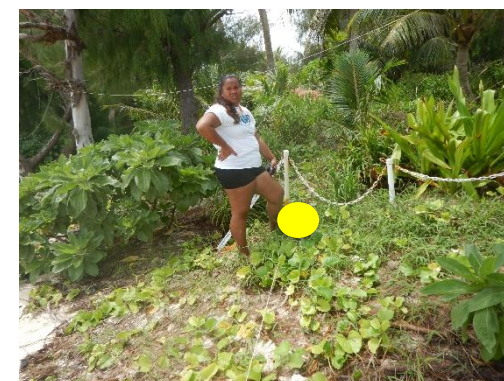
Mañagaha 6A appears to be eroding. The wrackline ranges from 40 to 43 ft. The elevation from the headstake to the furthest toe is around 6 ft.

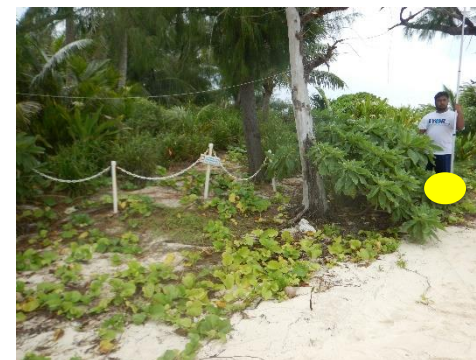
Mañagaha 6B appears to be eroding. However, there could be surveyor error in this transect. Future data entries will improve the understanding of this change trend. The wrackline ranges from 44 to 60 ft. The elevation from the headstake to the furthest toe is around 6 ft.

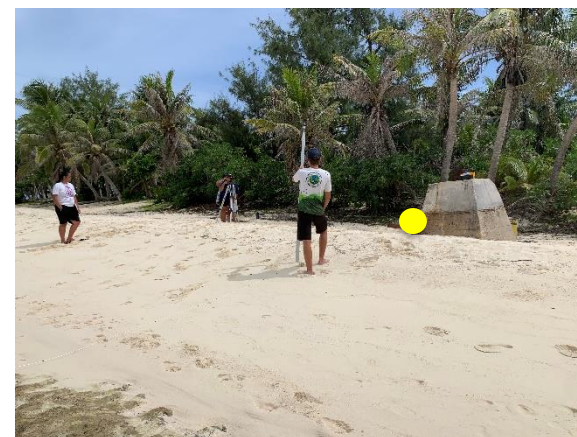
Mañagaha 7 appears to be relatively variable. Aug-20 transect record is an outlier. The wrackline ranges from 8 to 11 ft. Seasonal variation and tidal influence are potential factors for this deviation. The elevation from the headstake to the furthest toe is around 4 ft.

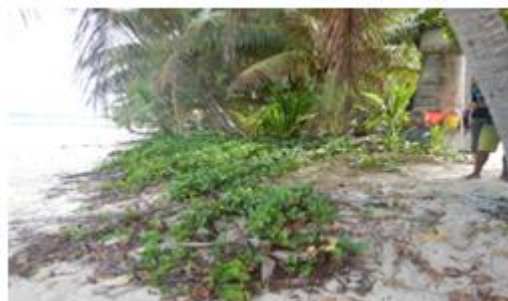
Berm

The nearly horizontal portion of the beach or backshore formed by the deposit of materials by wave action. (In the CNMI, the berm is a vertical drop.)

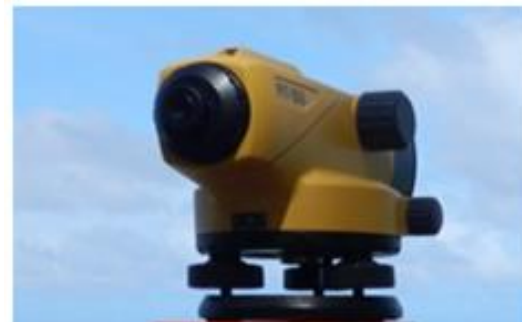
Berger Level

Used to accurately measure the height of an inaccessible object. Takes cross sectional picture of a beach's contour.

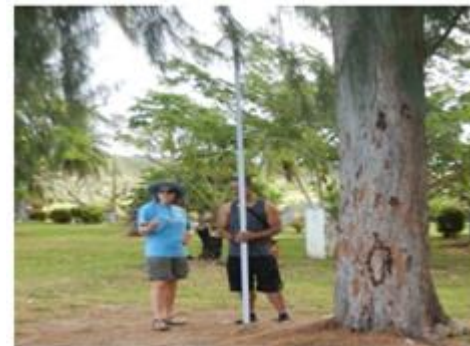
Level Rod

Used with a leveling instrument to determine the difference in height between points.

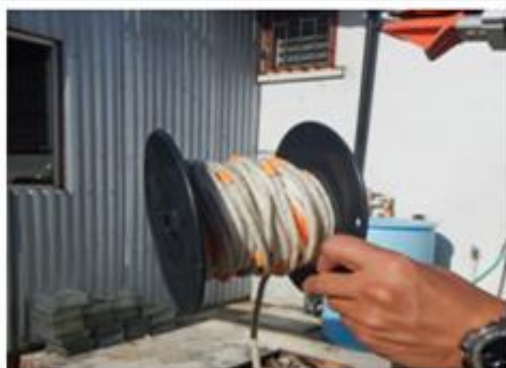
Measuring Rope

100 ft. rope measure is laid along the shore to be profiled.

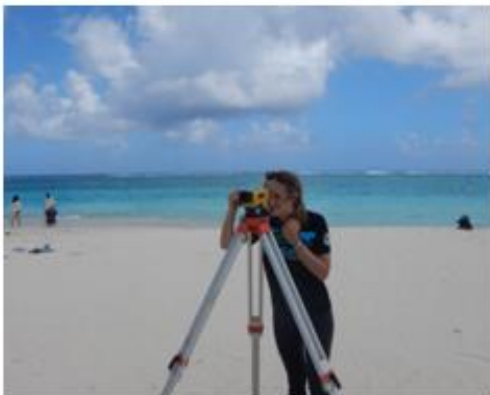
Tripod

Supports or holds the Berger Level.
