Shoreline Monitoring Beach Profile Report: Tinian and Rota

August 2023

Division of Coastal Resources Management
CNMI Bureau of Environmental Coastal Quality
Award No.: NA22NOS4190158

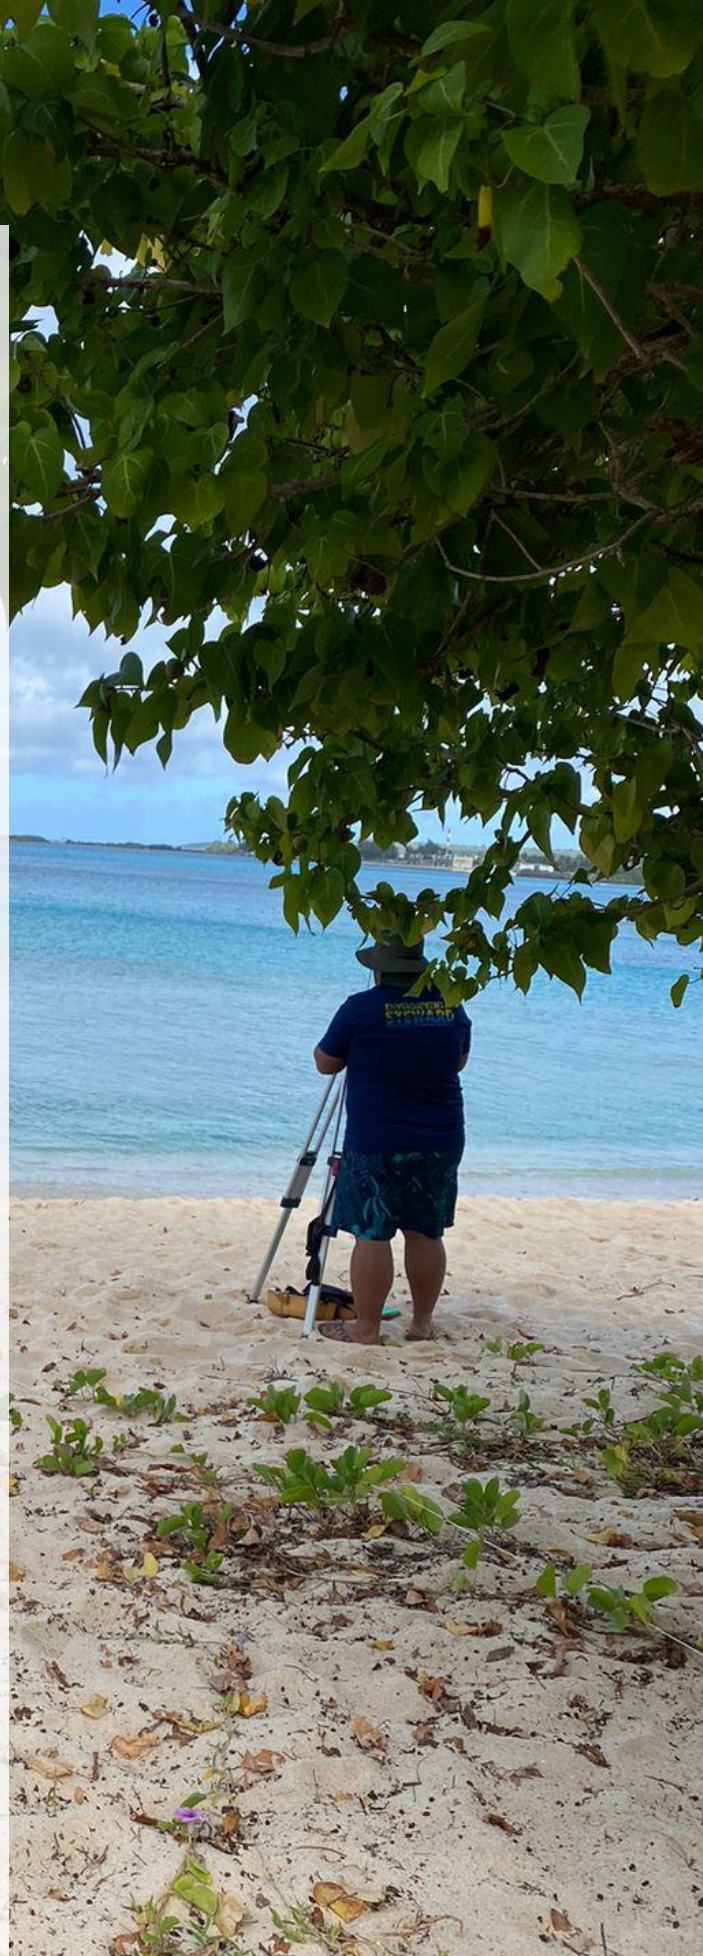
Cover photo is one crew member looking through the Total Station (left) and the other looking through the Berger Level on the right on the northern shoreline of Tachogna Beach (Tachogna North 3 transect).

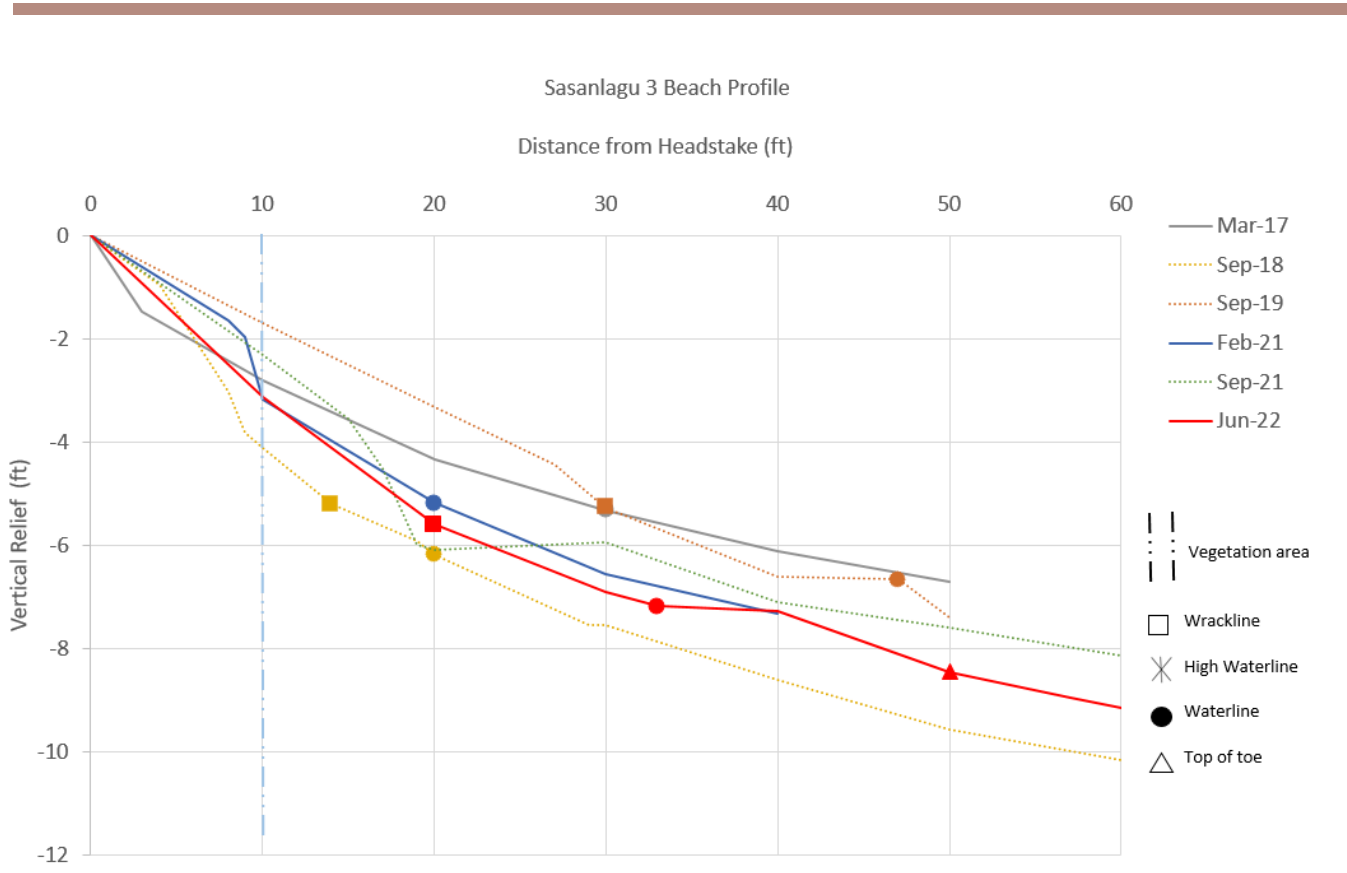
The feature below is the generated beach profile once data has been processed.

- The x-axis, horizontal, is the distance from the headstake in feet.
- The y-axis, vertical, is the vertical relief in feet.
- The vertical relief assumes that the headstake is at zero elevation and that the feet is the **elevation difference** from the headstake.

On the top right hand corner, there are different colored lines followed by dates. Each corresponding color line indicates a data entry captured at that day. The dotted lines are taken during the typhoon season trade wind conditions. For instance, the orange dotted line says that it was taken on Sept 2019. Time is an important factor for shoreline monitoring because entries taken at different times will be compared to understand shoreline change.

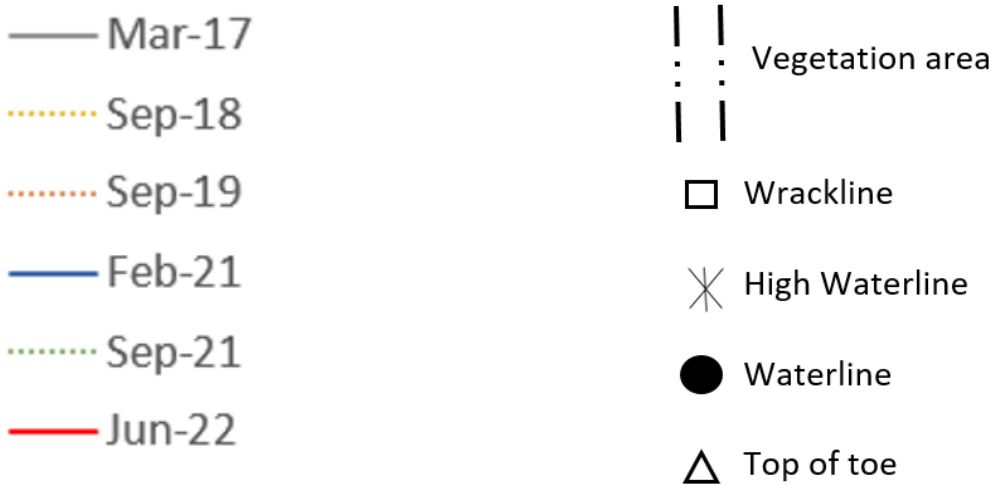
Symbology is used to label shoreline features and where they have been detected along the transect. These shoreline features have been selected as importance and common indicators of change. The color matches the date/time of the transect taken. The symbol matches the beach feature. **Vegetation** area has two lines. The left indicates 'Start of Vegetation' while the right indicates the 'End of Vegetation'. '**Wrackline**', '**high waterline**', '**waterline**', and 'top of (beach) **toe**' are generally detected as one point. Note that not all beach features may be detected in a single shoreline transect.

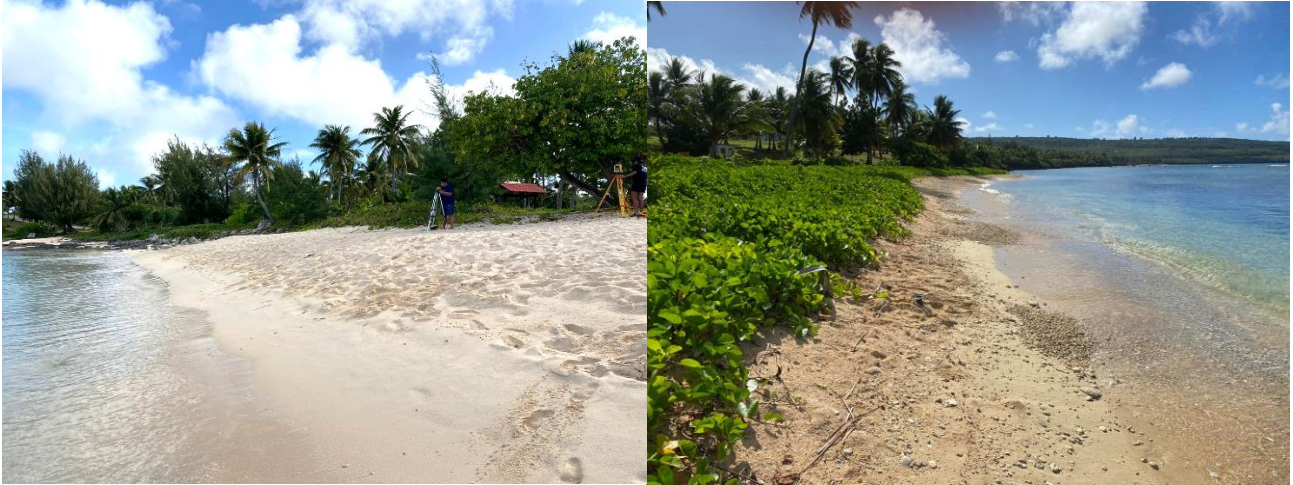
Tinian Beach Profiles and Key Findings

Tinian's shoreline comprise mostly of limestone cliff terraces and isolated sandy beaches protected by fringing reef. The 2015 Vulnerability assessment states that Tinian could be the least vulnerable island to coastal erosion given its protected geological character.

Headlands north and south of pocket beaches may also be a contributing sand source. Tachogna and Jones Beach are among the few sandy shoreline sites selected for monitoring due to their proximity to the densely populated San Jose village and economically valued Tinian Harbor. The channel, harbor, and breakwater may influence the ongoing longshore transport direction, which could be identified by a hydrodynamic study. The beaches exhibit high vulnerability to short-term erosion and storm surge during south, southwest, or west typhoon wave conditions.

Sea level rise is anticipated to bring an additional 2 - 3 feet of tidal influence, which would threaten the shoreline and recreational areas around Tinian Seaport and Taga Beach. Current development of a casino and hotel on the Tinian Harbor area are at risk of high wave events and will need guidance in building resilience to these coastal hazards.

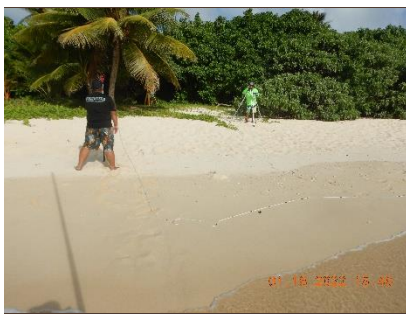
- STABLE in the short-term with a Wrackline that ranges 10 – 50 ft and an elevation difference of 10 ft
- This shoreline is at the end of the shoreline stretch and is subjected to change over time

For **Tachogna South 1**, the profile has changed many times throughout time. Given that the wrackline was at 10 ft, most of the shoreline could be wet during high tide. Sediment input and output are regular in this area, and does not seem to be dictated by the seasons much.

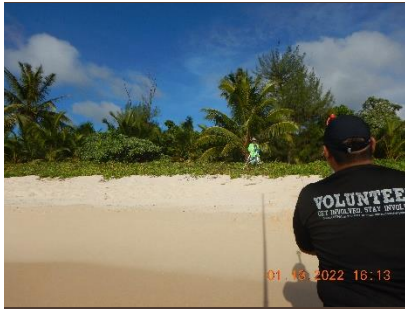
Tachogna South 2 has a new headstake because the previous one is difficult to survey due to overgrown vegetation. The current headstake is in the backshore area, closer to the road.

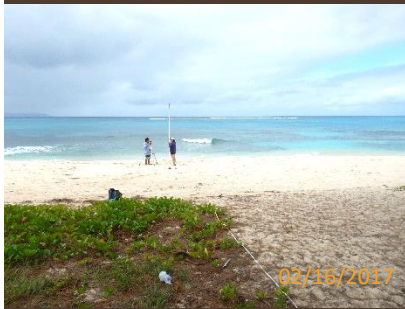
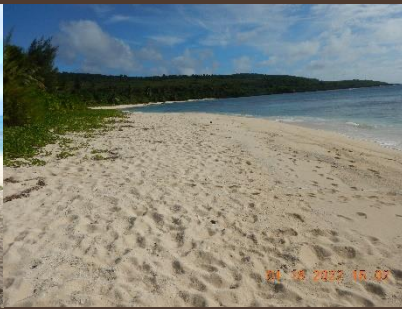
- STABLE in the short-term with a Wrackline that ranges 50 – 59 ft with an elevation difference of 9 ft
- The typhoon season may actually allow accretion of the shoreline.

For **Tachogna South 3**, the profile seems to be evident that seasonal variation occurs in the shoreline. The winter tradewind condition has brought more sand up the shoreline. Despite the erosion event in April 2021, the general trend is accretion.

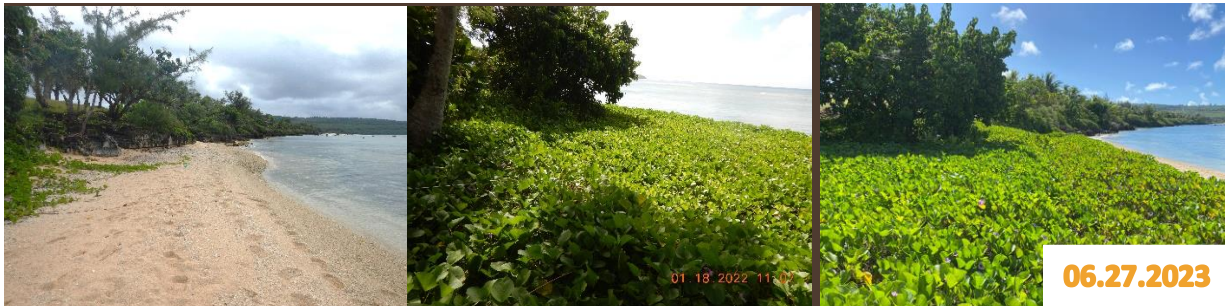
- ACCRETING – Sand has accumulated between 14 - 44 ft with a Wrackline that marks 44 ft and an elevation difference of 9 ft. Developing vegetation indicate stability or even growth of the shoreline.

Jones 1 has been growing since 2021 and morning glory has stabilized the sandy grounds.

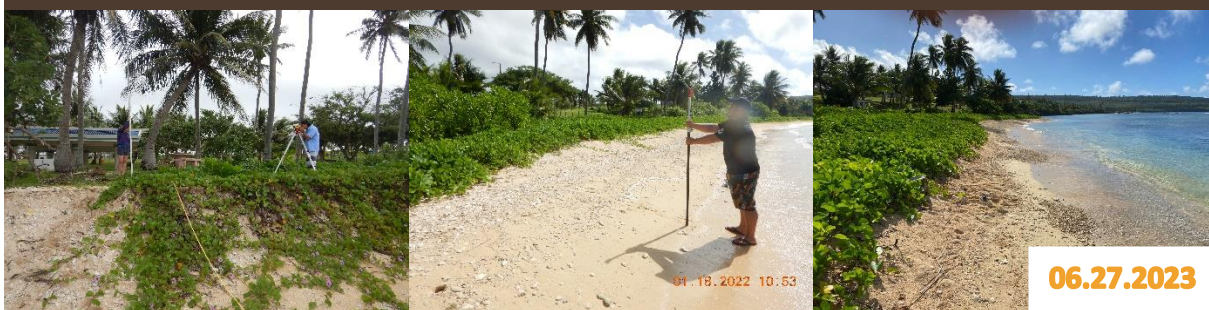
- STABLE with a Wrackline that ranges 63 ft with an elevation difference of 8 ft
- The development of vegetation indicates stability of the shore, a contrast to the erosion in 2017.

Jones 2 experienced erosion in 2017 and accreted until March 2023. The shoreline experienced short-term erosion in June 2023.

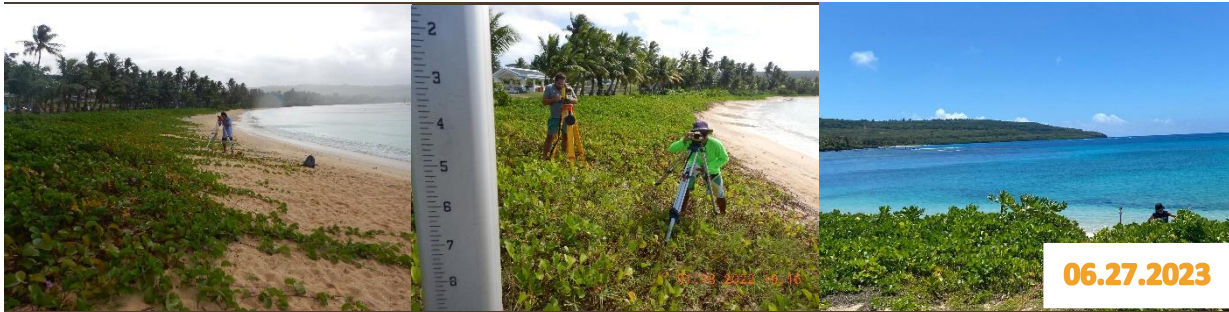
- STABLE with a Wrackline with an elevation difference of 11 ft
- Aug-19 showed accretion between 20 ft – 60 ft. Some volumes begin to erode in Apr-21 and continue to erode since then. Accretion followed as signified on Jun-23.

Jones 3 has steepened over the years due to erosion. The profile indicates accretion occurred after 2017 followed by erosion in 2019. Accretion followed as signified on Jun-23.

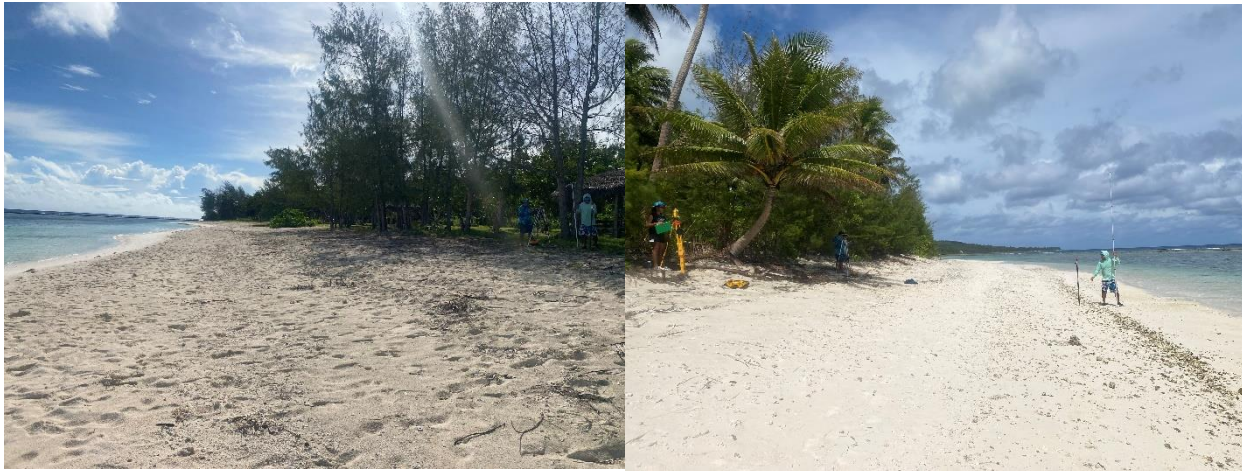
Rota Beach Profiles and Key Findings

Rota's sandy beaches are much closer to the reef, making it unique compared to its northern counterparts. The rocky reef structure functions as a source of sediment for the shoreline while acting as a barrier between land and the open ocean. However, its close proximity of the reef to the shoreline suggests the high potential of storm surge when waves overtop the reef. The low-lying village of Songsong and the road connecting from Songsong peninsula to the airport remain highly vulnerable to sea level rise and storm surge. Remnants of post-WWII relicts are found on lagoon of Sasanlagu, which may interact with sand movement processes. The residents of Songsong have reported 55-years of beach loss and raised concerns of how their private property may be impacted by sea level rise inundation, according to the 2015 vulnerability assessment.

DCRM has been monitoring Teteto, Guata, and Sasanlagu shorelines. Despite its vulnerability to storm surge, sandy beaches have naturally recovered after erosion events. The beach strand plant species in the backshore have been indicative of the stability of inland areas and also act as a buffer for wave energies.

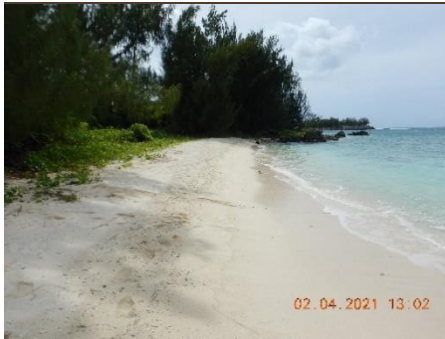
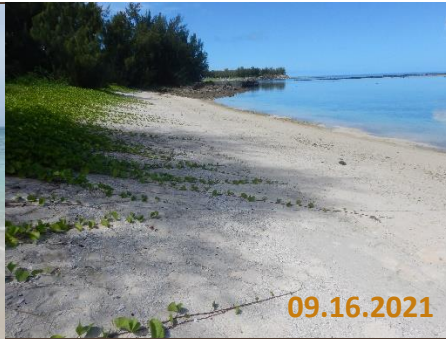
- STABLE with a Wrackline that ranges 20 – 40 ft and an elevation difference of 7 ft
- Seasonal changes have brought sand in and out of the profile.

For **Sasanlagu 1**, it is evident that seasonal variation occurs in the shoreline. The winter tradewind condition have damaged the vegetation but the west summerly tradewind brought more sand up the shoreline according to the beach profile. The shortened nearshore width during high tide conditions could enable waves to run up.

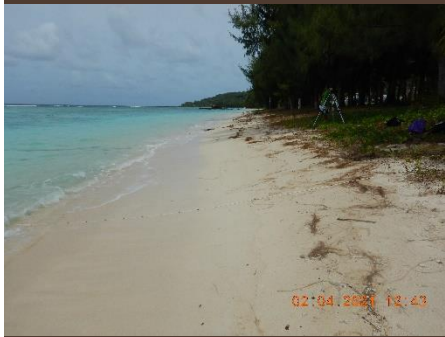
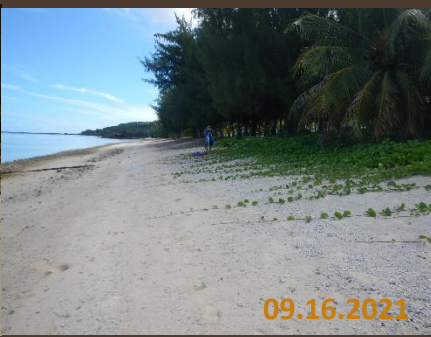
- STABLE with a Wrackline that ranges 24 – 44 ft with an elevation difference of 7 ft
- Seasonal changes have brought sand in and out of the profile.

For **Sasanlagu 2**, it is evident that seasonal variation occurs in the shoreline. The winter tradewind condition has actually pushed some sand up the profile but the width remains narrow. But the width of the nearshore during high tide conditions could concern the backshore.

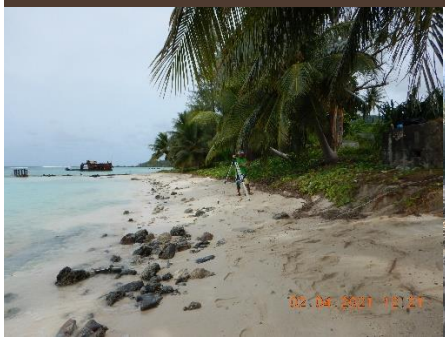
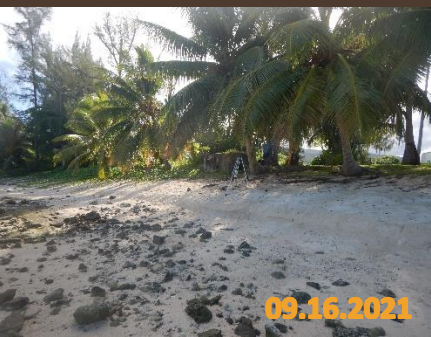
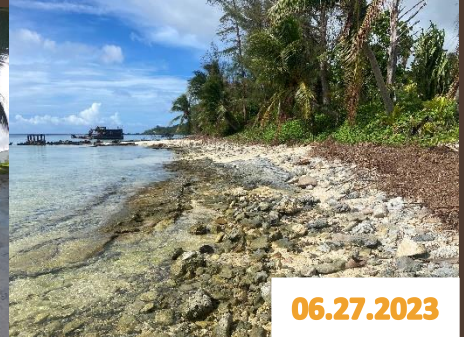
- ERODING with a Wrackline that ranges 14 – 30 ft with an elevation difference of 8 ft
- An erosion scarp is evident in this area.

For **Sasanlagu 3**, it is evident the eroding berm is retreating and deepening Seasonal variation occurs in the shoreline. The winter tradewind condition has actually pushed some sand up the profile but the width remains low.

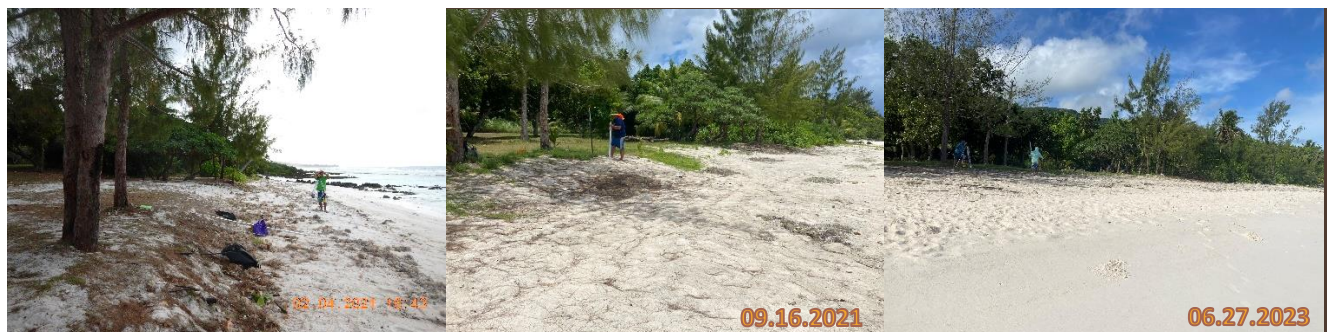
- STABLE is the general trend; ACCRETING in the short-term with a Wrackline that ranges 25 – 50 ft and an elevation difference of 9 ft

For Teteto 1, seasonal variation suggest erosion during the winter tradewind condition and accretion during the summer tradewind conditions. But the width of the nearshore during high tide conditions could concern the backshore.

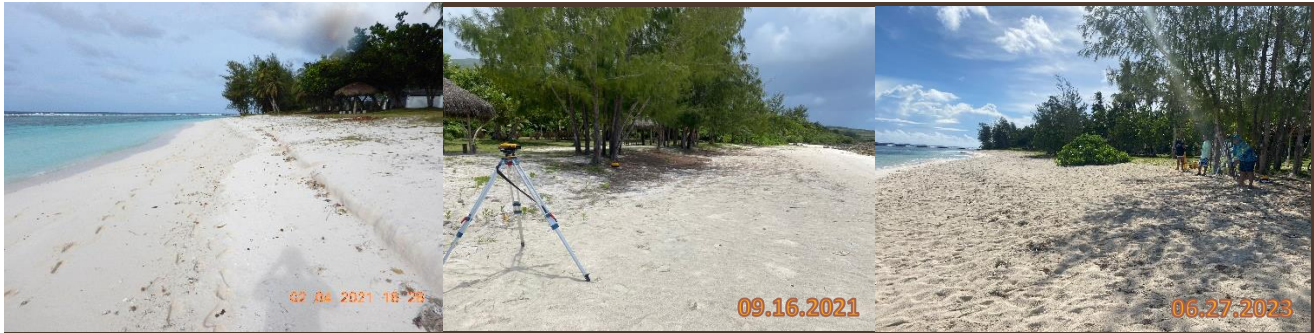
- UNDETERMINED is the general trend with a Wrackline that ranges 40 – 96 ft with an elevation difference of 9 ft

For **Teteto 2**, seasonal variation suggest erosion during the winter tradewind condition and accretion during the summer tradewind conditions. But the width of the nearshore during high tide conditions could concern the backshore.

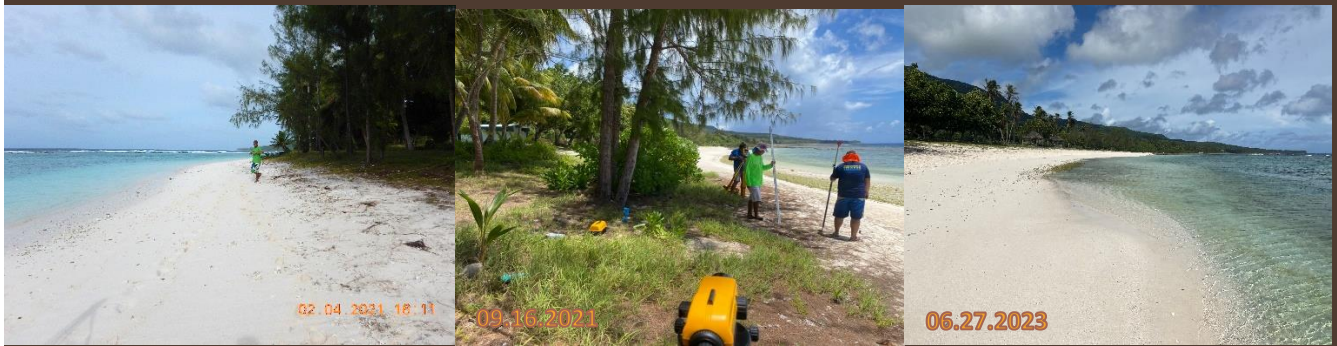
- STABLE is the general trend with a Wrackline that ranges 17 – 50 ft with an elevation difference of 8.5 ft

For **Teteto 3**, seasonal variation suggest erosion during the winter tradewind condition and accretion during the summer tradewind conditions. But the width of the nearshore during high tide conditions could concern the backshore.

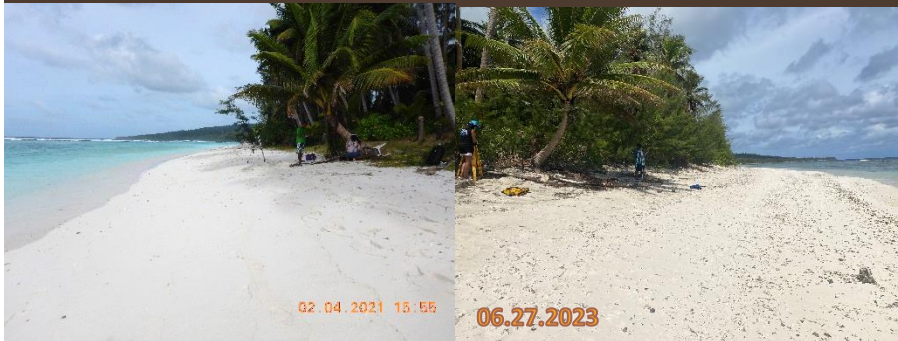
- ERODING short-term with a Wrackline that ranges 10 – 28 ft with an elevation difference of 6 ft

Picture not available for Sep-21. For **Teteto 4**, the berm has seen loss and gain through the seasons. The winter tradewind condition seems to suggest erosion while the typhoon tradewind condition might bring sand. But the width of the nearshore during high tide conditions could concern the backshore.

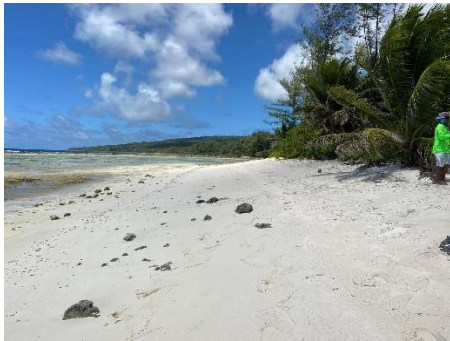
- ACCRETING with a Wrackline that ranges 24 – 45 ft and an elevation difference of 6 ft

Picture not available for Sep-21. For **Guata 1**, the berm is monitored but has seen loss and gain through the seasons. The winter tradewind condition seems to erode the shoreline while the winter and summer tradewind condition might bring sand. The width of the nearshore during high tide conditions could concern the backshore.

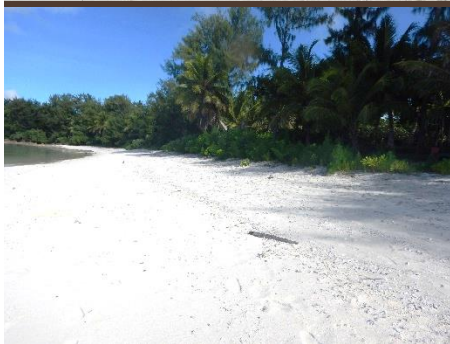
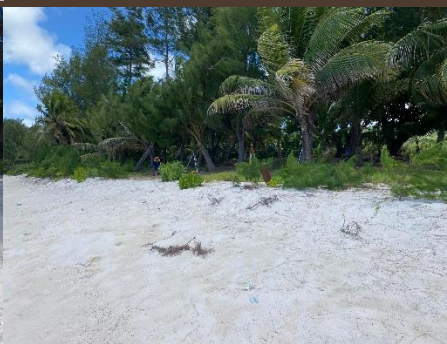
- ERODING with a Wrackline that ranges 30 – 60 ft with an elevation difference of 8 ft

Picture not available for Sep-21. For **Guata 2**, the berm has been retreating over time, due to the reach of the wrackline. Sediment input may occur downslope.

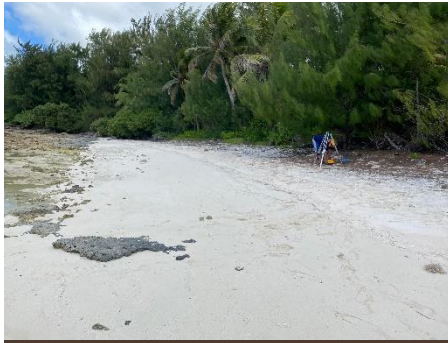
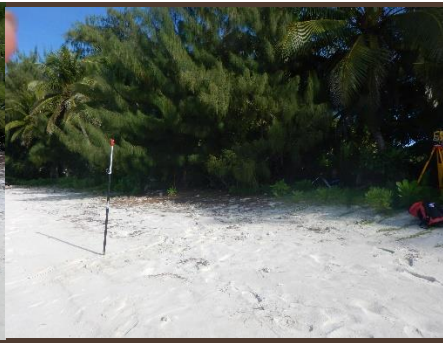
For **Guata 3**, the berm may be increasing over time. Due to the reach of the wrackline, the nearshore width is limited.
