DCRM Shoreline Profile Monitoring Data Report

Tinian and Rota

August 2021

Bureau of Environmental Coastal Quality - Division of Coastal Resources Management

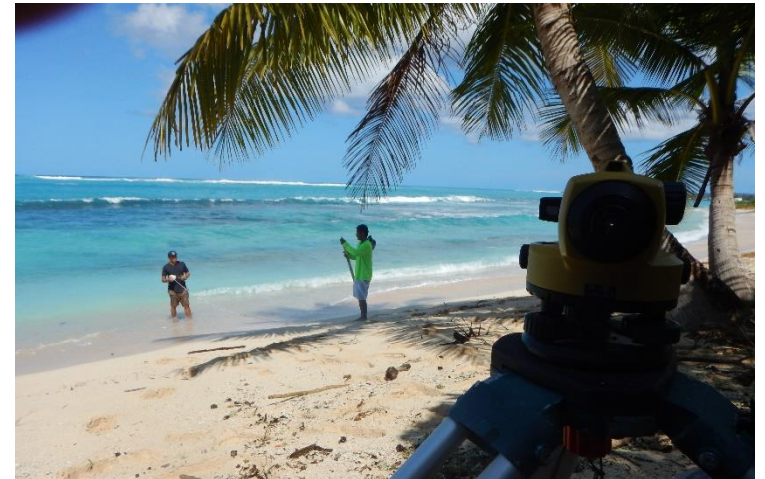
Rich S. and Art. C. laying out the transect during high tide and surf conditions at Tachonga South 1. On the right is the Berger Level on the tripod.

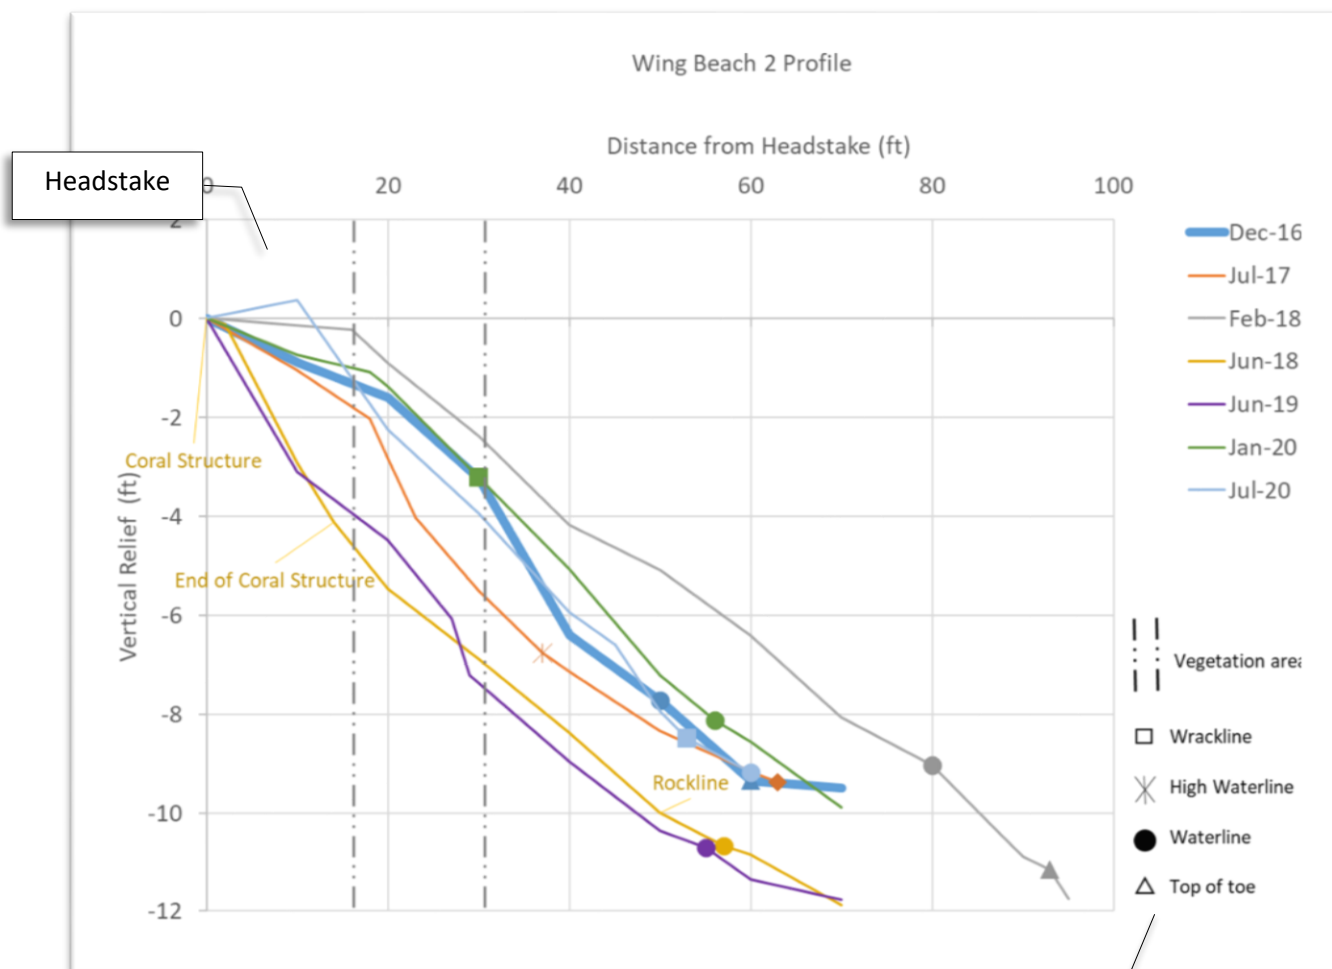
How to Read the Beach Profile

The beach profile, shown on the left, captures the contour of the shoreline from the headstake (starting point inland) to the bottom of the moat/toe.

Distance from the headstake is shown vertically in relation to the elevation difference from the headstake.

Each different colored line is a data entry at a different time. For instance, a transect survey taken on Dec-16 is shown in thick blue.

Symbology is used to indicate points where particular beach features have been detected along the transect. These beach features have been selected as importance and common indicators of shoreline profile change. The color matches the date/time of the transect taken. The symbol matches the beach feature. Vegetation area has two lines. The left indicates Start of Vegetation while the right indicates the End of Vegetation. Wrackline, high waterline, waterline, and top of toe are generally detected as one point. Note that not all beach features may be detected in a shoreline transect.

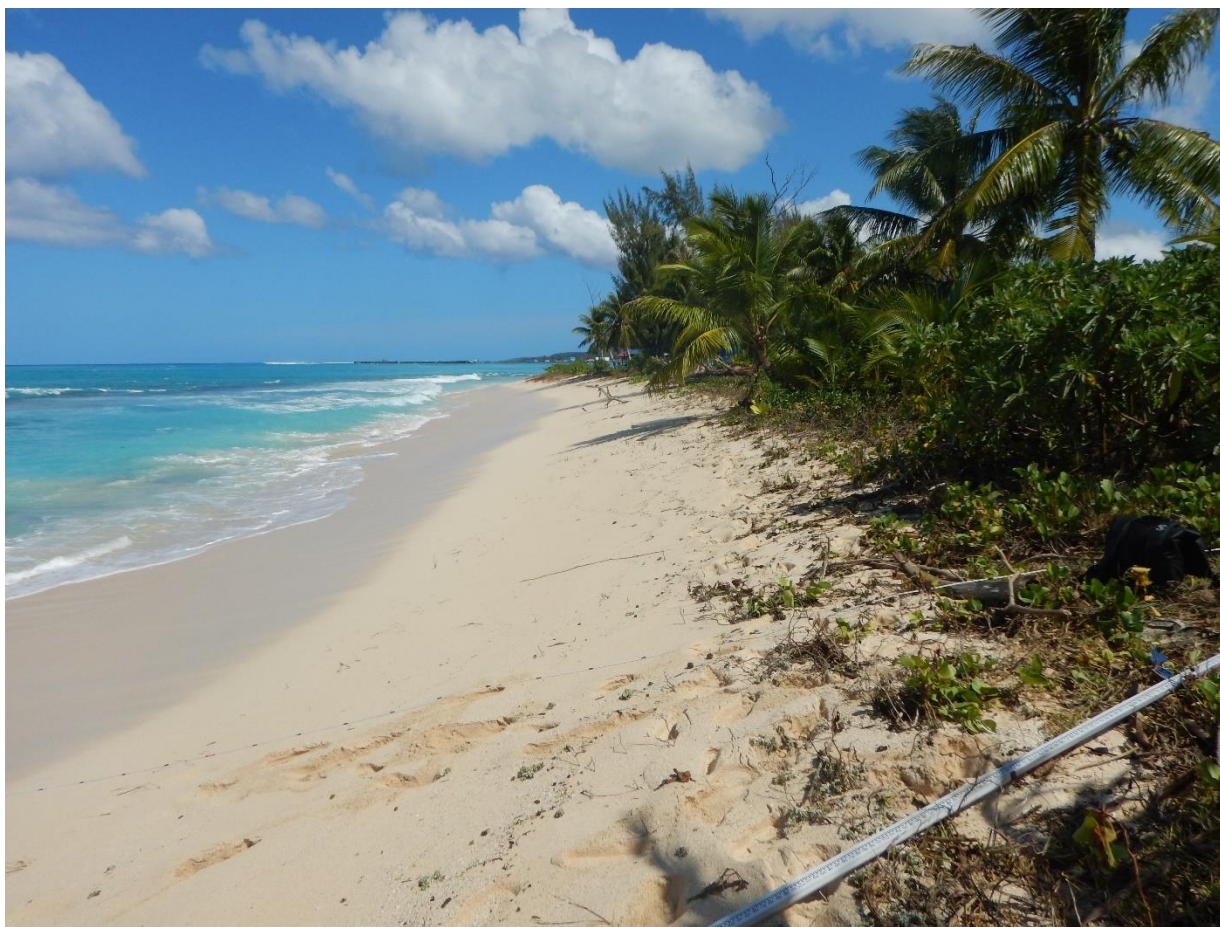
Tachonga Beach is important to Tinian's recreation and tourism as it is grounds for BBQs and marine sports. The southern part of the beach has a higher density of nearshore salt-tolerant vegetation, which acts as a sand stabilizer and buffer from waves for the backshore. Meanwhile, the northern section of the shoreline is more exposed since this area is more cleared and disturbed by recreational use. This area has historically been at risk of storm surge and tsunami events². Apr-21 records for transects in this site presents the impact of storm surge and high surf on the shoreline.

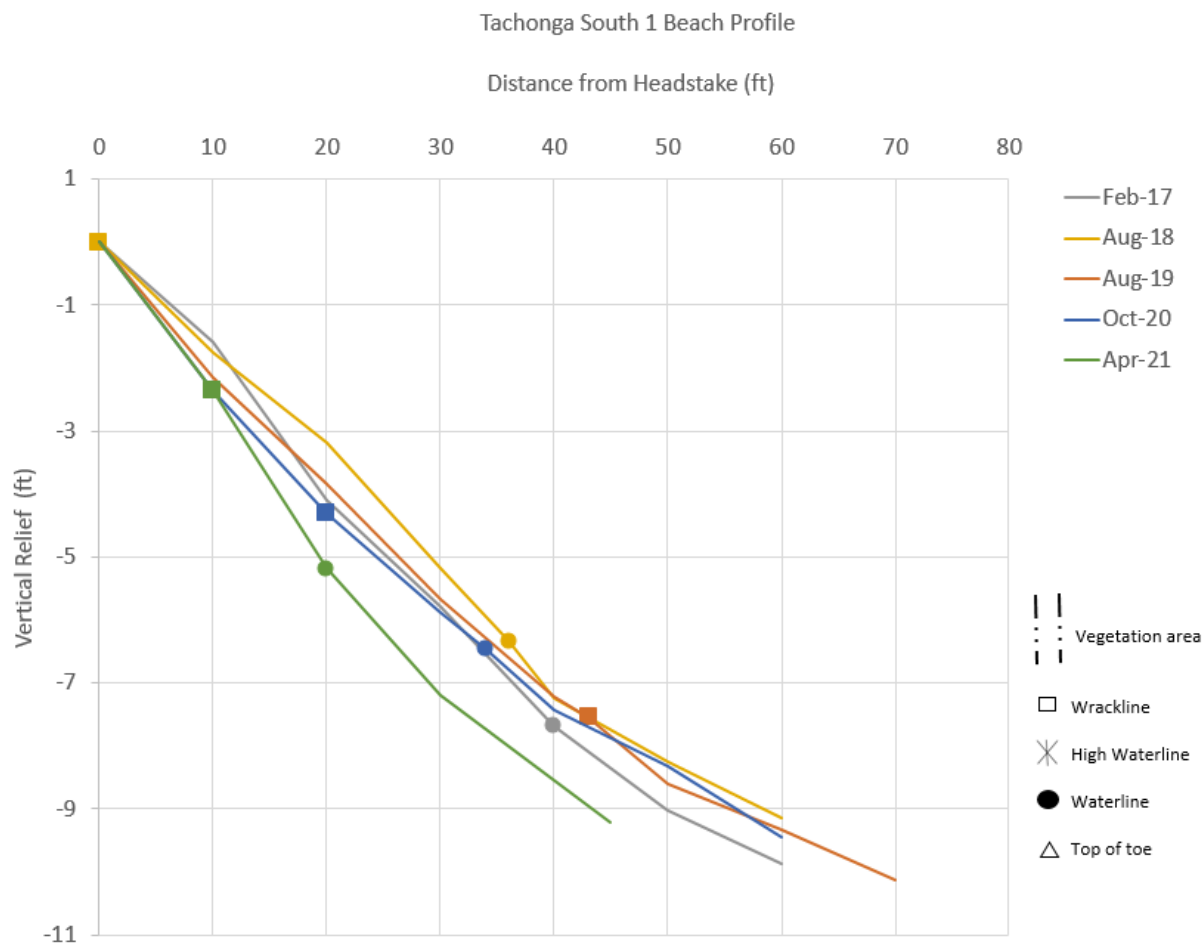
Day Recorded	Tide	Shoreline Length
Feb 16, 2017	1.46 ft	40 ft
Aug 30, 2018	1.59 ft	36 ft
Aug 27, 2019	0.6 ft	Not recorded
Oct 20, 2021	1.45 ft	34 ft
Apr 22, 2021	1.31 ft	20 ft
Average		32.5 ft

Tachonga South 1 appears to be generally eroding. The wrackline ranges from the headstake to 40 ft away. This area is on the southern end of the beach, which suggests its large wrackline range.

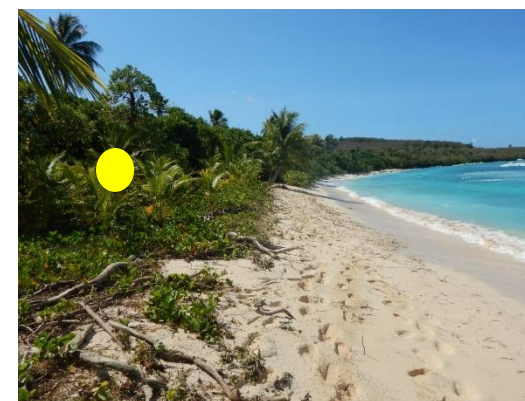
Day Recorded	Tide	Shoreline Length
Feb 16, 2017	1.51 ft	30 ft
Aug 30, 2018	1.52 ft	60 ft
Aug 27, 2019	-0.05 ft	60 ft
Apr 21, 2021	1.29 ft	25 ft
Average		43.75 ft

Tachonga South 2 appears to be eroding. Feb 2017 is an outlier with the misidentification of the headstake (a backshore plant). The wrackline ranges from 30 to 56 ft. The elevation difference from the headstake to the farthest top of toe is about 11 ft.

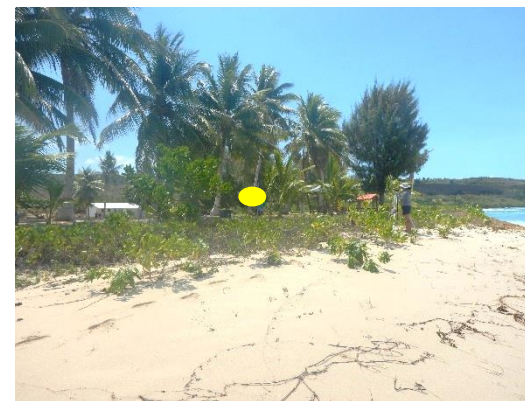
Day Recorded	Tide	Length
Feb 16, 2017	1.57	50 ft
Aug 30, 2018	1.41	56 ft
Oct 8, 2020	1.61	73 ft
Apr 21, 2020	1.31	Not recorded
Average		59.67 ft

Tachonga South 3 is eroding given the loss of the berm. Oct-20 shows accretion with a longer shoreline length, but the high surf event of Apr-21 chipped away at that accumulated sand. The wrackline ranges from 50 ft to 59 ft. The elevation difference from the headstake to the farthest top of toe is about 10 ft.

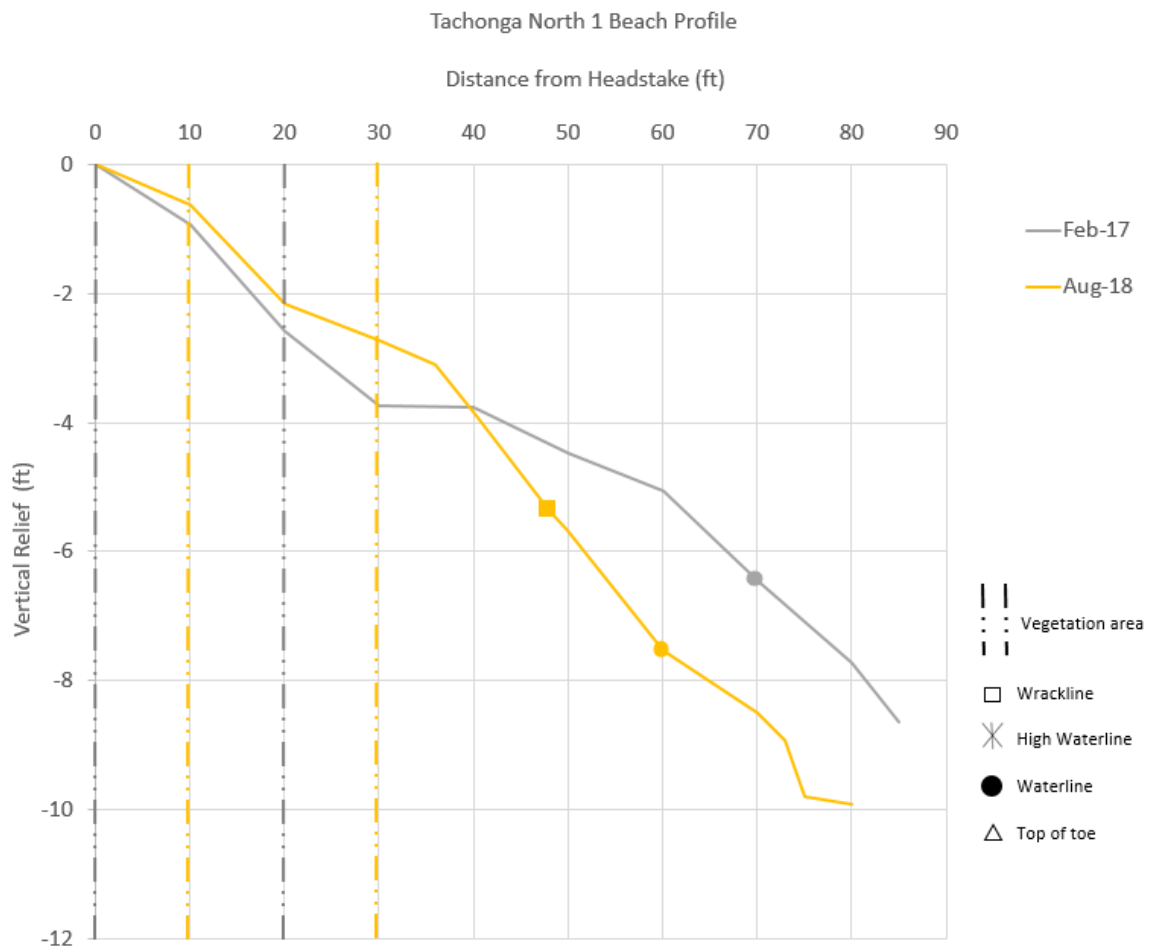
Day Recorded	Tide	Shoreline Length
Feb 16, 2017	Not recorded	70 ft
Aug 30, 2018	1.32 ft	60 ft
Average		65 ft

Tachonga North 1 is discontinued due to its difficulty in identifying the headstake. This headstake was in the vicinity of the beach parking lot and backshore meeting area. The shoreline from Feb-17 and Aug-18 appears to indicate erosion for this profile.

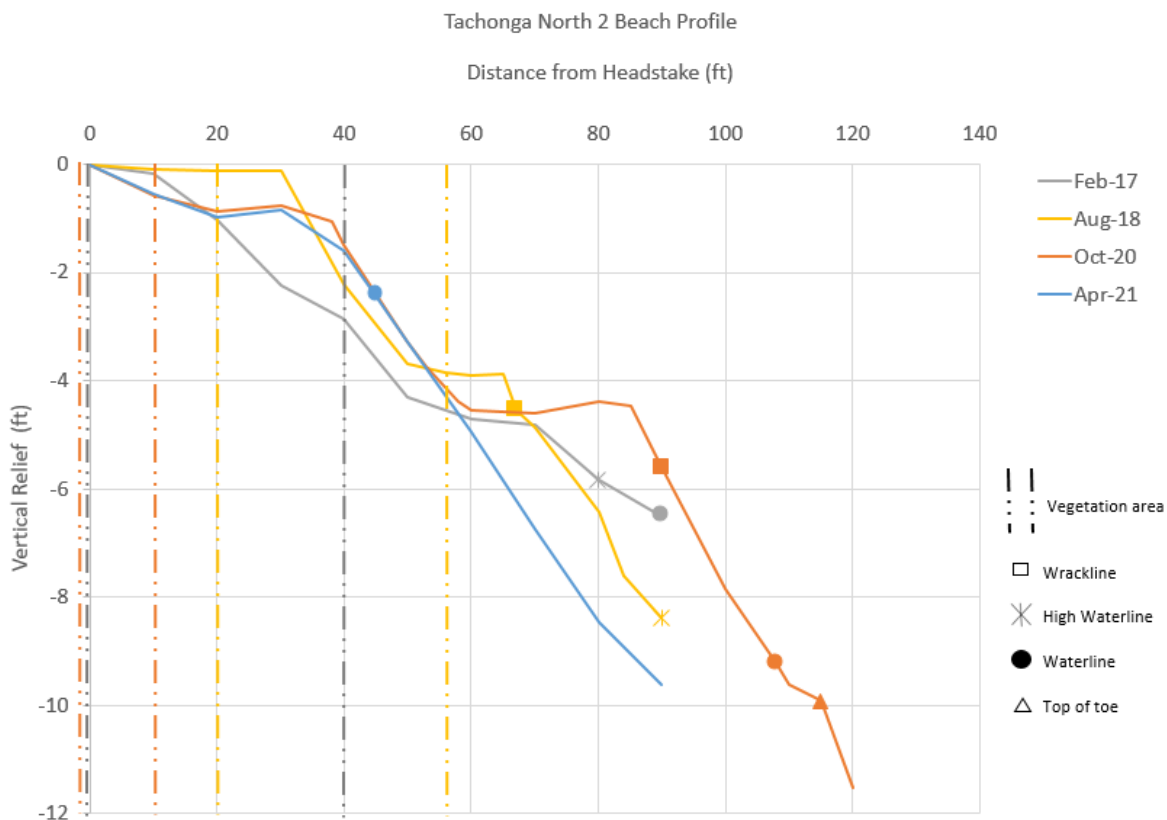
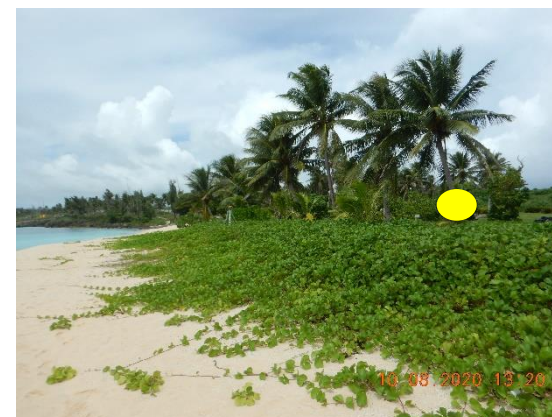
Day Recorded	Tide	Shoreline Length
Feb 16, 2016	Not recorded	90 ft
Aug 30, 2018	1.27 ft	Not recorded
Oct 8, 2020	1.58 ft	108 ft
Apr 21, 2021	1.36 ft	45 ft
Average		81 ft

Tachonga North 2 appears to have generally eroded. Oct-20 indicated that the shoreline could be longer under regular conditions. Apr-21 indicates the shoreline erosion during high tide and high surf conditions. The vegetation line was not captured during that time because they were damaged by wave conditions. The wrackline ranges from 67 to 90 ft during regular surf conditions.

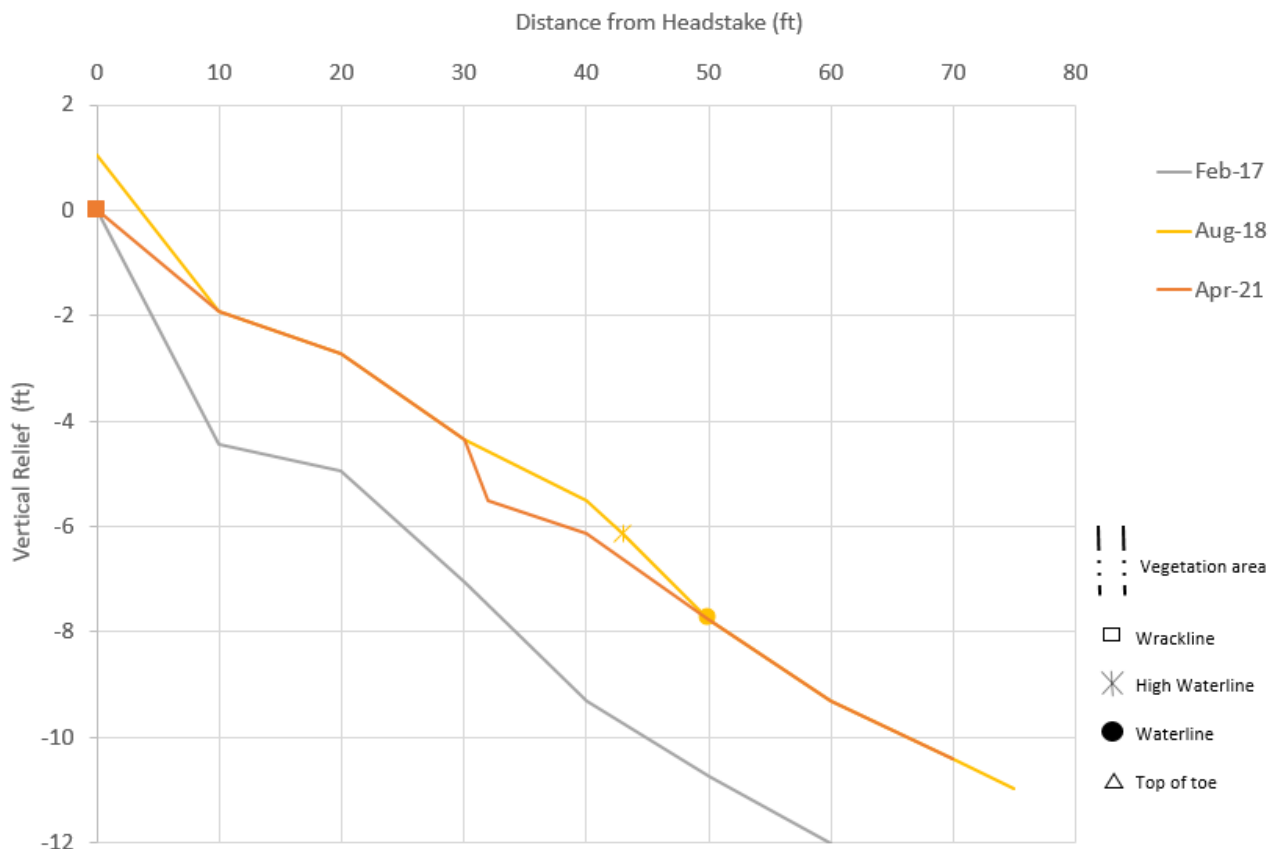
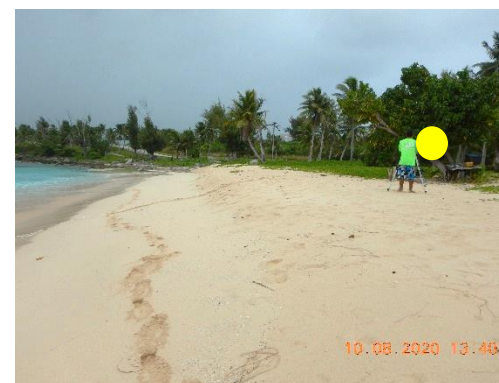
Tachonga North 3 Beach Profile

Day Recorded	Tide	Shoreline Length
Feb 16, 2017	1.78 ft	40 ft
Aug 30, 2018	1.17 ft	50 ft
Apr 21, 2021	1.38 ft	Not recorded
Average		45 ft

Tachonga North 3 appears have slightly eroded. According to surveyor and residential observations, high surf has pushed up new sand into the shoreline and this area is highly prone to wave run up. The wrackline reached the headstake in Apr-21.

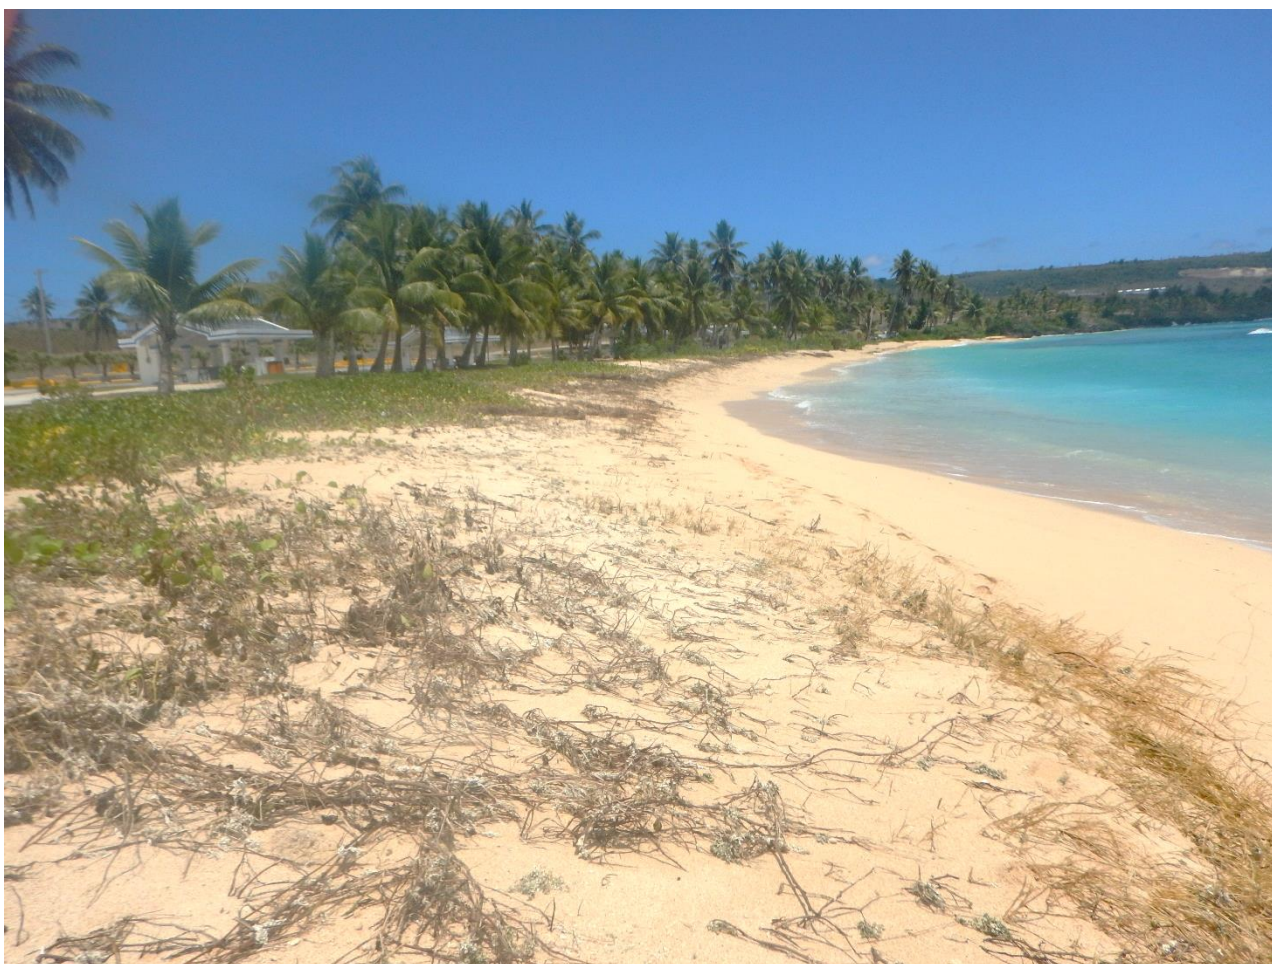
Formerly called “Kammer”, Jones Beach is a sandy beach park south of the Tinian Harbor. The northern portion of the shoreline which aligns with the boat harbor appears to have not as much coral and coastal protection. Jones Beach is closest to San Jose Village and the Tinian Harbor. The loss of this beach to sea level rise or erosion would push the risk of storm surge inland.

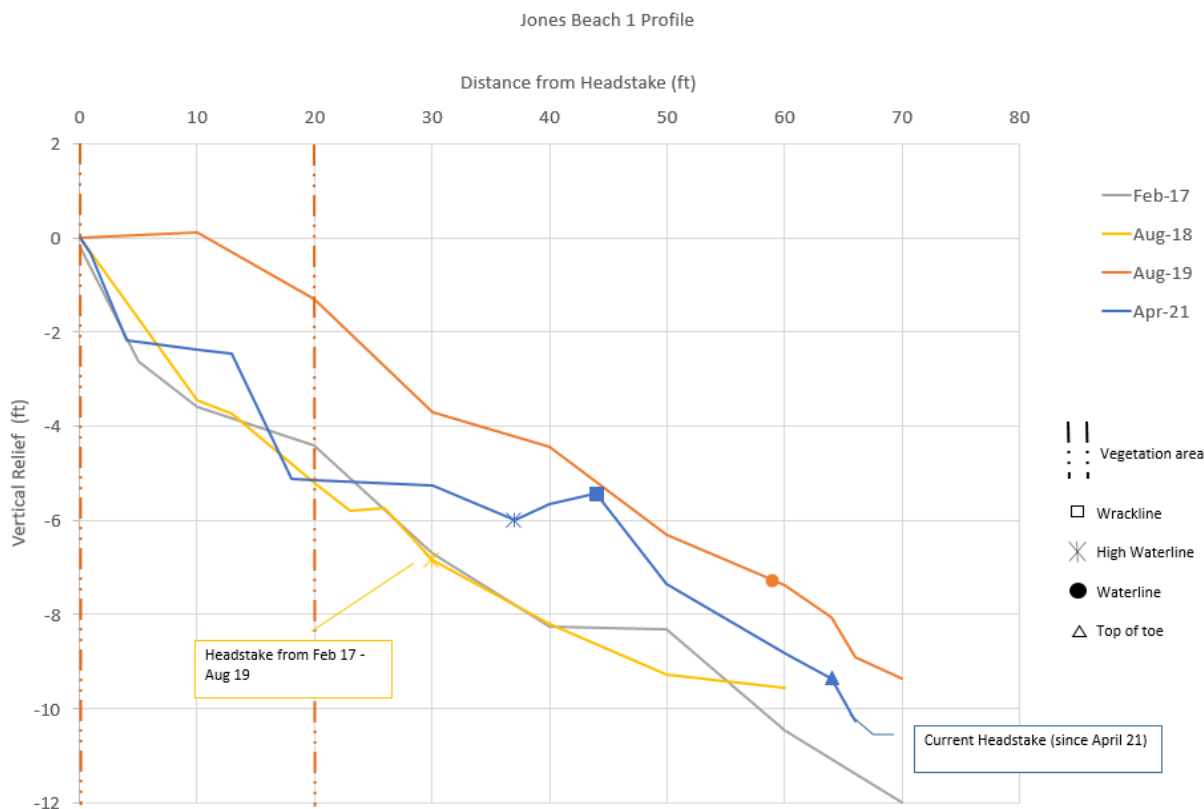
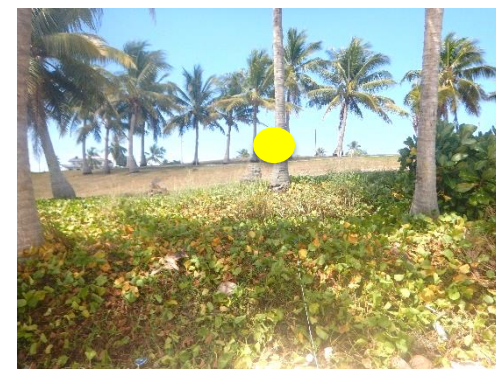
Day Recorded	Tide	Shoreline Length
Feb 16, 2017	1.07 ft	60 ft
Aug 30, 2018	0.55 ft	Not recorded
Aug 27, 2019	0.17 ft	59 ft
Apr 21, 2021	0.76 ft	Not recorded
Average		59.5 ft

Jones 1 is difficult to determine. The Aug-19 headstake was a tree that was growing larger in size, blocking the actual starting point and making the surveying difficult. The current headstake is new and is a coconut tree closer to the backshore the dirt closer to the pavilions. The elevation difference from the headstake to the farthest top of toe is about 9 ft.

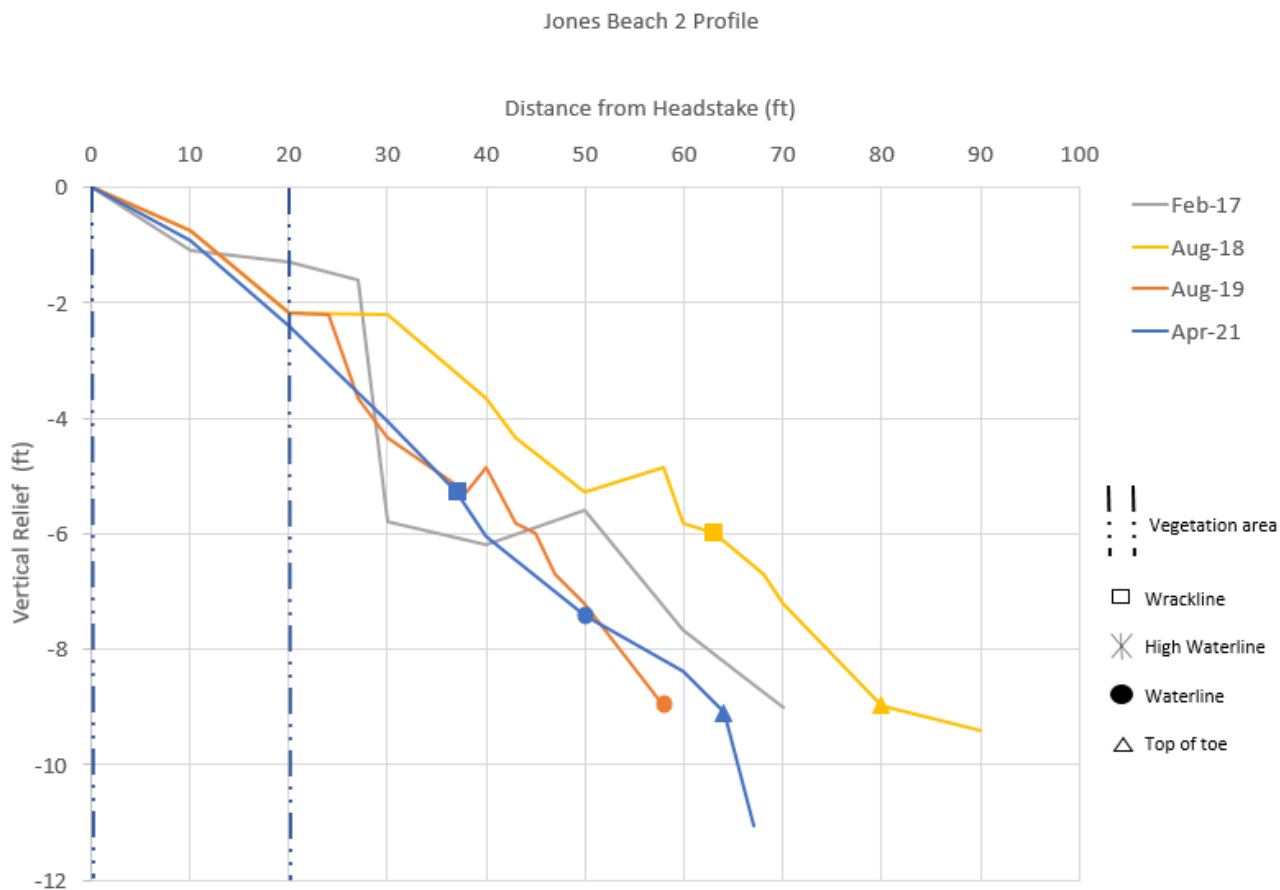
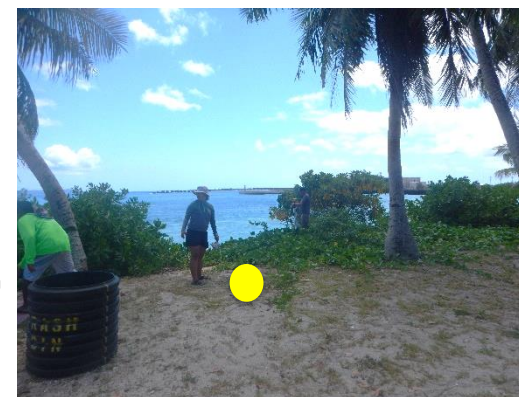
Day Recorded	Tide	Shoreline Length
Feb 16, 2017	1.21 ft	65 ft
Aug 30, 2018	0.69 ft	68 ft
Aug 27, 2019	1.4 ft	58 ft
Apr 21, 2021	1.21 ft	50 ft
Average		60.25 ft

Jones 2 is generally eroding. Aug 2018 appears to be an outlier. Through observation, it is speculated that storm surges from powerful storms may influence the shoreline vegetation dynamics. The elevation distance from the headstake to the furthest top of toe is 9 ft.

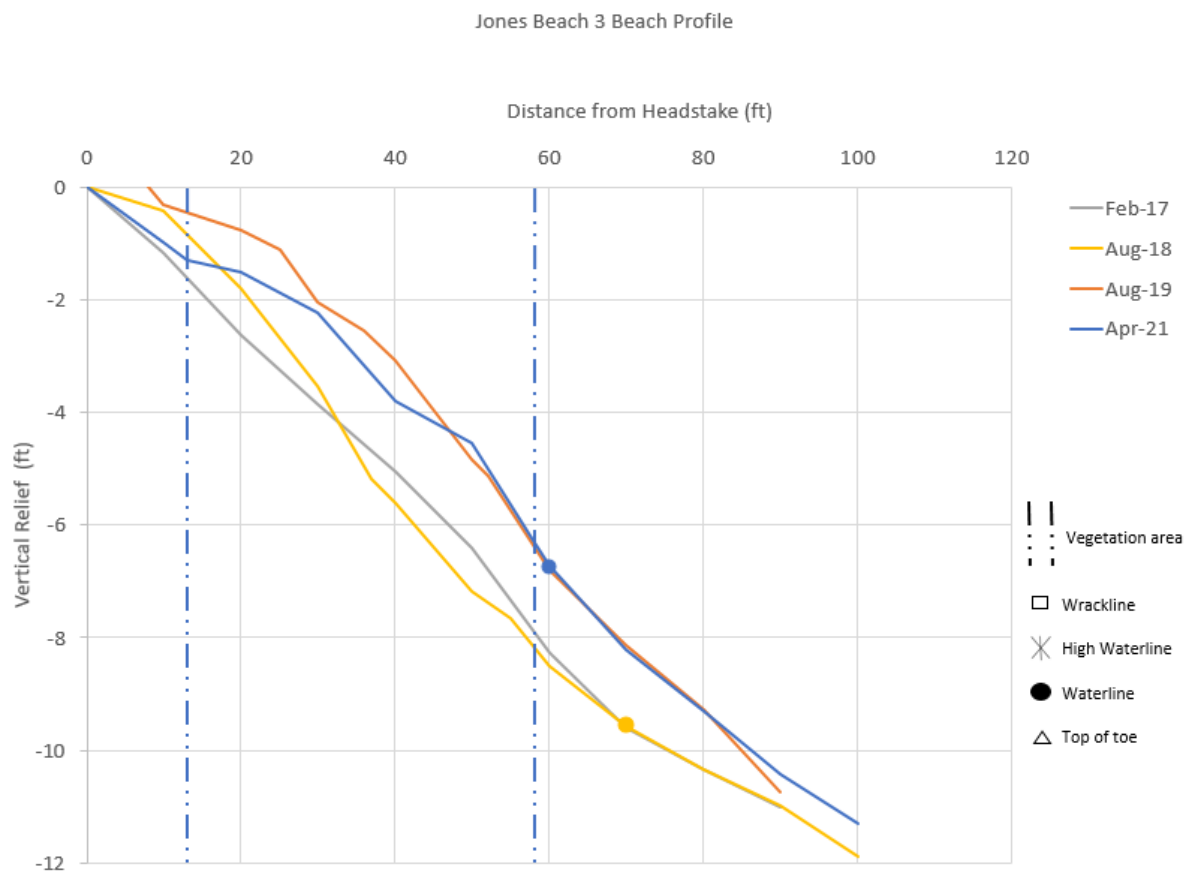
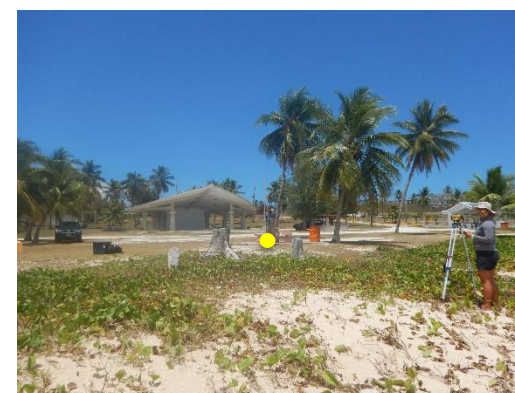
Day Recorded	Tide	Shoreline Length
Feb 16, 2017	1.35 ft	60 ft
Aug 30, 2018	0.82 ft	70 ft
Aug 27, 2019	-0.05 ft	Not recorded
Apr 21, 2021	0.52 ft	60 ft
Average		63.3 ft

Jones 3 appears to generally accrete. This transect is adjacent to the harbor. Future data collection would improve understanding of the shoreline and its effect by the harbor structure.

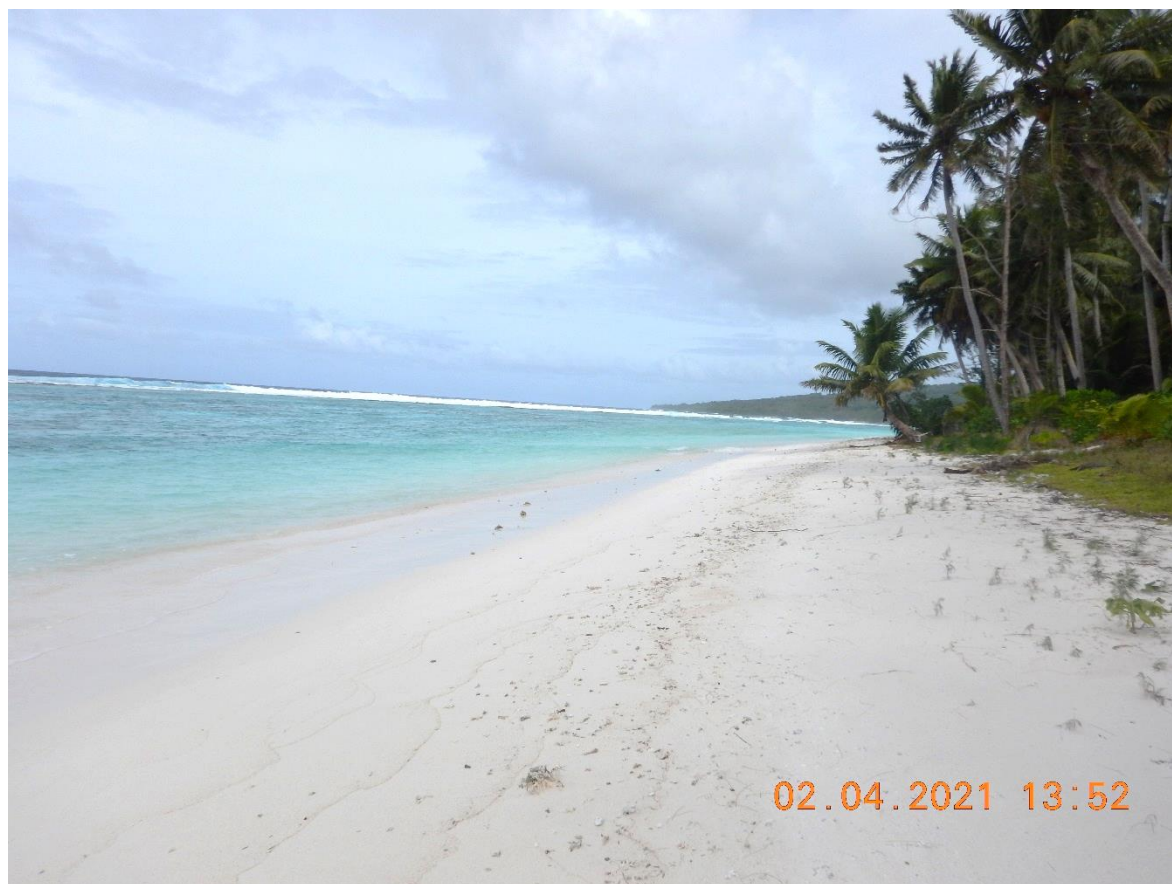
Guata Beach

Guata is the most northern monitoring site in Rota and a neighboring beach park to Teteto. This beach has high backshore vegetation density and provides excellent habitat for shoreline plant and animal species. The reef is at close proximity to shoreline. Inland, there are also multiple picnic palapas, a playground, and restroom and shower facilities. The park and shoreline are also adjacent to the only road on the island headed for the airport⁶. Since the road lacks proper drainage, stormwater runoff contributes to accelerated beach erosion. Projected 50 and 75-year sea level rise scenarios suggest that Guata will recede further⁷.

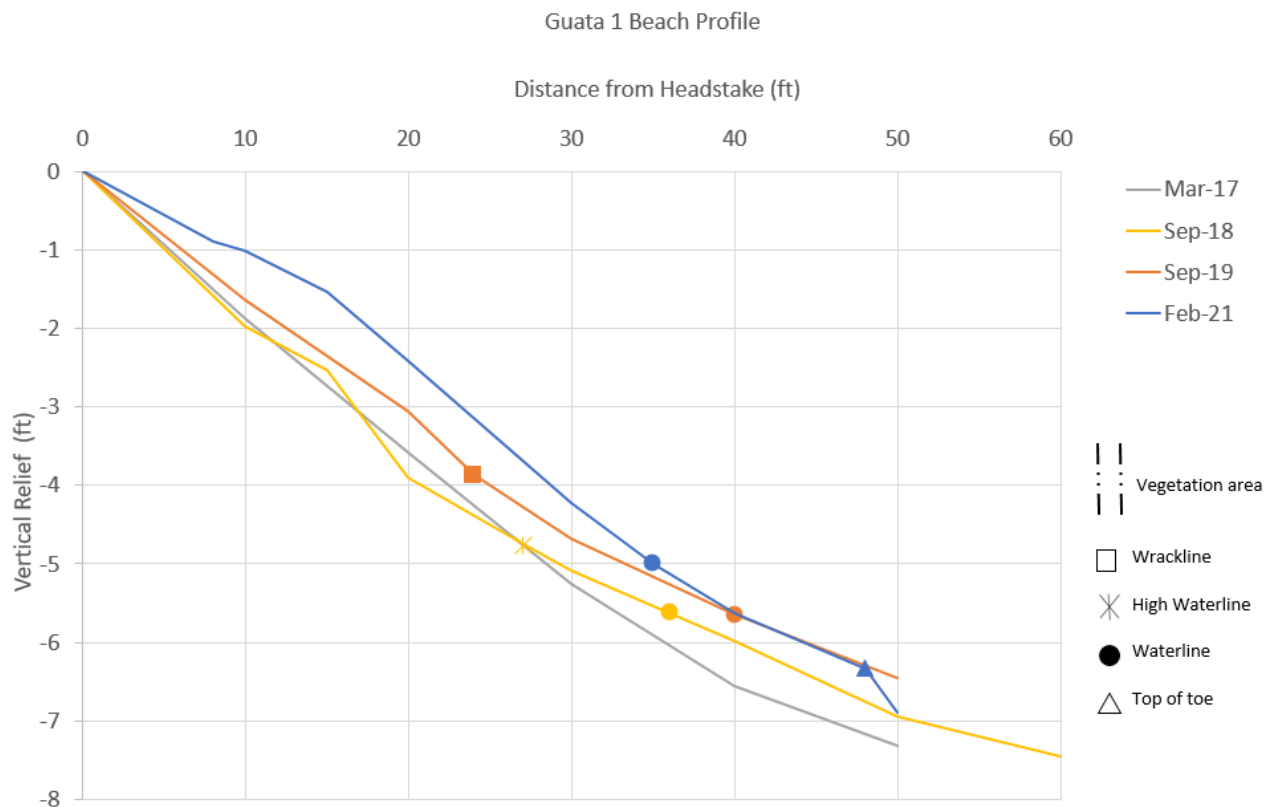
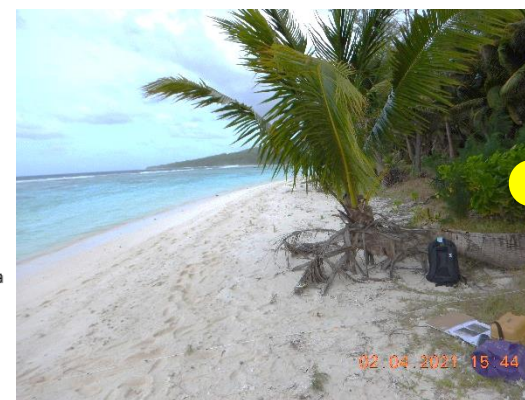
Day Recorded	Tide	Shoreline Length
Mar 14, 2017	1.35 ft	Not recorded
Sep 4, 2018	1.13 ft	36 ft
Sep 5, 2019	1.13 ft	40 ft
Feb 4, 2021	1.21 ft	35 ft

Guata 1 appears generally accreting. The elevation difference from the headstake to the top of the toe is approximately 6 ft.

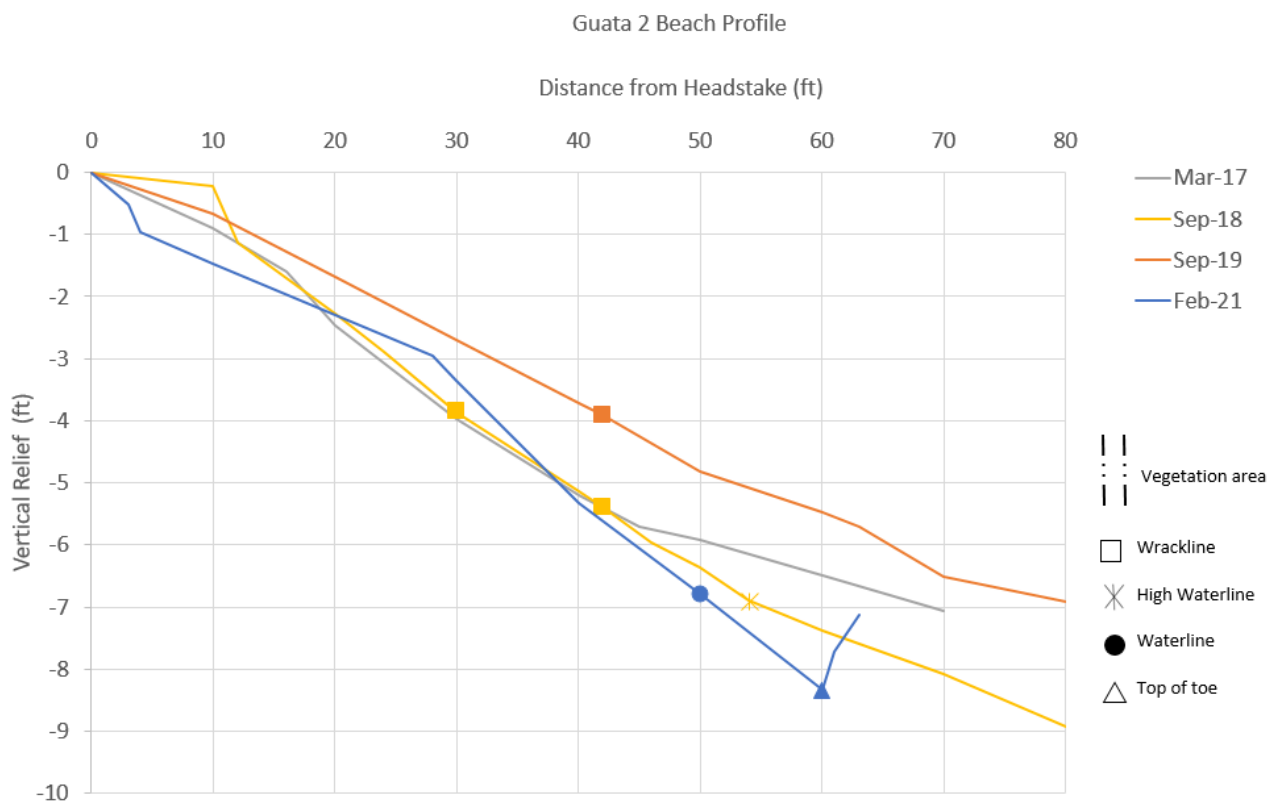
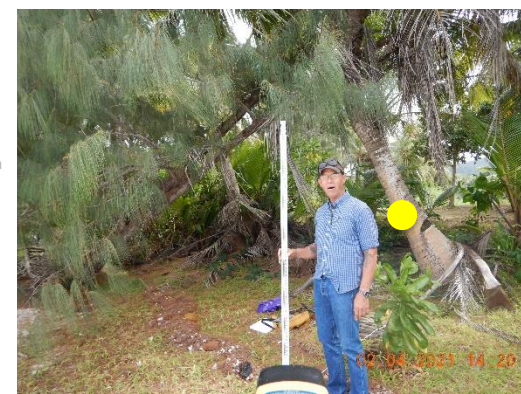
Day Recorded	Tide	Shoreline Length
Mar 14, 2017	1.58 ft	45 ft
Sep 4, 2018	1.25 ft	Not recorded
Sep 5, 2019	1.13 ft	63 ft
Feb 4, 2021	1.34 ft	50 ft

Guata 2 is eroding. The wrackline ranges from 30 ft to 42 ft. The elevation difference from the headstake to the top of the toe is approximately 8 ft.

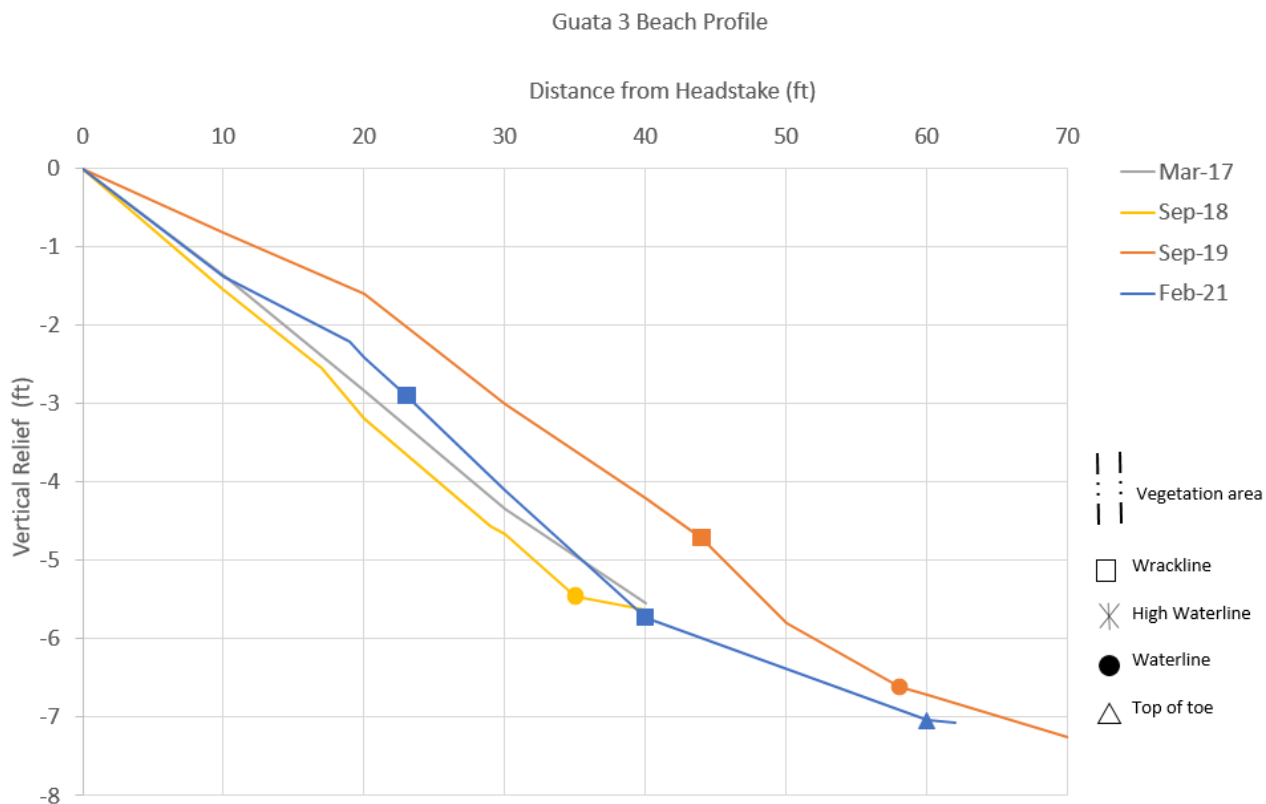
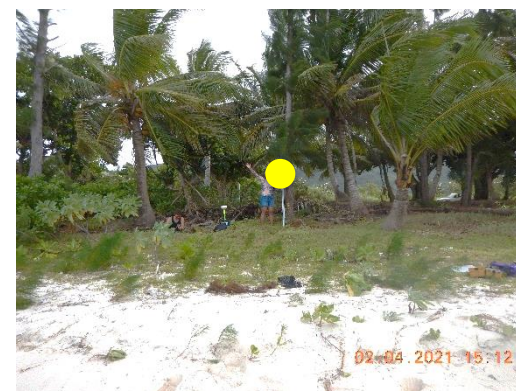
Day Recorded	Tide	Shoreline Length
Mar 14, 2017	1.58 ft	30 ft
Sep 4, 2018	1.25 ft	35 ft
Sep 5, 2019	1.13 ft	58 ft
Feb 4, 2018	Not recorded	Not recorded
Average		41 ft

Guata 3 appears to be dynamic but it is slightly accreting. The wrackline ranges from 23 ft to 44 ft. The elevation difference from the headstake to the top of the toe is 7 ft.

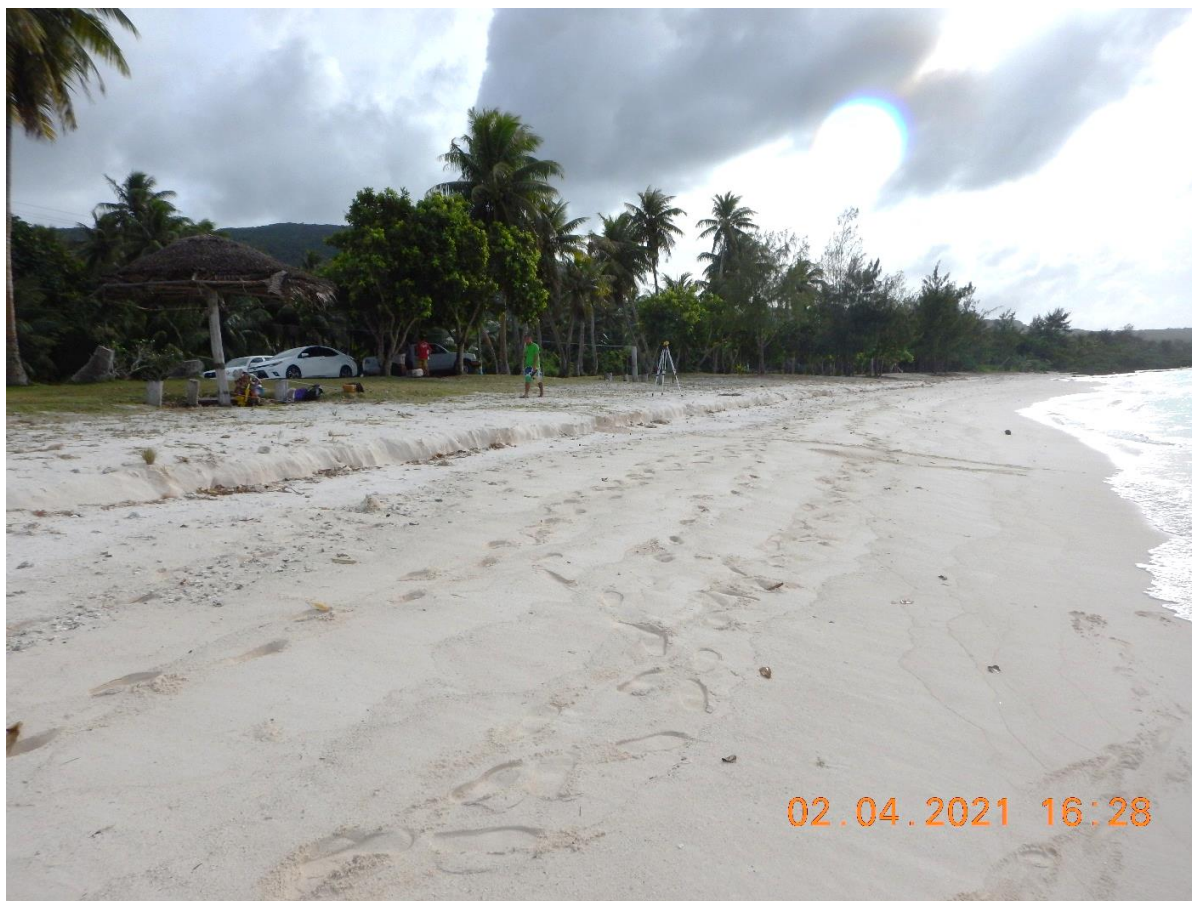
Teteto Beach Park contains picnicking areas and a parking area. The shoreline has higher foot traffic than Guata. Shoreline erosion is observed through the abrasion along the beach park.

Similarly to Guata beach, sea level rise projections suggest substantial loss of sand in the 50 and 75-year scenarios. The loss of beach as a buffer could damage the main road connecting Songsong to Sinapalo and inland areas during storm surge and high wave energy events.

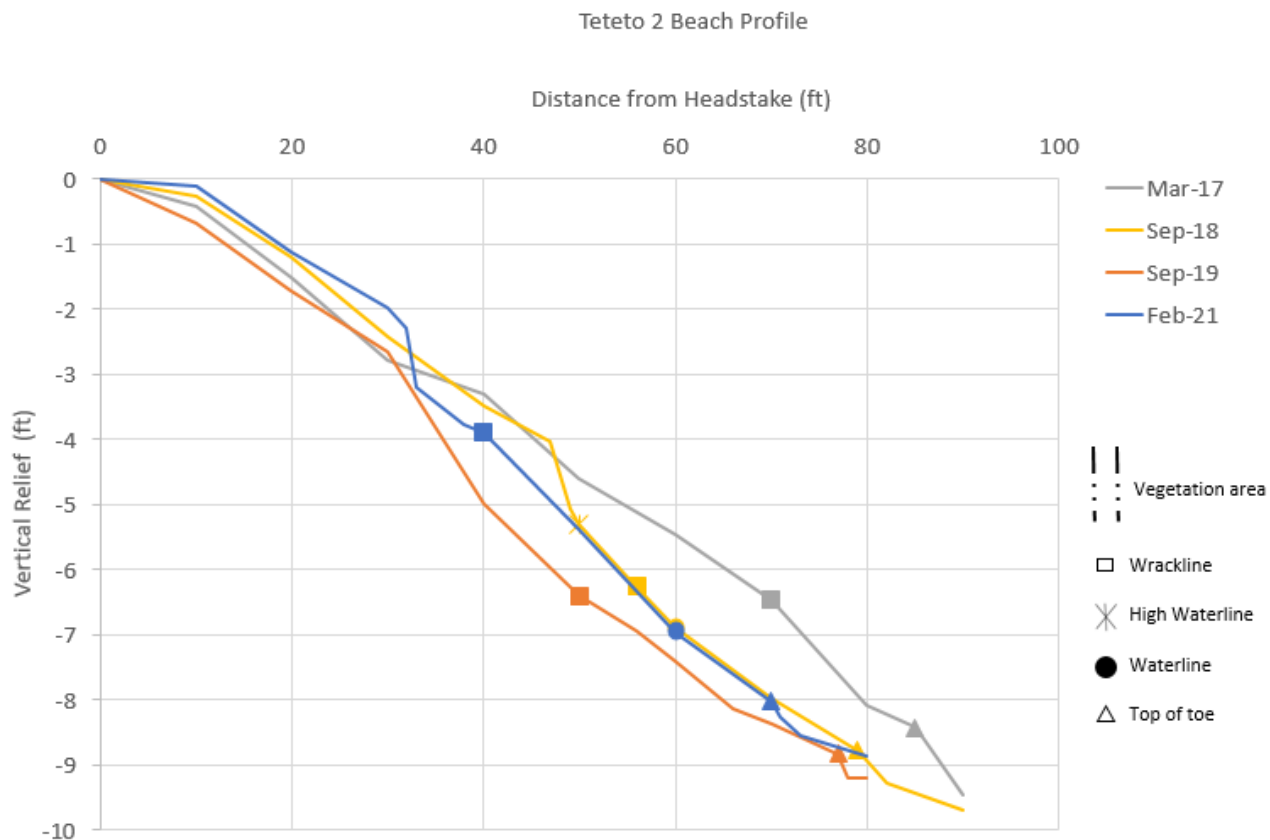
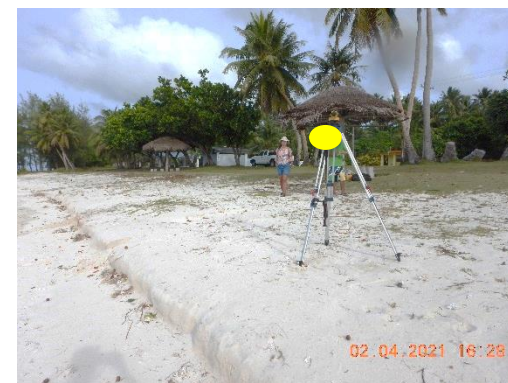
Day Recorded	Tide	Shoreline Length
Mar 14, 2017	1.74 ft	Not recorded
Sep 4, 2018	0.97 ft	60 ft
Sep 5, 2019	Not recorded	70 ft
Feb 4, 2021	1.5 ft	60 ft
Average		63.3 ft

Teteto 2 is generally eroding, but future trends could determine the long term shoreline change. Sep-19 to Feb-21 indicates accretion but compared to the baseline record, Mar-17, erosion has occurred at this stretch. The wrackline ranges from 40 to 70 ft. A small scarp was observed in the most recent field work. The elevation from the headstake to the top of the toe around 8.5 ft.
