DCRM Shoreline Profile Monitoring Data Report

Tinian and Rota

August 2021

Bureau of Environmental Coastal Quality - Division of Coastal Resources Management

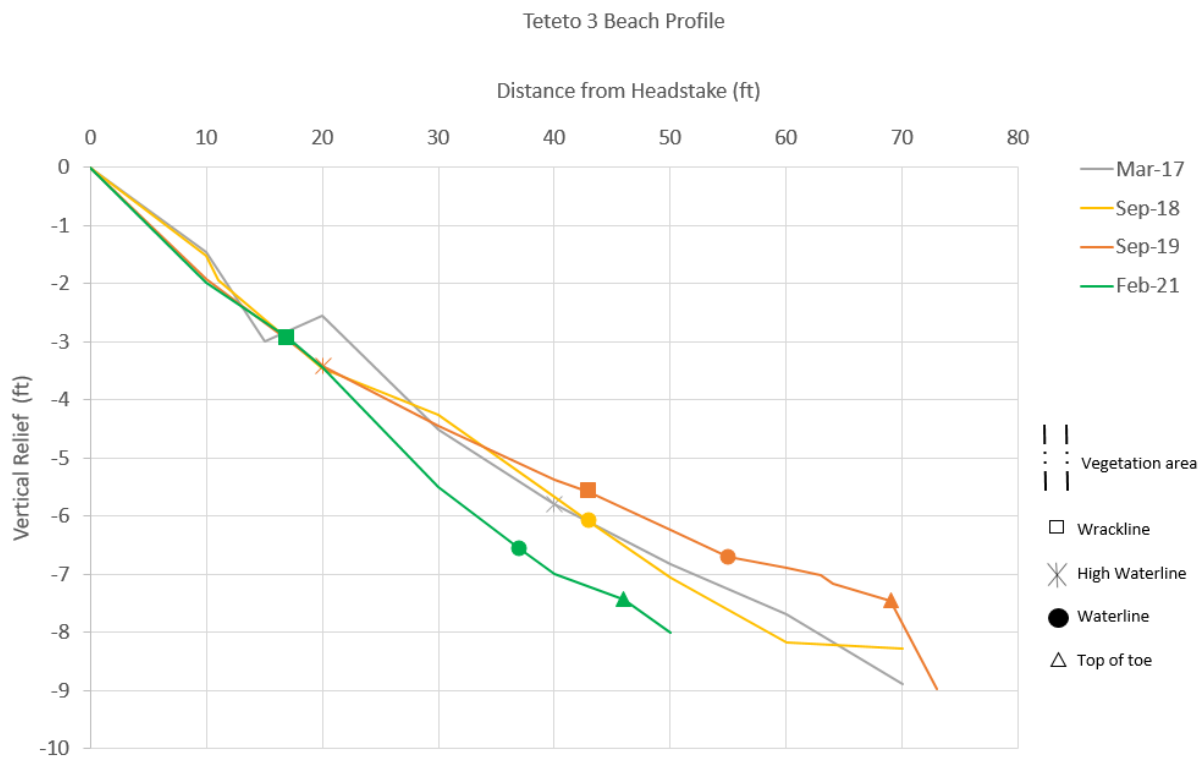
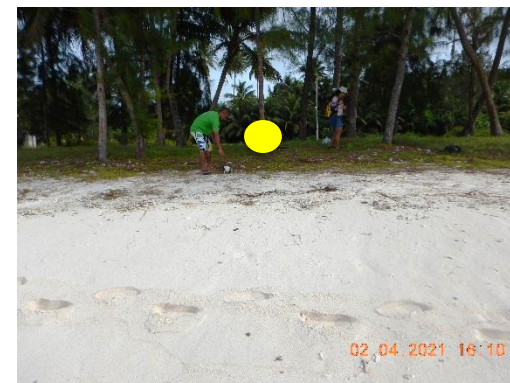
Day Recorded	Tide	Shoreline Length
Mar 14, 2017	1.74 ft	Not recorded
Sep 4, 2018	1.04 ft	43 ft
Sep 5, 2019	1.27 ft	55 ft
Feb 4, 2021	1.13 ft	37 ft
Average		45 ft

Teteto 3 has eroded over time. The berm has lost and the length of the shoreline has decreased over time. The wrackline ranges from 17 ft to 43 ft. The elevation difference from the headstake to the top of the toe is approximately 7 ft.

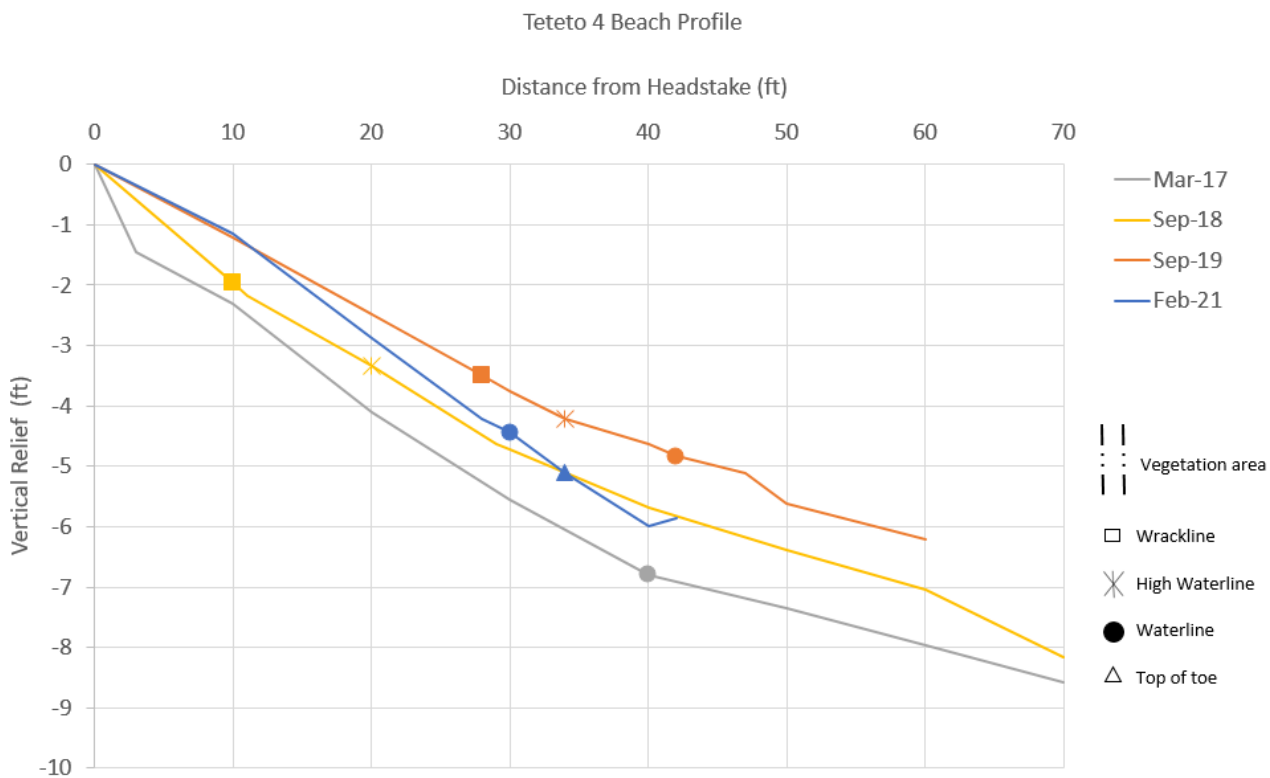
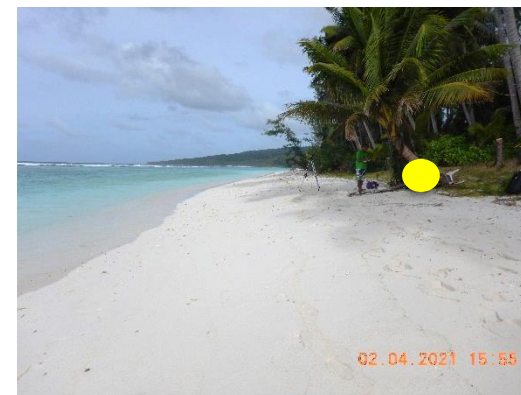
Day Recorded	Tide	Shoreline Length
Mar 14, 2017	1.74 ft	40 ft
Sep 4, 2018	Not recorded	Not recorded
Sep 5, 2019	1.13 ft	42 ft
Feb 4, 2021	1.15 ft	32 ft
Average		38 ft

Teteto 4 is generally accreting. The berm has grown since Sept-19. Further monitoring will better confirm the development of this berm or the shortening of the shoreline. The wrackline ranges from 10 ft to 28 ft.

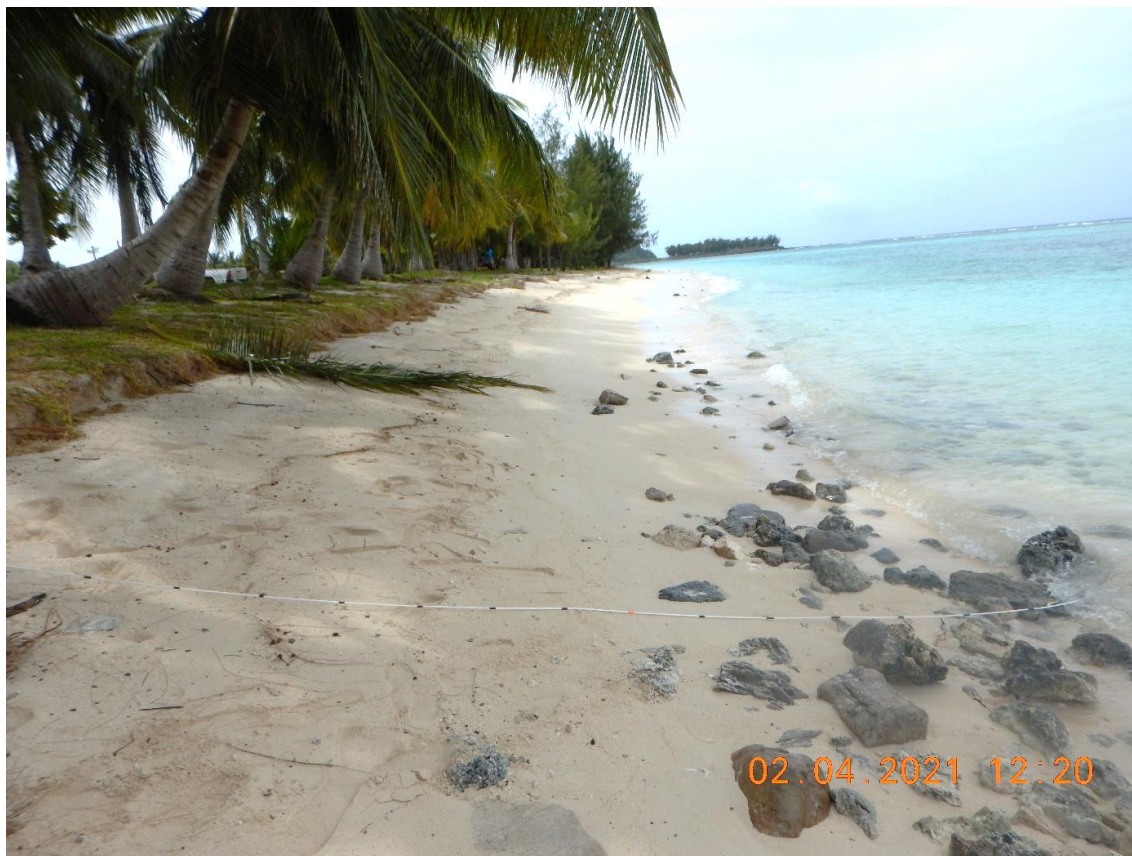
Sansanlagu

Sasanlagu monitoring site is also the popular Songsong beach park. The backshore are grounds for community events, shaded by rows of coconuts. Toward the West Harbor, the backshore vegetation density increases. Sections of the shoreline has been armored as indicated by concrete rubble scattered along with a concrete structure aligned with the line of coconut trees.

Typhoons and tropical disturbances have brought damaging storm surge to shoreline beach strands on the east and west sides of the peninsula boarding Songsong Village. In 2002, Typhoon Pongsona exhibited potential of an 18 to 22 feet surge according to the short proximity of the typhoon eye⁸. The loss of sandy beach to erosion will potentially increase the threat of future storm surge events.

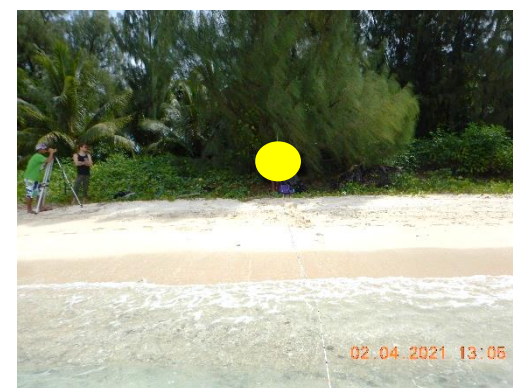
Day Recorded	Tide	Shoreline Length
Mar 14, 2017	0.59 ft	30 ft
Sep 4, 2018	1.28 ft	30 ft
Sep 5, 2019	1.13 ft	49 ft
Feb 4, 2021	Not recorded	24 ft
Average		33.25 ft

Sasanlagu 1 is generally accreting. The shoreline may have been longer in Sep-19 but the slope was steeper. The wrackline ranges from 16 ft to 26 ft. The elevation difference from the headstake to the top of the toe is 7 ft.

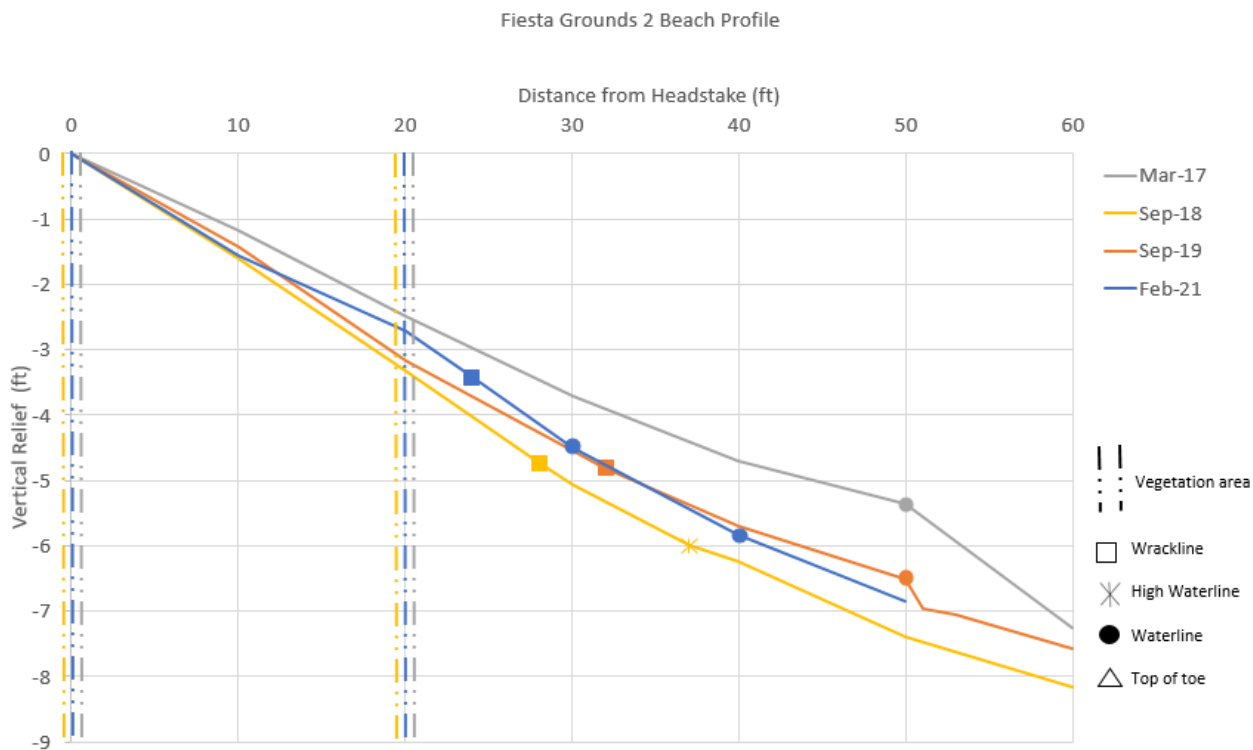
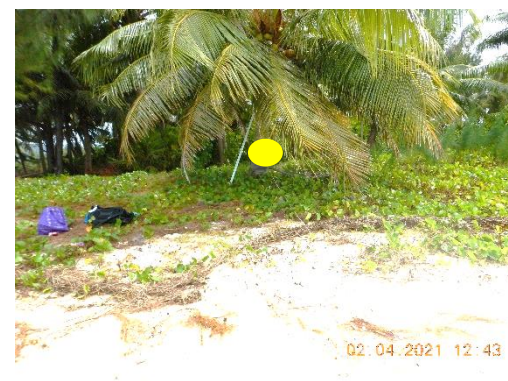
Day Recorded	Tide	Shoreline Length
Mar 14, 2017	0.58 ft	50 ft
Sep 4, 2018	1.58 ft	Not recorded
Sep 5, 2019	1.13 ft	Not recorded
Feb 4, 2021	1.93 ft	30 ft
Average		40 ft

Sasanlagu 2 is generally eroding. The wrackline ranges from 24 ft to 32 ft.

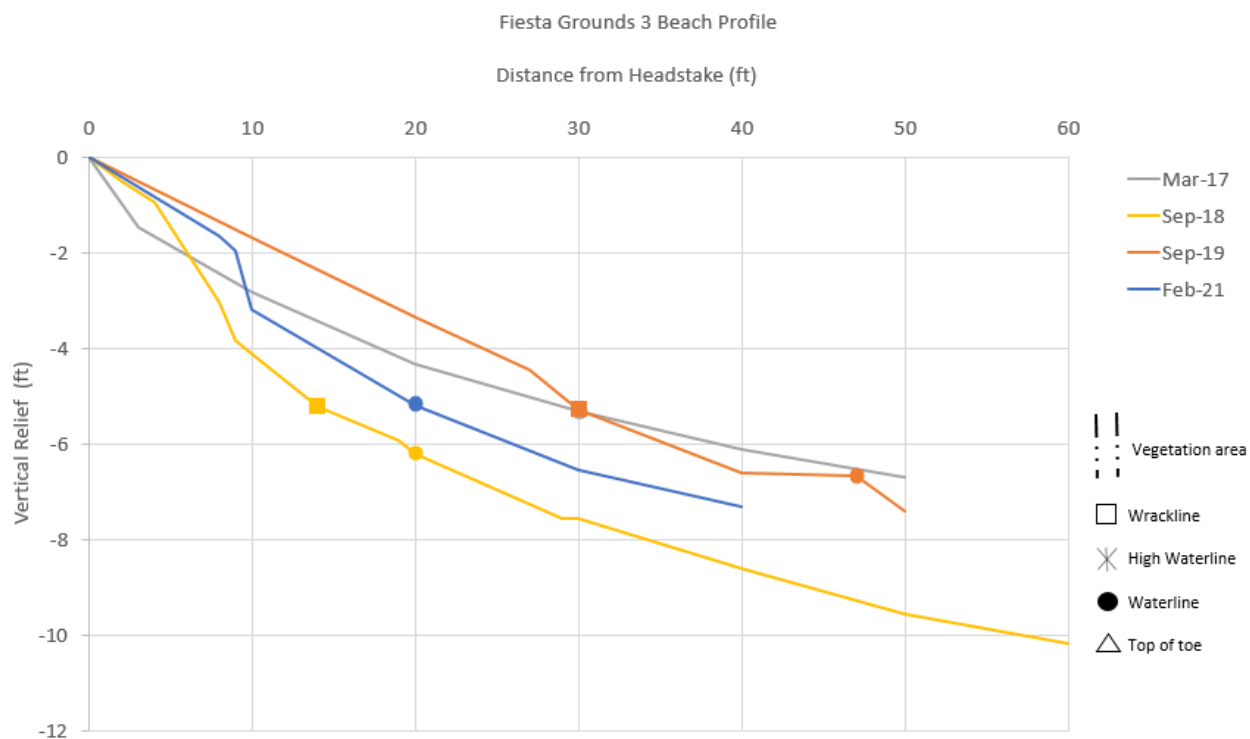
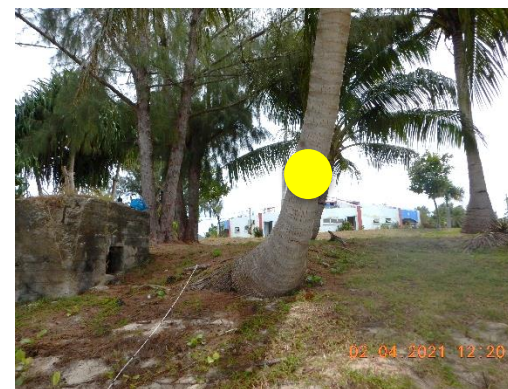
Day Recorded	Tide	Shoreline Length
Mar 13, 2017	0.56 ft	30 ft
Sep 4, 2018	1.58 ft	20 ft
Sep 5, 2019	1.13 ft	47 ft
Feb 4, 2021	1.93 ft	20 ft
Average		29.25 ft

Sasanlagu 3 is eroding but future monitoring could better inform the long term shoreline change rate. Sep-19 indicates accretion from Sep-18. Then erosion between Sep-19 and Feb-21. The wrackline ranges from 14 ft to 30 ft.

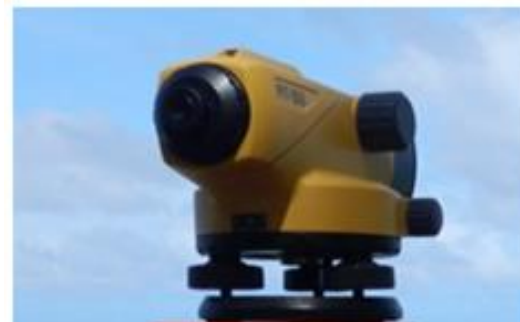
Berger Level

Used to accurately measure the height of an inaccessible object. Takes cross sectional picture of a beach's contour.

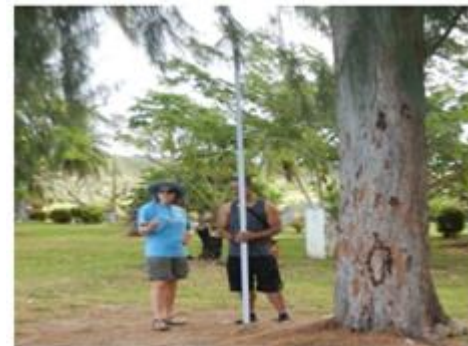
Level Rod

Used with a leveling instrument to determine the difference in height between points.

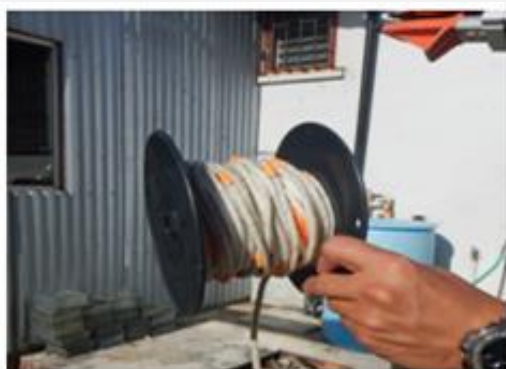
Measuring Rope

100 ft. rope measure is laid along the shore to be profiled.

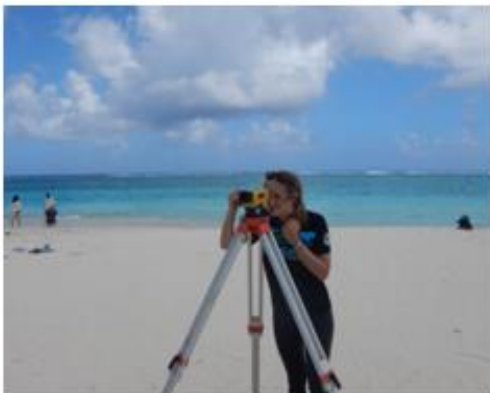
Tripod

Supports or holds the Berger Level.
