SAIPAN SHORELINE ACCESS AND SHORELINE ENHANCEMENT ASSESSMENT (SASEA)

Island of Saipan, Commonwealth of the Northern Mariana Islands

March 2018

Sea Engineering, Inc.
Makai Research Pier
41-305 Kalanianaʻole Hwy
Waimanalo, HI 96795

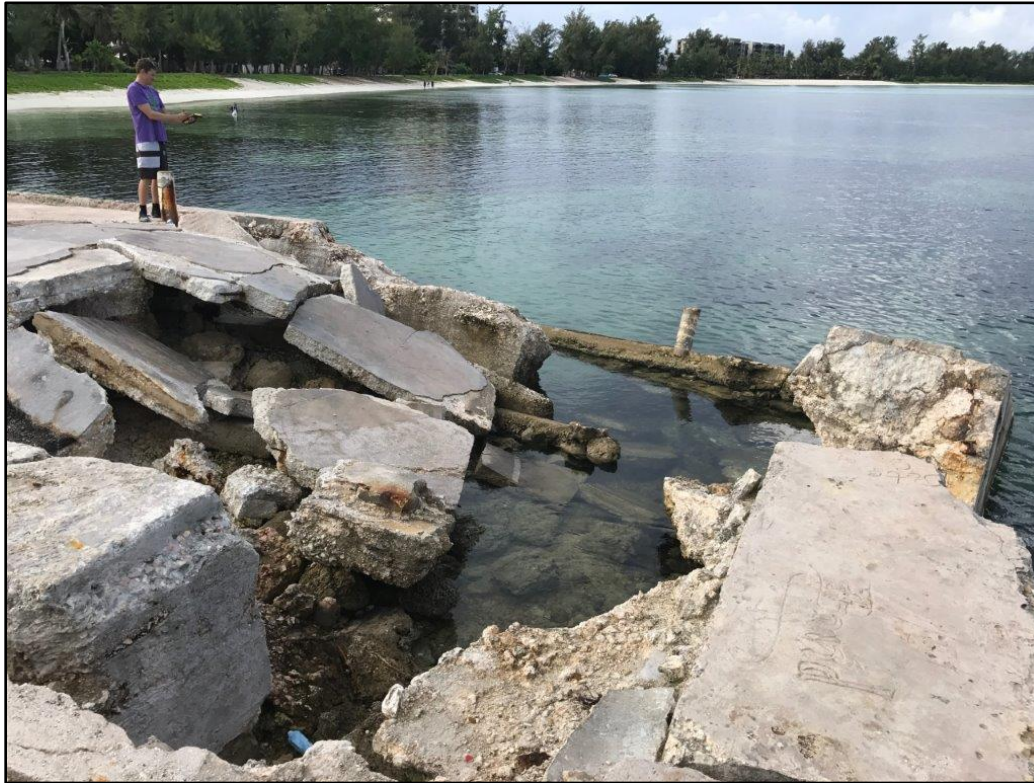
SEI observed several areas where public infrastructure was visibly damaged, particularly at Fishing Base and Sugar Dock (Figure 4). In both cases, the pier docks had sustained significant structural damage, presumably caused by typhoon waves. The damage may compromise the structural integrity of the structures or cause a potential risk to public health and safety.

Figure 4 Structural damage to pier at Sugar Dock

A licensed Structural Engineer should conduct an assessment to identify damage to public infrastructure, particularly at Fishing Base and Sugar Dock. The assessments should include repair recommendations and cost estimates to restore the structural integrity of the structures. It is important to engage a licensed Structural Engineer in the design phase to ensure that the design is structurally sufficient and the appropriate means, methods, and materials are used. Structural repairs could be prioritized to address public health and safety issues, economic impacts (e.g., loss of fishery or tourism revenues), environmental impacts, or aesthetic impacts.

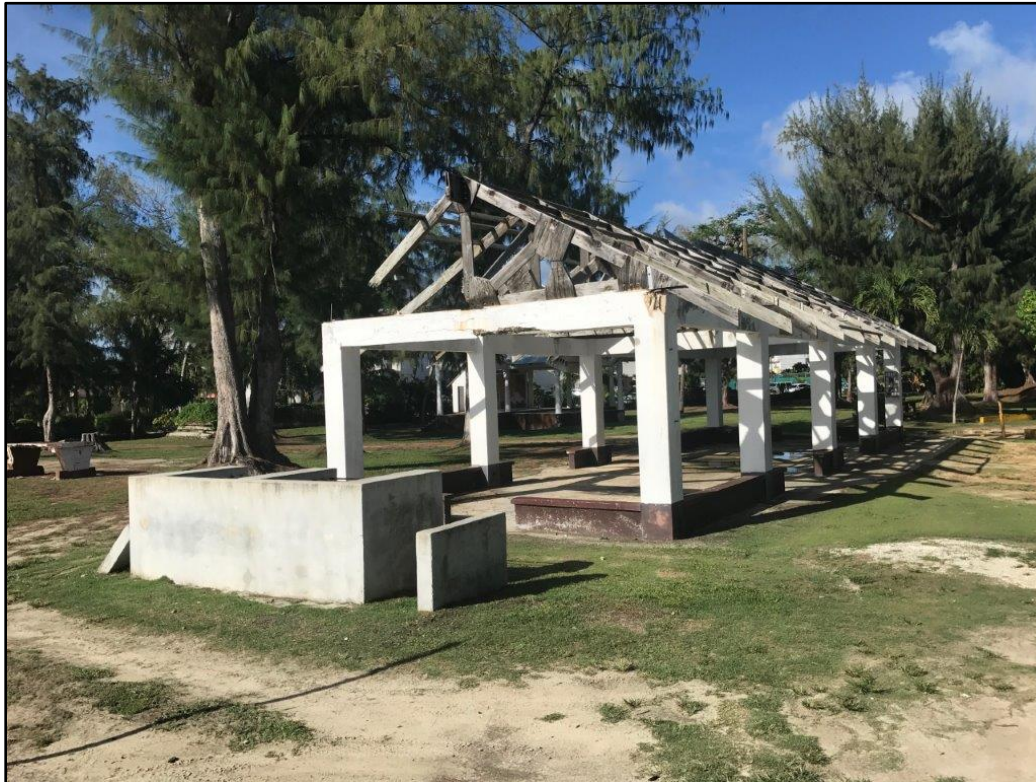
Amenities are an important part of the user experience at Saipan's beaches and parks. Access to basic amenities, such as trash/recycling receptacles and public restrooms, is necessary to maintain the environmental and aesthetic quality of beaches and parks. The public amenities at many beaches were in a deteriorated state and, in some cases, were completely unusable. Recreational amenities such as palapalas, picnic tables, benches, and grills/fire pits were in very poor condition, particularly at Laly 4 (San Isidro Beach Park), Sugar Dock Beach, Susupe Beach Park (Figure 5), Micro Beach, and Tanapag Beach and Boat Ramp.

Figure 5 Structural damage to palapala at Susupe Beach Park

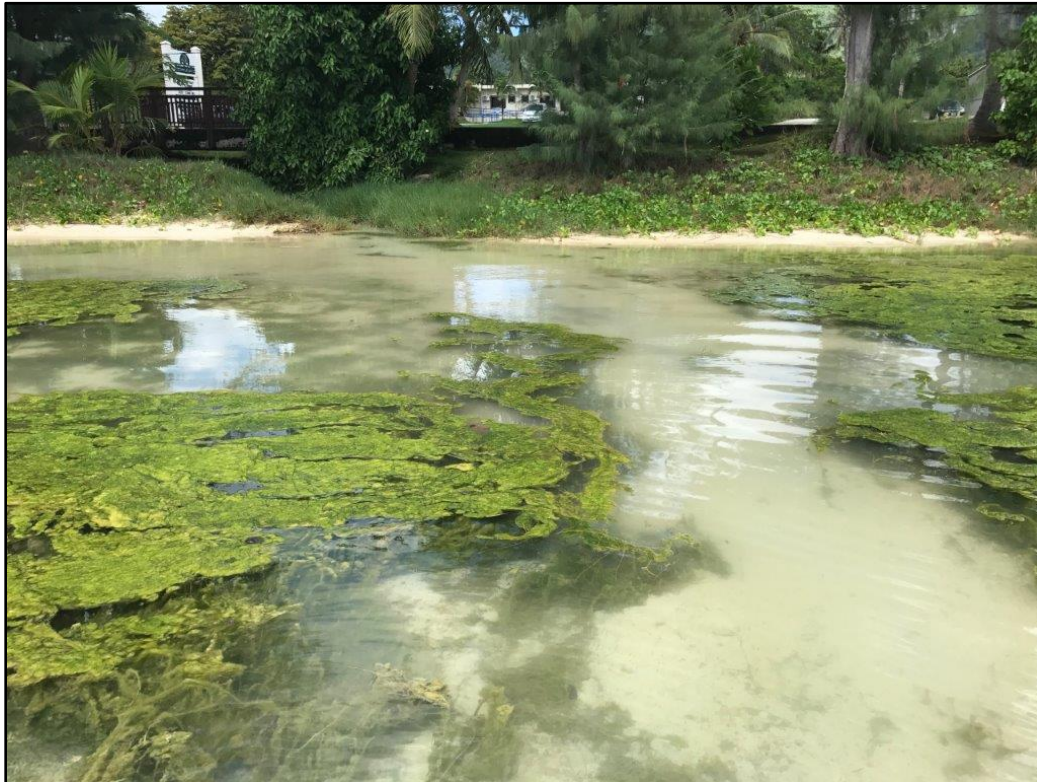
Drainage impacts were observed at many of the beaches included in this assessment. Drainage types included culverts, streams, and swales formed by surface water runoff. Erosion and beach deflation were observed in areas where beach berms were bisected by drainages and surface water runoff from impervious surfaces (e.g., parking lots). Some drainages appeared to impact nearshore water quality. Algal blooms were observed at Sugar Dock Beach, Quartermaster Area (Red Beach), Beach Road Pathway (Figure 6), Makaka Beach, Fiesta Beach, Hyatt Beach, Micro Beach, and American Memorial Park.

Figure 6 Drainage impacting berm and water quality at Beach Road Pathway

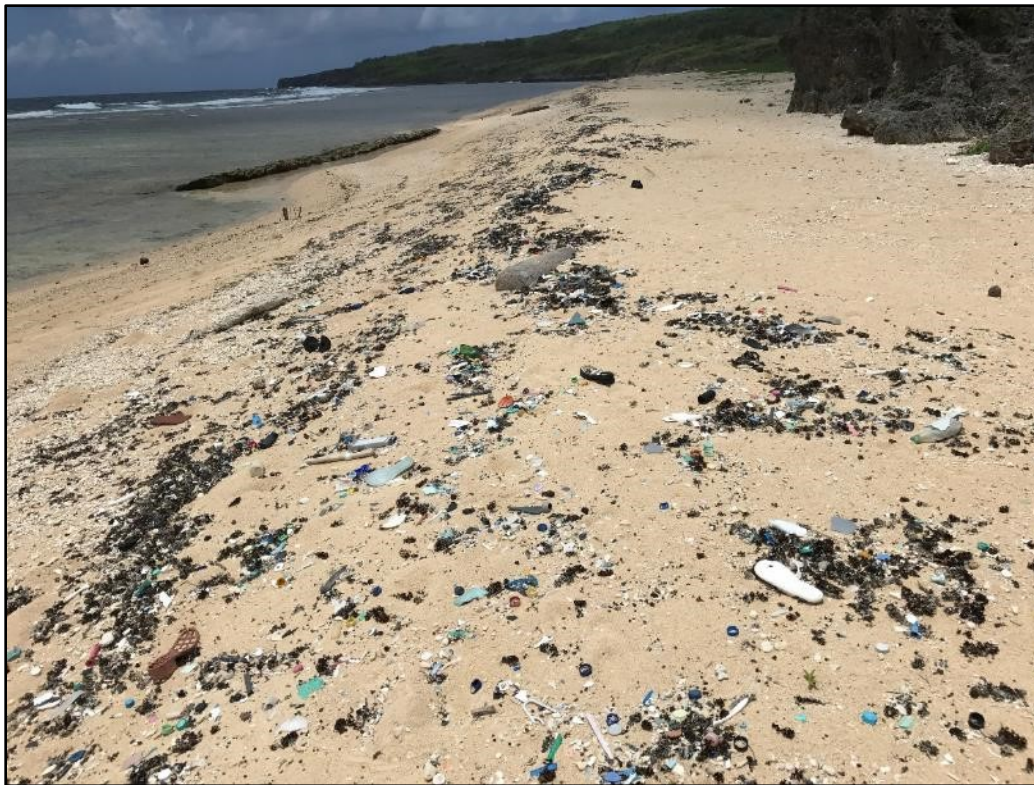
Marine debris is commonly found on beaches in the Pacific Islands. Common types of marine debris include plastics, metals, rubber, paper, textiles, and derelict fishing gear. Shorelines along the windward (east) coast of Saipan are particularly prone to the accumulation of marine debris due to their exposure to the prevailing tradewinds. SEI observed significant amounts of marine debris along the beaches at Jeffrey's Beach and Tank Beach (Figure 7).

Figure 7 Extensive marine debris on active beach at Tank Beach

The NOAA Marine Debris Program administers a grant program to support community-based marine debris removal projects. In 2015, the Micronesia Islands Nature Alliance received grant funding from NOAA to reduce littering and illegal dumping in Saipan by providing infrastructure for proper waste management, and conduct education and outreach to raise awareness about littering and marine debris. The NOAA Marine Debris Program has also funded non-profit organizations, such as Sustainable Coastlines Hawaii, to host beach cleanups and conduct educational programs in schools, businesses, government agencies, and community groups. Reducing the amount of marine debris along Saipan's shorelines would improve environmental quality and the overall visitor experience.

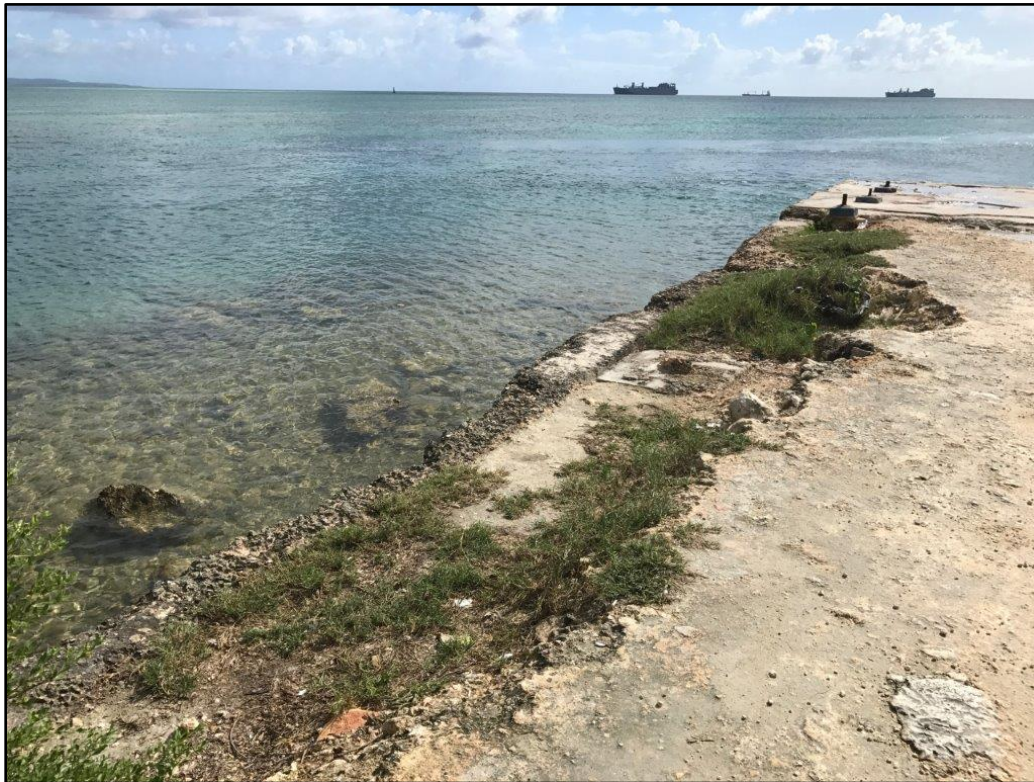
The seawalls surrounding Fishing Base pier are substantially damaged (Figure 9). Structural repairs to the pier are recommended for public health and safety reasons. Given the nearshore dredging and the filled backshore, Fishing Base does not appear to be a good candidate for a soft solution, such as beach nourishment. Beach nourishment could be successful in areas where a natural beach had previously formed; however, it is unlikely to be successful along this type of filled shoreline. Stabilizing structures, such as groins, might improve the stability of a beach nourishment project; however, the groins would likely extend into the deeper dredged area and could negatively affect boat traffic. A riprap or rubblemound revetment might be the most effective stabilizing structure along the Fishing Base shoreline. The revetment would fix the shoreline in place and protect the backshore from erosion threats, without affecting use of the pier and boat ramp.

Figure 9 Structural damage to pier at Fishing Base

- Perform a damage assessment and prioritize repairs to Fishing Base.
- Evaluate options for shore protection at Fishing Base.

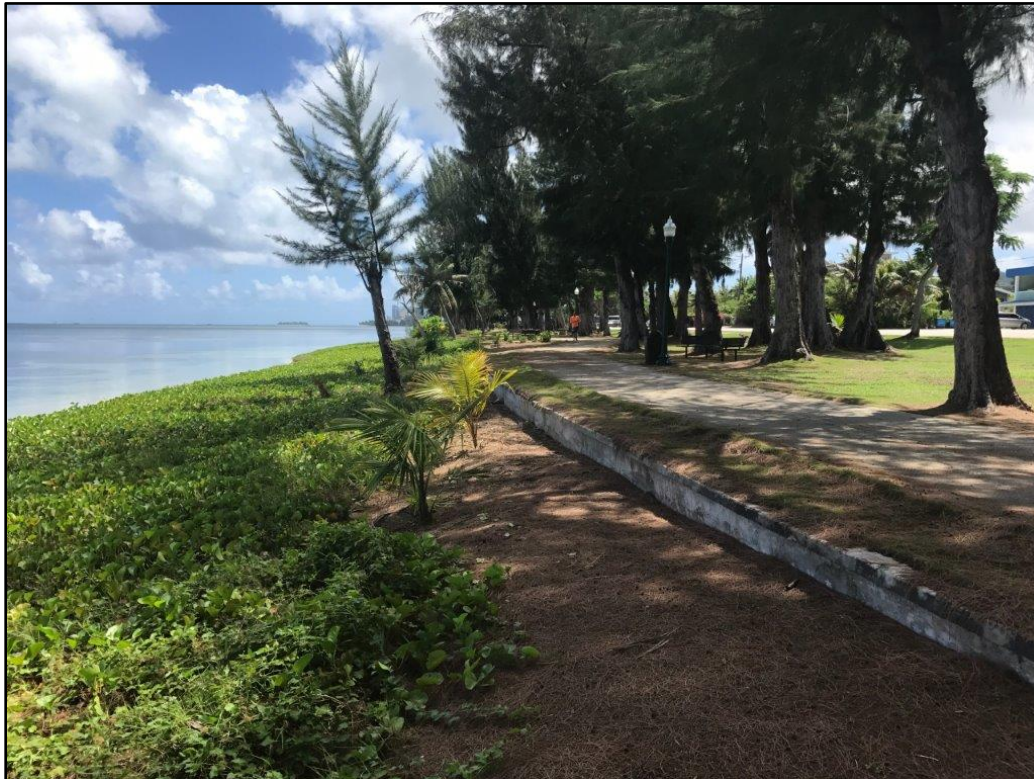
Quartermaster Area (Red Beach) and Beach Road Pathway together cover 850 m of shoreline along the western side of Beach Road, which is a heavily-utilized coastal road and the main thoroughfare between Garapan and the airport. A coastal path provides lateral access along the entire shoreline. While the coastal path and Beach Road are not presently threatened by erosion, rising sea levels and the frequency of typhoons could quickly degrade this shoreline. The importance of the coastal path and Beach Road resulted in these areas having *high* EHPRs.

Figure 10 Concrete coastal path at Quartermaster Area (Red Beach)

An appropriate erosion mitigation strategy for this area might be a buried seawall, sometimes referred to as a “backstop”, to protect the coastal path and maintain a protective buffer between the shoreline and Beach Road. The backstop would only become exposed during episodic erosion events, and it would then function as a seawall, protecting the backshore from further erosion. A revetment could also be used as a backstop; however, a revetment would have a much larger footprint than a buried seawall. Beach nourishment accompanied by sand stabilization structures (e.g., groins) to minimize sand movement would be an effective means for protecting the beach resource and the backshore land and infrastructure. A series of groin structures accompanied by beach fill would likely create a series of stable beach cells along this shoreline.

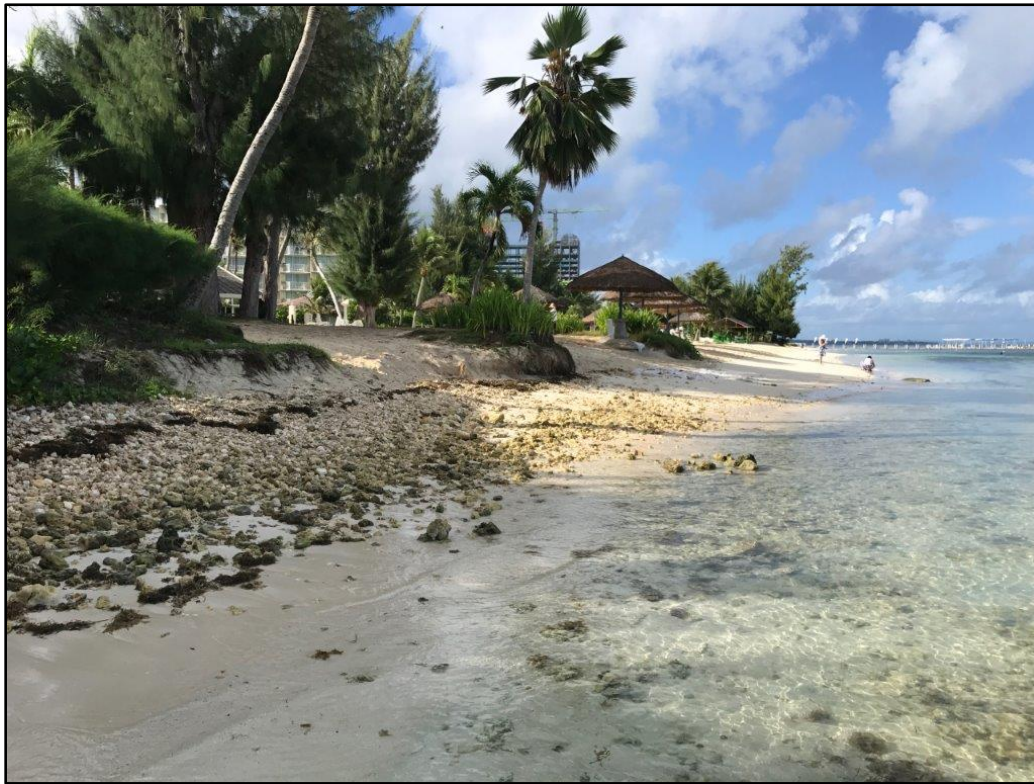
Fiesta Beach and Hyatt Beach received *high* EHPRs, primarily due to limited reef width, evidence of erosion, low backshore elevation, high-intensity development in the backshore area, popularity and use intensity in the area, and potential impacts of erosion on shoreline access. The backshore area consisted of a relatively flat area with sparse, low-lying vegetation. There was evidence of active erosion along shoreline, particularly at north and south ends of Hyatt Beach (Figure 11). The beach fronting both resorts had been cleared of vegetation (Figure 12). Vegetation clearing and grading of the beach berm exposes the backshore to increased risk of wave overtopping and flooding.

Figure 11 Erosion and beach narrowing at the north end of Hyatt Beach

- Evaluate options for berm enhancement, beach maintenance, and beach nourishment.
- Restore and maintain shoreline vegetation.

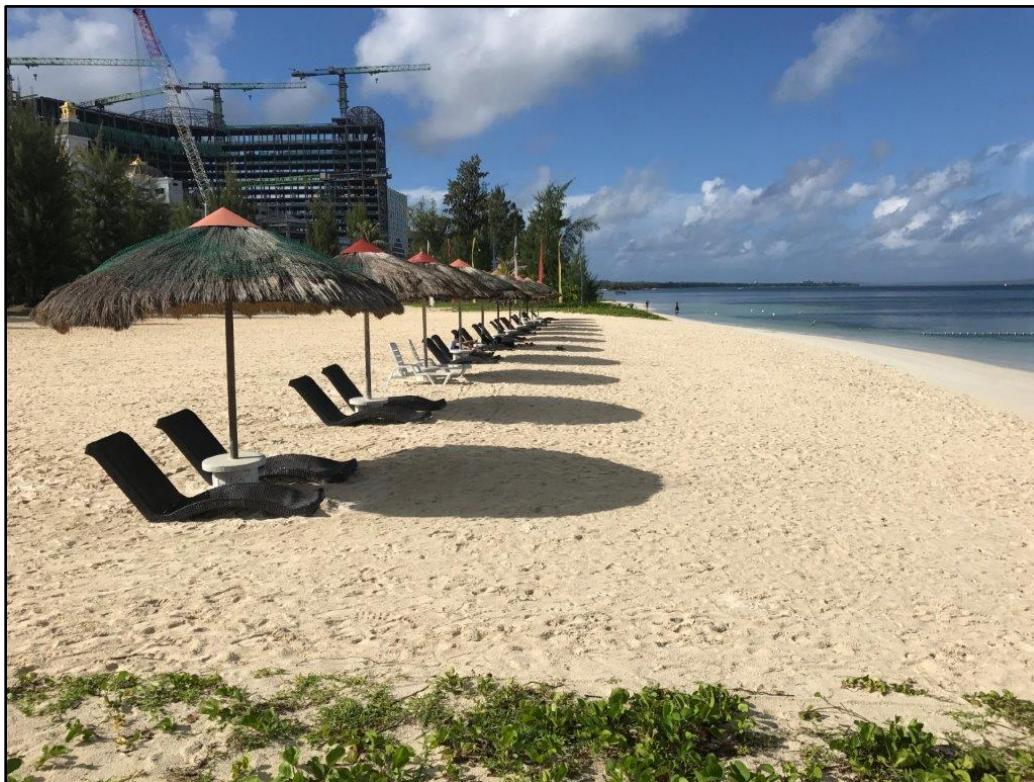
Figure 12 Active beach cleared of vegetation at Fiesta Beach

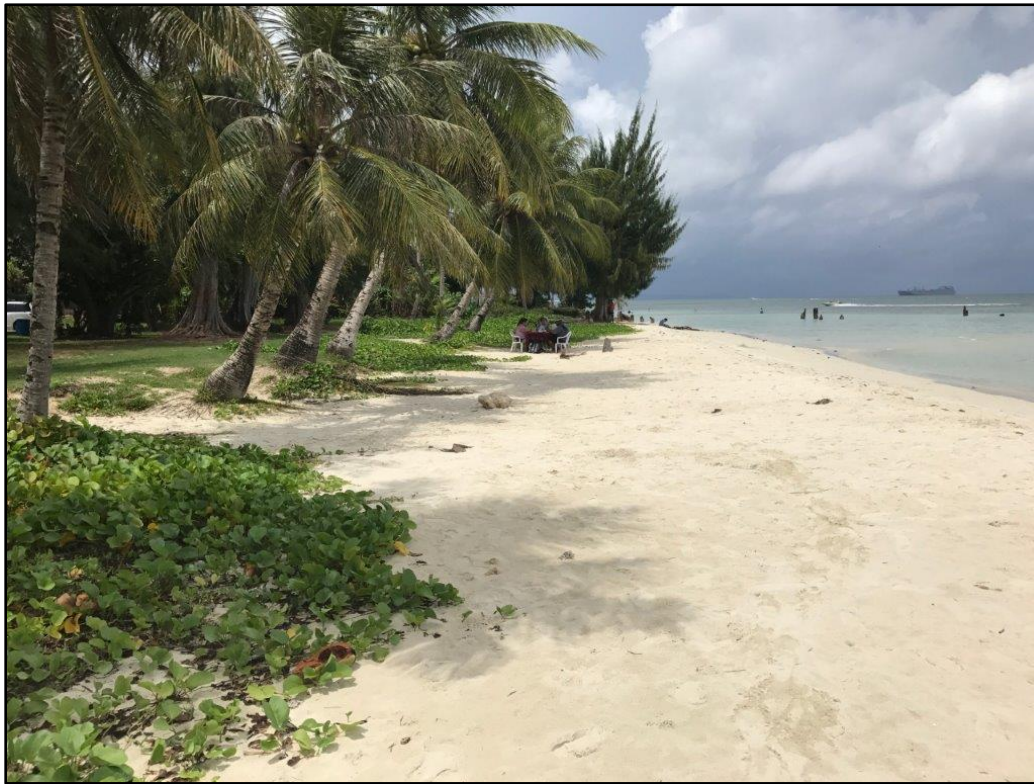
Micro Beach is vulnerable to erosion but received a *medium* EHPR, primarily due to the lack of development in the backshore area; however, Micro Beach can be included in this discussion since it is adjacent to Hyatt Beach, is part of a continuous beach system, and has a history of episodic erosion. In August-September 2017, a combination of typhoon waves and high tides caused severe erosion at Micro Beach. The condition of Micro Beach before and after the recent erosion event are shown in Figure 13 and Figure 14. Micro Beach may have the capacity for natural recovery through accretion but, given the history of episodic erosion, may be a good candidate for proactive erosion management.

Figure 13 Condition of Micro Bach prior to recent erosion event (July 2017)

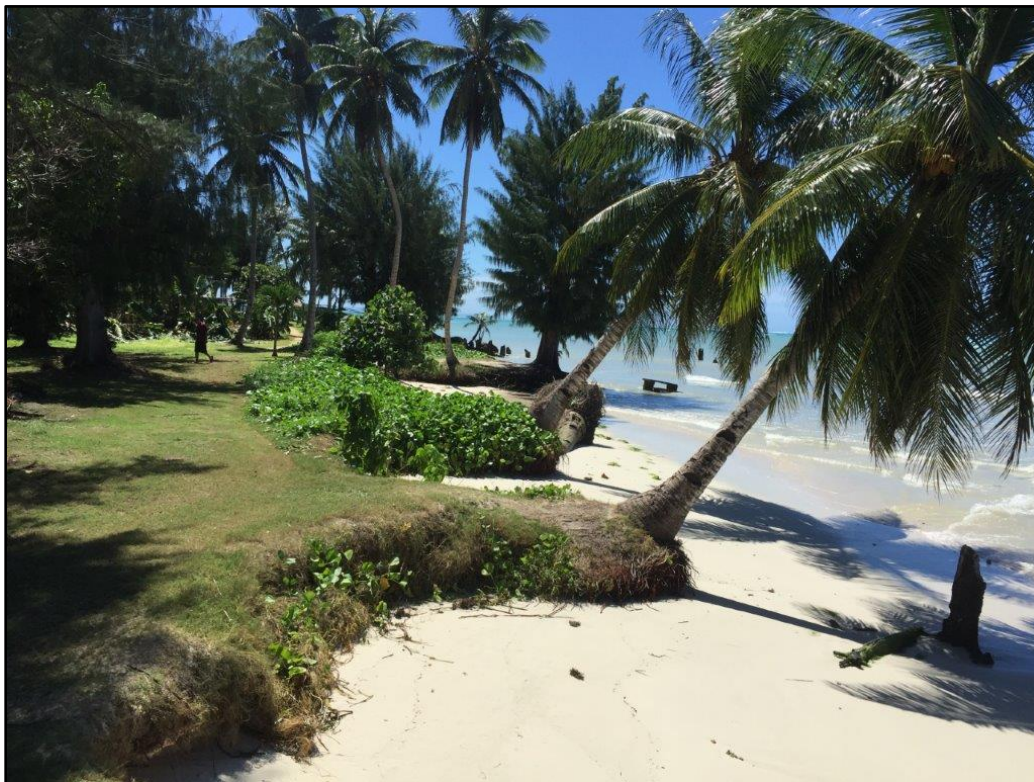
Figure 14 Condition of Micro Bach after recent erosion event (October 2017)

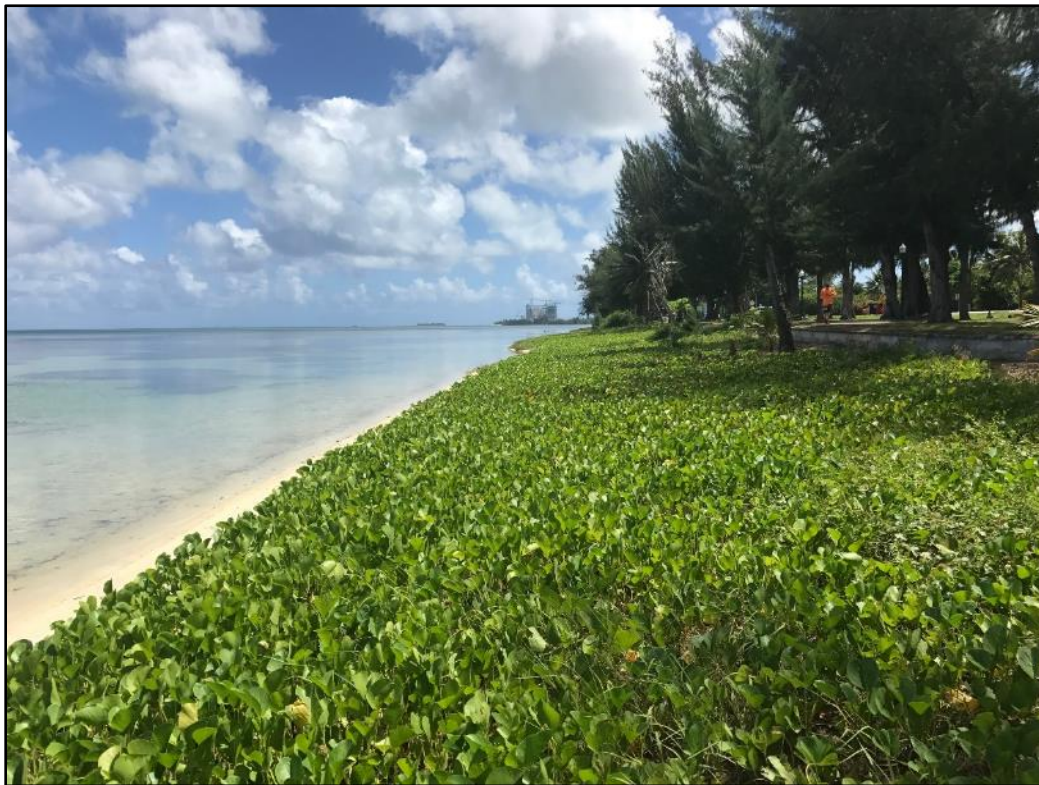
In some cases, prolific vegetation growth can negatively impact the scenic and recreational value of a beach. This was particularly evident at Laly 4 (San Isidro Beach Park), Beach Road Pathway, and Quartermaster Area (Red Beach) (Figure 17). In some areas, the entire beach was covered by encroaching vegetation and beach users were forced to wade through the water to move laterally along the shoreline. The State of Hawaii adopted a law establishing a “beach transit corridor” to protect the right of transit seaward of the shoreline. The law authorizes the State to require abutting landowners to remove vegetation that interferes or encroaches within beach transit corridors. The law is discretionary, which provides the State with flexibility in terms of enforcement. A similar law may be appropriate for Saipan.

Figure 17 Encroaching shoreline vegetation at Quartermaster Area (Red Beach)

The benefits of maintaining healthy vegetation along the shoreline should be balanced with the need to maintain high-quality beaches and safe lateral access along the shoreline. Removal of vegetation should not be permitted in areas where the removal would negatively impact the beach or expose the backshore area to inundation or erosion; however, a reasonable amount of vegetation removal and/or maintenance should be permitted in order to maintain recreational beach areas and enhance lateral shoreline public access.

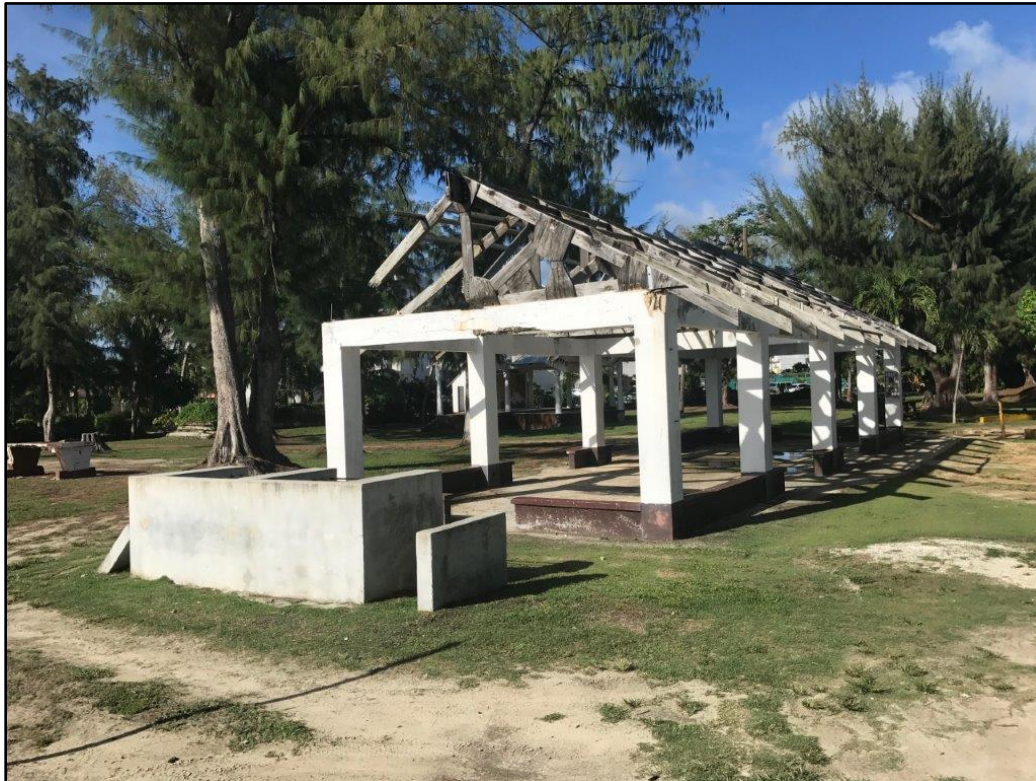
Laly 4 (San Isidro Beach Park), Sugar Dock Beach, Susupe Beach Park (Figure 20), Micro Beach, and Tanapag Beach and Boat Ramp. Trash/recycling receptacles were only observed at half of the beaches. Public restrooms were even less common, and restrooms at Laly 4 (San Isidro Beach Park), Susupe Beach Park, Kilili Beach (Civic Center), and Pau Pau Beach were closed due to structural damage. Only one functional restroom was observed at American Memorial Park. Portable restrooms were available at Fishing Base and Pau Pau Beach. Portable restrooms were observed at Laly 4 (San Isidro Beach Park), Fishing Base, and Pau Pau Beach.

Figure 20 Structural damage to palapala at Susupe Beach Park

Recommendation I(i): Assess damage and prioritize improvements to damaged amenities.

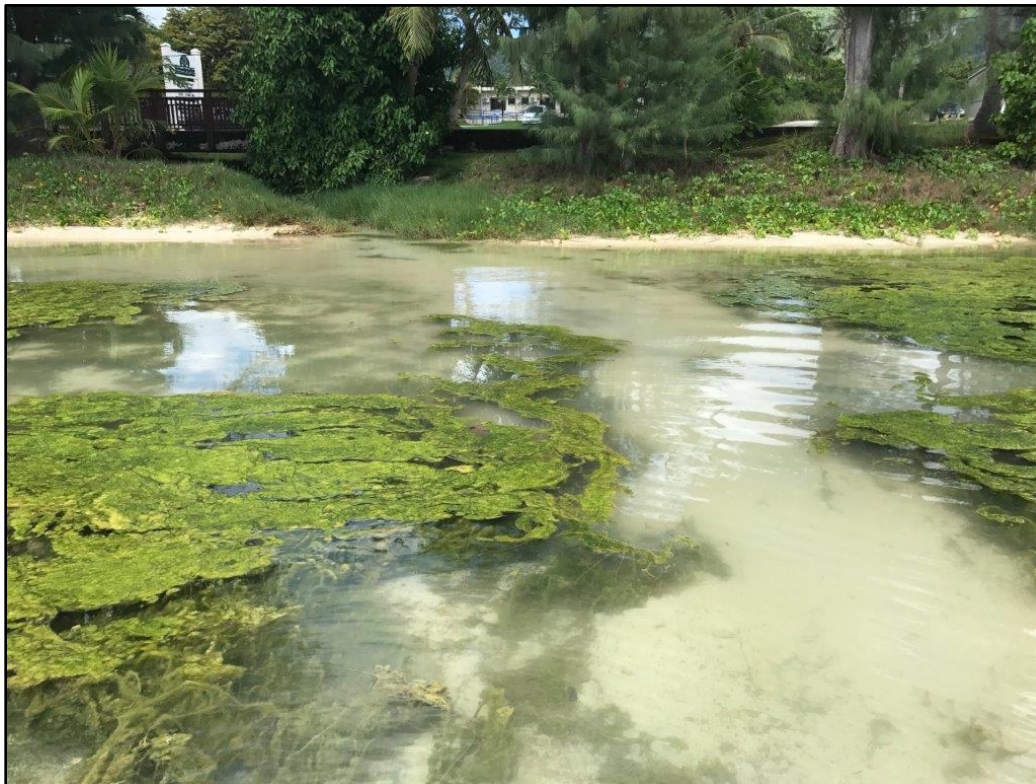
Drainage issues were identified at many of the beaches included in this assessment. Drainage types included culverts, stream mouths, and swales formed by surface water runoff. Erosion and beach deflation was observed in areas where beach berms were bisected by drainages and surface water runoff from impervious surfaces (e.g., parking lots). Some drainages appeared to impact nearshore water quality. Algal blooms were observed at Quartermaster Area (Red Beach) and Beach Road Pathway (Figure 21), and water quality appeared to be visually impaired within the Talofofo Stream drainage at Jeffrey's Beach. Algal blooms were also observed at Makaka Beach, Fiesta Beach, Hyatt Beach, Micro Beach, and American Memorial Park

Figure 21 Drainage impacting berm and water quality at Beach Road Pathway

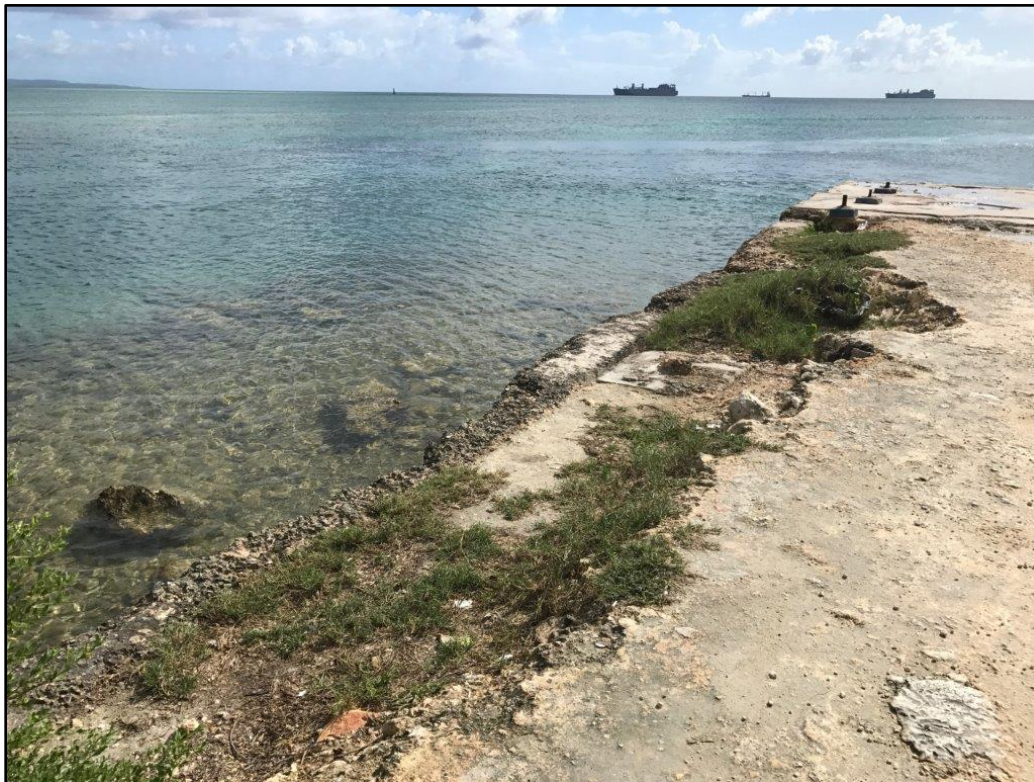
The primary facilities at Fishing Base are a pier and a boat ramp which are managed by the Department of Lands and Natural Resources. A number of relict structural features remain along the shoreline, including seawalls, piles, concrete and rock rubble, and metal debris. The shoreline, which is composed primarily of fill material, appears to have limited recreational value, with the exception of the pier and boat ramp. No sand was noted along the shoreline, and dredging around the pier and along the shoreline was apparent. The seawalls surrounding Fishing Base pier are substantially damaged (Figure 25). Structural repairs to the pier are recommended for public health and safety reasons.

Figure 25 Structural damage to pier at Fishing Base

- Perform a damage assessment and prioritize repairs to Fishing Base.
- Evaluate options for shore protection at Fishing Base.

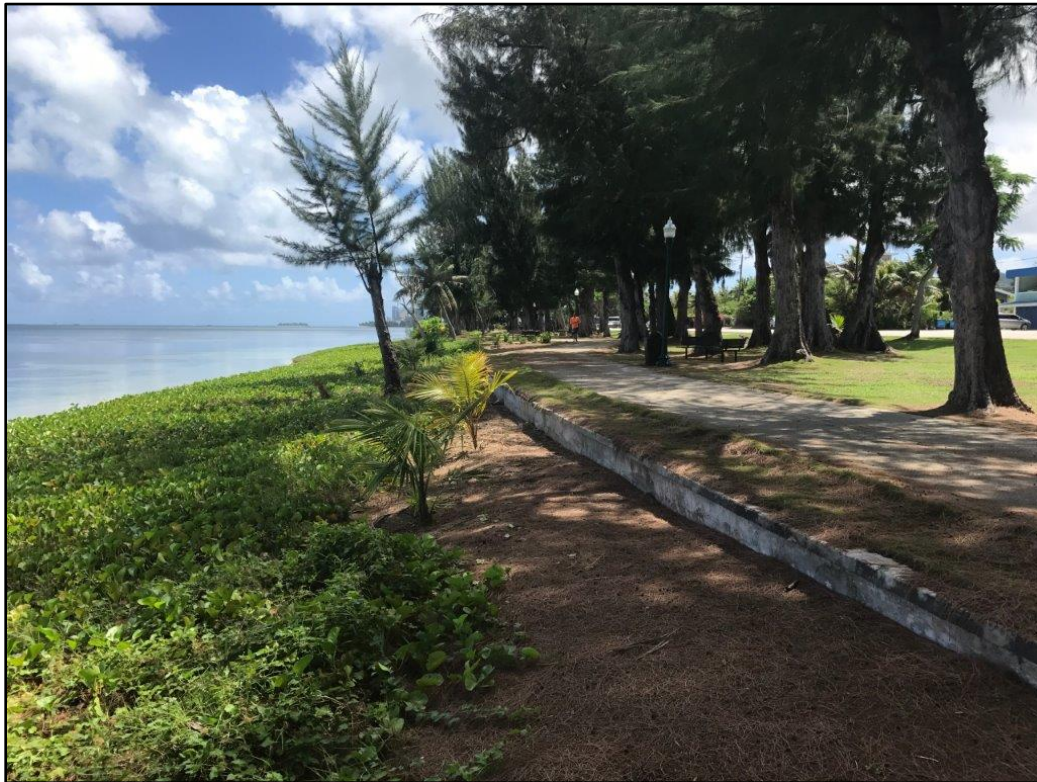
Figure 26 Concrete coastal path at Quatermaster Area (Red Beach)

- Evaluate options for beach nourishment with stabilizing structures (e.g., groins).
- Evaluate options for permanent shore protection (e.g., seawall or revetment).

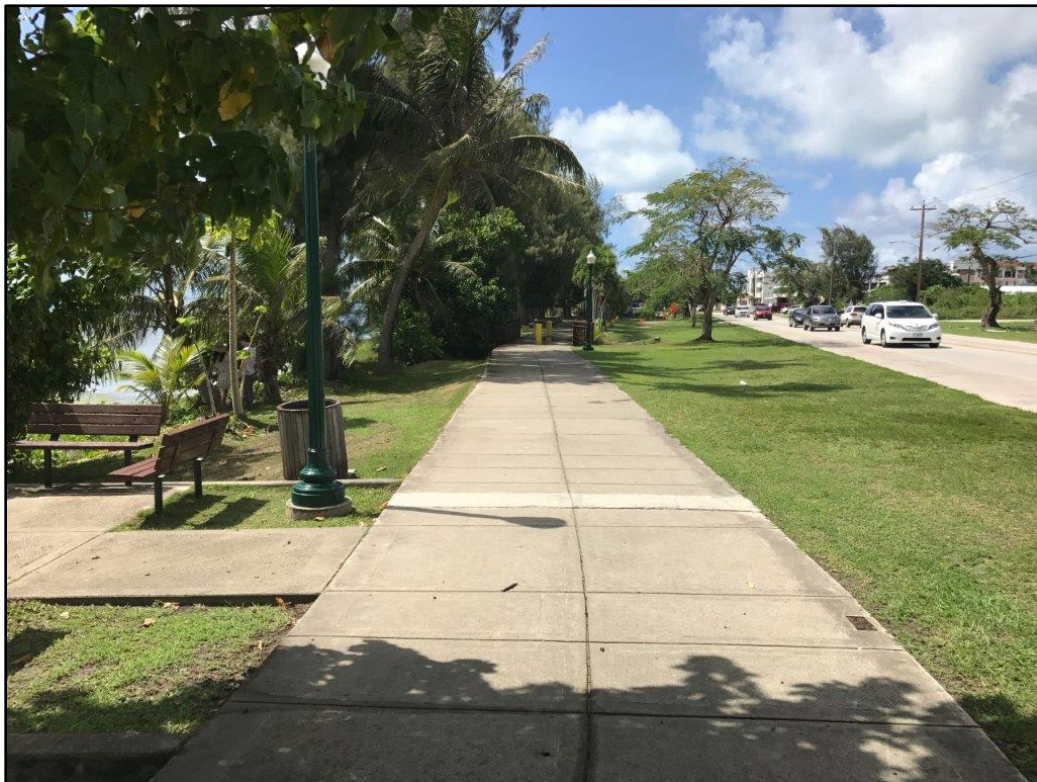
Figure 27 Proximity of Beach Road and Beach Road Pathway to shoreline

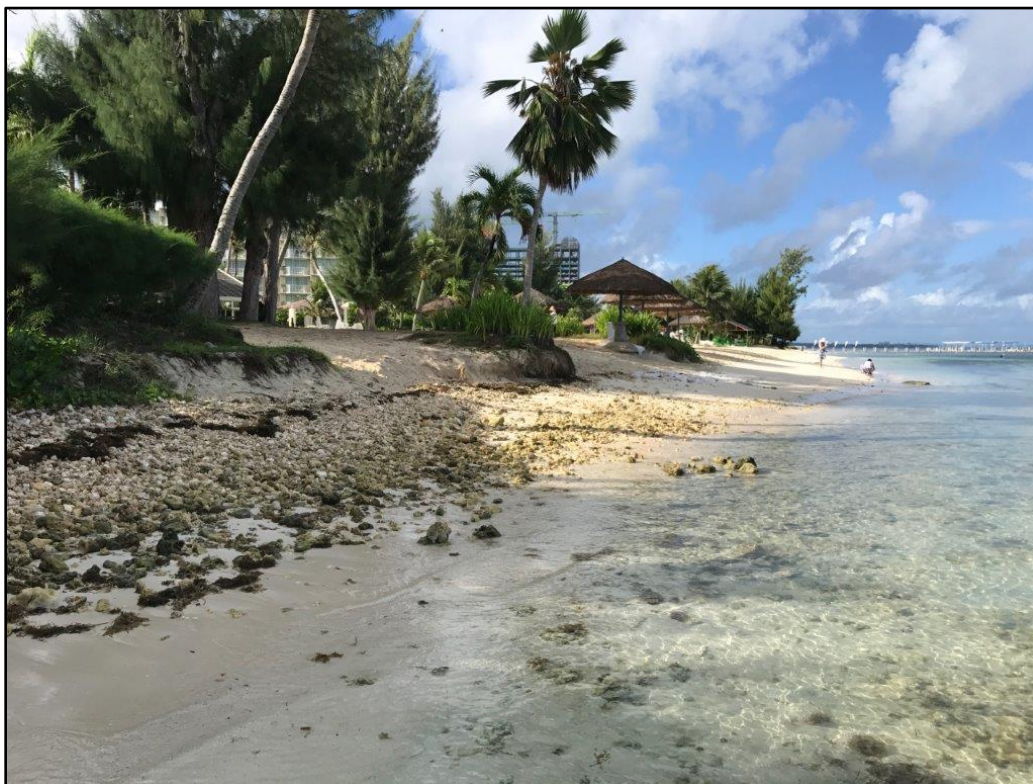
Figure 28 Erosion and beach narrowing at the north end of Hyatt Beach

- Evaluate options for berm enhancement, beach maintenance, and beach nourishment.
- Restore and maintain shoreline vegetation.

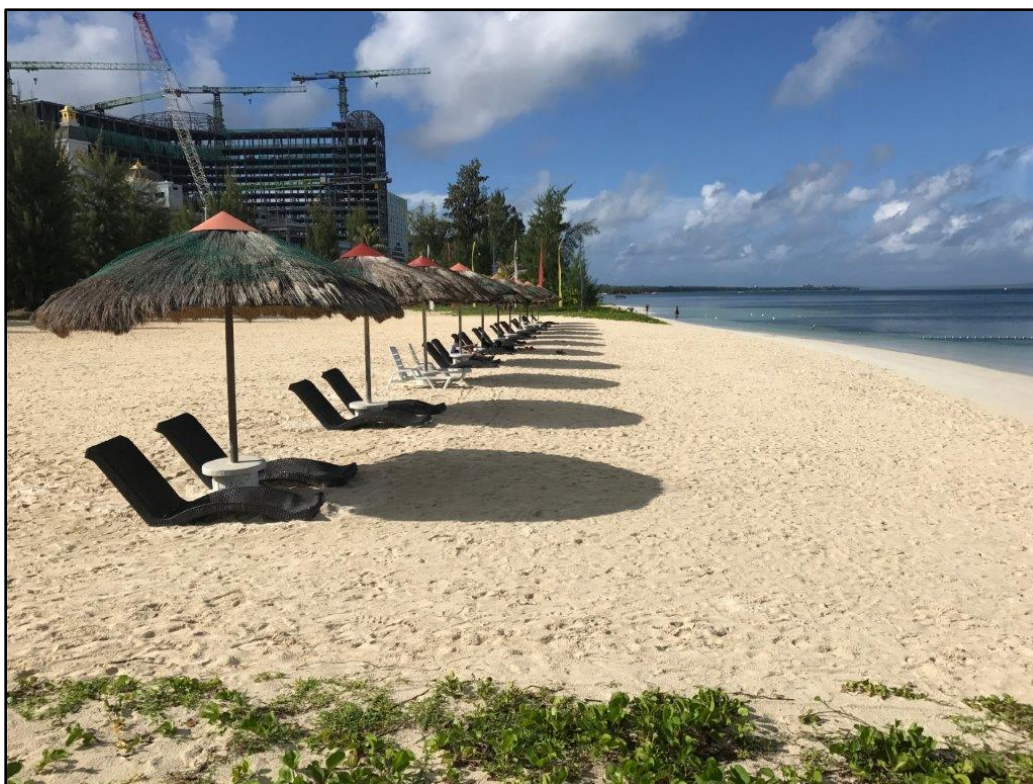
Figure 29 Active beach cleared of vegetation at Fiesta Beach

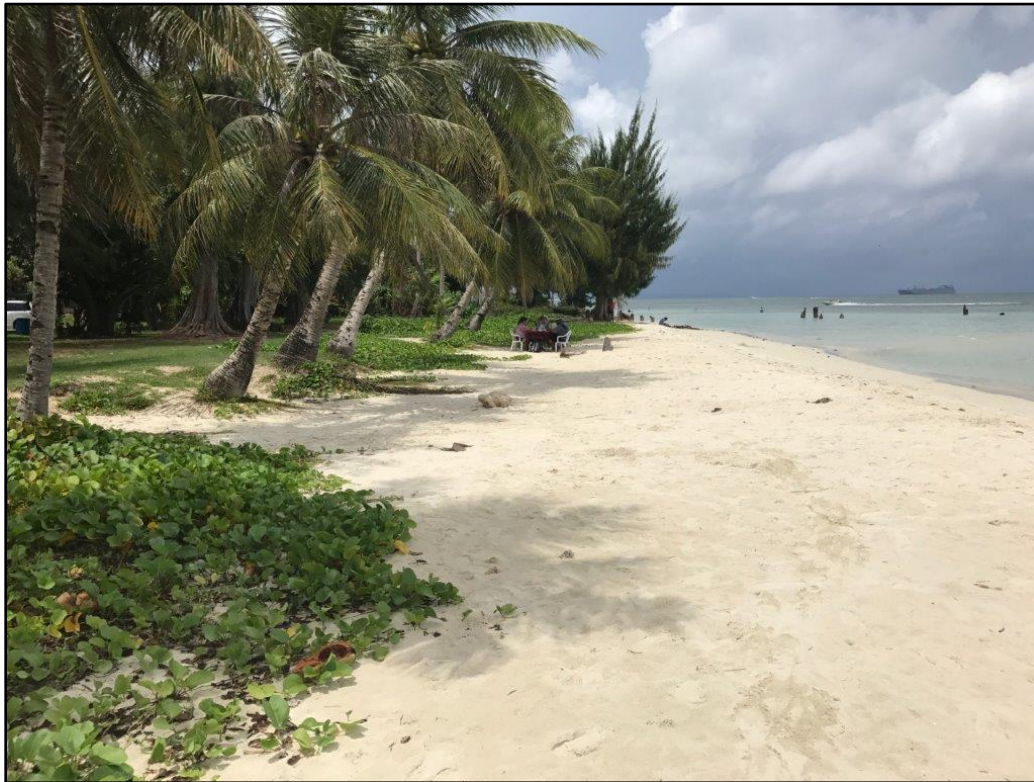
Figure 30 Condition of Micro Bach prior to recent erosion event (July 2017)

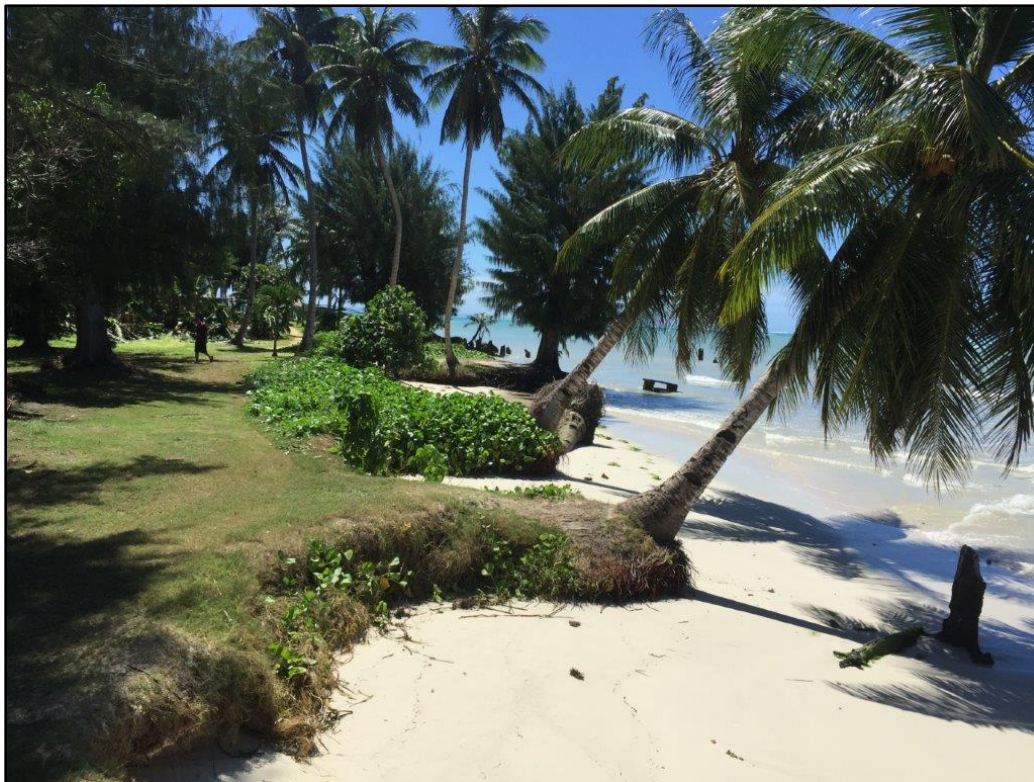
Micro Beach is vulnerable to erosion but received a *medium* EHPR, primarily due to the lack of development in the backshore area; however, Micro Beach can be included in this discussion since it is adjacent to Hyatt Beach, is part of a continuous beach system, and has a history of episodic erosion. In August-September 2017, a combination of typhoon waves and high tides caused severe erosion at Micro Beach. The condition of Micro Beach before and after the recent erosion event are shown in Figure 30 and Figure 31. Micro Beach may have the capacity for natural recovery through accretion but, given the history of episodic erosion, may be a good candidate for proactive erosion management.

Figure 31 Condition of Micro Bach after recent erosion event (October 2017)

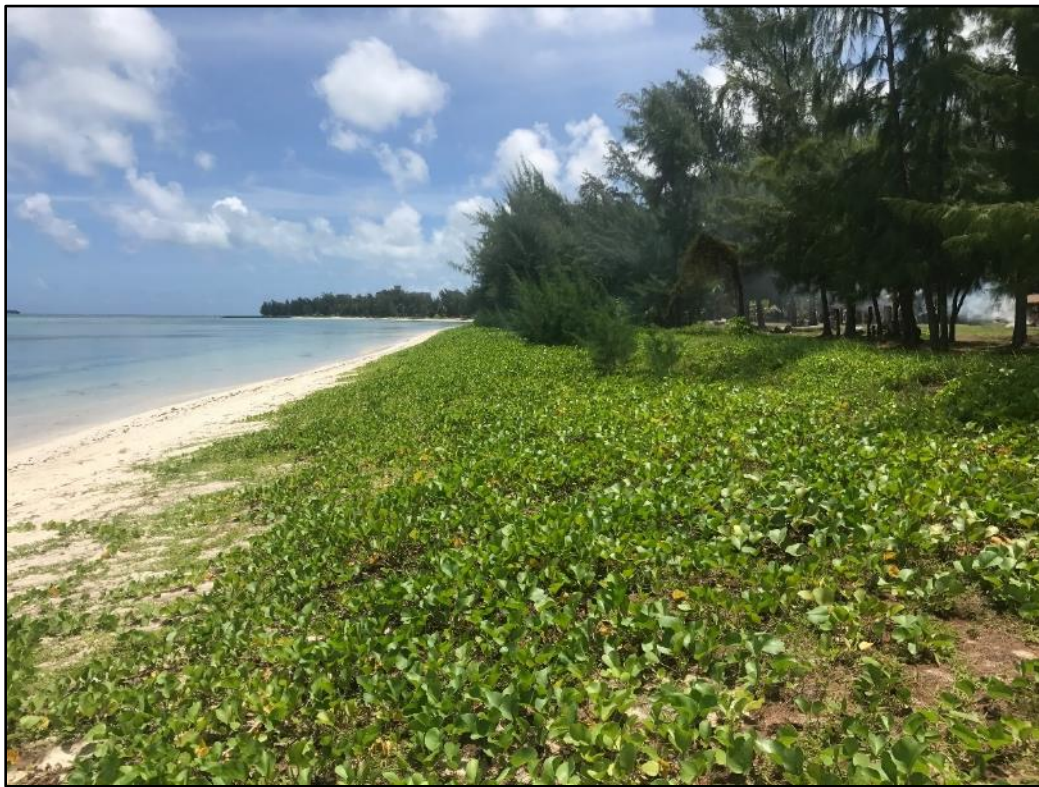
Figure 5 Laly 4 (San Isidro Beach Park), transient vegetation on active beach face (6/30/2017)

- Increase enforcement capacity and education to reduce driving and parking on berms.
- Identify and prioritize improvements to public amenities.
- Manage shoreline vegetation to increase available beach area.
- Install and maintain trash/recycling receptacles.
- Repair and maintain public restrooms.

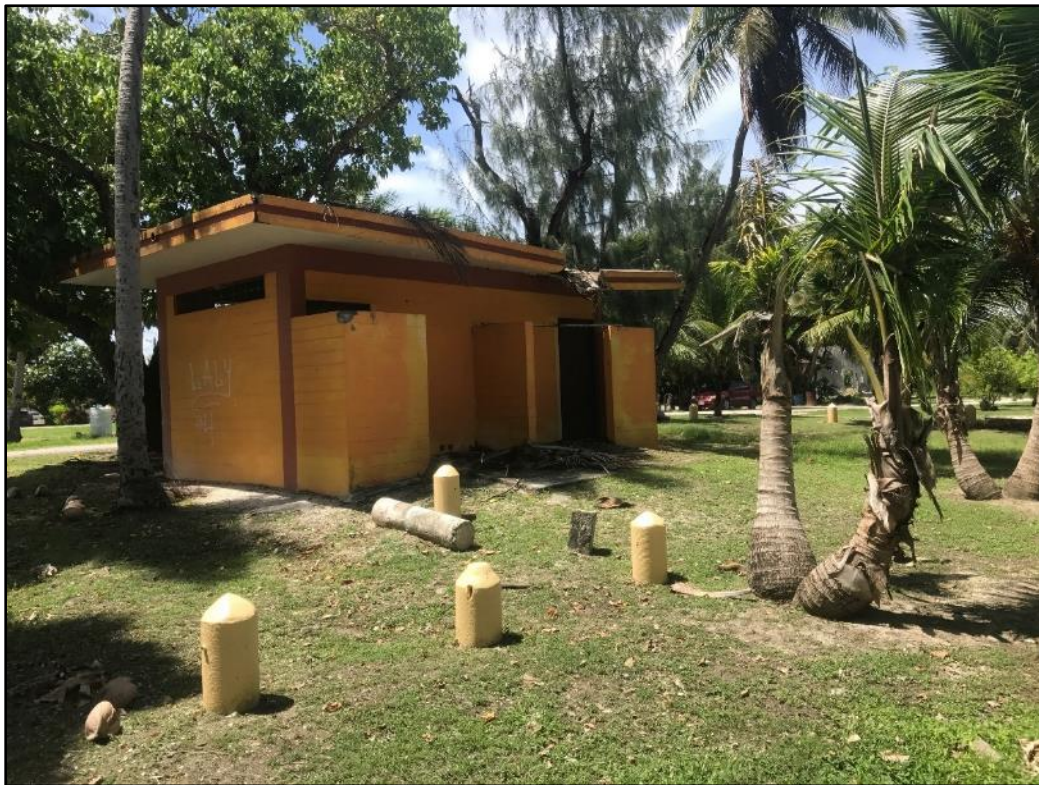
The grassy backshore area appeared to be well-maintained. Many of the structures (e.g., palapalas, grills, benches, etc.) were in a deteriorated condition. There was only one public restroom within the park, but it was closed due to apparent structural damage (Figure 11). There were no trash or recycling receptacles observed within the park. There was no evidence of erosion. The only issue that negatively affected the quality and condition of the beach was the extensive amount of transient vegetation encroaching over the active beach face. While this signifies a healthy, accreting beach, the encroaching vegetation significantly reduced the amount of sandy beach area available for public use.

Figure 10 Laly 4 (San Isidro Beach Park), closed public restroom (6/30/2017)

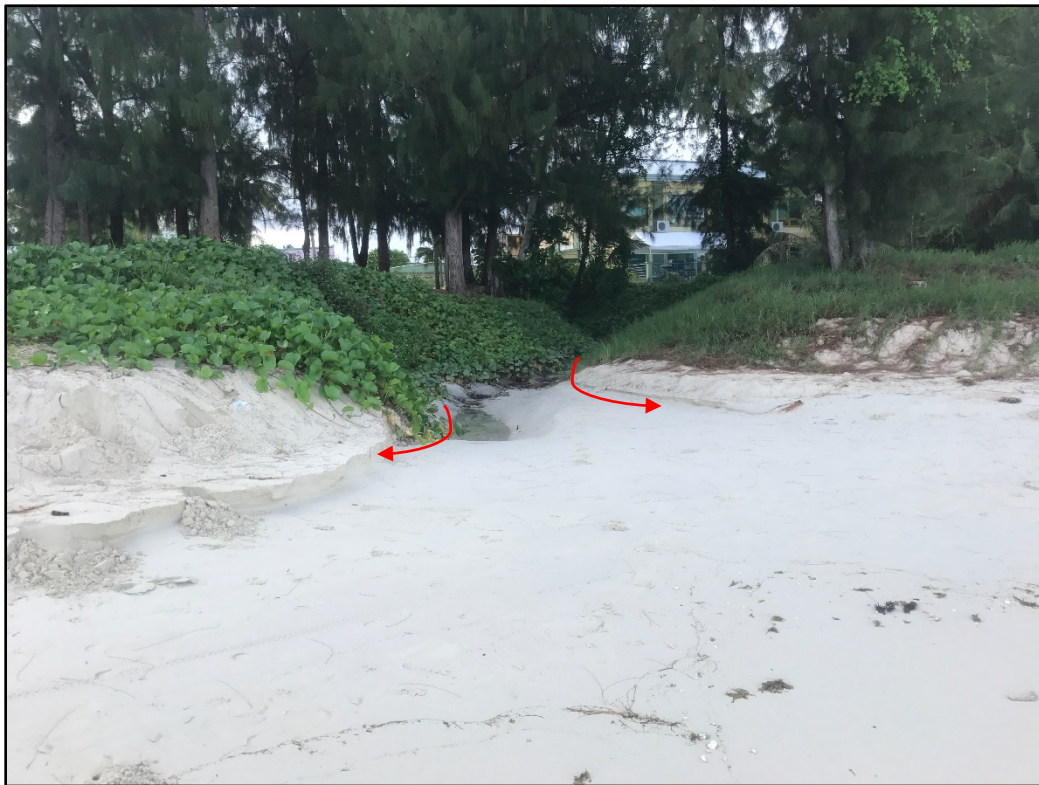
Figure 16 Sugar Dock Beach, berm bisected by drainage (6/30/2017)
