SAIPAN SHORELINE ACCESS AND SHORELINE ENHANCEMENT ASSESSMENT (SASEA)

Island of Saipan, Commonwealth of the Northern Mariana Islands

March 2018

Sea Engineering, Inc.
Makai Research Pier
41-305 Kalanianaʻole Hwy
Waimanalo, HI 96795

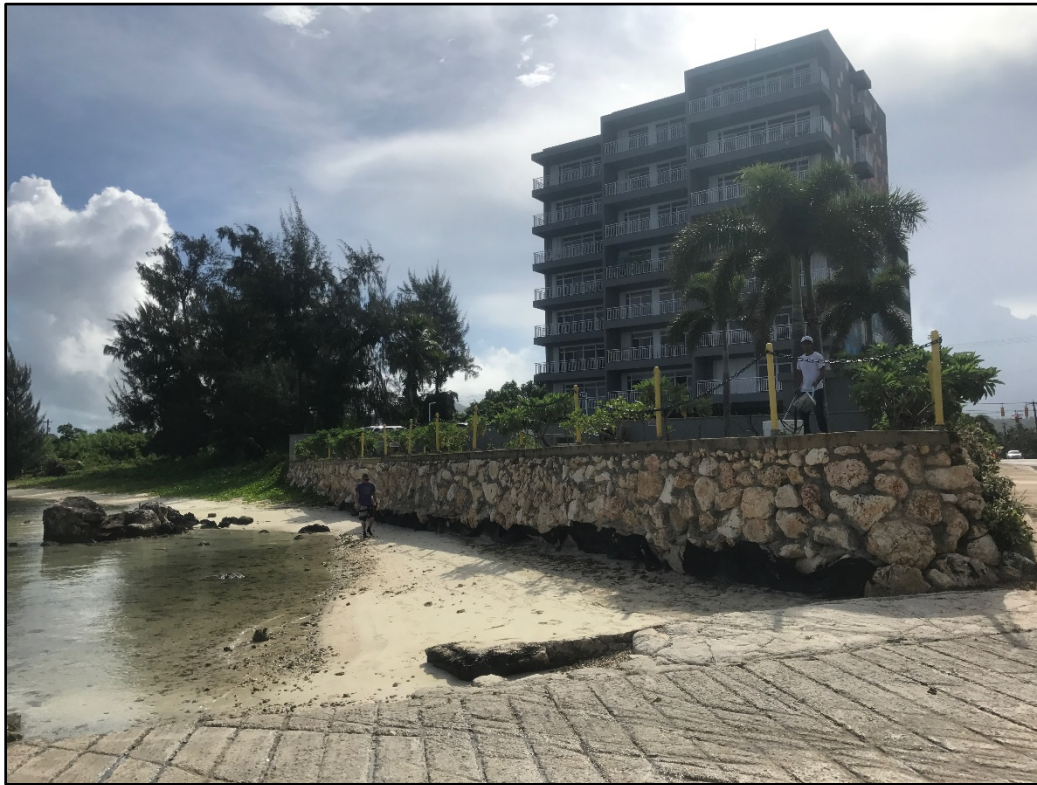
A seawall was constructed along the shoreline north of the boat ramp between 2014 and 2016. The seawall was constructed to protect a new multi-story public housing project (Figure 22). The seawall appeared to be damaged due to undermining (Figure 23). There was also a large pile of concrete and metal debris seaward of the seawall.

Figure 21 Sugar Dock Beach, new construction and seawall north of boat ramp (6/30/2017)

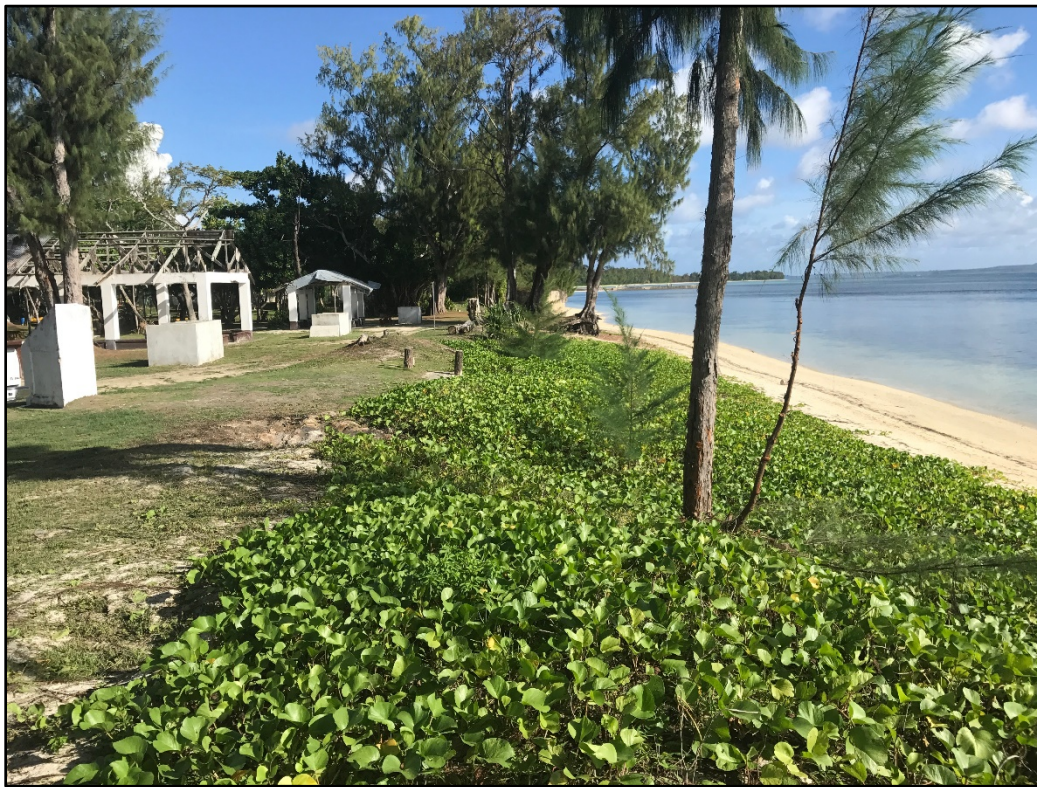
Figure 29 Susupe Beach Park, vegetation growth on upper beach face (6/30/2017)

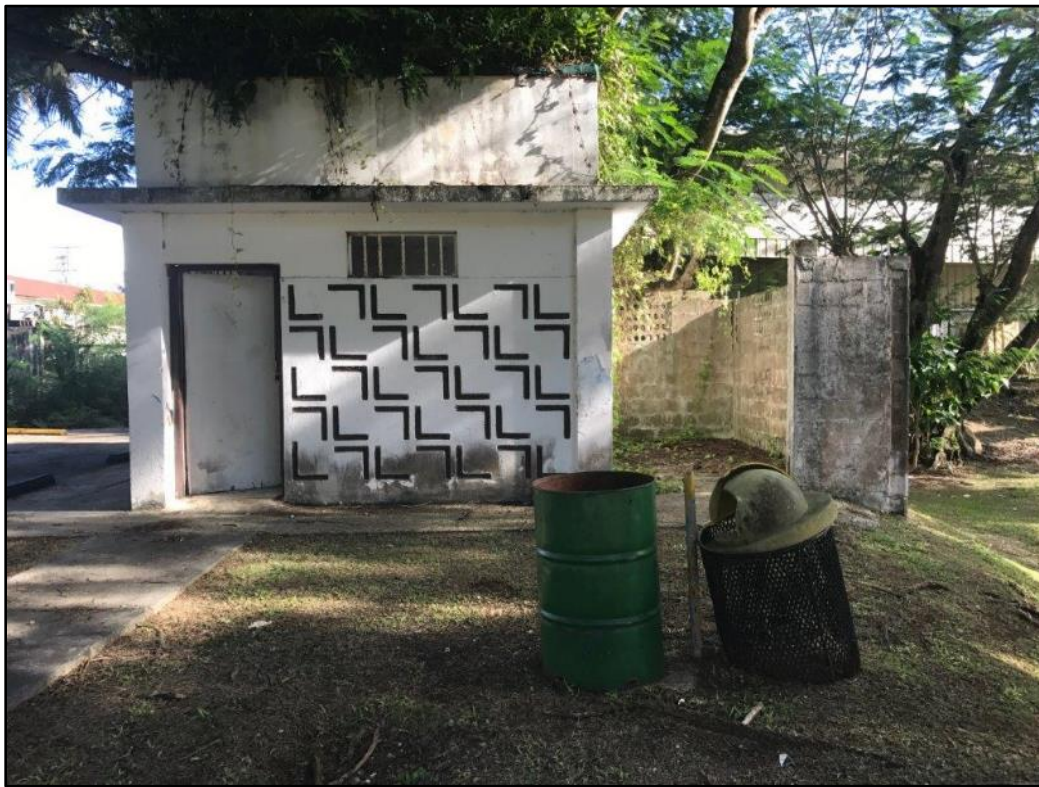
The undeveloped backshore and upper berm were highly compacted due to vehicle traffic. Many of the structures (e.g., palapalas, grills/fire pits, benches, and picnic tables) were in a very deteriorated condition. There was only one public restroom within the park, but it was closed due to apparent structural damage (Figure 32). There was physical evidence of historical erosion but current evidence indicated that the beach has been accreting since the last major erosion event. The only issue identified as negatively affecting the quality of the park was the deteriorated condition of the amenities. Several of the palapalas were heavily damaged, presumably by typhoon winds. Damage included exposed rebar, concrete spalling, and roof damage (Figure 33). Several of the structures appeared to be unstable and may present a potential risk to public health and safety.

Figure 31 Susupe Beach Park, closed public restroom (6/30/2017)

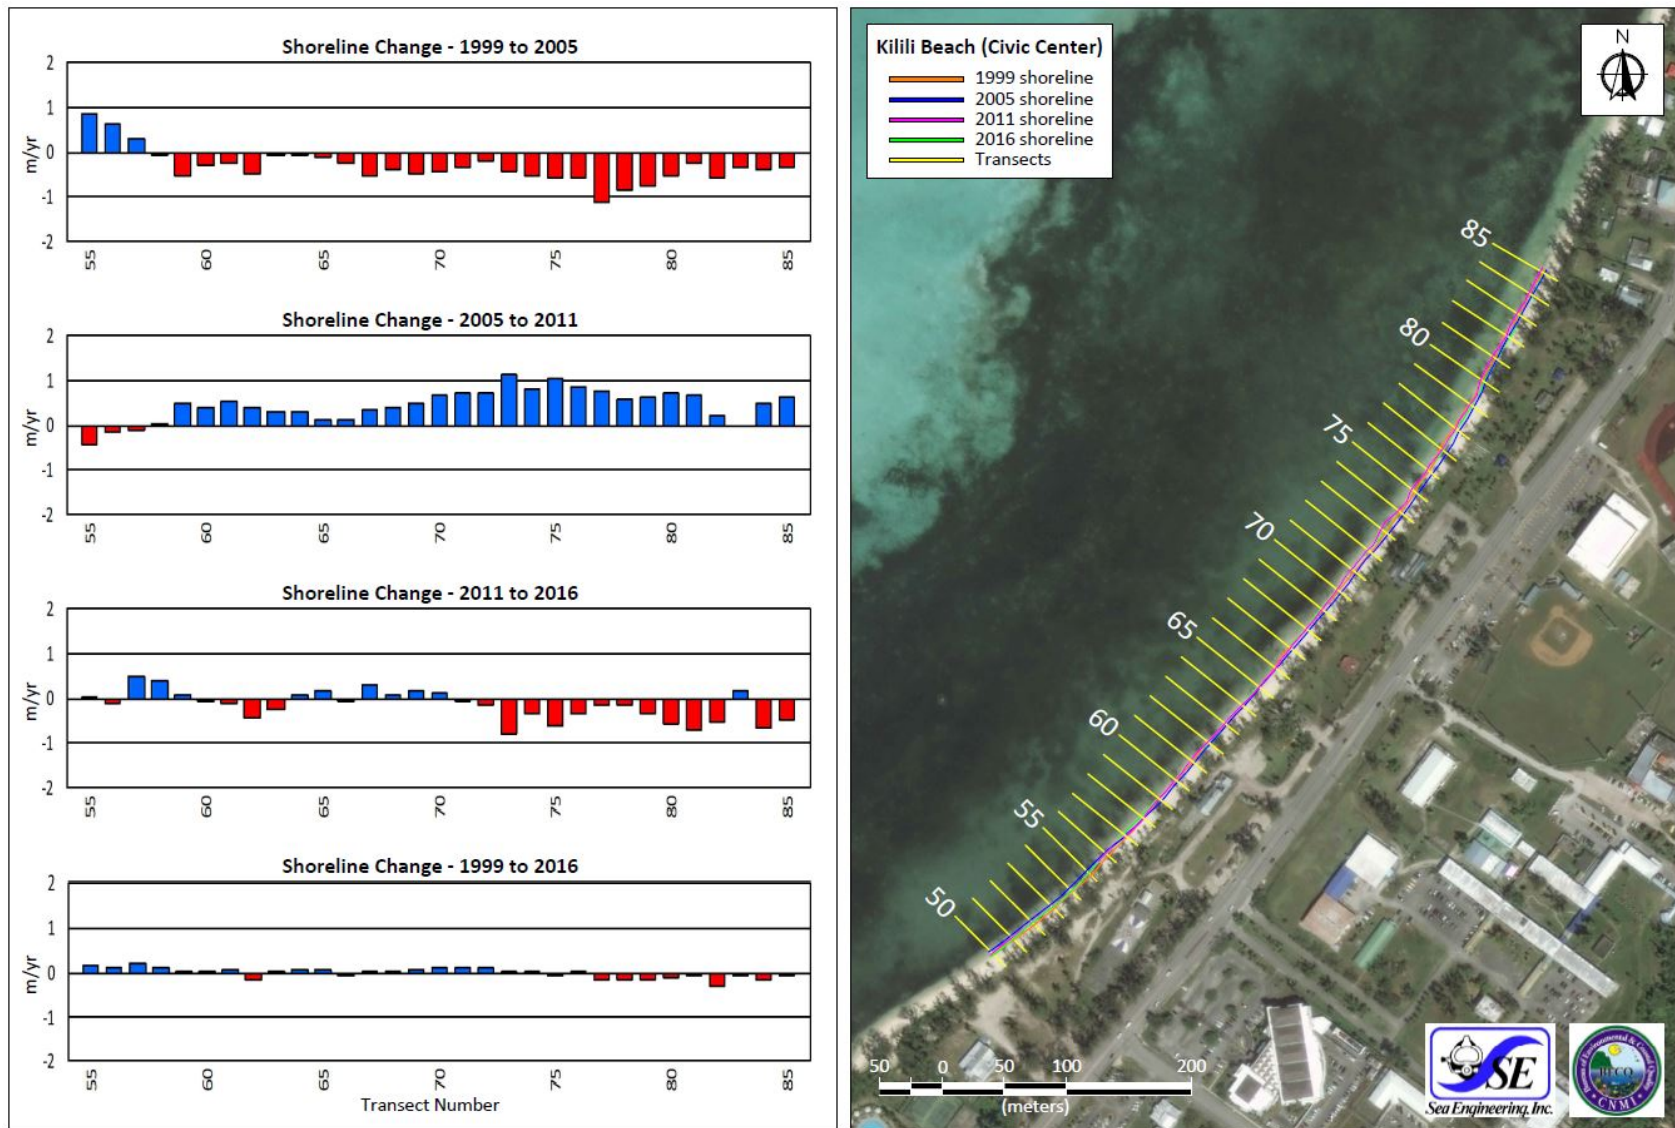
Map 4 Kilili Beach (Civic Center) historical shoreline change (1999 to 2016)

The historical shoreline change map for Kili Beach (Civic Center) is shown as transects 50 through 85 on Map 4. For the complete time series of the analysis (1999-2016), there was no appreciative change in the shoreline positions, and thus no long-term change. For the other time periods within the overall analysis, the shoreline cycled between erosion and accretion, with rates of up to about 1 m/yr for either condition.

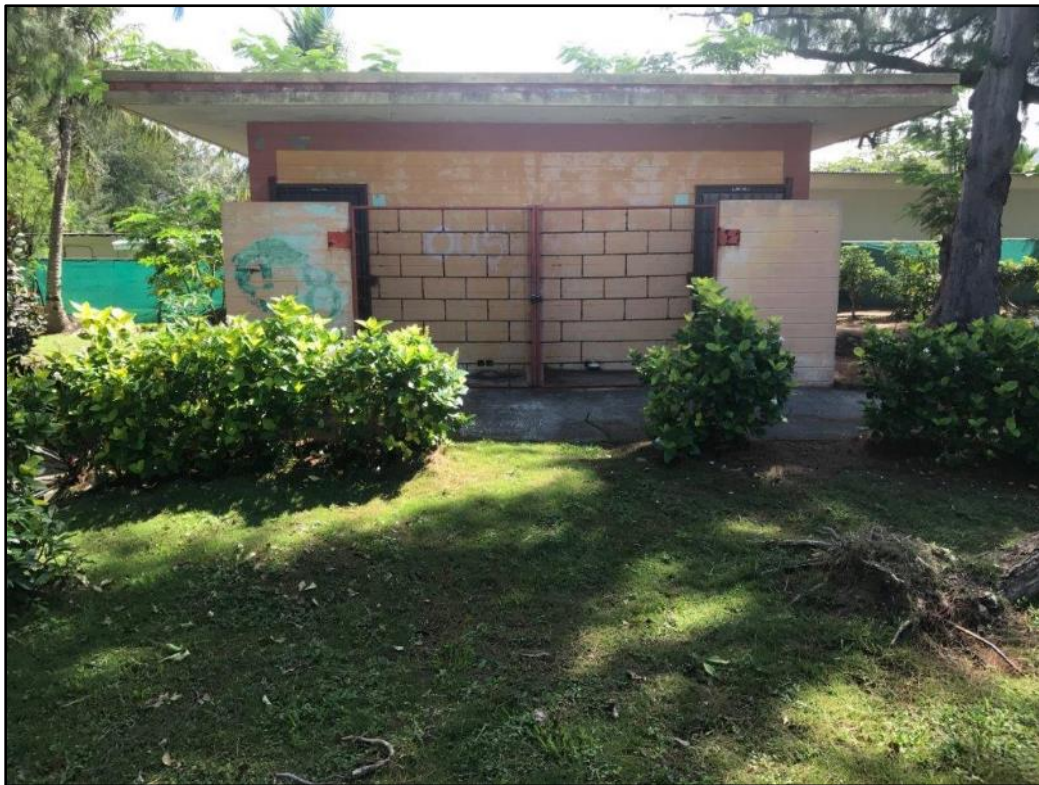
The undeveloped backshore and upper berm were highly compacted. Most of the structures (e.g., palapalas, grills/fire pits, benches, and picnic tables) were in relatively good condition. There was only one public restroom within the park, but it was closed due to apparent structural damage (Figure 45). There was physical evidence of erosion but it did not appear to be recent. The most active erosion areas appeared to be caused by surface water runoff from several drainages and parking lots, which bisected the berm and deflated the beach face (Figure 46). Erosion also appeared to be caused by foot traffic at the outrigger canoes launch site (Figure 47).

Figure 44 Kilili Beach (Civic Center), closed public restroom (6/30/2017)

- Increase enforcement capacity and education to reduce driving and parking on berms.
- Identify and prioritize improvements to public amenities.
- Identify and prioritize drainage improvements.
- Repair and maintain public restrooms.

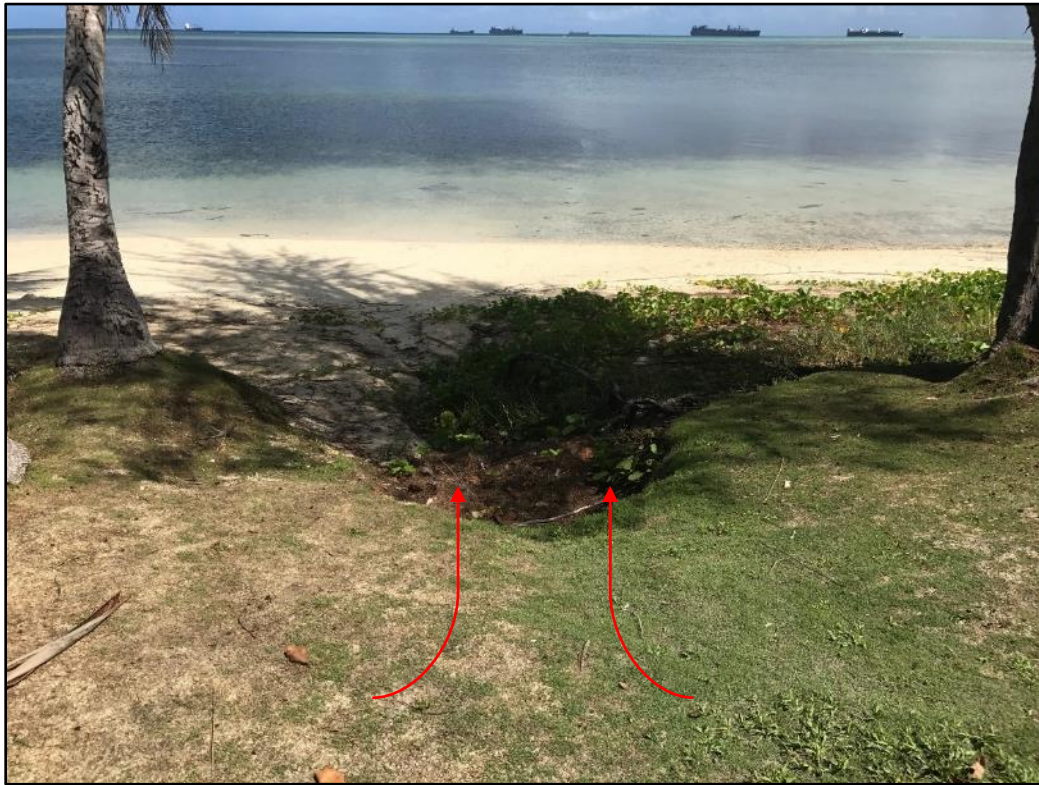
The undeveloped backshore area and upper berm were highly compacted. There was only one public restroom within the park, but it was closed due to apparent structural damage. The most active erosion areas appeared to be caused by surface water runoff from several drainages and parking lots, which bisected the berm and deflated the beach face. Erosion also appeared to be caused by foot traffic at the launch site for outrigger canoes.

Figure 45 Kilili Beach (Civic Center), erosion due to surface runoff from parking lot (6/30/2017)

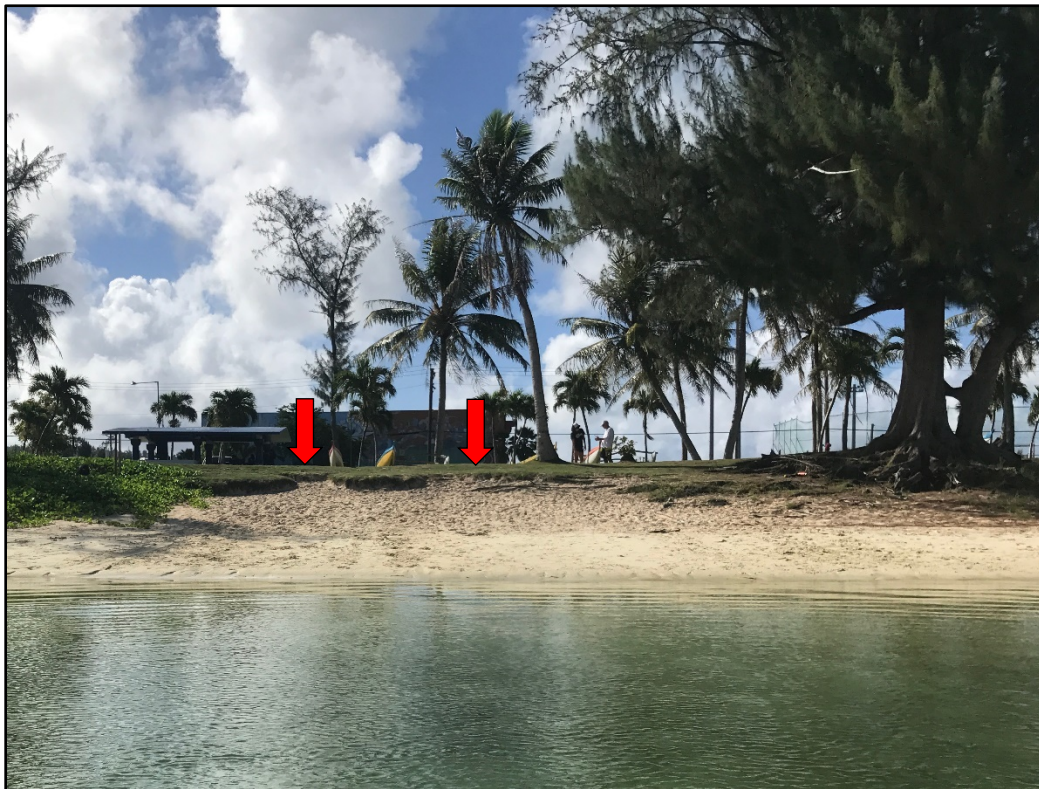
Figure 46 Kilili Beach (Civic Center), erosion due to foot traffic at canoe launch site (6/30/2017)

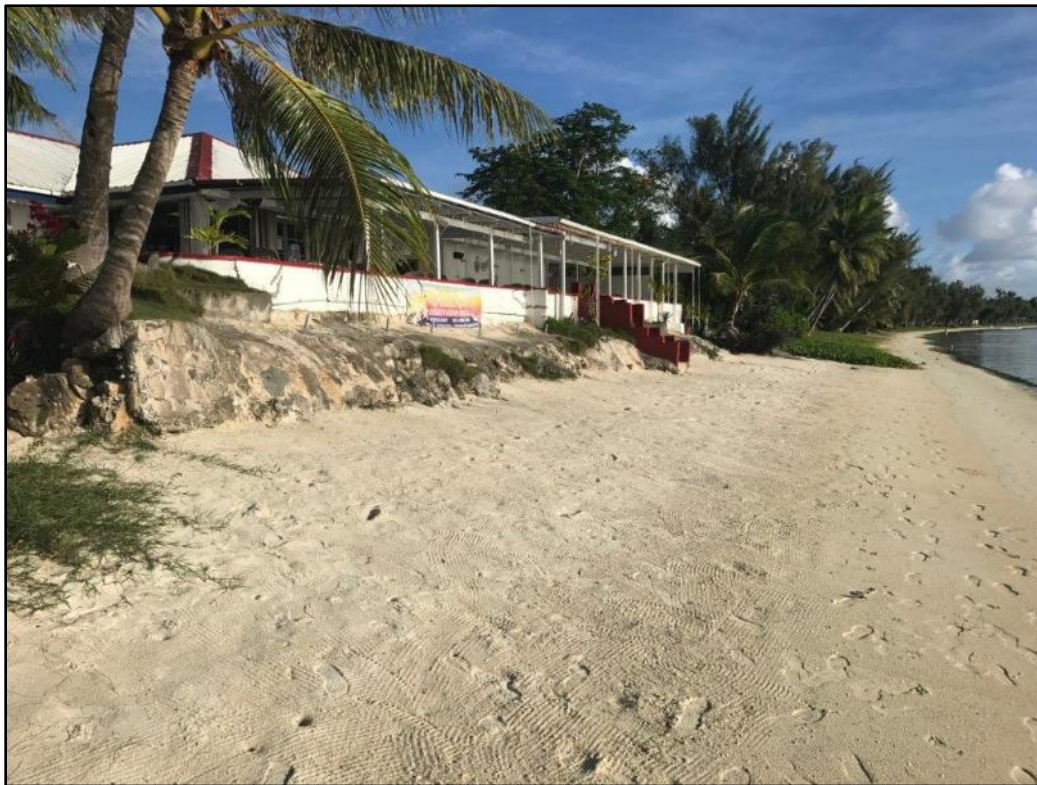
The undeveloped backshore and upper berm were highly compacted. Most of the structures (e.g., palapalas, grills/fire pits, benches, and picnic tables) were in relatively good condition. There were no public restrooms observed in the area. The Oleai Beach Bar & Grill is fronted by a seawall constructed of rock and concrete. There was no evidence to indicate that the seawall is impacting beach width (Figure 55). There was evidence of erosion but it did not appear to be recent. The most active erosion appeared where the berm was bisected by surface water runoff from the unpaved parking lot (Figure 56 and Figure 57).

Figure 54 Oleai Beach, seawall fronting Oleai Beach Bar & Grill (6/30/2017)

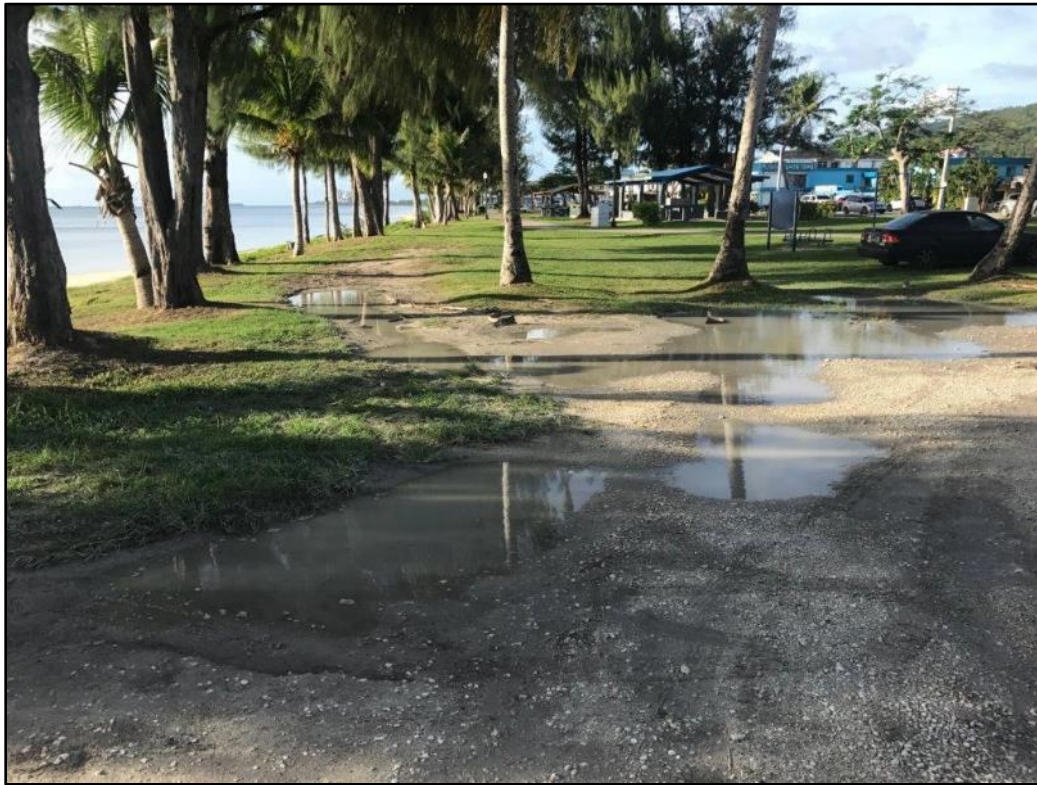
Figure 55 Oleai Beach, flooding in unpaved parking area (6/30/2017)

- Increase enforcement capacity and education to reduce driving and parking on berms.
- Identify and prioritize drainage improvements.
- Install and maintain public restrooms.

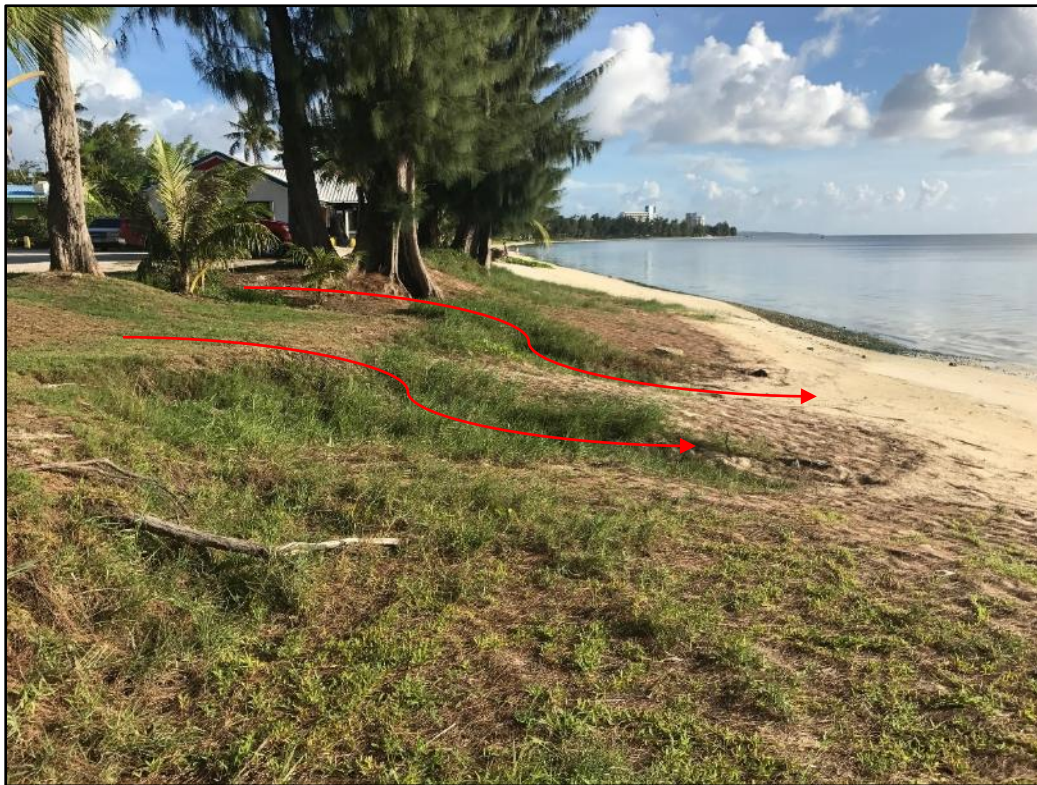
The undeveloped backshore area and upper berm were highly compacted. There were no public restrooms observed in the area. The Oleai Beach Bar & Grill is fronted by a rock and concrete seawall. There was no evidence to indicate that the seawall is impacting beach width. There was physical evidence of erosion but it did not appear to be recent. The most active erosion appeared where the berm was bisected by surface water runoff from the unpaved parking lot.

Figure 56 Oleai Beach, berm bisected by surface water runoff (6/30/2017)

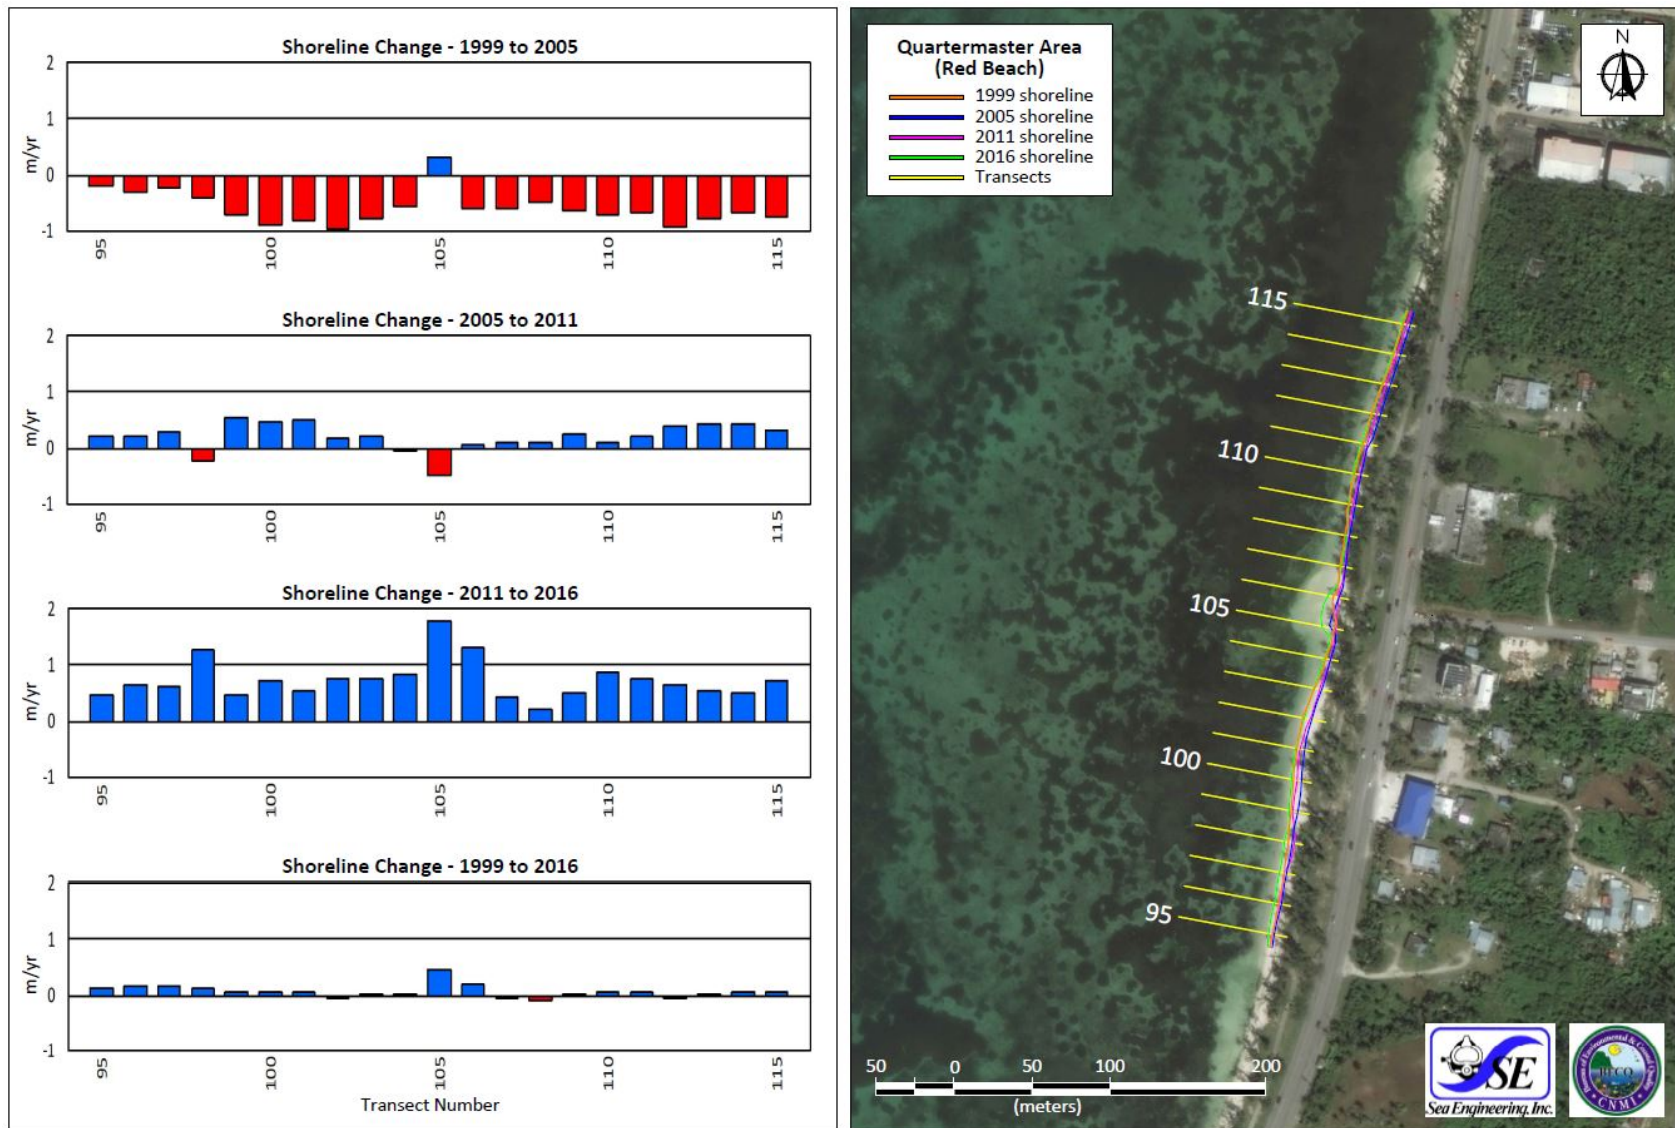
Map 6 Quartermaster Area (Red Beach) historical shoreline change (1999 to 2016)

The undeveloped backshore area and upper berm were highly compacted. Most of the structures (e.g., picnic tables, benches) were in good condition. There were no public restrooms observed in the area. The beach was very narrow and significant portions were entirely covered by encroaching vegetation. Lateral shoreline access was limited as beach users were forced to wade through the water to access small pocket beaches. Erosion was observed where the berm was bisected by drainage features

- Evaluate options for beach nourishment with stabilizing structures (e.g., groins).
- Evaluate options for permanent shore protection (e.g., seawall or revetment).
- Increase enforcement capacity and education to reduce driving and parking on berms.
- Identify and prioritize drainage improvements.
- Manage shoreline vegetation to increase available beach area.
- Install and maintain public restrooms.

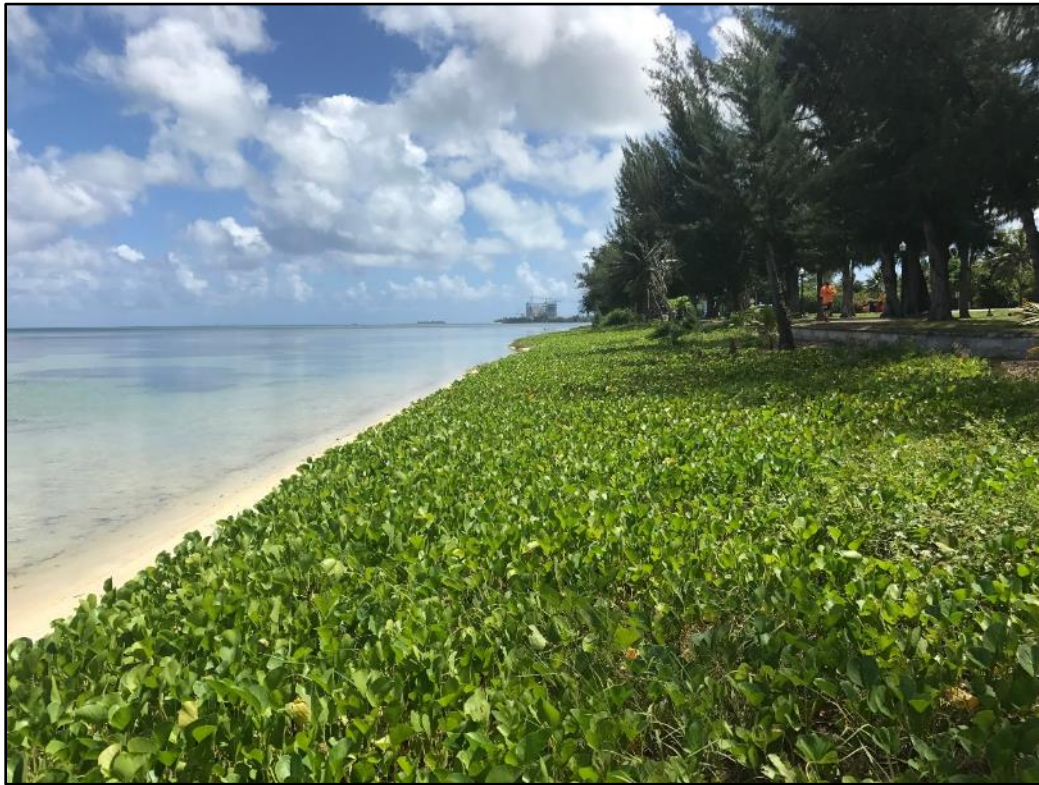
The undeveloped backshore area and upper berm were highly compacted. Most of the structures (e.g., picnic tables, benches) were in good condition. There were no public restrooms observed in the area. The beach was very narrow and significant portions were entirely covered by encroaching vegetation (Figure 66). Lateral shoreline access was limited as beach goers were forced to wade through the water to access small pocket beaches. The beach was widest near the drainage culvert along the central section of the shoreline. There was evidence of erosion but it did not appear to be recent. Evidence of active erosion was observed where the berm was bisected by drainage features (Figure 67).

Figure 65 Quartermaster Area (Red Beach), vegetation encroaching over beach (7/1/2017)

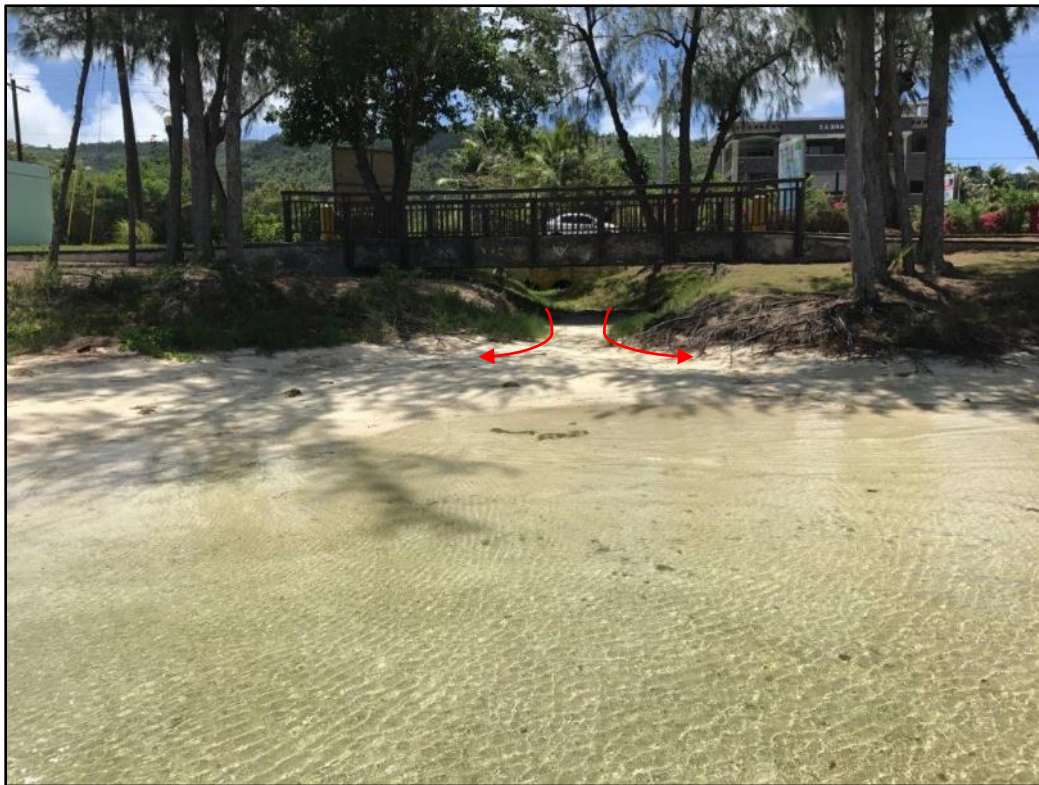
Figure 66 Quartermaster Area (Red Beach), berm bisected by drainage (7/1/2017)

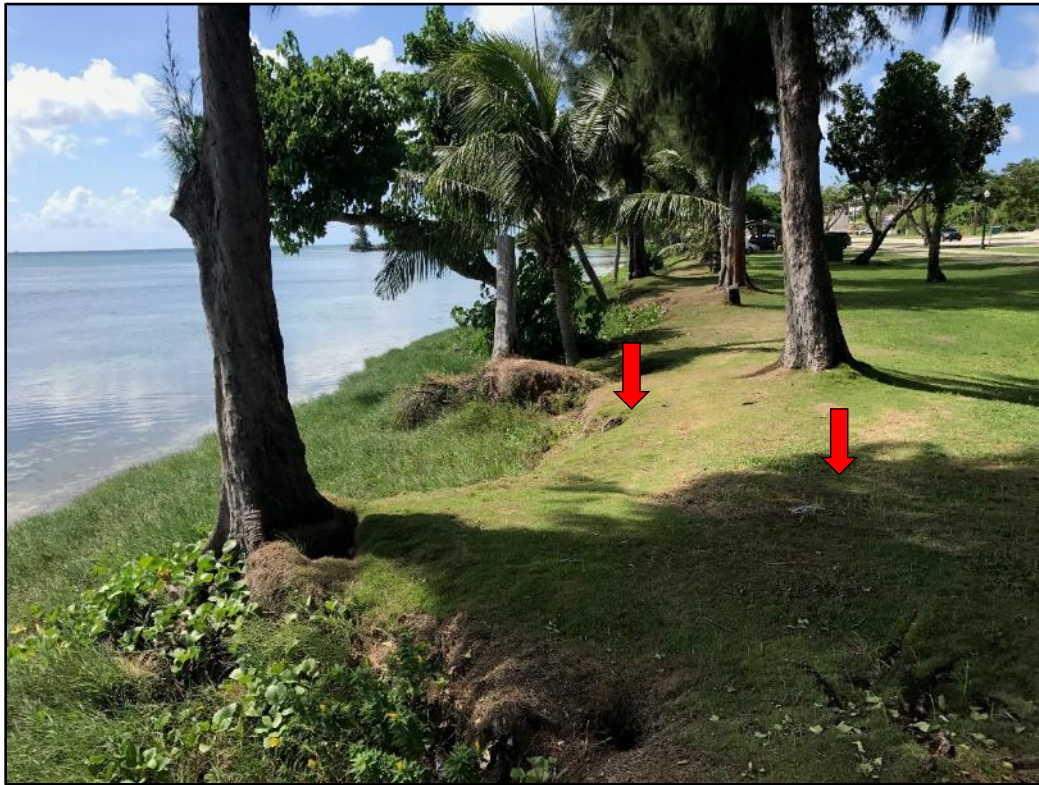
The backshore consisted of a narrow grassy area with mature Ironwood trees and soils composed of the Chinen-Urban land complex (Figure 73). The backshore topography was gently-sloping from Beach Road to the upper berm. The erosion scarp along the upper berm did not appear to be active (Figure 74). There was evidence of erosion including a relict erosion scarp and undermining of Ironwood root systems; however, the erosion did not appear to be recent. Evidence of active erosion was observed where the berm was bisected by drainage features (Figure 75). There was no evidence of erosion or inundation inshore of the erosion scarp.

Figure 73 Beach Road Pathway, erosion scarp and compacted berm (7/1/2017)

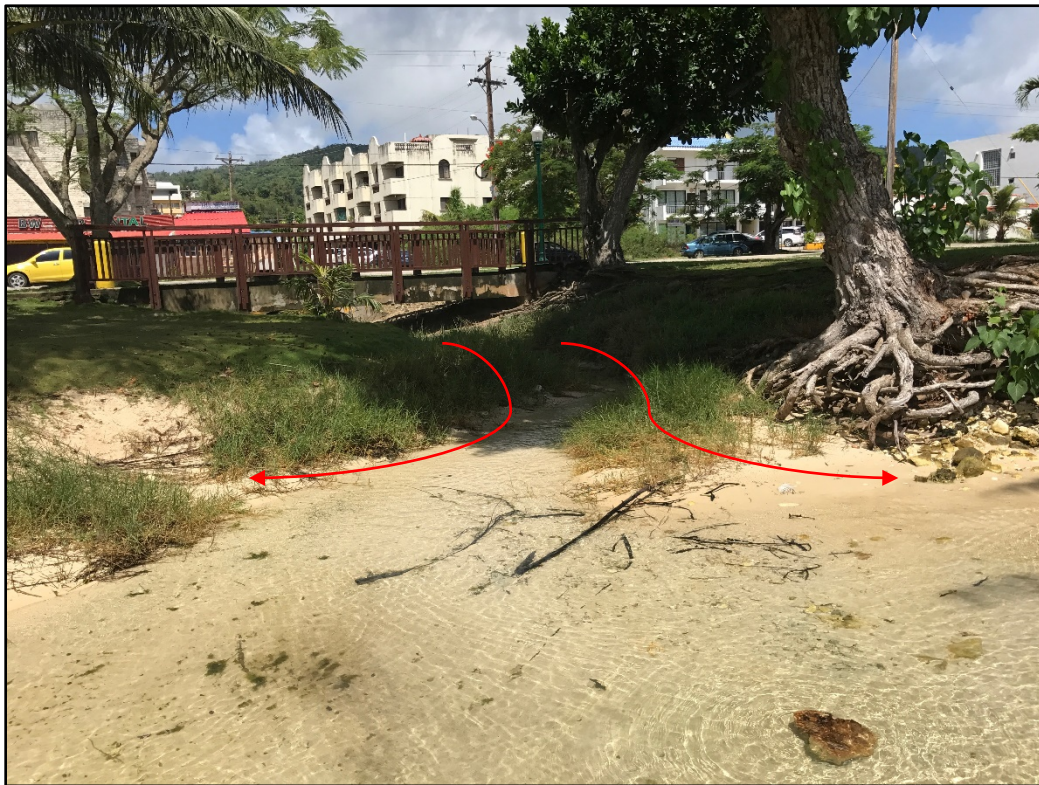
Figure 74 Beach Road Pathway, berm bisected by drainage (7/1/2017)

- Evaluate options for beach nourishment with stabilizing structures (e.g., groins).
- Evaluate options for permanent shore protection (e.g., seawall or revetment).
- Increase enforcement capacity and education to reduce driving and parking on berms.
- Identify and prioritize drainage improvements.
- Manage shoreline vegetation to increase available beach area.
- Install and maintain public restrooms.

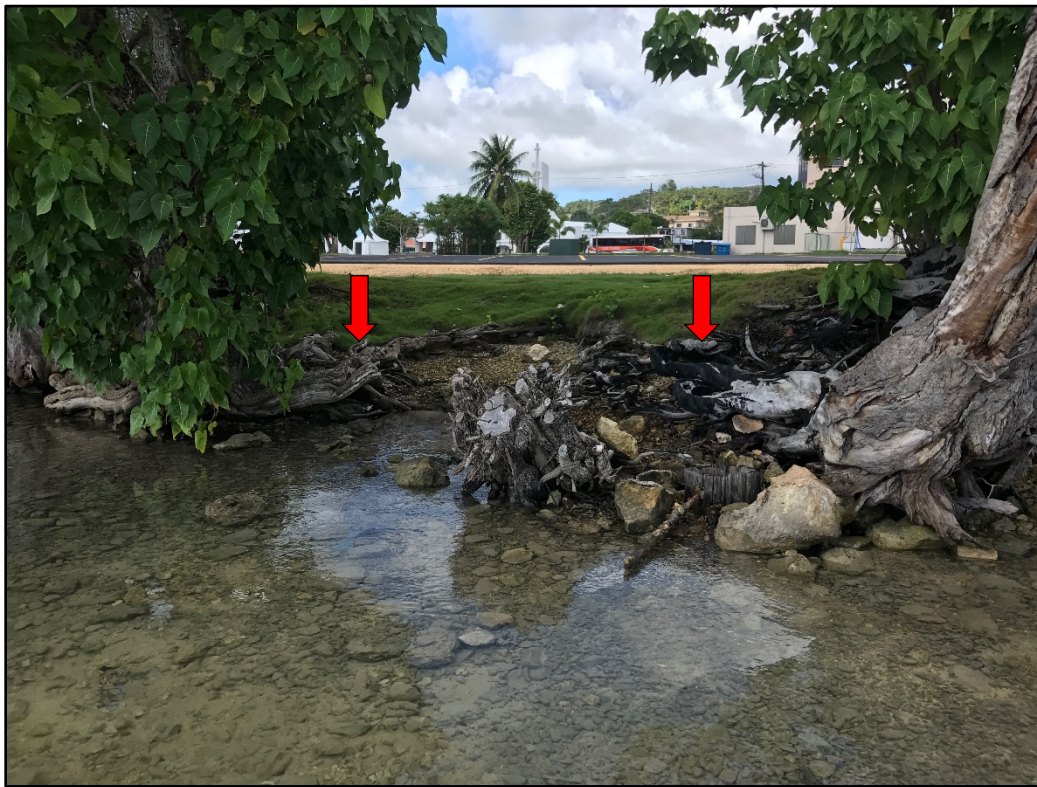
Figure 79 Fishing Base, active erosion along south section of shoreline (7/1/2017)

- Perform a damage assessment and prioritize repairs to Fishing Base.
- Evaluate options for permanent shore protection at Fishing Base.
- Install and maintain trash/recycling receptacles.
- Install and maintain public restrooms.

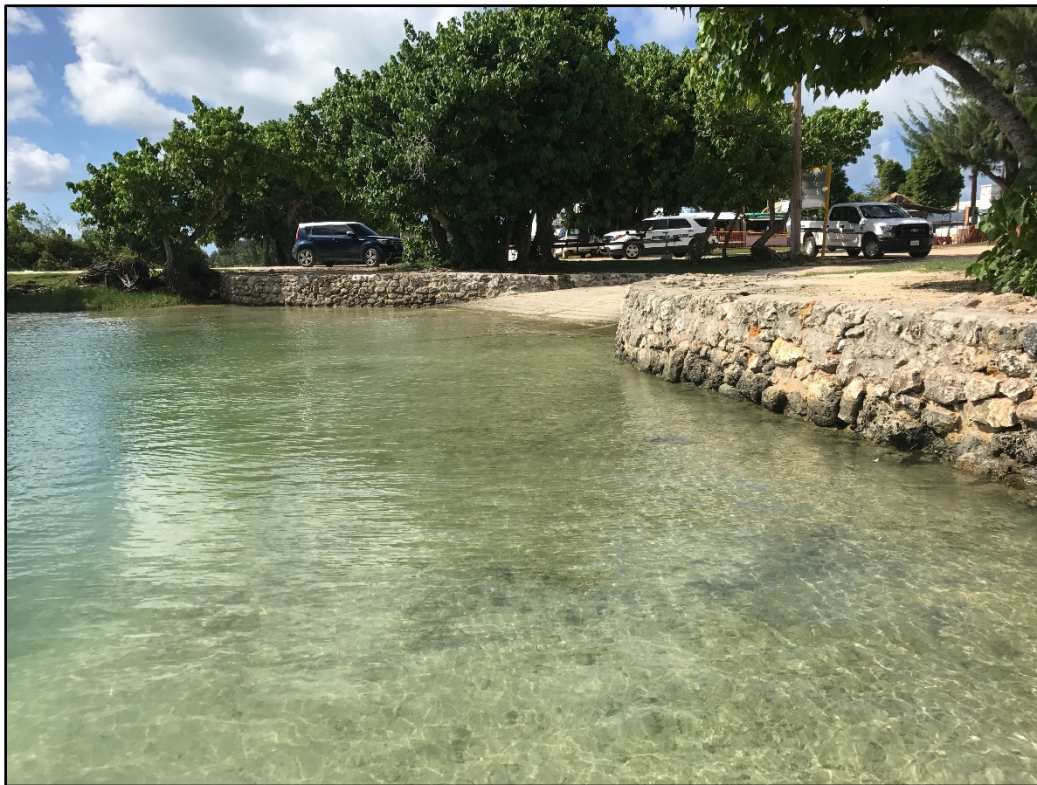
Figure 80 Fishing Base, seawall and public boat ramp (7/1/2017)

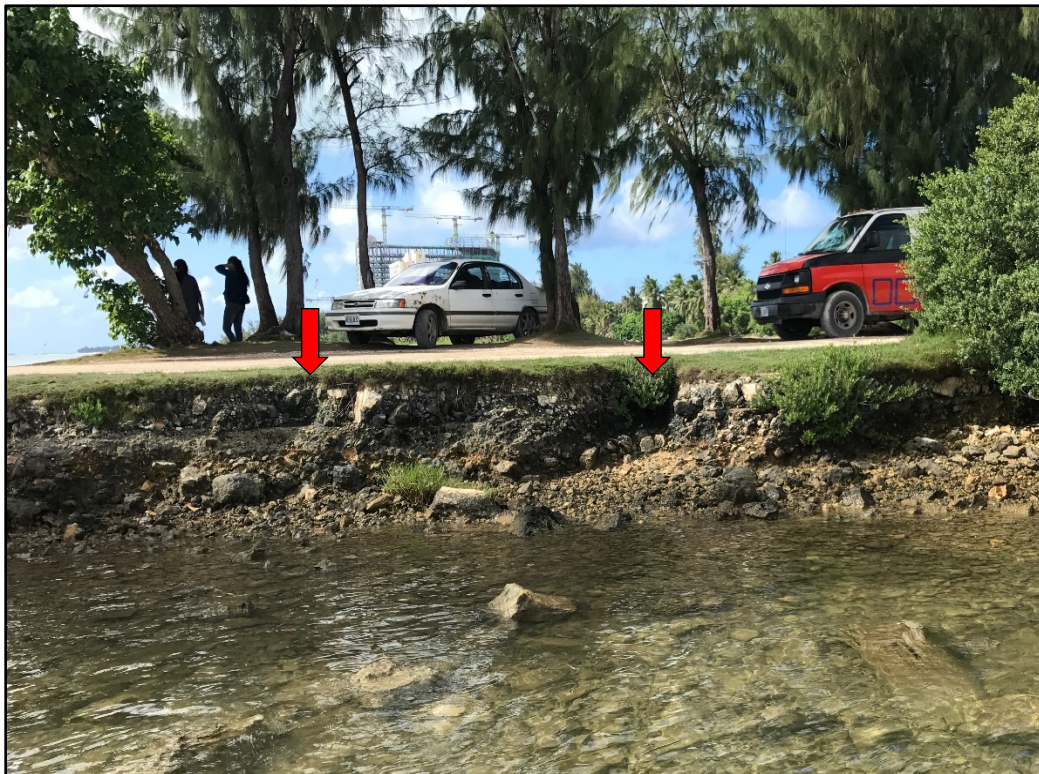
Figure 82 Fishing Base, active erosion along south side of pier (7/1/2017)

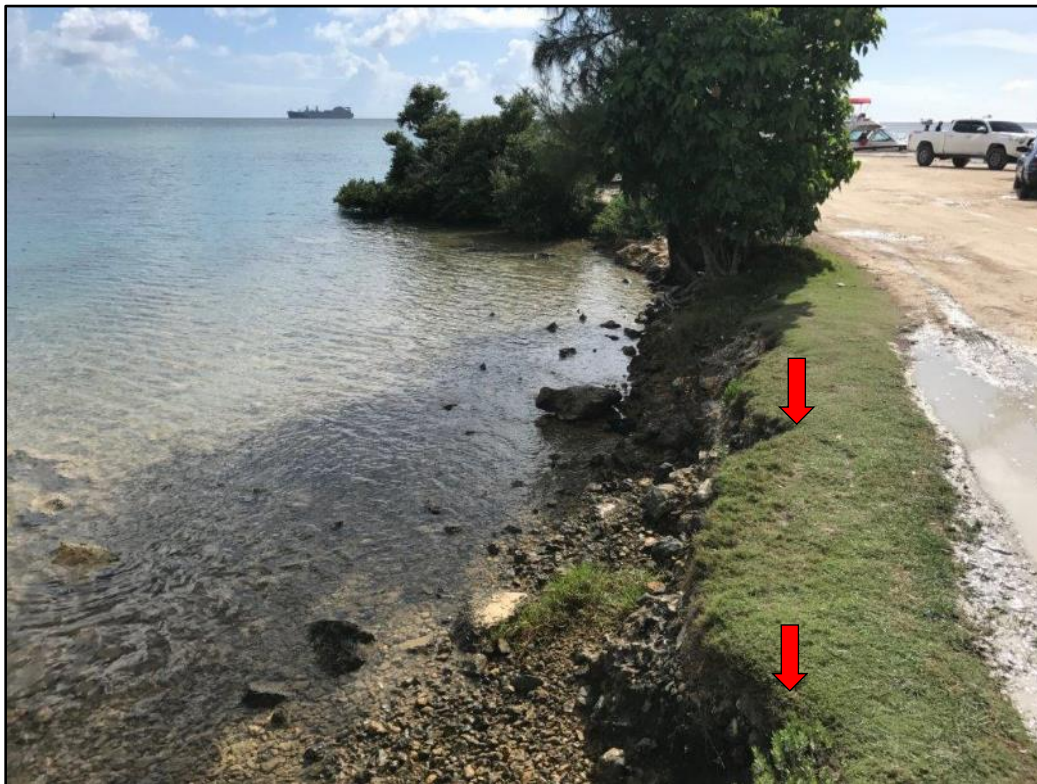
Figure 83 Fishing Base, active erosion along south side of pier (7/1/2017)

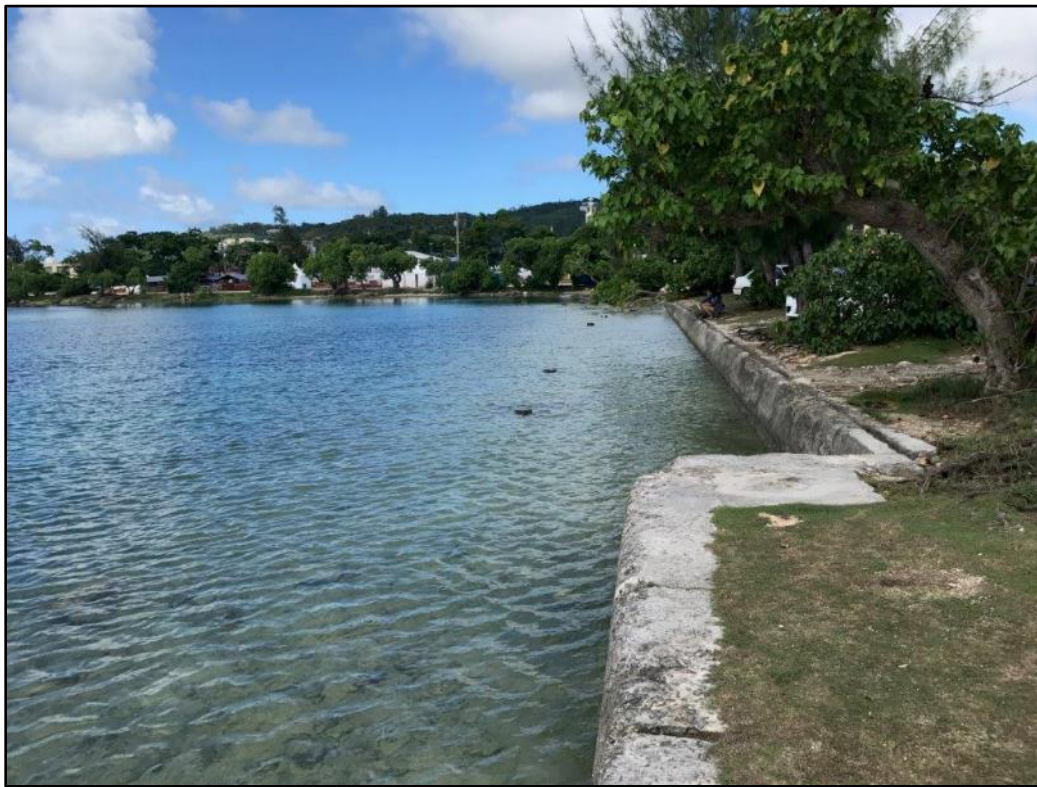
Figure 85 Fishing Base, seawalls on north side of pier (7/1/2017)

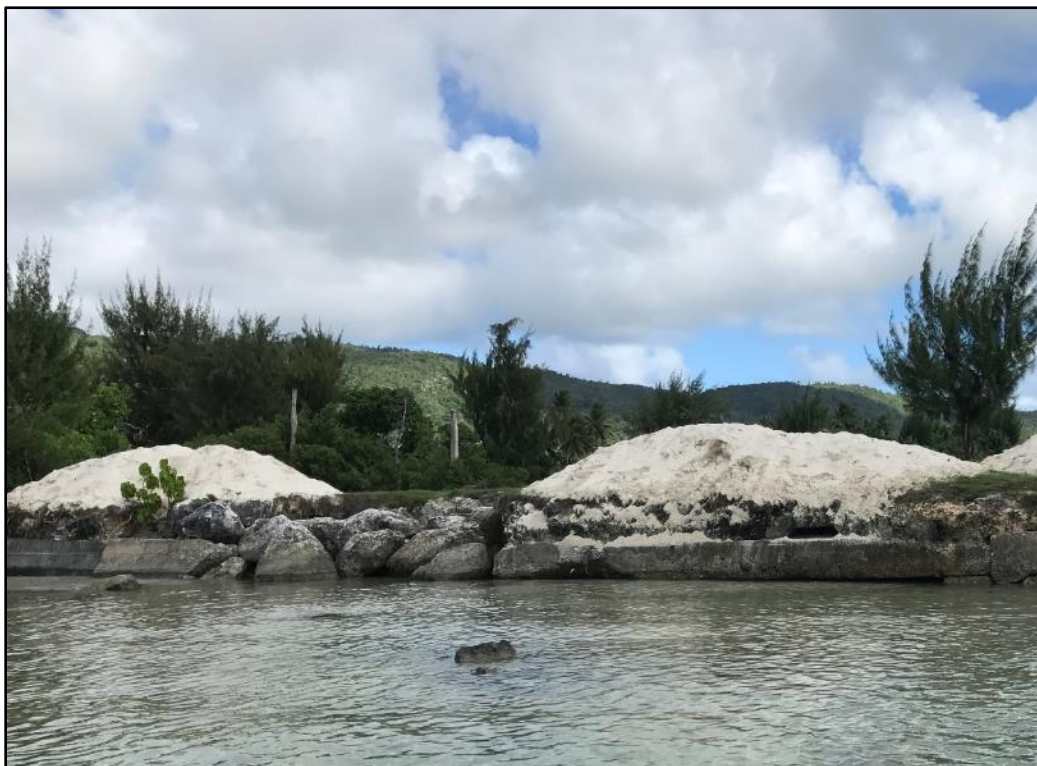
The central section of the Fishing Base shoreline consisted of the Fishing Base pier, which extended approximately 140 m seaward of the shoreline (Figure 82). The pier appeared to be constructed of multiple layers of fill material consisting of boulders, rock, and coral. There was no shore protection present along the south side of the pier, which appeared to be actively eroding (Figure 83). The seaward end of the pier was armored by a seawall that appeared to be damaged (Figure 85). The north side of the pier was armored by a concrete seawall (Figure 86). Several sections of the seawall on the north side of the pier appeared to be damaged with one section having collapsed (Figure 87).

Figure 86 Fishing Base, seawall damage along north side of pier (7/1/2017)

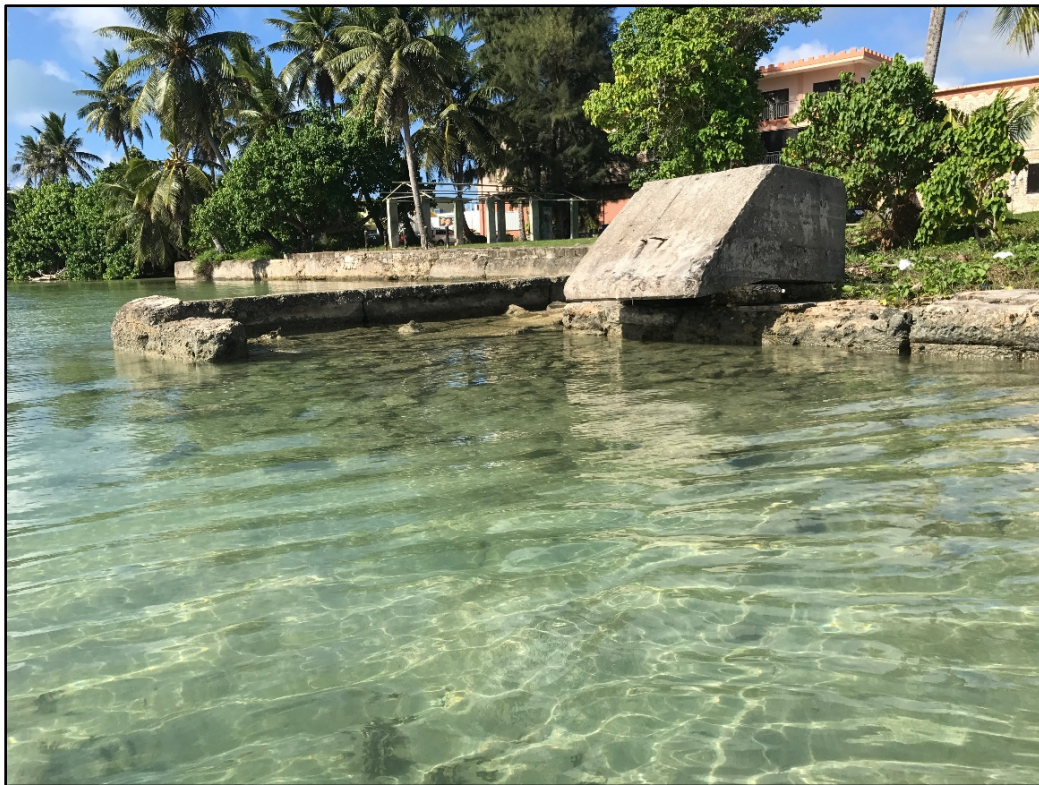
Figure 88 Fishing Base, collapsed structure and seawall at north end of shoreline (7/1/2017)
