SAIPAN SHORELINE ACCESS AND SHORELINE ENHANCEMENT ASSESSMENT (SASEA)

Island of Saipan, Commonwealth of the Northern Mariana Islands

March 2018

Sea Engineering, Inc.
Makai Research Pier
41-305 Kalanianaʻole Hwy
Waimanalo, HI 96795

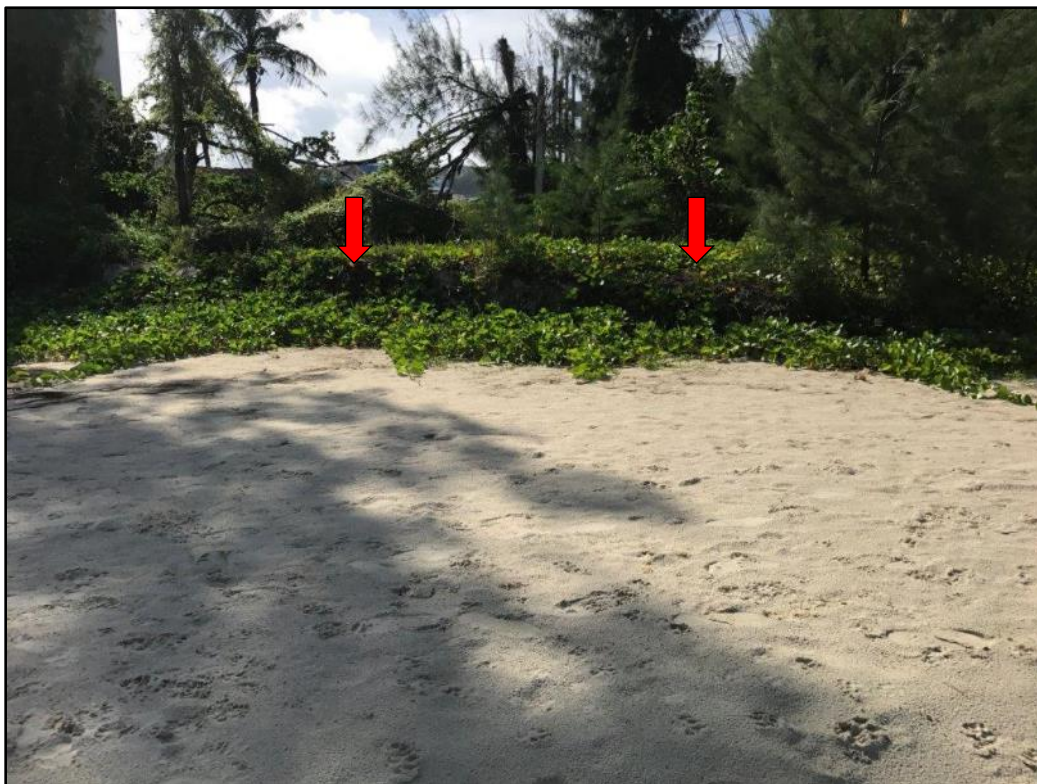
Figure 96 Makaka Beach, relict erosion scarp on back beach (7/2/2017)

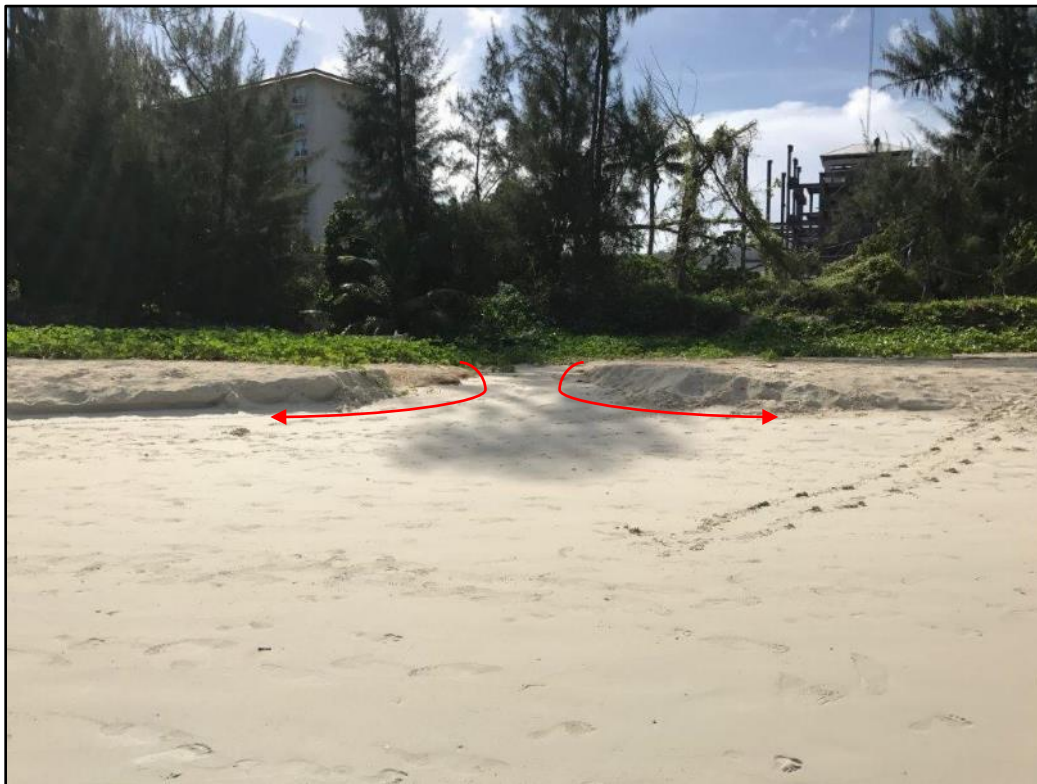
The undeveloped backshore area appeared to be natural and undisturbed, despite the intensity of the inshore development (Figure 99). There were no public restrooms or trash/recycling receptacles observed in the area. There was evidence of erosion along the back beach but it did not appear to be recent. The only active erosion appeared where the berm was bisected by a drainage (Figure 100 and Figure 101).

Figure 99 Makaka Beach, beach berm bisected by drainage (7/2/2017)

- Identify and prioritize drainage improvements.
- Install and maintain trash/recycling receptacles.
- Install and maintain public restrooms.

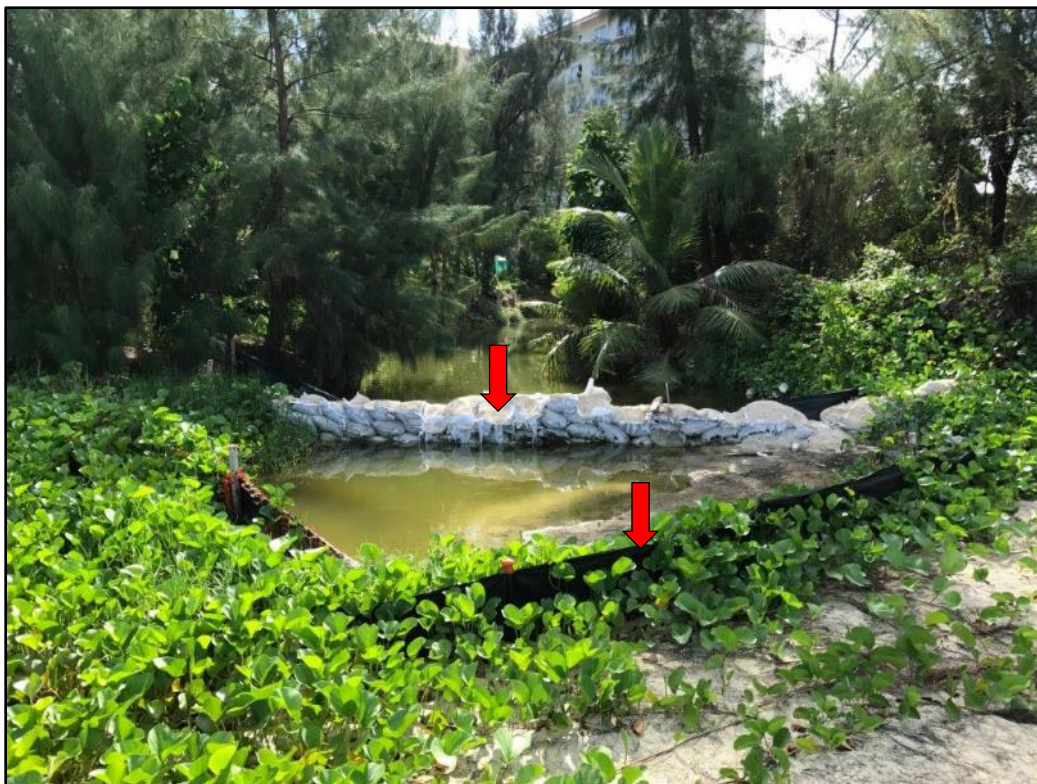
Figure 100 Makaka Beach, flood control at drainage mouth (7/2/2017)

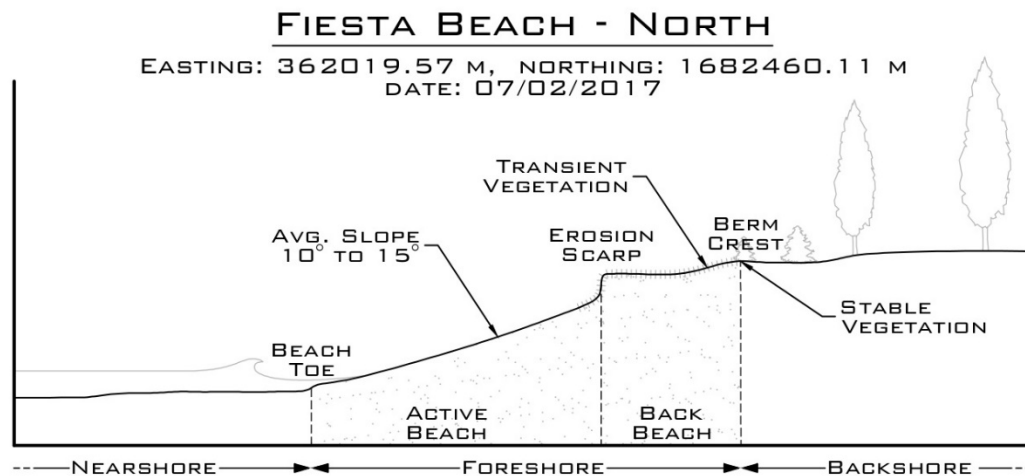
Profile 11 Typical beach profile along north section of Fiesta Beach

The north section of Fiesta Beach spans approximately 60 m of shoreline frontage south of Hyatt Beach. A typical beach profile was recorded along the north section of the Fiesta Beach shoreline (Profile 11). Photographs showing the location of the beach profile are shown in Figure 108 and Figure 109. The lower beach was moderately-sloping (10 to 15 degrees) and consisted of a narrow, exposed sand beach that progressed inshore to an active erosion scarp along the edge of vegetation. The back beach consisted of multiple berms covered by transient vegetation. The back beach progressed inshore to a berm crest. The backshore consisted of a relatively flat area with sparse, low-lying vegetation. There was evidence of active erosion along the scarp and inundation inshore of the erosion scarp.

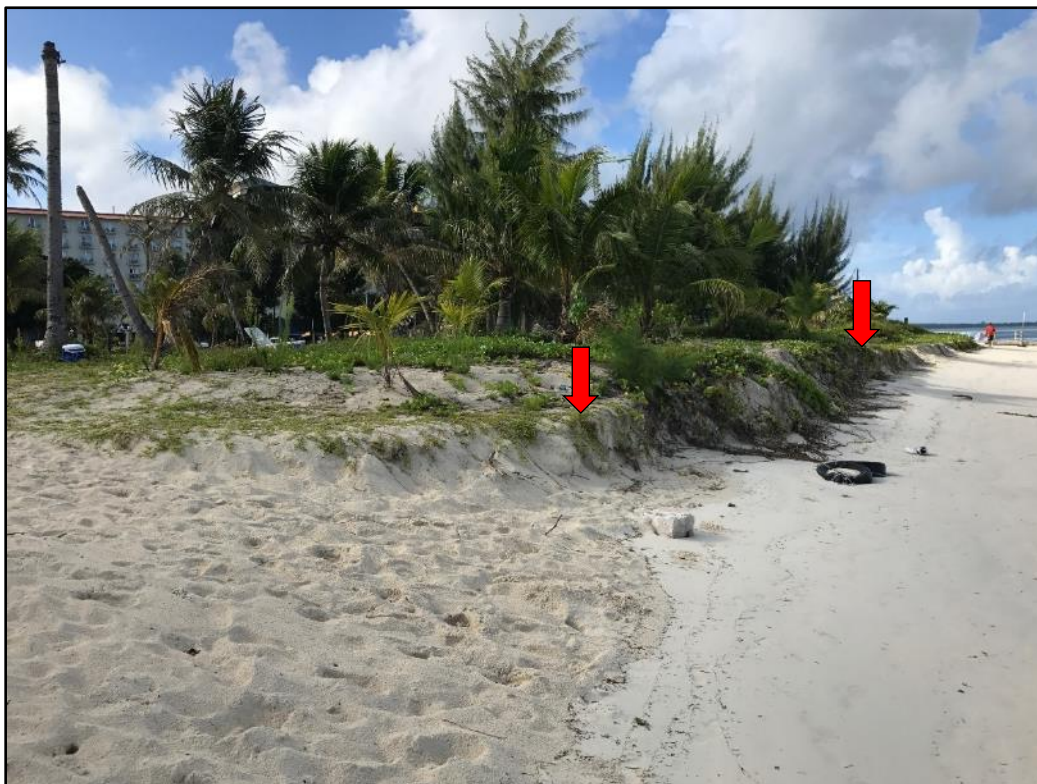
The beach had been cleared of vegetation and is actively graded and was being actively maintained by resort staff. There were no public restrooms or trash/recycling receptacles observed in the area. Fiesta Resort restroom facilities are available to the public; however, there was no signage to direct beach users to the restroom facilities. There was physical evidence of erosion along the north section of the shoreline adjacent to Hyatt Beach (Figure 113).

Figure 112 Fiesta Beach, active erosion scarp along north section of shoreline (7/2/2017)

- Evaluate options for berm enhancement, beach maintenance, and beach nourishment.
- Restore and maintain shoreline vegetation.
- Install and maintain trash/recycling receptacles.
- Provide signage to direct the public to resort restroom facilities.

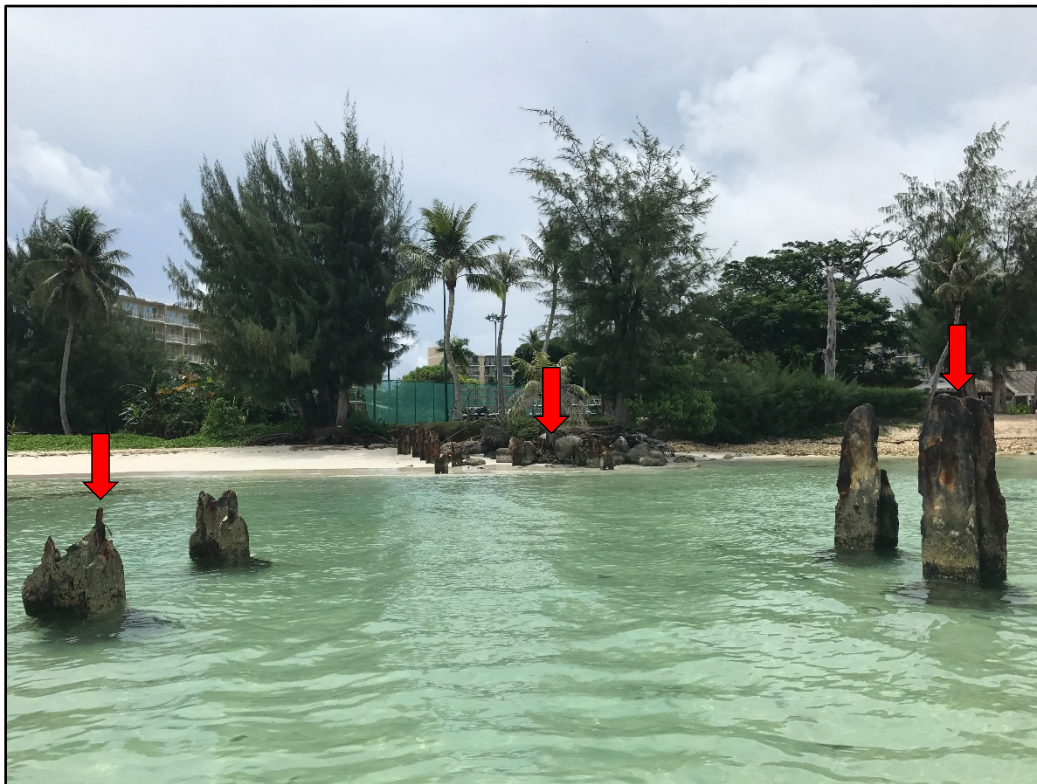
The north section of the Hyatt Beach shoreline spans approximately 50 m of shoreline frontage south of Micro Beach. A typical beach profile was recorded along the north section of the Hyatt Beach shoreline (Profile 13). Photographs showing the location of the beach profile are shown in Figure 118 and Figure 119. The lower beach was moderately-sloping (10 to 15 degrees) and consisted of a narrow beach composed of sand, gravel, and coral cobble that progressed inshore to an active erosion scarp. The backshore consisted of a relatively flat grassy area. There was no evidence of erosion or inundation inshore of the erosion scarp. Remnants of a collapsed pier extended into the nearshore at the north end of the shoreline (Figure 120).

Figure 119 Hyatt Beach, remnants of collapsed pier at north end of shoreline (7/2/2017)

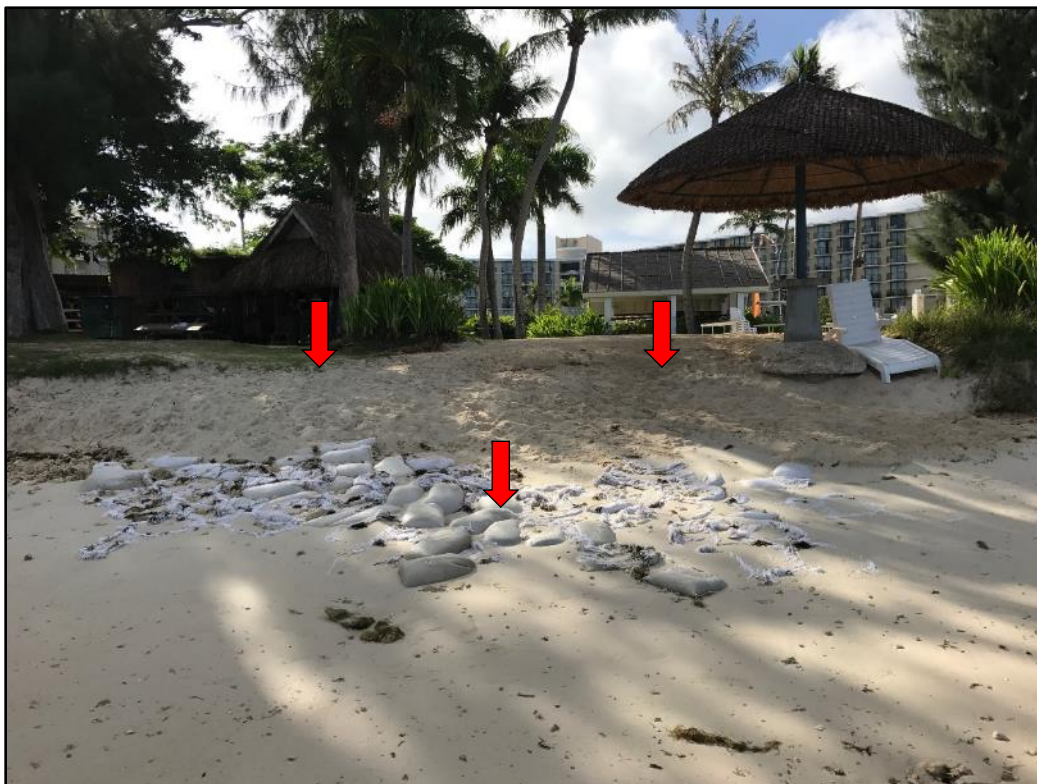
The beach was cleared of vegetation and is actively graded and maintained by resort staff. There were no public restrooms or trash/recycling receptacles observed in the area. There was evidence of erosion along the north section of the shoreline adjacent to Micro Beach. Additional erosion was observed adjacent to the water sports rental operation at the north end of the shoreline (Figure 121). Sandbags were installed to address the erosion in this area, which is presumably caused by foot traffic to and from the water sports rental operation.

Figure 120 Hyatt Beach, erosion due to foot traffic (7/2/2017)

- Evaluate options for berm enhancement, beach maintenance, and beach nourishment.
- Restore and maintain shoreline vegetation.
- Install and maintain trash/recycling receptacles.
- Install and maintain public restrooms.

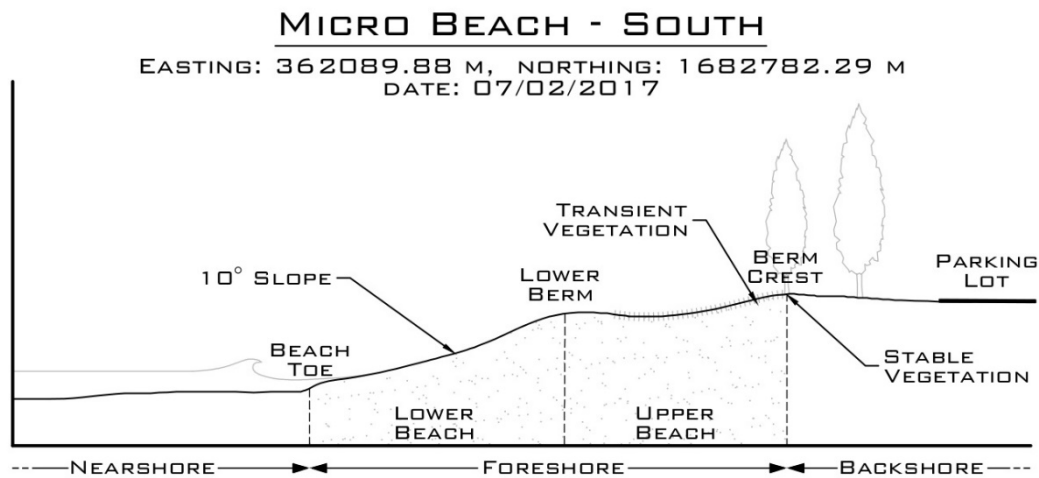
Profile 14 Typical beach profile along south section of Micro Beach

The south section of the Micro Beach shoreline spans approximately 100 m of shoreline frontage north of Hyatt Beach. A typical beach profile was recorded along the south section of the Micro Beach shoreline (Profile 14). Photographs showing the location of the beach profile are shown in Figure 124 and Figure 125. The lower beach was moderately-sloping (10 to 15 degrees) and consisted of a moderately-wide, exposed sand beach that progressed inshore to a transient berm along the vegetation line. The upper beach was slightly concave and covered by transient vegetation (Morning Glory) and mature vegetation (Ironwood, Coconut trees). The upper beach progressed inshore to a stable berm crest along the edge of the grassy backshore area. A relict erosion scarp was visible along some sections of the berm crest; however, there was no evidence of active erosion. The backshore was relatively flat and consisted of an open grassy park area and paved parking lot. There was no evidence of erosion or inundation inshore of the berm crest.

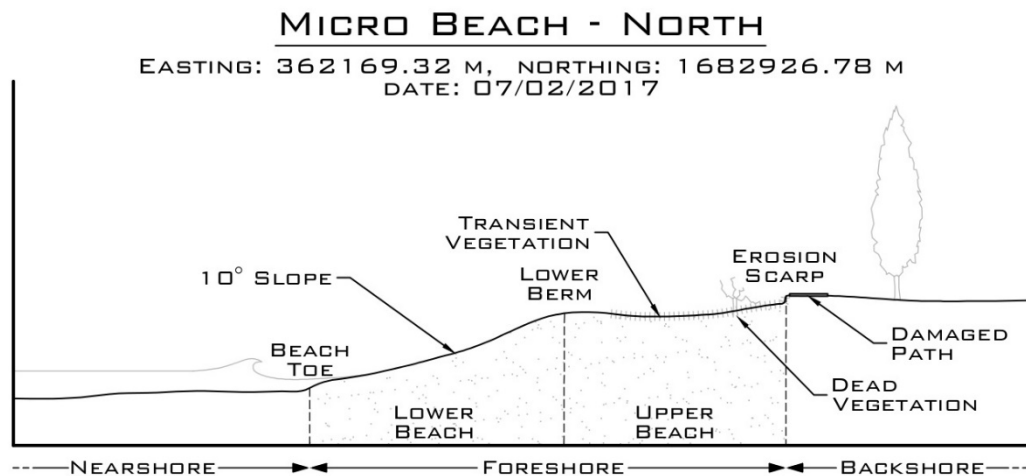
Profile 15 Typical beach profile along north section of Micro Beach

The north section of the Micro Beach shoreline spans approximately 100 m of shoreline frontage south of American Memorial Park. A typical beach profile was recorded along the north section of the Micro Beach shoreline (Profile 15). Photographs showing the location of the beach profile are shown in Figure 126 and Figure 127. The lower beach was moderately-sloping (10 to 15 degrees) and consisted of a moderately-wide, exposed sand beach that progressed inshore to a transient berm along the vegetation line. The upper beach was slightly concave and covered by transient vegetation (Morning Glory) and mature vegetation (Ironwood trees and saplings). The upper beach progressed inshore to a relict erosion scarp along the edge of the grassy backshore area. The backshore area was relatively flat and consisted of an open grassy park area. A concrete coastal access path terminated at the erosion scarp. A 50-meter section of the path was damaged by erosion and storm surge caused by a typhoon (Figure 128). The erosion scarp did not appear to be active and there was no evidence of recent erosion. There was no evidence of erosion or inundation inshore of the berm crest.

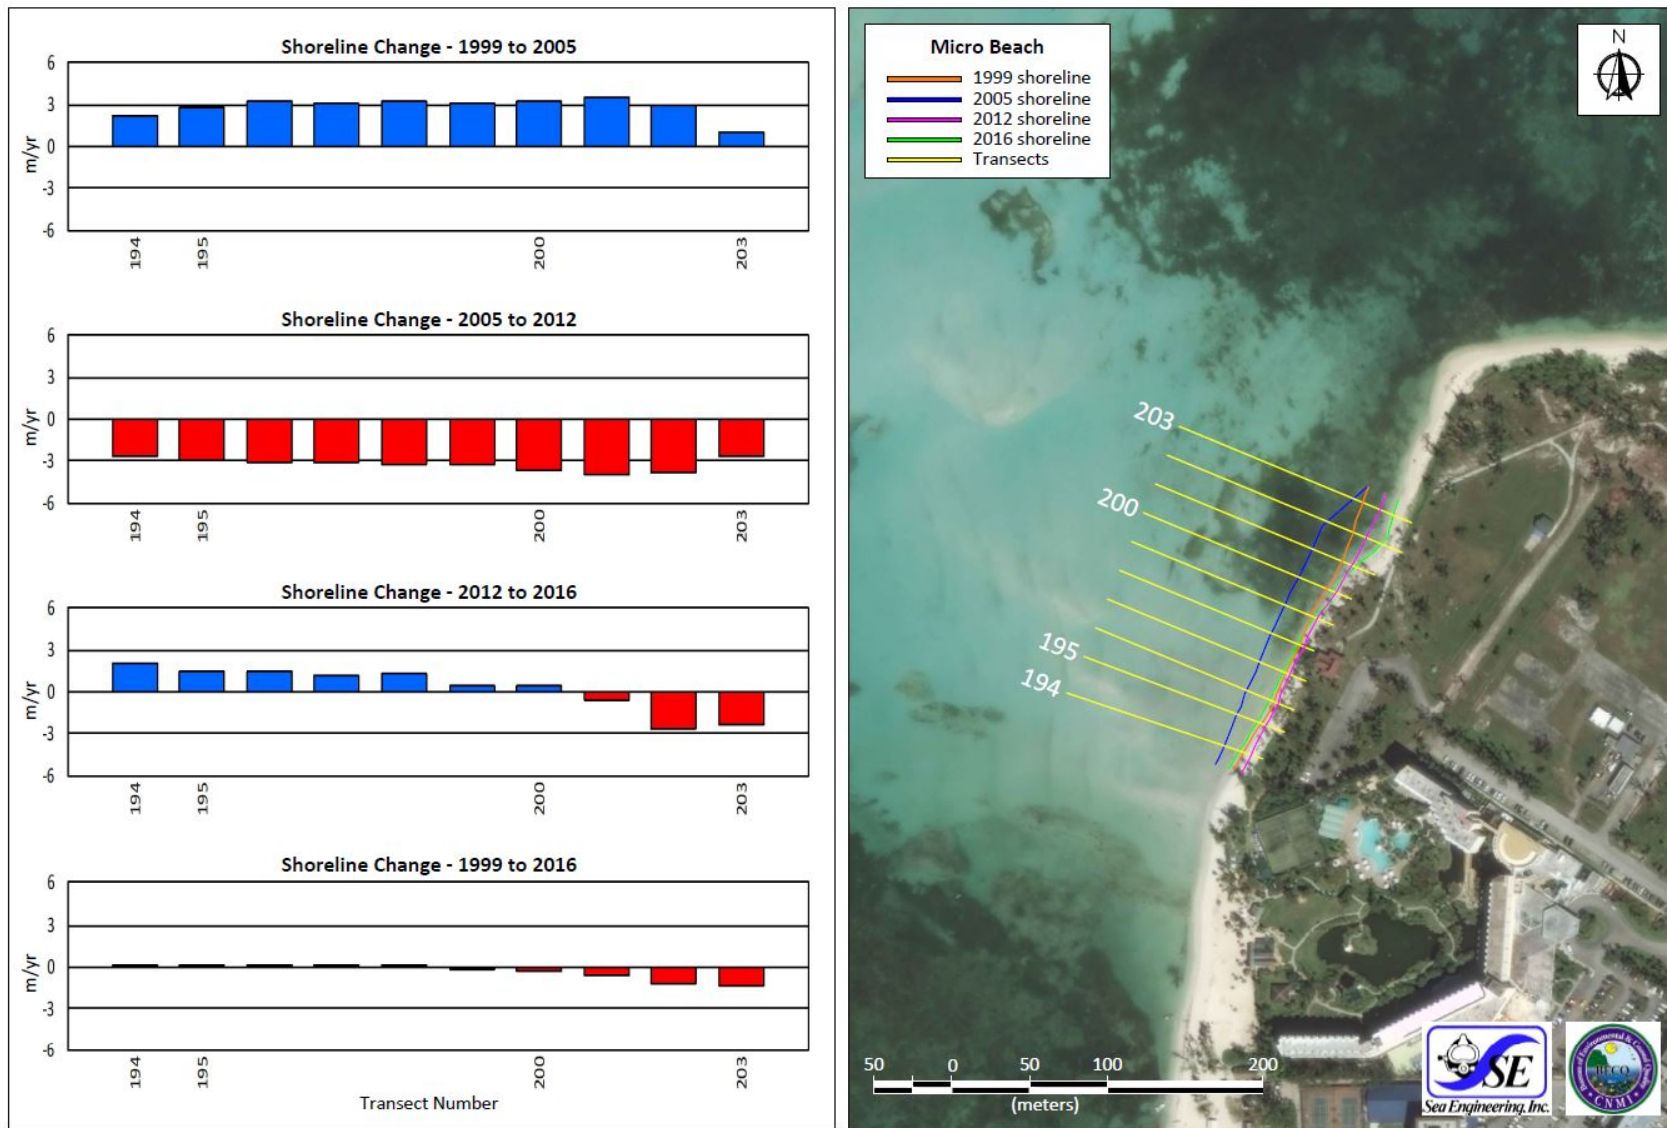
Map 12 Micro Beach historical shoreline change (1999 to 2016)

The Micro Beach shoreline appears to be fairly dynamic and vulnerable to episodic erosion. There was evidence of active erosion along the south end of the shoreline where remnants of a collapsed pier extended from the beach into the nearshore. There were dead Ironwood trees on the upper beach on the north section of the shoreline that were presumably felled by storm surge and/or high winds caused by storm surge. The beach fronting the damaged concrete path had recovered and was 35 to 40 meters wide and covered with transient vegetation at the time of the site visit.

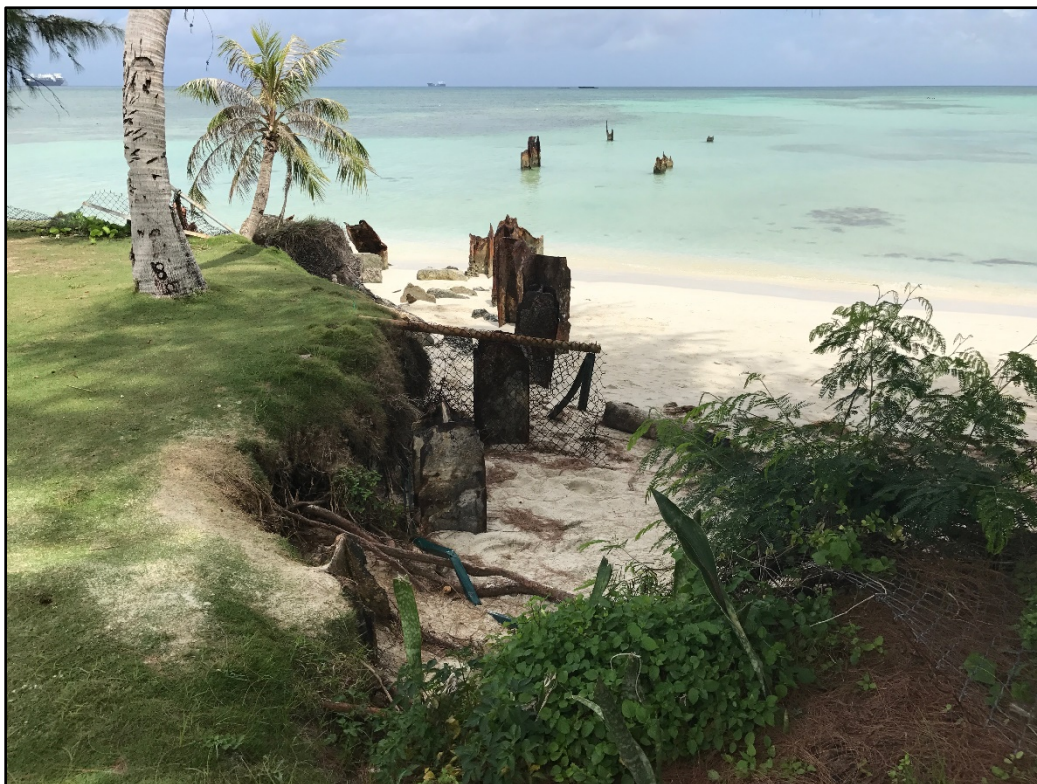
There was evidence of active erosion along the south end of the shoreline (Figure 131). There were three dead Ironwood trees on the upper beach on the north section of the shoreline that were presumably felled by storm surge and/or high winds caused by a typhoon (Figure 132). Micro Beach appears to be fairly dynamic and is vulnerable to episodic erosion events. The beach fronting the damaged concrete path had recovered and was 35 to 40 m wide and covered by transient vegetation (Morning Glory and Ironwood saplings) at the time of the site visit (Figure 133). The presence of Ironwood saplings suggests that this section of the shoreline has been accreting since the last major erosion event.

Figure 130 Micro Beach, active erosion at south end of shoreline (7/2/2017)

- Evaluate options for berm enhancement, beach maintenance, and beach nourishment.
- Repair coastal access path.
- Evaluate options to relocate the coastal access path further landward.
- Install and maintain trash/recycling receptacles.
- Install and maintain public restrooms.

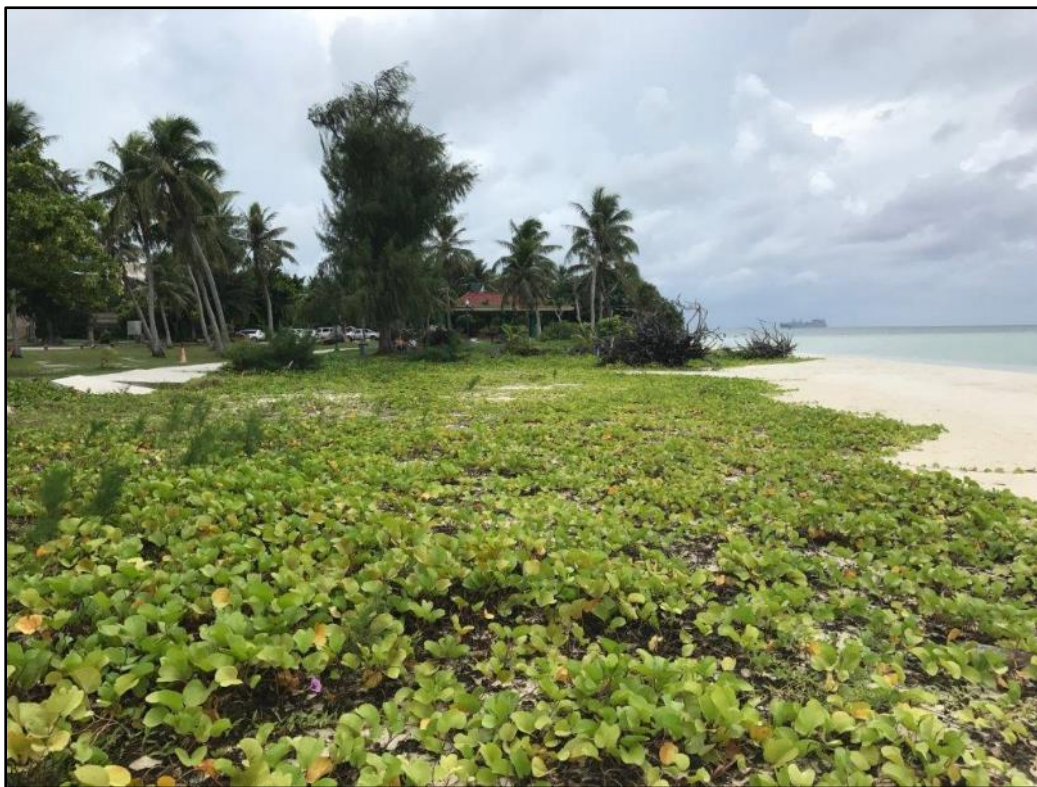
Figure 132 Micro Beach, transient vegetation on upper beach (7/2/2017)

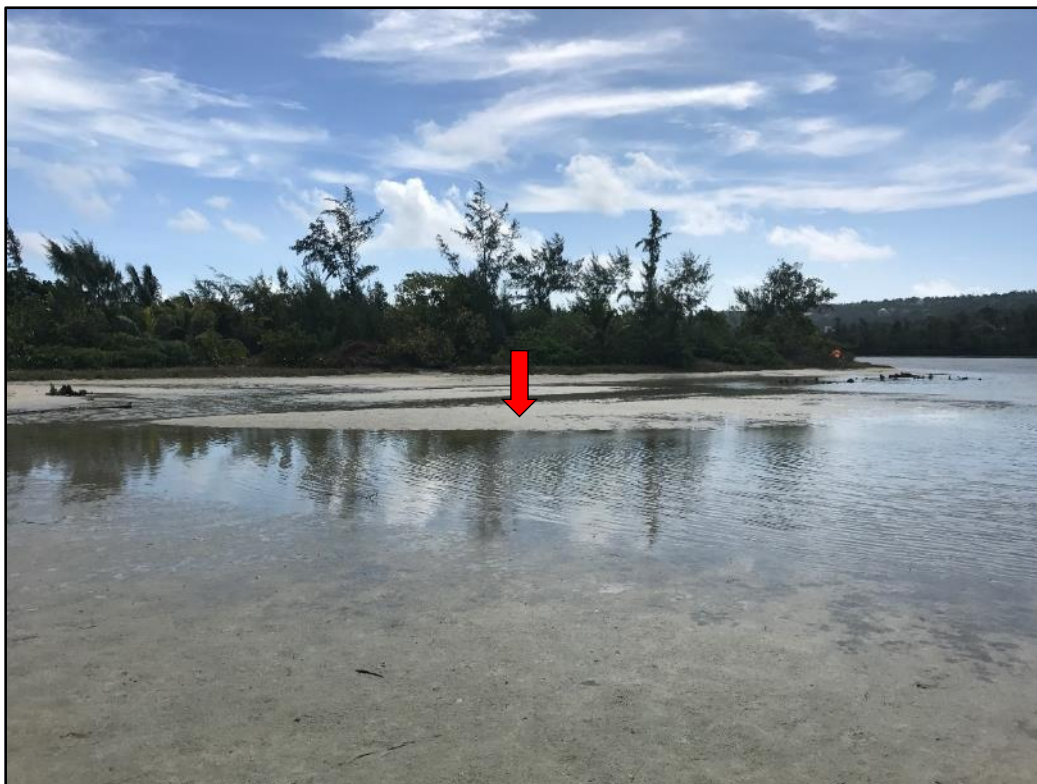
Figure 142 American Memorial Park, sand shoal in Smiling Cove (7/3/2017)

- Consider dredging the entrance to Smiling Cove Marina to ensure safe navigation.

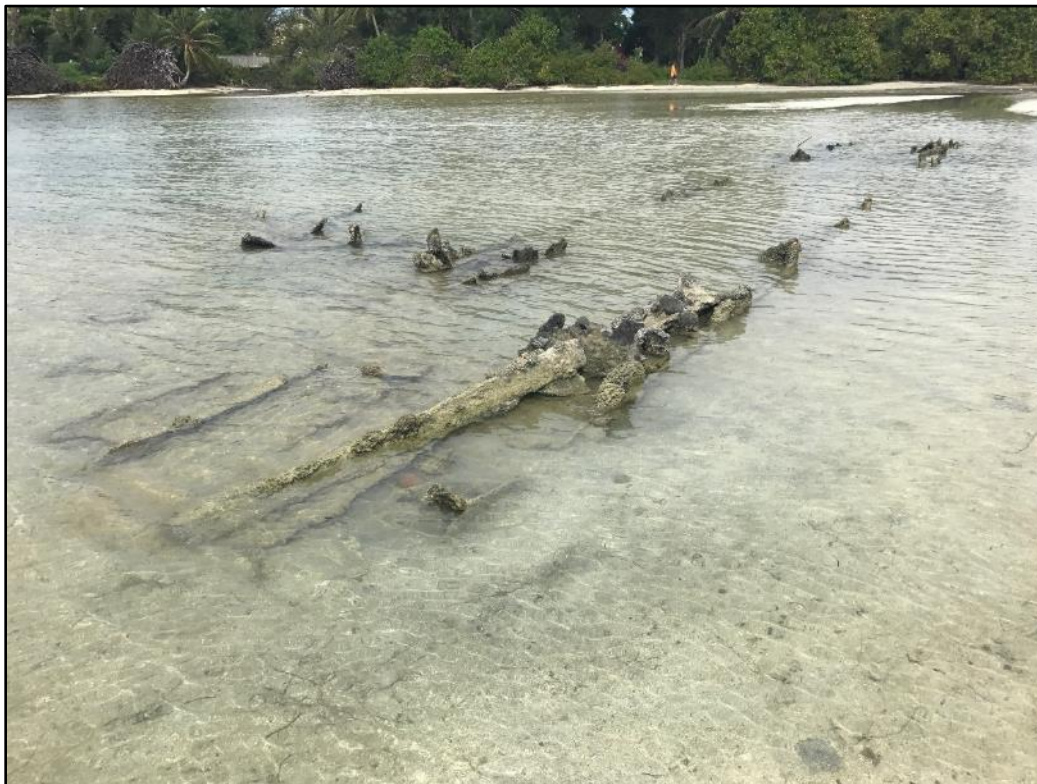
Figure 143 American Memorial Park, pier remnants in Smiling Cove (7/3/2017)

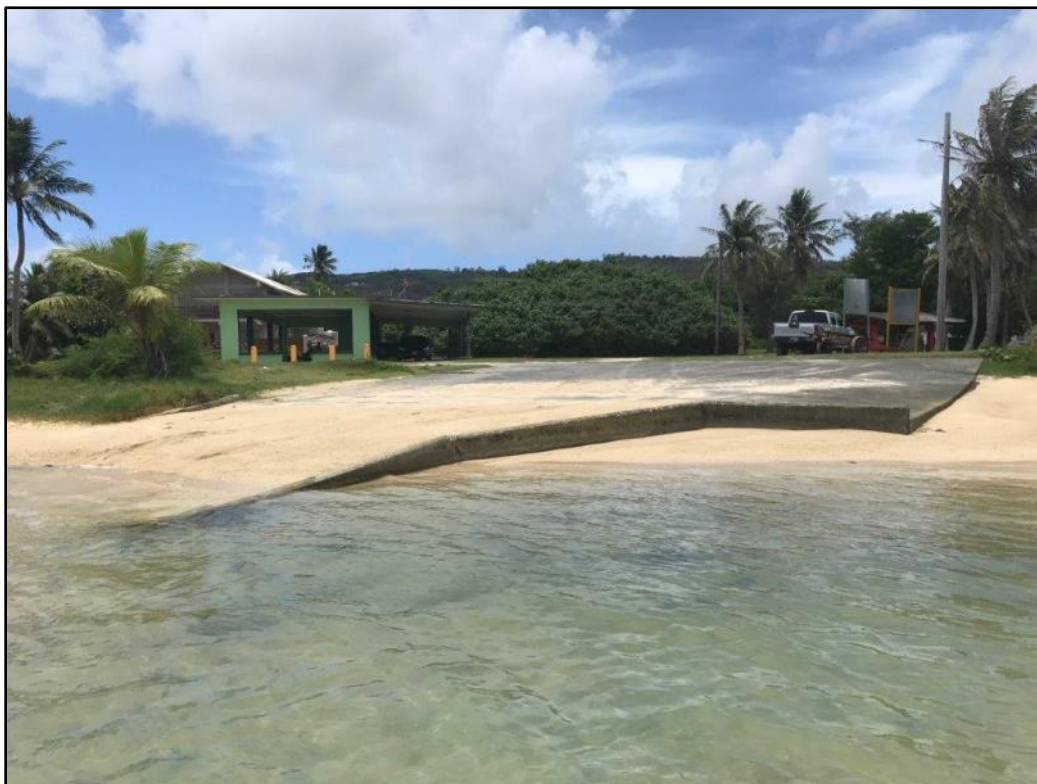
Figure 151 Tanapag Beach, stream drainage and sand shoal (7/3/2017)

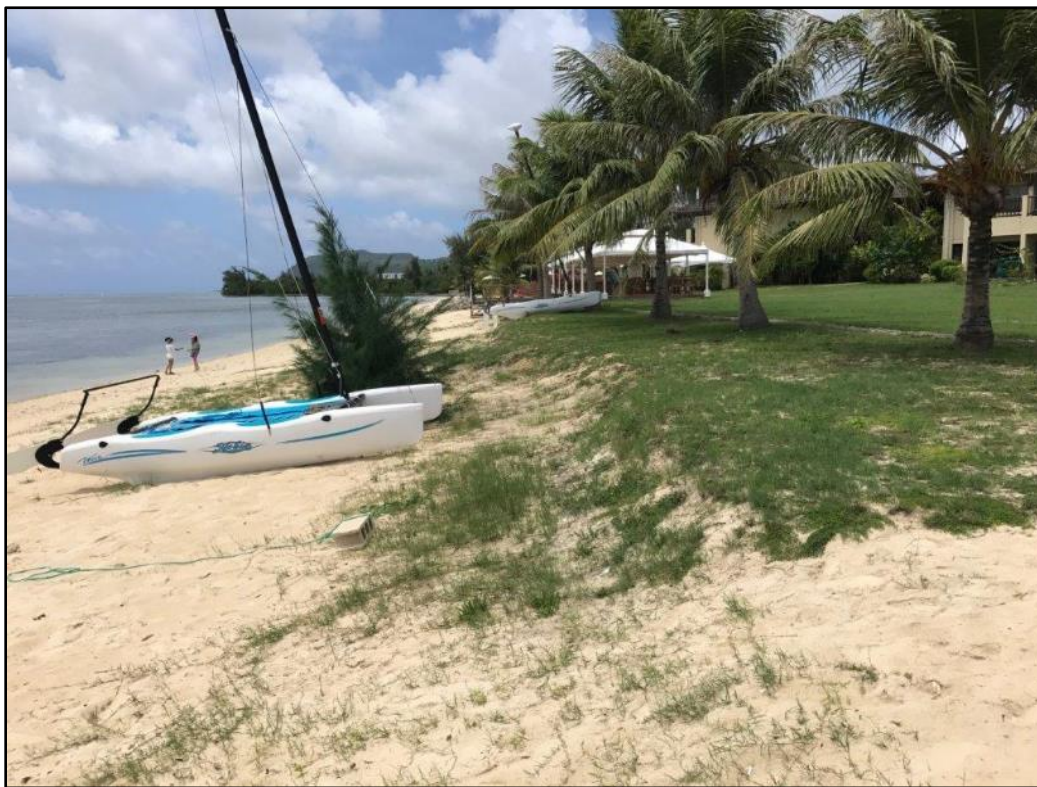
Figure 158 Aqua Resort Beach, active erosion scarp along upper berm (7/3/2017)

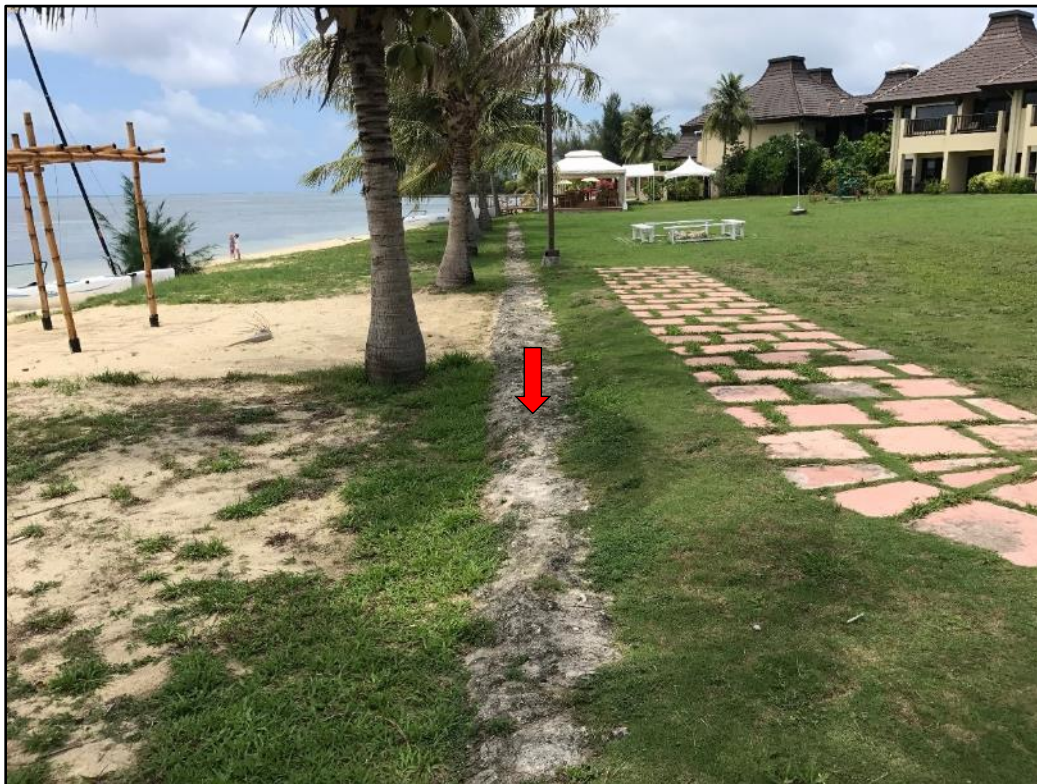
Figure 159 Aqua Resort Beach, buried seawall in backshore (7/3/2017)

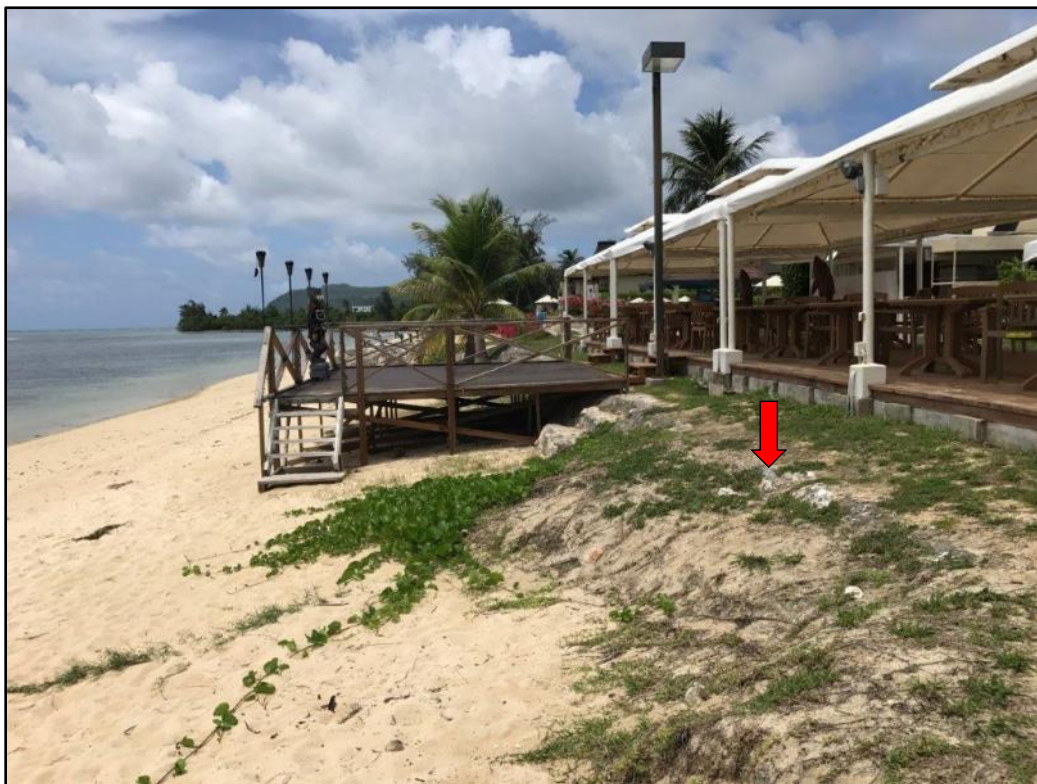
Figure 160 Aqua Resort Beach, resort infrastructure and exposed portion of seawall (7/3/2017)

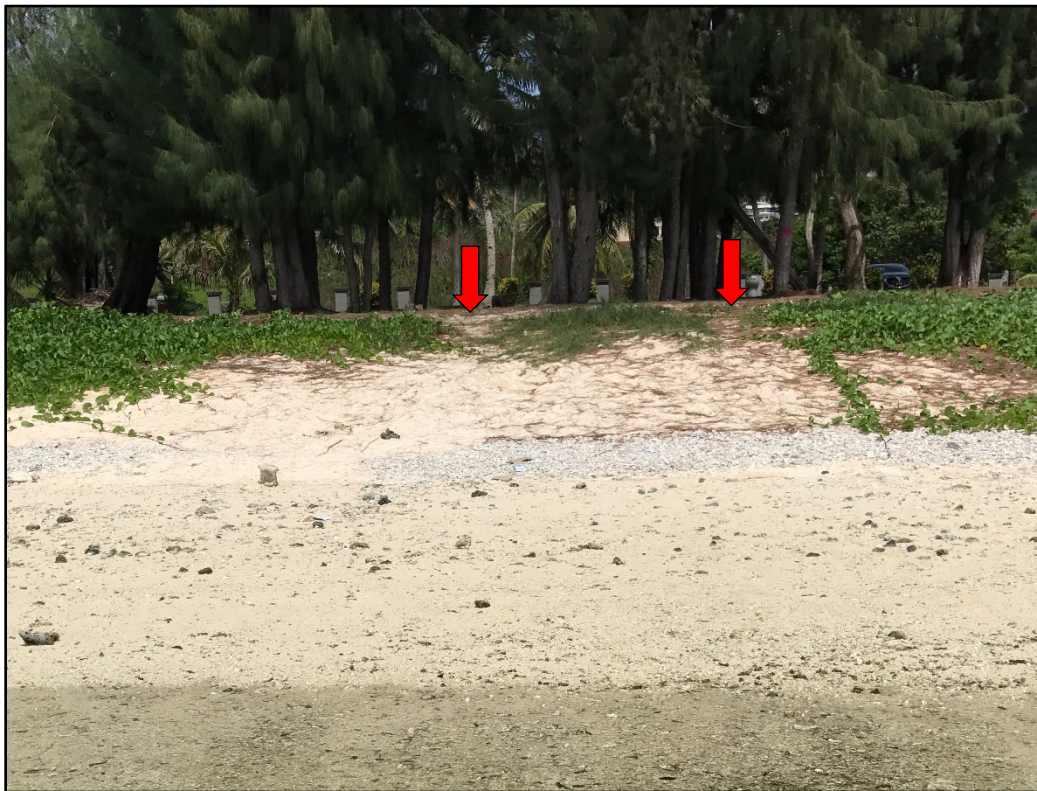
Figure 169 Pau Pau Beach, erosion scarp along the upper berm (7/3/2017)

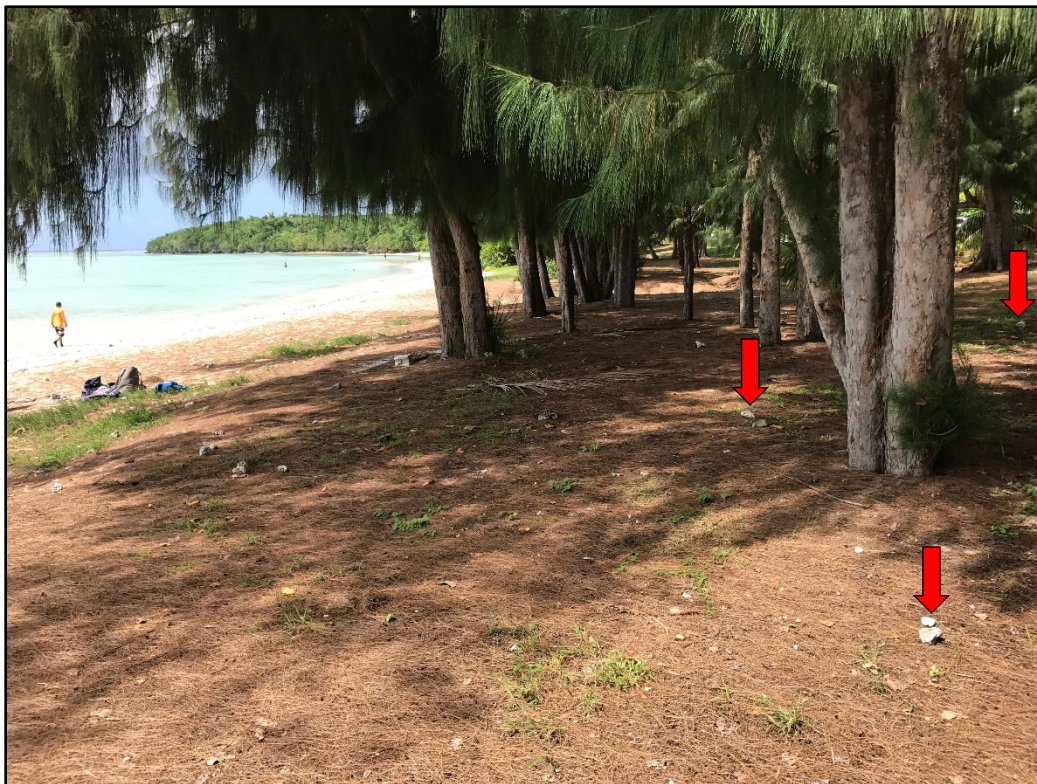
Figure 170 Pau Pau Beach, coral cobble overwash deposits in backshore area (7/3/2017)

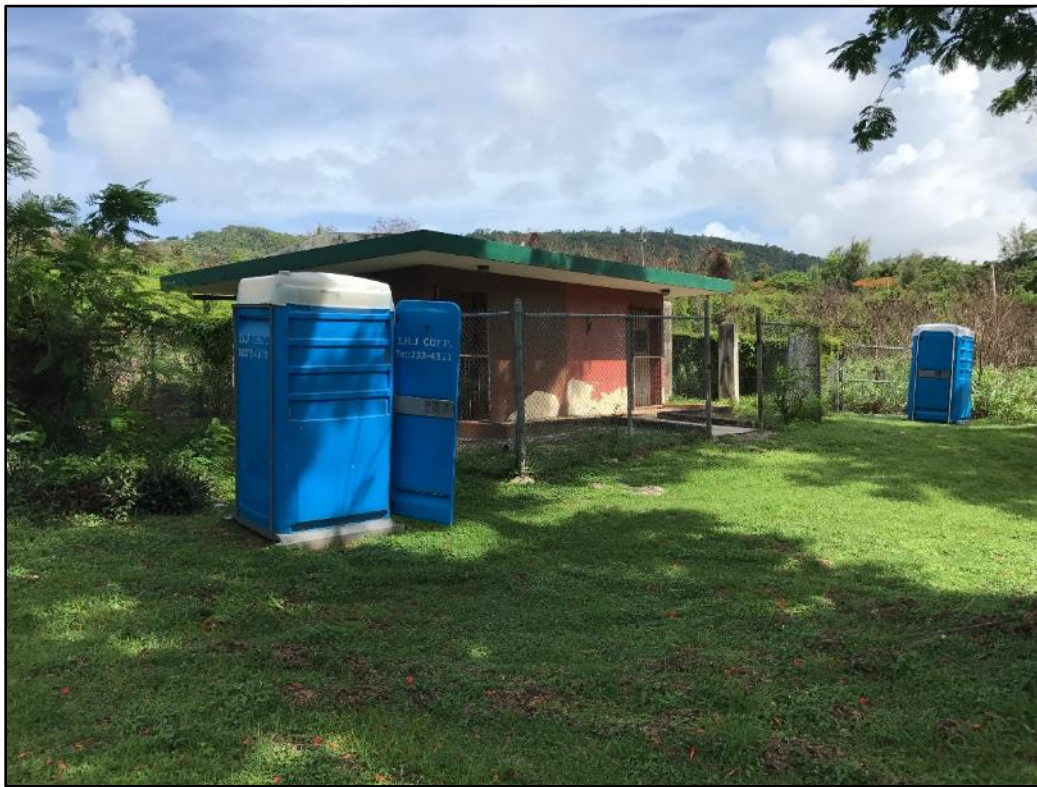
There was only one public restroom observed within the park, but it was closed due to apparent structural damage (Figure 174). Two portable restrooms were observed in the park. Vehicular access was available via Pau Pau Beach Drive, a paved road that connects to Middle Road. Parking was available in two paved parking lots with approximately 85 stalls available (Figure 175). Public access was available laterally along the shoreline.

Figure 173 Pau Pau Beach, closed public restroom (7/3/2017)

- Prioritize weekend maintenance of trash/recycling receptacles.
- Increase enforcement capacity and education to reduce driving and parking on berms.
- Identify and prioritize drainage improvements.
- Repair and maintain public restrooms.

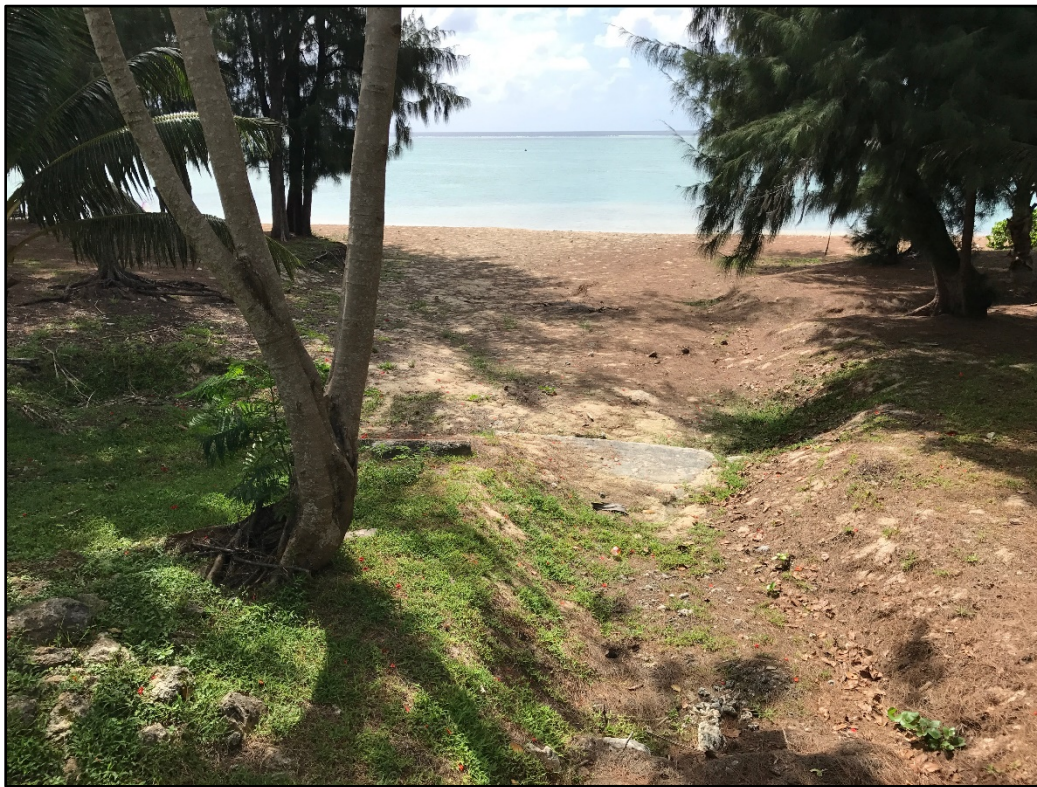
The backshore area was well-maintained and the structures appeared to be in good condition. There was evidence of active erosion along the upper berm, but it appeared to be minor. The berm was bisected at several locations by drainage features (Figure 176) and surface water runoff from the paved parking areas (Figure 177).

Figure 175 Pau Pau Beach, berm bisected by drainage (7/3/2017)

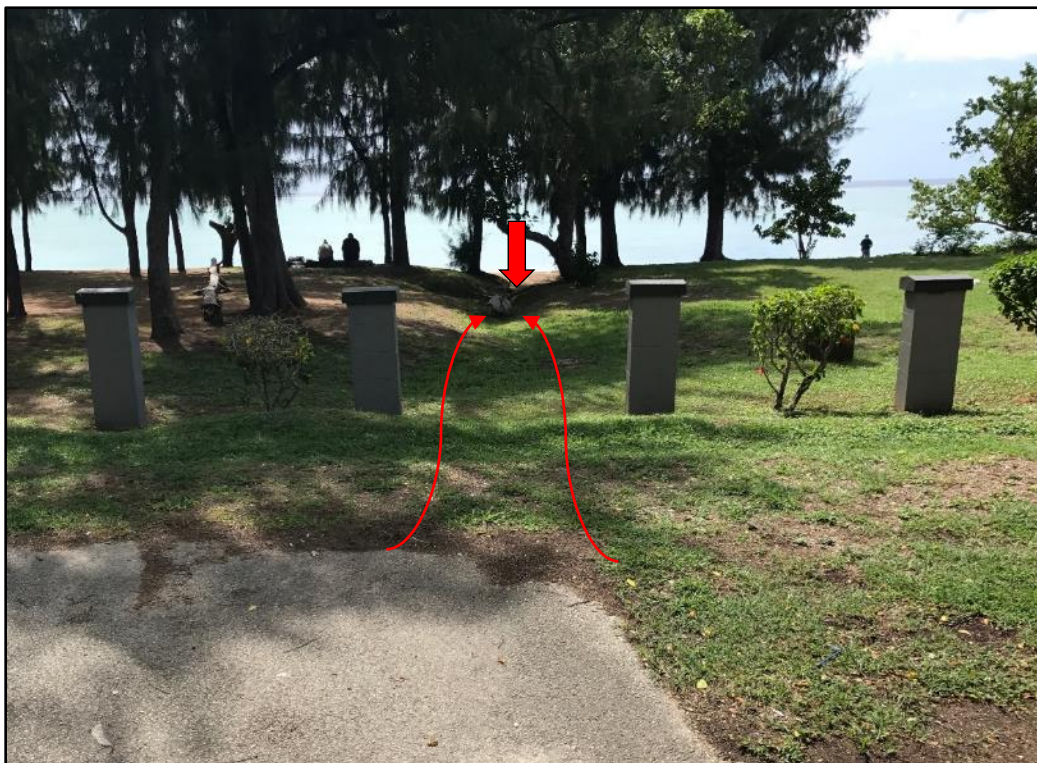
Figure 176 Pau Pau Beach, berm bisected by surface water runoff from parking lot (7/3/2017)

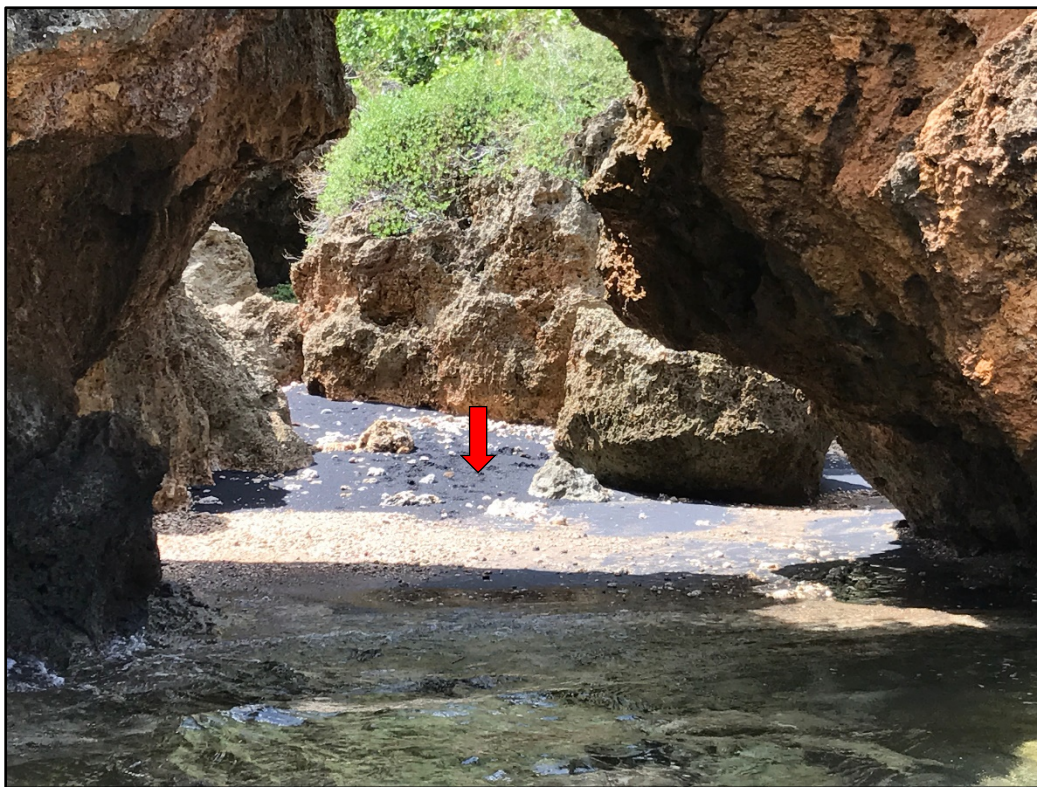
Issues that affected the overall user experience at Jeffrey's Beach included limited access, lack of amenities, and the extensive amount of marine debris along the shoreline. Parking and walking along Route 36 is dangerous and hiking conditions along the unpaved access road are very poor. There were no amenities, trash/recycling receptacles, or public restrooms observed in the area. There are also concerns regarding water quality in the Talofoto Stream drainage (Figure 189). Water quality could potentially be degraded due to various sources of pollution from the upland area of the watershed. Heavy rain events may transport sediment and pollutants to the shoreline, which could result in excess nutrients and macroalgae in the Talofoto Stream and the nearshore waters.

Figure 183 Jeffrey's Beach, marine debris along the shoreline (7/4/2017)
