SAIPAN SHORELINE ACCESS AND SHORELINE ENHANCEMENT ASSESSMENT (SASEA)

Island of Saipan, Commonwealth of the Northern Mariana Islands

March 2018

Sea Engineering, Inc.
Makai Research Pier
41-305 Kalanianaʻole Hwy
Waimanalo, HI 96795

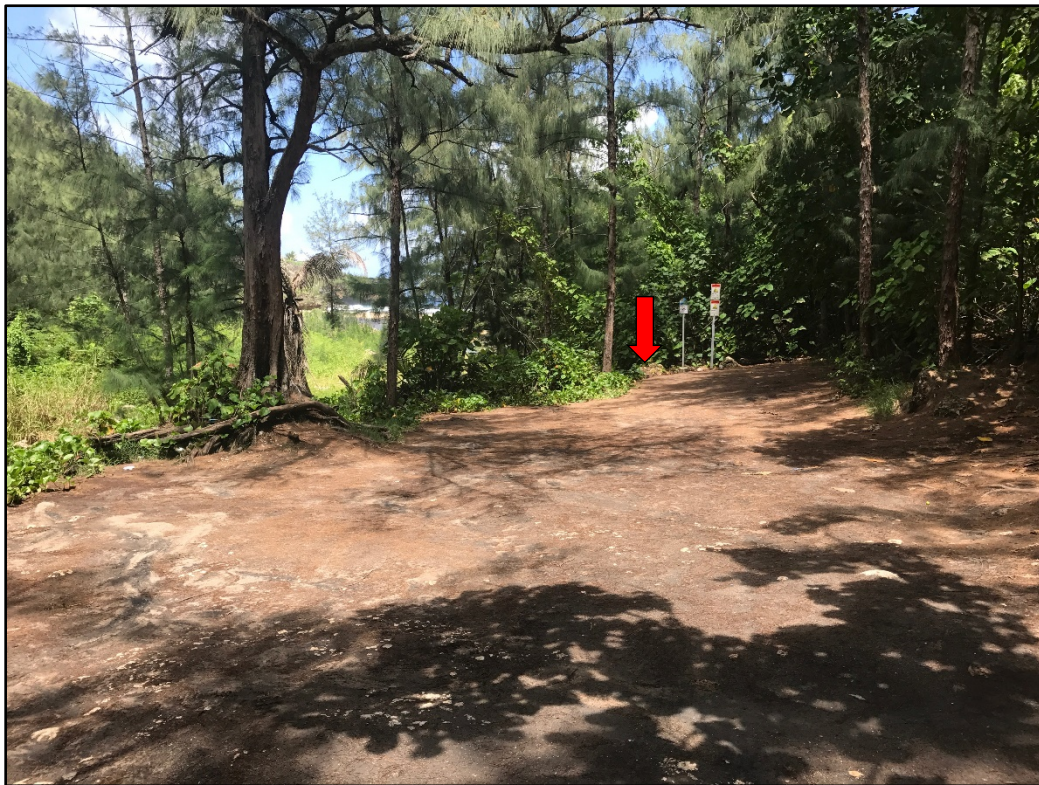
Issues that affected the overall user experience at Jeffrey's Beach included limited access, lack of amenities, and the extensive amount of marine debris along the shoreline. Parking and walking along Route 36 is dangerous and hiking conditions along the unpaved access road are very poor. There were no amenities, trash/recycling receptacles, or public restrooms observed in the area. There are also concerns regarding water quality in the Talofoto Stream drainage (Figure 189). Water quality could potentially be degraded due to various sources of pollution from the upland area of the watershed. Heavy rain events may transport sediment and pollutants to the shoreline, which could result in excess nutrients and macroalgae in the Talofoto Stream and the nearshore waters.

Figure 185 Jeffrey's Beach, unpaved coastal access road (7/4/2017)

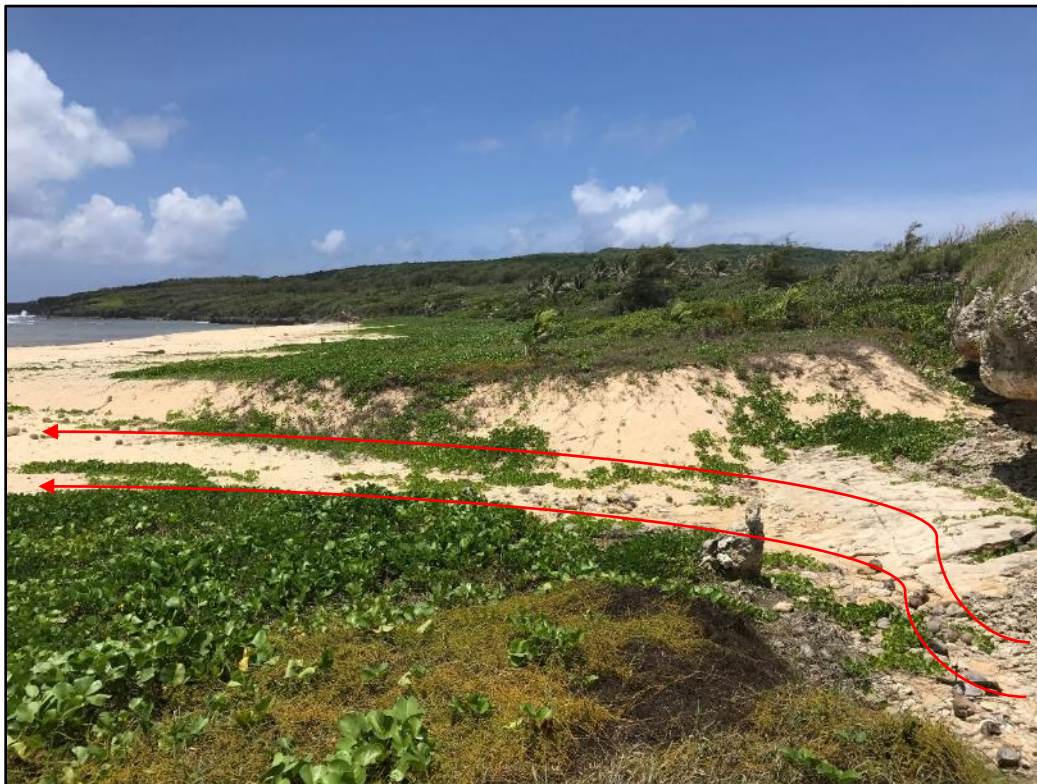
There was evidence of active erosion along the upper beach and dune, particularly in the areas where the dune was bisected by drainage features. The amount of coral cobble in the back beach indicates that Tank Beach is exposed to very high wave energy. Tank Beach is bounded by nearly-vertical limestone cliffs to the north and south, so the dominant direction of sediment transport is presumably cross-shore. A review of historical aerial images from 2005 to 2017 showed dramatic fluctuations in beach width; however, the beach appeared to be relatively stable over time.

Figure 195 Tank Beach, dune bisected by drainage (7/4/2017)

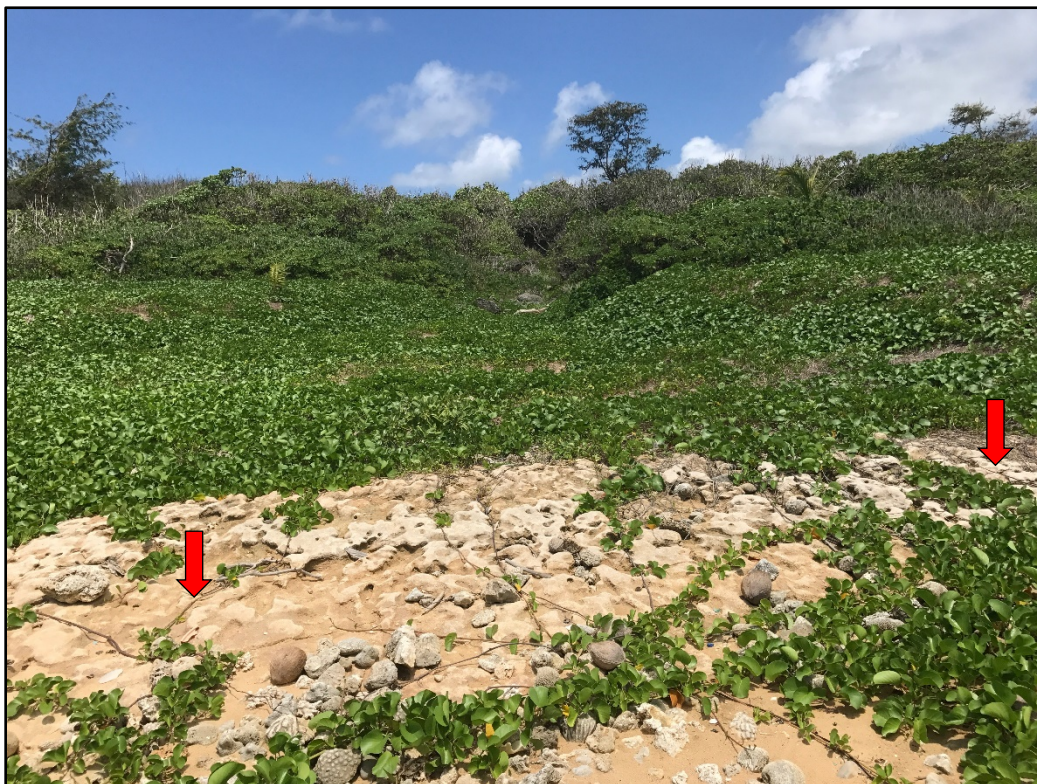
Figure 196 Tank Beach, intermittent outcrops of lithified beach rock (7/4/2017)

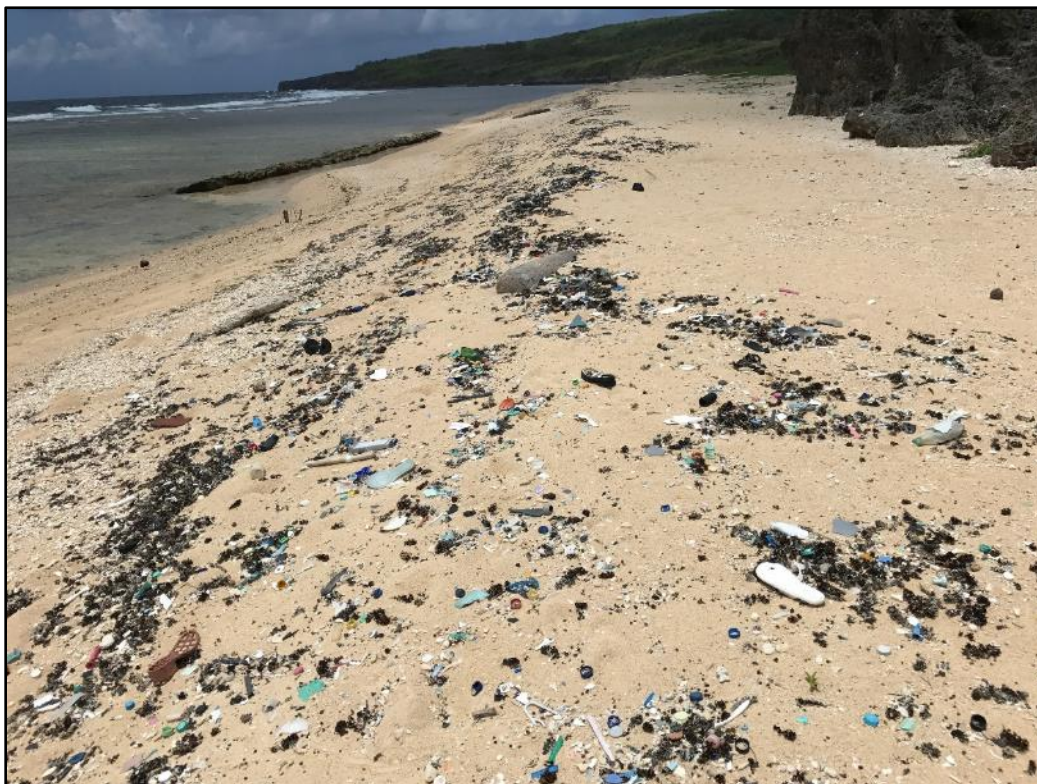
Amenities were limited to the coastal access trail and a trash receptacle. There were no public restrooms observed in the area. Food and beverages were available for purchase at a small hut located at the trailhead. Issues that affected the overall user experience at Tank Beach included the lack of amenities and the extensive amount of marine debris along the shoreline (Figure 201).

Figure 200 Tank Beach, marine debris lines (7/4/2017)

- Install and maintain trash/recycling receptacles.
- Install and maintain public restrooms (possibly a composting toilet).
- Coordinate beach cleanups to remove marine debris.
