# Laolao Bay Watershed

## Existing Conditions and Opportunities

### Interim Report

August 2020 DRAFT

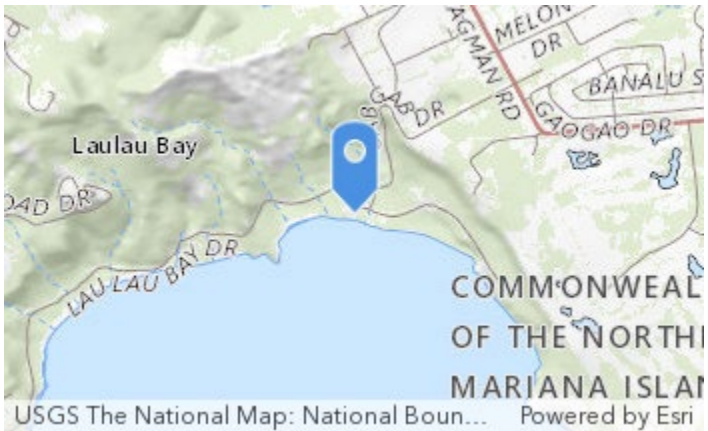
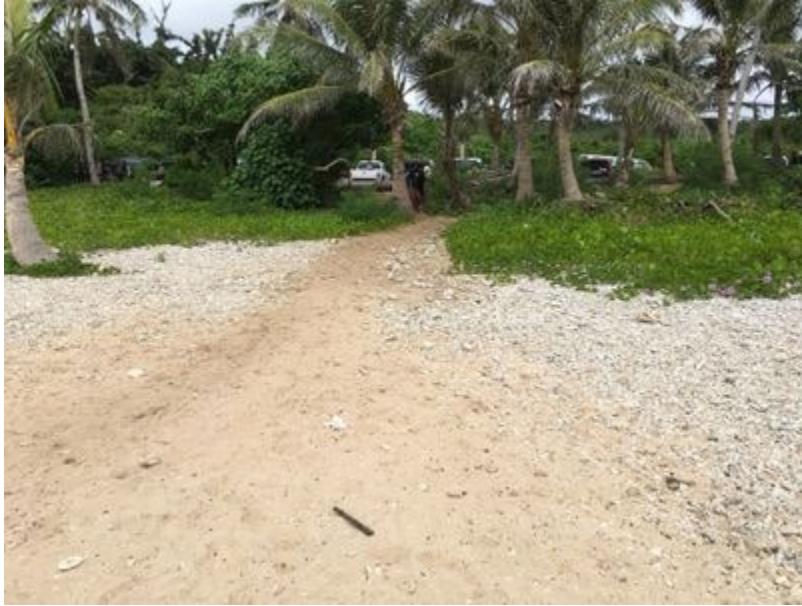
<b>Site ID:</b> LL103	<b>Watershed:</b> Laolao
<b>Crew:</b> EH	<b>Date/Time:</b> 01/21/2020 8:44 PM
<b>Project Type:</b> <ul style="list-style-type: none"> <li>Shoreline Stabilization</li> <li>Watershed Education/Signage</li> </ul>

<b>Enforcement Needed:</b> No	
<b>Severity Rating:</b> 3	
<b>Implementation Priority:</b> Love it! (High)	
<b>Descriptions of Existing Conditions:</b> Uncontrolled pedestrian circulation eroding shoreline. Multiple access points to beach.	
<b>Description of Proposed Opportunity:</b> Organize circulation. Limit access points to 2. Stabilize path, add boardwalk? Part of dive site improvement/organization. Educational opportunity with signage etc.	
<b>Challenges/Constraints:</b> Heavy use, storms, hard to change user habits.	
<b>Additional Notes:</b> See previous dive site concept.	
<b>Site Photo</b>

**Additional Photo Caption:** West

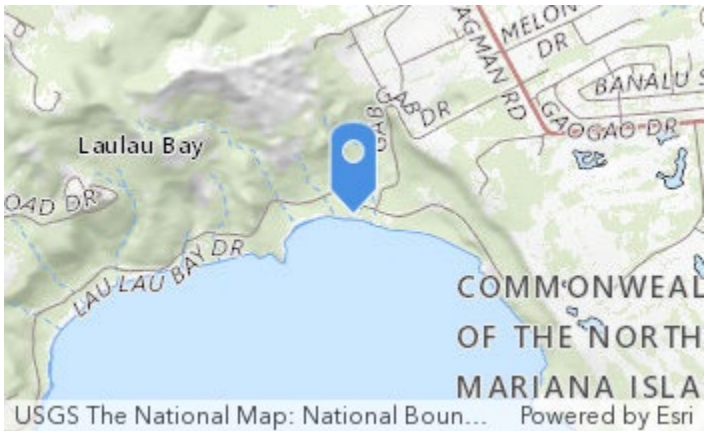
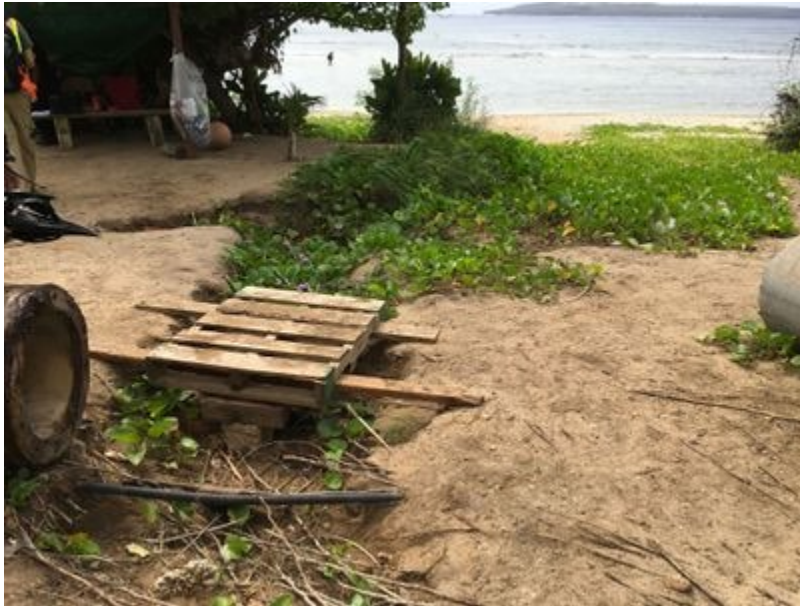
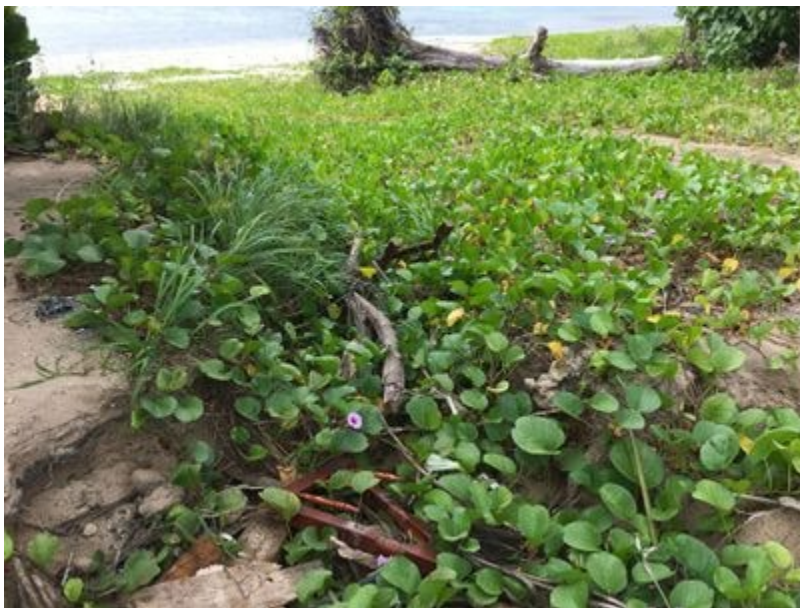
<b>Site ID:</b> LL104	<b>Watershed:</b> Laolao
<b>Crew:</b> EH	<b>Date/Time:</b> 01/21/2020 8:48 PM
<b>Project Type:</b> <ul style="list-style-type: none"> <li>Stormwater Retrofit</li> <li>Shoreline Stabilization</li> <li>Watershed Education/Signage</li> </ul>

<b>Enforcement Needed:</b> No	
<b>Severity Rating:</b> 4	
<b>Implementation Priority:</b> Love it! (High)	
<b>Descriptions of Existing Conditions:</b> Parking lot runoff eroding shoreline along pedestrian path.	
<b>Description of Proposed Opportunity:</b> Parking lot reorganization. Control drainage. Stabilization and reorganization of circulation. Stabilize path.	
<b>Challenges/Constraints:</b> Heavy use, hard to change user habits.	
<b>Additional Notes:</b> See previous dive site concept and new sketch.	
<b>Site Photo</b>

**Additional Photo Caption:** Trash in gully.

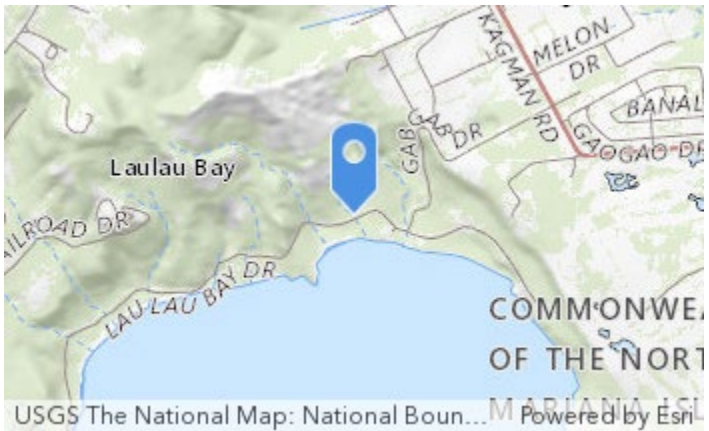
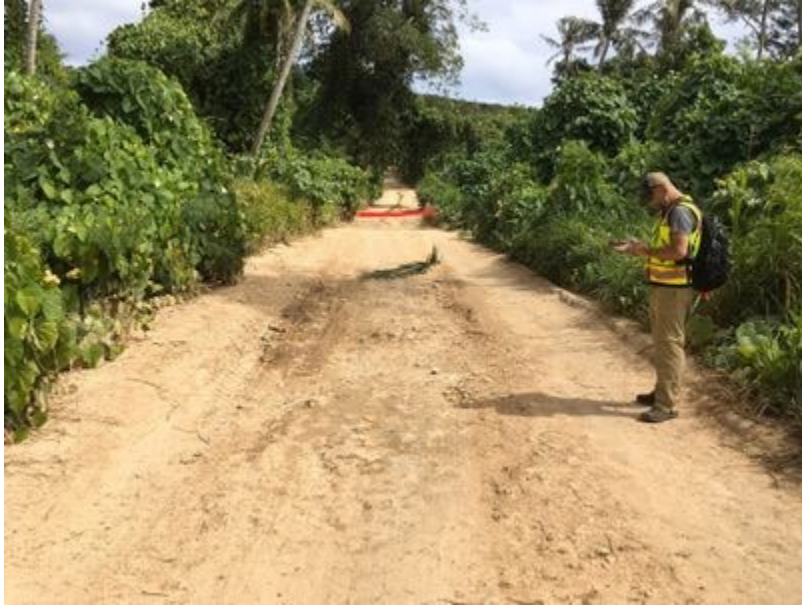
<b>Site ID:</b> LL112	<b>Watershed:</b> Laolao
<b>Crew:</b> EH	<b>Date/Time:</b> 01/21/2020 9:45 PM
<b>Project Type:</b> <ul style="list-style-type: none"> <li>• Drainage Infrastr., Maint. &amp; Repair</li> <li>• Stormwater Retrofit</li> <li>• Unpaved Road Stabilization</li> </ul>

Lau Lau Bay Dr. LL112	Culvert concentrates flow into narrow channel. Road grading is rough mounds and dips. <i>Replace and widen culvert (convert to a large box culvert). Construct broad dip or other diversion at low point to direct road runoff into ditch.</i>	4	H	\$\$	●				
Lau Lau Bay Dr. LL113	Runoff discharges off road at uncontrolled location causing scouring and erosion down to very deep pool. 9' down to 3' wide plunge pool. Inflow to east comes onto road ~100 ft uphill and runs along road contributing to runoff at shoreline. <i>Create broad dip and formalize overflow. Upstream drainage: pitch discharges to road. Runs along eastern edge to informal drainage overflow.</i>	5	H	\$	●		●		
Gap Gap Rd. LL124/ 125/ 126	Washout and erosion of steep, unpaved road surface. <i>See PIWI conceptual plans. Proposed improvements to drainage were confirmed and remain valid.</i>	5	H	\$\$	●				
LL127	Swales on both side of paved road are filled with vegetation preventing runoff from entering. Runoff remains on paved surface and drains down Gap Gap Rd. Clean and cut back vegetation & reestablish/clean road swales. <i>Construct broad dip or waterbar (speed bump) at top of</i>	4	H	\$	●	●

<b>Enforcement Needed:</b> No	
<b>Severity Rating:</b> 4	
<b>Implementation Priority:</b> Love it! (High)	
<b>Descriptions of Existing Conditions:</b> Culvert at road concentrates flow into narrow channel. Road grading is rough mounds and dips.	
<b>Description of Proposed Opportunity:</b> Replace and widen culvert (convert to a large box culvert). Construct broad dip or other diversion at low point to direct road runoff into ditch.	
<b>Challenges/Constraints:</b> Road traffic and frequency of use. Subsurface material? Depth of culvert (very deep from road surface).	
<b>Additional Notes:</b>	
<b>Site Photo</b>

**Additional Photo Caption:** culvert crossing in red

REPLACE / WIDEN CULVERT - SAME LARGE BOX CULVERT  
CONSTRUCT BROAD DIP OR OTHER DIVERSION @ LOW POINT  
TO DIRECT ROAD RUNOFF INTO DITCH

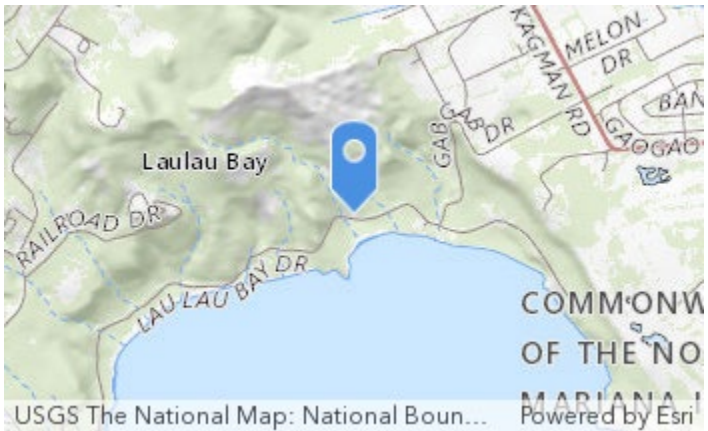
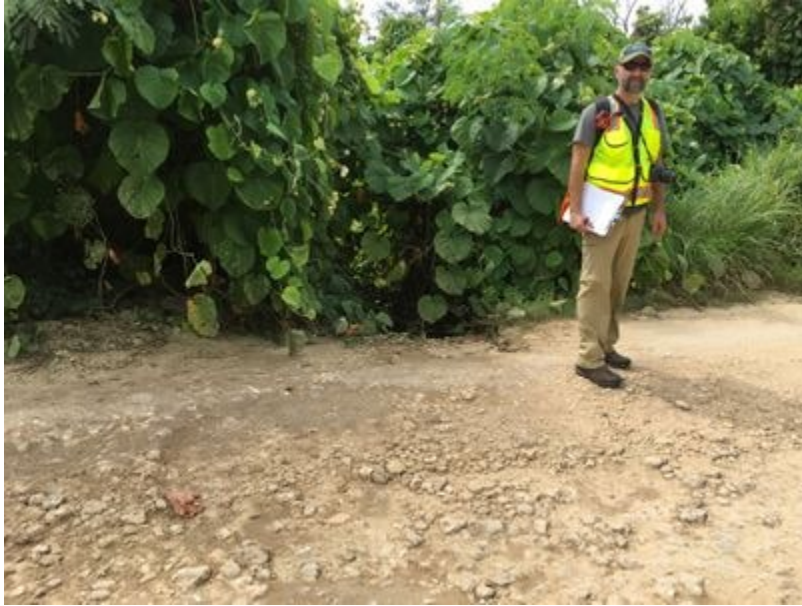
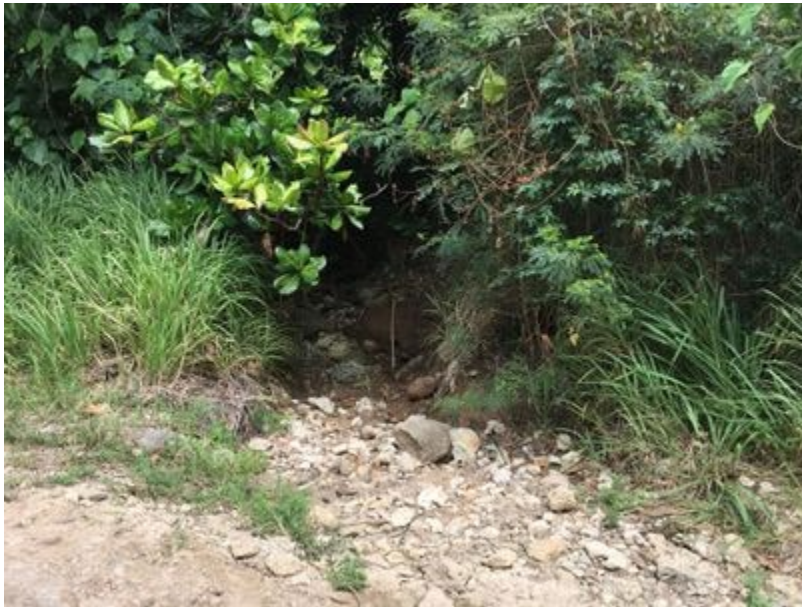
<b>Site ID:</b> LL113	<b>Watershed:</b> Laolao
<b>Crew:</b> EH	<b>Date/Time:</b> 01/21/2020 9:57 PM
<b>Project Type:</b> <ul style="list-style-type: none"> <li>• Drainage Infrastr., Maint. &amp; Repair</li> <li>• Unpaved Road Stabilization</li> </ul>

<b>Enforcement Needed:</b> No	
<b>Severity Rating:</b> 5 (Severe)	
<b>Implementation Priority:</b> Love it! (High)	
<b>Descriptions of Existing Conditions:</b> Runoff discharges off road at uncontrolled location causing scouring and erosion down to very deep pool. 9' down to plunge pool. 3' wide. Inflow to east comes onto road ~100 ft uphill and runs along road. Contributing	
<b>Description of Proposed Opportunity:</b> Create broad dip and formalize overflow. Upstream drainage: pitch discharges to road. Runs along eastern edge to informal drainage overflow.	
<b>Challenges/Constraints:</b> Large volume and high velocity of runoff discharge onto road. No culvert crossing.

LARGE VOLUME / HIGH VELOCITY RUN OFF DISCHARGE  
ONTO ROAD - NO CULVERT CROSSING

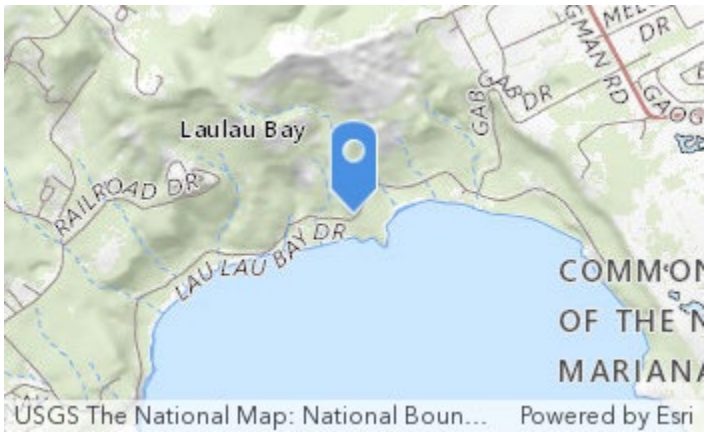
<b>Site ID:</b> LL117	<b>Watershed:</b> Laolao
<b>Crew:</b> EH	<b>Date/Time:</b> 01/21/2020 10:21 PM
<b>Project Type:</b>

<b>Enforcement Needed:</b> No	
<b>Severity Rating:</b> 1	
<b>Implementation Priority:</b> Not that important (Low)	
<b>Descriptions of Existing Conditions:</b> Grass track, possibly to homestead or lookout?	
<b>Description of Proposed Opportunity:</b> Monitor for possible issues.	
<b>Challenges/Constraints:</b>	
<b>Additional Notes:</b>	
<b>Site Photo</b>

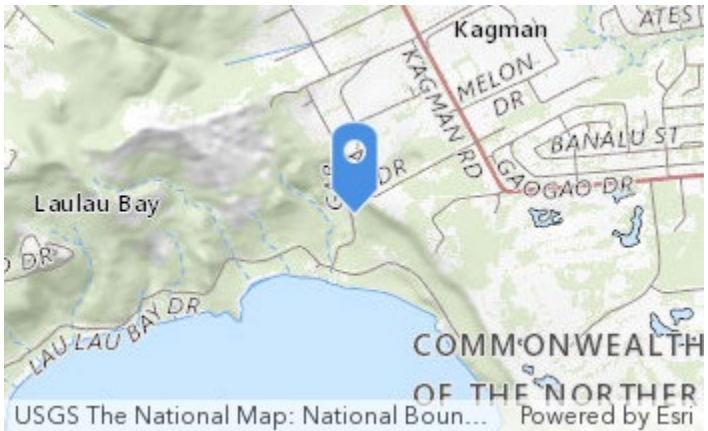
<b>Site ID:</b> LL124	<b>Watershed:</b> Laolao
<b>Crew:</b> EH	<b>Date/Time:</b> 01/21/2020 11:06 PM
<b>Project Type:</b> <ul style="list-style-type: none"> <li>Stormwater Retrofit</li> <li>Unpaved Road Stabilization</li> </ul>

<b>Enforcement Needed:</b> No	
<b>Severity Rating:</b> 5 (Severe)	
<b>Implementation Priority:</b> Love it! (High)	
<b>Descriptions of Existing Conditions:</b> Washout and erosion along Gap Gap Road. See previous conceptual plans	
<b>Description of Proposed Opportunity:</b> See previous plans. Proposed improvements to drainage were confirmed and remain valid.	
<b>Challenges/Constraints:</b> Very steep road, accessibility and long-term maintenance.	
<b>Additional Notes:</b>	
<b>Site Photo</b>

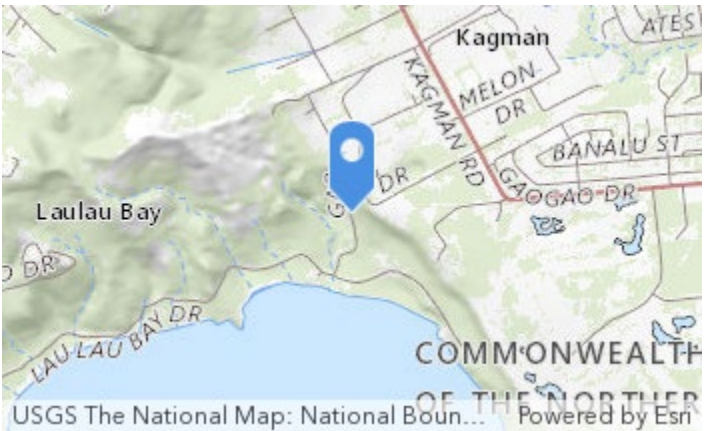
<b>Site ID:</b> LL125	<b>Watershed:</b> Laolao
<b>Crew:</b> BK	<b>Date/Time:</b> 01/21/2020 11:08 PM
<b>Project Type:</b> <ul style="list-style-type: none"> <li>Unpaved Road Stabilization</li> </ul>

<b>Enforcement Needed:</b> No	
<b>Severity Rating:</b> 5 (Severe)	
<b>Implementation Priority:</b> Love it! (High)	
<b>Descriptions of Existing Conditions:</b> Washout and erosion along Gap Gap Road. See previous conceptual plans	
<b>Description of Proposed Opportunity:</b> See previous plans. Proposed improvements to drainage were confirmed and remain valid.	
<b>Challenges/Constraints:</b> Very steep road, accessibility and long-term maintenance.	
<b>Additional Notes:</b>	
<b>Site Photo</b>

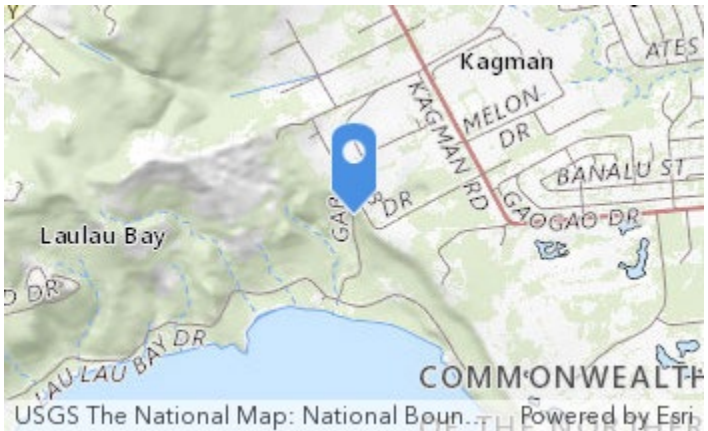
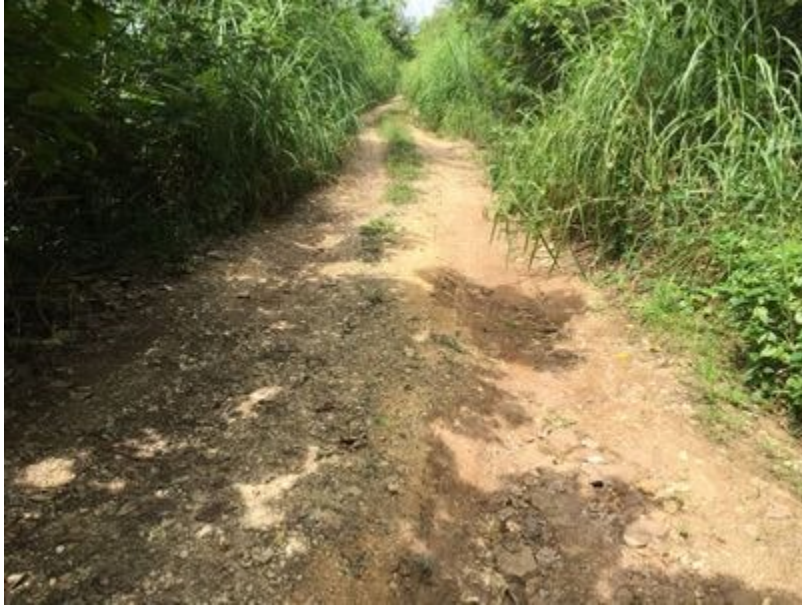
<b>Site ID:</b> LL126	<b>Watershed:</b> Laolao
<b>Crew:</b> BK	<b>Date/Time:</b> 01/21/2020 11:14 PM
<b>Project Type:</b> <ul style="list-style-type: none"> <li>Unpaved Road Stabilization</li> </ul>

<b>Enforcement Needed:</b> No	
<b>Severity Rating:</b> 5 (Severe)	
<b>Implementation Priority:</b> Love it! (High)	
<b>Descriptions of Existing Conditions:</b> Washout and erosion along Gap Gap Road. See previous conceptual plans	
<b>Description of Proposed Opportunity:</b> See previous plans. Proposed improvements to drainage were confirmed and remain valid.	
<b>Challenges/Constraints:</b> Very steep road, accessibility and long-term maintenance.	
<b>Additional Notes:</b>	
<b>Site Photo</b>

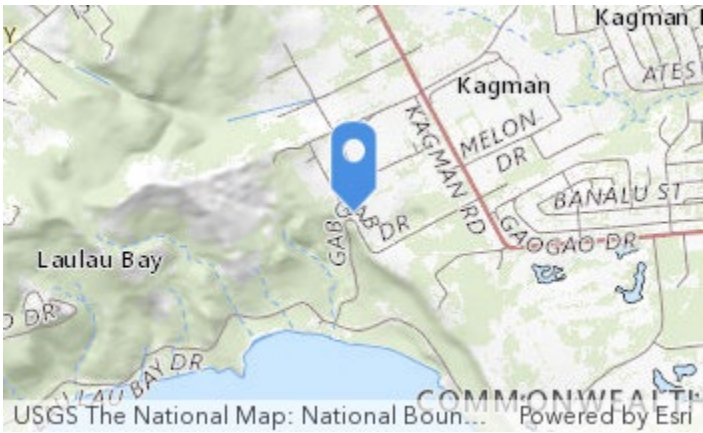
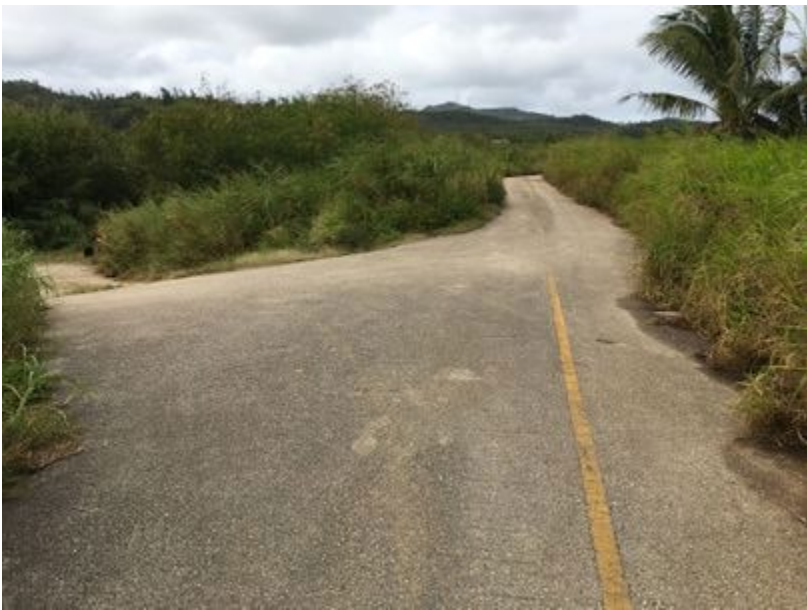
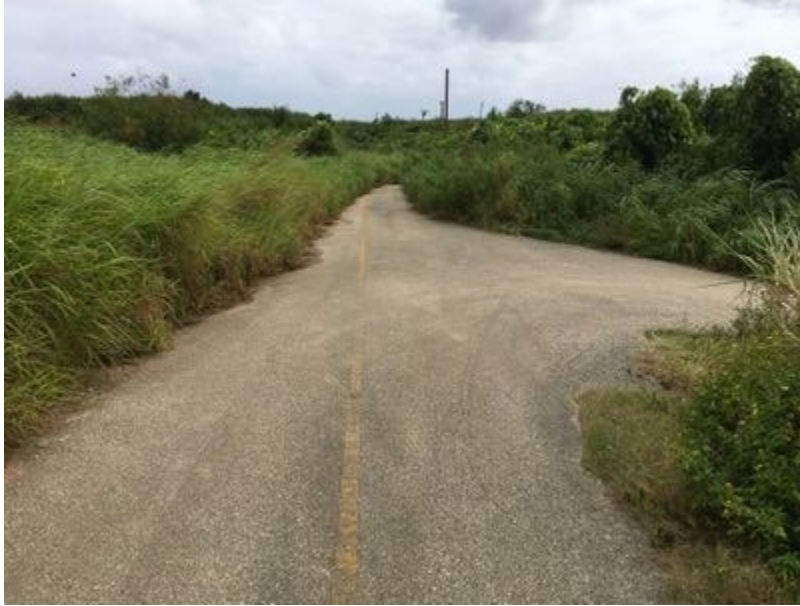
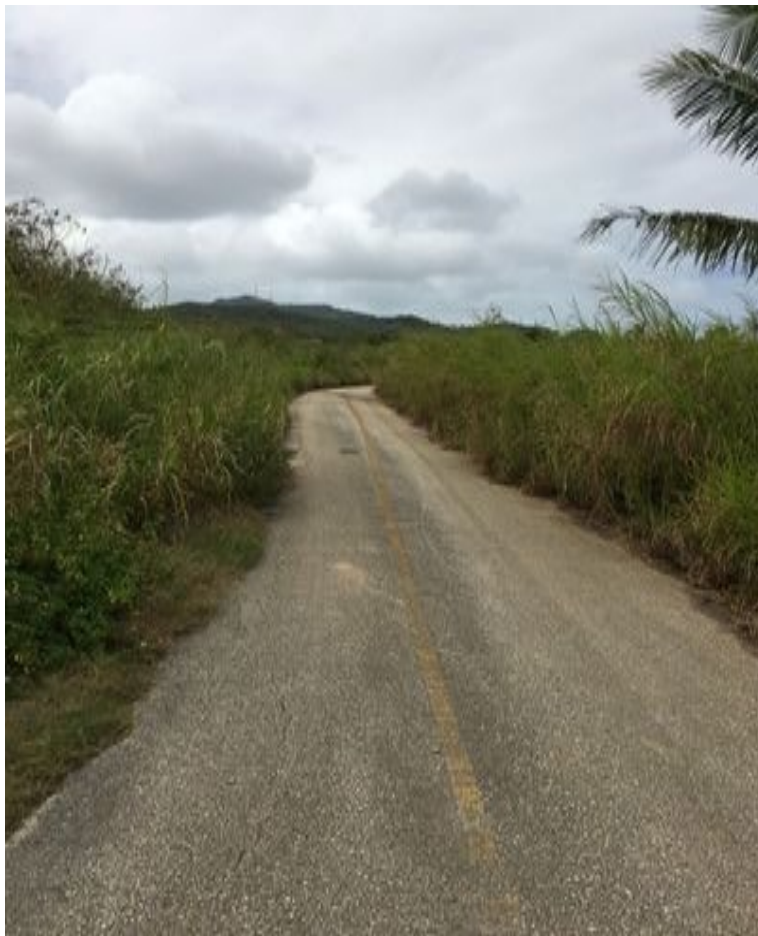
<b>Site ID:</b> LL127	<b>Watershed:</b> Laolao
<b>Crew:</b> BK	<b>Date/Time:</b> 01/21/2020 11:25 PM
<b>Project Type:</b> <ul style="list-style-type: none"> <li>• Drainage Infrastr., Maint. &amp; Repair</li> <li>• Unpaved Road Stabilization</li> </ul>

<b>Enforcement Needed:</b> No	
<b>Severity Rating:</b> 4	
<b>Implementation Priority:</b> Love it! (High)	
<b>Descriptions of Existing Conditions:</b> Swales on both side of paved road are filled with vegetation and runoff cannot get into swales. Runoff remains on paved surface and drains down Gap Gap Road.	
<b>Description of Proposed Opportunity:</b> Clean and cut back vegetation & reestablish/clean road swales. Construct broad dip or waterbar (speed bump) at top of Gap Gap Road to keep runoff on pavement/off Gap Gap. Possibly use bioretention, but may	
<b>Challenges/Constraints:</b> Swale maintenance. Has been difficult to get anything implemented at this site, which has been identified several times. Bioretention would have slope/grading changes.

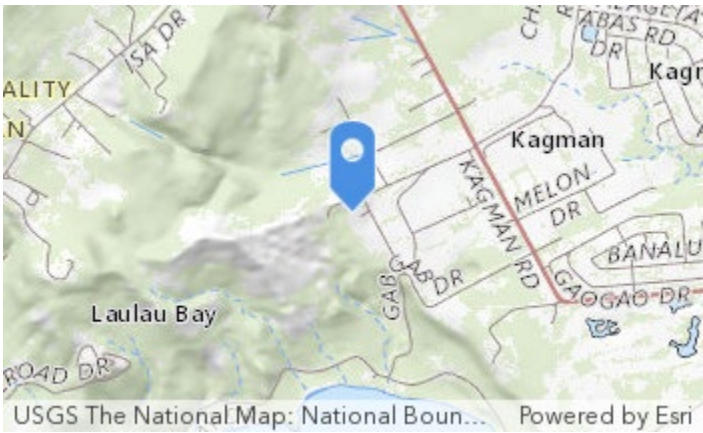
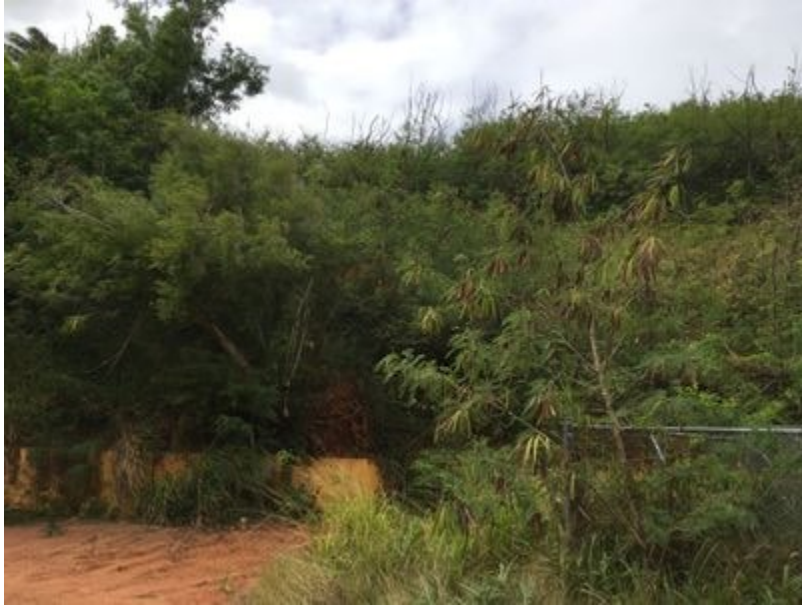
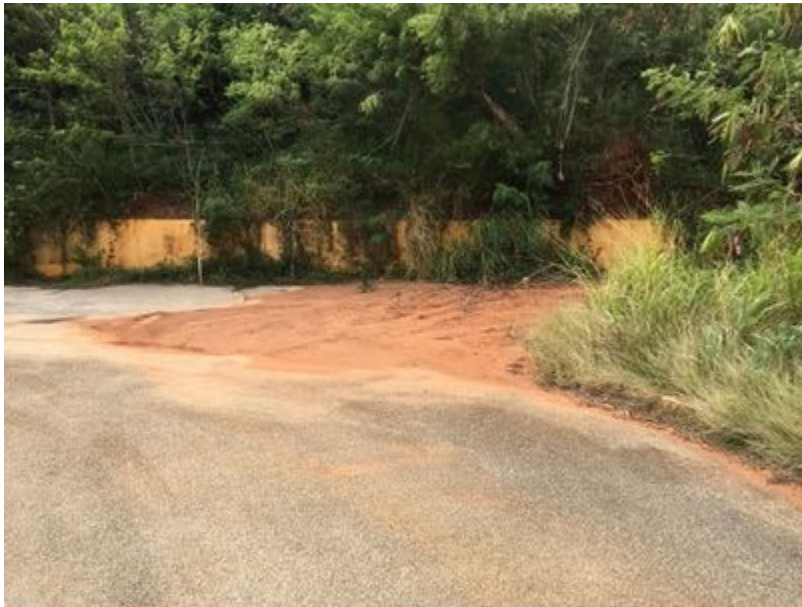
<b>Site ID:</b> LL132	<b>Watershed:</b> Laolao
<b>Crew:</b> EH	<b>Date/Time:</b> 01/21/2020 11:51 PM
<b>Project Type:</b> <ul style="list-style-type: none"> <li>Upland Revegetation/Restoration</li> </ul>

<b>Enforcement Needed:</b> Yes	
<b>Severity Rating:</b> 5 (Severe)	
<b>Implementation Priority:</b> It's OK (Med)	
<b>Descriptions of Existing Conditions:</b> Tree blown down over retaining wall with root destabilization. Excessively steep slope above retaining wall (which appears too short). Bare dirt/mudslide on steep slope. Sediment source to parking lot/rain garden and	
<b>Description of Proposed Opportunity:</b> Clean up sediment and slope. Extend wall and stabilize slope.	
<b>Challenges/Constraints:</b> Very steep slopes. Detention center may be abandoned so may only be feasible if detention center is in use.	
<b>Additional Notes:</b>	
<b>Site Photo</b>

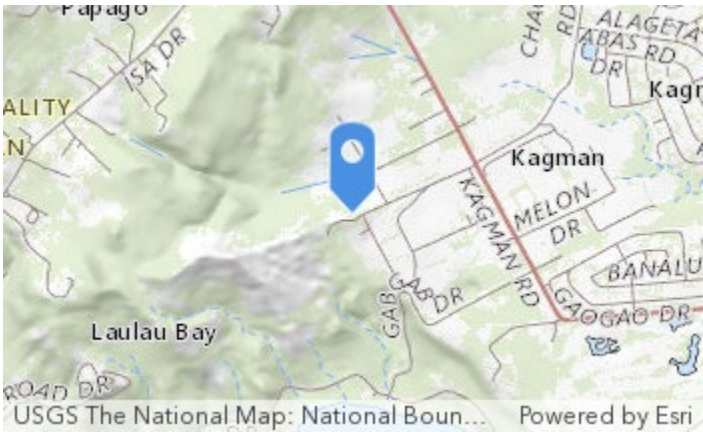
<b>Site ID:</b> LL133	<b>Watershed:</b> Laolao
<b>Crew:</b> EH	<b>Date/Time:</b> 01/22/2020 12:00 AM
<b>Project Type:</b> <ul style="list-style-type: none"> <li>Unpaved Road Stabilization</li> </ul>

<p>USGS The National Map: National Boun... Powered by Esri</p>
<b>Enforcement Needed:</b> Yes	
<b>Severity Rating:</b> 4	
<b>Implementation Priority:</b> Not that important (Low)	
<b>Descriptions of Existing Conditions:</b> Eroded dirt road to water tank at top of watershed.	
<b>Description of Proposed Opportunity:</b> Stabilize and remove sediment source. Apply dirt road strategies, such as dips and water bars to shed runoff. Regrade & stabilize.	
<b>Challenges/Constraints:</b> Steep slopes.	
<b>Additional Notes:</b>	
<b>Site Photo</b>

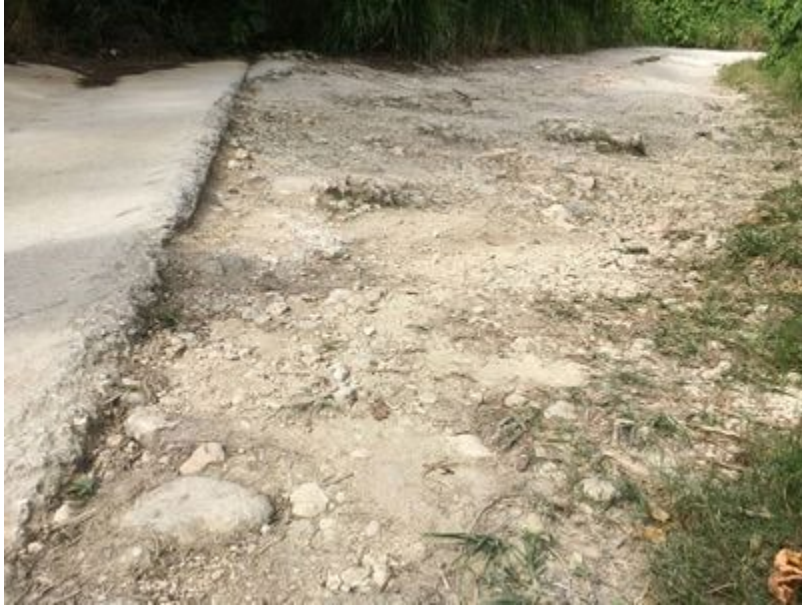
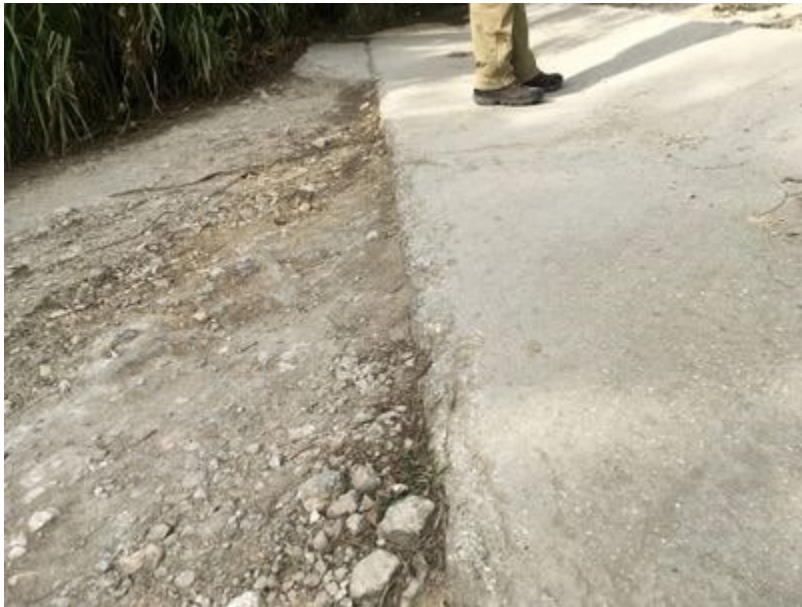
<b>Enforcement Needed:</b> No	
<b>Severity Rating:</b> 3	
<b>Implementation Priority:</b> It's OK (Med)	
<b>Descriptions of Existing Conditions:</b> Broad dip with swales (formalized downstream)	
<b>Description of Proposed Opportunity:</b> Clean swale, regrade road. Add second broad dip uphill.	
<b>Challenges/Constraints:</b> Steel slope, erosion at edge of conc. Ongoing maintenance and erosion at interface of concrete and dirt road.	
<b>Additional Notes:</b> Appears to be functional.	
<b>Site Photo</b>

**Additional Photo Caption:** Uphill

**Additional Photo Caption:** Downhill

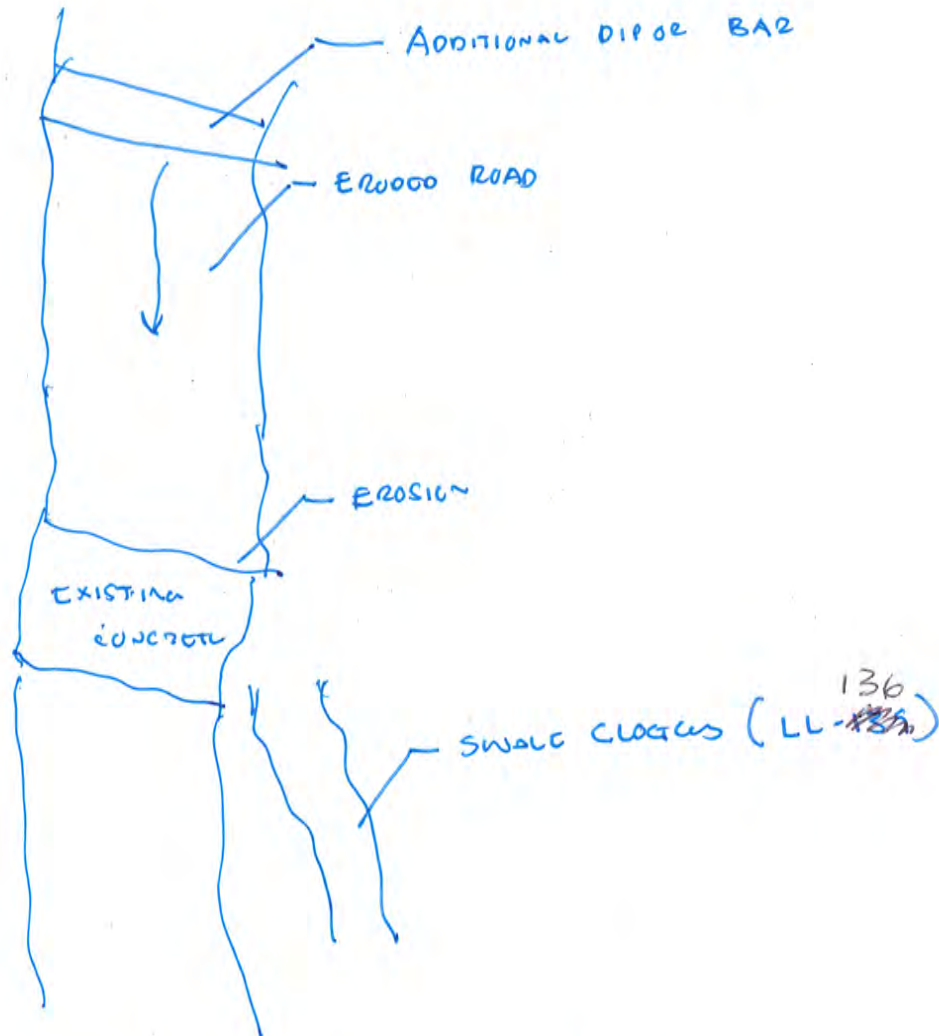
+ BROAD DIP ~~BE~~ (LOW WATER CROSSING - LWC) NEEDS REPAIR  
+ SWALES NEAR TO BE CLEANED

Challenges/Constraints: ON GOING MAINTENANCE AND DRAIN ALONG  
INTERFACE OF CONCRETE & DIRT ROAD

SEE ALSO LOW WATER CROSSING DESIGN PLANS.

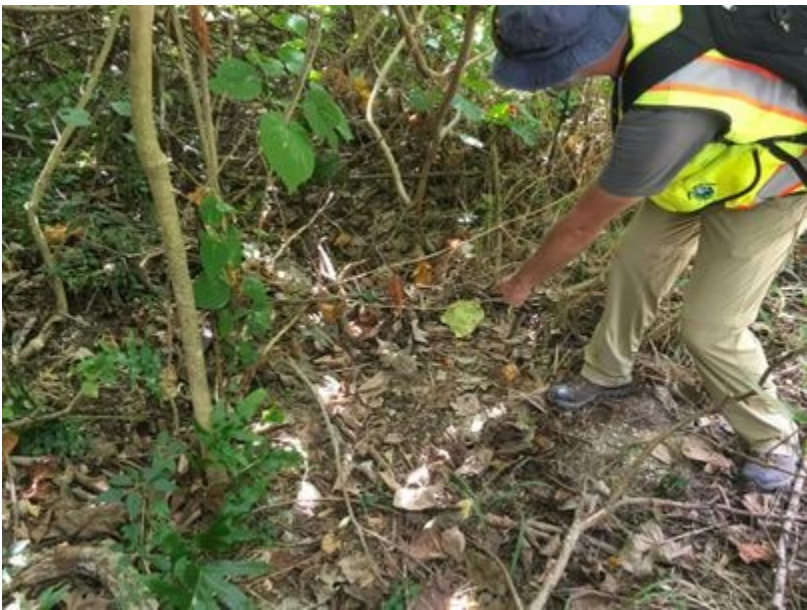
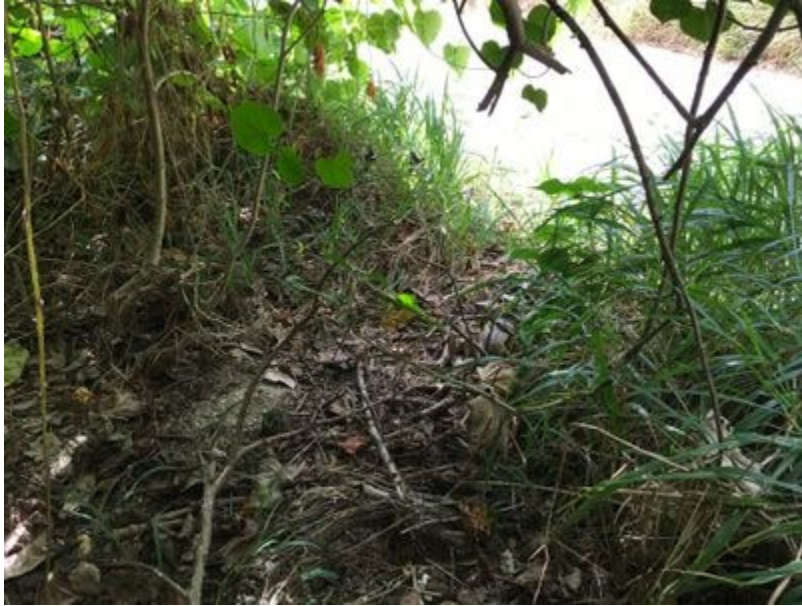
<b>Enforcement Needed:</b> Yes	
<b>Severity Rating:</b> 5 (Severe)	
<b>Implementation Priority:</b> Love it! (High)	
<b>Descriptions of Existing Conditions:</b> Clogged formalized swale. See LL135.	
<b>Description of Proposed Opportunity:</b> Clean and redirect to restore flow.	
<b>Challenges/Constraints:</b> Maintenance.	
<b>Additional Notes:</b>	
<b>Site Photo</b>

<b>Site Overview Caption:</b> Formalized channel to right. Current flow to left.

**Additional Photo Caption:** Current flow path.

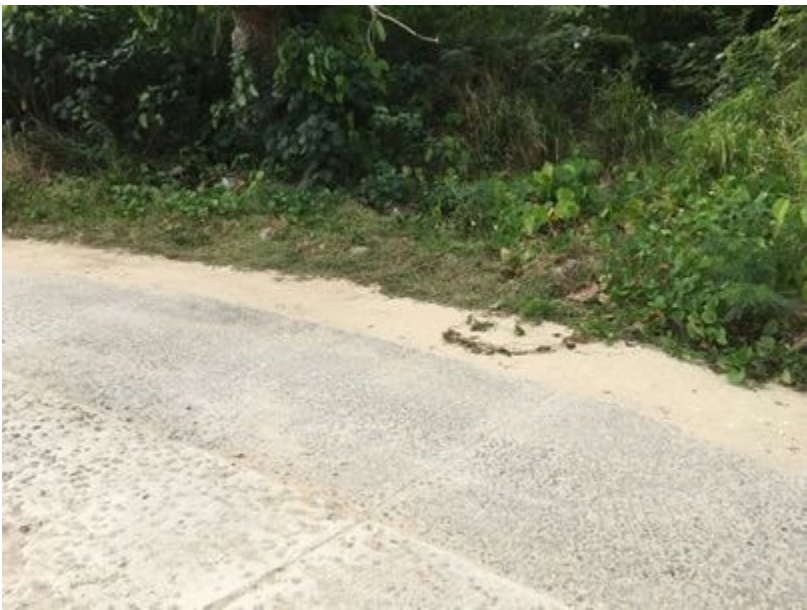
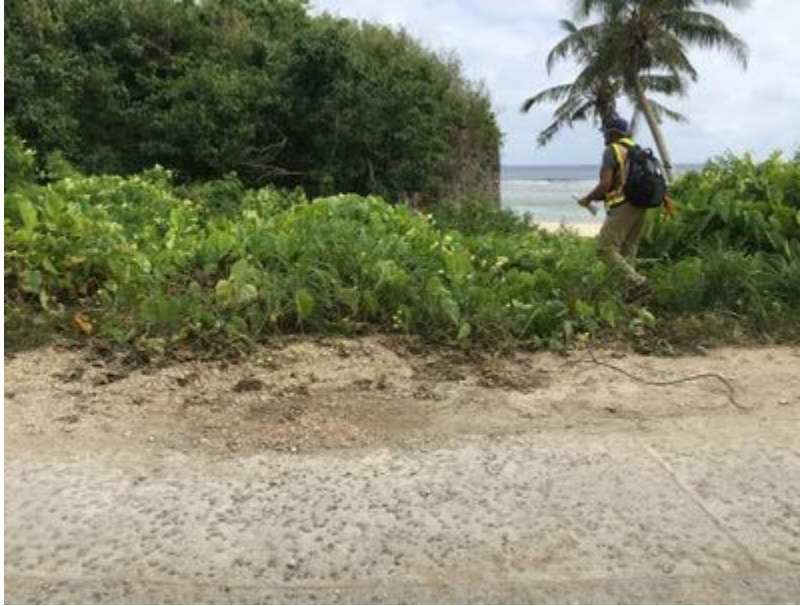
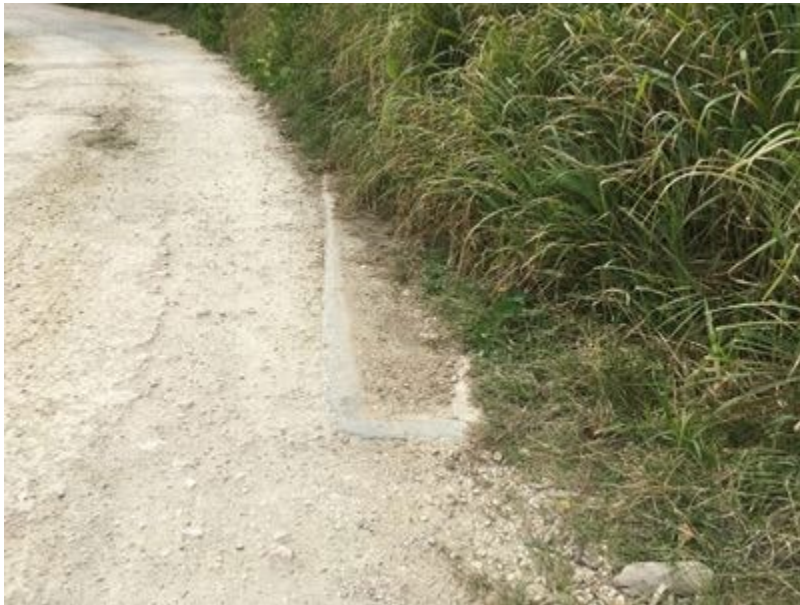
<b>Enforcement Needed:</b> Yes	
<b>Severity Rating:</b> 5 (Severe)	
<b>Implementation Priority:</b> Love it! (High)	
<b>Descriptions of Existing Conditions:</b> Lots of sediment on broad dip and in swales.	
<b>Description of Proposed Opportunity:</b> Clean! Remove vegetation at outlet.	
<b>Challenges/Constraints:</b> Maintenance.	
<b>Additional Notes:</b>	
<b>Site Photo</b>

**Additional Photo Caption:** intended flow path middle left (pile of dirt). Current flow path on right.

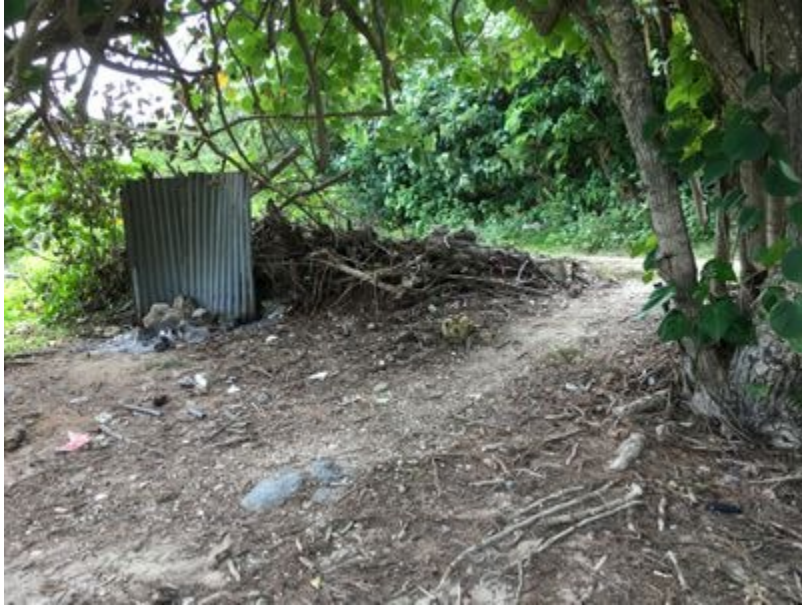
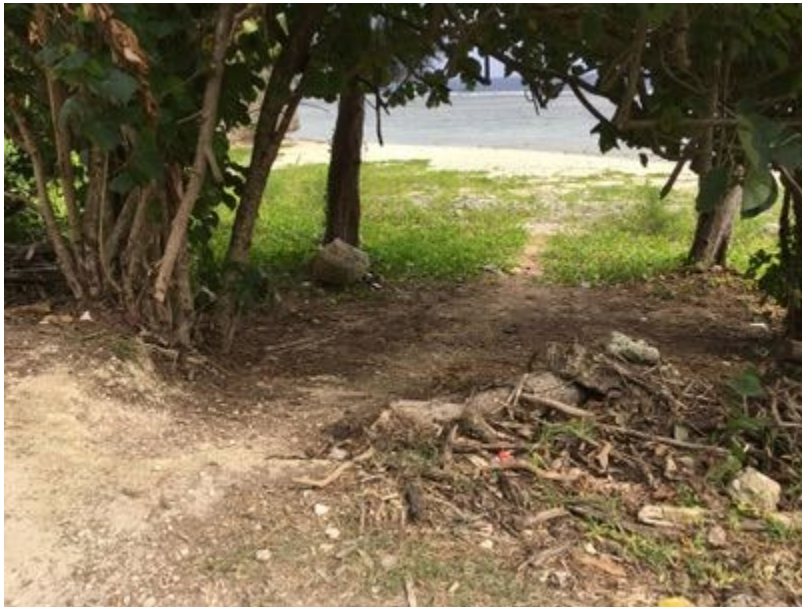
<b>Enforcement Needed:</b> No	
<b>Severity Rating:</b> 4	
<b>Implementation Priority:</b> It's OK (Med)	
<b>Descriptions of Existing Conditions:</b> Seaward edge of road. 3' drop at start. Guess low energy. Rocky sand. Trees present. (with LL143)	
<b>Description of Proposed Opportunity:</b> Start living shoreline. Use gabion walls or green walls.	
<b>Challenges/Constraints:</b> Road abuts top of shoreline, so limited space. High traffic, exposure to future storms.	
<b>Additional Notes:</b>	
<b>Site Photo</b>

**Additional Photo Caption:** From above

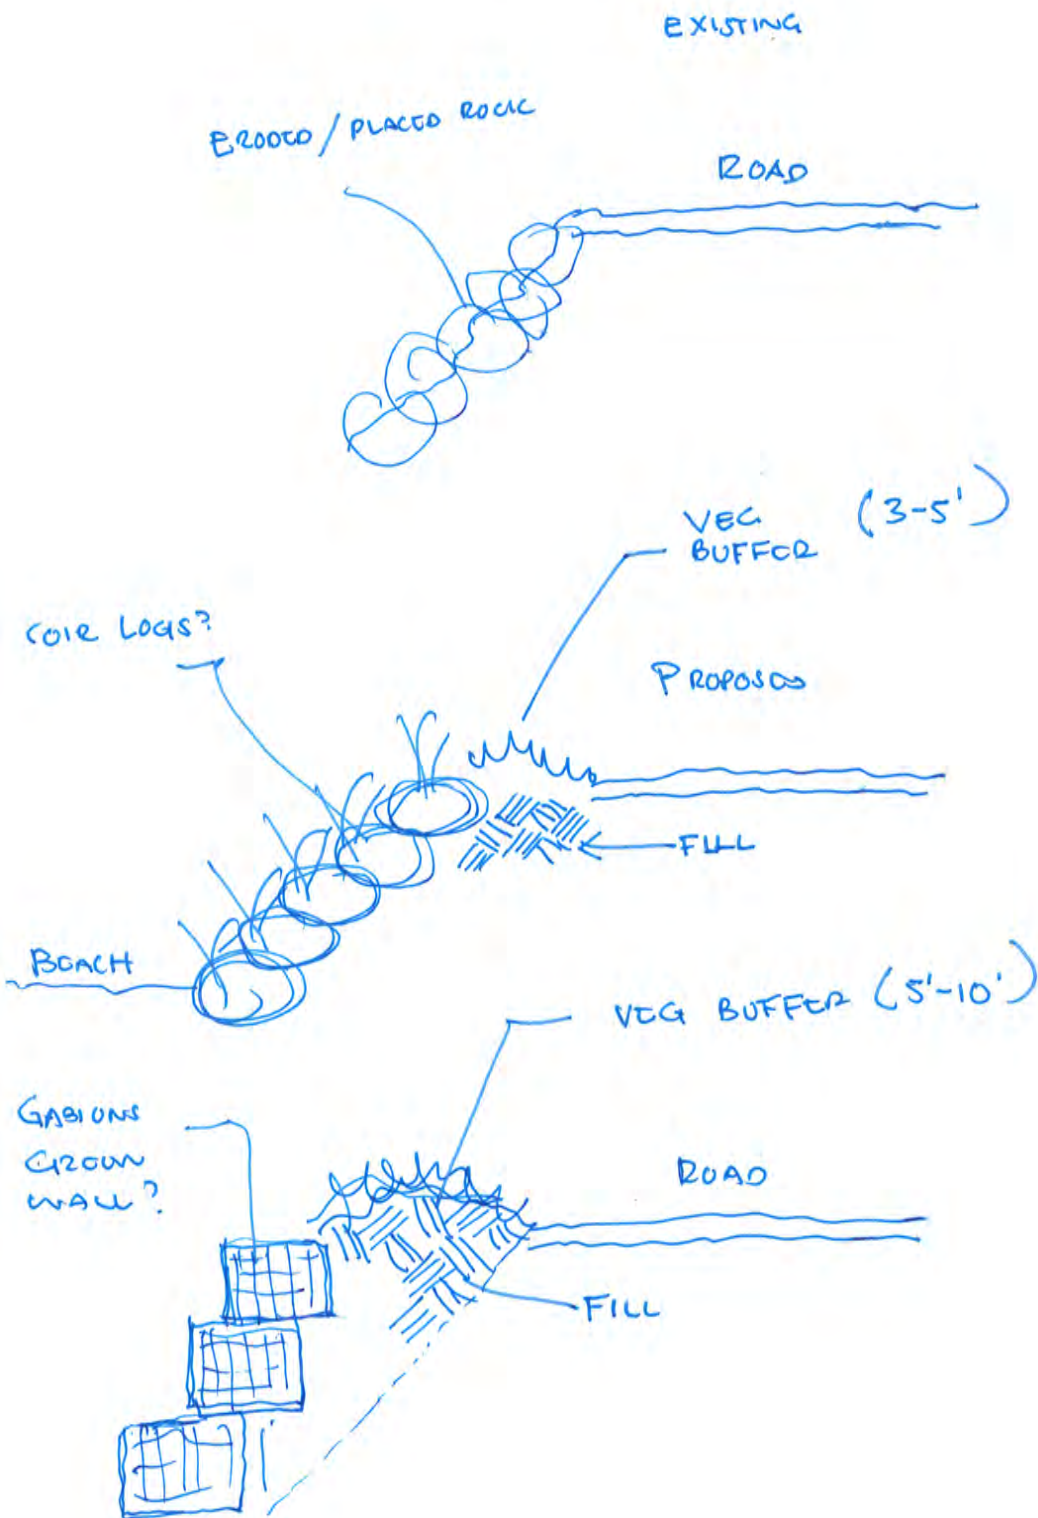
REPAIRS UNSIGHTLY. LOCATION APPEARS TO BE LOW ENERGY  
AREA

EXPOSURE TO FUTURE STORMS

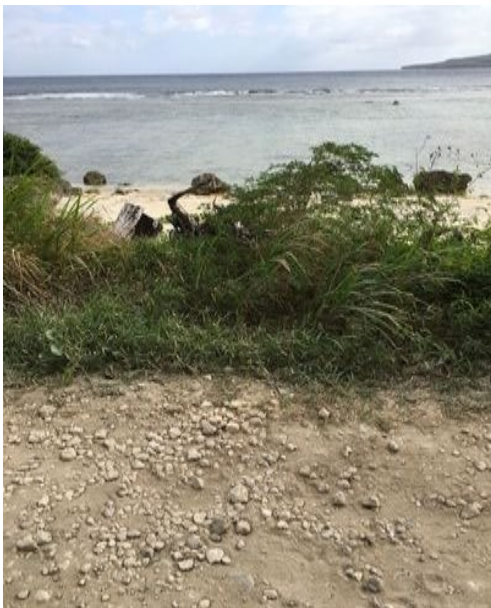
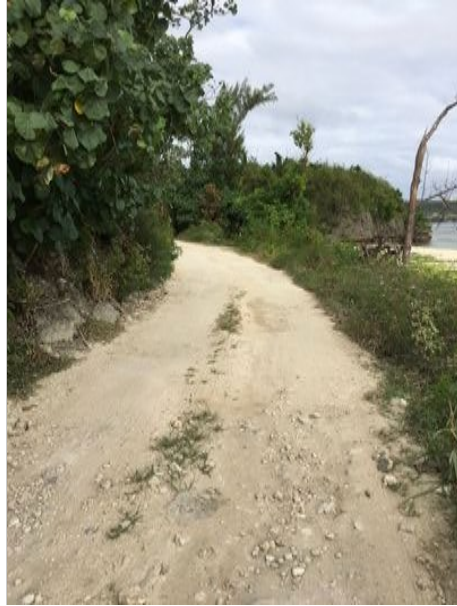
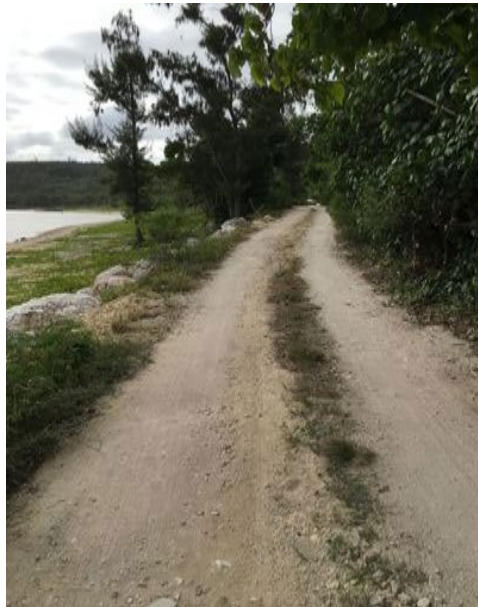
<b>Enforcement Needed:</b> No	
<b>Severity Rating:</b> 2	
<b>Implementation Priority:</b> It's OK (Med)	
<b>Descriptions of Existing Conditions:</b> Low point in rd. Discharges toward LL139 & LL143.	
<b>Description of Proposed Opportunity:</b> Address stormwater as part of shoreline restoration	
<b>Challenges/Constraints:</b> Erosion	
<b>Additional Notes:</b> None	
<b>Site Photo</b>

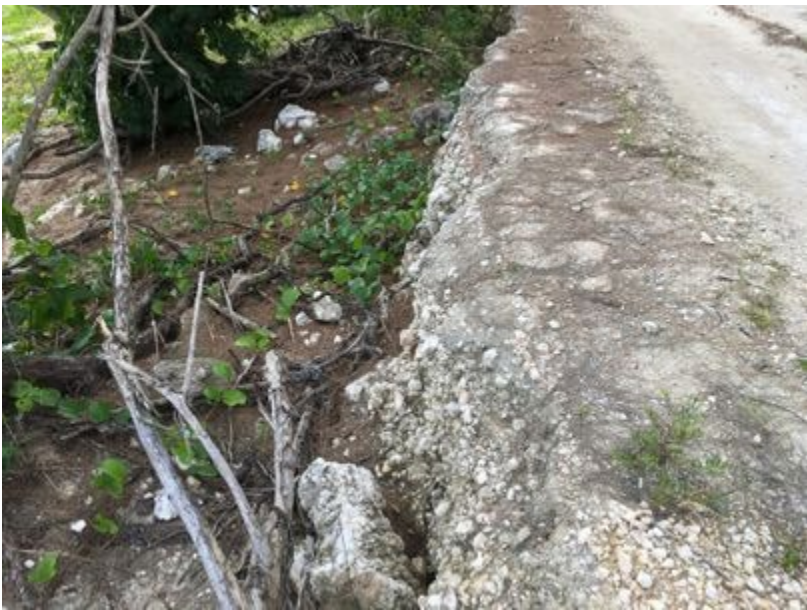
<b>Enforcement Needed:</b> No	
<b>Severity Rating:</b> 4	
<b>Implementation Priority:</b> It's OK (Med)	
<b>Descriptions of Existing Conditions:</b> Start shoreline restoration. (with LL146)	
<b>Description of Proposed Opportunity:</b> Living shoreline (see notes for LL139/LL143/LL144)	
<b>Challenges/Constraints:</b>	
<b>Additional Notes:</b>	
<b>Site Photo</b>

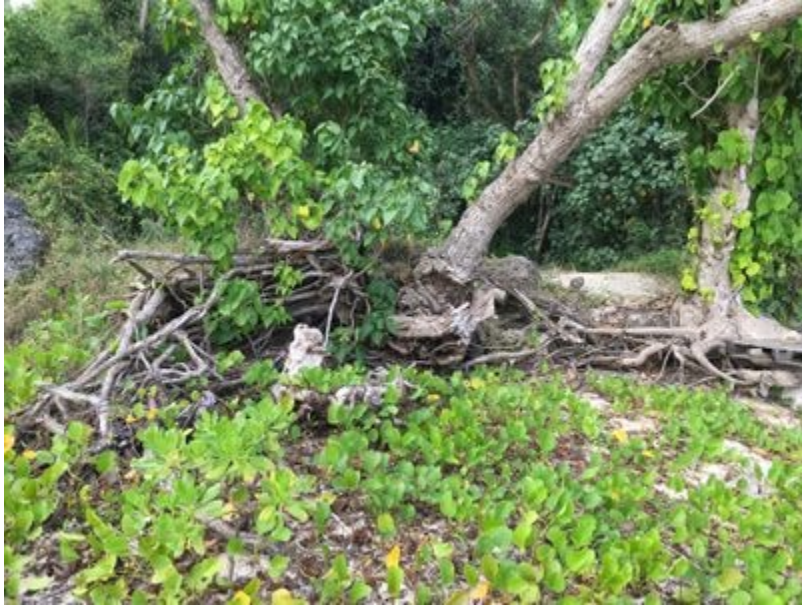
<b>Enforcement Needed:</b> No	
<b>Severity Rating:</b> 4	
<b>Implementation Priority:</b> It's OK (Med)	
<b>Descriptions of Existing Conditions:</b> End shoreline restoration. (with LL145)	
<b>Description of Proposed Opportunity:</b> Living shoreline (see notes for LL139/LL143/LL144)	
<b>Challenges/Constraints:</b>	
<b>Additional Notes:</b>	
<b>Site Photo</b>

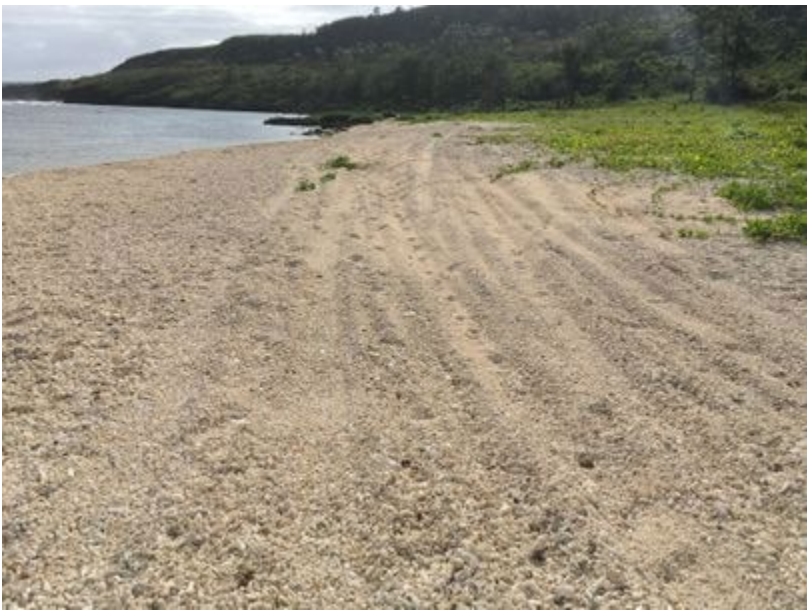
<b>Enforcement Needed:</b> Yes	
<b>Severity Rating:</b> 3	
<b>Implementation Priority:</b> Unsure	
<b>Descriptions of Existing Conditions:</b> Driving on beach	
<b>Description of Proposed Opportunity:</b> Prevent driving on beach. Signage or physical barrier?	
<b>Challenges/Constraints:</b>	
<b>Additional Notes:</b>	
<b>Site Photo</b>
