# Laolao Bay Watershed

## Existing Conditions and Opportunities

### Interim Report

August 2020 DRAFT

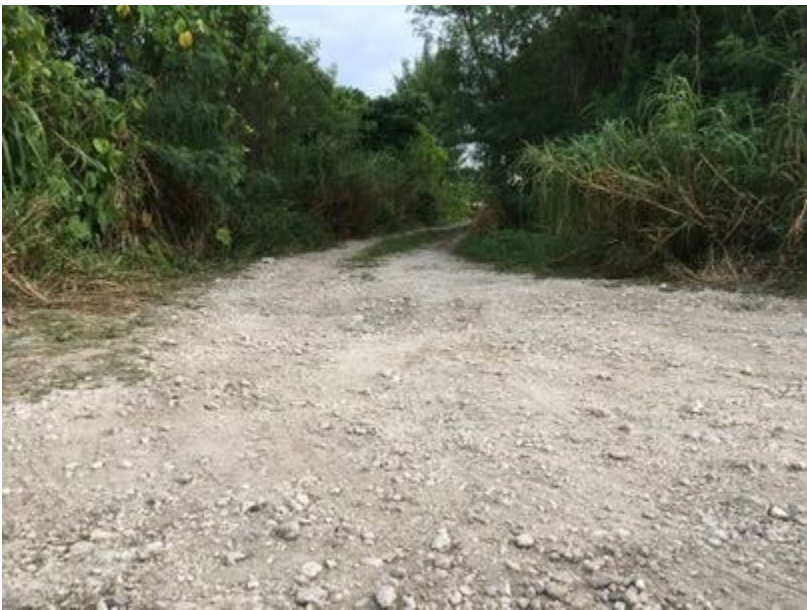
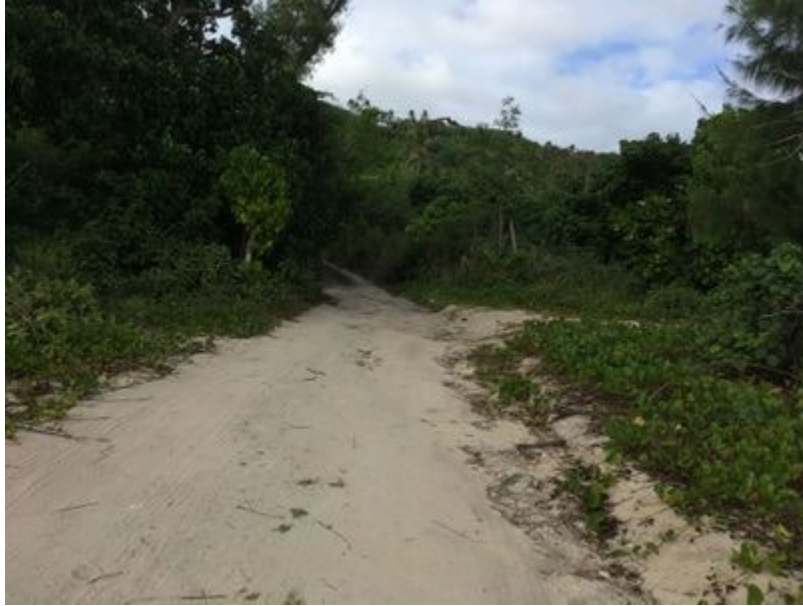
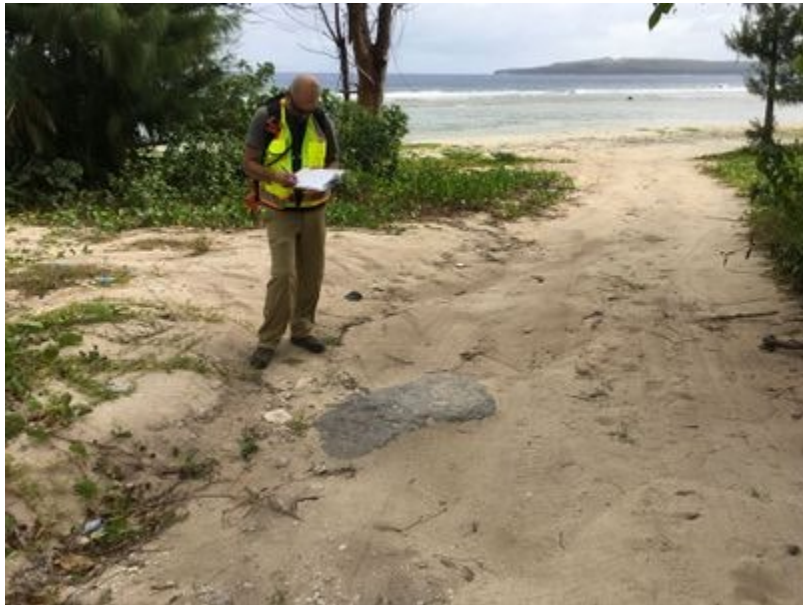
<p>USGS The National Map: National Boun... Powered by Esri</p>
<b>Enforcement Needed:</b> No	
<b>Severity Rating:</b> 4	
<b>Implementation Priority:</b> It's OK (Med)	
<b>Descriptions of Existing Conditions:</b> Runoff drains down boat ramp access eroding and washing out onto beach.	
<b>Description of Proposed Opportunity:</b> Water bar or broad dip at top of access to direct runoff away from ramp and into vegetation.	
<b>Challenges/Constraints:</b> Heavy use, not a lot of space to discharge.	
<b>Additional Notes:</b>	
<b>Site Photo</b>

<b>Site Overview Caption:</b> Top of ramp

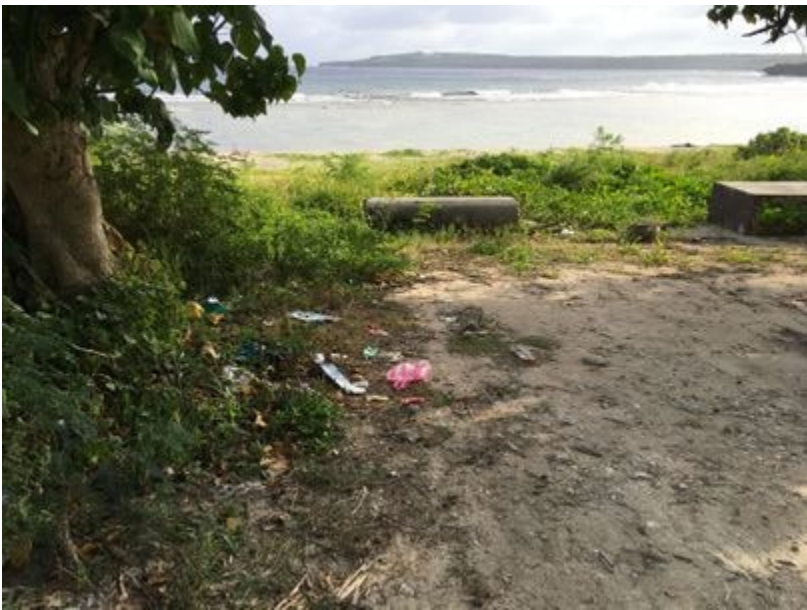
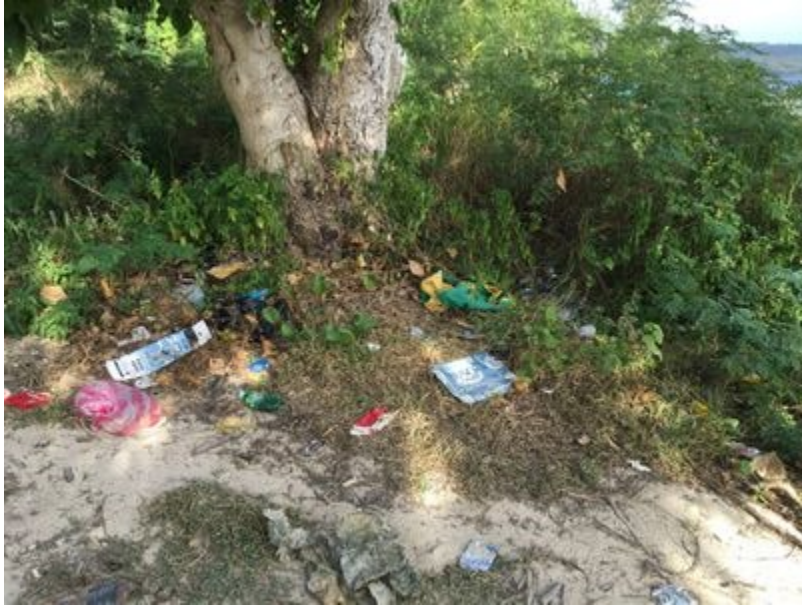
<b>Enforcement Needed:</b> Yes	
<b>Severity Rating:</b> 5 (Severe)	
<b>Implementation Priority:</b> Love it! (High)	
<b>Descriptions of Existing Conditions:</b> Lots of trash	
<b>Description of Proposed Opportunity:</b> Trash pickup, educational signage.	
<b>Challenges/Constraints:</b>	
<b>Additional Notes:</b>	
<b>Site Photo</b>

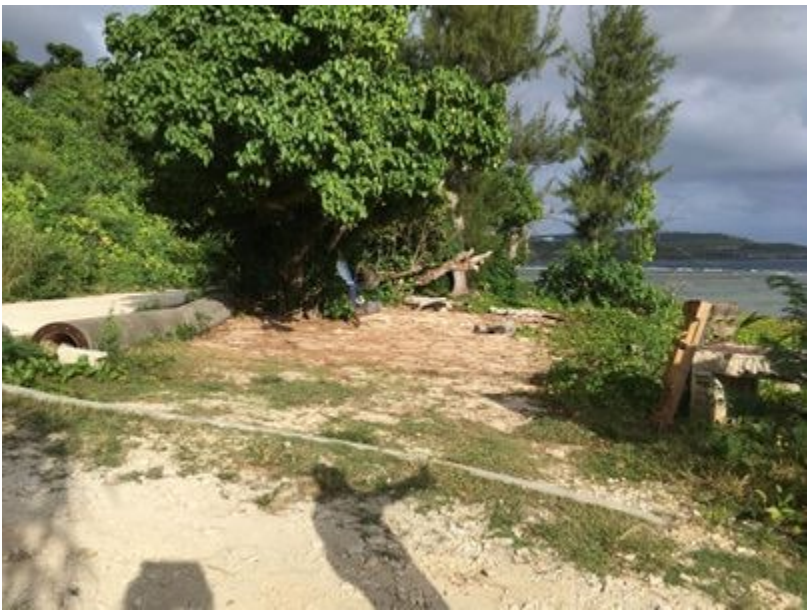
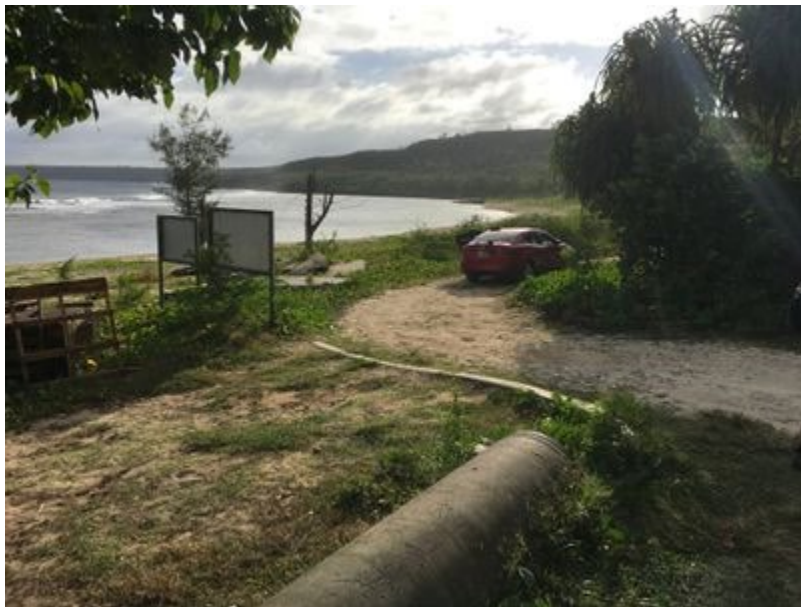
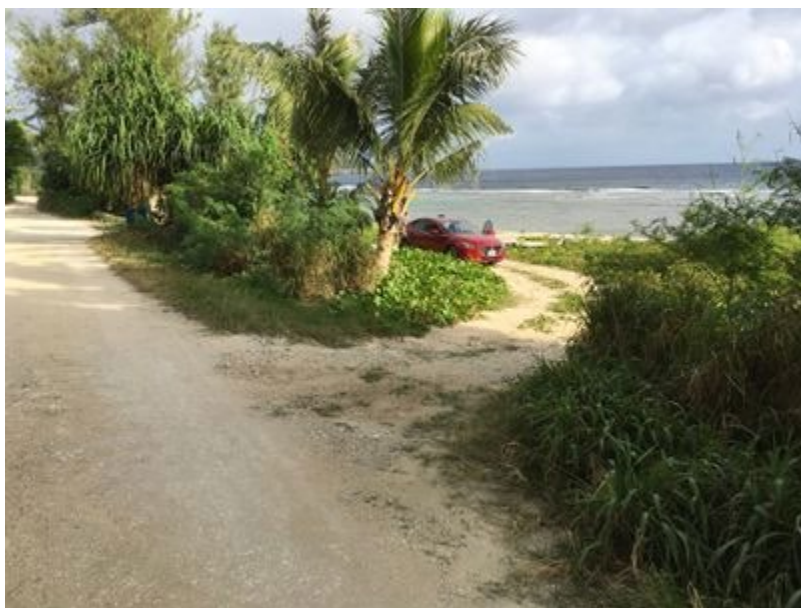
<b>Enforcement Needed:</b> No	
<b>Severity Rating:</b> 5 (Severe)	
<b>Implementation Priority:</b> Love it! (High)	
<b>Descriptions of Existing Conditions:</b> Former parking lot washed out during Yutu. Parking now uncontrolled and new areas east and west of former parking area now degraded.	
<b>Description of Proposed Opportunity:</b> Restore parking lot and shoreline. Living shoreline.	
<b>Challenges/Constraints:</b> Receding shoreline, heavy use, exposure to storms. Very little room.	
<b>Additional Notes:</b>	
<b>Site Photo</b>

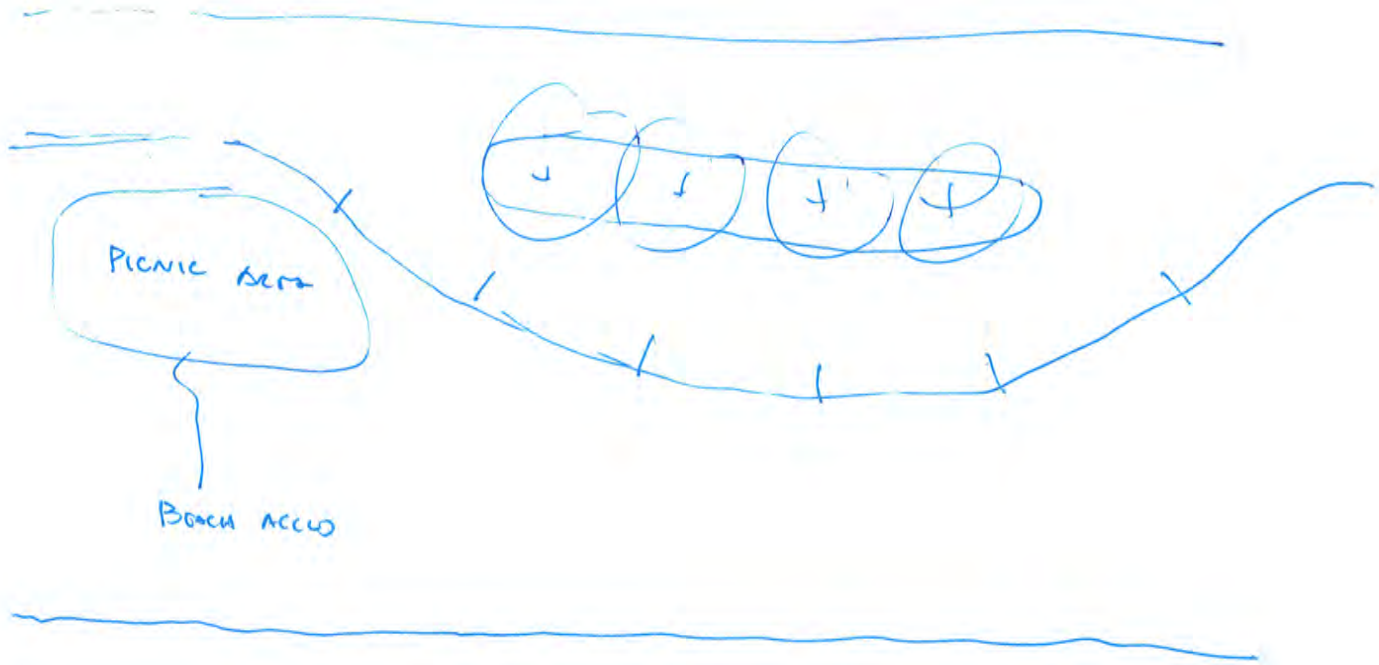
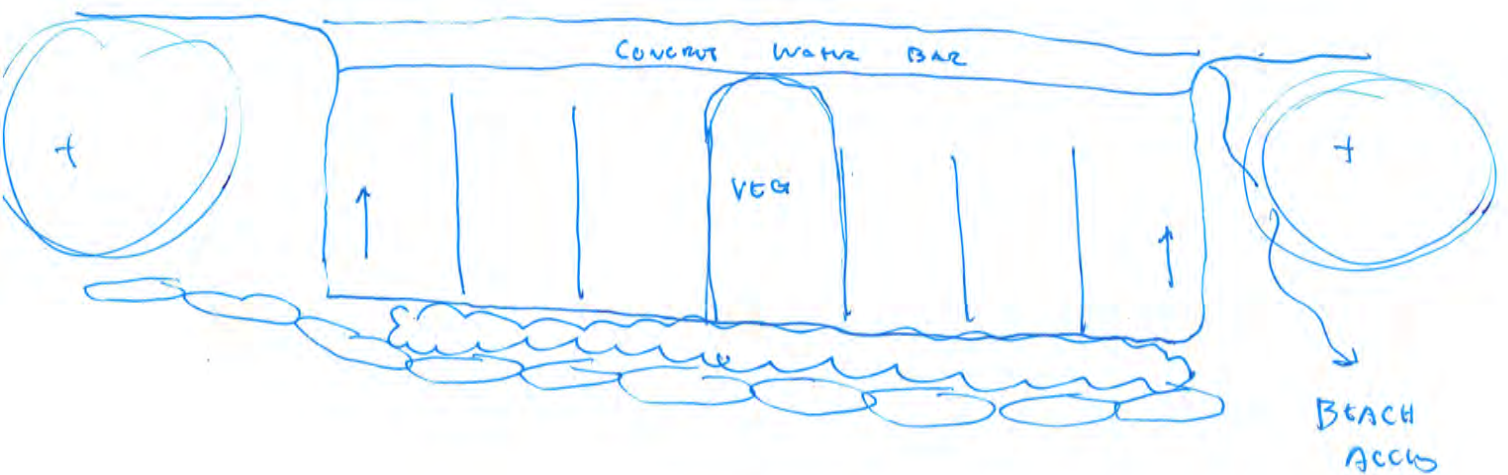
Now Area BOTH NORTH & SOUTH OF PARKING AREA  
NOW DEGRADED

HEAVY USE, EXPOSED TO STORMS - HIGH SURFACE  
NO ROOM TO RETREAT

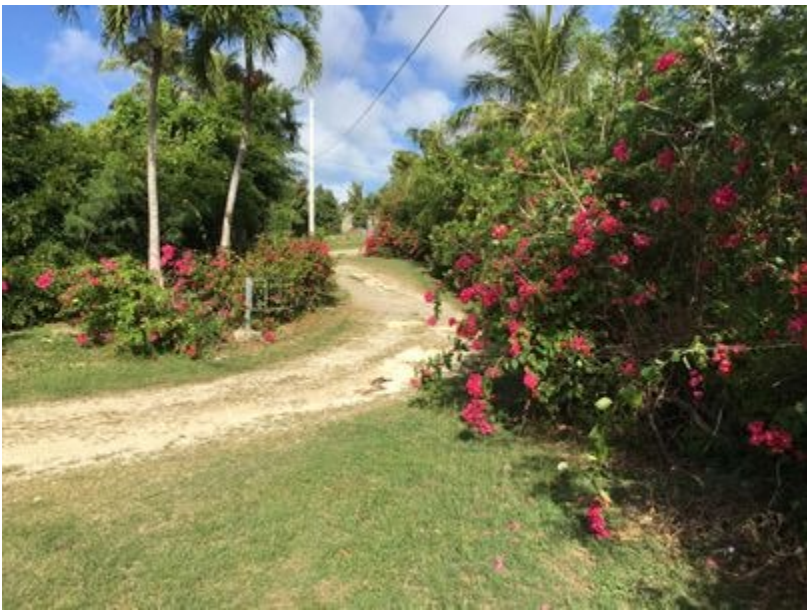
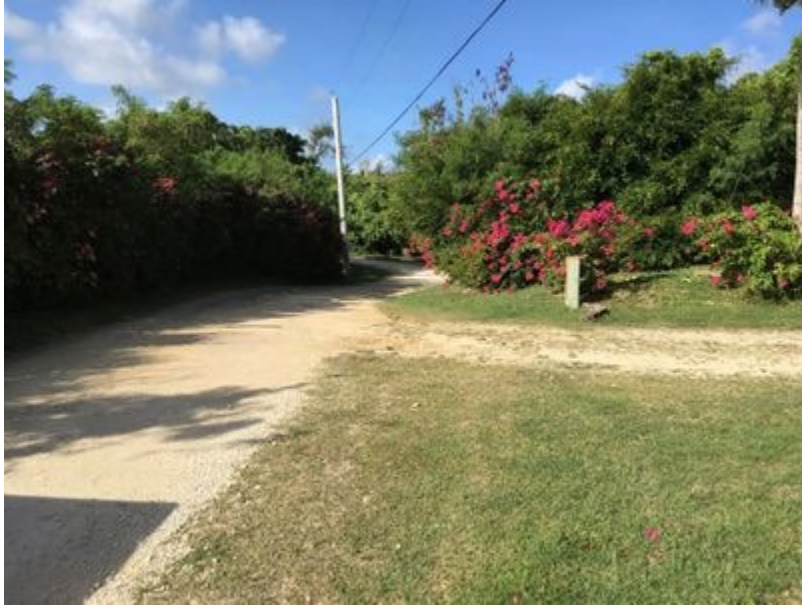
<b>Site ID:</b> LL157	<b>Watershed:</b> Laolao
<b>Crew:</b> EH	<b>Date/Time:</b> 01/22/2020 7:16 PM
<b>Project Type:</b> <ul style="list-style-type: none"> <li>Residential Stewardship</li> </ul>

<p>USGS The National Map: National Boun... Powered by Esri</p>
<b>Enforcement Needed:</b> No	
<b>Severity Rating:</b> 4	
<b>Implementation Priority:</b> It's OK (Med)	
<b>Descriptions of Existing Conditions:</b> Gravel driveway flows onto road. Sediment ends up in broad dip.	
<b>Description of Proposed Opportunity:</b> Waterbar on driveway. Intercept runoff before reaching road.	
<b>Challenges/Constraints:</b> On private land, would require landowner cooperation.	
<b>Additional Notes:</b>	
<b>Site Photo</b>

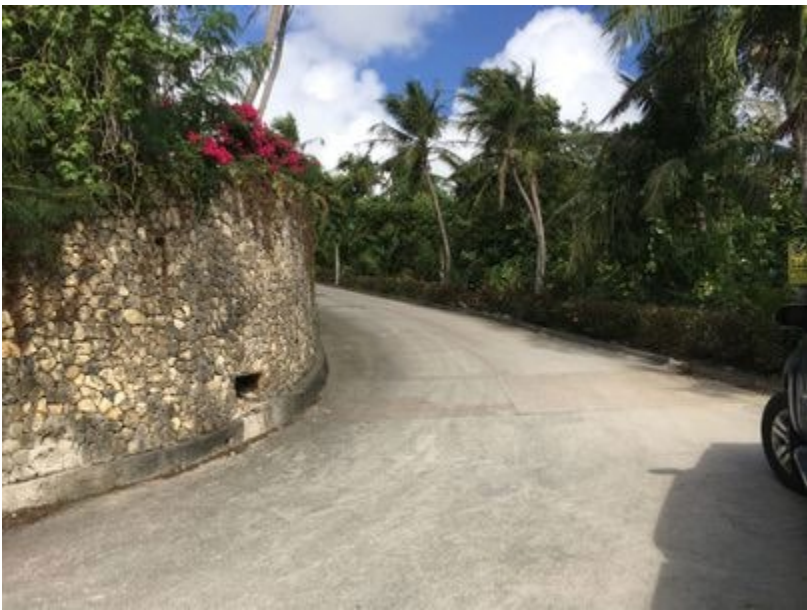
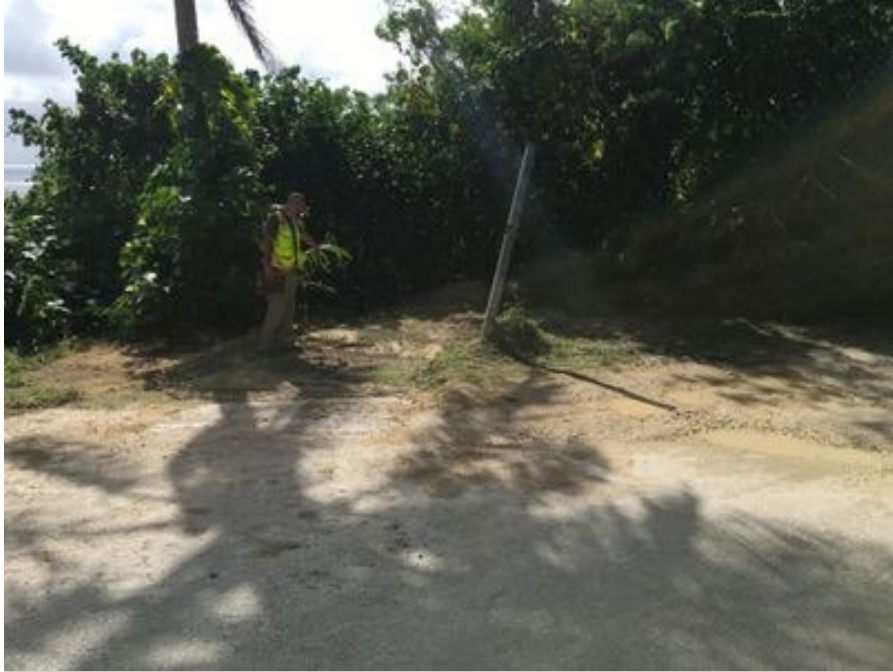
<b>Site ID:</b> LL161	<b>Watershed:</b> Laolao
<b>Crew:</b> EH	<b>Date/Time:</b> 01/22/2020 7:52 PM
<b>Project Type:</b> <ul style="list-style-type: none"> <li>• Drainage Infrastr., Maint. &amp; Repair</li> <li>• Stormwater Retrofit</li> </ul>

<b>Enforcement Needed:</b> No	
<b>Severity Rating:</b> 4	
<b>Implementation Priority:</b> It's OK (Med)	
<b>Descriptions of Existing Conditions:</b> Paved road runoff flows to informal discharge point.	
<b>Description of Proposed Opportunity:</b> Formalize drainage/control outfall.	
<b>Challenges/Constraints:</b> Very steep, not much room.	
<b>Additional Notes:</b>	
<b>Site Photo</b>

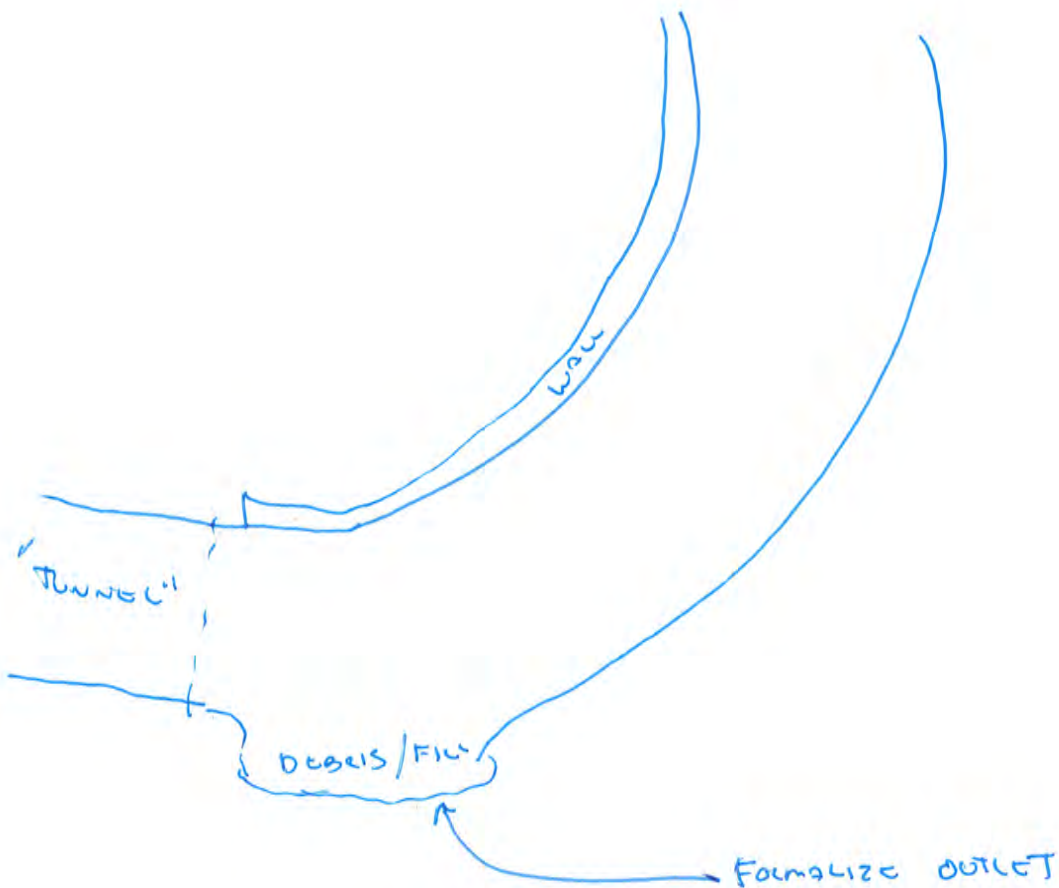
STEEP SLOPES - LIMITED SPACE ; CONCENTRATED HIGH  
VELOCITY FLOW

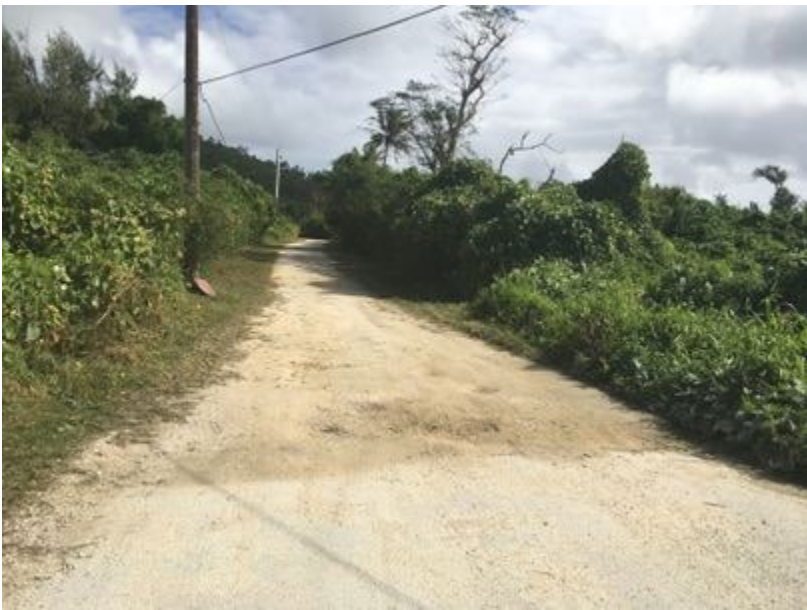
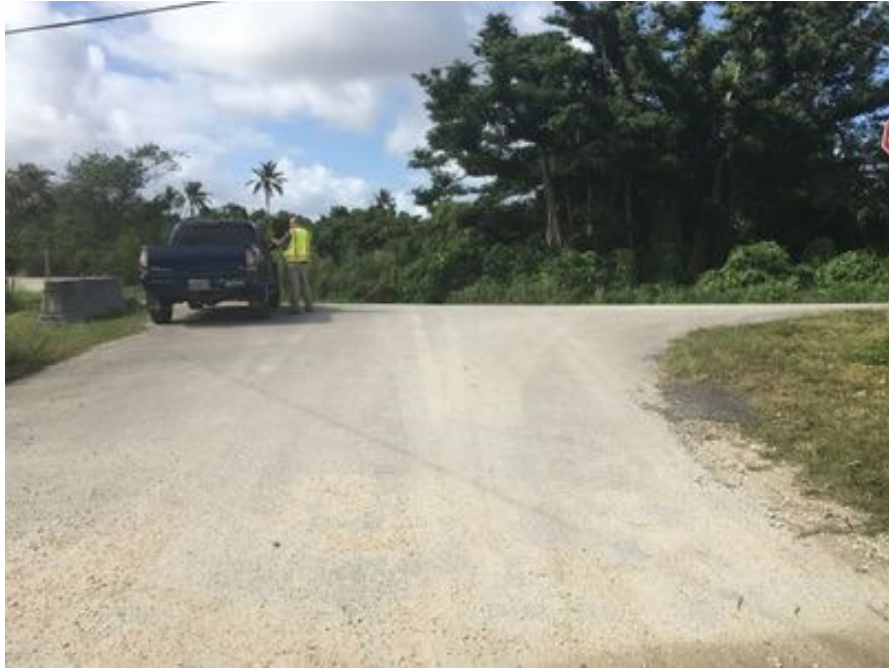
<b>Site ID:</b> LL167	<b>Watershed:</b> Laolao
<b>Crew:</b> EH	<b>Date/Time:</b> 01/22/2020 8:22 PM
<b>Project Type:</b> <ul style="list-style-type: none"> <li>Stormwater Retrofit</li> </ul>

<b>Enforcement Needed:</b> No	
<b>Severity Rating:</b> 3	
<b>Implementation Priority:</b> It's OK (Med)	
<b>Descriptions of Existing Conditions:</b> Low point at at dirt/pavement transition. Runoff discharges off site.	
<b>Description of Proposed Opportunity:</b> Formalize/stabilize low point to reduce erosion. Could be built in conjunction with LL173.	
<b>Challenges/Constraints:</b> May cause erosion further up the road at new trnsition between stabilized low point and dirt road.	
<b>Additional Notes:</b>	
<b>Site Photo</b>

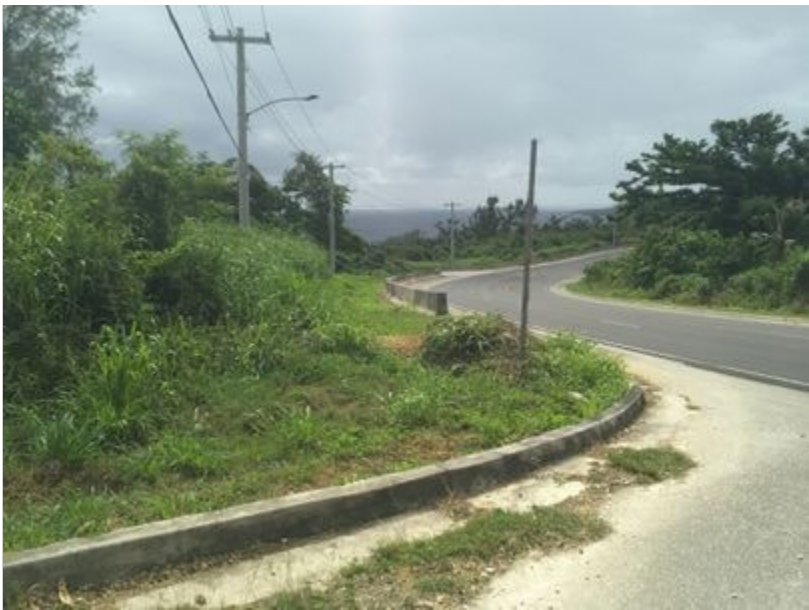
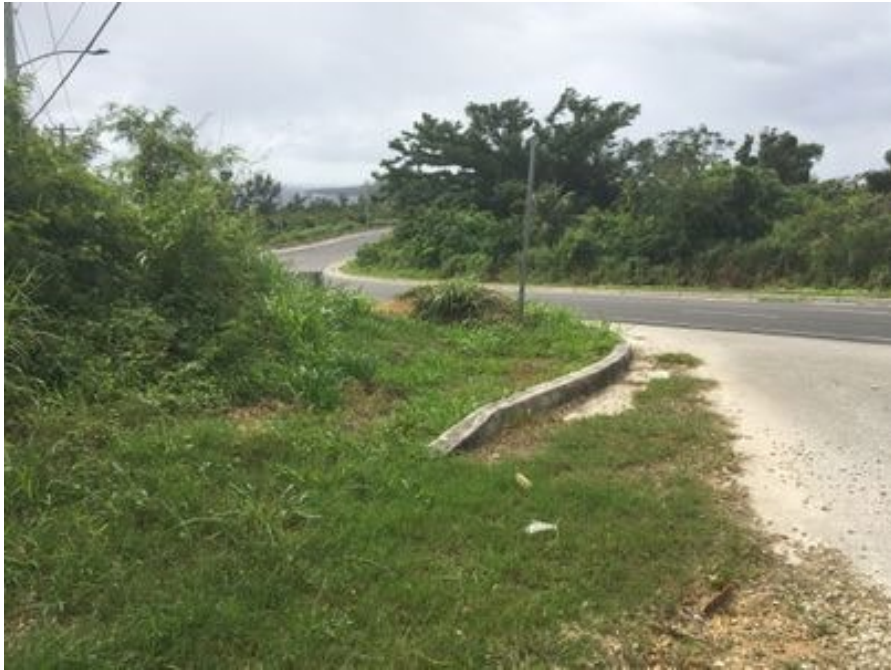
<b>Site ID:</b> LL173	<b>Watershed:</b> Laolao
<b>Crew:</b> EH	<b>Date/Time:</b> 01/22/2020 8:54 PM
<b>Project Type:</b> <ul style="list-style-type: none"> <li>Drainage Infrastr., Maint. &amp; Repair</li> </ul>

<b>Enforcement Needed:</b> No	
<b>Severity Rating:</b> 4	
<b>Implementation Priority:</b> Love it! (High)	
<b>Descriptions of Existing Conditions:</b> Appears to be an existing vegetated swale with heavily clogged inlet. Runoff from dirt road bypasses swale and discharges to main road.	
<b>Description of Proposed Opportunity:</b> Clean and re-establish inlet. Consider broad dip to intercept runoff upgradient. See LL167-- can be same project.	
<b>Challenges/Constraints:</b> Future clogging from dirt road. Ongoing maintenance.	
<b>Additional Notes:</b>	
<b>Site Photo</b>

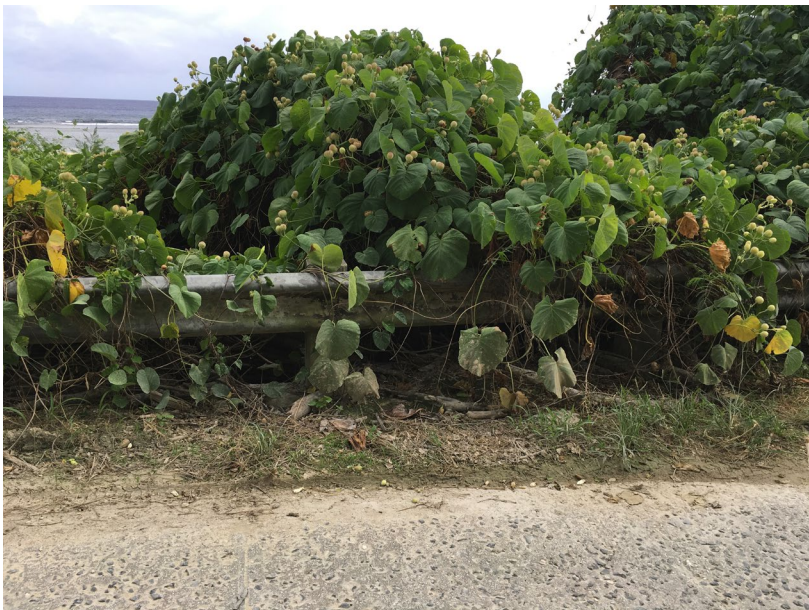
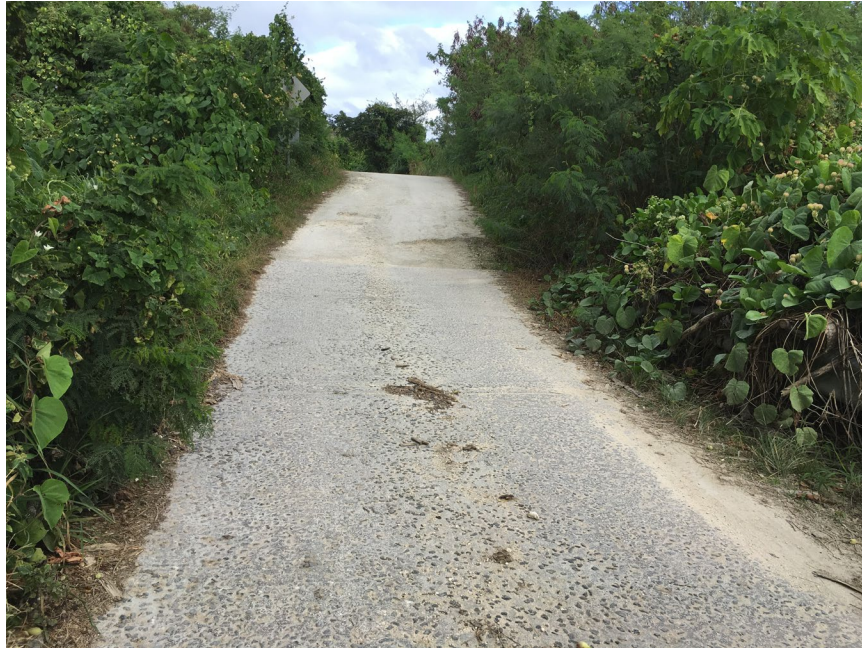
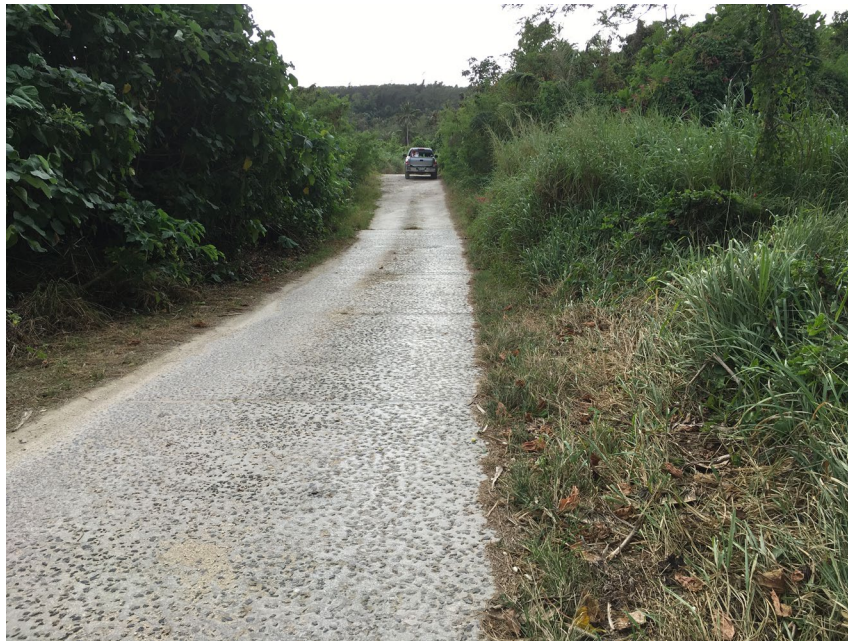
<b>Site ID:</b> LL204	<b>Watershed:</b> Laolao
<b>Crew:</b> EH	<b>Date/Time:</b>
<b>Project Type:</b> <ul style="list-style-type: none"> <li>Drainage Infrastr., Maint. &amp; Repair</li> </ul>

<b>Enforcement Needed:</b> Yes	
<b>Severity Rating:</b> 2	
<b>Implementation Priority:</b> Love it! (High)	
<b>Descriptions of Existing Conditions:</b> Broad dip across road (see LL149) with branches and debris.	
<b>Description of Proposed Opportunity:</b> Clean and clear.	
<b>Challenges/Constraints:</b>	
<b>Additional Notes:</b>	
<b>Site Photo</b>

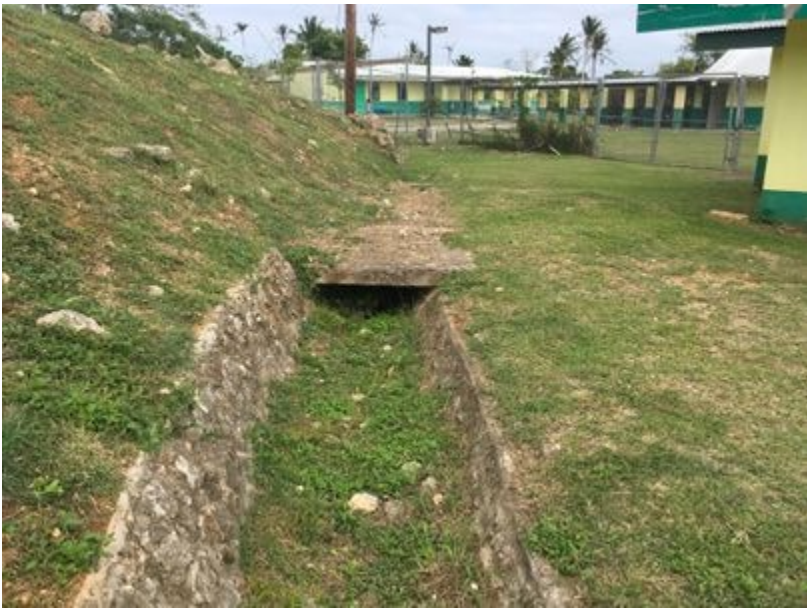
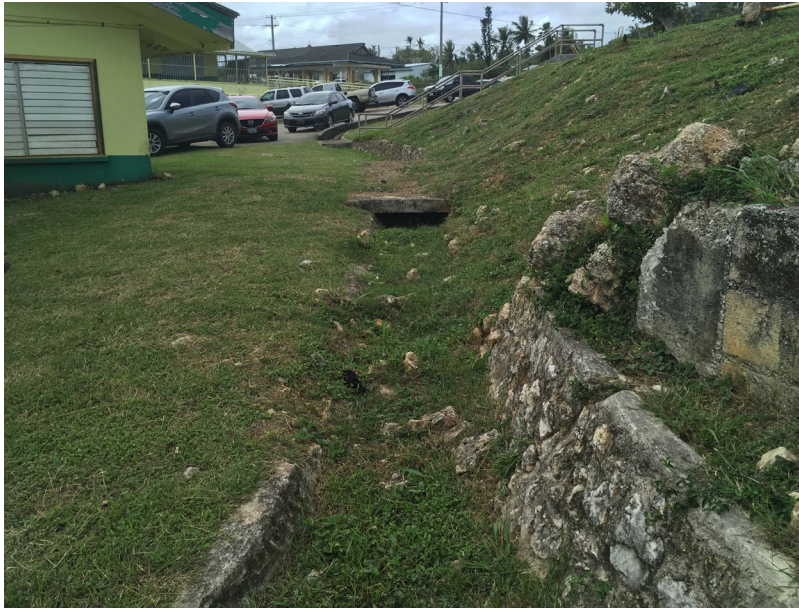
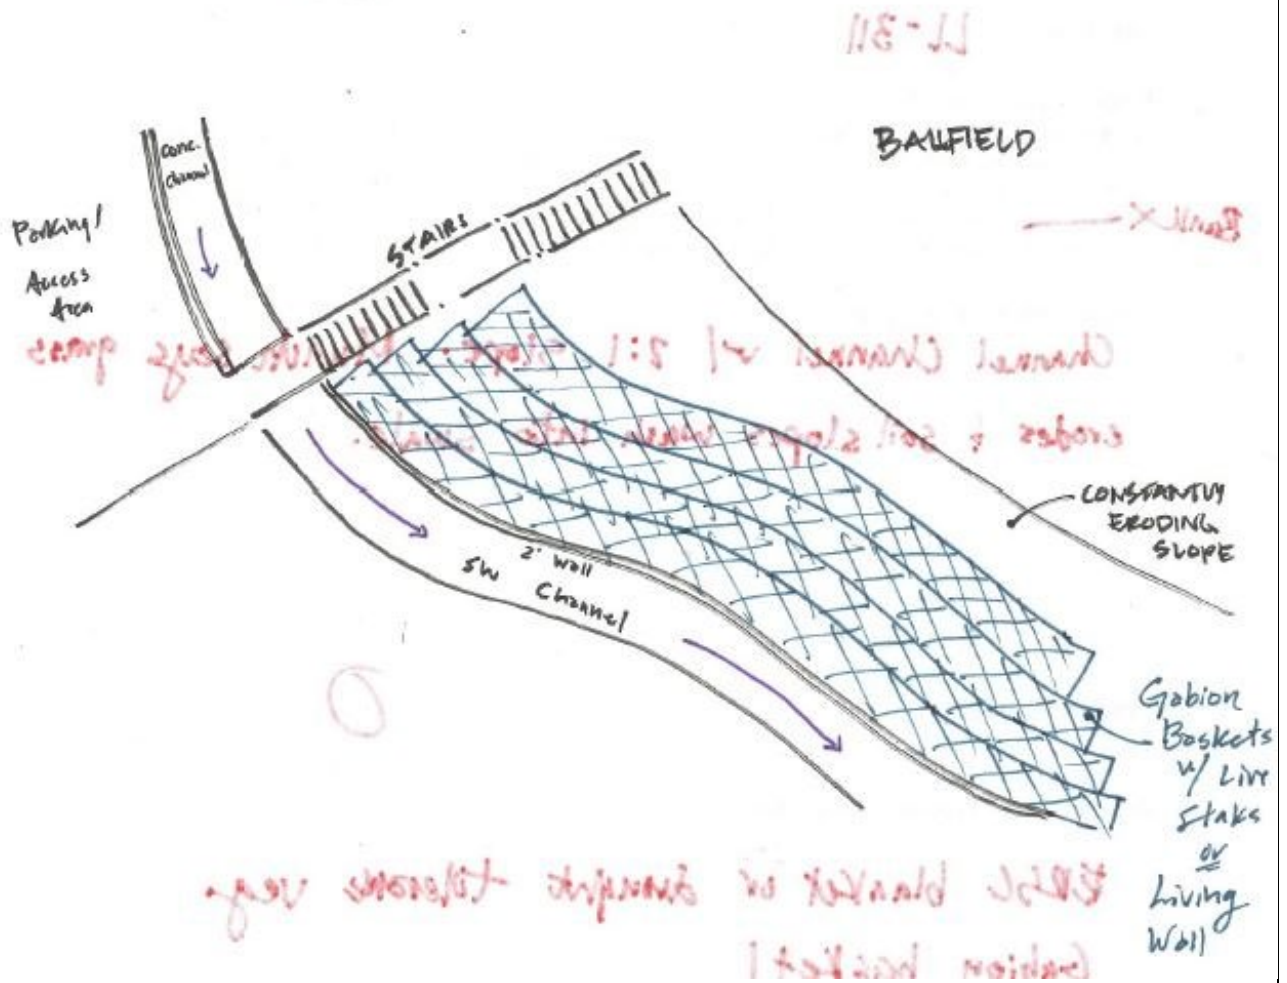
<b>Site ID:</b> LL311	<b>Watershed:</b> Laolao
<b>Crew:</b> JI	<b>Date/Time:</b> 01/21/2020 11:31 PM
<b>Project Type:</b> <ul style="list-style-type: none"> <li>Bank stabilization</li> </ul>

<p>USGS The National Map: National Boun... Powered by Esri</p>
<b>Enforcement Needed:</b> No	
<b>Severity Rating:</b> 2	
<b>Implementation Priority:</b> Not that important (Low)	
<b>Descriptions of Existing Conditions:</b> channel with 2:1 slope. Munch says grass erodes and soil slopes wash into swale.	
<b>Description of Proposed Opportunity:</b> ERSC blanket or drought tolerant vegetation. Gabion basket!	
<b>Challenges/Constraints:</b> Flex MSE wall? stone gabions? ground cover with ERSC blanket?	
<b>Additional Notes:</b>	
<b>Site Photo</b>

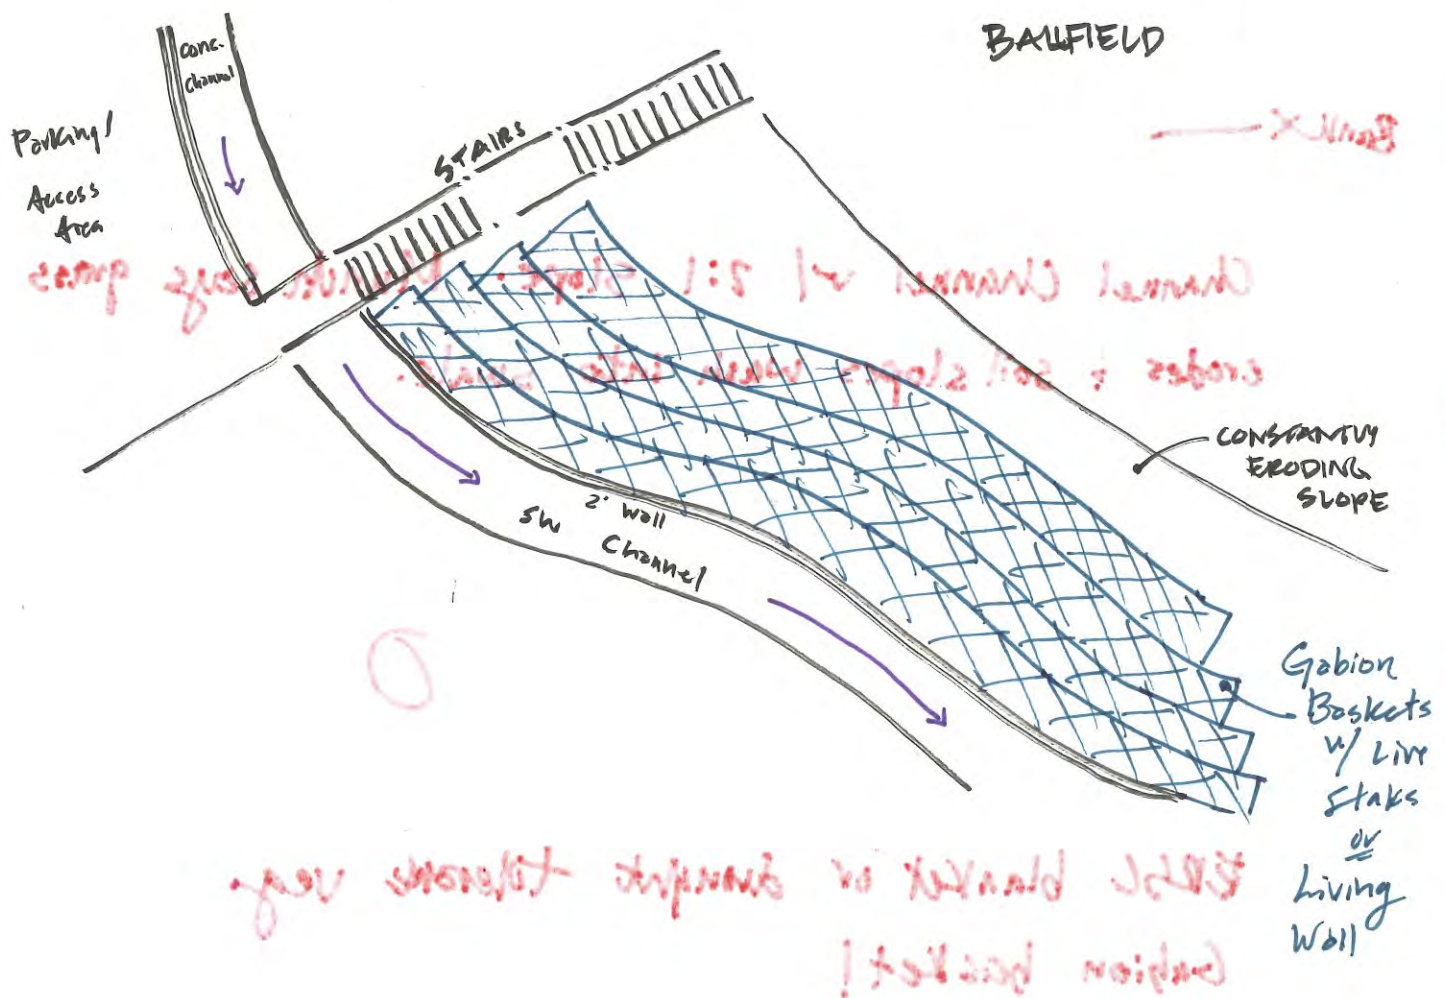
Ground cover with ERSC blanket?

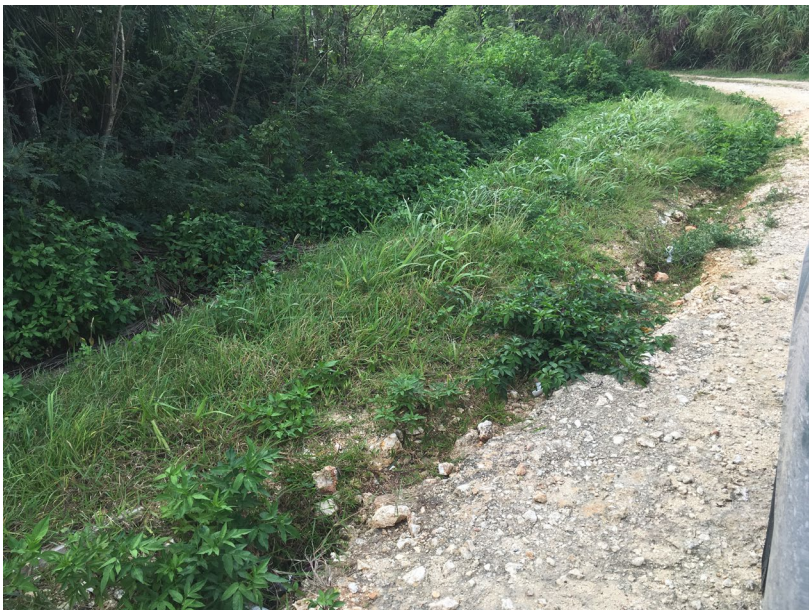
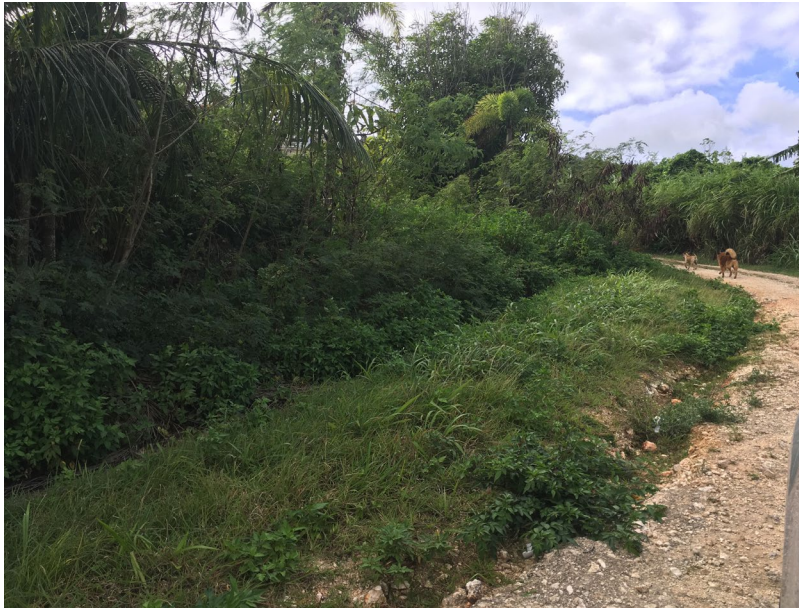
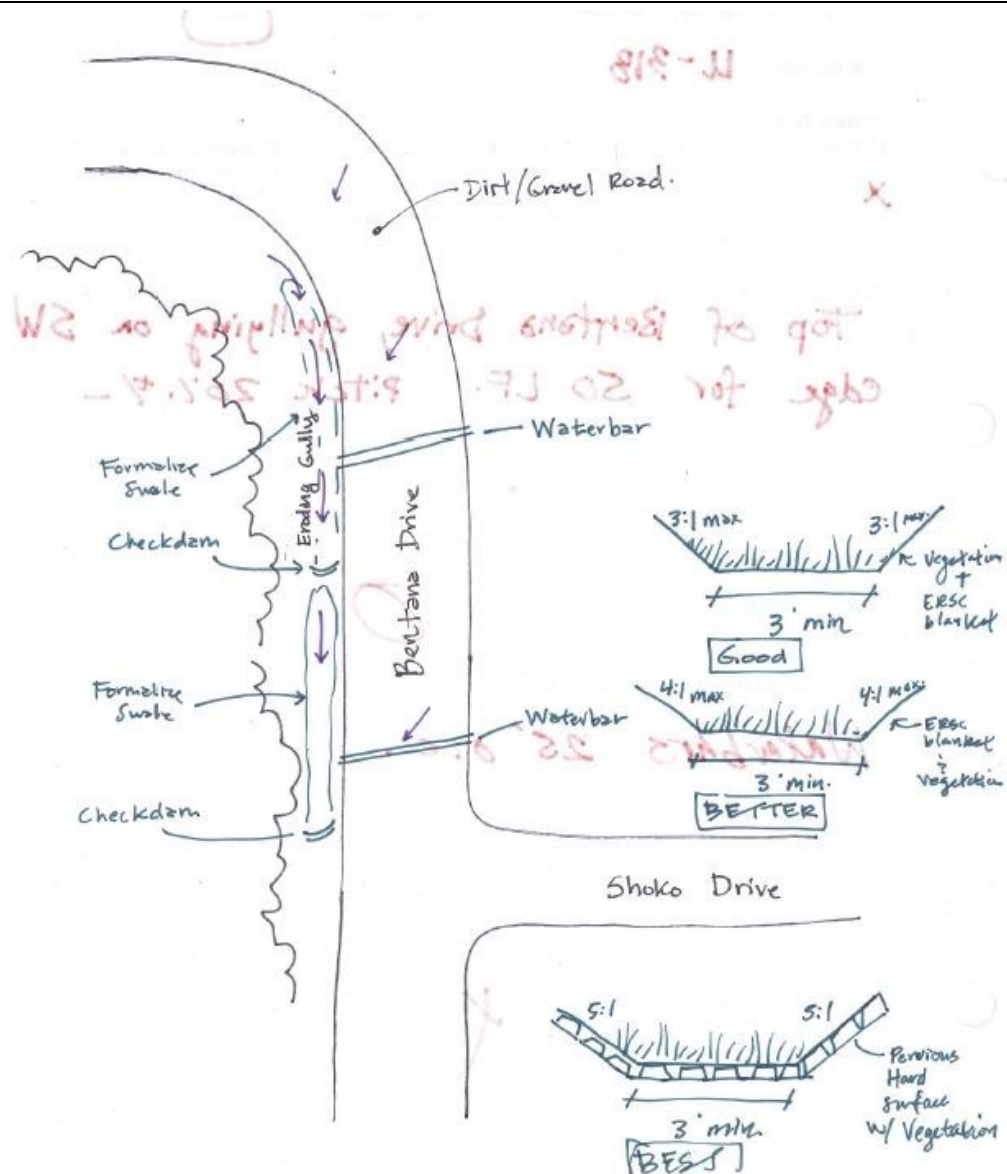
<b>Site ID:</b> LL318	<b>Watershed:</b> Laolao
<b>Crew:</b> JI	<b>Date/Time:</b> 01/22/2020 1:27 AM
<b>Project Type:</b> <ul style="list-style-type: none"> <li>Unpaved Road Stabilization</li> </ul>

<p>USGS The National Map: National Boun... Powered by Esri</p>
<b>Enforcement Needed:</b> No	
<b>Severity Rating:</b> 3	
<b>Implementation Priority:</b> It's OK (Med)	
<b>Descriptions of Existing Conditions:</b> Dirt road gullyng. Top of Bentana Drive, gullyng on SW edge for 50 LF. pitch 20% +/-	
<b>Description of Proposed Opportunity:</b> Waterbars 25' O.C.	
<b>Challenges/Constraints:</b>	
<b>Additional Notes:</b>	
<b>Site Photo</b>

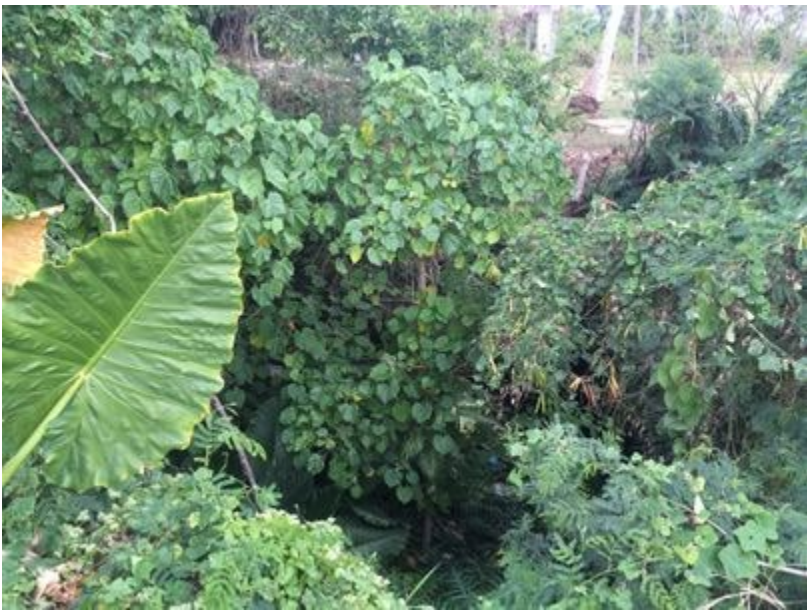
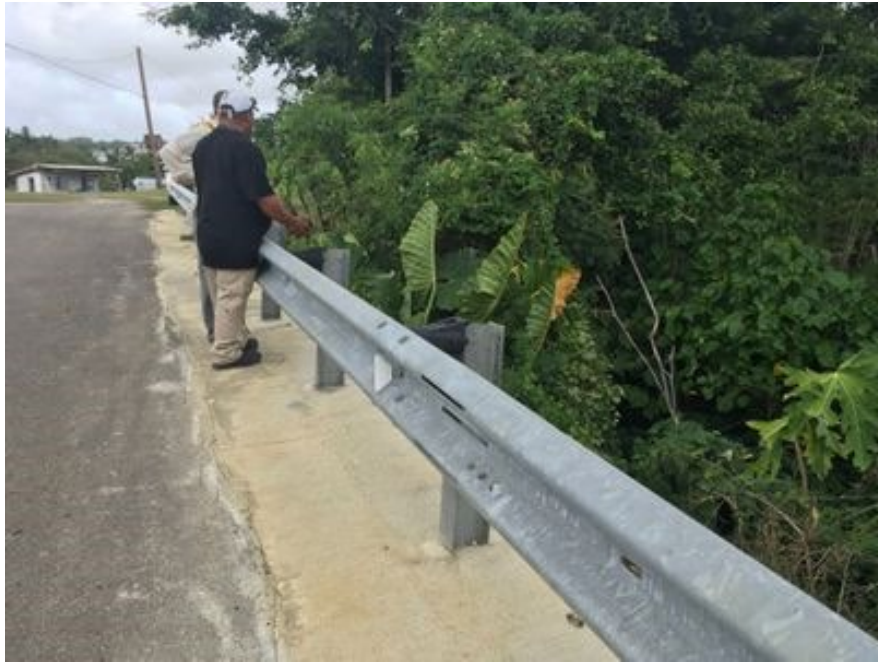
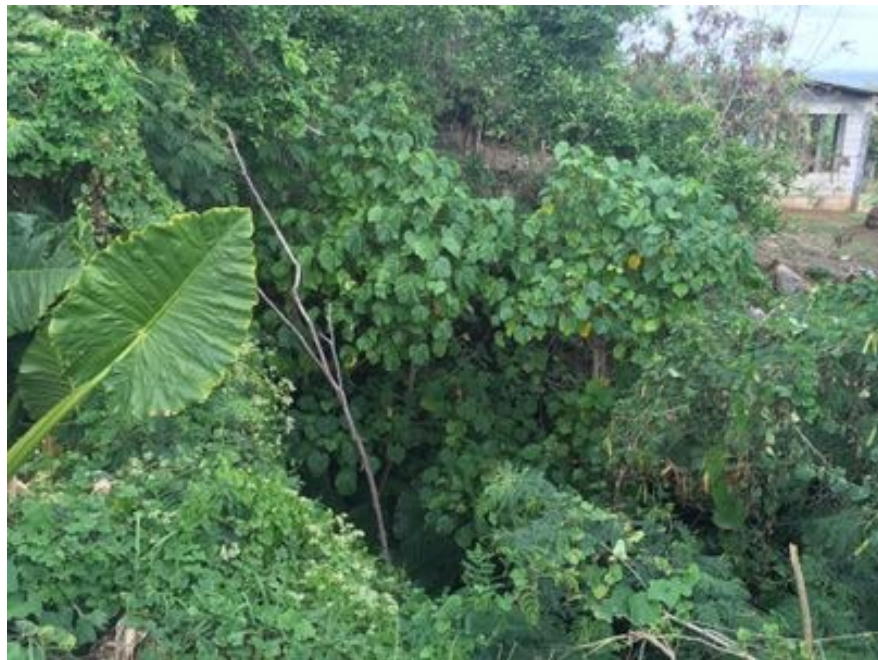
<b>Site ID:</b> LL336	<b>Watershed:</b> Laolao
<b>Crew:</b> JI	<b>Date/Time:</b> 01/22/2020 12:04 AM
<b>Project Type:</b> <ul style="list-style-type: none"> <li>Watershed Education/Signage</li> </ul>

<b>Enforcement Needed:</b> Yes	
<b>Severity Rating:</b> 4	
<b>Implementation Priority:</b> It's OK (Med)	
<b>Descriptions of Existing Conditions:</b> Sinkhole on private property - connects to a stream and then directly to the ocean. It is currently an illegal trash dumping site.	
<b>Description of Proposed Opportunity:</b> Clean up trash. Create educational opportunity and tourist attraction for people to go into the hole and listen to the ocean.	
<b>Challenges/Constraints:</b> Private property	
<b>Additional Notes:</b>	
<b>Site Photo</b>
