# Laolao Bay Watershed

## Existing Conditions and Opportunities

### Interim Report

August 2020 DRAFT

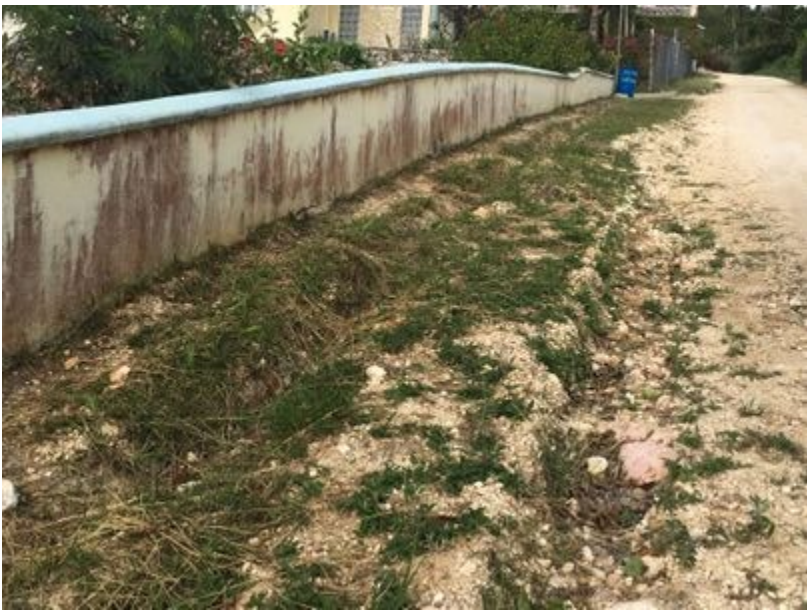
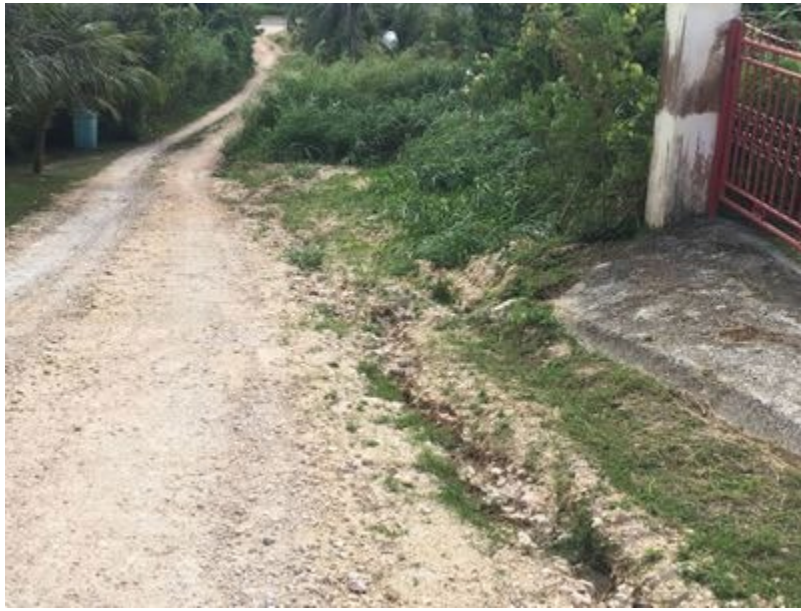
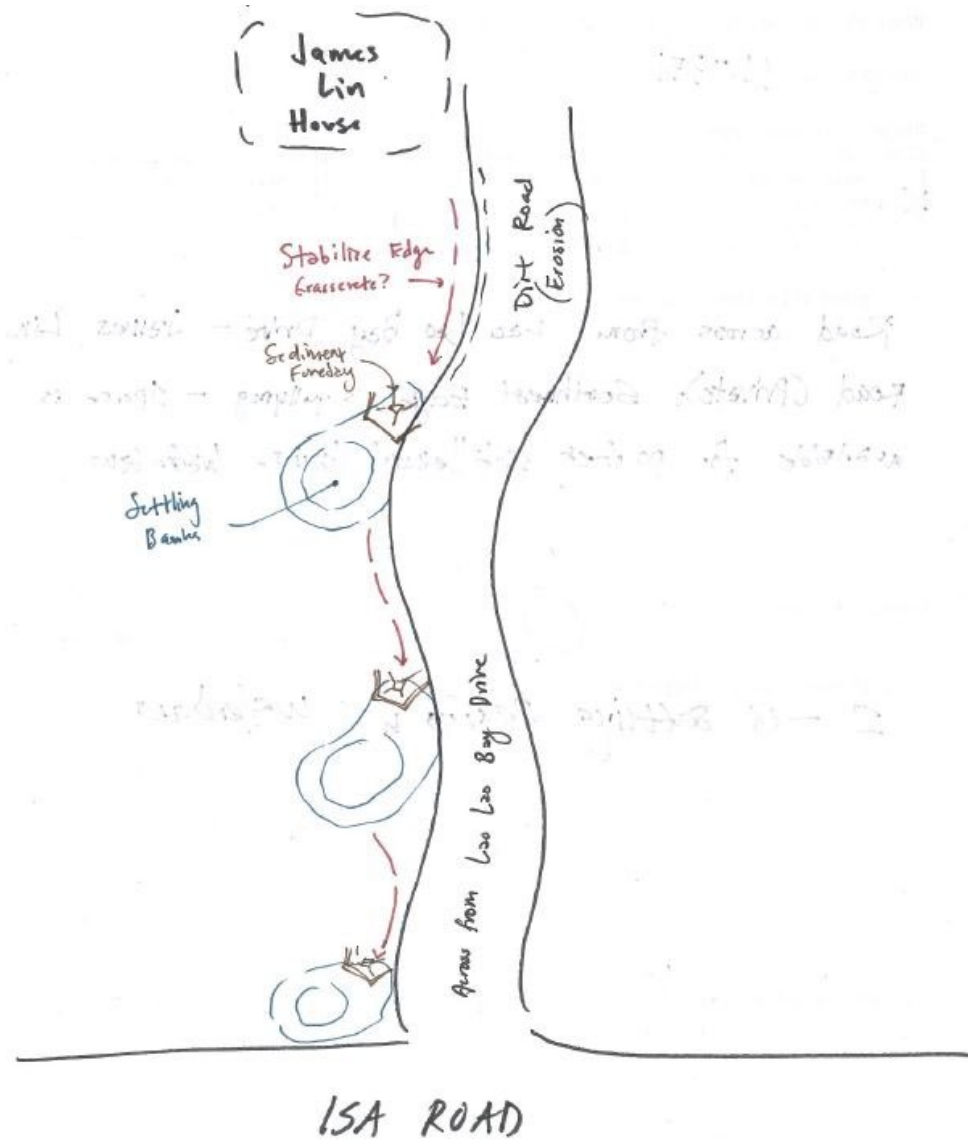
<b>Site ID:</b> LL351	<b>Watershed:</b> Laolao
<b>Crew:</b> JI	<b>Date/Time:</b> 01/22/2020 8:25 PM
<b>Project Type:</b> <ul style="list-style-type: none"> <li>Unpaved Road Stabilization</li> </ul>

<p>USGS The National Map: National Boun... Powered by Esri</p>
<b>Enforcement Needed:</b> No	
<b>Severity Rating:</b> 4	
<b>Implementation Priority:</b> Love it! (High)	
<b>Descriptions of Existing Conditions:</b> Serious erosion on one side of the road/ Road across from Lao Lao Bay Drive - James Lin road (private) - southwest edge is gullyng. space is available for pocket settlement basins. waterbars.	
<b>Description of Proposed Opportunity:</b> 2-3 settling basins with waterbars	
<b>Challenges/Constraints:</b> Private road, need to go to dpw or mayor	
<b>Additional Notes:</b> Contributing to Lao Lao Bay settling basin (target source not symptom)	
<b>Site Photo</b>

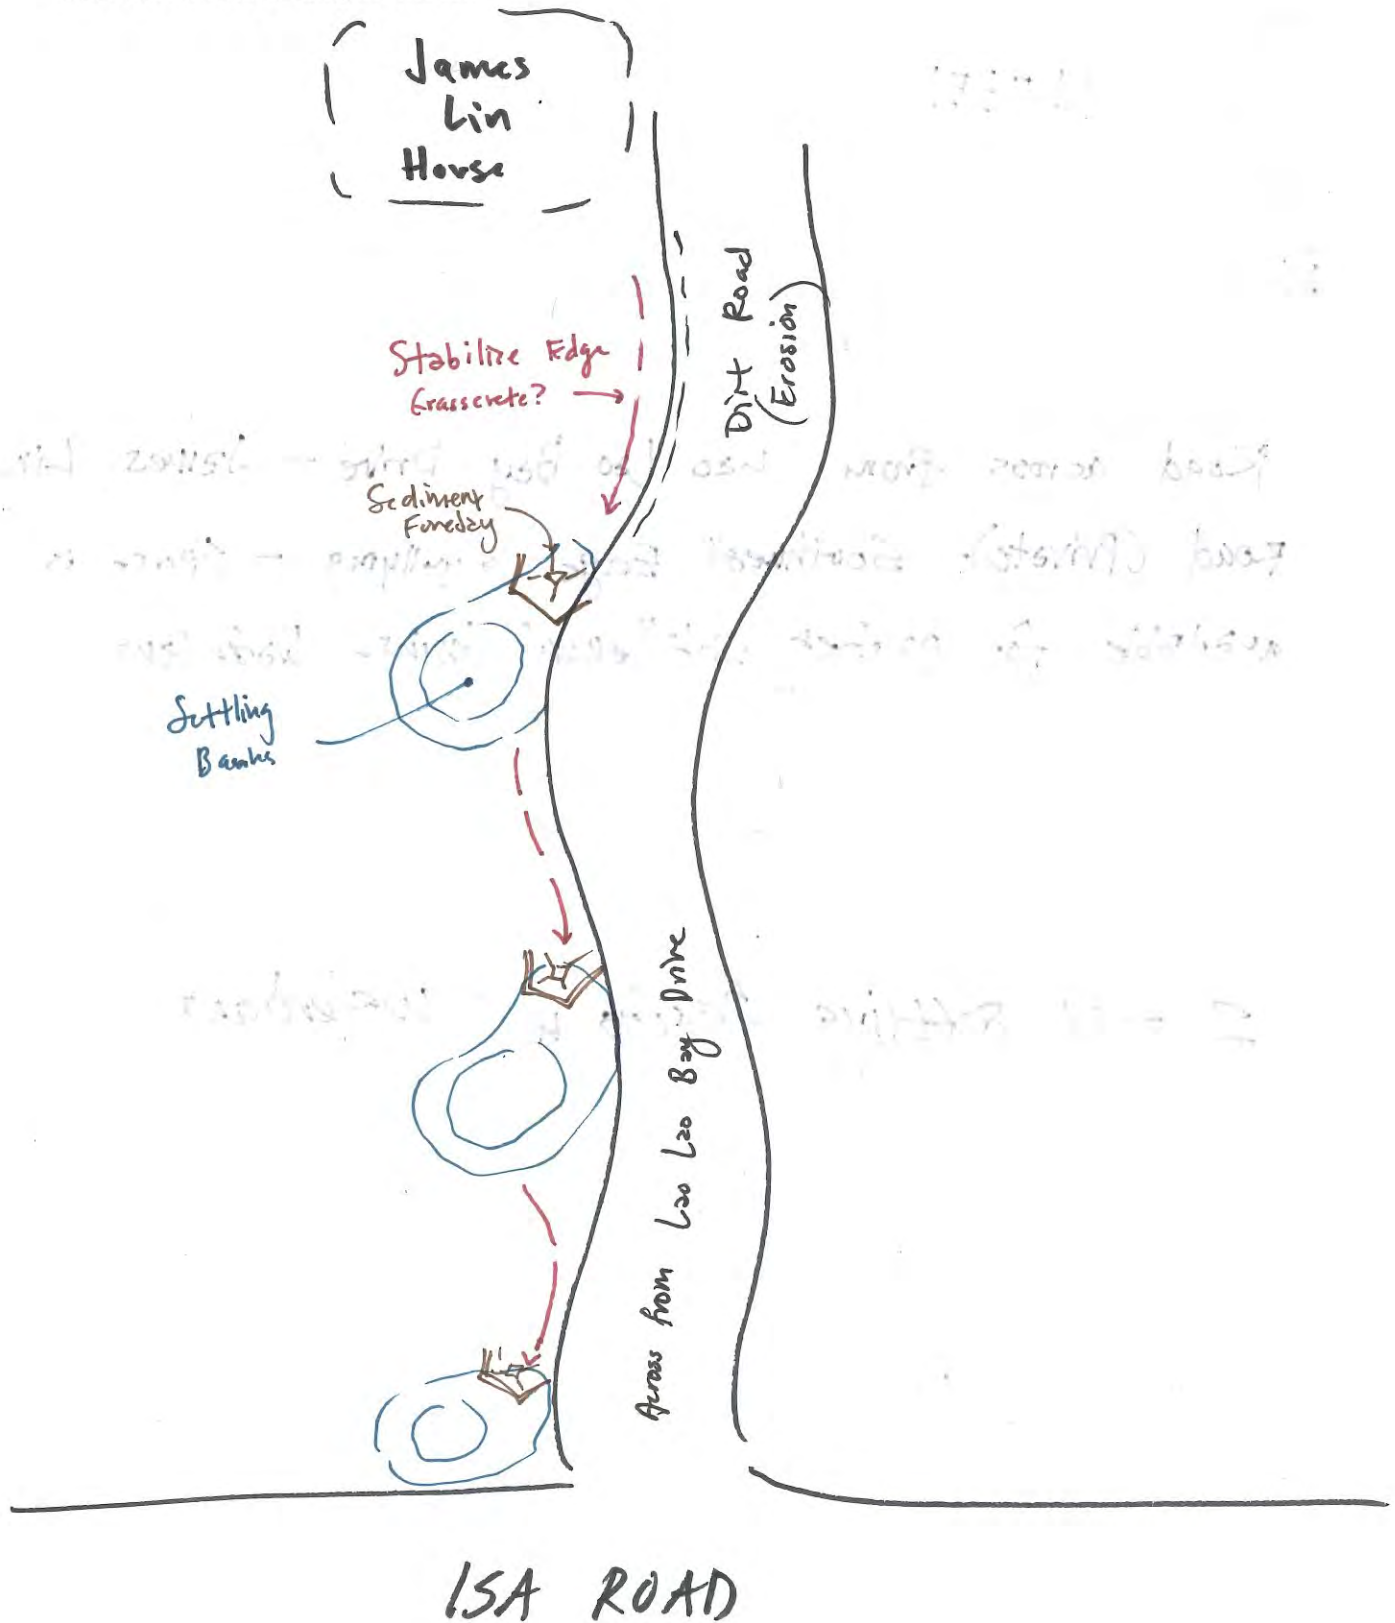
Challenges/Constraints: Contributing to Lao Lao Bay Settling Basin  
(Target Source not Symptom)

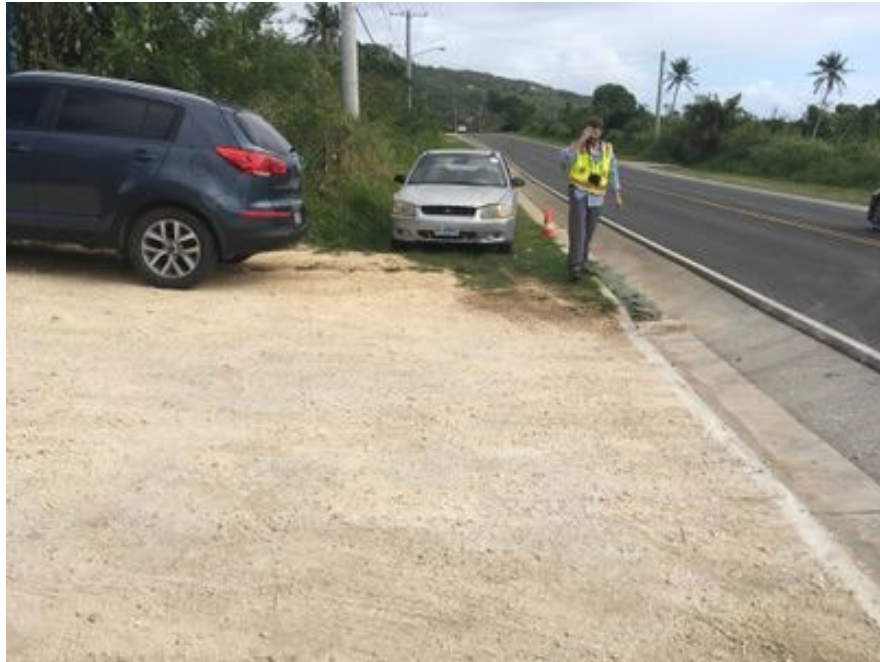
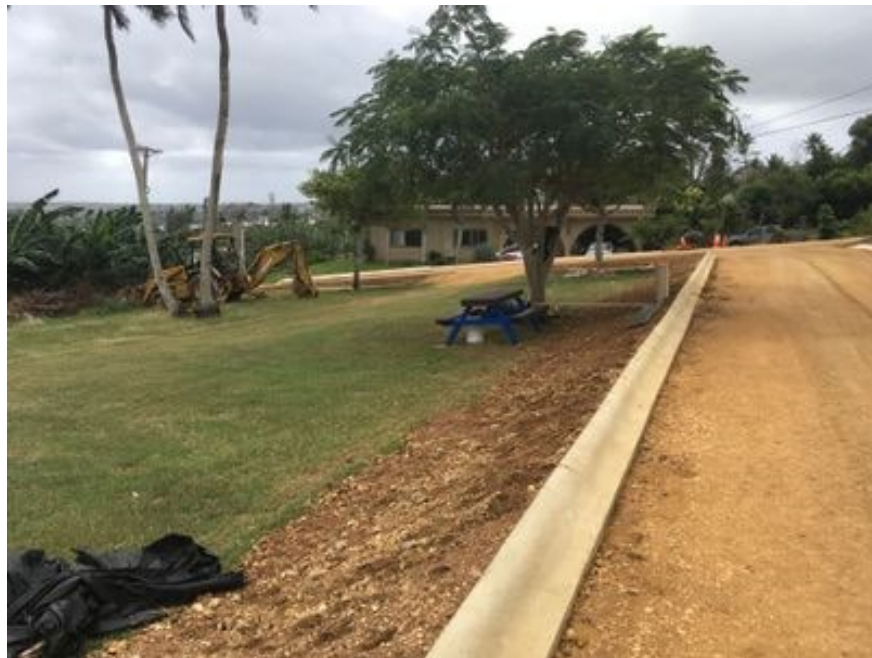
<b>Site ID:</b> LL352	<b>Watershed:</b> Laolao
<b>Crew:</b> JI	<b>Date/Time:</b> 01/22/2020 8:46 PM
<b>Project Type:</b> <ul style="list-style-type: none"> <li>Construction Site ESC</li> </ul>

<p>USGS The National Map: National Boun... Powered by Esri</p>
<b>Enforcement Needed:</b> Yes	
<b>Severity Rating:</b> 5 (Severe)	
<b>Implementation Priority:</b> Love it! (High)	
<b>Descriptions of Existing Conditions:</b> Palu Road construction. No ERSC - full catch basin at Isa Dr. No silt sack. No track pad. Staging area at top of hill with brush clear. Street next to Palu Road also has construction and not much ESC was observed.	
<b>Description of Proposed Opportunity:</b> Enforcement. ERSC - lack of awareness by DPW. Silt sack in ex. cbs. cover stockpiles, silt sock around stockpiles.	
<b>Challenges/Constraints:</b> Saw this too much at construction site. clearing before ERSC.	
<b>Additional Notes:</b> No erosion control measures from construction up above, staging area at top of hill but no ESC

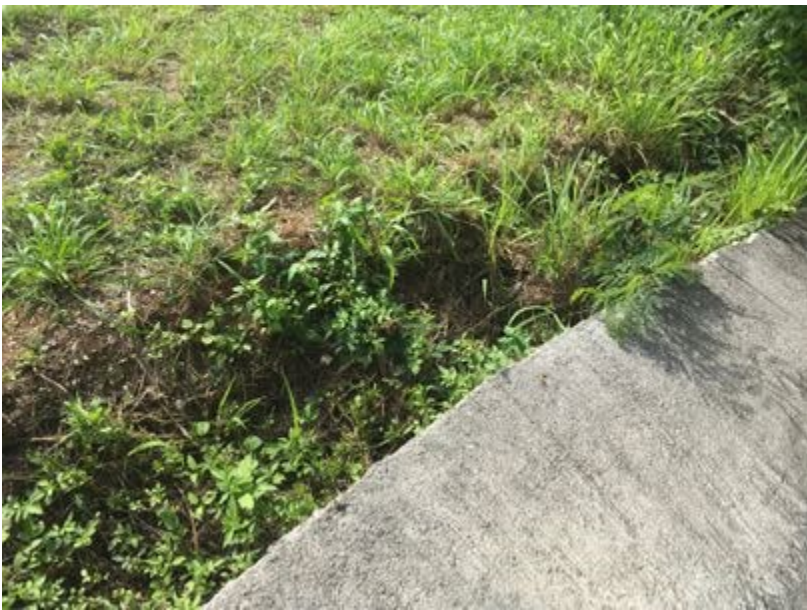
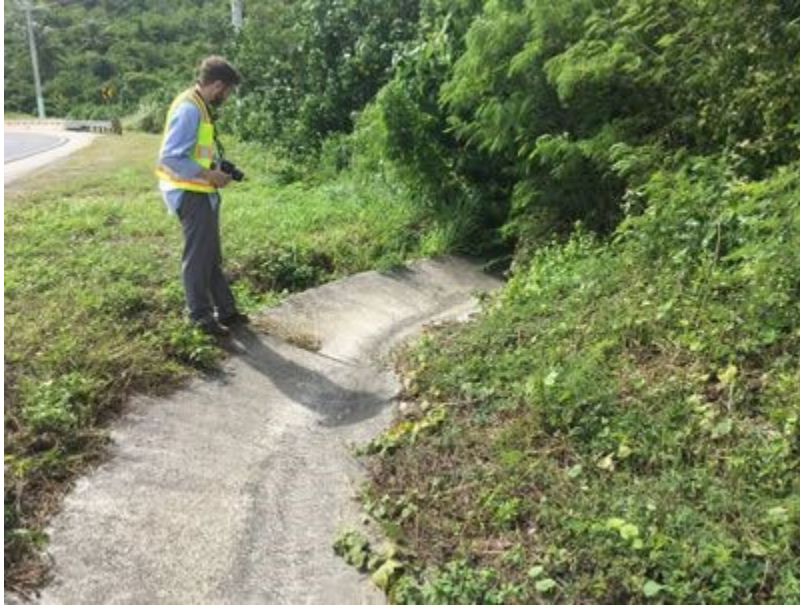
<b>Site ID:</b> LL377	<b>Watershed:</b> Laolao
<b>Crew:</b> JI	<b>Date/Time:</b> 01/22/2020 11:56 PM
<b>Project Type:</b> <ul style="list-style-type: none"> <li>Drainage Infrastr., Maint. &amp; Repair</li> </ul>

<b>Enforcement Needed:</b> No	
<b>Severity Rating:</b> 3	
<b>Implementation Priority:</b> It's OK (Med)	
<b>Descriptions of Existing Conditions:</b> Washout along side of concrete swale into woods. Flume into wooded area is blown out on road side. runoff can't make turn.	
<b>Description of Proposed Opportunity:</b> Add berm or curb edge. simple and easy to avoid sediment input.	
<b>Challenges/Constraints:</b>	
<b>Additional Notes:</b>	
<b>Site Photo</b>

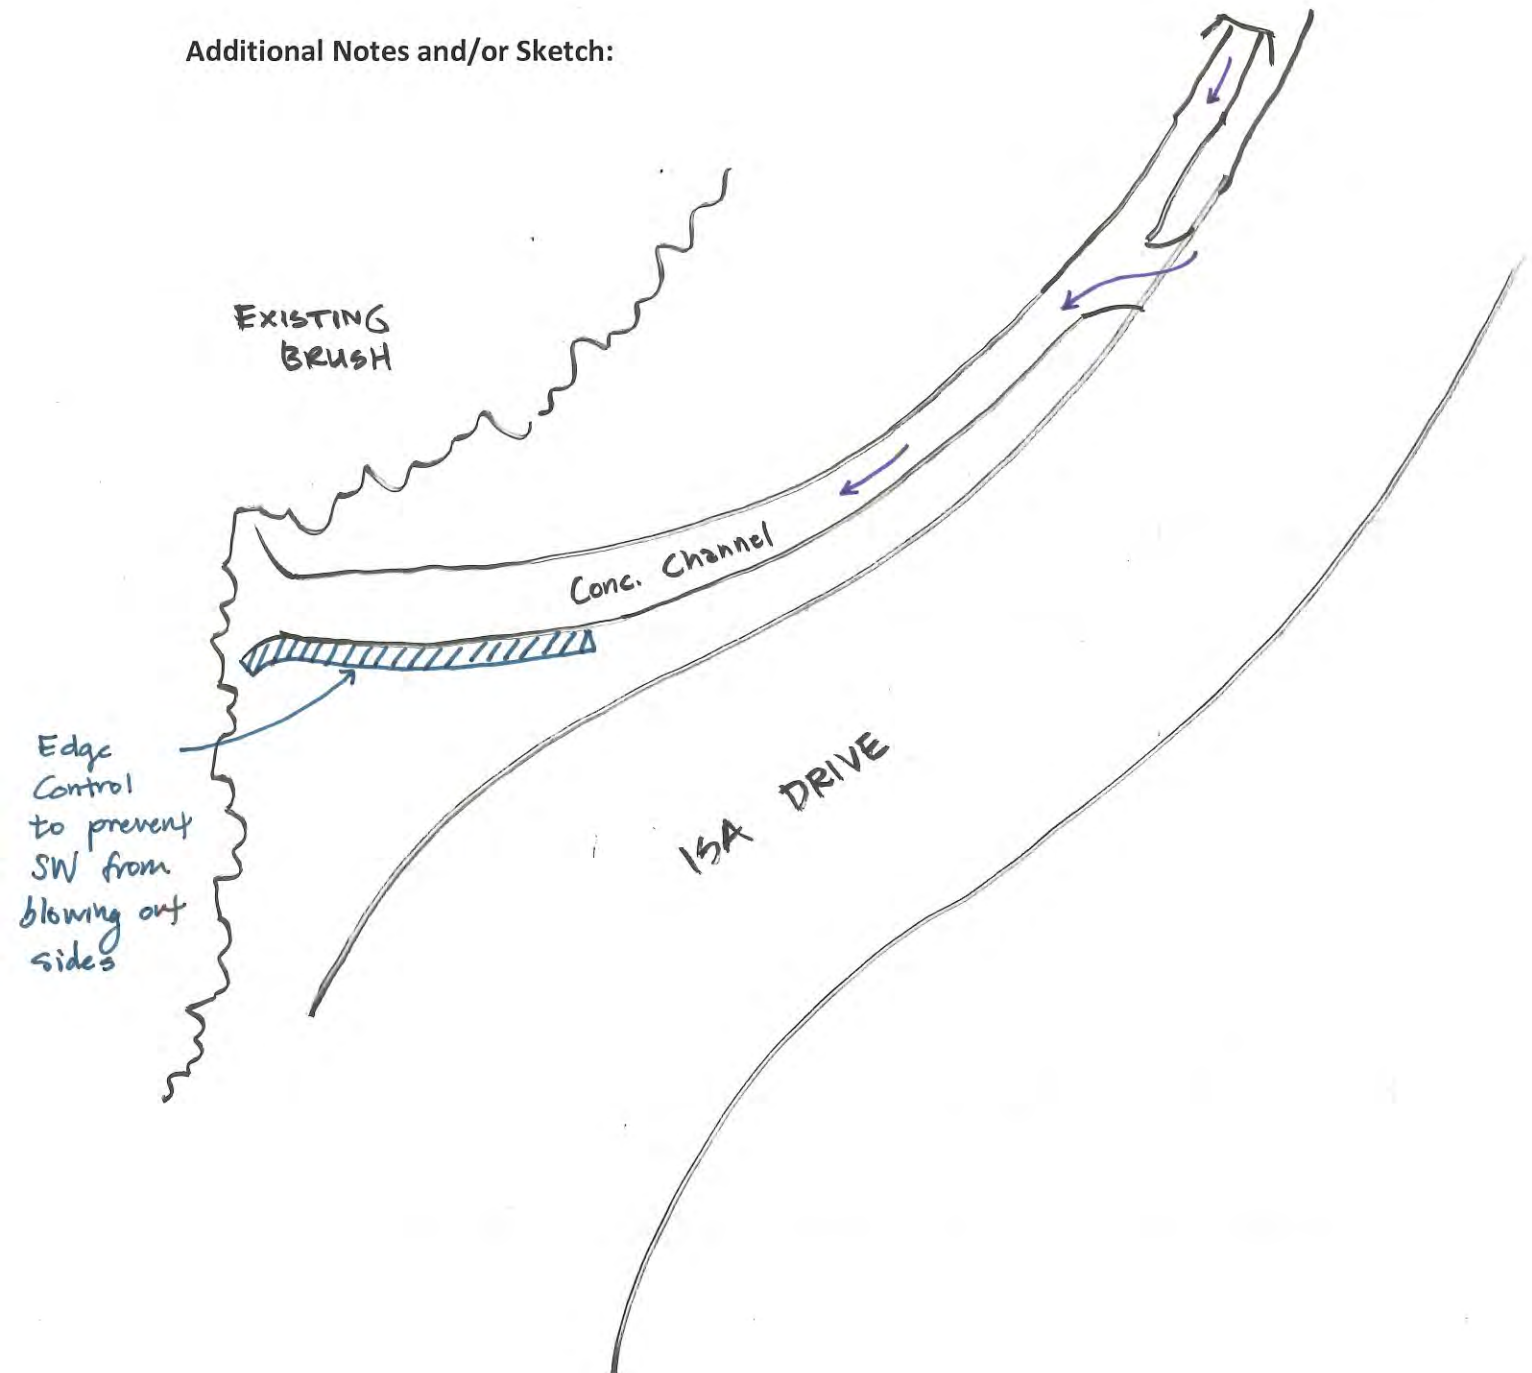
Challenges/Constraints: SW is moving extremely fast downhill & doesn't want to make turn with channel. Side slope is being eroded as result.

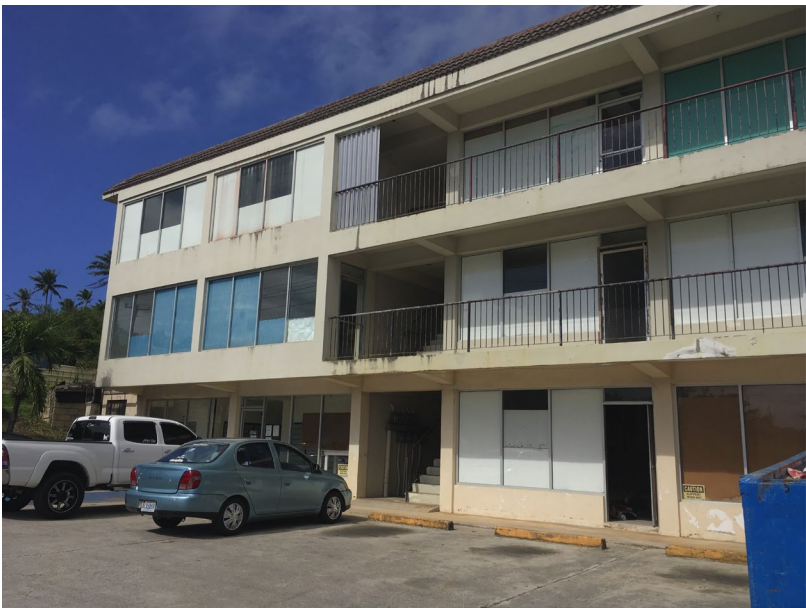
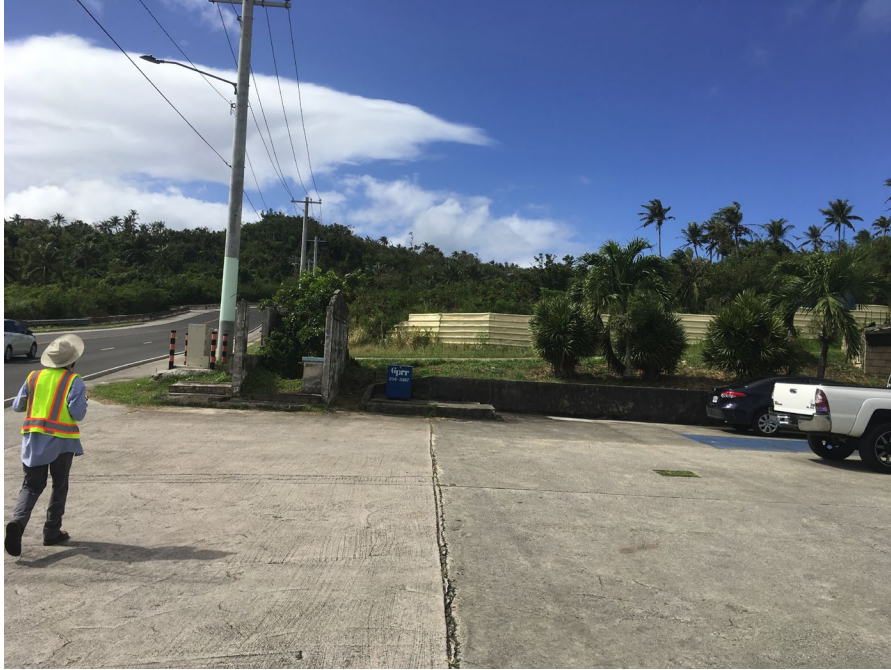
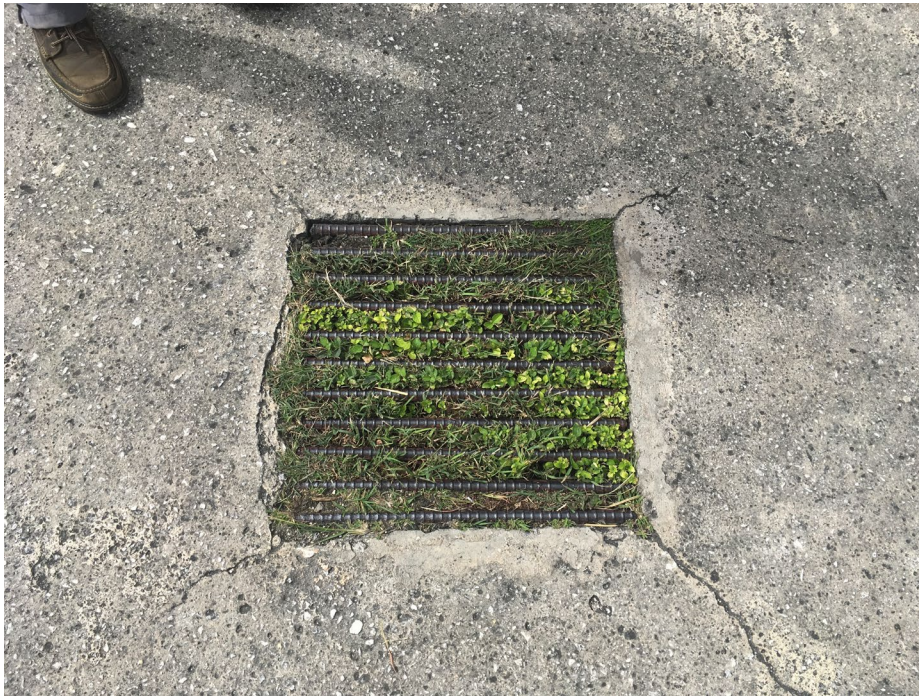
<b>Site ID:</b> LL382	<b>Watershed:</b> Laolao
<b>Crew:</b> JI	<b>Date/Time:</b>
<b>Project Type:</b> <ul style="list-style-type: none"> <li>Drainage Infrastr., Maint. &amp; Repair</li> </ul>

<b>Enforcement Needed:</b> Yes	
<b>Severity Rating:</b> 5 (Severe)	
<b>Implementation Priority:</b> It's OK (Med)	
<b>Descriptions of Existing Conditions:</b> catch basin in post office parking lot is full of vegetation	
<b>Description of Proposed Opportunity:</b> clean out catch basin	
<b>Challenges/Constraints:</b>	
<b>Additional Notes:</b>	
<b>Site Photo</b>
