Shoreline Monitoring Beach Profile Report: Saipan and Mañagaha

March 2021 – March 2022

Division of Coastal Resources Management
CNMI Bureau of Environmental Coastal
Quality

Award No.: NA20NOS4190179

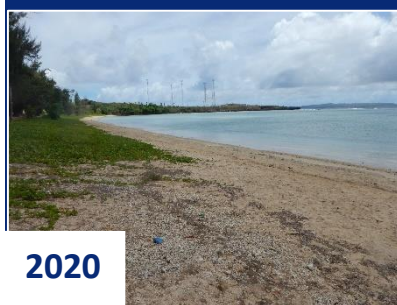
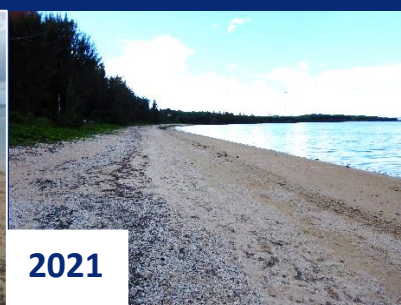
Pak Pak 3 Highlights:

- STABLE with a Wrackline that ranges 47 – 77 ft with an elevation difference of 8 ft
- Seasonal variation may bring some fresh sediment to the shoreline. The nearby outfall northward may have some influence. Vegetation has developed indicating that storm surge has not impacted the area since 2019.

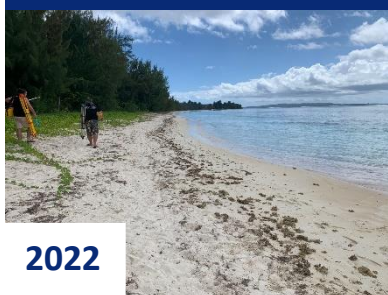
Hopwood 3 Highlights:

- DYNAMIC that ranges 27 – 47 ft and an elevation difference of 7 ft
- Variation in entries are influenced by the outfall north of the headstake.

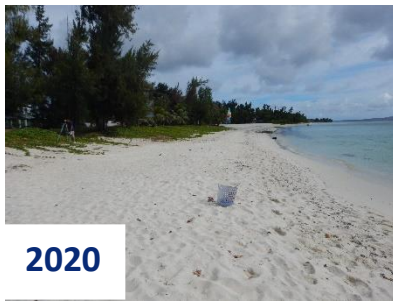
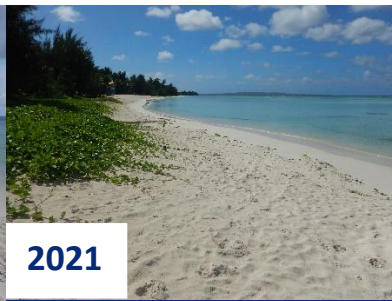
Aquarius 1

- ACCRETING in the short-term; STABLE in the long-term
- Wrackline that ranges 35 – 92 ft with an elevation difference of 10 ft
- Short-term erosion events have occurred. The sand bar could influence this dynamic behavior, suggesting that sand is pushed during typical winter conditions and pulled during typhoon conditions.

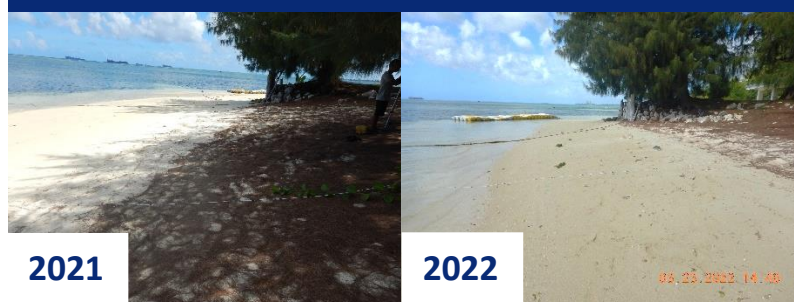
Susupe Beach Park 3

- STABLE with a Wrackline that ranges 29 – 50 ft and an elevation difference of 7 ft

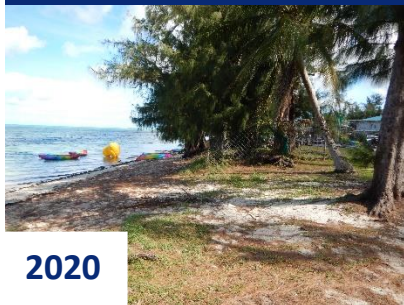
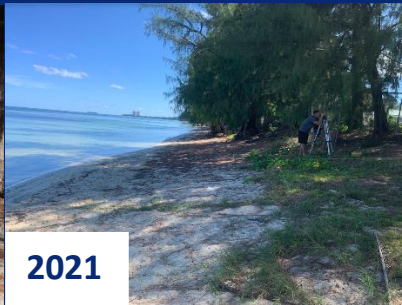
Kilili North 3

- ERODING with a Wrackline that ranges 26 – 54 ft with an elevation difference of 8 ft

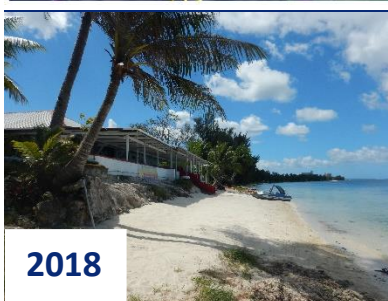
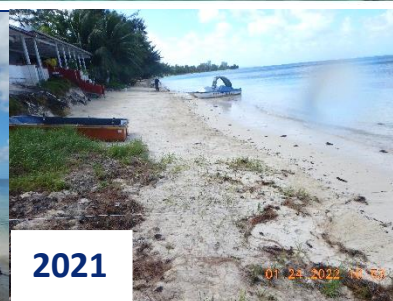
Oleai 1

- ERODING with a Wrackline that ranges 8 – 33 ft and an elevation difference of more than 6 ft
- Tides and seasonal wave conditions influence the beach width. The shoreline receives grooming through the restaurant's management to move washed up debris more inland to expose a sandy shoreline.

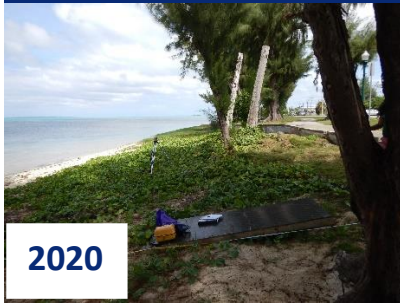
Quartermaster 2

- STABLE with a Wrackline that ranges 30 – 52 ft with an elevation difference of 7 ft
- Low tide difference is high

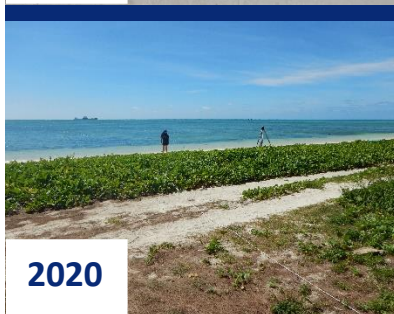
Hafa Adai 3

- ACCRETING with a Wrackline that that ranges 40 – 88 ft and an elevation difference of 6.5 ft
- As the shoreline has been gaining volume and length in three years, this stretch of shore naturally developed infrastructure. From July 2020 through Feb 2021, a row of ironwood trees grew and blocked the transect, making surveying difficult from Feb 2021 and onward.

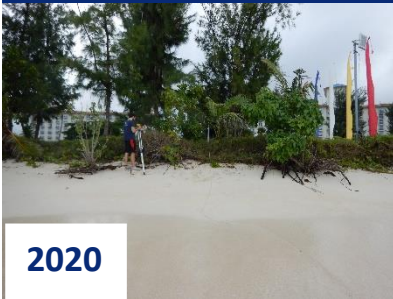
Fiesta 2

- ERODING and REPLACED
- LOSS of shoreline by ~20 ft since 2018
- Beach profile of Feb 2021 to Jul 2021 showed the **High Waterline** ranges 30 – 40 ft with an elevation difference of 6 ft
- **History:** The January 2018 to July 2020 headstake indicated a berm loss of around 10 ft from Jan 2018 through July 2020. The shoreline grew steeper, which enabled further erosion of the shoreline. The one displayed here preceded and was abraded by a September 2021 storm.

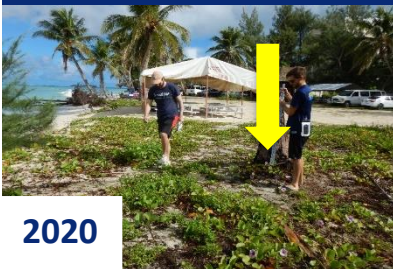
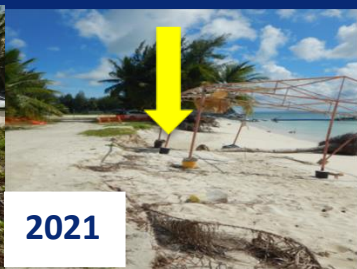
Fiesta 3

- ERODING and REPLACED
- LOSS of shoreline by ~60 ft since 2017
- Beach profile of Jun 2017 to Jun 2021 showed the **High Waterline** ranges 30 – 55 ft with an elevation difference of less than 6 ft
- **History:** From 2017 – 2020, the berm has retreated ~36 ft. Then from Feb 2020 – Jun 2021, erosion has reached the headstake, indicating additional of loss 16 ft. Storm-induced wave action is abrading the beach and weakening the sand. The late storms of 2021 have eaten up to the headstake and reached the road. Vehicles accessing this road are subjected to getting stuck in the softened sand or falling into the water. They are also compacting the sand. The wrackline is nonexistent due to a lack of seagrass or other potential debris in the adjacent waters.

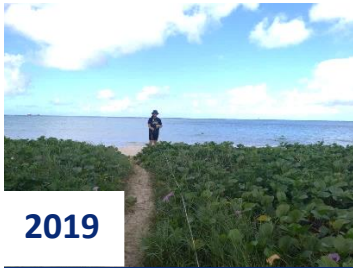
American Memorial Park South 2

- ERODING in the short-term and REPLACED
- Wrackline ranges 30 – 60 ft and an **elevation difference** of less than 5 ft
- LOSS of shoreline is less than 70 ft since 2020
- In 2017, the sediment input appears to increase in the summer of 2017. The typhoon season of that year abraded the shoreline. After Super Typhoon Yutu, the berm has retreated significantly and the toe is deeper and closer to the waterline. Then the beach accreted until Feb 2021, when storms started eating away at the beach and ripped up the vegetation. Similar to AMP South 1, the seasonal sediment input may be a great contributor to a different shoreline position.

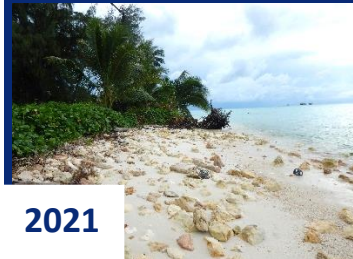
American Memorial Park Point 1

Cover photo is the eroded shoreline of American Memorial Park Point 1.

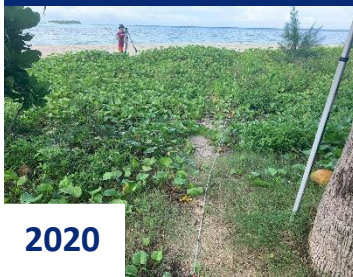
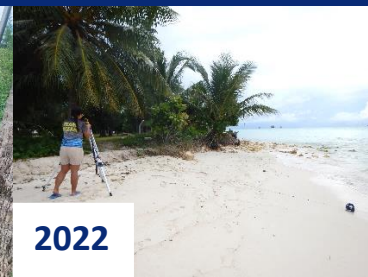
American Memorial Park Point 2

- ERODING in the short-term with a Wrackline that ranges 45– 150 ft and an **elevation difference** of less than 5 ft
- LOSS of shoreline is less than 70 ft since 2020
- **History:** This profile is subjected to damage by storms. It has accreted on Jan 2017 – July 2018. After Super Typhoon Yutu, the shoreline noticeably abraded. However, the September 2021 storm has eroded the shoreline by more than 50 feet. The sand in this area migrated to the northern transects. There is potential for the beach to rebuild itself.

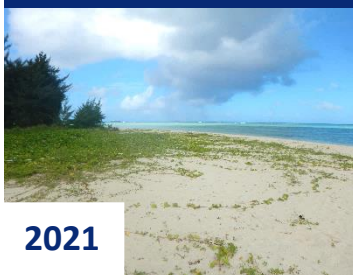
American Memorial Park North 2

- ACCRETING in the long-term with an elevation difference of more than 6 ft since 2017
- GAIN of shoreline by more than 110 ft since 2017
- Sand from southern shorelines (South 1 through Point 2) may be migrating up northern as suggested by the width tripling in the last two years.

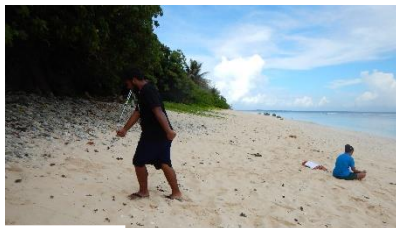
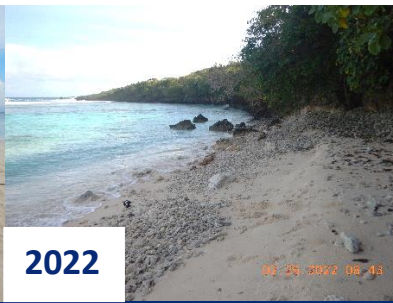
Wing 2

- DYNAMIC with an elevation difference of 11 ft
- Based on observations from the Feb-21 record shows, a high tide with a high wave event greatly abrades the berm along this transect. With the input of coral rubble from the nearby reef, recovery to the average shoreline length is anticipated.

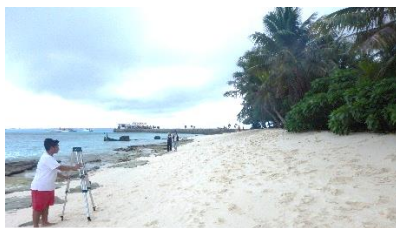
Mañagaha 7

- ERODING in the short-term with a Wrackline that ranges 0 – 11 ft and an elevation difference of 4 ft
- This current headstake receives sediment; however, it is observed that high energy and high tides have allowed the waterline to strike the headstake.
