Mañagaha Island Shoreline Stability Assessment

Coastal Resources Management Office
Commonwealth of the Northern Mariana Islands
2007

Coastal Geology Group, Department of Geology and Geophysics,
School of Ocean and Earth Science and Technology (SOEST), University of Hawaii
1680 East-West Road, Honolulu, HI, 96822 USA

Fletcher, C.H., Barbee, M., Dyer, M., Genz, A., Vitousek, S., 2007. Mañagaha Island Shoreline Stability Assessment, Report to the Coastal Resources Management Office, Commonwealth of the Northern Mariana Islands, Saipan, 90 p.

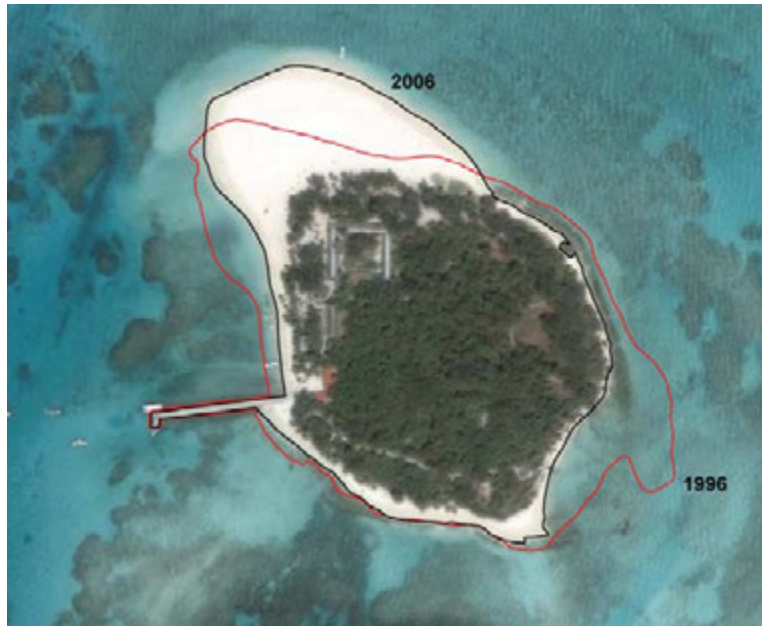
Dramatic and accelerated shoreline change at Mañagaha has been documented since 1996 (Fig. 5) when debris was removed (Fig. 6) on and near the immediate shoreline. Since then, the contiguous southeast, east, and northeast shorelines of Mañagaha have experienced persistent erosion and shoreline retreat.

Figure 5. Shoreline changes at Mañagaha accelerated following debris removal in 1996. (QuickBird, 2006)

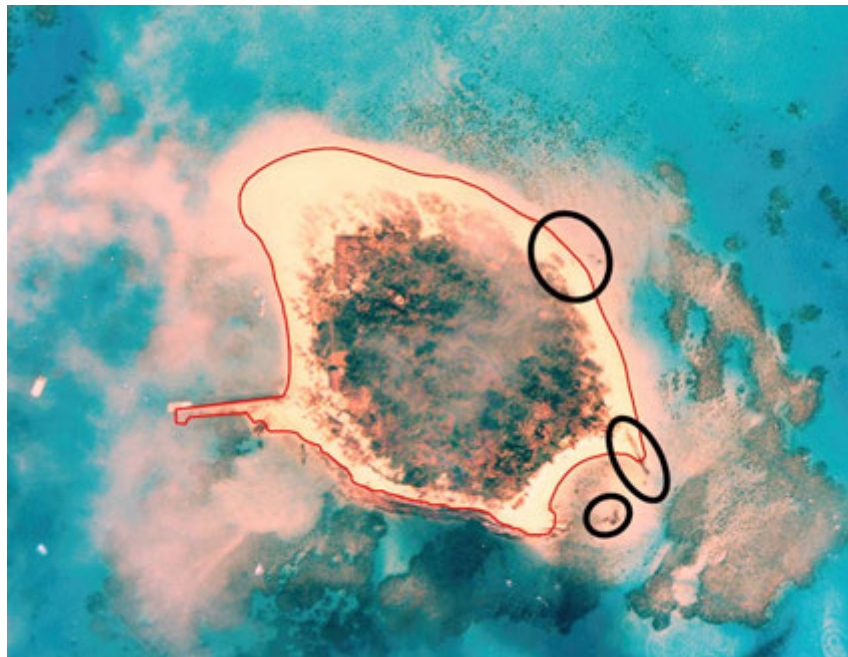
sediment deficiency and or dynamic processes capable of transporting sand. However, the historical rate of erosion at Mañagaha appears to have accelerated, and some previously stable areas have begun to erode following the 1996 removal of WWII debris (ship wrecks and a pier) posing a safety hazard in the area. This history implies that wave and current modification provided by the debris were significant to island stability.

Figure 6. Debris (circled) in the area of modern erosion was removed in 1996. (1987 aerial photo)

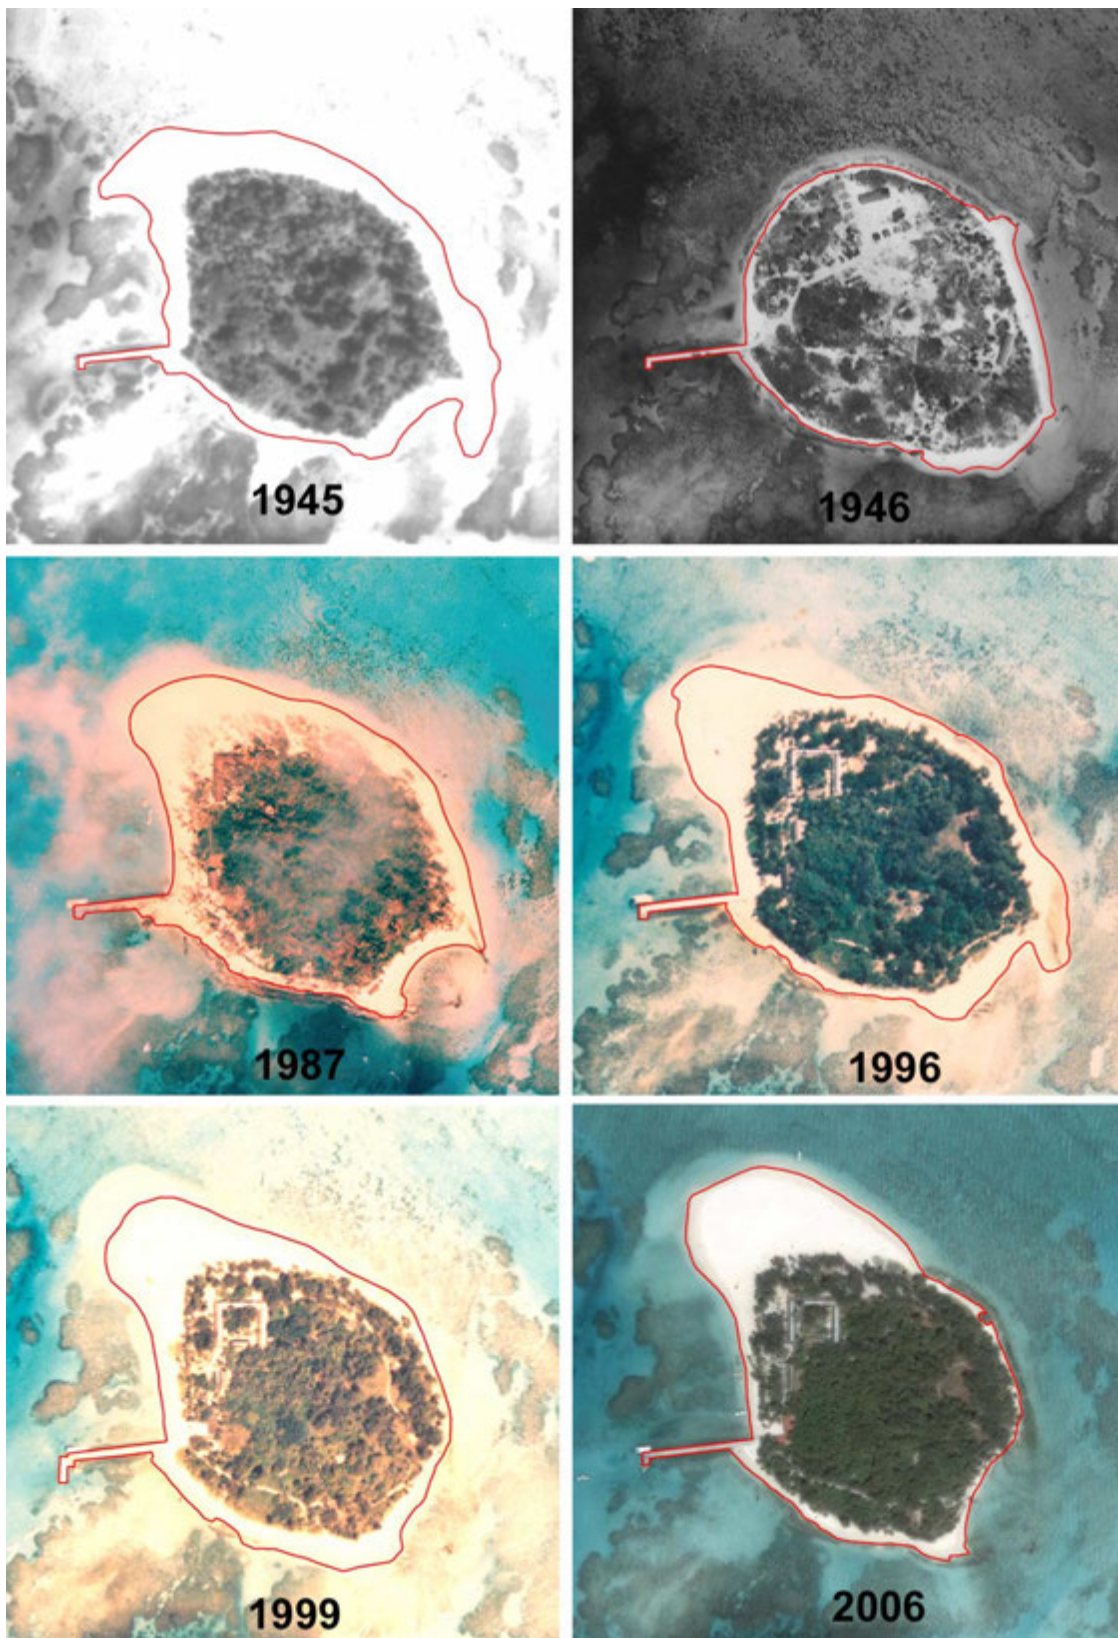
1945 - Present: At the time of aerial photography (Fig. 7) in 1945, a sandy spit extended to the south from the eastern shoreline of Mañagaha. In the following 50 years, this spit sporadically

Figure 7. Historical changes to Mañagaha Island. Red vector marks the low water shoreline.

retreated at rates ranging from 1 to >7 m/yr. Sand leaving the region fueled dramatic shoreline accretion on the northwest side of the island, reaching rates exceeding 5 m/yr.

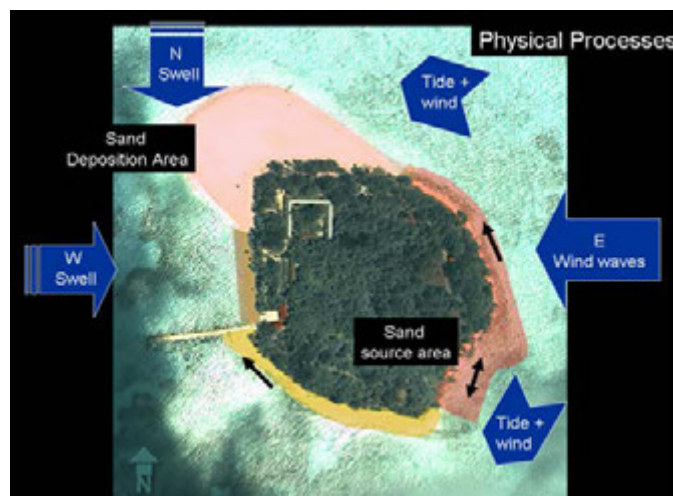
Below, we offer a general description of conditions at Mañagaha Island using this scheme. The shoreline has moved into a condition of net accretion in Region 1 largely due to trade-wind driven, alongshore sediment transport whereby sand in Region 2 feeds Region 1 (Fig. 18). Chronic erosion characterizes Region 2 as it yields sand to both Region 1 and the eastern section of Region 3 under energy conditions associated with typical trade wind flow. Region 3 is characterized by quasi-stability to moderate accretion in the eastern section due to sediment input from Region 2 and erosion in the central section that has perhaps temporarily stabilized (ca. March, 2007). Region 4, starved of alongshore sand delivery by accretion in Region 1, is sediment deficient. Aerial photographs also reveal down drift offset due to sediment impoundment in Region 3 by the pier.

Figure 18. General physical processes and sediment transport directions (black arrows).

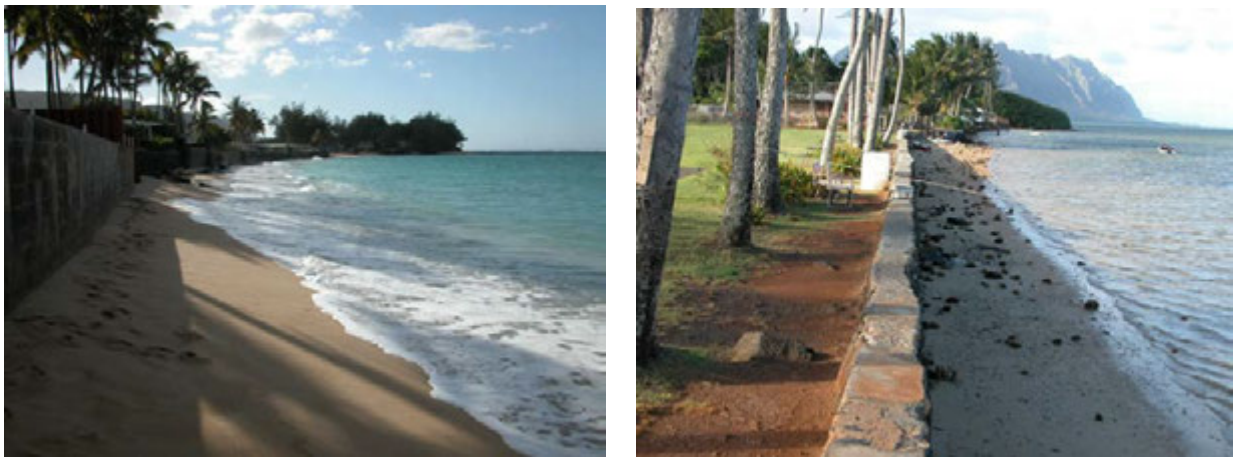
Figure 24. Beach narrowing, sand impoundment, and beach loss occur when a wall is built on a chronically eroding beach.

Cons - While a seawall is useful as an immediate solution to a coastal land loss problem it is not an effective solution where the beach is an important feature. Seawalls tend to cause sand deficiencies and increase wave energy at the shoreline leading to seafloor scour. Walls built in areas of chronic erosion/shoreline recession will lead to beach narrowing and loss (Fig. 24). Seawalls should not be used if beach conservation is a goal. Mobile beach sand can respond to changing wave and current dynamics. This allows a beach to change shape to buffer wave energy. If sand is impounded behind a wall, the natural ability of a beach to respond to changing

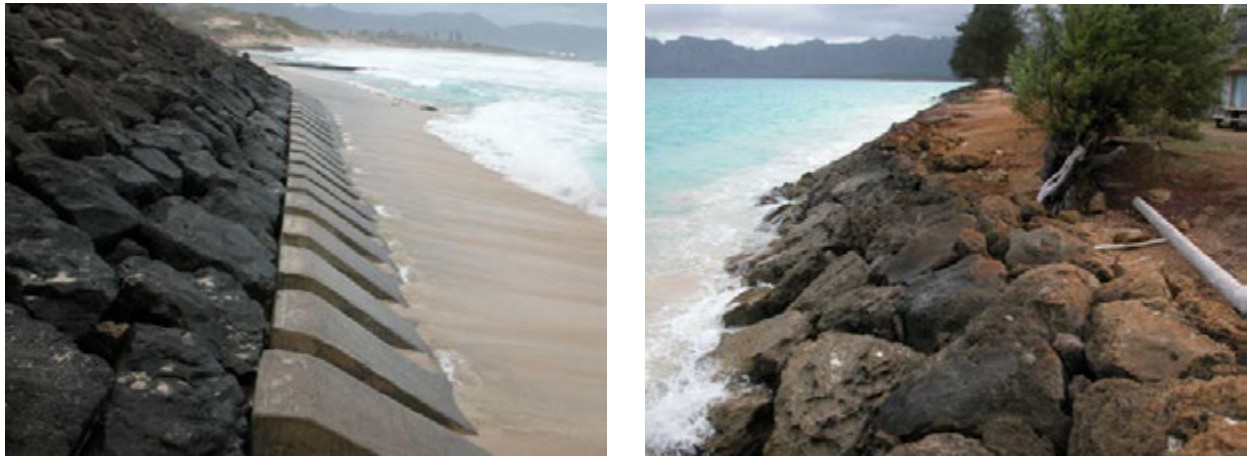
Cons -A revetment functions in much the same way as a seawall in that it is designed to protect land but does not consider the beach as a goal of preservation. Revetments impound sand in the same way that a seawall does, hence it leads to a sediment deficiency, flanking, and beach narrowing and loss on retreating shorelines. Revetments require more footprint space than a seawall, leading to “placement beach loss” (the area under the footprint). In the long-term, a revetment will still have the same effect on sand located seaward and landward of the structure that a sea wall does, and as a result the pros and cons will be very similar to a sea wall.

Figure 25. Photographs of two different revetments. The shoreline is protected landward of the structure but the beach is lost.

Building a revetment at Mañagaha will require consideration of the large footprint of the structure. A strip of land or shallow seafloor, or both will need to be sacrificed to accommodate this. No particular benefit is obtained by using a revetment instead of a seawall, provided the seawall is well constructed and not vulnerable to collapse. All of the impacts resulting from building a seawall, such as sand impoundment and impacts to other island shorelines are also likely to occur in the case of a revetment because it does not manage sand.

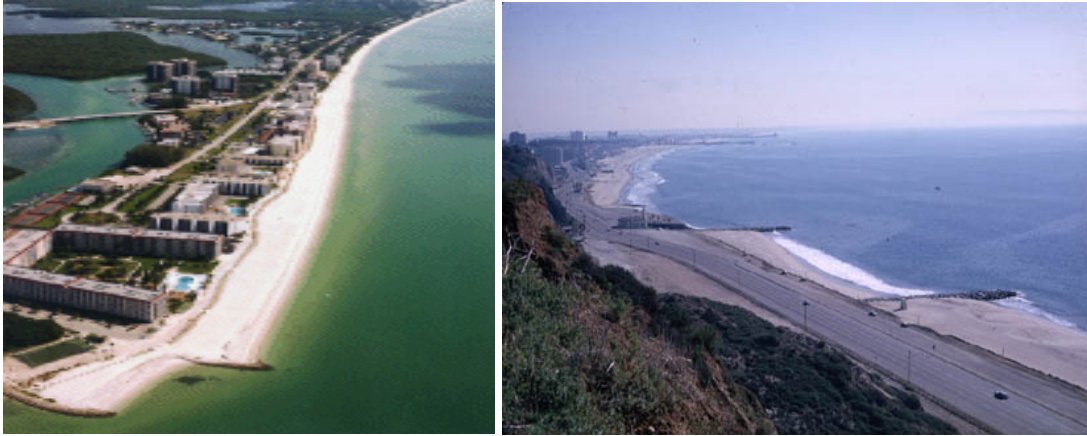
deficiencies on the other (down current). The Mañagaha Pier acts as a groin and the disparity in sediment movement can be seen in aerial photographs showing shoreline progradation to the south of the pier and shoreline recession on the north side.

Figure 26. Groins are effective at capturing sand on one side but cause a depletion of sand on the other.

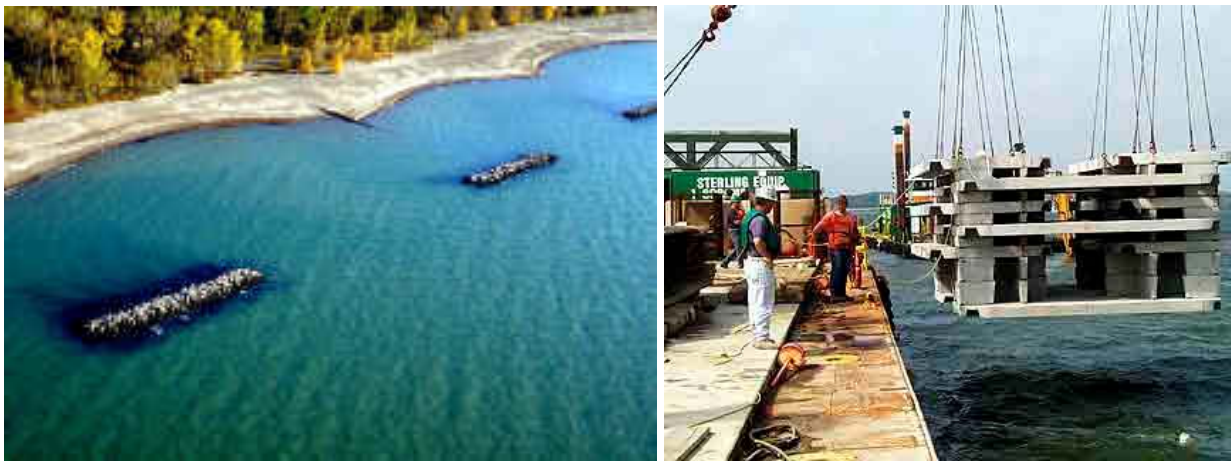
Figure 27. Breakwater (left) and artificial reefs (right) can be designed in a variety of sizes and shapes. But they are vulnerable to storm surge and may lead to unintended impacts.

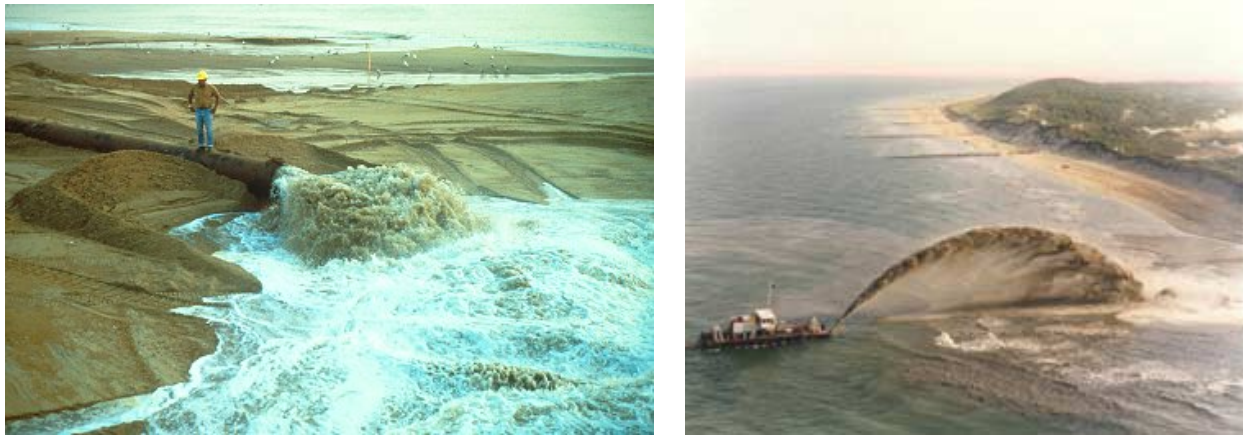
Figure 28. Beach nourishment projects under way showing methods of sand delivery.

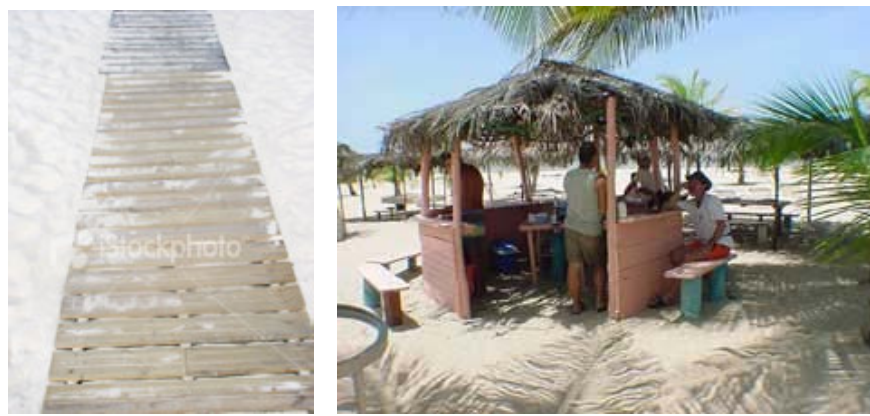
Mañagaha shoreline has shown a past tendency to stabilize relative to hydrodynamic forces. It may still be in the process of stabilizing since the disruption of 1996. Another method for erosion management would be to allow the beach and shoreline to achieve, without intervention, its own state of equilibrium (Fig. 29). Allowing a shoreline to achieve a natural equilibrium requires that human infrastructure be designed for relocation, flexibility, and rapid response to erosion events as well as long-term chronic shoreline change. Unfortunately, it is not known when, or even if, the island shoreline will stabilize and erosion may decrease.

Figure 29. Lightweight, easily moveable infrastructure is an economical erosion management option.
