Shoreline Monitoring Beach Profile Report: Saipan and Mañagaha

May 2023

Division of Coastal Resources Management -
CNMI Bureau of Environmental Coastal
Quality

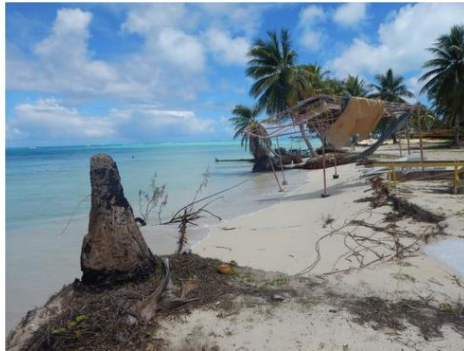
This site between Crowne Plaza and Hyatt has been actively eroding since 2019. This photo was captured in 2021, when beach loss was significant.

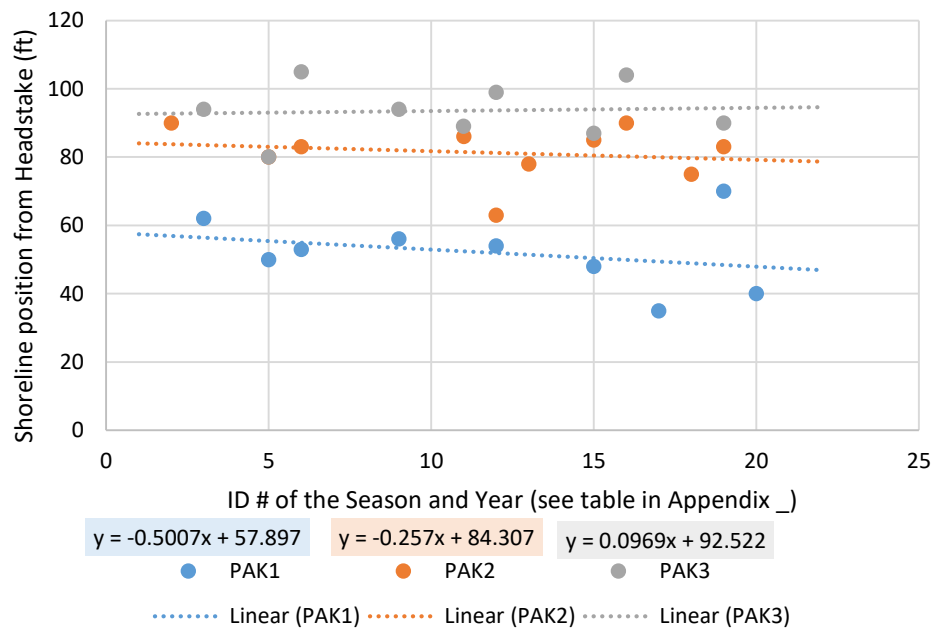
Pak Pak Beach Linear Regression Analysis (2016-2023)

- STABLE
- Wrackline that ranges 47 – 77 ft with an elevation difference of 8 ft
- Seasonal variation may bring some fresh sediment to the shoreline. The nearby outfall northward may have some influence. Vegetation has developed indicating that storm surge has not impacted the area since 2019.
- Based on the Shoreline linear regression analysis (see pg 15), the shoreline has at a rate of -0.09 ft from 2016-2023.

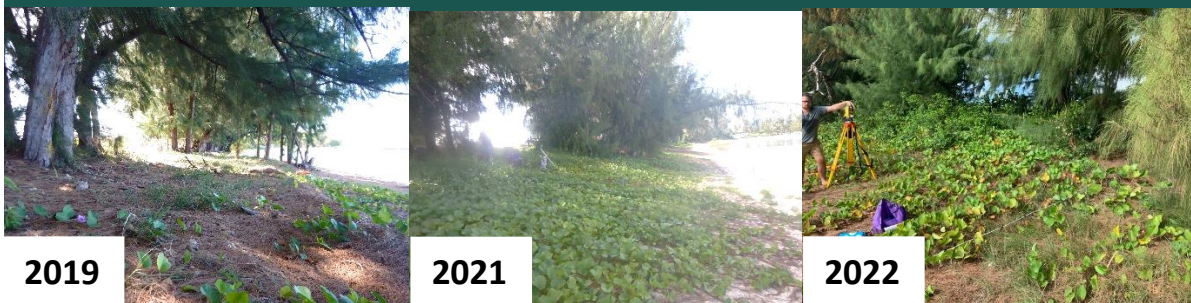
Sugar Dock North 3

- ERODING
- Wrackline that ranges 35 – 38 ft with an elevation difference of 7 ft
- Based on the Shoreline linear regression analysis (see pg 34), the shoreline has at a rate of -0.4 ft from 2016-2023.

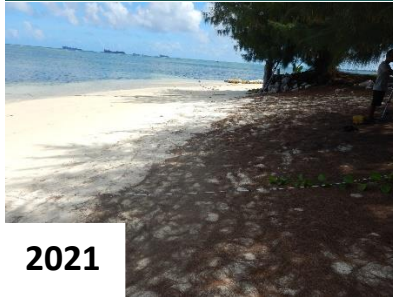
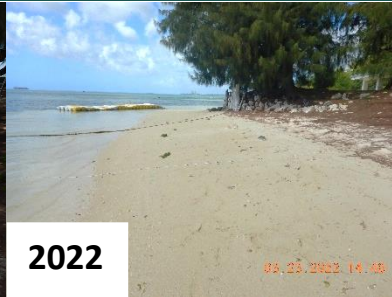
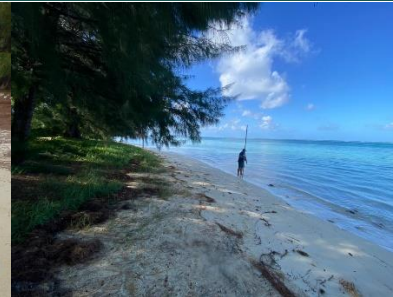
Susupe Beach Park 3

- ACCRETING
- Wrackline that ranges 30 – 60 ft and an elevation difference of 8 ft
- Based on the Shoreline linear regression analysis (see pg 41), the shoreline has been a rate of +1.5 ft from 2016-2023.

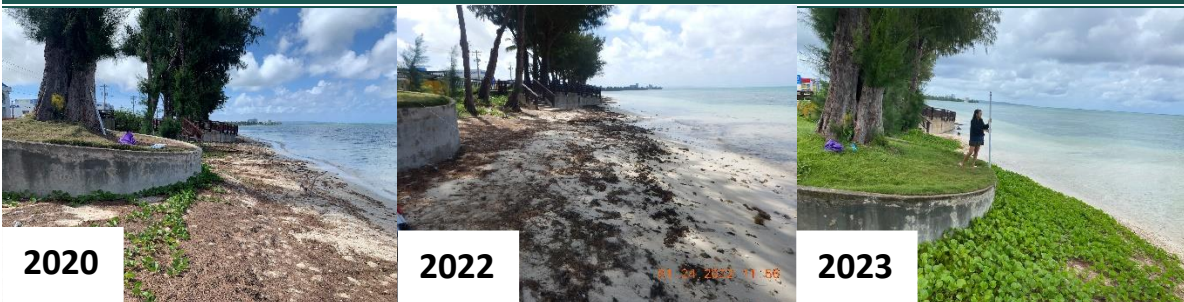
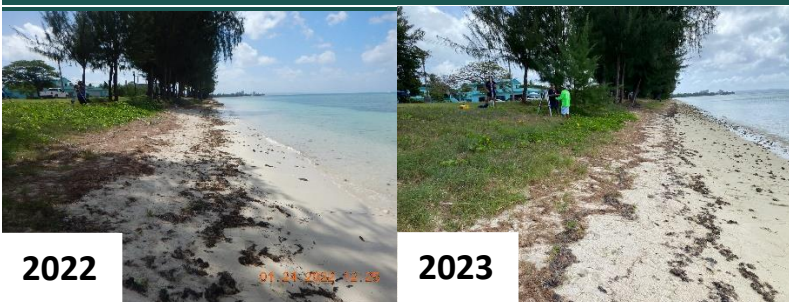
Toyota 3 Highlights:

- ACCRETING
- Wrackline that ranges 30 – 58 ft and an elevation difference of 8 ft
- Periods of erosion and accretion
- Based on the Shoreline linear regression analysis (see pg 63), the shoreline has a rate of +2.7 ft from 2016-2023.

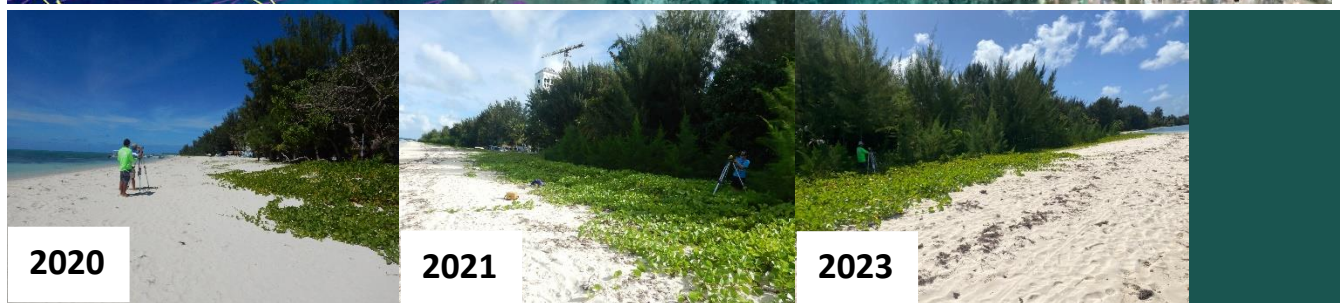
Hafa Adai 1

- ACCRETING
- REPLACED after July 2022
- There is insufficient information to conduct a shoreline linear regression analysis this period.
- Outfall influenced
- PREVIOUS HEADSTAKE showed that the shoreline has accreted over 40 ft since 2017

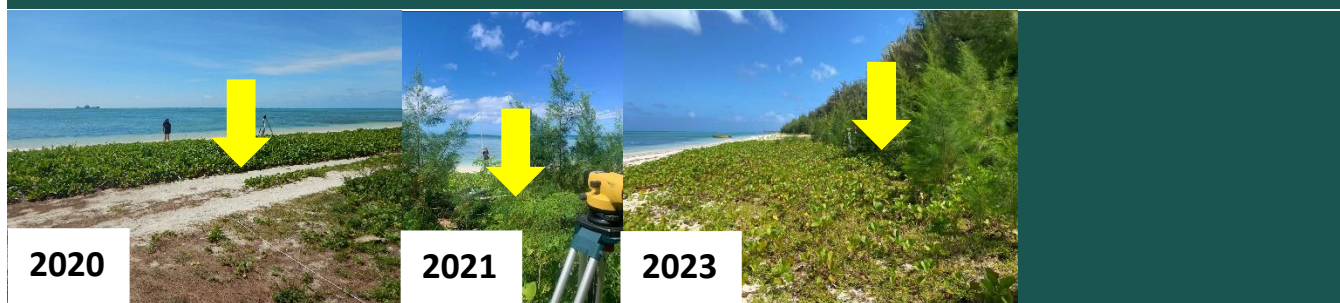
Hafa Adai 3 Highlights:

- ACCRETING
- Wrackline that that ranges 40 – 88 ft and an elevation difference of 6.5 ft
- As the shoreline has been gaining volume and length in three years, this stretch of shore naturally developed infrastructure. From July 2020 through Feb 2021, a row of ironwood trees grew and blocked the transect, making surveying difficult from Feb 2021 and onward.
- Based on the Shoreline linear regression analysis (see pg 74), the shoreline has a rate of +1.3 ft from 2016-2023.

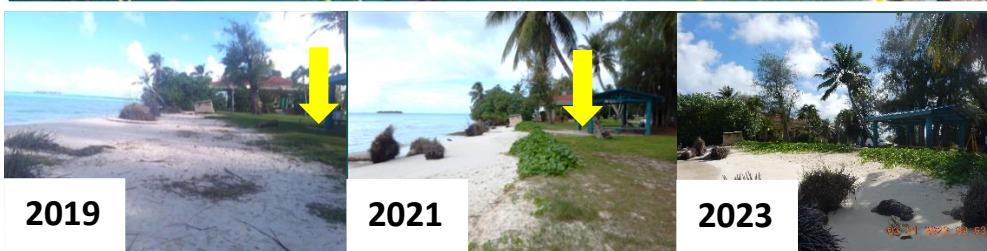
American Memorial Park South 1

- This shoreline has shown great accretion and erosion events throughout the years. There would be months in between when it is stable.
- **History:** This profile is subjected to damage by storms. It has accreted on Jan 2017 – July 2018. After Super Typhoon Yutu, the shoreline noticeably abraded. However, the September 2021 storm has eroded the shoreline by more than 50 feet. The sand in this area migrated to the northern transects. The beach is rebuilding itself.

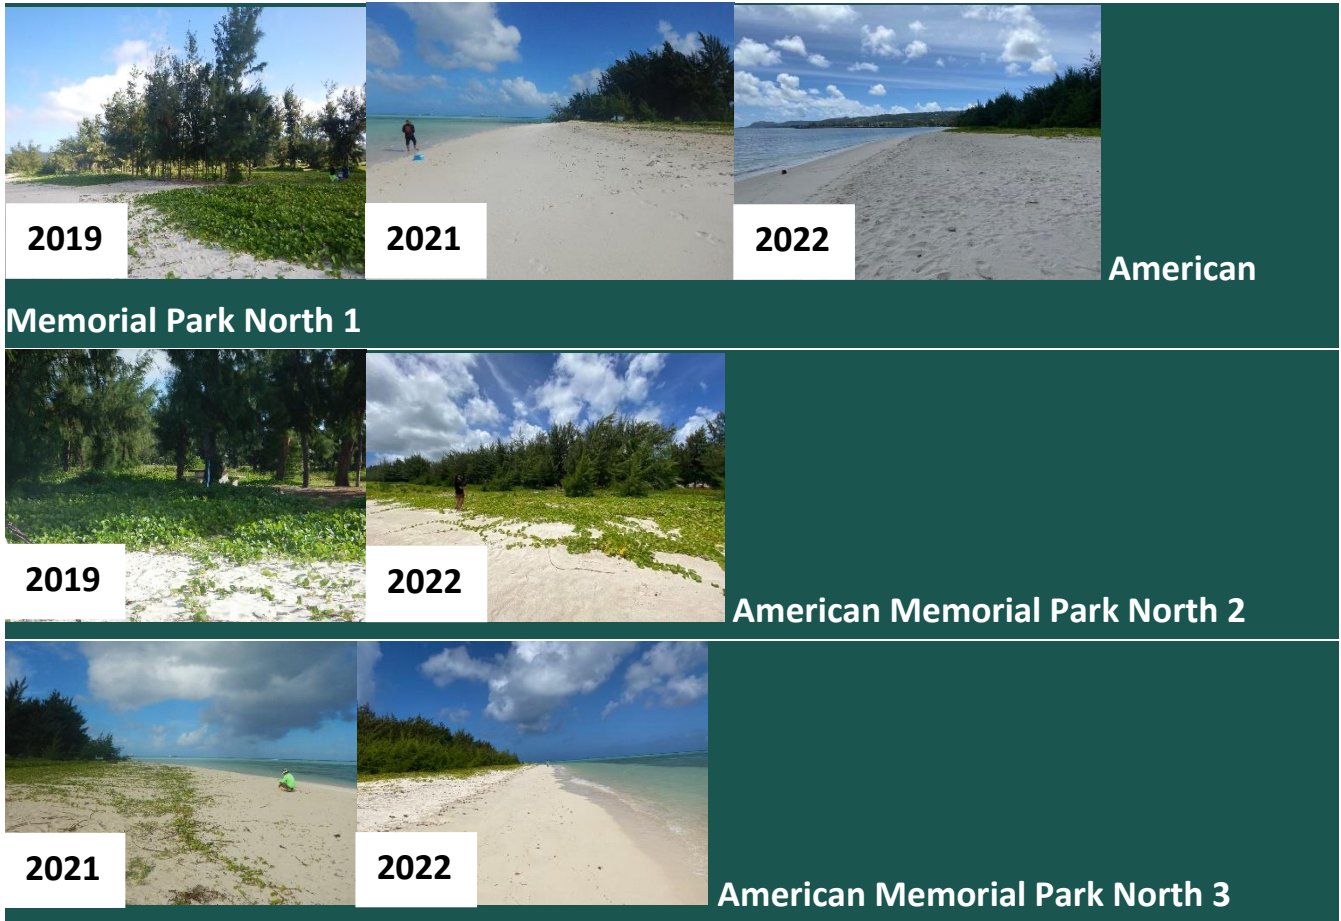
American Memorial Park Linear Regression Analysis (2017-2023)

- ACCRETING in the long-term with an elevation difference of more than 6 ft since 2017
- GAIN of shoreline by 70 ft since 2019
- Sand from southern shorelines (South 1 through Point 2) may be migrating up northern as suggested by the width tripling in the last two years.
- Based on the Shoreline linear regression analysis, the shoreline has been at a rate of +7.25 ft from 2017-2023.

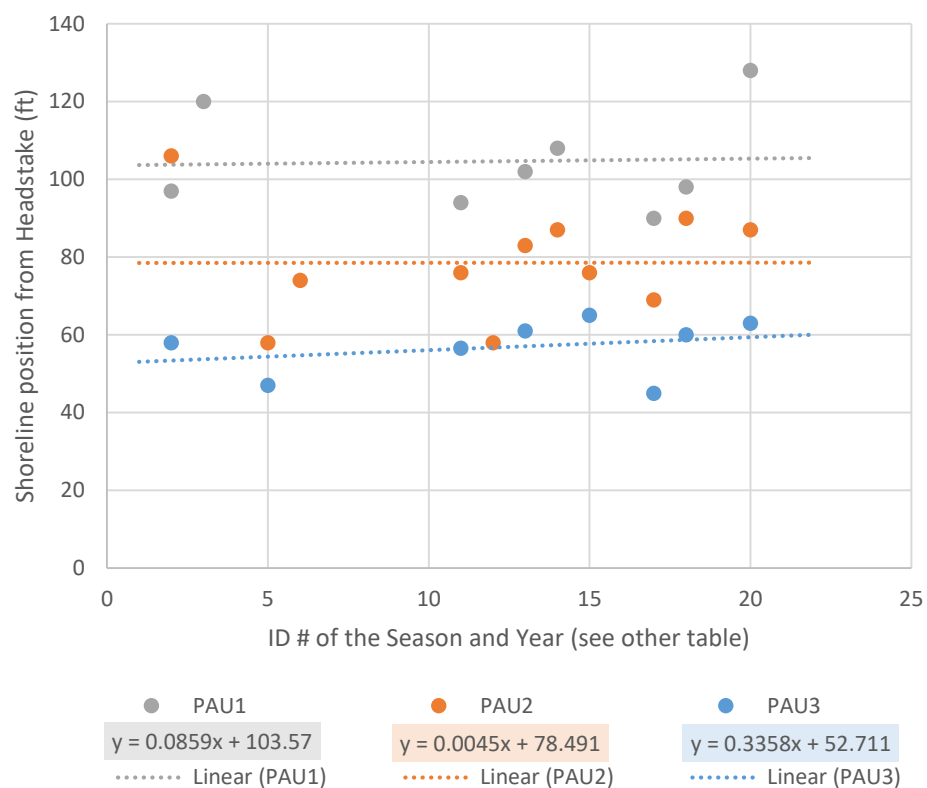
Pau Pau Linear Regression Analysis (2017-2023)

- STABLE
- REPLACED with a headstake that is further inland and adjacent to the previous headstake
- **History:** This beach profile seems to vary from time to time, dependent on deposits from the nearby reef. The headstake is at a distance in the backshore, closer to the parking lot.
- Based on the Shoreline linear regression analysis (see pg 100), the shoreline has a rate of +0.09 ft from 2017-2023.

- STABLE
- Wrackline that that ranges 26 – 50 ft and an elevation difference of 9.5 ft
- This beach profile is variable compared to the other two transects in the site.
- Based on the Shoreline linear regression analysis (see pg 100), the shoreline has a rate of +0.34 ft from 2017-2023.
