Shoreline Monitoring Beach Profile Report: Saipan and Mañagaha

August 2024

Division of Coastal Resources Management
- CNMI Bureau of Environmental Coastal
Quality

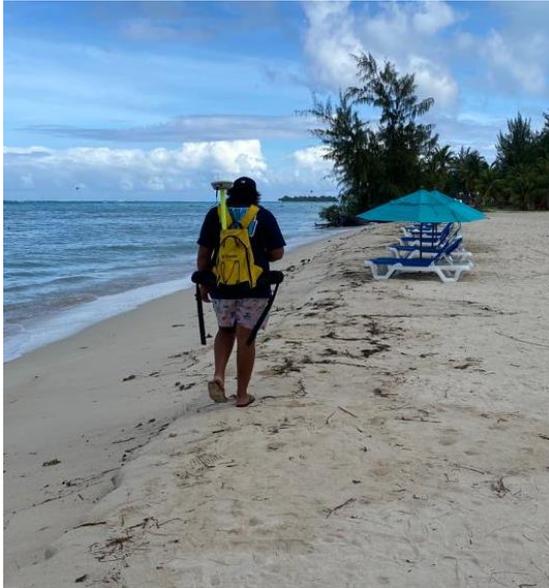
Figure 2 - Chris P. walks the erosion scarp and wrackline fronting Crowne Plaza after a winterly swell event using the Trimble Geo7x.

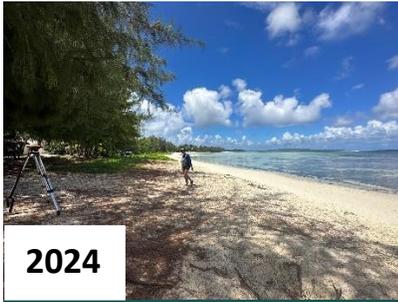
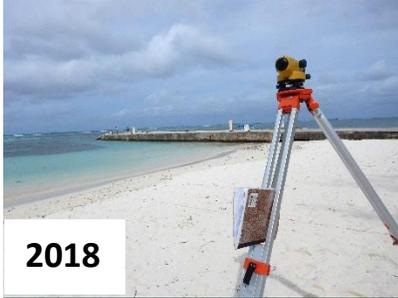
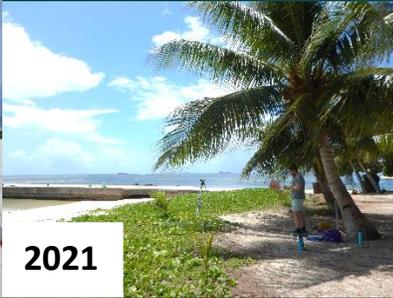
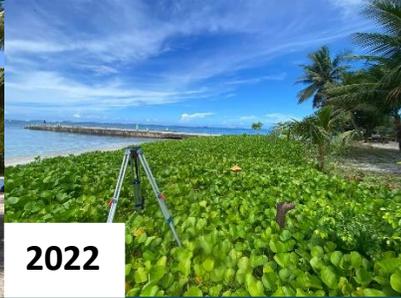
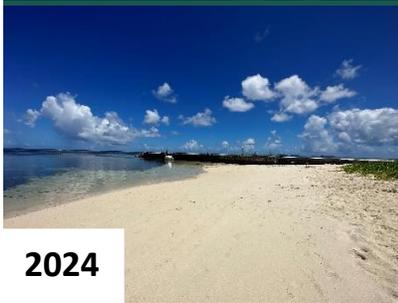
Sugar Dock South 2

- STABLE
- Wrackline that ranges 20 – 31 ft with an elevation difference of 9 ft
- The berm has completely worn away, so the headstake (tree) is right when the slope begins to steadily drop into the waterline. This suggests long-term erosion and sediment deficiency for this stretch.
- Based on the Shoreline linear regression analysis (see pg 37), the shoreline has a rate of -0.5 ft from 2016-2023.

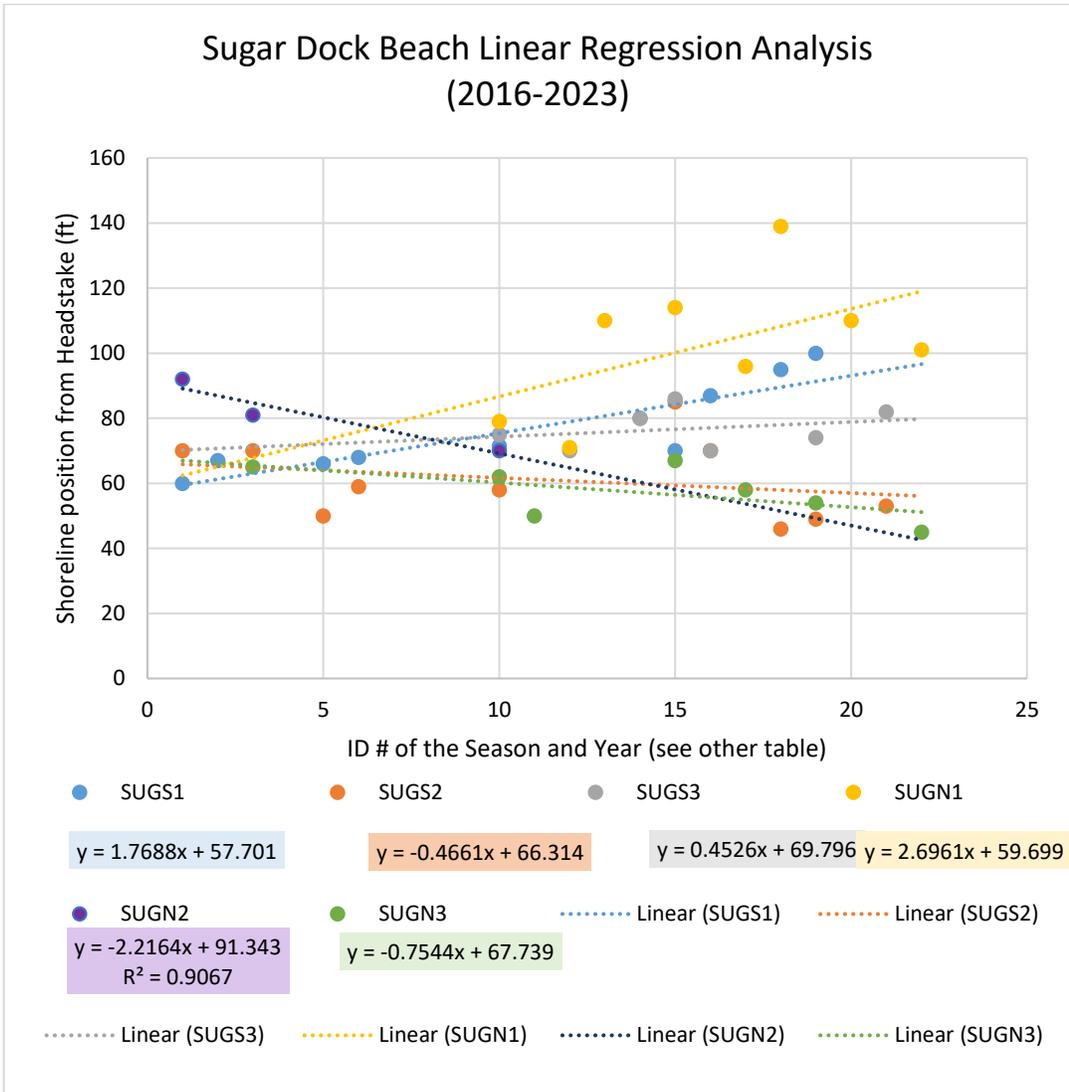
Figure 17 - Sugar Dock Beach Linear Regression Analysis table shows time in seasons over shoreline position (top of toe) from the headstake.

- ACCRETING
- Wrackline that ranges 30 – 77 ft with an elevation difference of 9 ft
- Short-term erosion and accretion events define this profile. The channel influences this dynamic behavior, suggesting that sand is pushed during typical winter conditions and pulled during typhoon conditions. The sand bar is a sediment source.
- Based on the shoreline linear regression analysis (see pg 37), the shoreline has a rate of +1.8 ft from 2016-2023.

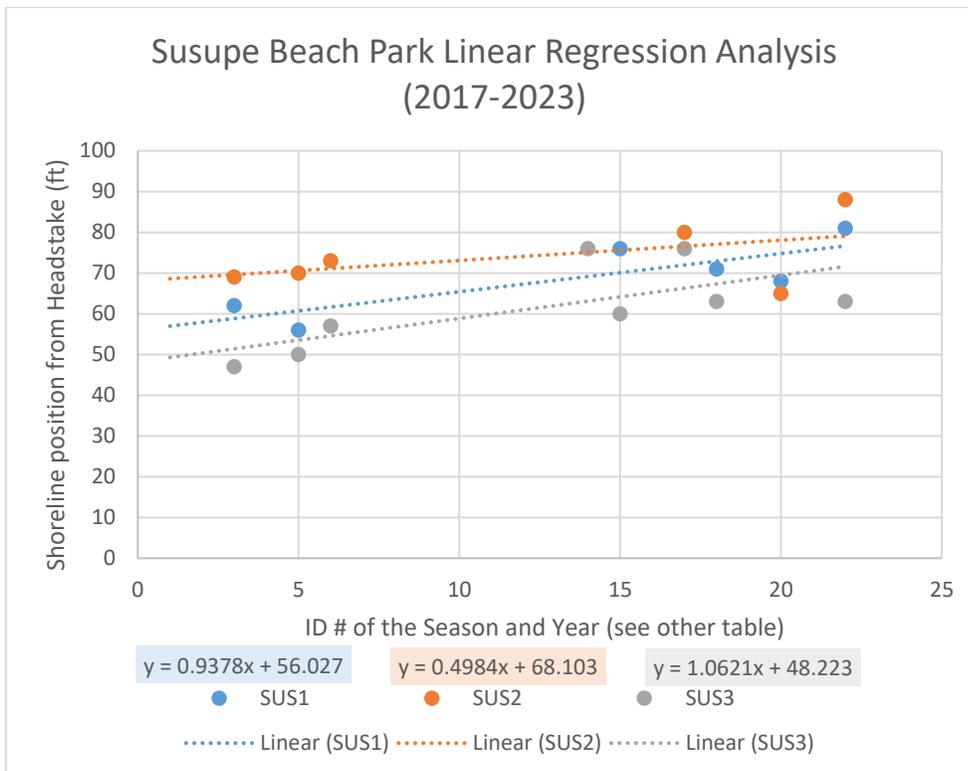
Figure 18 – Susupe Beach Park Linear Regression Analysis table shows time in seasons over shoreline position (top of toe) from the headstake.

- ACCRETING
- Wrackline that ranges 30 – 60 ft and an elevation difference of 8 ft
- Based on the Shoreline linear regression analysis (see pg 44), the shoreline has been a rate of +1.1 ft from 2016-2023.

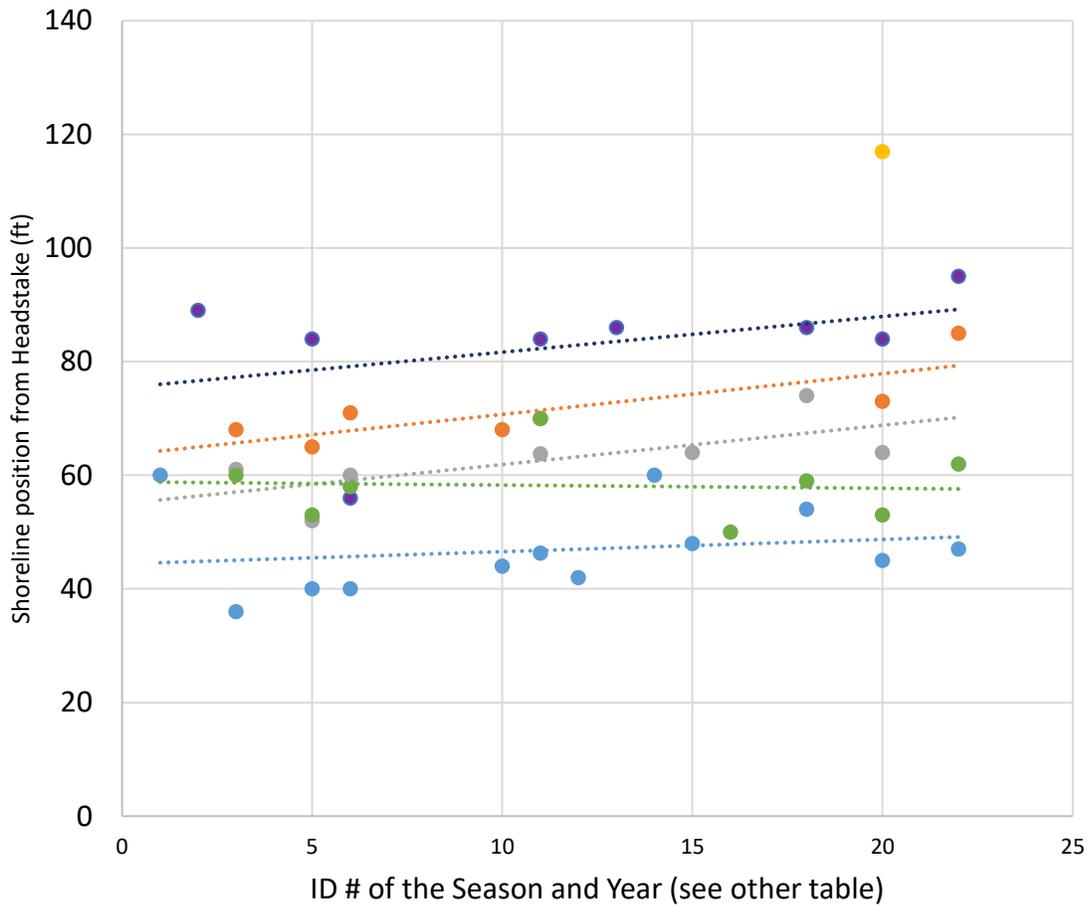
Figure 20 - Kilili Beach Linear Regression Analysis table shows time in seasons over shoreline position (top of toe) from the headstake.

- Wrackline that ranges 58 – 88 ft with an elevation difference of 8 ft
- There are discrepancies in the data caused by surveyor error. Given that the headstake is further inland, this profile is expected to be longer and indicates an estimation of the proximity to the high tide line, or wrackline, is from the pavilions.
- Based on the Shoreline linear regression analysis (see pg 49), the shoreline has a rate of +0.6 ft from 2016-2023.

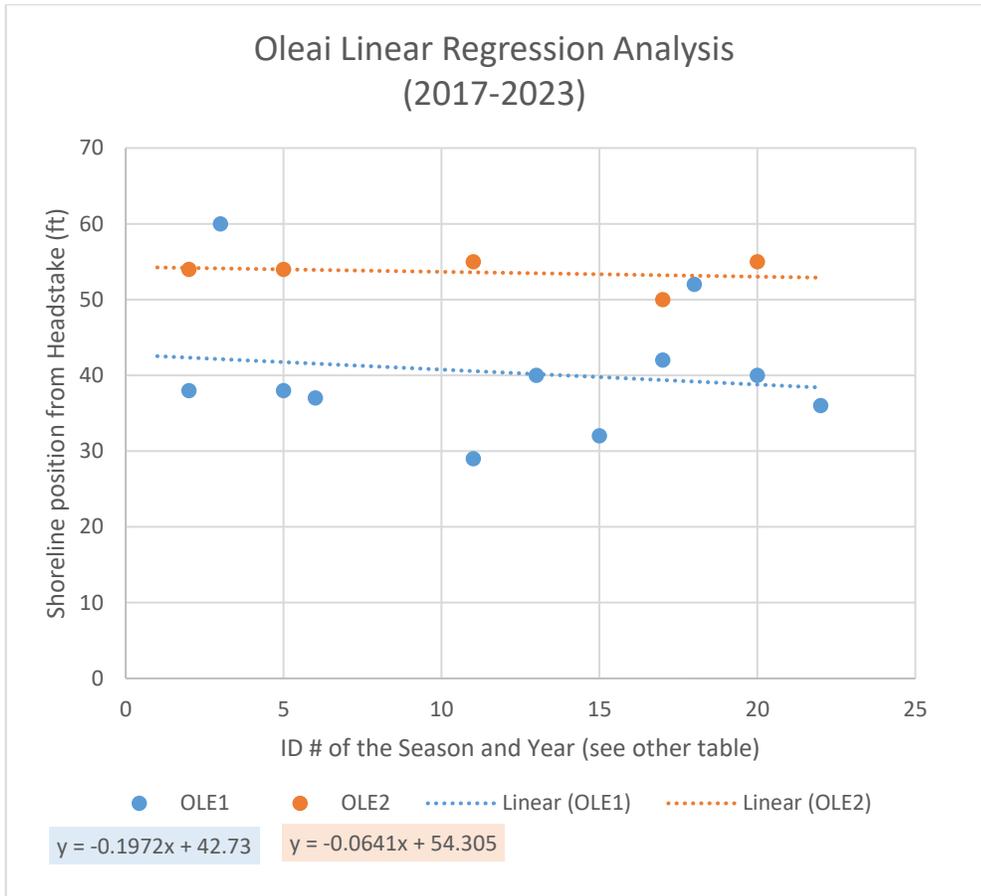
- STABLE
- Wrackline that ranges 8 – 33 ft and an elevation difference of more than 6 ft
- Tides and seasonal wave conditions influence the beach width. Restaurant management grooms the shoreline by pushing washed up debris more inland in a pile.
- Based on the Shoreline linear regression analysis (see pg 58), the shoreline has a rate of -0.2 ft from 2016-2023.

Figure 22 - Oleai Beach Linear Regression Analysis table shows time in seasons over shoreline position (top of toe) from the headstake.

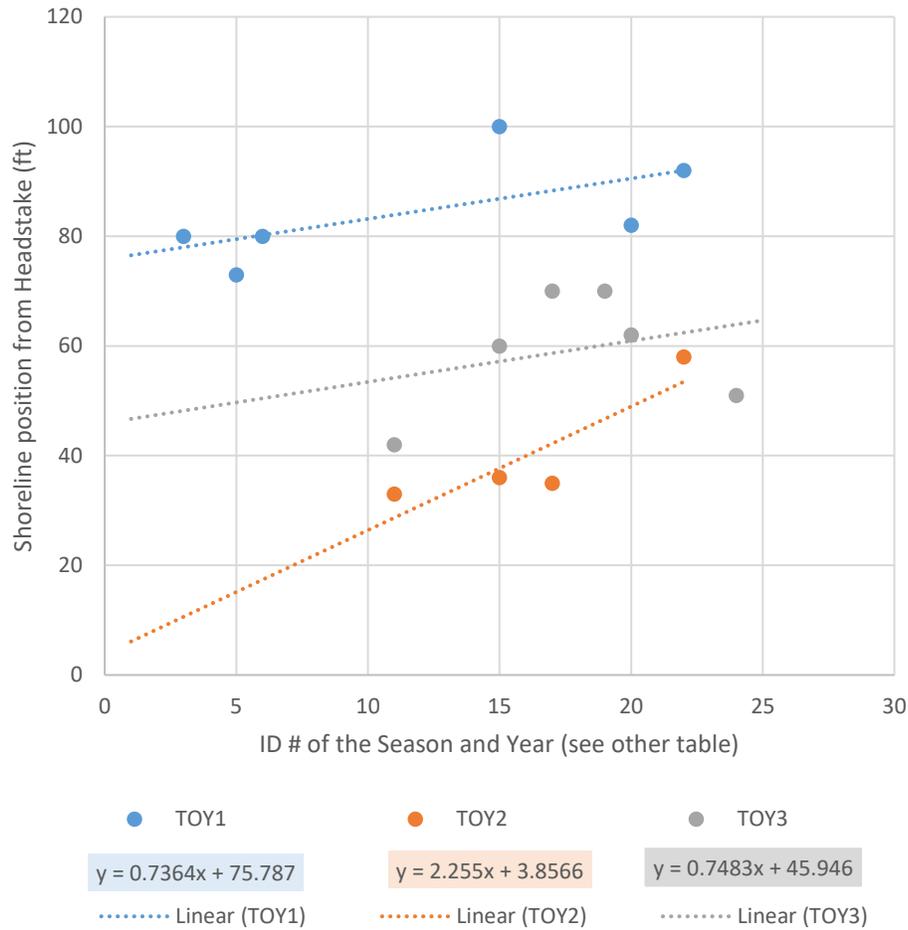
Toyota Linear Regression Analysis (2017-2023)

Figure 24 - Toyota Beach Linear Regression Analysis table shows time in seasons over shoreline position (top of toe) from the headstake.

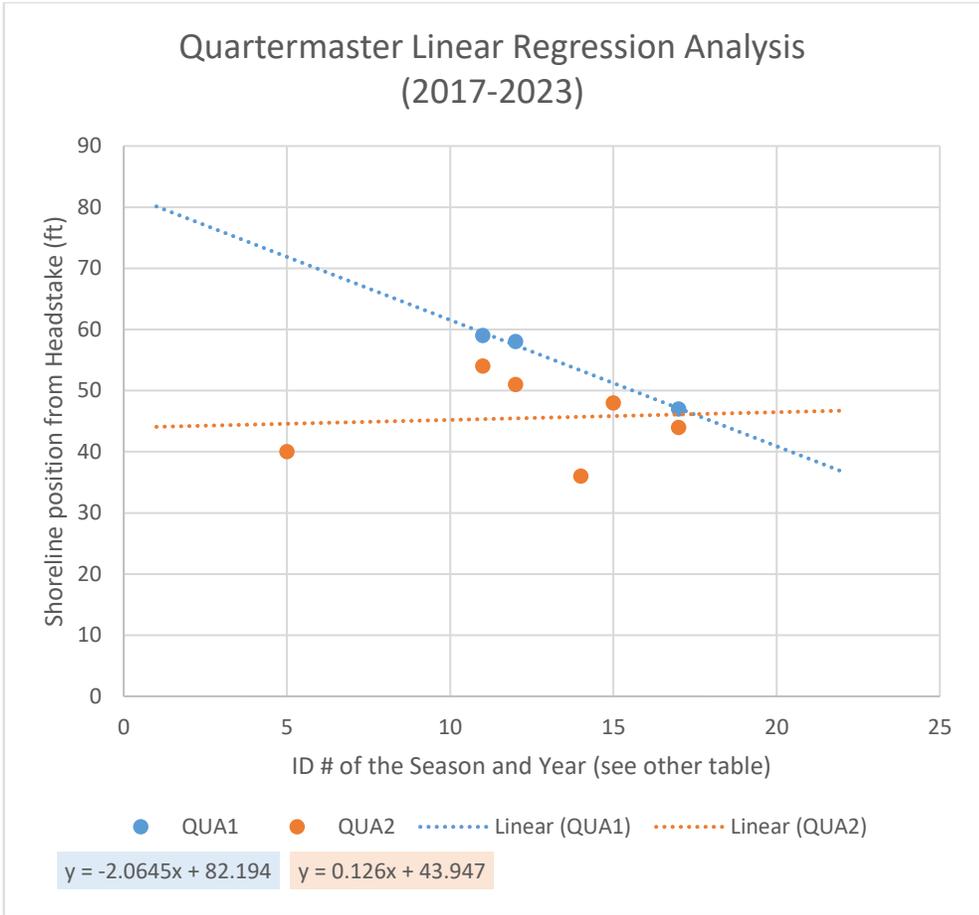
Figure 26 - Quartermaster Beach Linear Regression Analysis table shows time in seasons over shoreline position (top of toe) from the headstake.

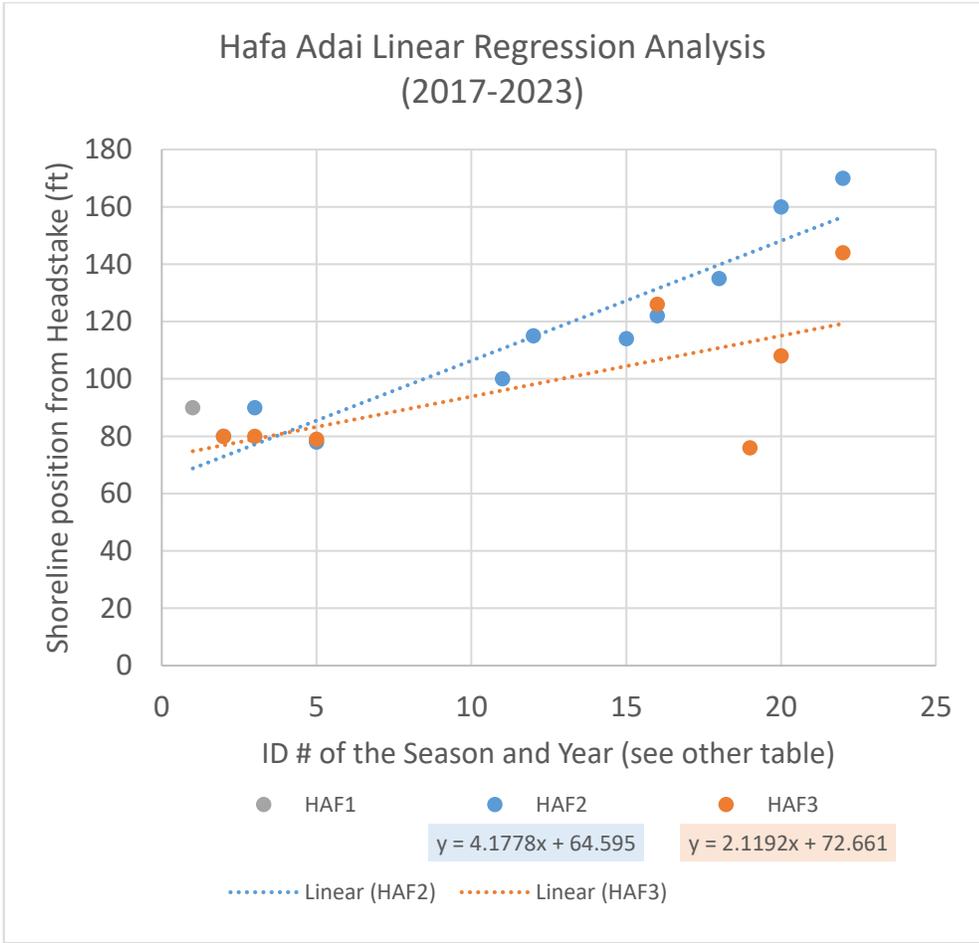
Figure 28 - Hafa Adai Beach Linear Regression Analysis table shows time in seasons over shoreline position (top of toe) from the headstake.

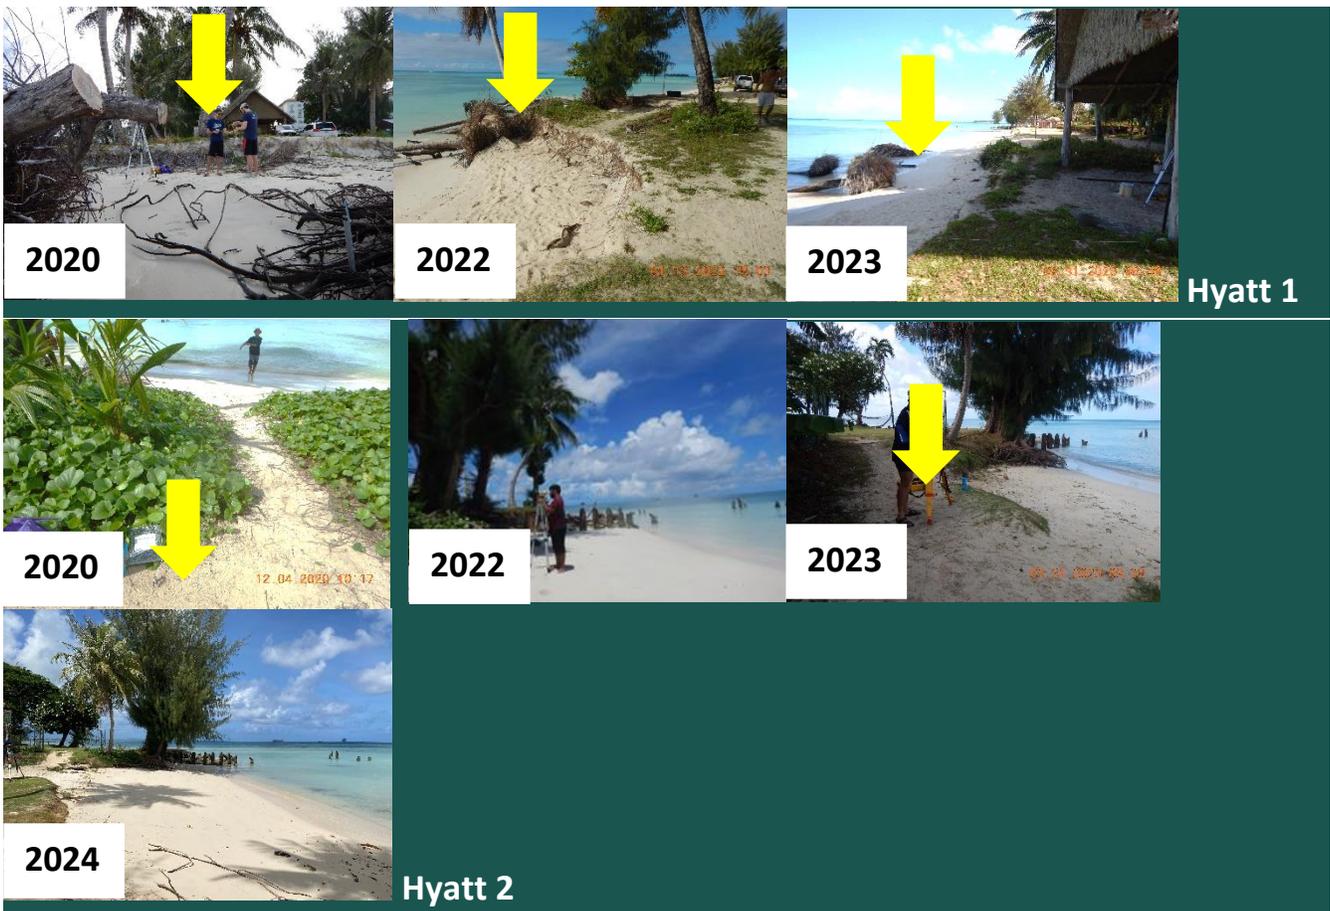
Figure 30 - Hydrodynamic map of the stretch of Hafa Adai, Fiesta, and Hyatt sites with the ocean wave energies buffered by the reef, openings enable higher wave energies to enter into the reef. The arrows show the intensity of waves generated from the south west

The Hyatt shoreline in this area has been actively eroding, similar to Fiesta, because of powerful waves caused by storms. Two head stakes were pulled into the water and have become ineffective. The shoreline is being eroded by the increased wave energy from storm conditions and higher sea levels entering through the channel. The tropical disturbance in September 2021 caused significant damage in a short period of time from north-northwest flows. Southwest typhoon wave conditions also contribute to the erosion of the shoreline.

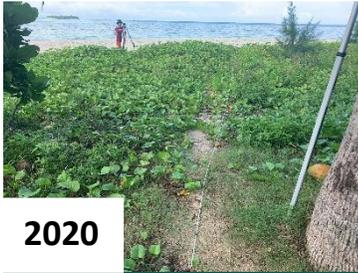
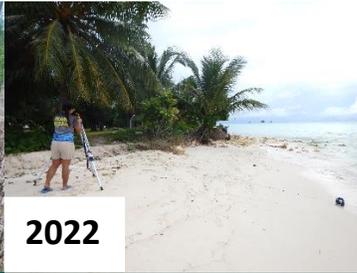
American Memorial Park Point 1

[No photo is available for 2023. Conditions

had naturally replenished sand.]

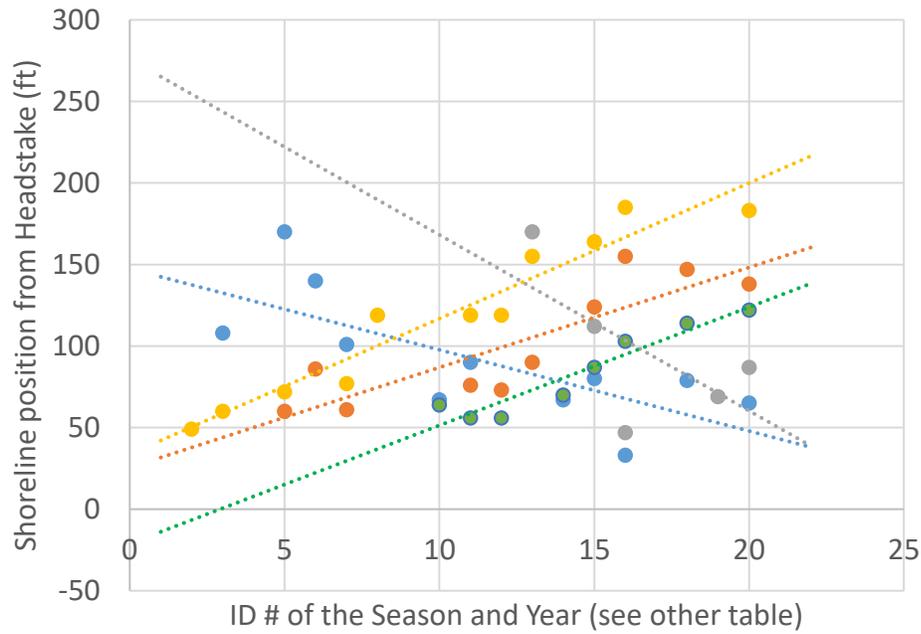
Figure 32 - American Memorial Park Beach Linear Regression Analysis table shows time in seasons over shoreline position (top of toe) from the headstake.

- ACCRETING in the long-term with an elevation difference of more than 6 ft since 2017
- GAIN of shoreline by 70 ft since 2019
- Sand from southern shorelines (South 1 through Point 2) may be migrating up northern as suggested by the width tripling in the last two years.
- Based on the Shoreline linear regression analysis, the shoreline has been at a rate of +7.25 ft from 2017-2023.

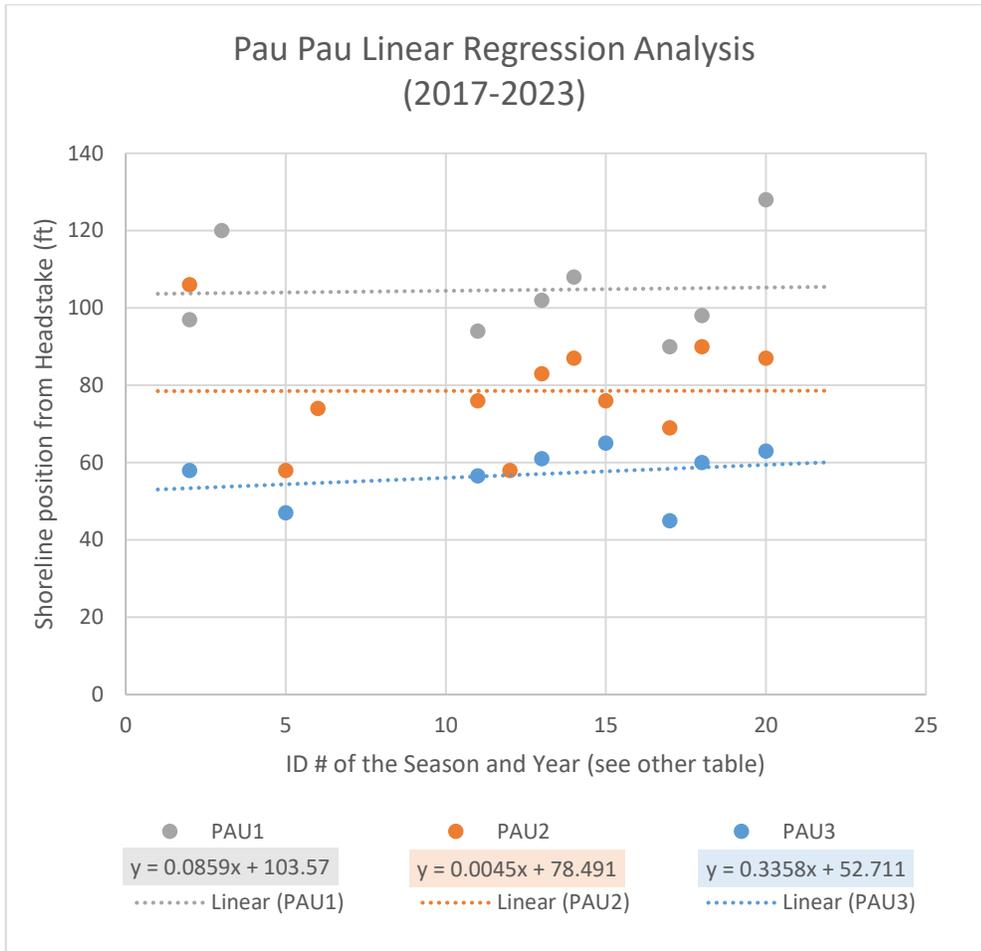
Figure 34 – Pau Pau Beach Linear Regression Analysis table shows time in seasons over shoreline position (top of toe) from the headstake.

- STABLE
- REPLACED with a headstake that is further inland and adjacent to the previous headstake
- **History:** This beach profile seems to vary from time to time, dependent on deposits from the nearby reef. The headstake is at a distance in the backshore, closer to the parking lot.
- Based on the Shoreline linear regression analysis (see pg 100), the shoreline has a rate of +0.09 ft from 2017-2023.

- STABLE
- Wrackline that that ranges 26 – 50 ft and an elevation difference of 9.5 ft
- This beach profile is variable compared to the other two transects in the site.
- Based on the Shoreline linear regression analysis (see pg 100), the shoreline has a rate of +0.34 ft from 2017-2023.

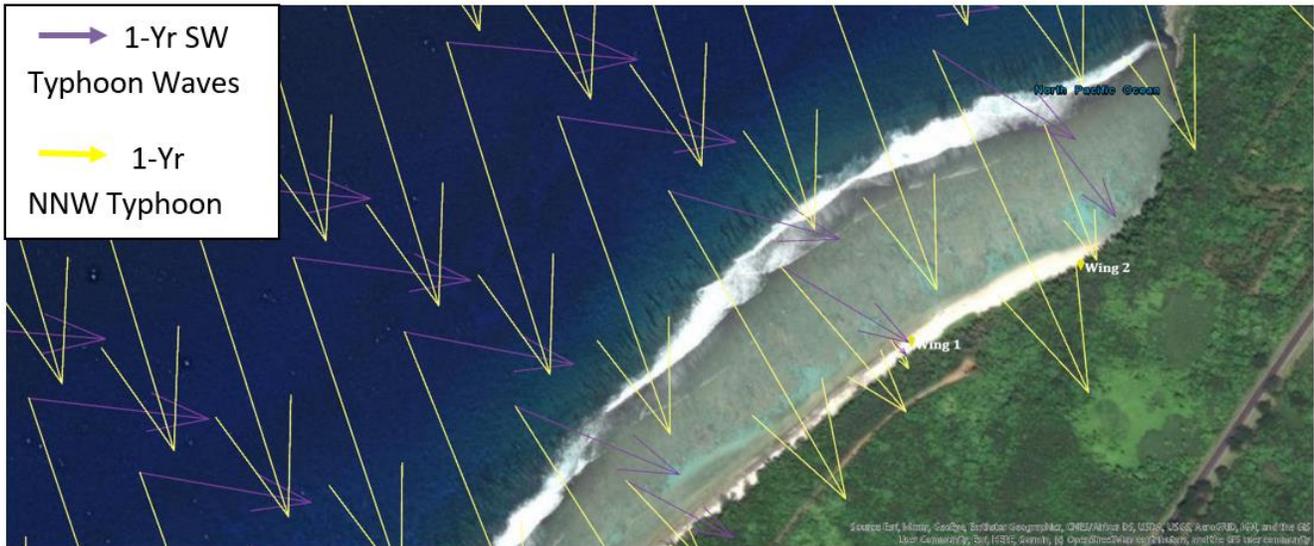
Figure 35 - Hydrodynamic map of the stretch of Wing Beach with high ocean wave energies going past reef. The arrows show the intensity of waves generated from the south west.

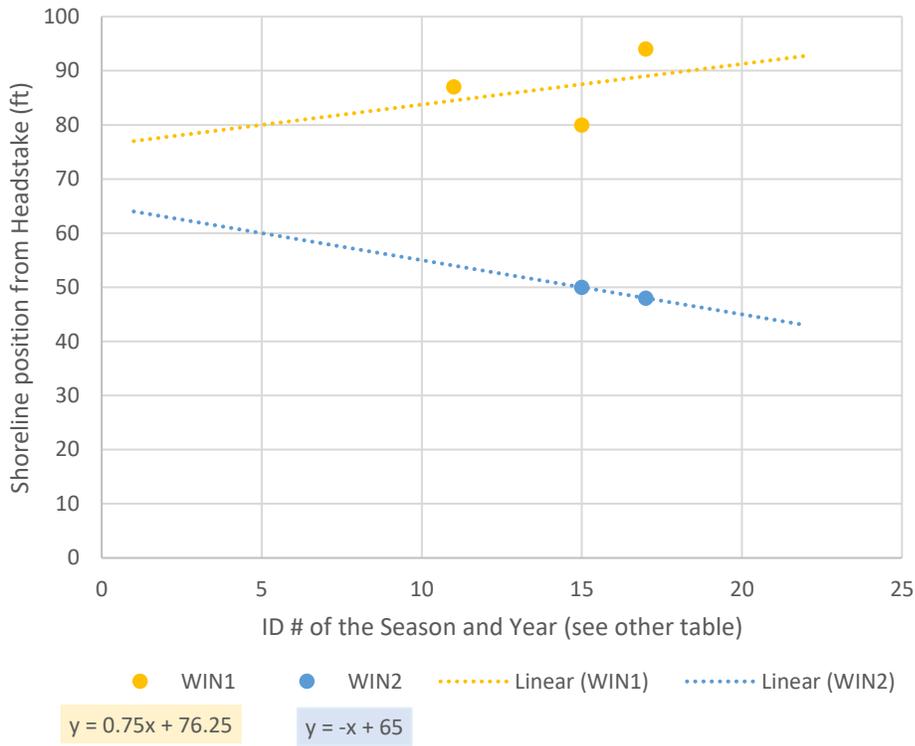
Wing Linear Regression Analysis (2017-2023)

- ERODING
- Wrackline that ranges 30 –54ft and an elevation difference of 9 ft
- Based on observations from the Feb-21 record shows, a high tide with a high wave event greatly abrades the berm along this transect. With the input of coral rubble from the nearby reef, recovery to the average shoreline length is anticipated.
- Based on the Shoreline linear regression analysis (see pg 106), the shoreline has been eroding at a rate of 1.0 ft from 2017-2023.

Figure 36 - Wing Beach Linear Regression Analysis table shows time in seasons over shoreline position (top of toe) from the headstake.

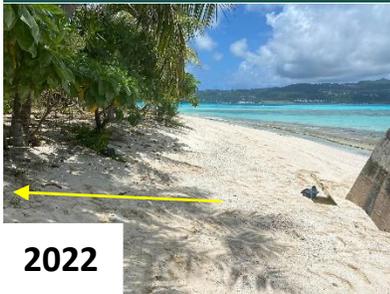
Mañagaha 7

- ERODING
- REPLACED the previous headstake (large blockular relict) where the waterline would hit during high surf events. New headstake is further backshore but aligns with the previous headstake.
- This current headstake receives sediment; however, it is observed that high energy and high tides have allowed the waterline to strike the headstake.

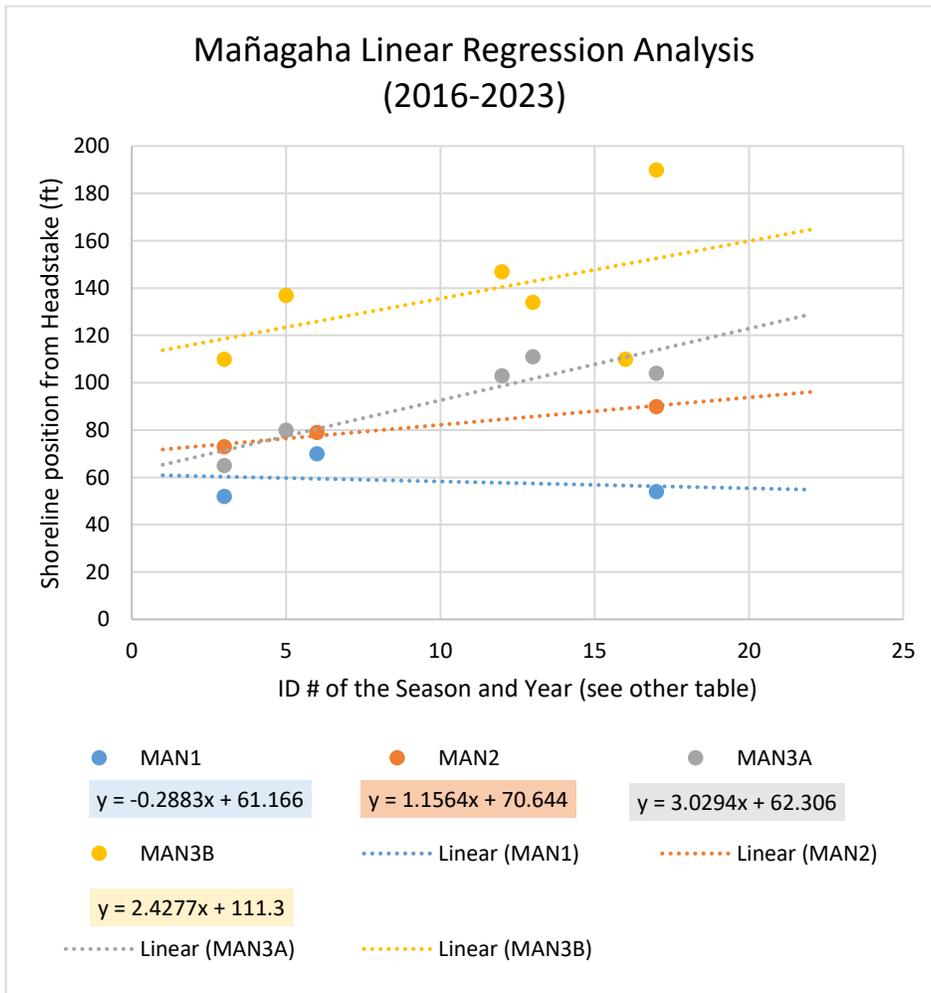
- REPLACED
- Previous headstake: ACCRETING
- Wrackline that ranges 50 – 84 ft and an elevation difference of 8 ft
- Second berm has formed.
- Based on the Shoreline linear regression analysis (see pg 112), the shoreline has a rate of +3.03 ft from 2017-2023.

- REPLACED
- Previous headstake: ACCRETING
- Wrackline that ranges 90 – 100 ft and elevation difference of 7 ft
- Based on the Shoreline linear regression analysis (see pg 112), the shoreline has a rate of +2.43 ft from 2017-2023.

Figure 40 – Mañagaha Linear Regression Analysis table shows time in seasons over shoreline position (top of toe) from the headstake.

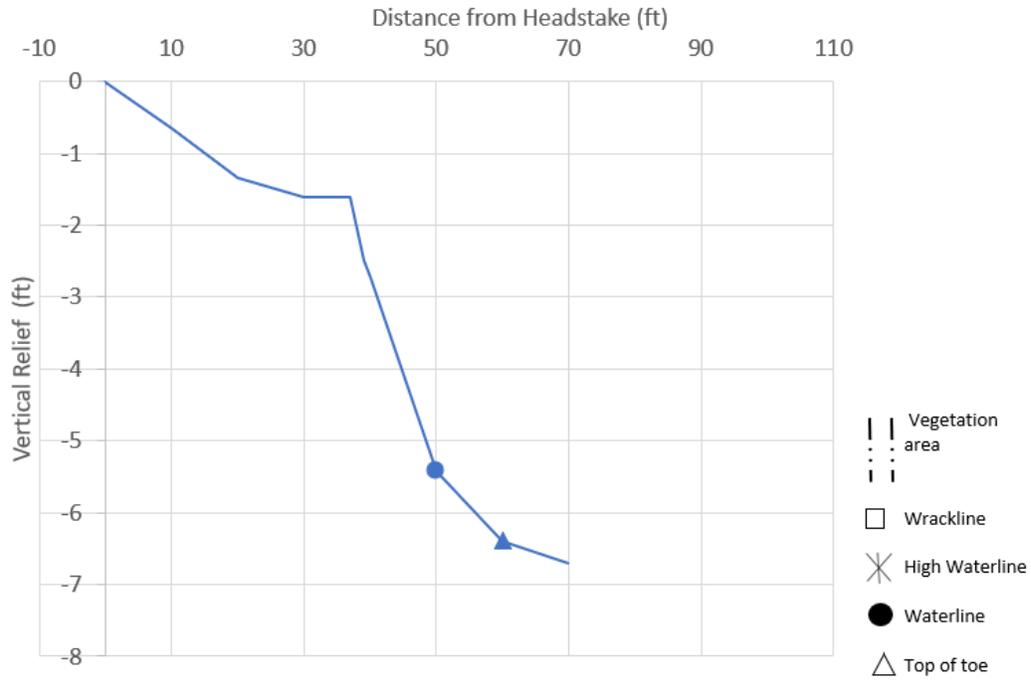
Managaha 6 Beach Profile

- REPLACED previous headstake
- Scarp and ripped trees are evident in this area.
- **History:** The previous headstake was a post of the shearwater bird habitat boundary that got ripped away. There was a strong erosion trend from July 2017 – 2020.

- UNDETERMINED AND REPLACED previous headstake
- Scarp and ripped trees are evident in this area.
- Erosion is known and observed in the long-term.
