ACHUGAO WATERSHED MANAGEMENT PLAN 2020-2030

November 2022 DRAFT

Horsley Witten Group, Inc.
KOA Consulting, Inc.
Sea Change Consulting

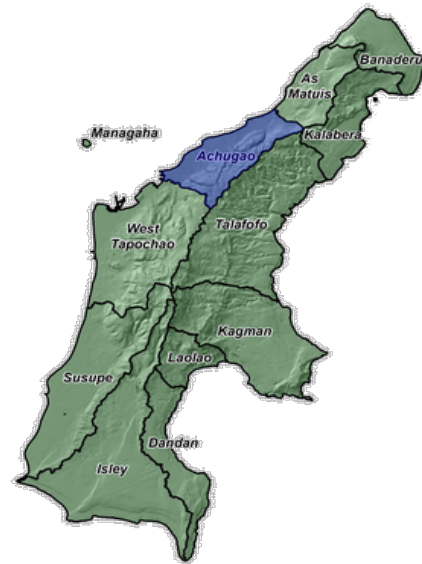
Figure 1. Location of the Achugao Watershed on Saipan, CNMI

The 1,610-ac (2.5 sq mi) Achugao Watershed contributes surface drainage from Wireless Ridge down to the Tanapag Lagoon via four major streams: Agatan, Dogas, Achugao, and San Roque (**Map 1**). The watershed contains several large freshwater wetland complexes, including the Falig mitigation site. Coastal receiving waters and streams are impaired for one or more parameters including dissolved oxygen, marine benthic habitat, heavy metals, and bacteria. Site contamination from past military operations, piggeries, unmanaged stormwater runoff, sewer overflows and septic systems, and wildfires are some of the known issues affecting watershed health. Achugao has begun to show water quality improvement over the past few years, likely due to wastewater system repairs and upgrades.

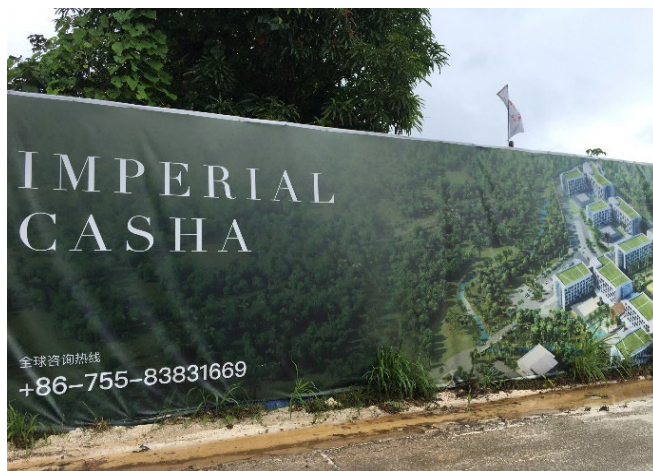
Soils at this 25-acre resort construction site have remained exposed since mass clearing in 2017 resulting in egregious site erosion and sedimentation impacts downstream.

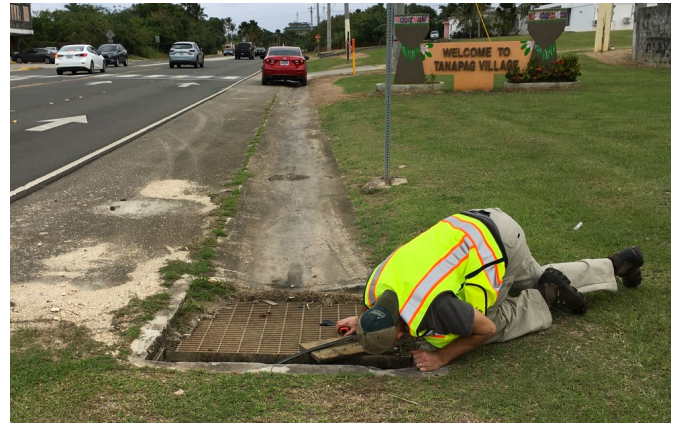
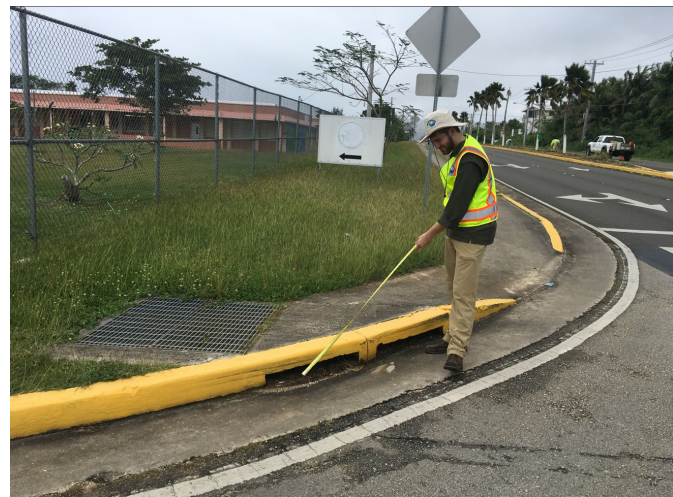
Drainage infrastructure evaluation and mapping and condition assessment in Tanapag.

During the week of January 20, 2020, HW, KOA, and BECQ field crews mapped and assessed over 100 drainage structures (e.g., inlets and catch basins, culverts, manholes, BMPs, outfalls, stream outlets, and other). Much of the stormwater infrastructure found throughout the Achugao Watershed is mostly closed pipe conveyance systems. The condition, dimensions, and invert elevations were documented for most structures.

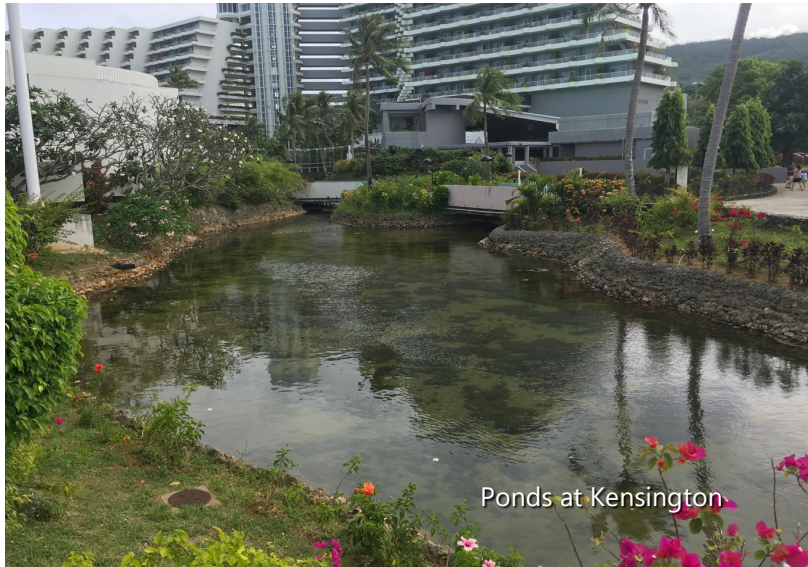
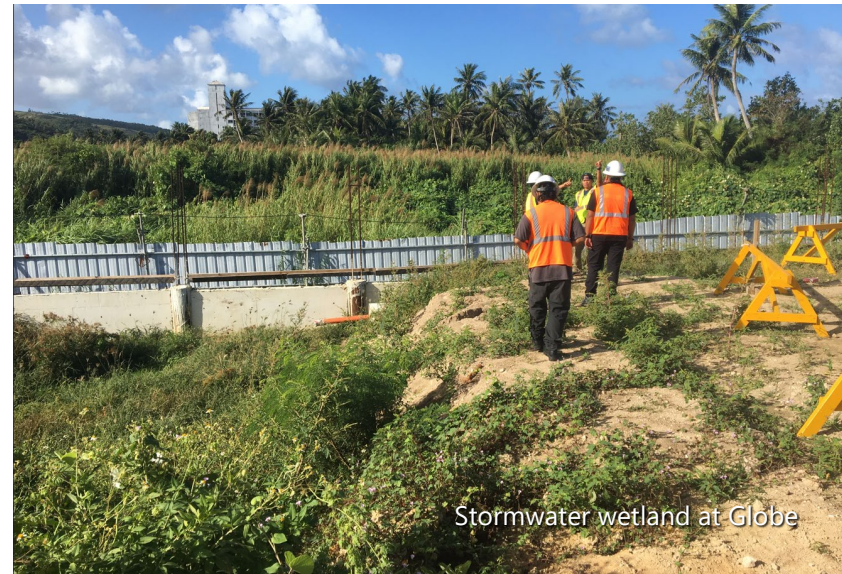
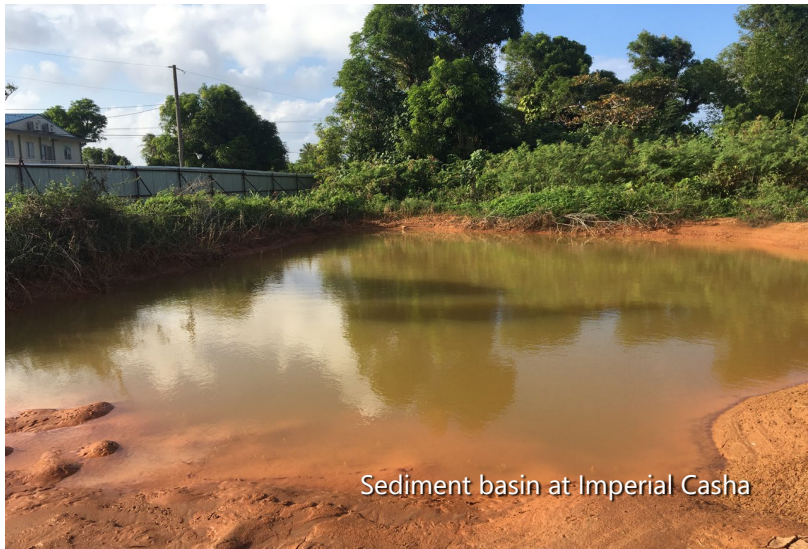
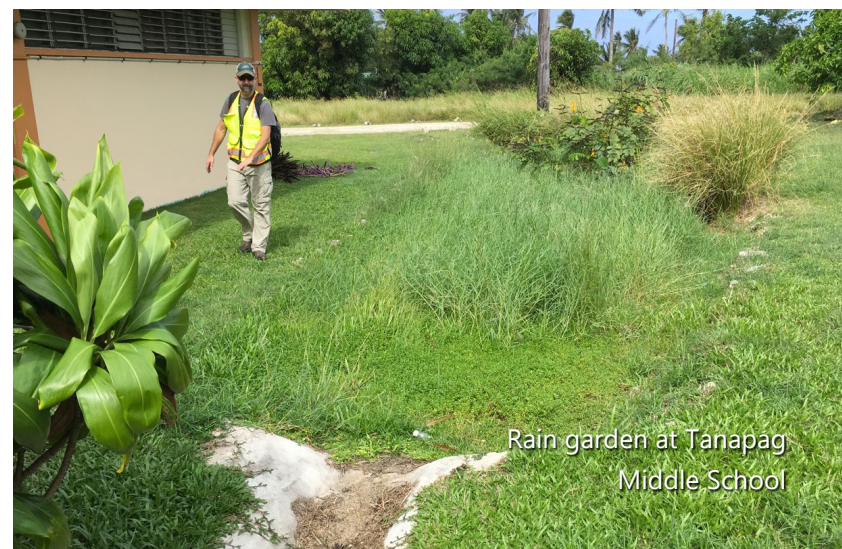
Existing stormwater management facilities identified in the Achugao Watershed.

Based on field observations, almost 60% of the structures evaluated require maintenance or repair/replacement due to clogging, sediment accumulation, visible damage, or erosion. Existing stormwater management facilities were located during watershed assessments and the contributing drainage area and amount of impervious cover managed were estimated (**Table 8**). Approximately 15 acres of impervious cover are currently managed by stormwater facilities.

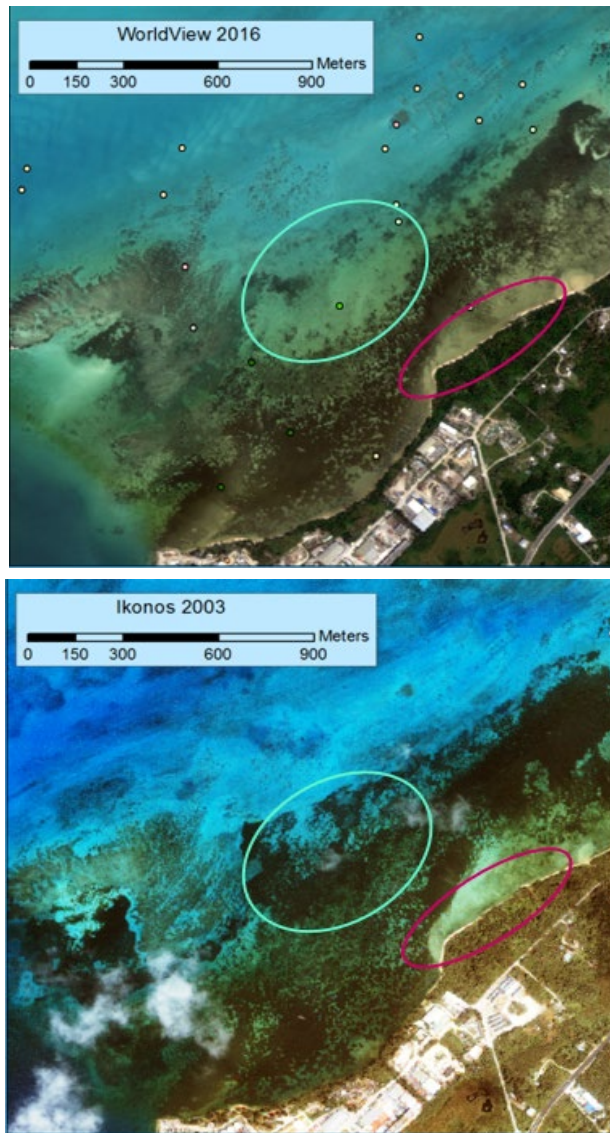
Figure 17. Comparison of seagrass coverage (blue) and shoreline extent (pink) between 2003 and 2016 imagery (presented by Steve McKagan, 2017).

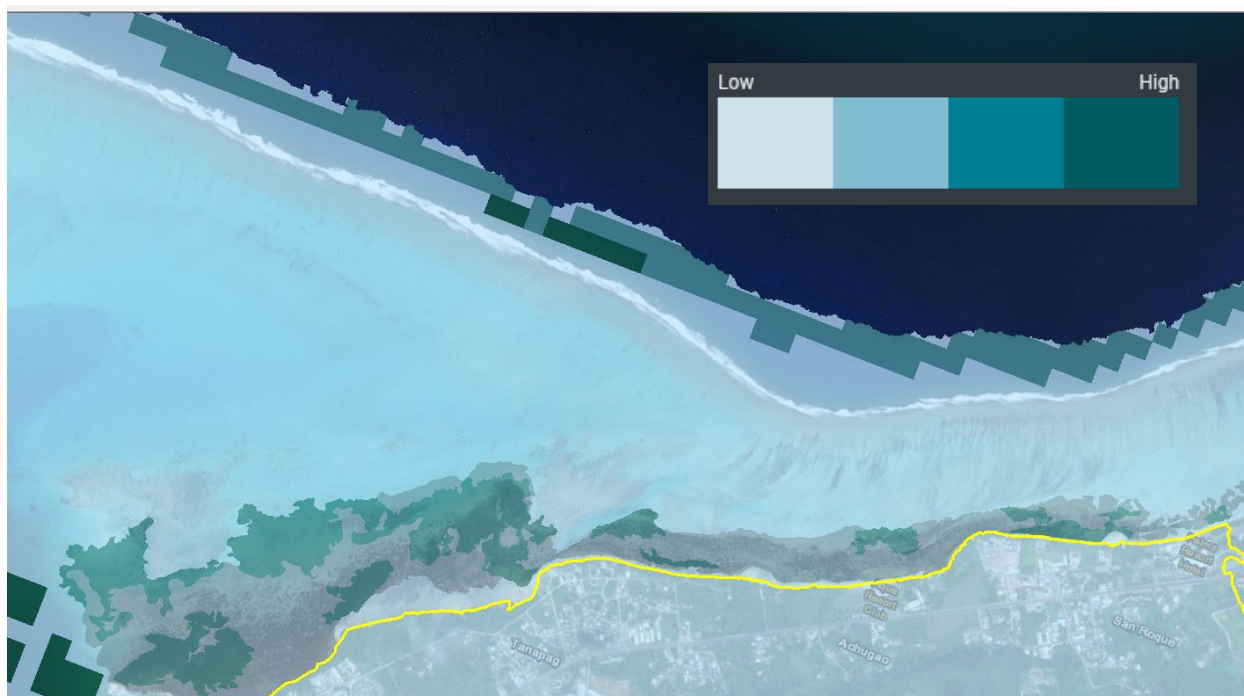
Figure 22. Marine habitat index (Dobson et al., 2020)

An evaluation of marine habitat services was conducted as part of a resiliency analysis by Dobson et al. (2020) that identified the most important habitats for coastal protection and aquatic organisms. **Figure 22** shows high value reefs and seagrass off Achugao.

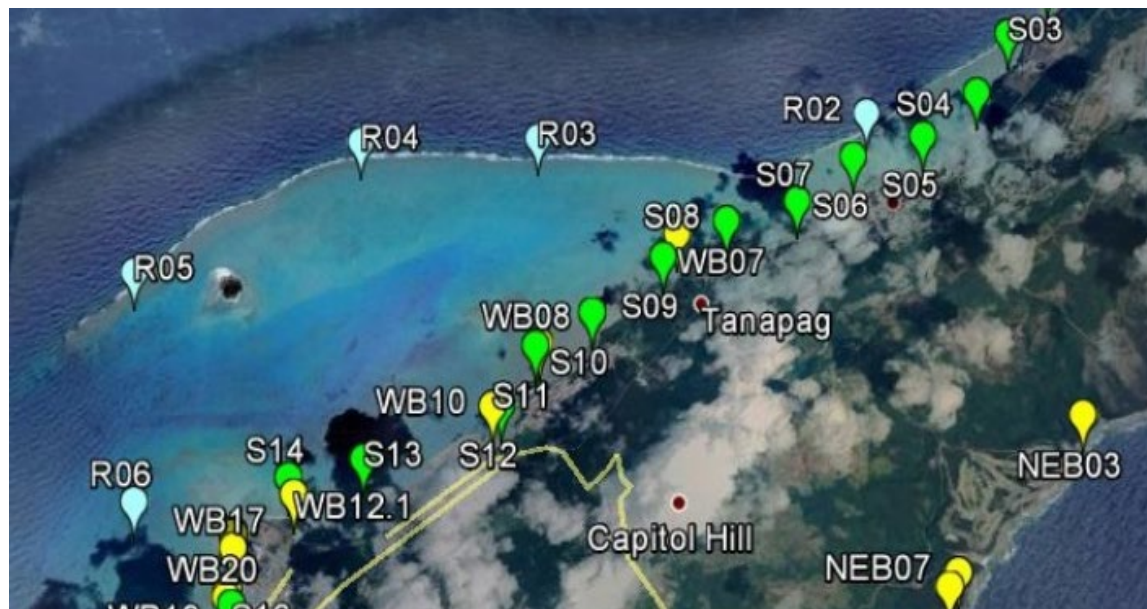
Figure 29. MST and nutrient study sites in and around Achugao (Sinigalliano et al 2020 and Kim, 2019)

Enterococci monitoring can be useful for identifying water quality “hot spots,” but doesn’t necessarily inform managers of where microbial contamination is generated. In 2018, molecular microbial source tracking for fecal indicating bacteria (FIB) was conducted at over 60 sites around Saipan to determine if sources were human, pig, cow, seabird, or dog (**Figure 29**). Several of these sites were within or near the Achugao watershed: WB07 (Tanapag Meeting House), WB08 (Central Repair Shop), and shoreline samples S04-S10.

Sinigalliano et al. (2020) reports that high levels of dog FIB were found at the Tanapag Meeting House (WB07) and S09 stations. Most shoreline samples returned insignificant counts of human FIB, with the exception of S09 in March 2018 and WB07 in July 2018. These findings indicate that dog waste may be the primary source of bacteria. Sinigalliano recommends BECQ gain a better understanding of temporal and spatial dog waste contributions regionally as well as additional investigation into stormwater runoff contamination in Tanapag.

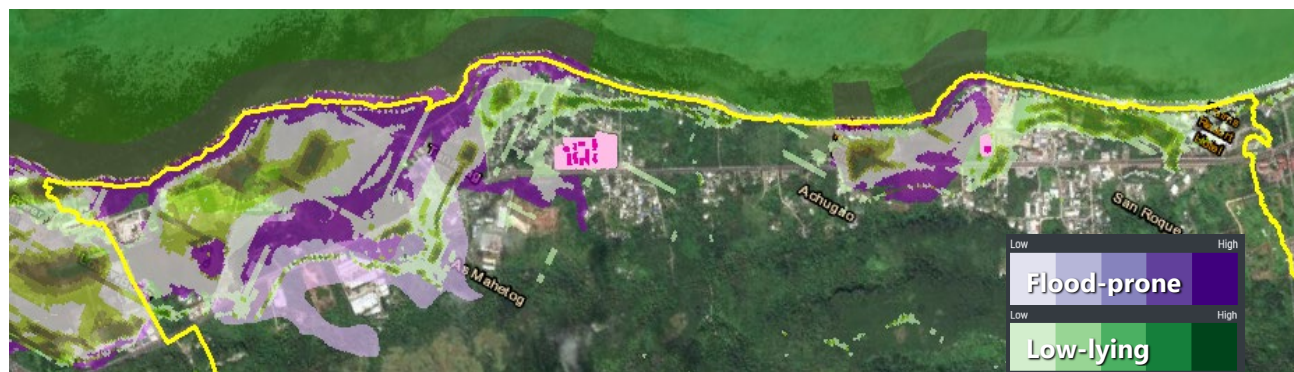
Figure 32. Achugao areas prone to flooding (100-500 yr storms) and low-lying areas likely to retain water with critical facilities in pink (CREST, 2020).

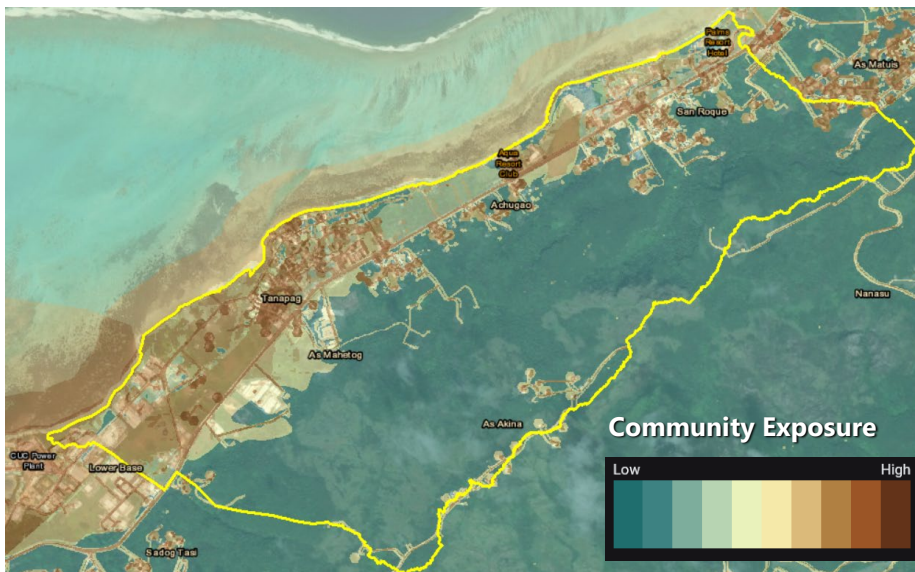
Figure 35. Spatial Analysis of Resiliency Indices in the Achugao Watershed (<https://resilientcoasts.org>)

Hubs are identified and prioritized based on a combination of four indices (**Figure 35**):

1. Community Assets—considers population density, critical facilities (schools, fire station, shelters), critical infrastructure (roads, utilities, etc.), and social vulnerability.
2. Threats—indicators of flood-related factors such as impervious cover and soils, low-lying areas, sea level rise, storm surge, and soil erodibility.
3. Community Exposure—the product of assets and threats which indicates where essential assets are most at risk of flooding.
4. Fish and Wildlife—indicates high value habitats for marine and terrestrial species.
