APPENDIX B: KEY PROJECT DESCRIPTIONS

Table B1. Summary of key projects from Achugao WMP

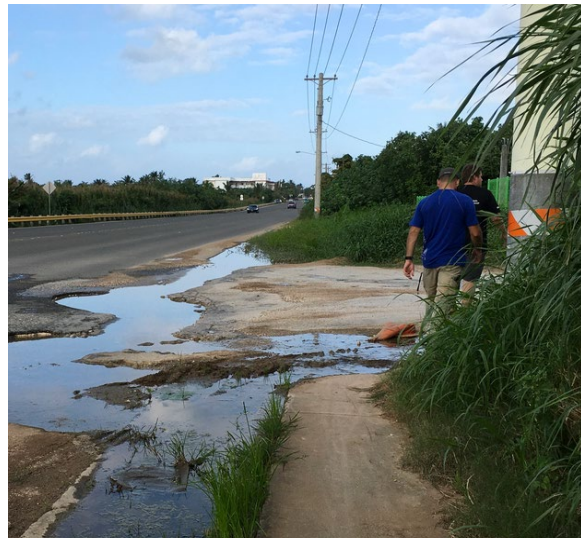
Consistent flooding along Middle Rd. could be alleviated with a stream/wetland restoration project.

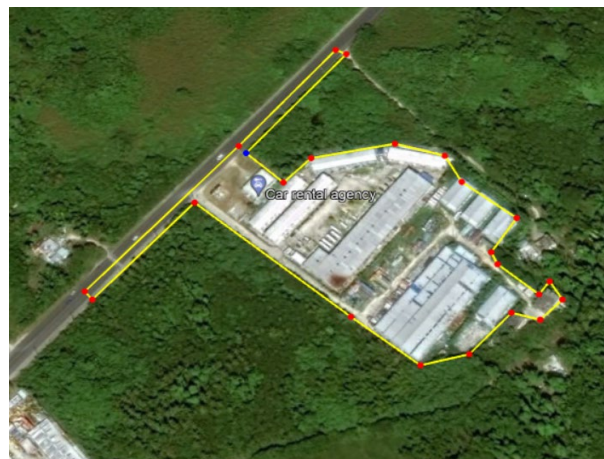
Area of impervious cover estimated to this retrofit location. Any project design would need to be offline to accommodate stream flow.

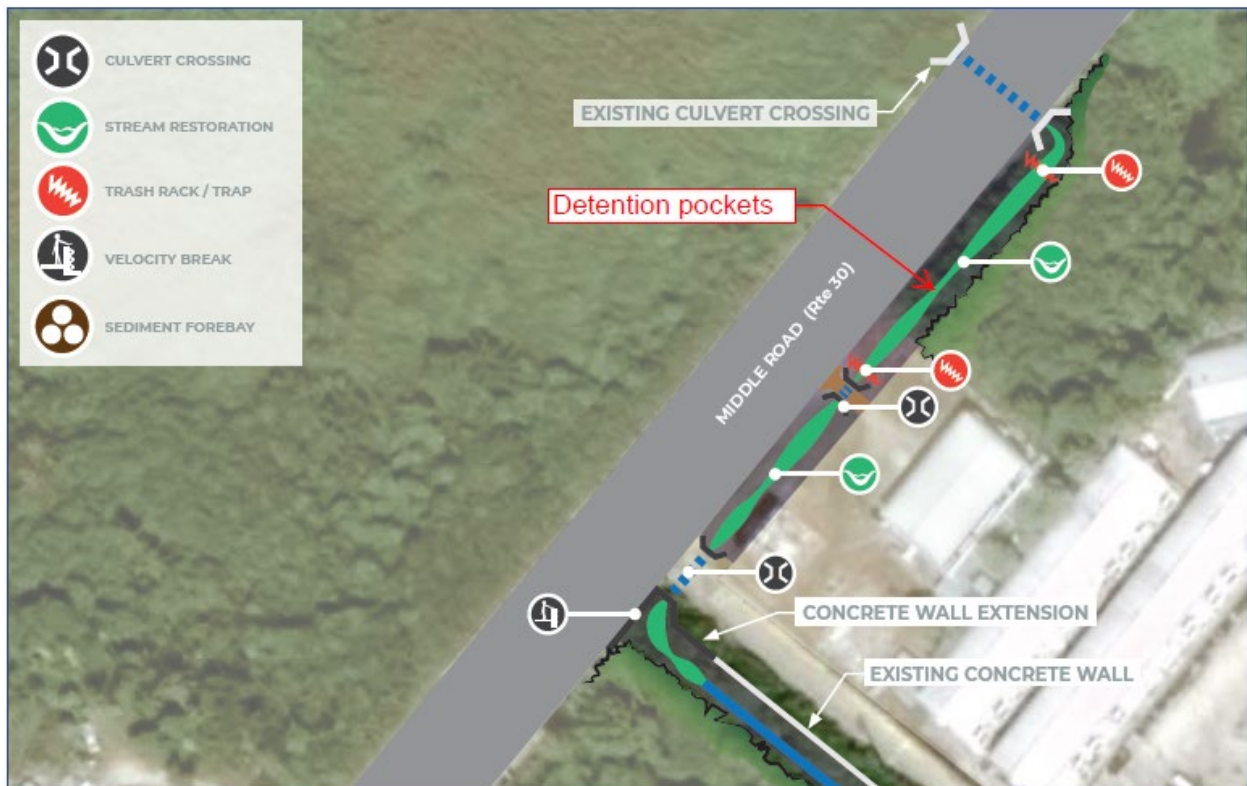
Conceptual Schematic

The goal of this project is to restore more natural stream conditions and enhance the floodplain to better handle rain events and improve wildlife habitat. It involves adding a culvert under the access road, recreating a floodplain wetland that can safely manage base flows, and treatment of stormwater runoff from the road and factory impervious cover using green stormwater infrastructure to remove trash and sediment and other pollutants. Buffer enhancement should include removal of invasive species and the planting of native riparian buffer vegetation to improve wildlife benefits. Excluding stream contributions, this retrofit would need to manage >9 impervious acres.

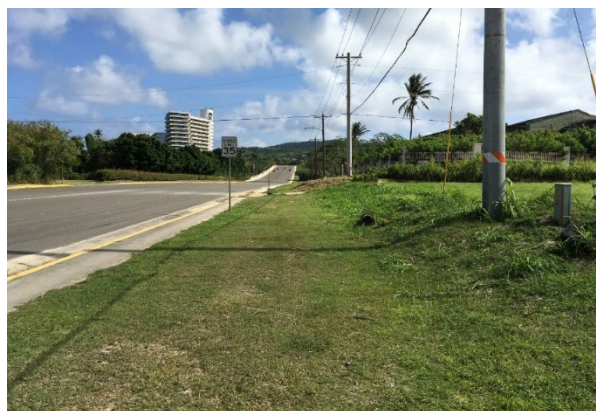
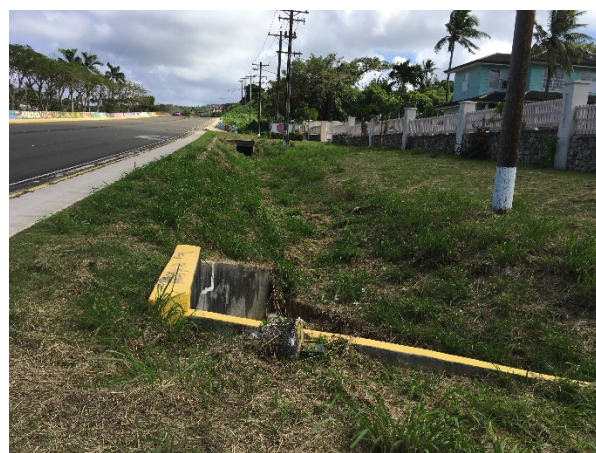
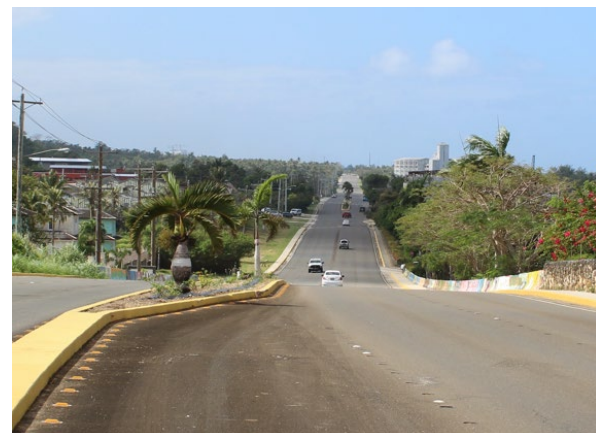
Green street opportunities along Middle Rd.

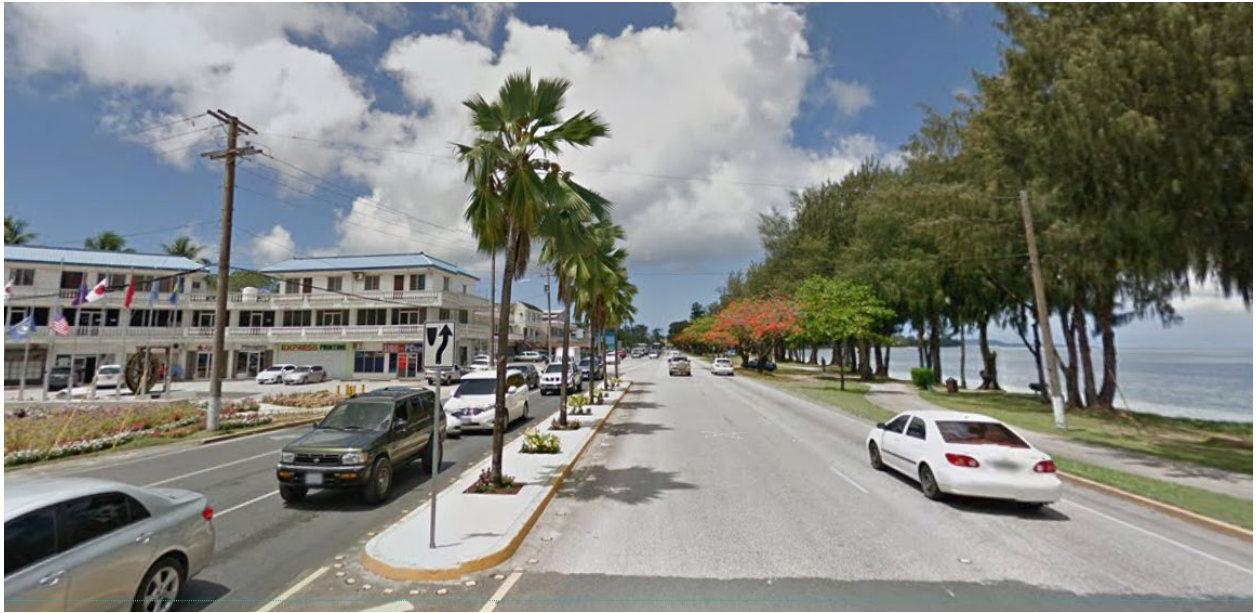
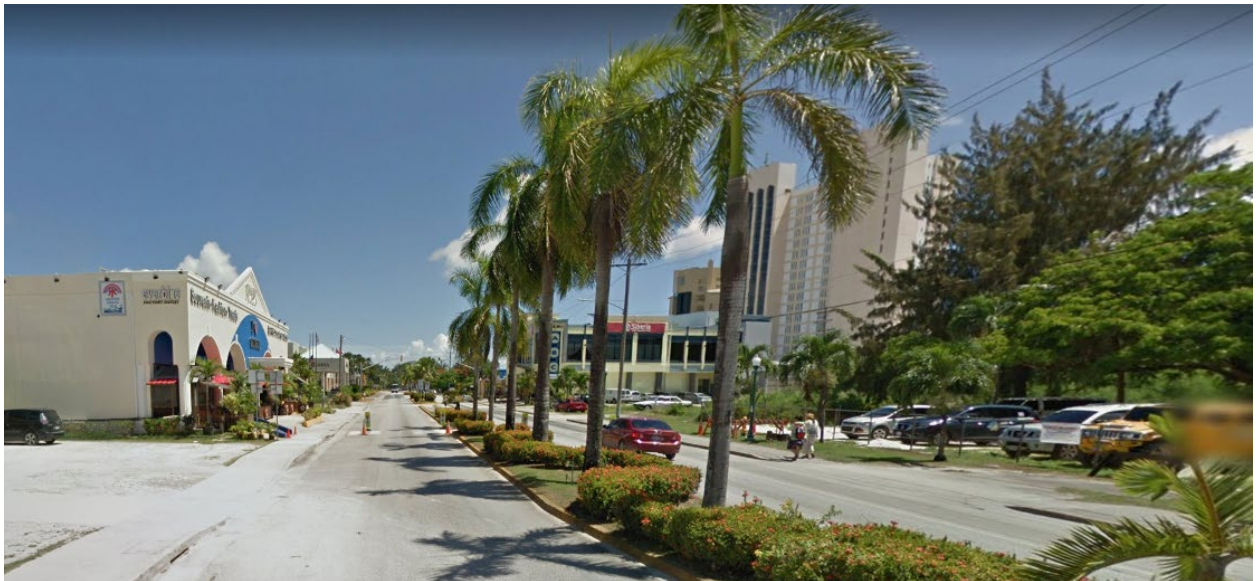
Figure 1. Examples on Saipan of street landscape medians that are not used to manage stormwater (top and middle) and a schematic showing one green street options with stormwater planters in the median and on road edge (bottom).

At several locations south of Kensington, opportunities were identified to install vegetated swales, street trees, or rain gardens within the grass road shoulders (or within a new landscaped median) to improve aesthetics, and water quality, particularly around commercial entrances. Figure 1 shows examples of Additional study of the stream system and wetland complex on the seaward side of the highway need to be further evaluated to identify feasibility of restoring natural flow paths and wetland habitats. Sediment from several unpaved roads and parking lots can be better managed by disconnecting them from Middle Rd. and providing road stabilization techniques.

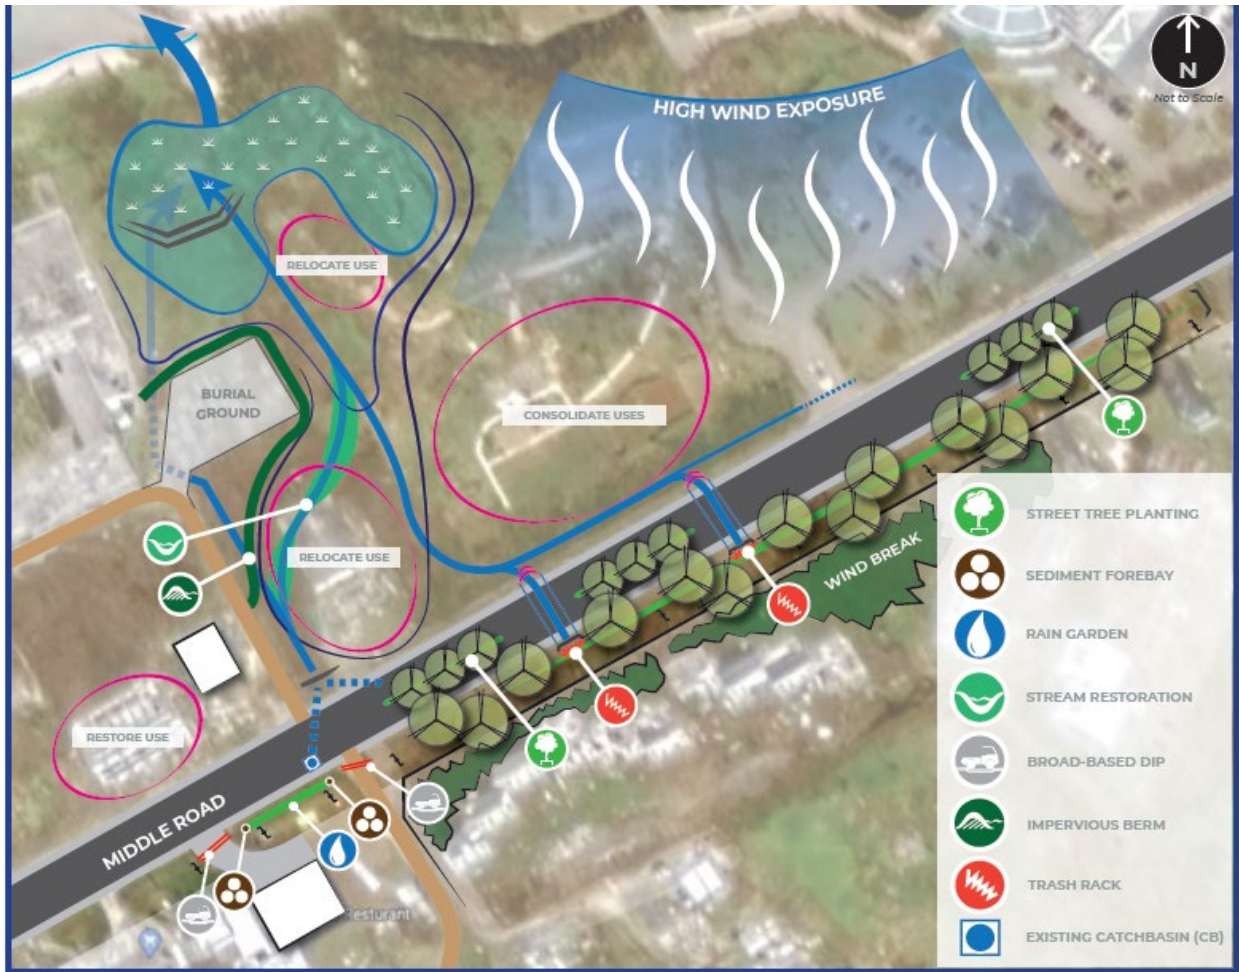
Schematic of green streets concept for portion of Middle Rd. near Kensington that includes median and ROW tree planting. Schematic also illustrates preliminary concepts on downstream stream realignment and wetland enhancement.

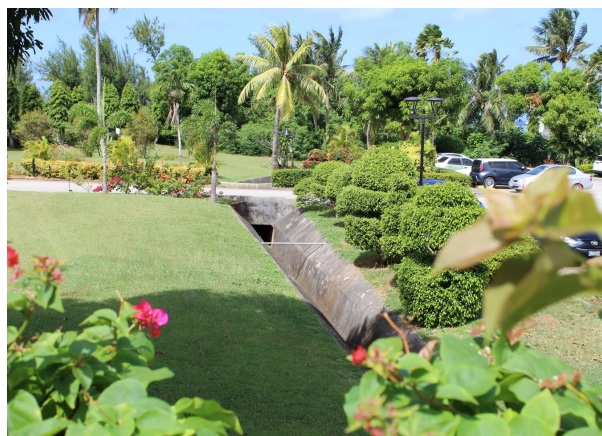
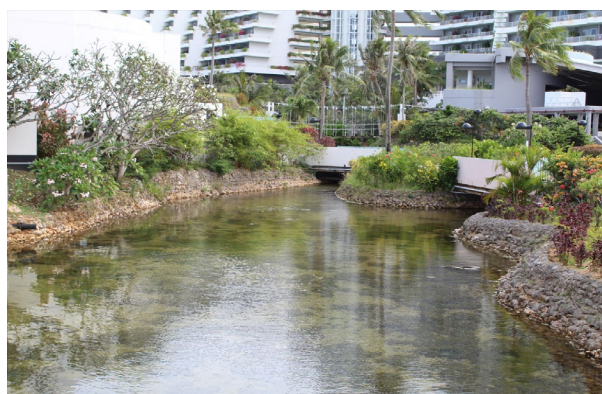
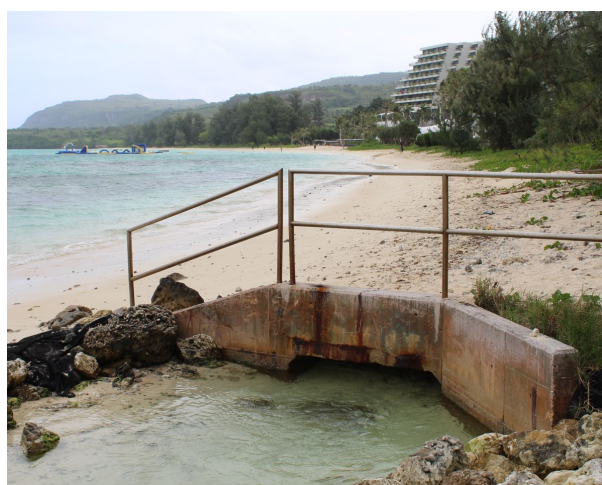
Drainage infrastructure at the Kensington Hotel.

The Kensington Resort has a series of ponds that collect drainage from the property and discharge to the lagoon at a concrete outfall on the beach. The parking lots drain through a series of concrete channels that convey stormwater runoff into a small wetland that either drains to the stream system to the south of the hotel or connects into the main pond system. At the lower pond's outlet structure, extensive algal mats and decaying organic matter buildup were observed that could lead to outlet clogging, odors, and additional water quality issues. Opportunities were identified to improve the overall pollutant removal performance (and aesthetics) of the existing drainage system and implement principals outlined in the CNMI Sustainable Hotel Guide.

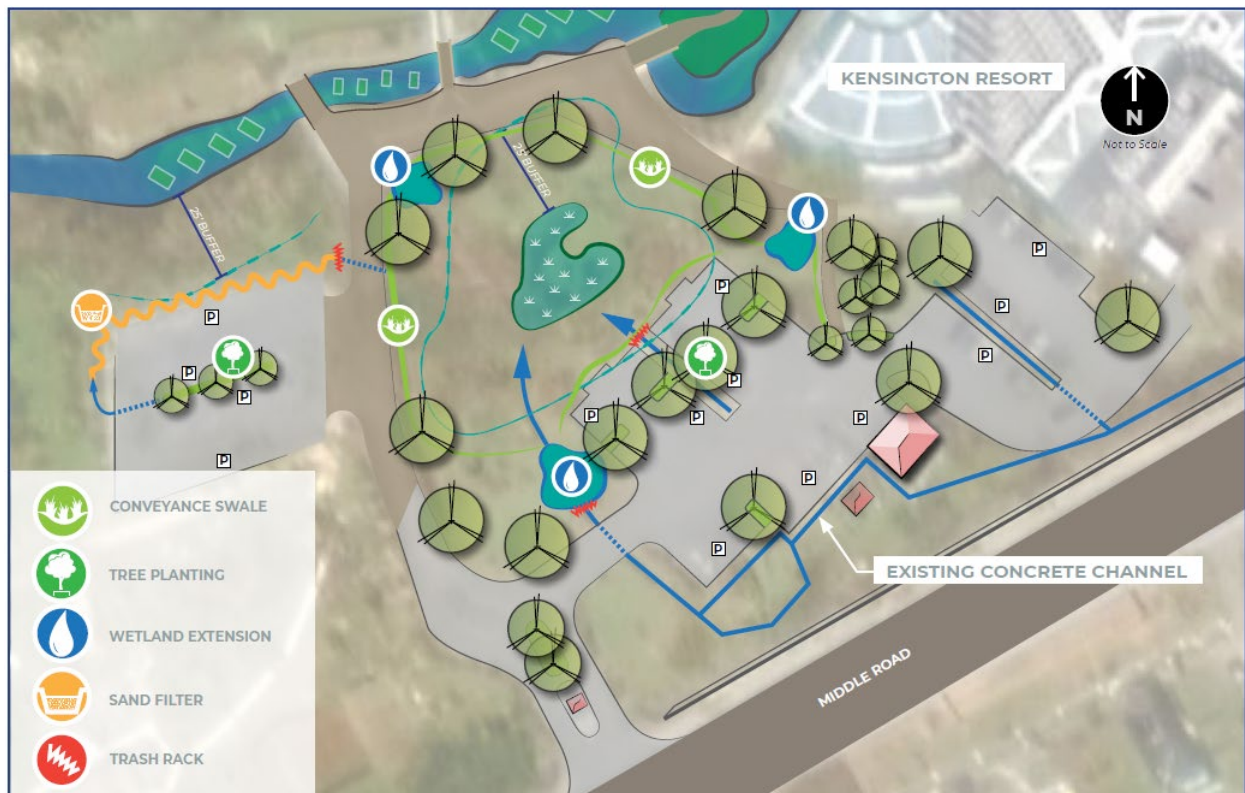
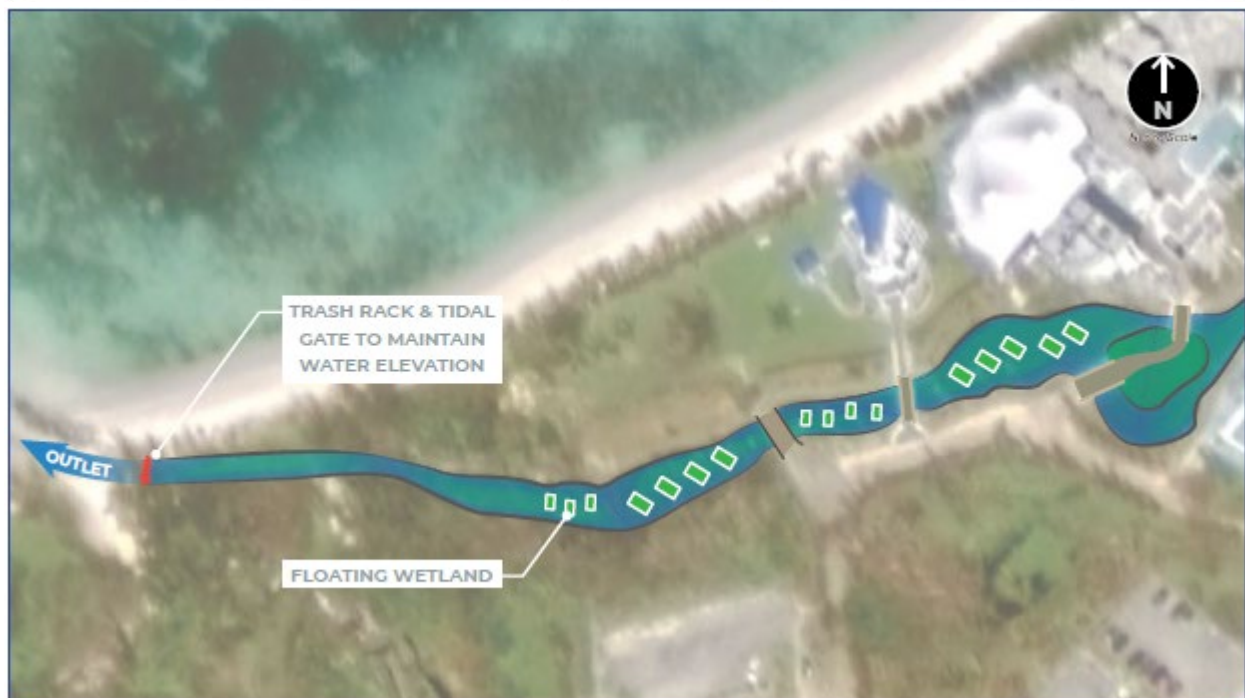
Preliminary schematics for parking lot stormwater improvements and floating treatment wetlands at Kensington Resort to improve water quality.

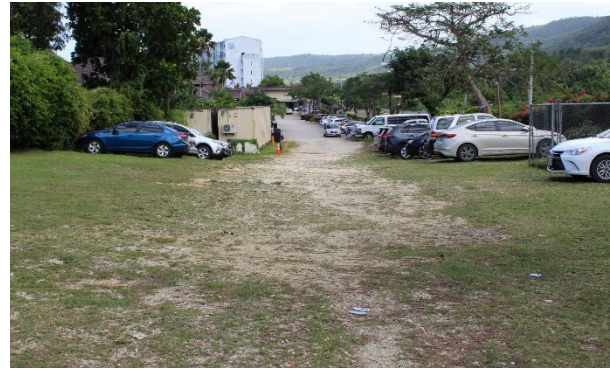
Unpaved overflow parking at the Aqua Resort.

The overflow parking area at Aqua Resort is unpaved and heavily compacted due to vehicular traffic. The overflow lot drains back towards storage containers and a catchbasin in the adjacent paved parking lot. The existing catch basin is clogged with sediment and debris.

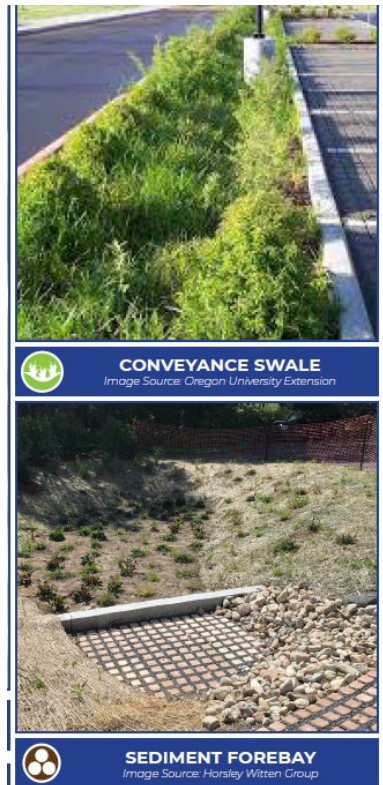
Schematic design for parking lot stormwater management at Aqua Resorts.

There is an opportunity here to better manage stormwater from the parking lot (volume reduction and water quality) and provide for more formalized parking. At a minimum, the storage units should be relocated to the other end of the parking area at a higher elevation and a shallow bioretention or rain garden constructed at the low point. A sediment forebay should be incorporated into the bioretention. A sediment forebay is an isolated depression that collects sediment and trash before it enters the rain garden. Sediment forebays are designed with maintenance in mind to provide an accessible, small area to remove accumulated debris.

The overflow parking can be converted to a permeable surfacing with a perimeter swale to bypass offsite runoff or carry any overflows to the bioretention. Porous pavers, such as Ecoraster E40, Turfstone, or a brick designed/manufactured on island can be used to distribute the heavy load of vehicles and improve soil permeability while also working to retain the loose aggregate surface material and minimize erosion. Depending on design, speed bumps can divide the contributing drainage area and to help direct runoff.

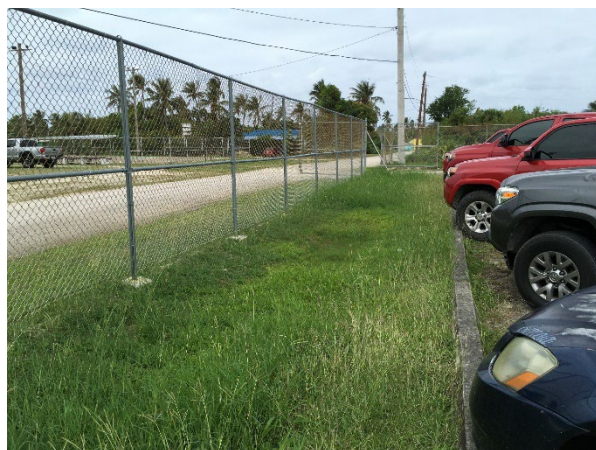
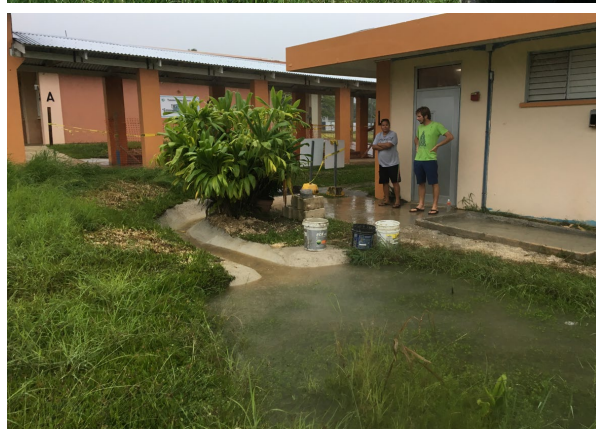
Tanapag Middle School participates in the Watershed Warrior Program and has a rain garden on-site (needs some attention).

Tanapag Middle school has a rain garden and participates in the Watershed Warriors program. The school sits at a lower elevation than the adjacent Middle Road. The 2'x2' metal inlet grate is located above the gutter line/curb on the road, easily clogs, and is frequently bypassed during rain events. When this happens, stormwater from the road is directed towards the middle school. Stormwater runoff from the schoolyard and parking lot is directed to an existing swale. The two surface inlets and outlet to/from this swale are clogged and need to be cleaned. Some drainage likely bypasses the swale and makes its way over to the park / basketball court across the street. The rain garden in the back often fills up and overflows back towards the main office.

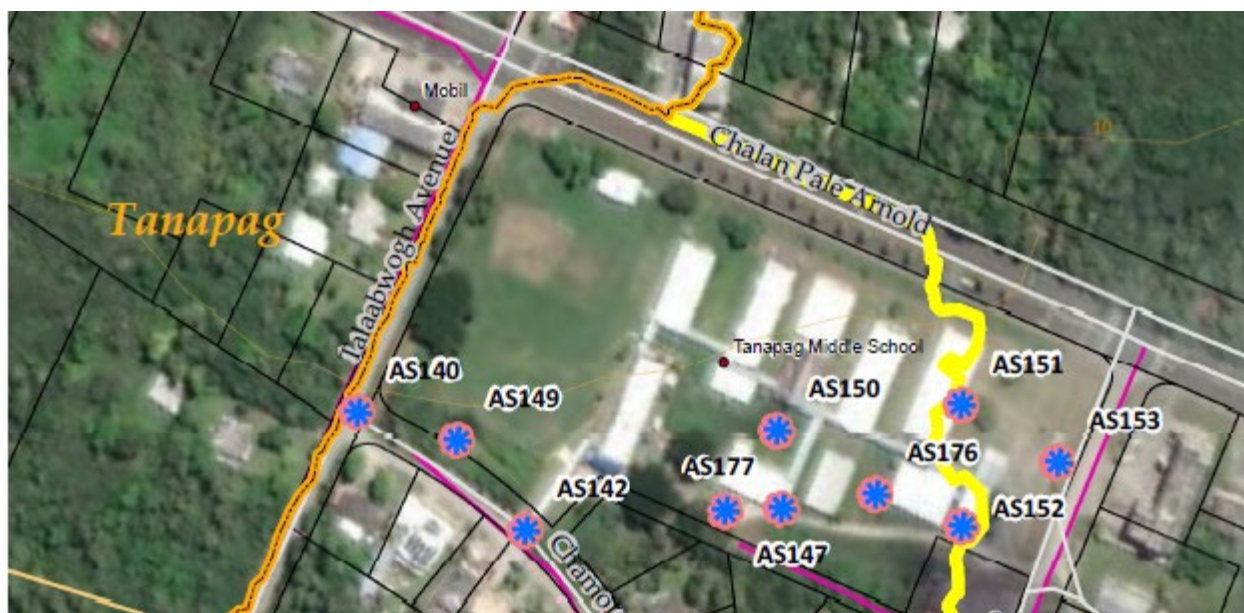
There are a lot of stormwater retrofit, coastal resiliency, and education at the Tanapag school that could be the focus of a school stormwater master plan.

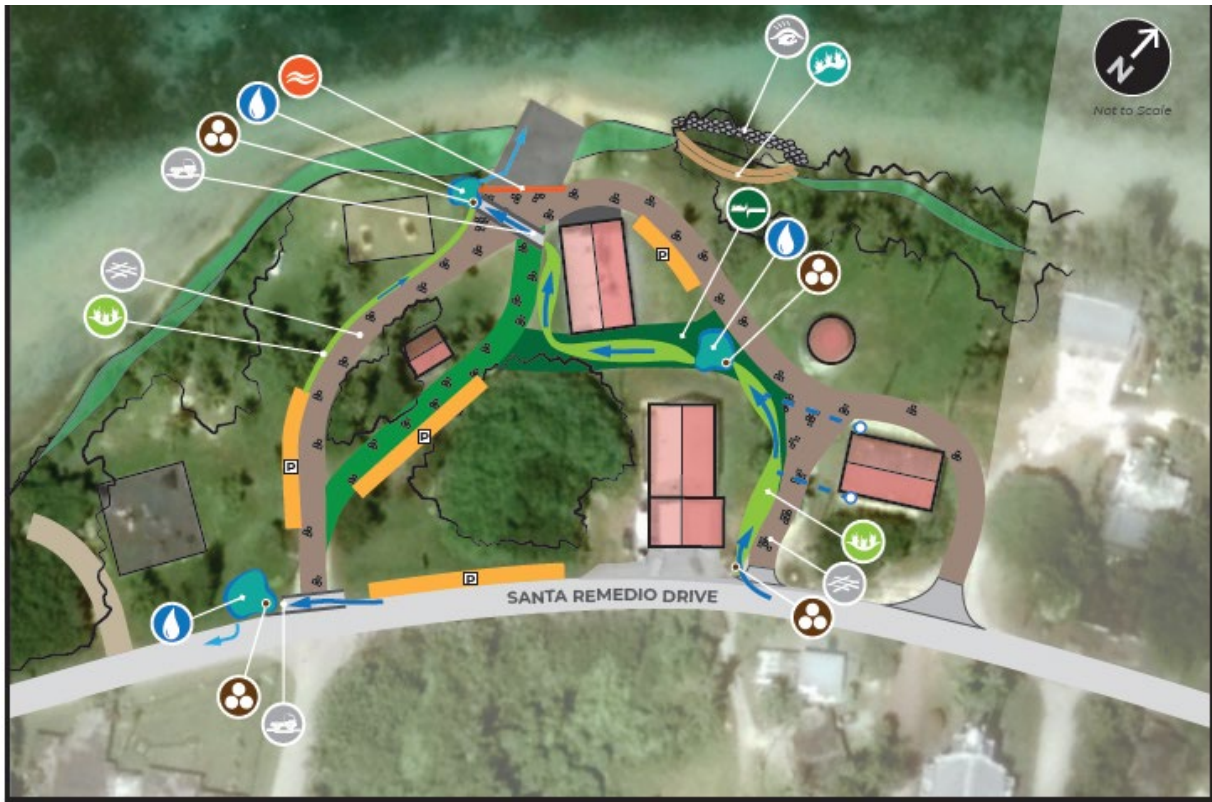
Preliminary schematic design to start community design meetings.

The goal is to work with the community to design a more resilient park using green infrastructure to manage stormwater drainage, protect the shoreline from erosion, and improve habitat and landscaping with strategically placed native plantings. A conceptual plan has been prepared to start the process including a grass swale network, rain garden features, permeable surfacing, educational signage, and a living shoreline. This project, however, will involve several rounds of community meetings and design alternatives to ensure recreational and environmental objectives are met.

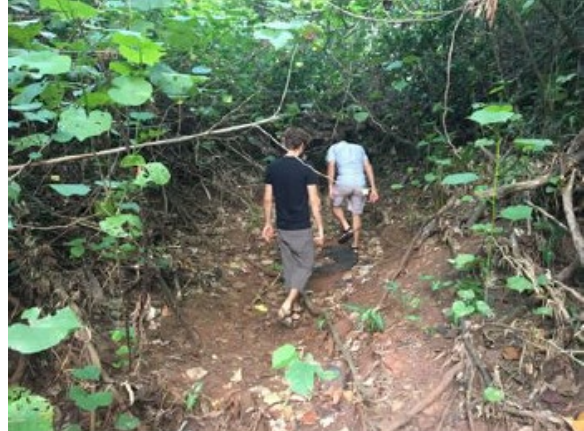
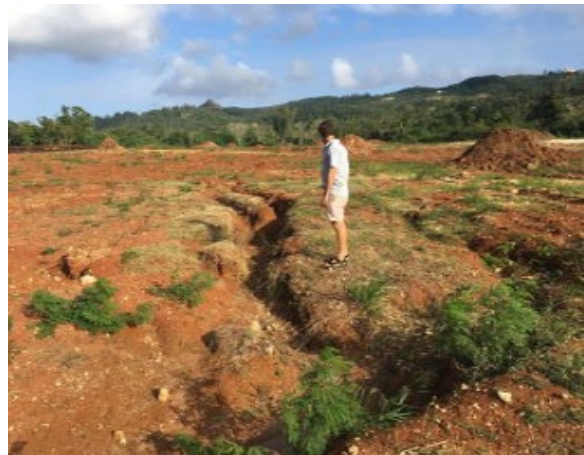
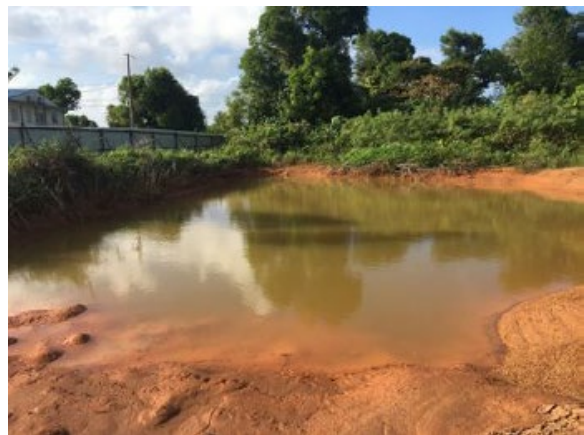
Left abandoned for >5 years, failure to stabilize cleared land does not meet federal or territorial NPDES erosion control requirements for construction activities.

The riparian buffer was impacted at several locations and stream walks revealed evidence of significant sediment accumulation in the stream bed. The status of the isolated wetland onsite is unknown, but presumably has been impacted. The operator of this site is in clear violation of the CNMI stormwater regulations, and their land development permits. This site drains to the Dogas stream and is the likely source of sediment plumes into the Tanapag Lagoon.

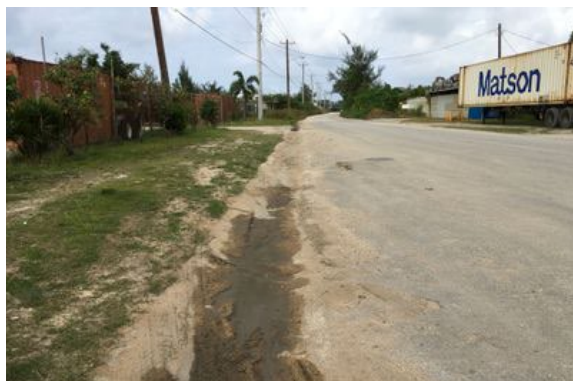
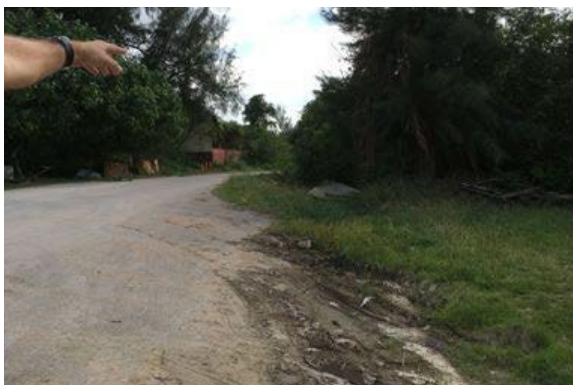
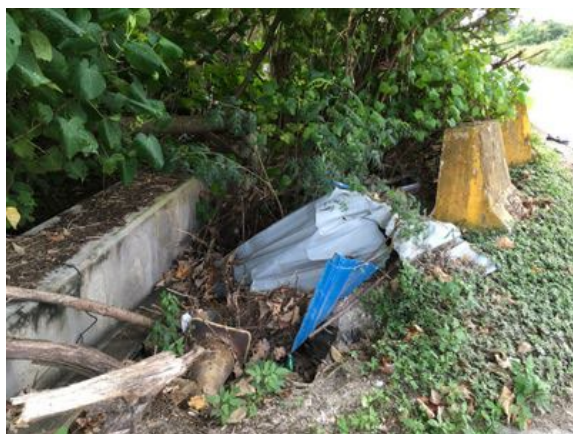
Sediment in concrete swale from adjacent industrial properties (top). Locations in the road ROW to trap sediment (middle). Collapsed culvert (bottom).

There are several good locations where drainage structures can be cleaned or repaired. The main culvert should be replaced and stream side slopes stabilized. Sediment forebays, swales, or other BMPs can be added within the road right-of-way to improve sediment removal and water quality treatment. In addition to the work in publicly owned spaces, this project involves collaboration with each of the business owners in the area to identify pollution prevention opportunities on site and develop Stormwater Pollution Prevention Plans (SWPPPs) with concept designs to reduce sediment and other polluted runoff on individual properties. It would

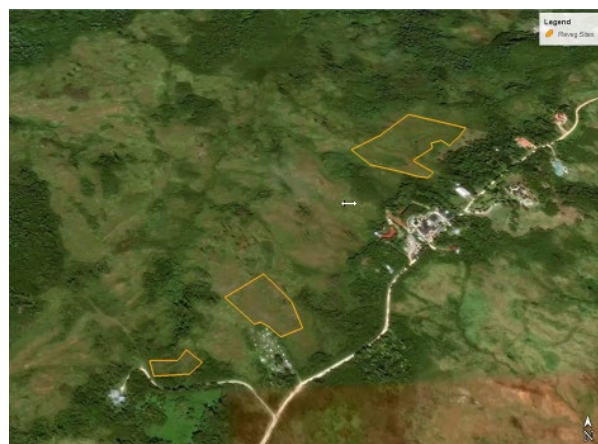
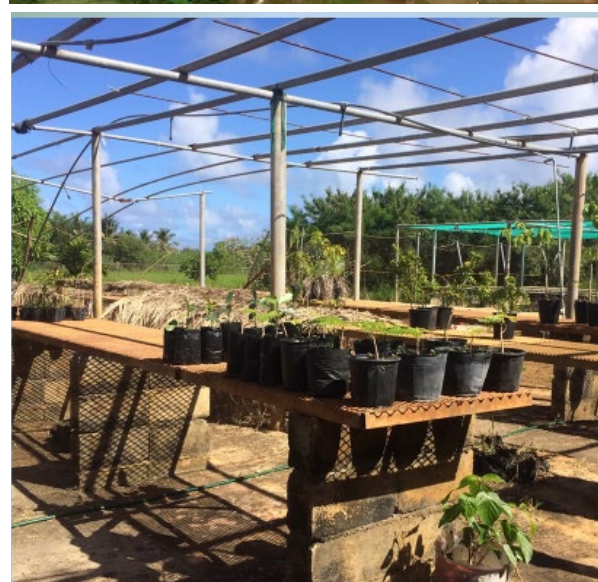
Key locations for upland reforestation efforts (top); Kagman nursery repairs (bottom)

Reforest priority areas starting at the upper ridges of Achugao, converting fire-vulnerable grasslands back into native forest. DCRM hired a coordinator and secured a 2020-2023 DOI CRCP Grant to identify priority areas for reforestation; purchase materials for native tree propagation; DFW and HPO permitting; and conduct out-planting, maintenance, and monitoring to reforest the Achugao watershed. Three areas totaling > 6 acres were identified along Wireless Ridge for initial implementation. DLNR-Forestry is taking the lead on the propagation of native
