2020
Commonwealth of the Northern Mariana Islands
305(b) and 303(d)
Water Quality Assessment Integrated Report

Bureau of Environmental and Coastal Quality
December 2020

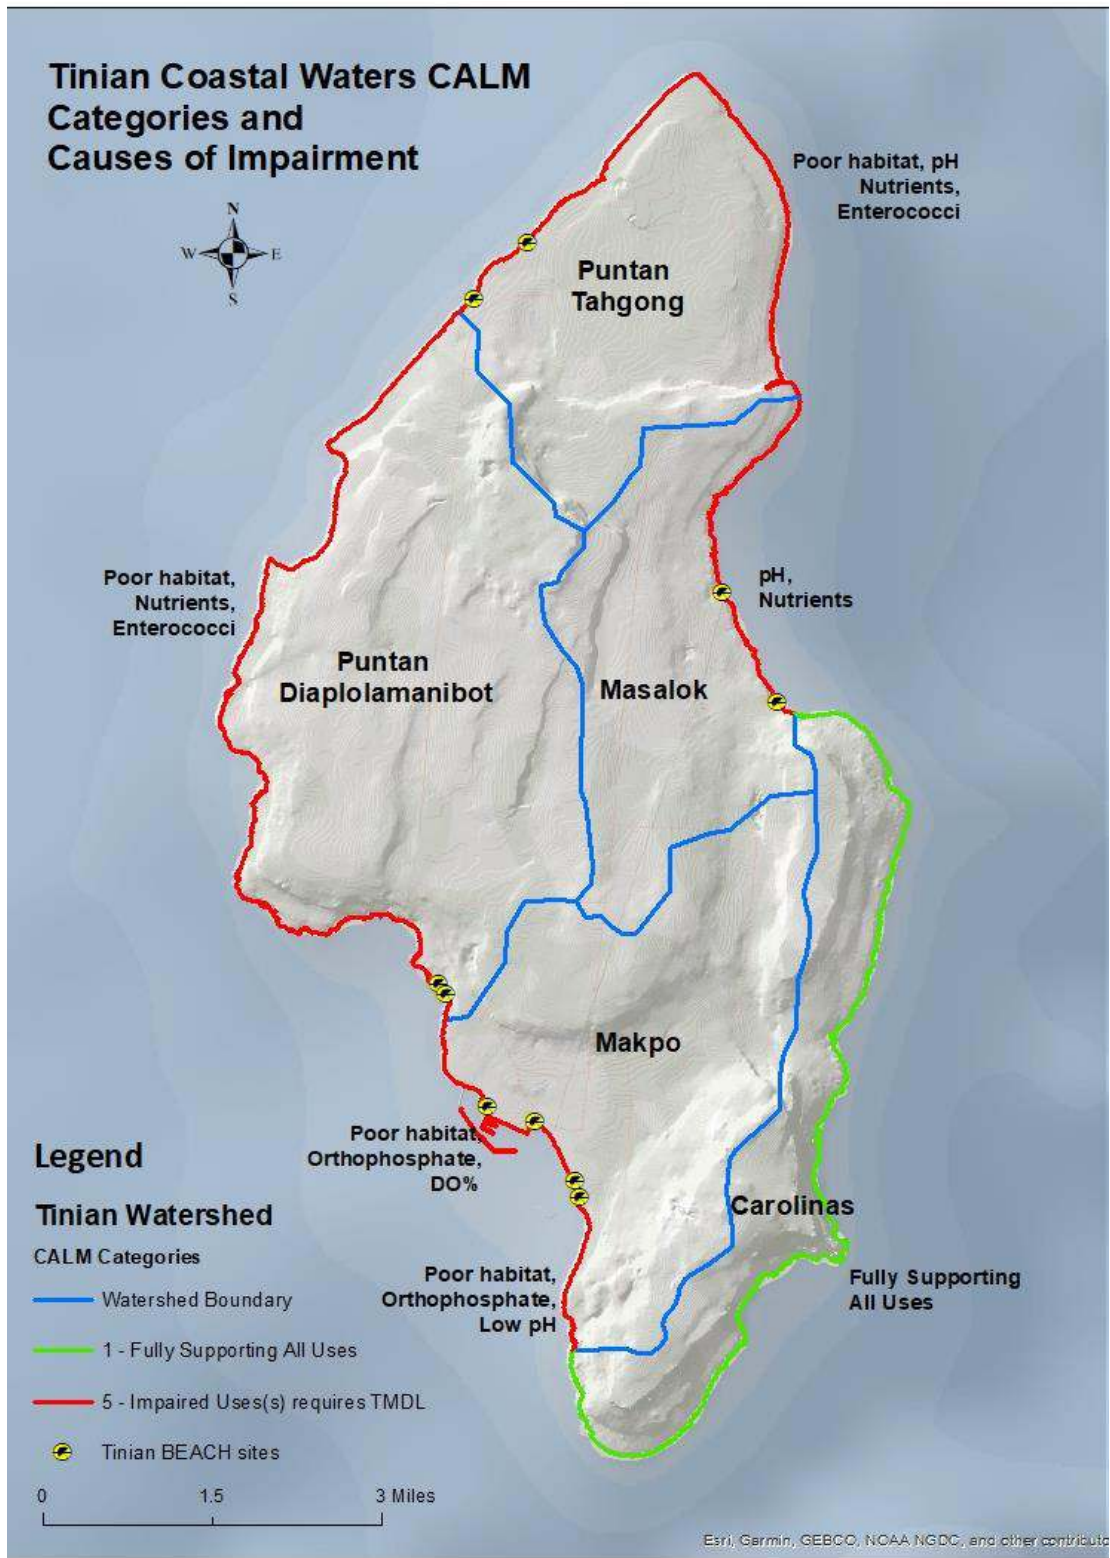
FIGURE III. Tinian Coastal CALM Categories and Causes of Impaired Designated Uses

Figures III., on the following page maps Tinian watersheds' CALM Categories and the various causes of coastal water impairment.

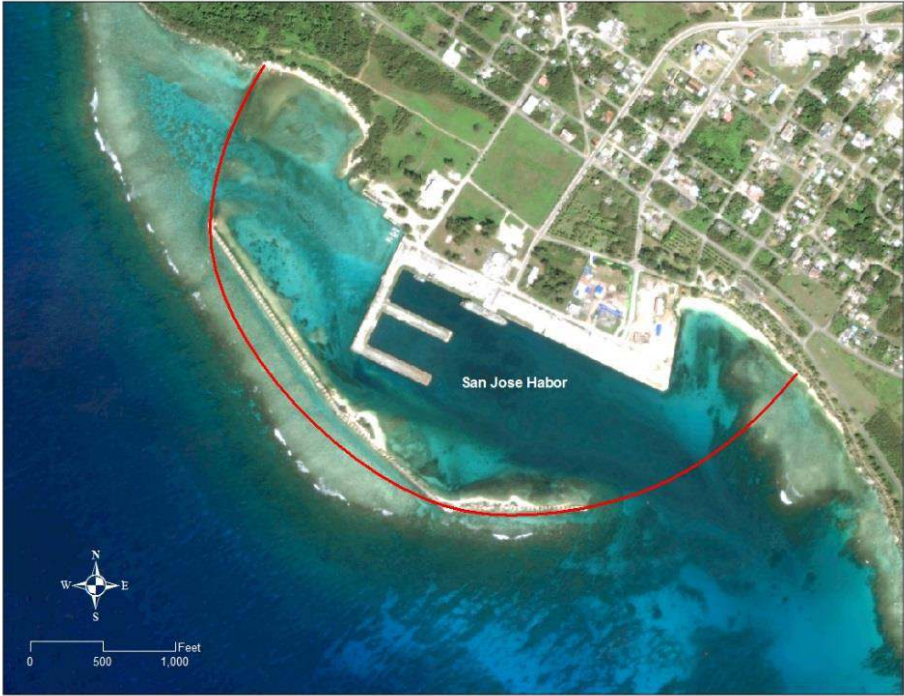
FIGURE B-4. Class A Waters of San Jose Harbor, Tinian

The other Class A waters are limited to the existing harbors on Tinian and Rota.

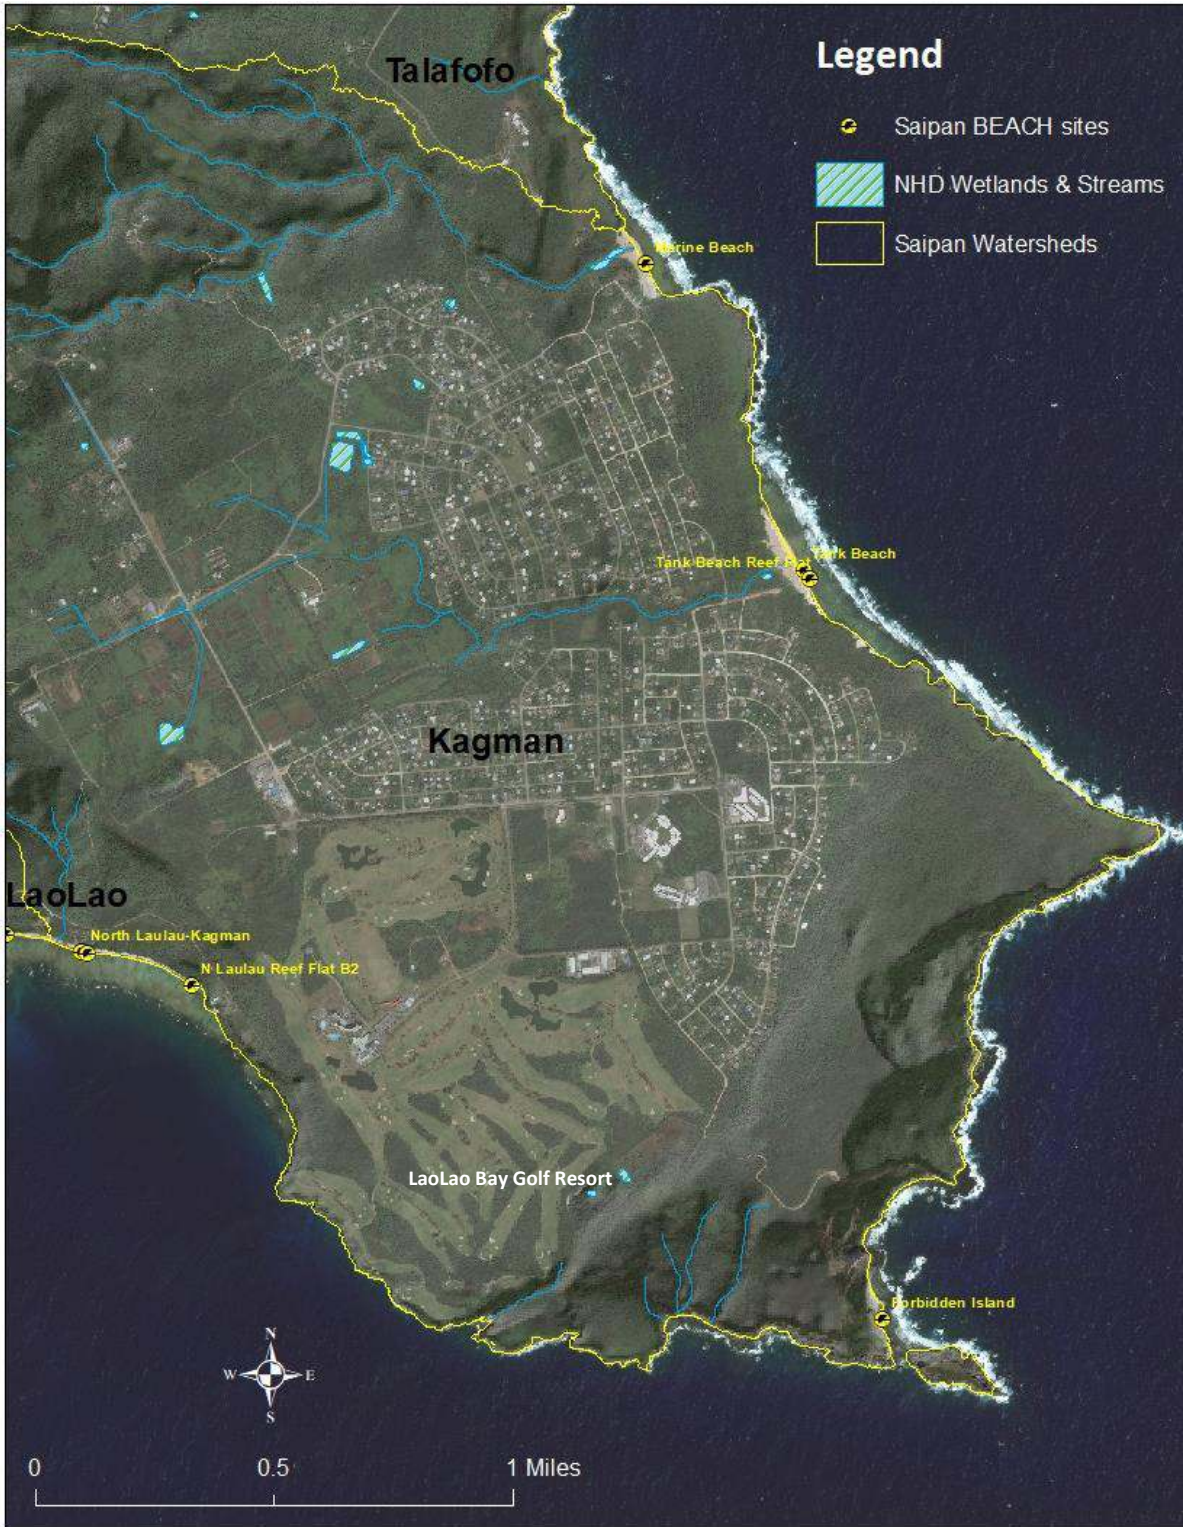
FIGURE C-10. Kagman Watershed (Segment 14)

The ARRA sites were established in 2010 to evaluate the efficacy of the LaoLao Bay road construction project, and revegetation and community outreach efforts. The project's aim was to minimize the amount of sediment and other NPS pollution from entering LaoLao Bay. These ARRA sites in addition to the Tank Beach reef flat site (CNMI-29) are all within wading distance to the shoreline and are monitored regularly. These sites are adjacent to LaoLao's northern beach, one of Saipan's most popular dive sites.

Kagman's uplands are composed of porous karst soil that allows surface water to percolate into the ground water aquifer and flow out to coastal waters through freshwater seeps. Kagman watershed also has one of the highest incidence rates of rainfall, and a relatively shallow slope in the lower watershed, which is why it has become "The single largest concentration of cropland" on Saipan (CNMI SWCS, Soil survey 1986).

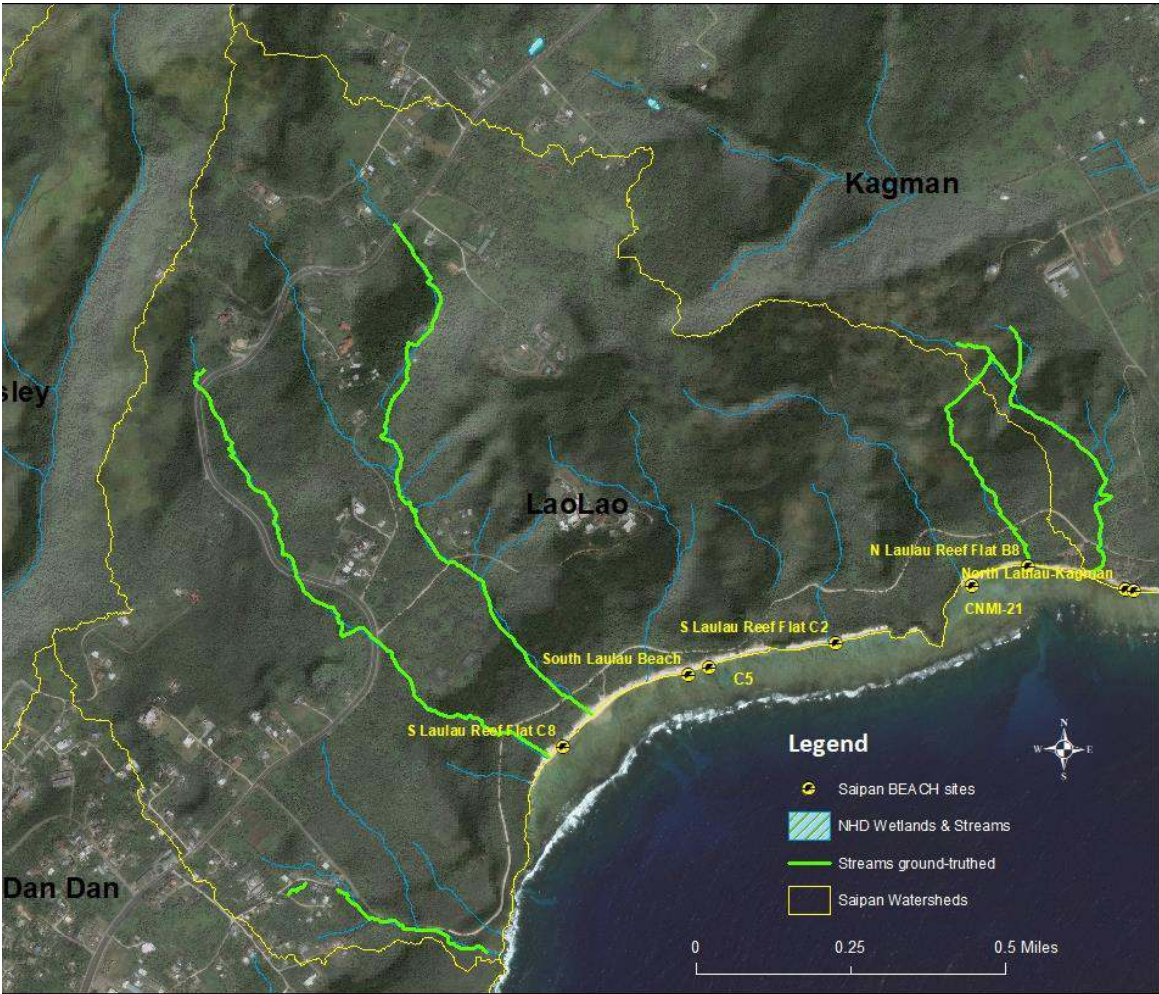
FIGURE C-11. Laolao Watershed (Segment 15)

The LaoLao watershed has one long-term BEACH monitoring site, South LaoLao (SEB 03); three (3) ARRA reef flat sites (C2, C5 and C8); and one MMT biological reef flat site (CNMI-21) that are used for assessing LaoLao watershed's coastal waters.

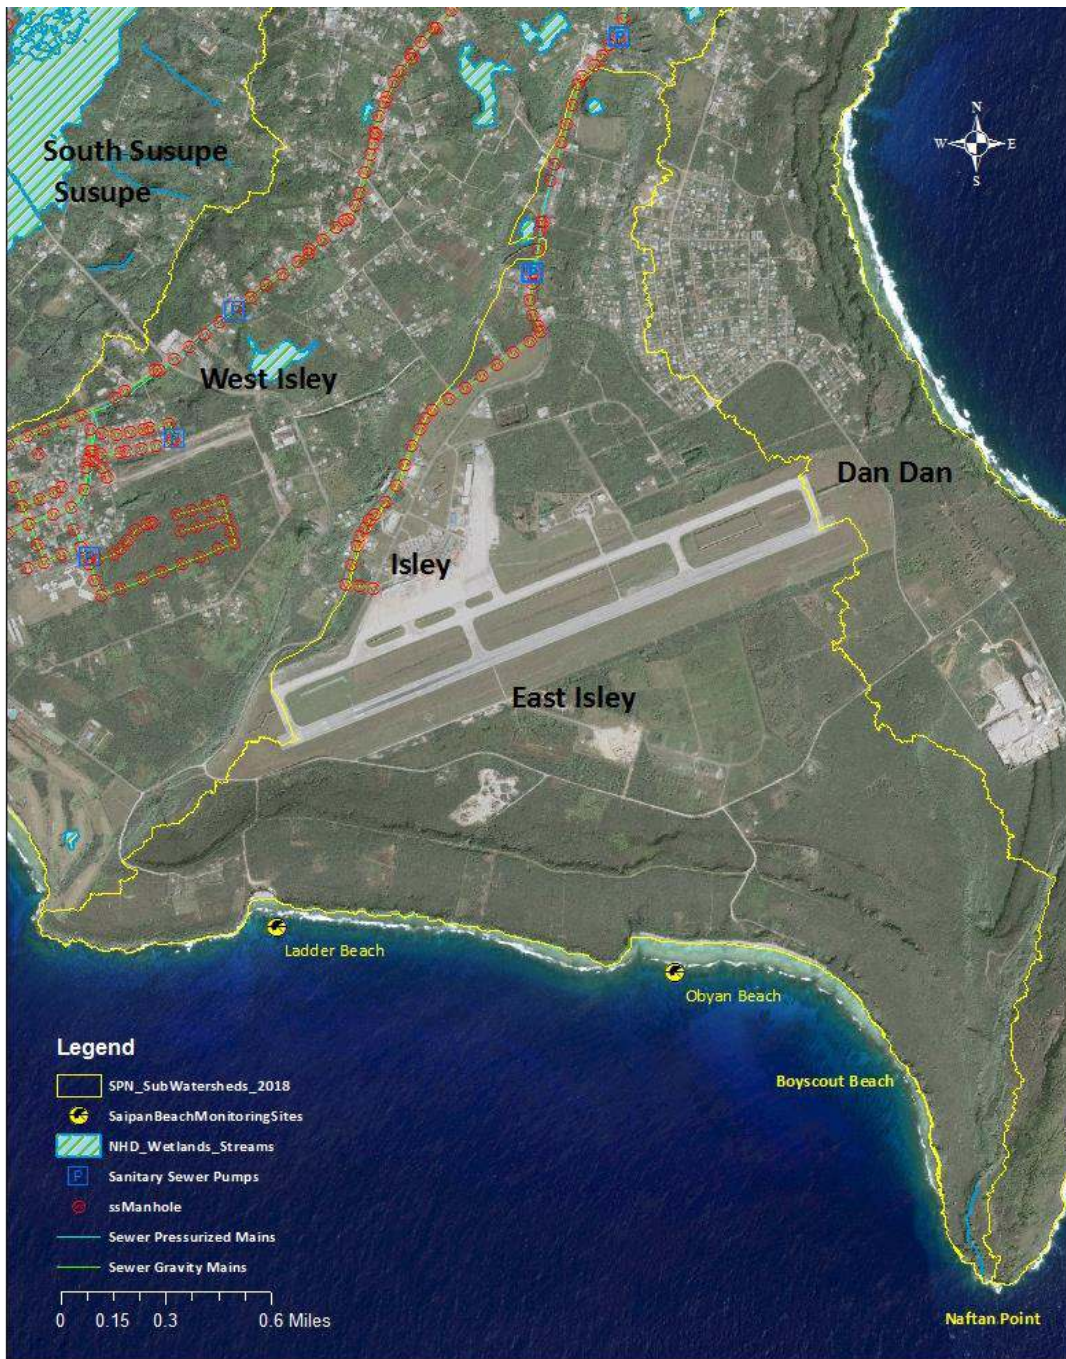
FIGURE C-14. East Isley Watershed (Segment 17B)

East Isley’s Watershed (Figure C-14.) contains Saipan’s present day, Francisco C. Ada International Airport, and a WWII military dumpsite located at Naftan Point.

The East Isley watershed is sparsely populated with a few homes compared to the west. There are two long-term BEACH monitoring sites located at Obyan, and Ladder beaches, one reef flat site off Ladder Beach, and an MMT biological monitoring site at Boy Scout Beach.

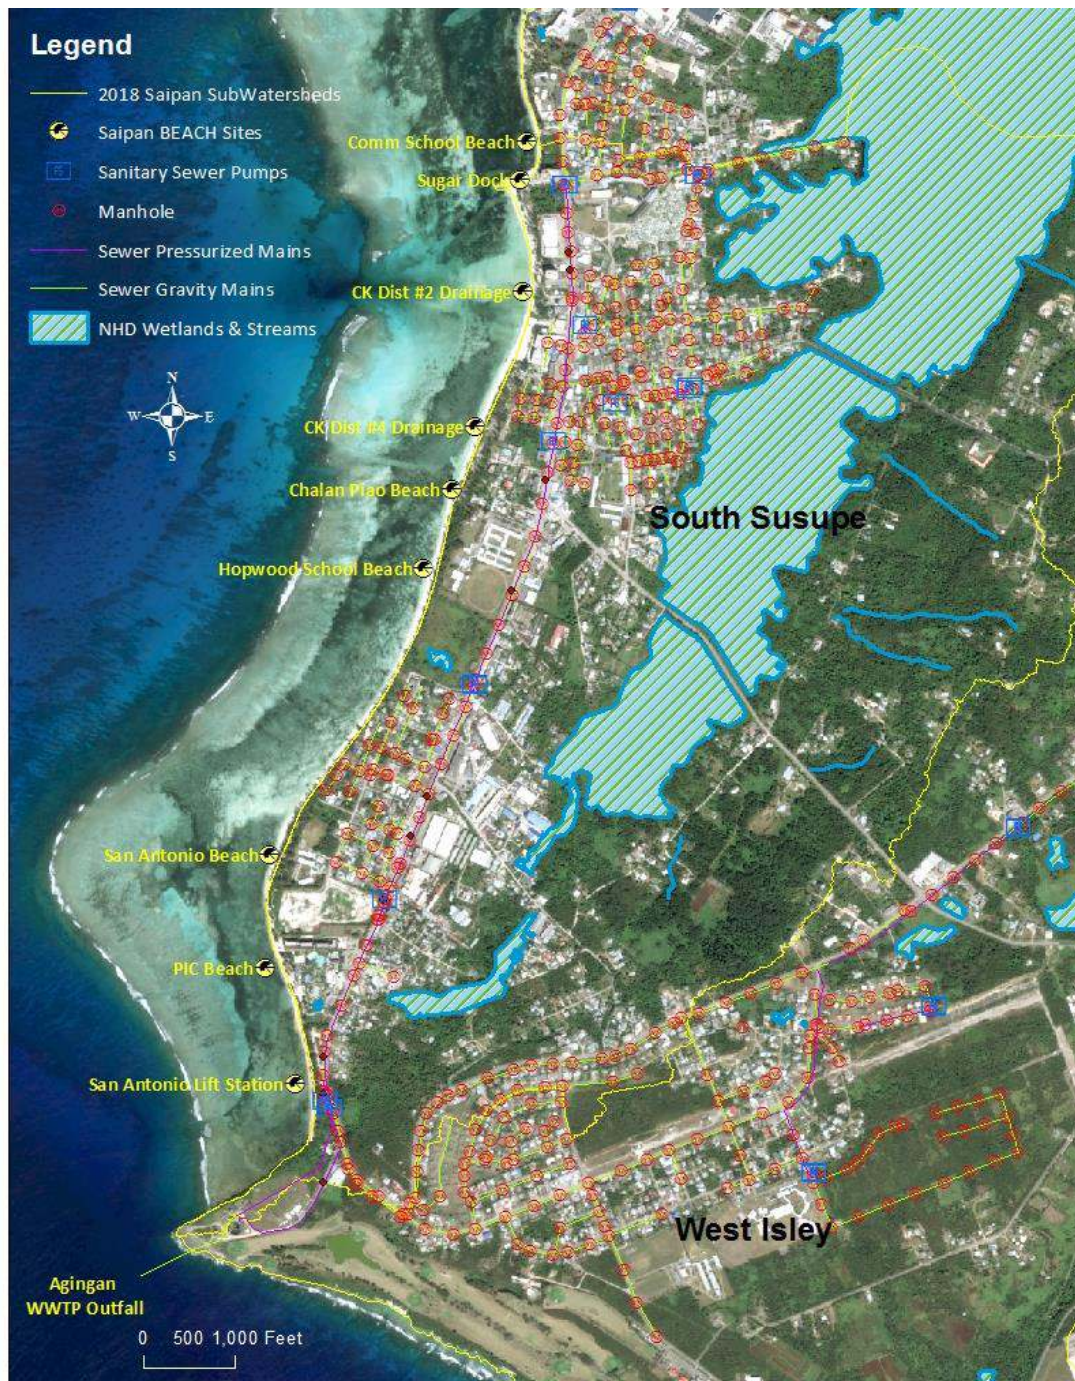
FIGURE C-18. South Susupe Watershed (Segment 18B)

South Susupe Watershed contains the largest wetland in the CNMI covering 292.4 acres and the only lake on Saipan (57.4 acres), Figure C-18.

There are eight (8) long-term BEACH monitoring sites. The CUC San Antonio Sewer Lift Station A-16 is the southernmost Site. Sugar Dock is the northernmost site and contains a boat launch. It is a popular swimming and boogie boarding site. The end of the dock is also used as a dive platform for jumping into Saipan Lagoon's clear waters.

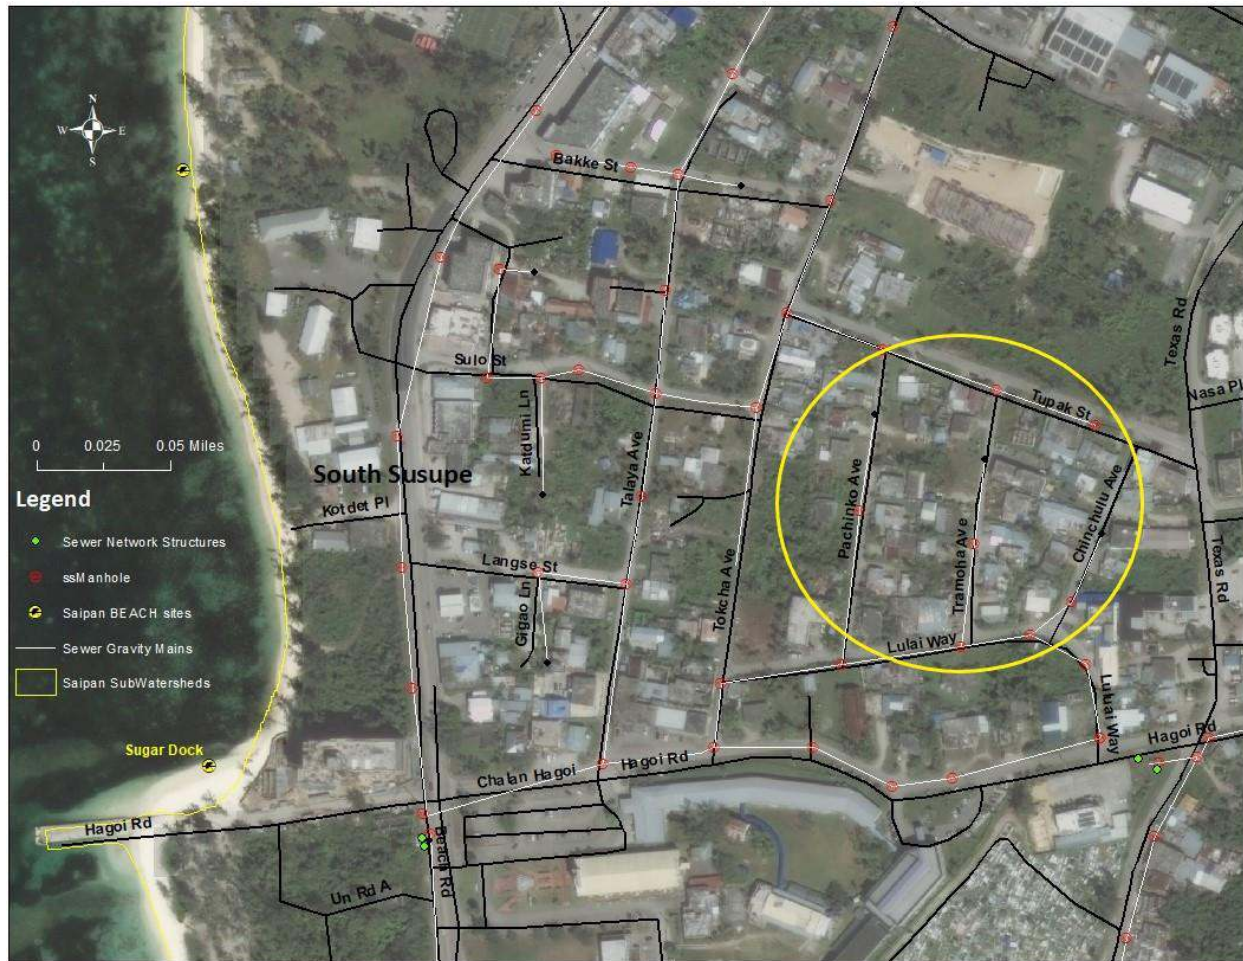
FIGURE C-19. South Susupe Sewer Line Replacement Project - North East of Sugar Dock

The South Susupe coastal waters remain impaired due to Enterococci exceedances of the WQS at Sugar Dock, and CK District #2 drainage BEACH monitoring sites. It should be noted that CUC is actively trying to improve the sewer lines in this area. In FY 2018, CUC replaced dilapidated asbestos cement pipes, installed new sewer manholes, and rehabilitated existing manholes inland of Sugar Dock (2020. As reported by Larry Manacop, CUC engineer). The area is outlined in yellow in Figure C-19.

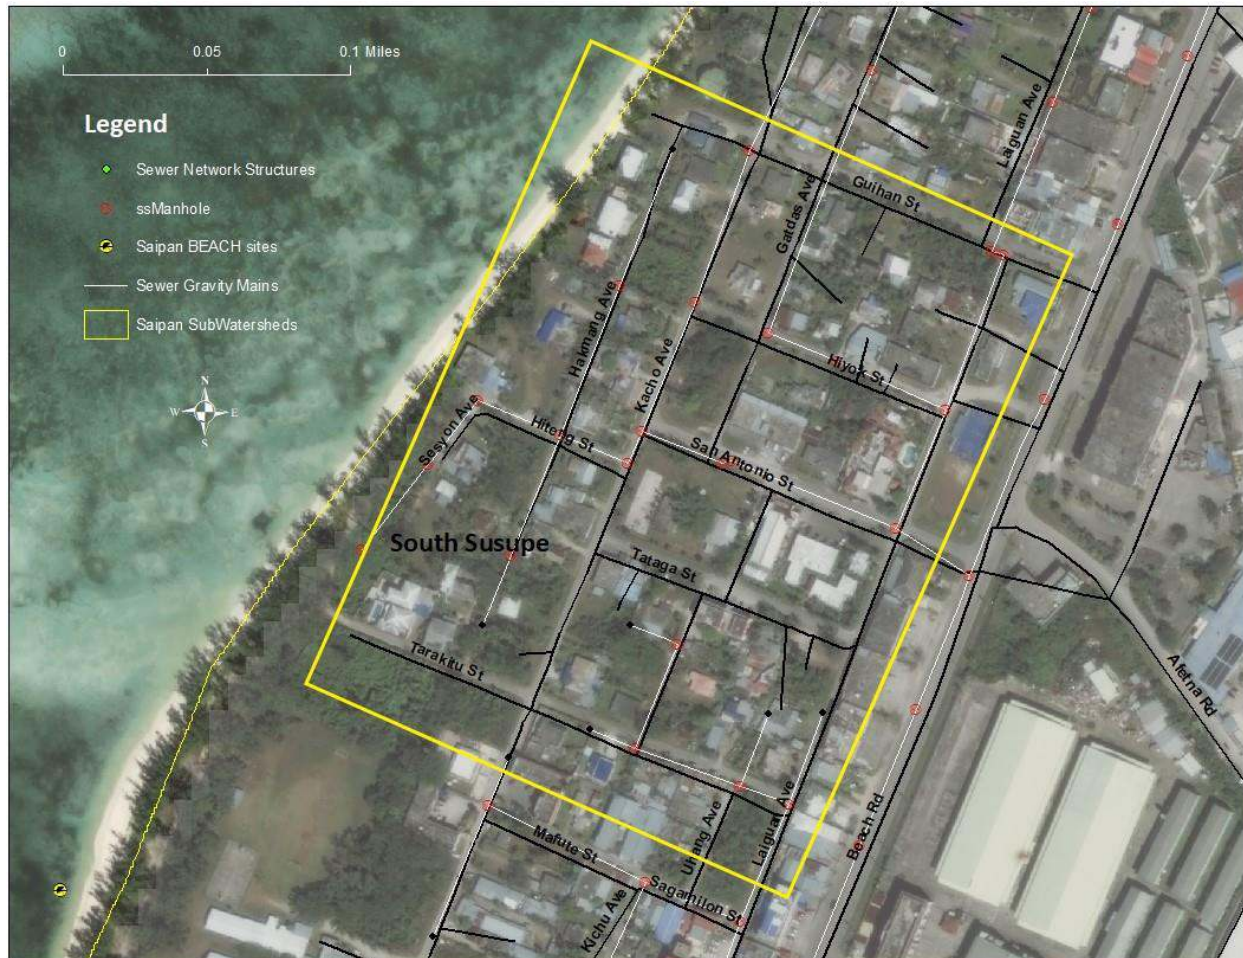
FIGURE C-21. South Susupe Sewer Line Replacement Project – East of Afetna Road

It should be noted that the other BEACH sites located south of CK District #2 drainage have met the CNMI WQS for Enterococci for the past four years. This may be due to CUC’s successful sewer line upgrades across from Afetna Road in 2018 (Figure C-21 on the following page).

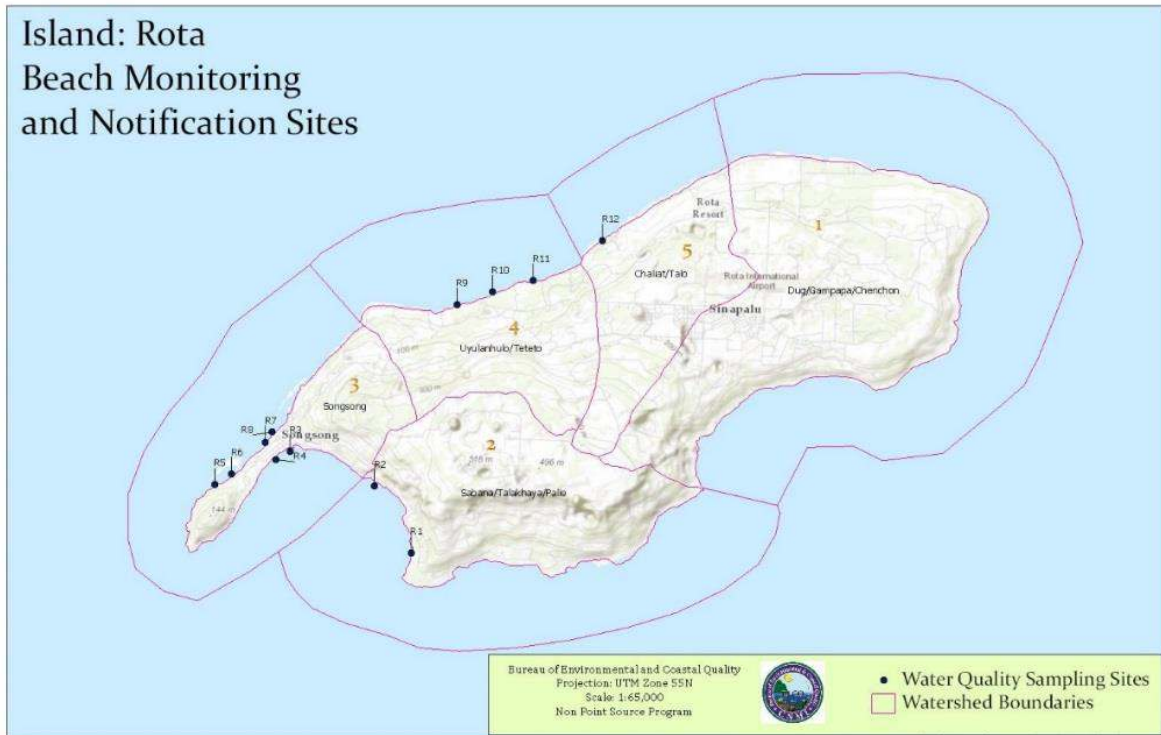
FIGURE C-34. Rota's BEACH Water Quality Monitoring Sites

Rota is split into five (5) watersheds, with 12 regularly monitored BEACH sites. In addition, Rota has three wildlife preserves: The Wedding Cake Mountain Region on the southwest peninsula; Sabana Heights in the island's upper plateau; and l'Chenchon Park on the Dugi/Gampapa/Chenchon watershed's coastline. Rota also has one Marine Protected Area, the Sasanhaya Fish Reserve off the Sabana/Talakhaya/Palie coastline.

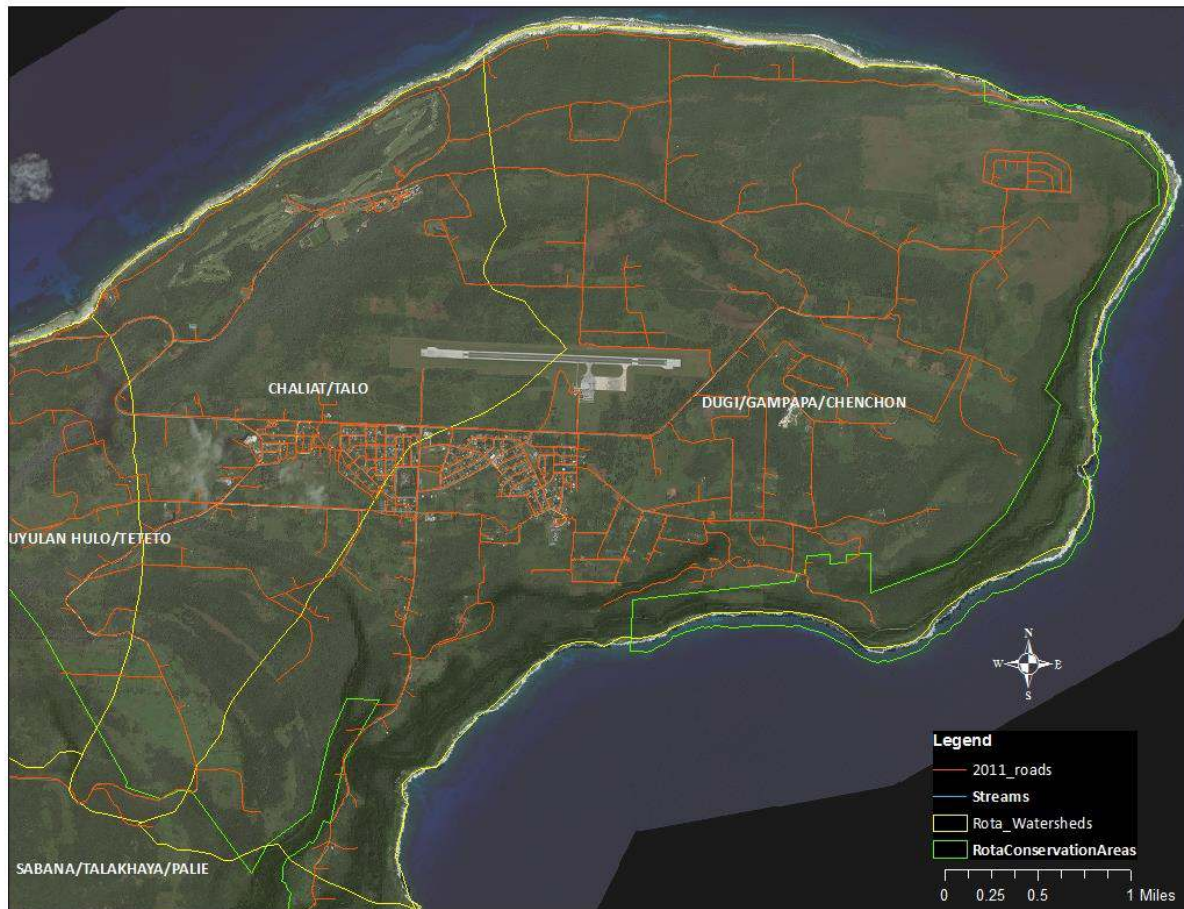
FIGURE C-36. Dugi/Gampapa/Chenchon (Segment 1)

The Dugi/Gampapa/Chenchon watershed does not contain paved roads or any consistently well-maintained trails to allow easy access to the remote coastline for regular water quality monitoring. Therefore, there is not an established long-term BEACH monitoring site for this watershed. The rugged cliff line drops off to deep water, with extremely hazardous surf most of the year. This has resulted in very limited water quality data as samples may only be collected by boat during calm weather, which is usually done in conjunction with biological monitoring of reef flat sites.

The Dugi/Gampapa/Chenchon is the largest watershed on Rota based on land coverage and is the most remote and undeveloped area, as shown in Figure C-36., on the following page. Rota’s Benjamin Taisacan Manglona International Airport is located here.

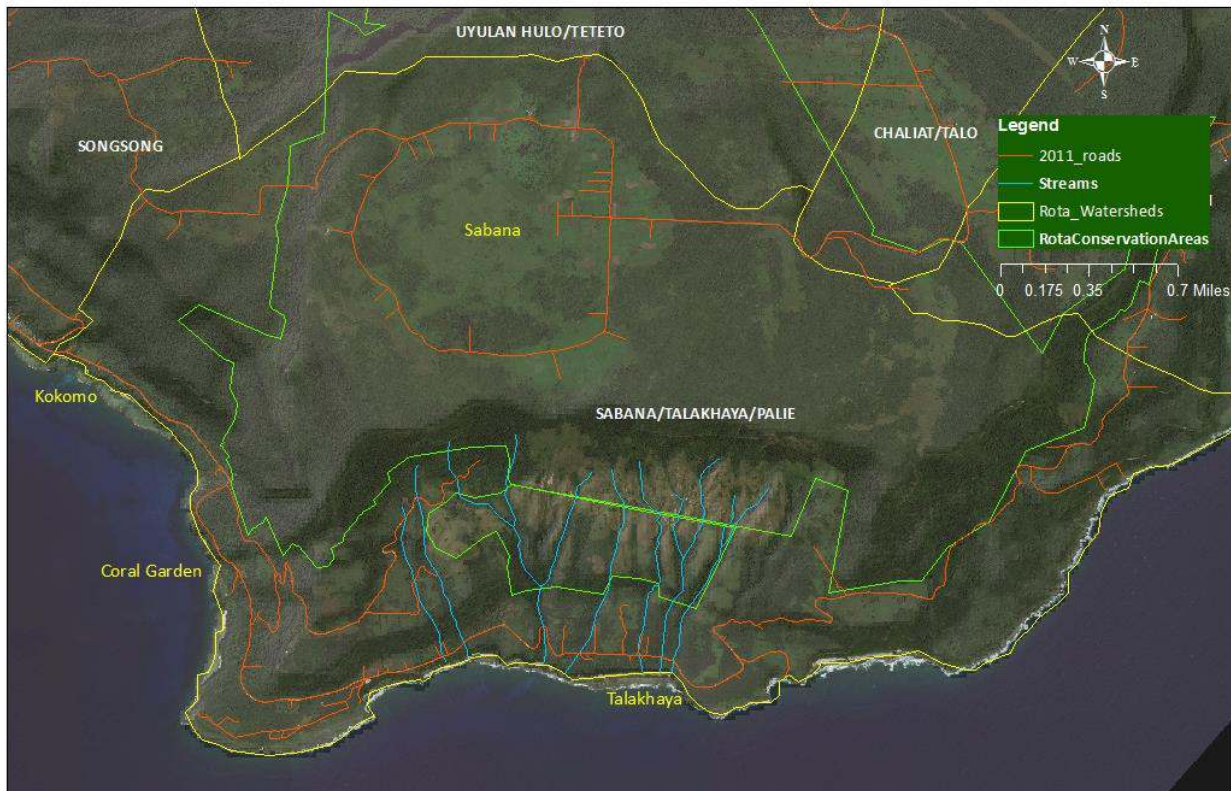
FIGURE C-37. Sabana/Talakhaya/Palie (Segment 2)

These findings resulted in a significant decrease in the benthic substrate of the sites near the Talakhaya BEACH site and the Talakhaya stream outlets, which were considered in “Poor” condition compared to “Fair” in previous IRs. There was no significant change to the Coral Garden reef site, which remains in “Good” condition. Therefore, Sabana/Talakhaya/Palie’s coastal waters retain an overall ALUS ranking of “Fair” again this reporting cycle.

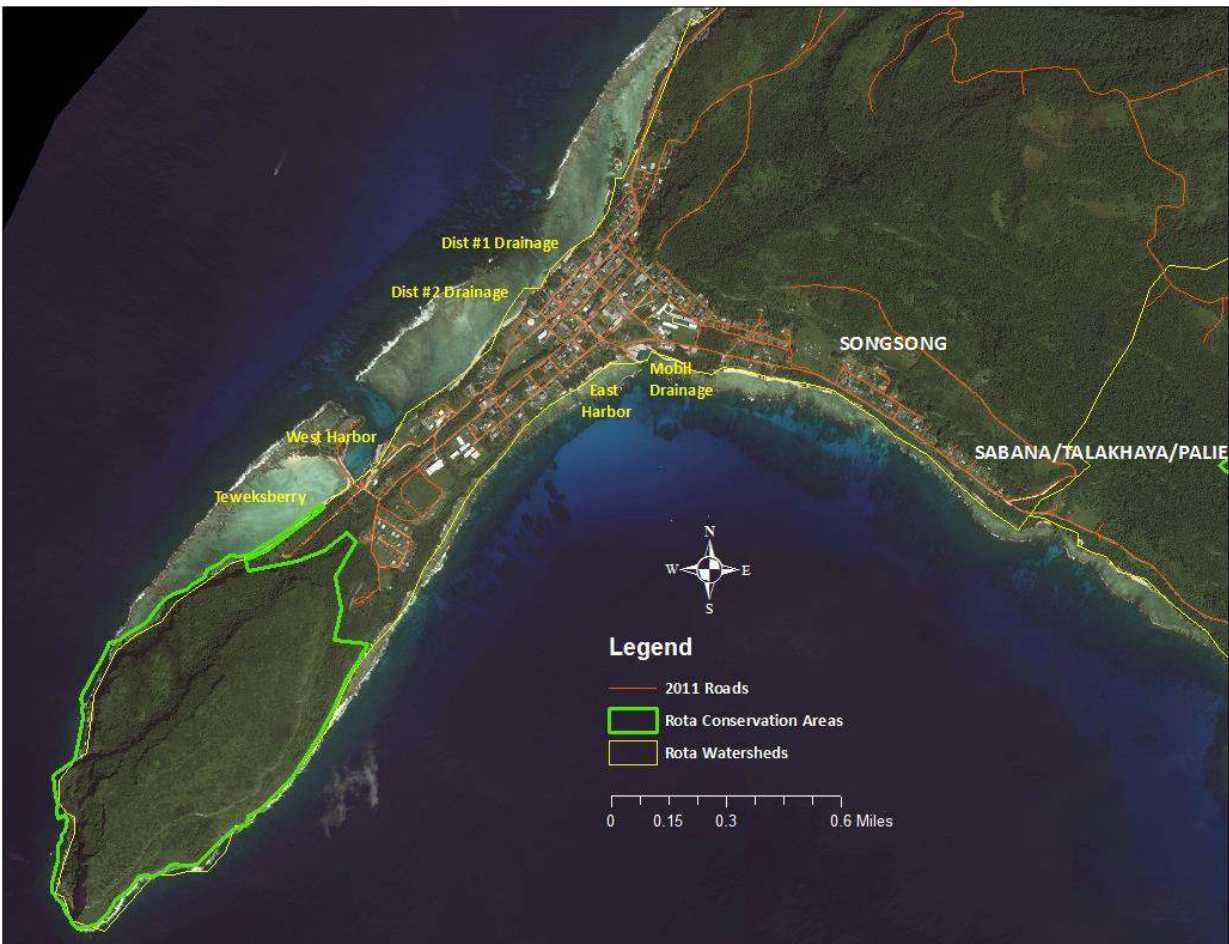
FIGURE C-39. Songsong (Segment 3)

There are six (6) long-term BEACH monitoring sites surrounding the Songsong watershed on Rota's western peninsula (Figure C-39., on the following page). The peninsula contains the most developed and densely populated area on Rota, Songsong Village. It also contains the East and West Harbor and the Mobil fuel depot, which are Rota's only designated Class A waters.

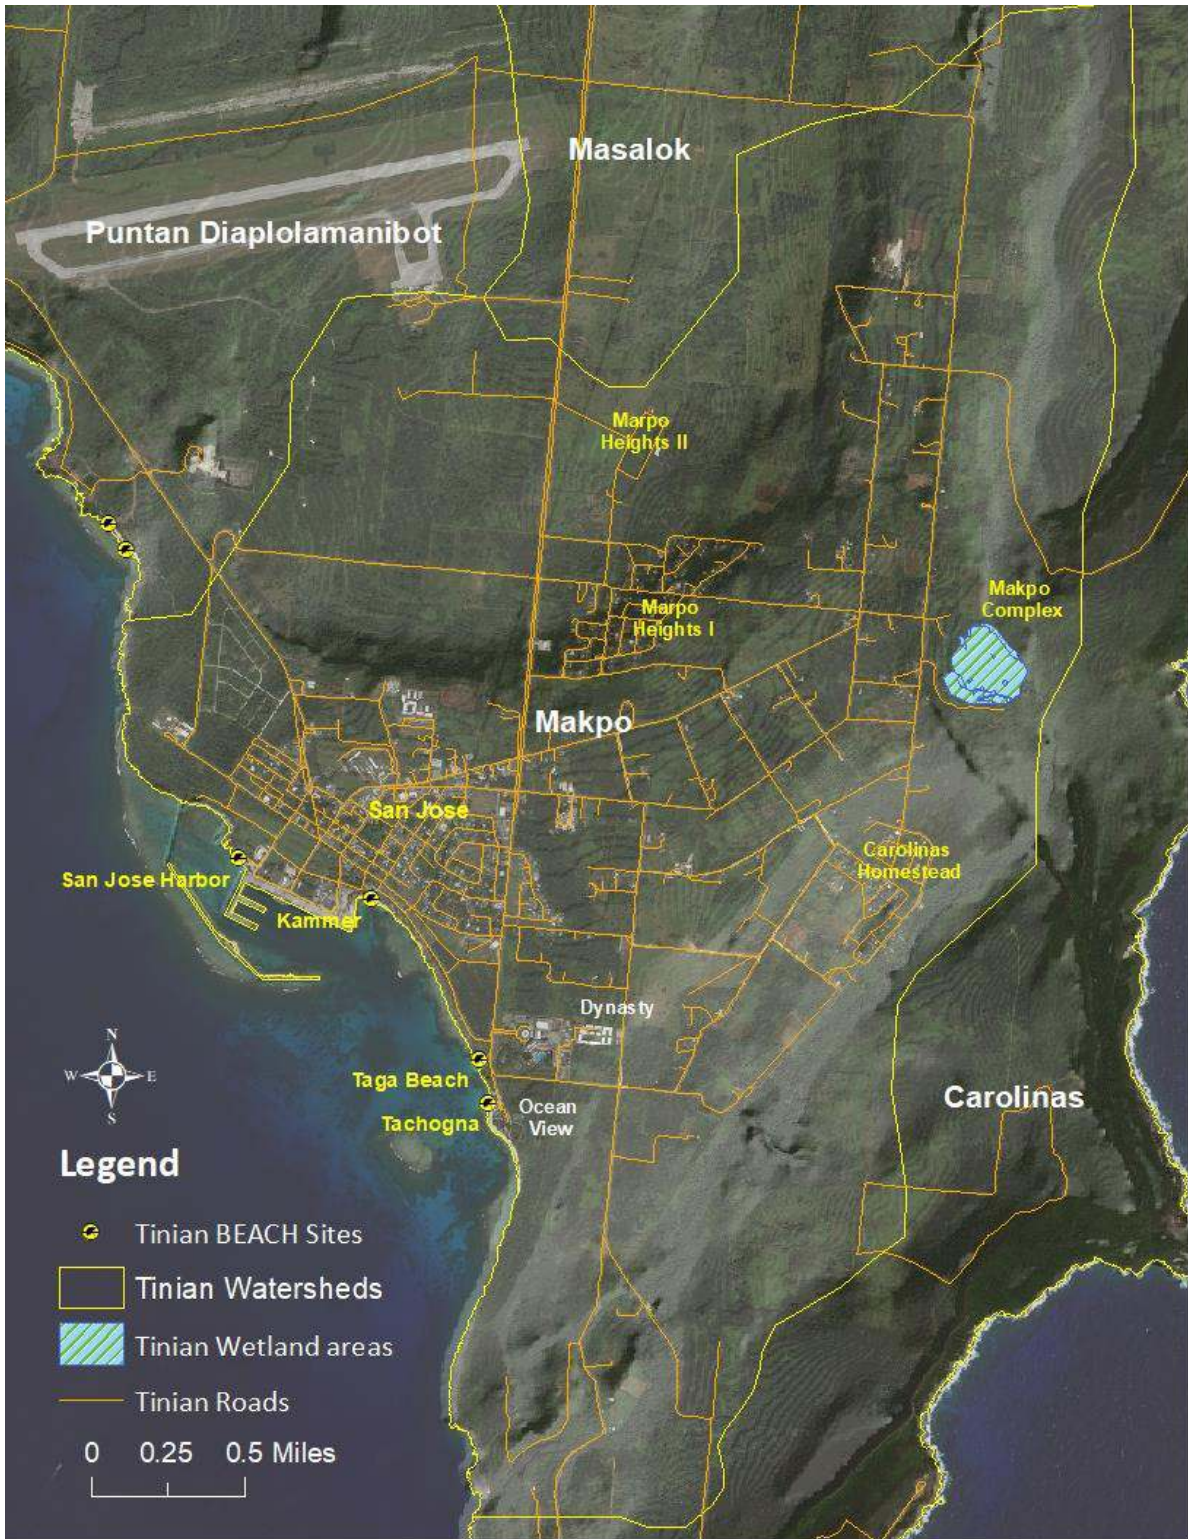
FIGURE C-47. Makpo and Makpo's "San Jose" Harbor (Segment 9 and 9H)

Makpo coastal waters retain a CALM Category 5 due to pH, and elevated Orthophosphate levels, which is unsupportive of the *Propagation of Aquatic Life* and *Recreational* DUs.

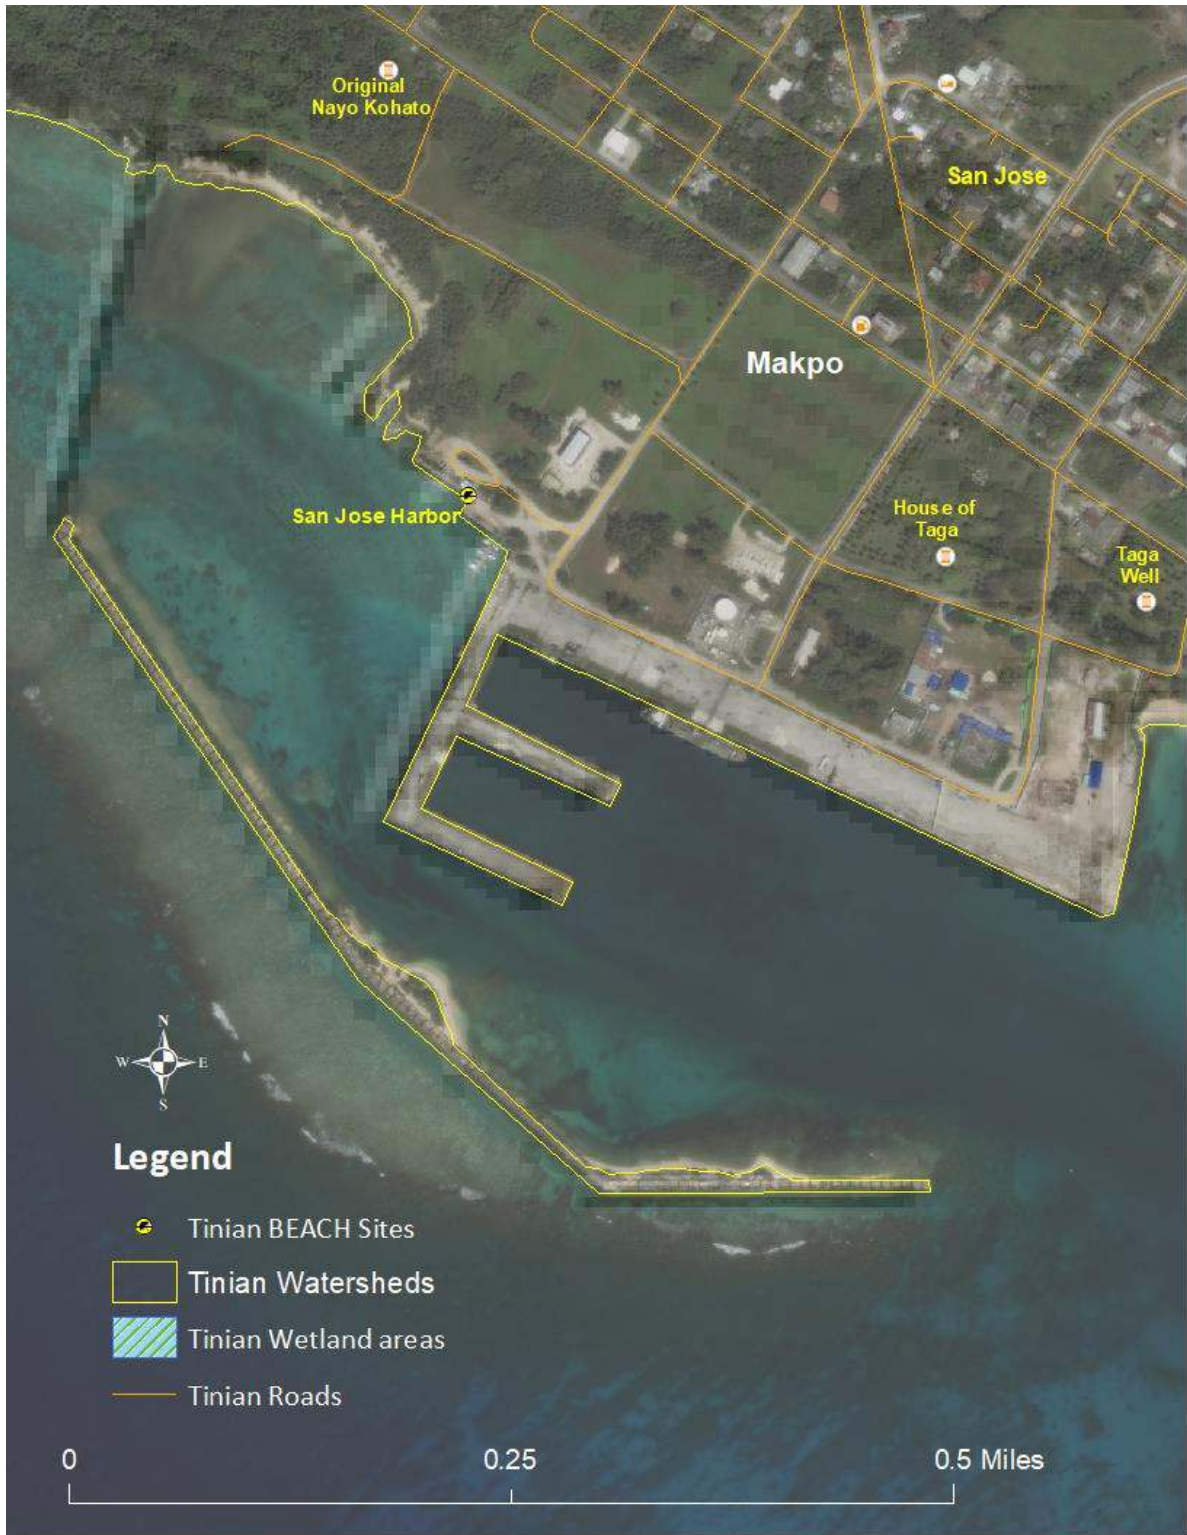
FIGURE C-48. San Jose Harbor (Segment 9H)

Makpo Harbor’s coastal waters retain a CALM Category 5 due to diminished DO% levels, and elevated Orthophosphate, which are unsupportive of the *Propagation of Aquatic Life* DU.

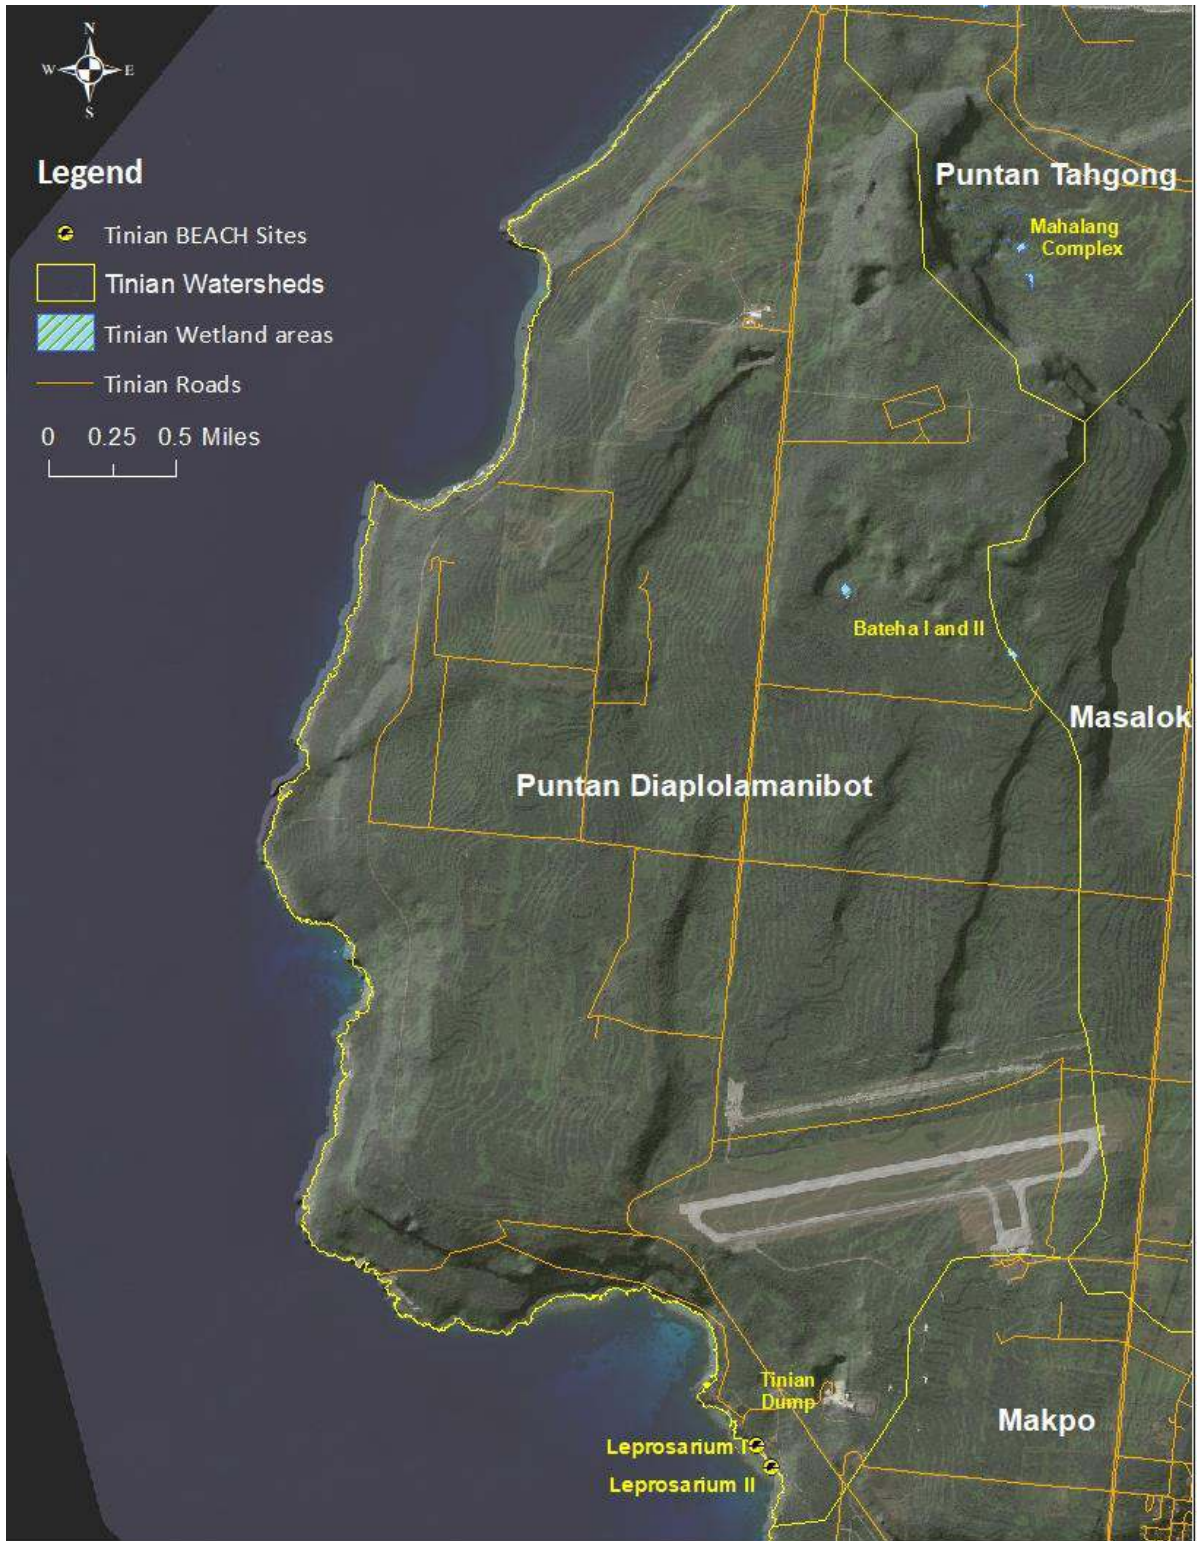
FIGURE C-49. Puntan/Diaplolamanibot (Segment 10)

This reporting cycle Puntan/Diapolamanibot coastal waters were tested for nutrients. Both Orthophosphate and NO₃-N exceeded the CNMI WQS. Therefore, these coastal waters were added to the 303(d) list as impaired for Nitrates, and they remain listed for phosphate. Since these coastal waters are located down slope from Tinian’s open dump, there is the potential for nutrient loading from leachate. Therefore, Puntan/Diapolamanibot coastal waters do not support the *Propagation of Aquatic Life* DU.
