2020
Commonwealth of the Northern Mariana Islands
305(b) and 303(d)
Water Quality Assessment Integrated Report

Bureau of Environmental and Coastal Quality
December 2020

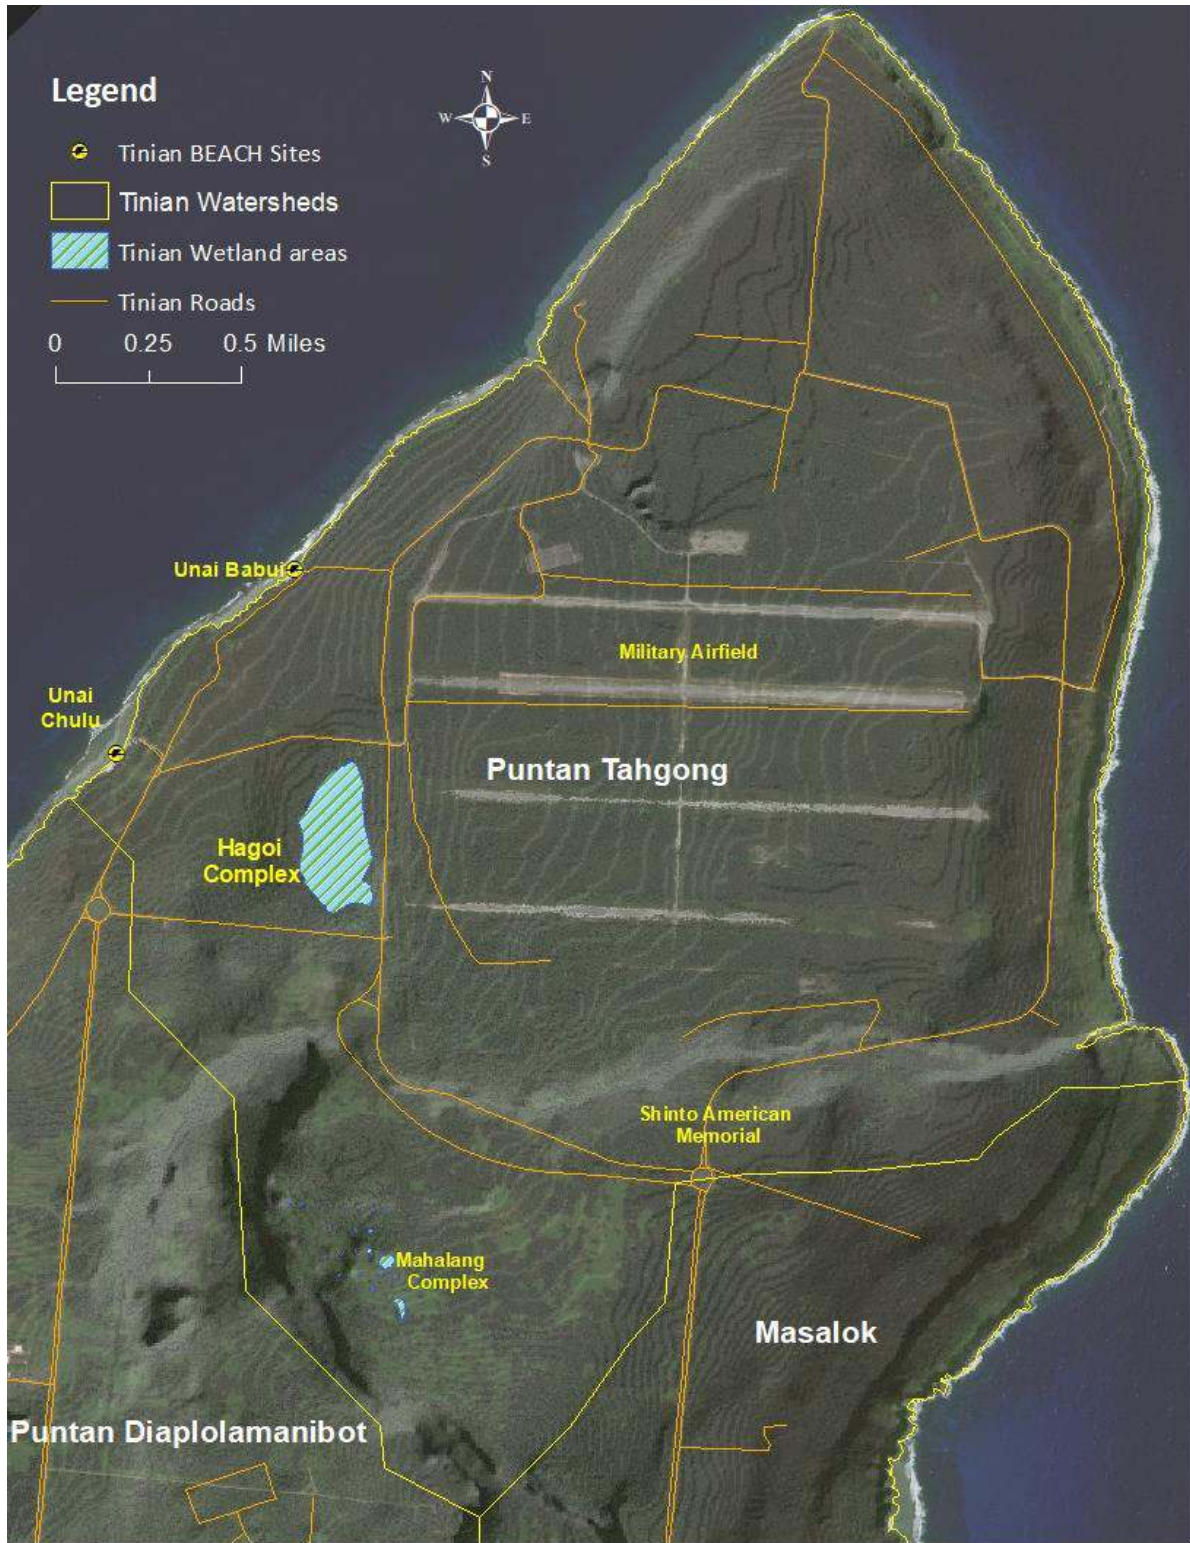
FIGURE C-50. Puntan/Tahgong (Segment 11)

The northern most watershed on Tinian is the Puntan/Tahgong watershed, which is contained in the US Military leased land area. It also contains two long-term BEACH monitoring sites, Unai Babui ("Pig Beach") and Unai Chulu beaches (see Figure C-50., on the following page). Both beaches have energetic shorelines that make them hazardous for swimmers. They are undeveloped, remote, and are not as frequented by tourists or residents as other Tinian beaches. This leaves them in a nearly pristine state with few anthropogenic stressors.

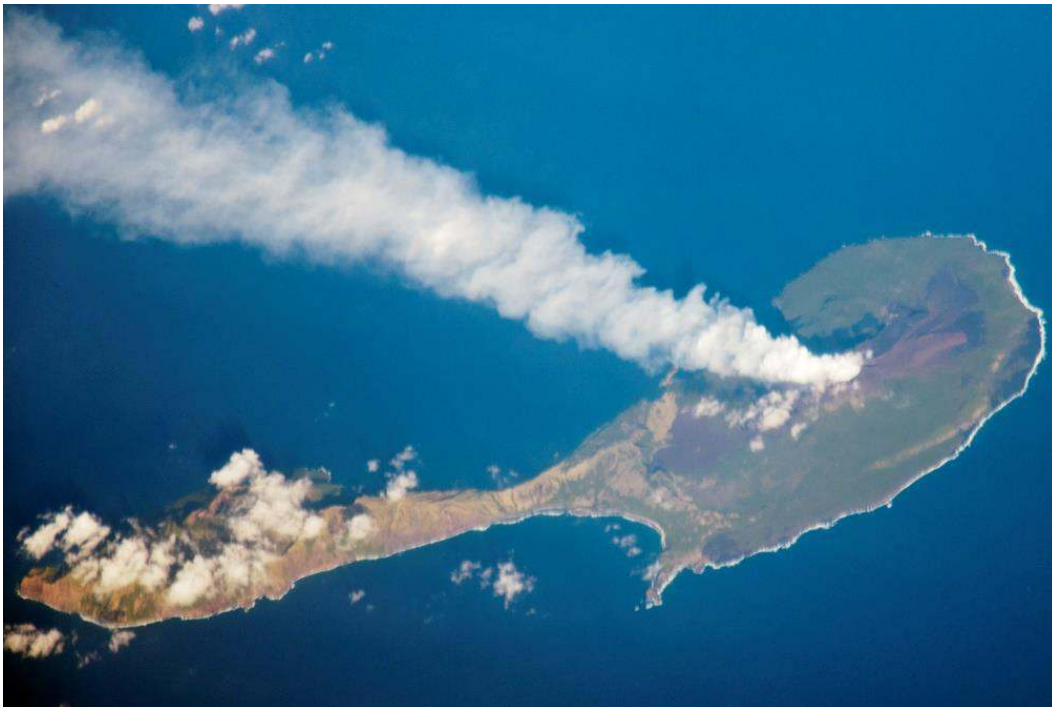
FIGURE C-58. 2012 Eruption as seen from the International Space Station

The northern volcano, Mt. Pagan erupted once again in 2006. This was followed by another eruption of both Mt. Pagan and the southern volcanoes in 2012 (Smithsonian GVP). Figure C-58., is a photo taken from the International Space station at that time, showing a large steam plume from Mt. Pagan.

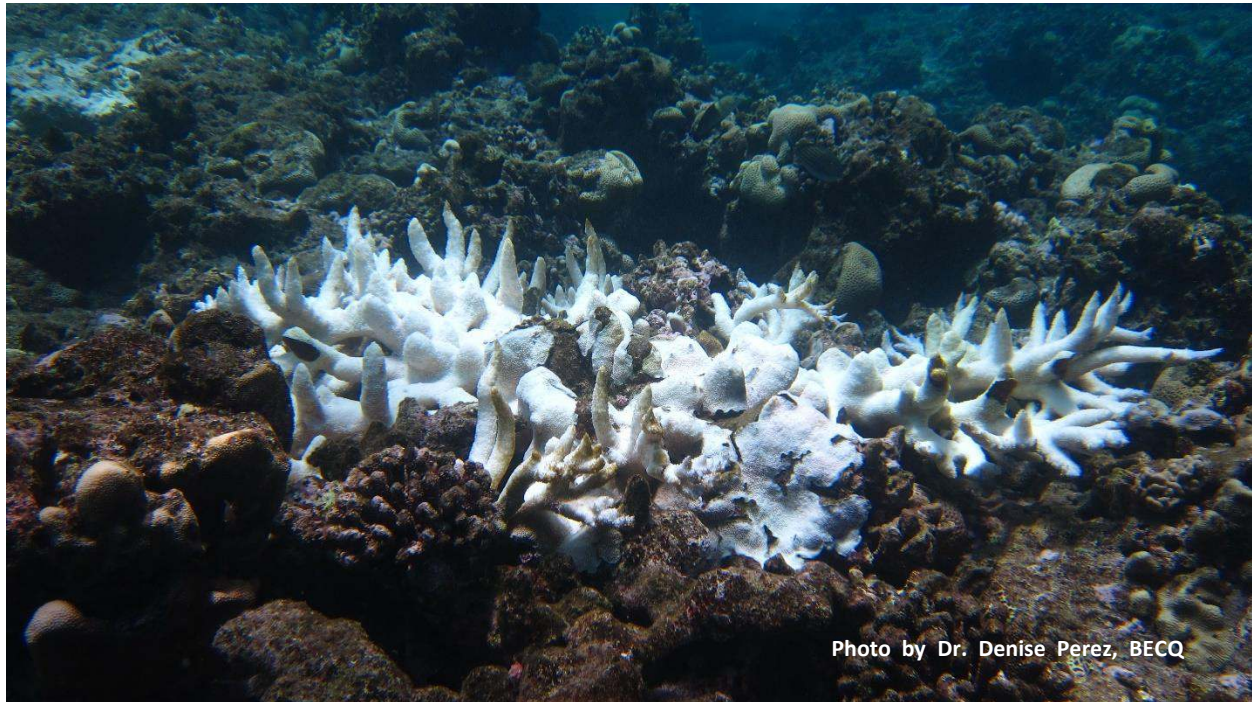
FIGURE C-60. 2014 Coral Bleaching on Pagan’s Reef

In 2014, the MMT noted that the reefs around Pagan, along with the rest of the Northern Islands experienced widespread bleaching due to increases in sea surface temperatures.

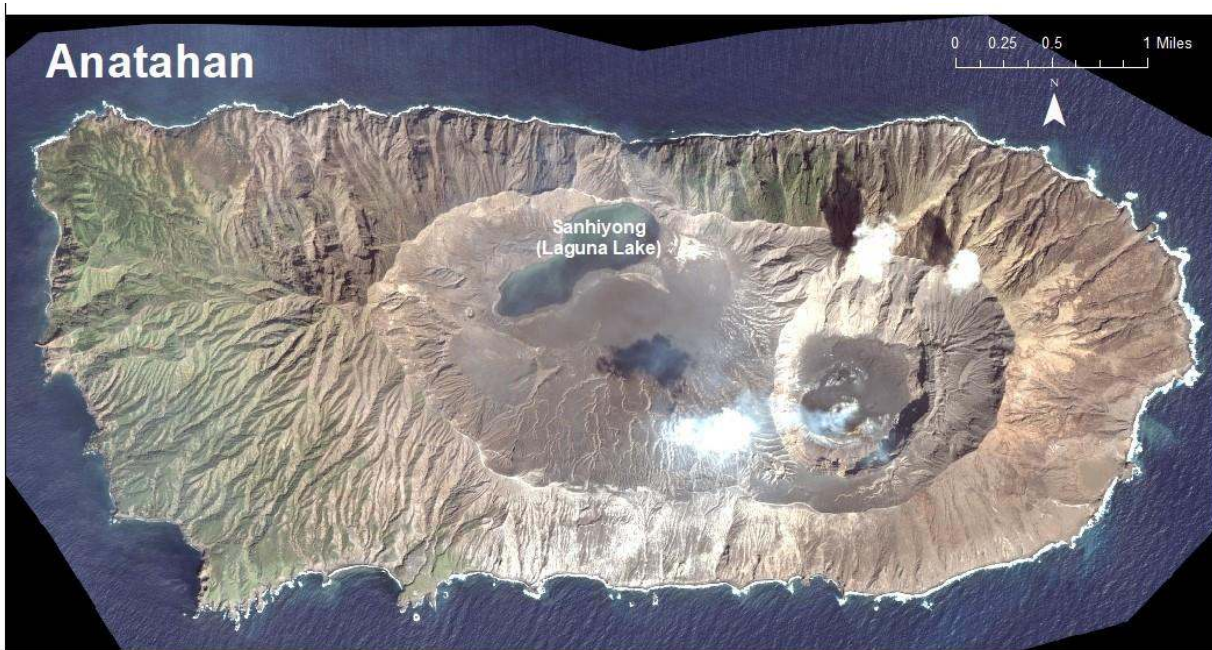
FIGURE C-68. Anatahan (Segment 25) in 2005.

Trusdell, stated that Anatahan has two peaks, the highest being approximately 2600 ft (787 m) above sea level (2009. Gillespie). Its central caldera contains a crater to the west, and a deeper crater to the east. Figure C-68., below shows an active vent emitting a white plume from the eastern crater.

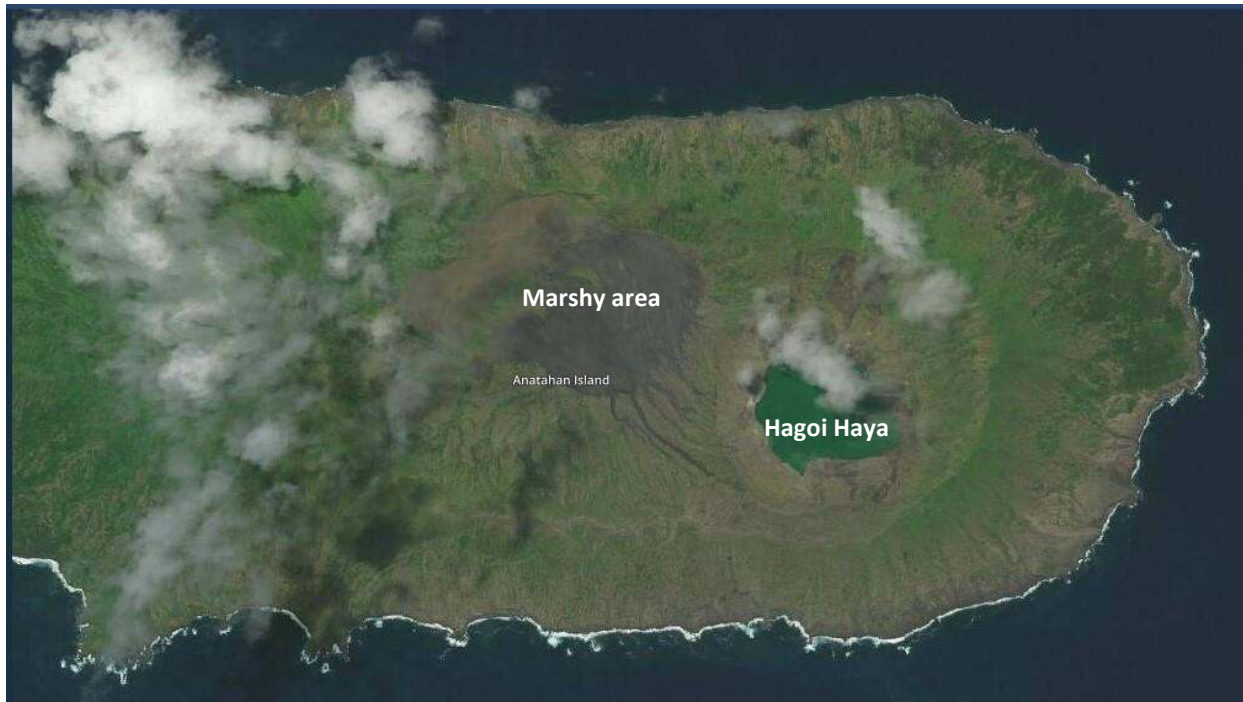
FIGURE C-70. Anatahan's Eastern Lake (Image by: 2019, Digital Globe)

A more recent 2019 image provided by Trusdell is shown in Figure C-70., on the following page. The Lake at the base of the western crater no longer exists. Trusdell explained, that this lake is transient in nature, “... because meteoric water collects, in the rainy season, over a fine ash layer that is semi impervious to water. The fine volcanic ash works as an aquatard ...” During the dry season, the meteoric water, “water derived from precipitation”, then evaporates. (2019. Personal email, Trusdell).”

Trusdell also explained that the deeper pit in the eastern side of the crater formed what is now Hagoi Haya, and that it, “... is a combination of seawater and meteoric water. With the largest component being seawater. The green color is due to volcanic gases being dissolved or mixing with the water.”, (2019. Personal email, Trusdell).
