## Restoration of LaoLao Watershed by Implementing Best Management Practices and Conservation Action Plans

### I. Waterbody Overview

The LaoLao watershed (Water Body Segment ID 15) is located on the island of Saipan within the Commonwealth of the Northern Mariana Islands (CNMI) archipelago. LaoLao was first included in the Clean Water Act (CWA) section 303(d) list of impaired waters for failing to support the Recreational and Aquatic Life use designations (UD) in 2004. However, sedimentation was noted as a potential problem to LaoLao Bay in the first CNMI 305(b) and 303(d) Water Quality Assessment Integrated Report (IR), in 1998.

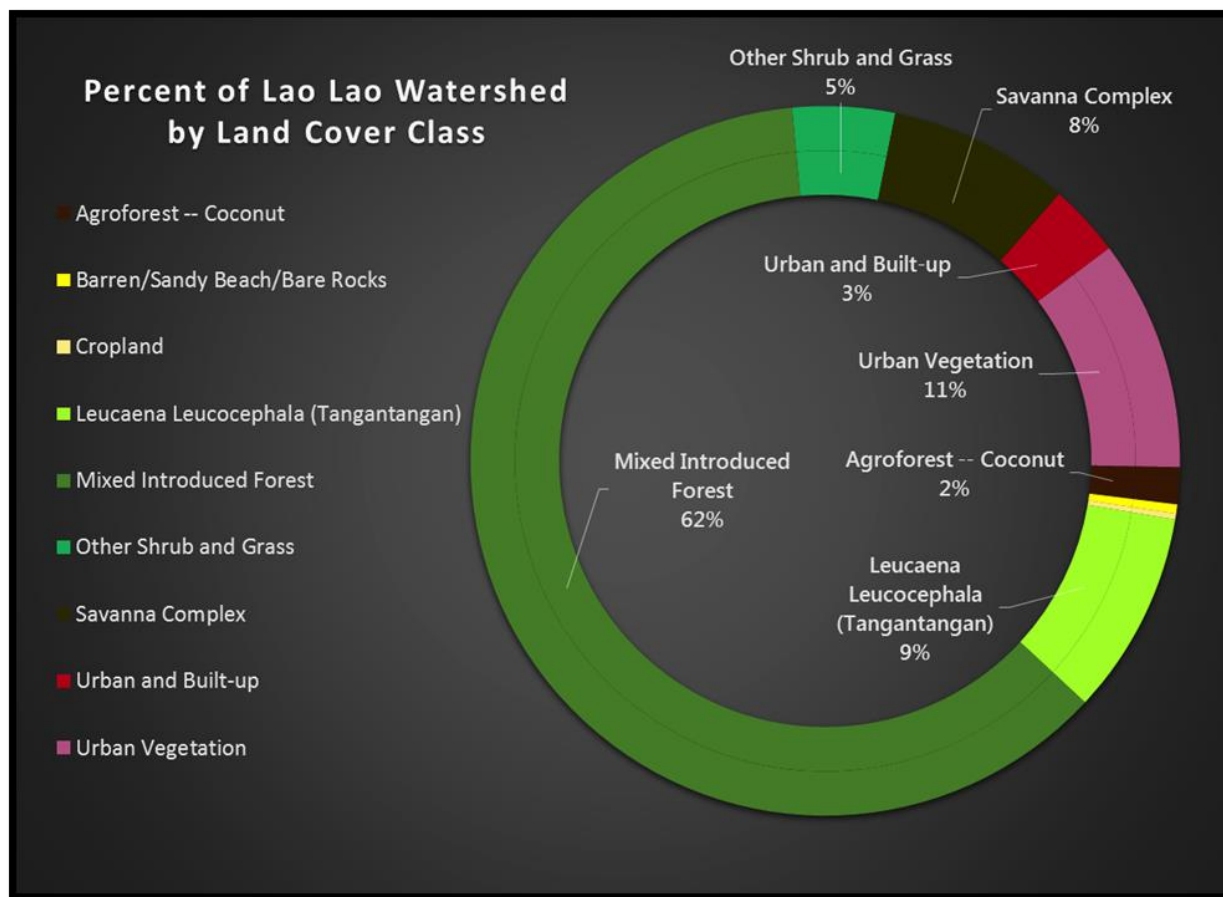
FIGURE 3 shows the percentage of each type of land use by class.

**FIGURE 3: LaoLao Percent of Land Usage by Class**

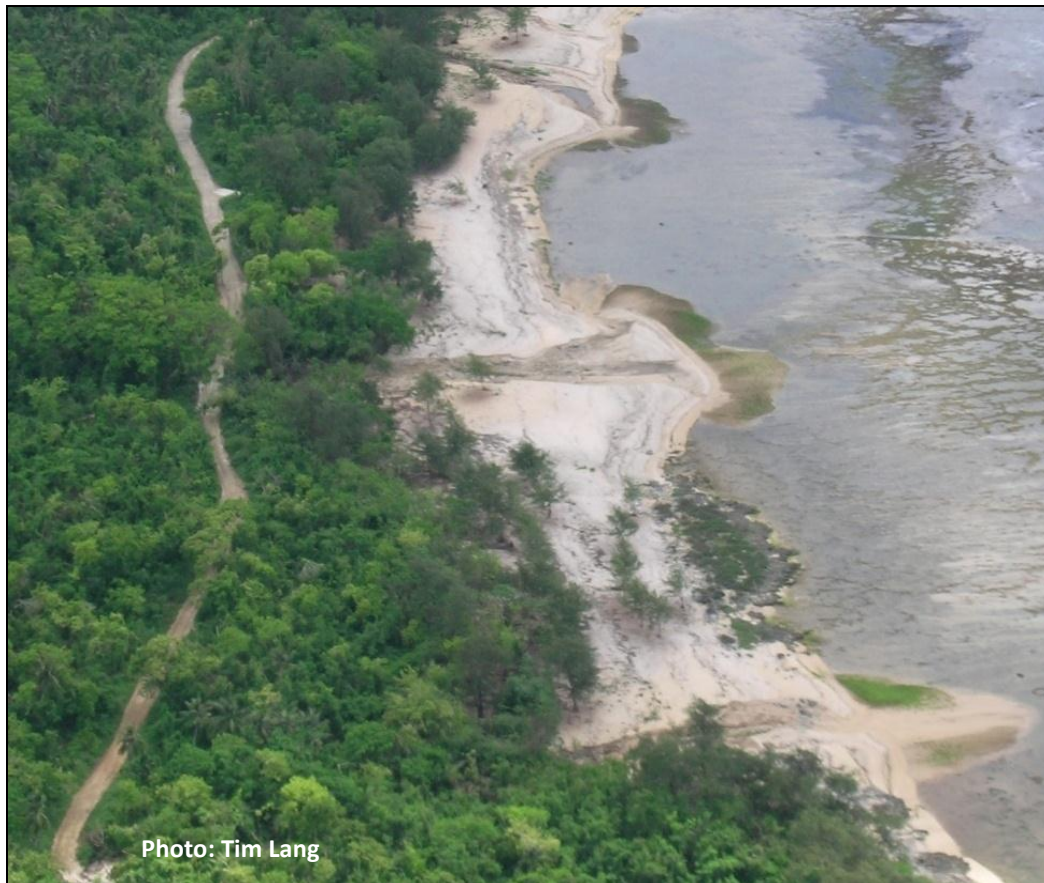
**FIGURE 4: Sedimentation at LaoLao Bay Stream Outfalls (2004)**

Sedimentation in LaoLao Bay has long been noted by residents. In the mid 1990's, fires in the upper badlands led to significant erosion and consequently, sedimentation in LaoLao Bay (FIGURE 4). Some fires were set intentionally by hunters wishing to attract deer to fresh growing shoots, while others were the result of dry conditions leading to brush fires. Several concerns about the Bay's diminished water visibility and coral conditions were reported by SCUBA divers and fishermen to CNMI natural resource agencies at that time.

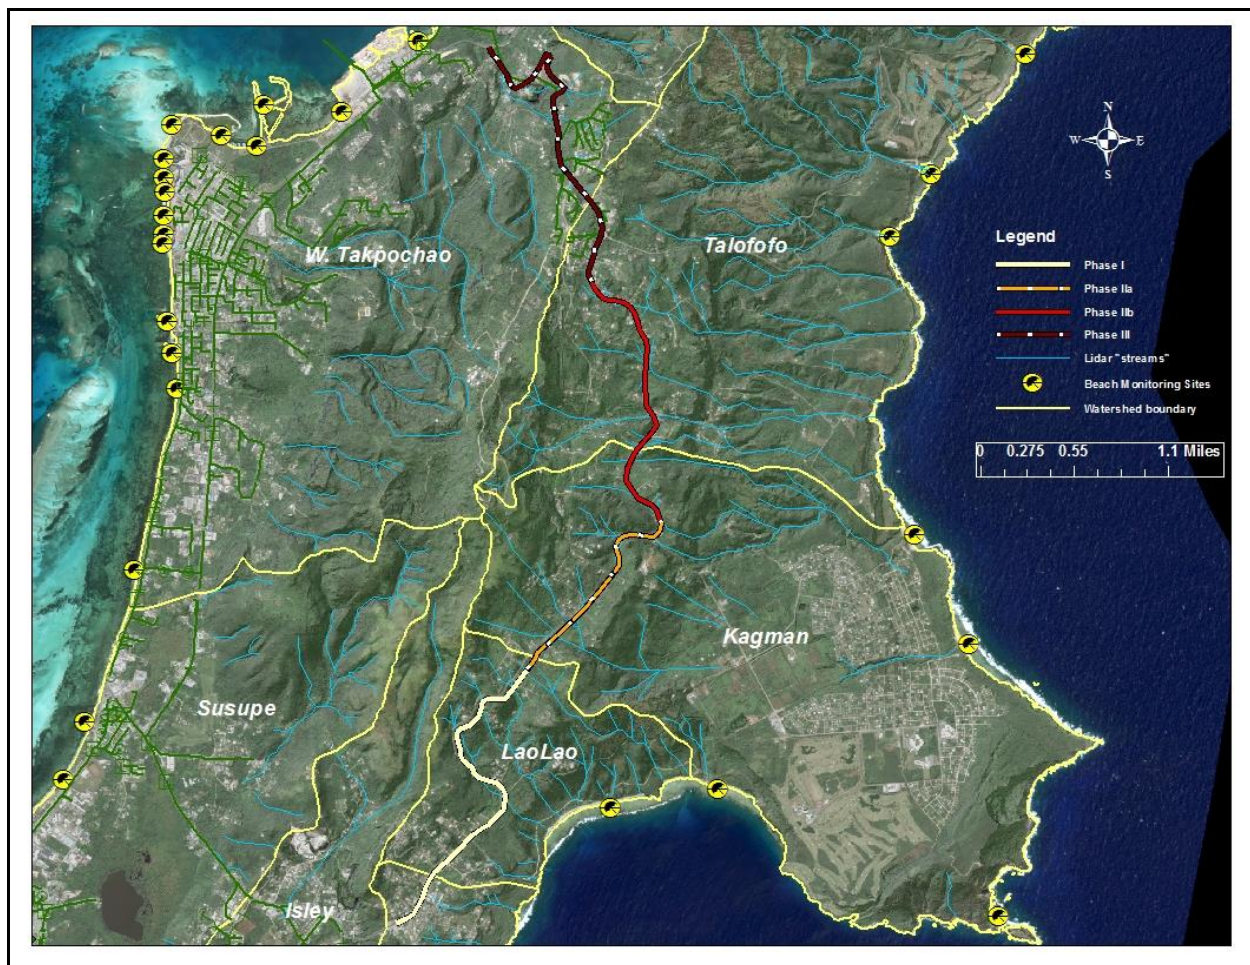
**FIGURE 5: Phases of DPW Cross Island Roadway Reconstruction Project**

Another large plan to address stormwater impacts, is DPW's multi-million dollar *Cross Island Roadway Reconstruction Project* that began in 2009. Cross Island Road traverses four of Saipan's impaired watersheds, LaoLao, Kagman, Talofofo and West Takpochao (see Figure 5). The Project was supported by Federal Highway Administration funding. Phase I began in October of that year and crossed almost the entire LaoLao watershed, costing \$6.1 million at its completion in September 2012 (01/17/17, personal communication, Henry Bautista, DPW engineer). Phase IIa began concurrently in August 2010, and was completed in August 2014 at \$3.7 Million.

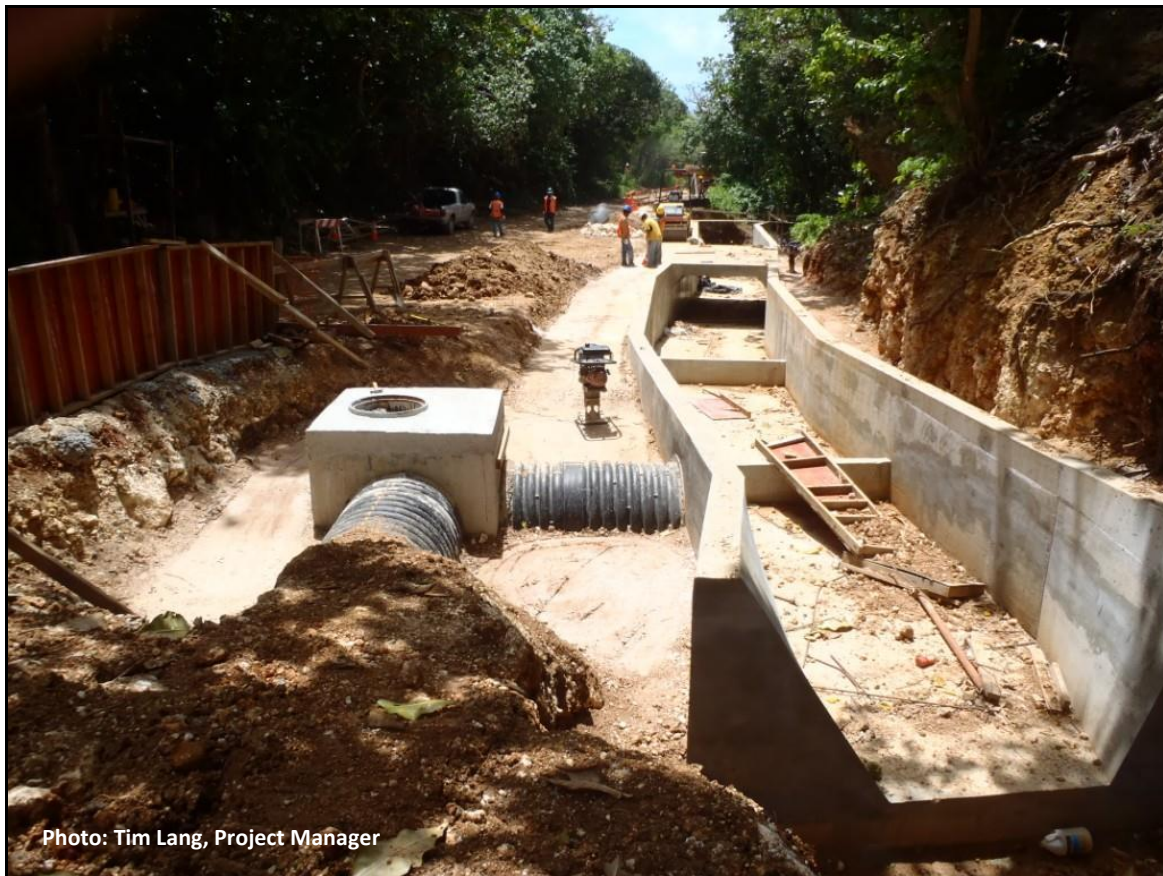
**FIGURE 6: LaoLao Bay Rd. Catchment Basin System with Terminal Sediment Chamber**

Remediation and restoration activities within the LaoLao CAP were financed with \$2,604,164 of American Restoration and Recovery Act (ARRA), and \$65,926 of EPA grant funding (LaoLao Bay Road & Coastal Management Improvement Plan ARRA/NOAA Grant No. NA09NMF4630291 Project Summary, Dec 2012). Implementation included paving the upper half of LaoLao Bay Drive, which is a secondary road leading down to the Bay, and constructing various BMPs, e.g., culverts, concrete stream crossings, and sediment chambers (FIGURE 6). Construction of which was completed in September 2012.

Staff from BECQ, DPW, and Saipan Mayor's Office, and volunteers from MINA maintain the culverts and sediment basins by removing collected litter and sediment at least annually. BECQ records show that the amount of sediment removed in the 2015 and 2016 clean up efforts, compared to previous years had diminished from 7 cubic yards in 2013 to 3 cubic yards,

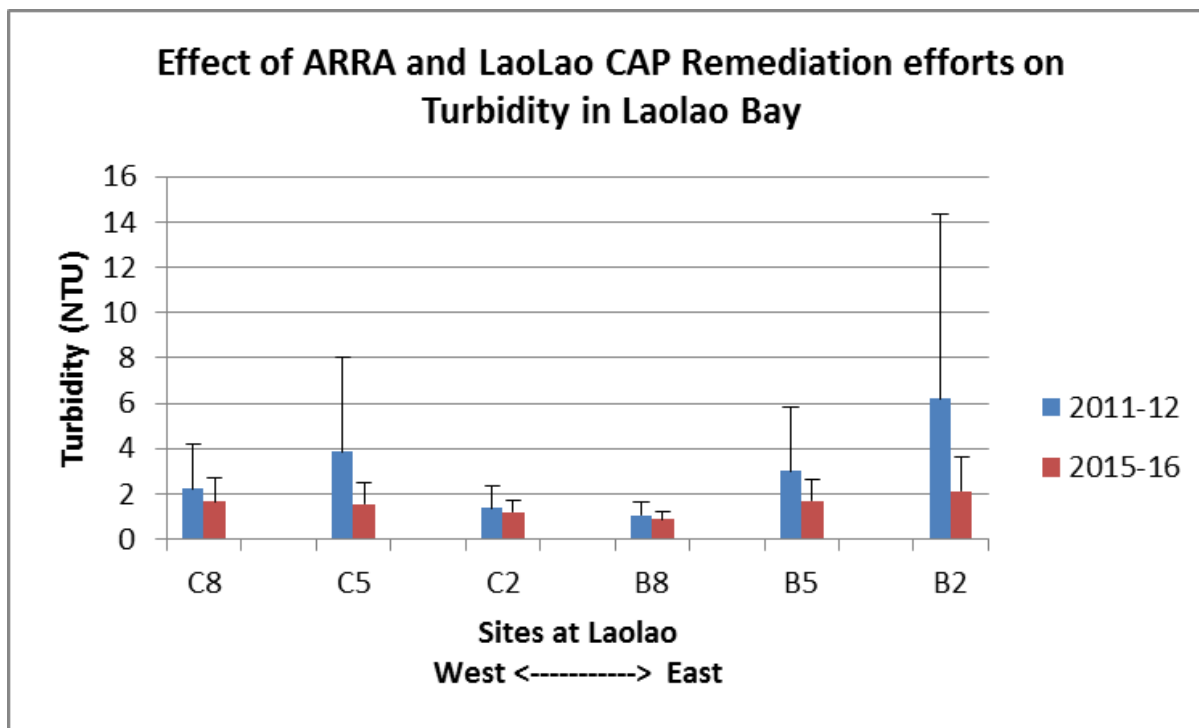
This is demonstrated in FIGURE 7. A comparison between turbidity levels at the LaoLao reef flats sites after road improvements (Fiscal years 2015-2016) compared to baseline water quality data collected in Fiscal Year 2011-2012 show significant decreases.

**FIGURE 7: Decrease in Turbidity of Water at LaoLao Reef Flat Sites**

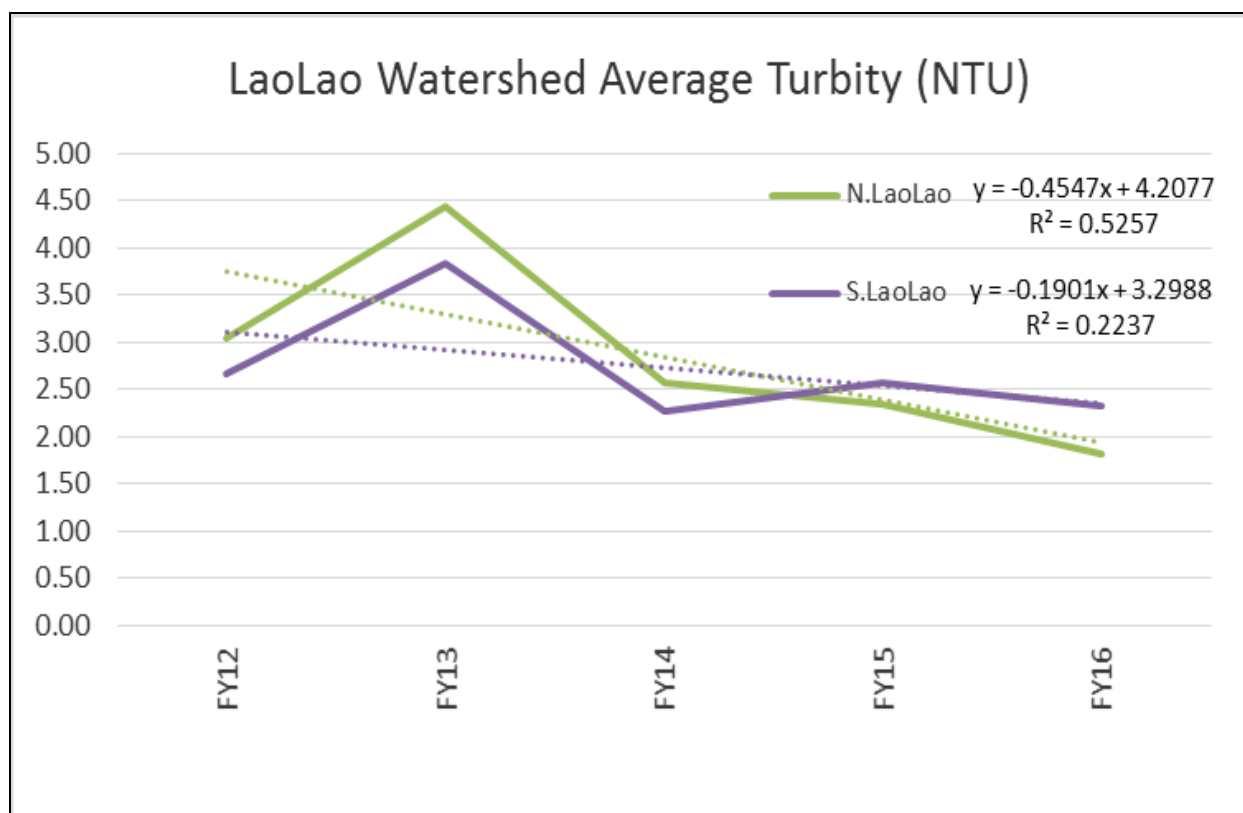
This is supported by data from the two BEACH sites. FIGURE 8 on the following page shows a decreasing trend in turbidity levels at North LaoLao ( $R^2 = 0.53$ ) and at South LaoLao ( $R^2 = 0.22$ ) BEACH sites respectively.

**FIGURE 8: Decrease in Turbidity of Water at LaoLao BEACH Monitoring Sites**

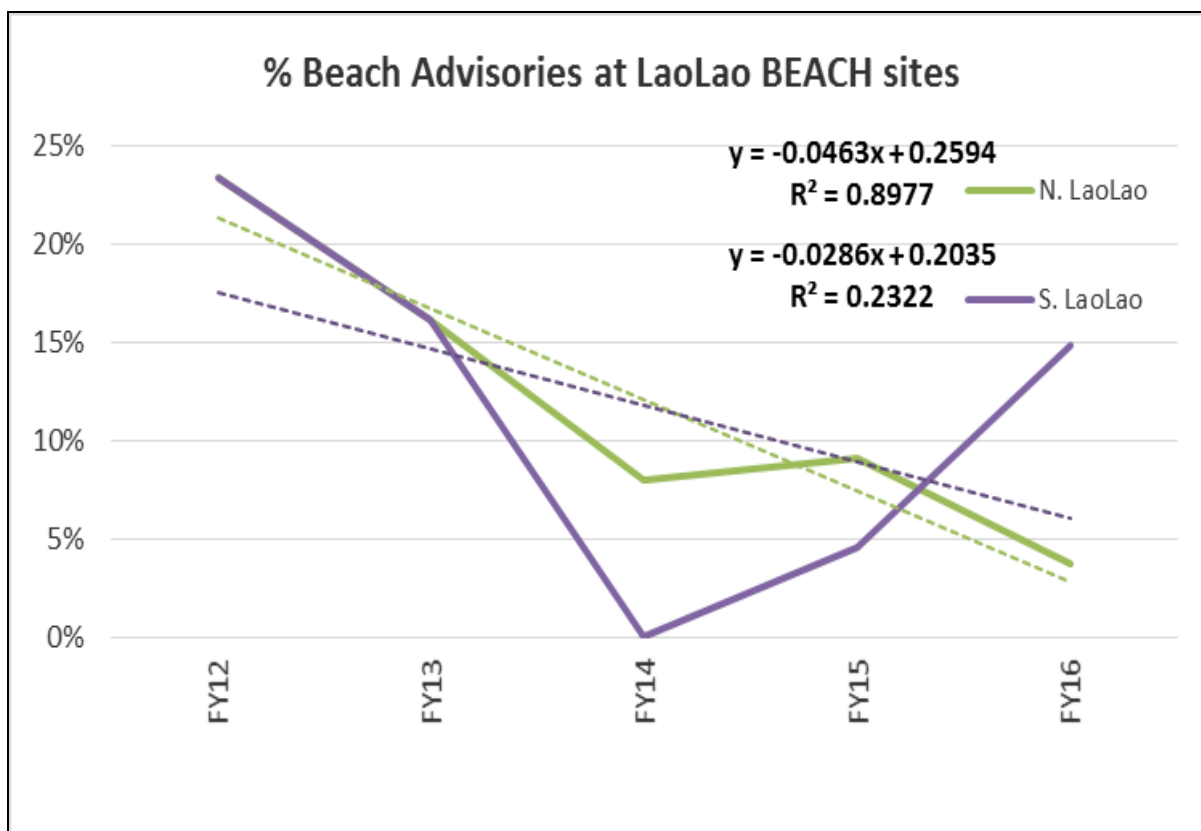
The decrease in sedimentation led to a decrease in *Enterococci* violations as well. A linear regression of the percent of Beach Advisories (WQS violations) over a five year period from fiscal year 2012 to 2016 shows a significant decrease at LaoLao BEACH monitoring sites (North LaoLao  $R^2 = 0.90$  and South LaoLao  $R^2 = 0.23$ ) as demonstrated (FIGURE 10).

**FIGURE 10: Significant Decrease in LaoLao Watershed's Beach Advisories**

Of note, there was a sudden increase in *Enterococci* violations as the Rainy season began in fiscal year 2016. Super Typhoon Soudelor swept directly over Saipan on August 3 through 5, 2015, causing extensive flooding, landslides, and the destruction of a PACIOOS tower located off shore of the North LaoLao BEACH site. These violations, are therefore considered anomalies associated with sedimentation carrying naturally occurring *Enterococci*, as opposed to fecal contamination, given that there are no sewer lines in the immediate area.
