# 2017 CNMI Recreational Mooring Buoy Program Enhancement and Maintenance Report

RFP17-BECQ/DCRM-080

***Pacific Coastal Research &  
Planning***

***Dive Rota***

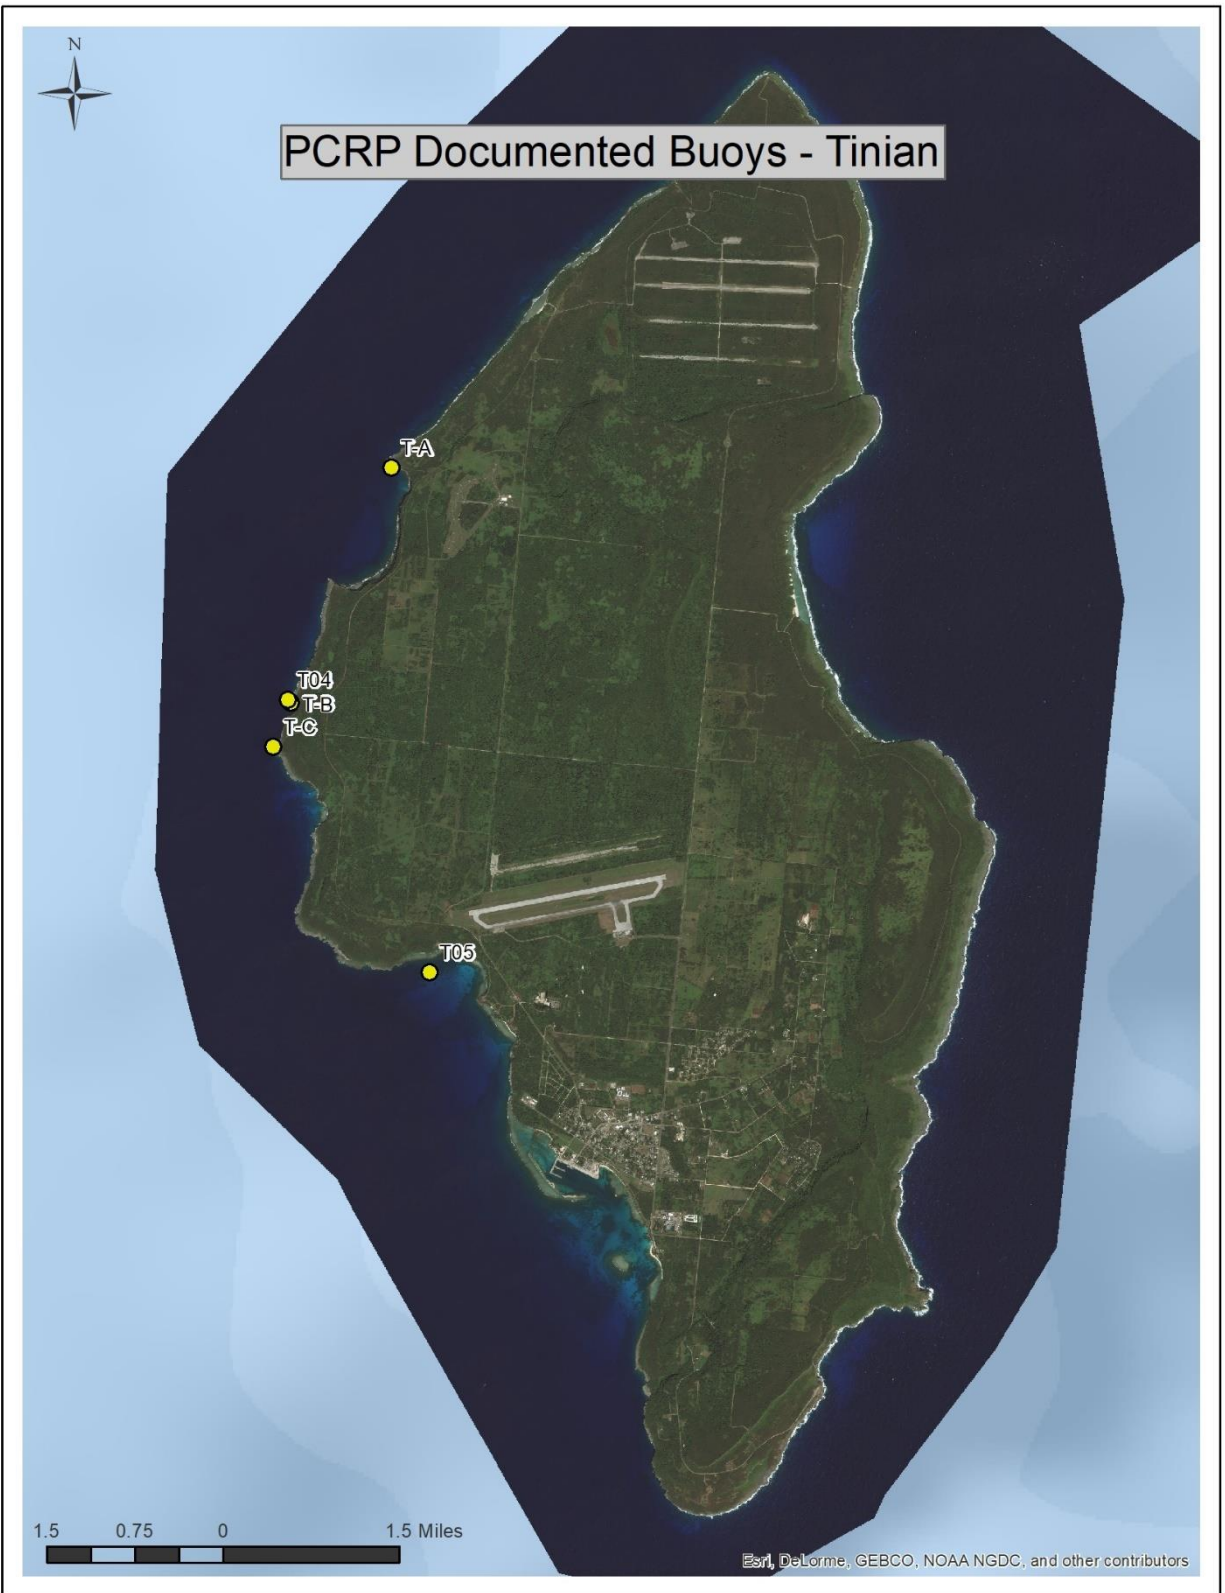
Map 2: PCRCP surveyed buoys on Tinian.

\* - This buoy was not found during surveys; therefore no GPS coordinate was taken.

Map 1: PCRCP surveyed buoys on Saipan. ....	3
Map 2: PCRCP surveyed buoys on Tinian.....	19
Map 3: PCRCP surveyed buoys on Rota.....	25
